# **Remedial Action Summary Report Free Product Recovery**

SWMU 62 New Housing Fuel Leak Area,  
Area 303, and Additional Sites

## **Former Naval Complex**

Adak, Alaska

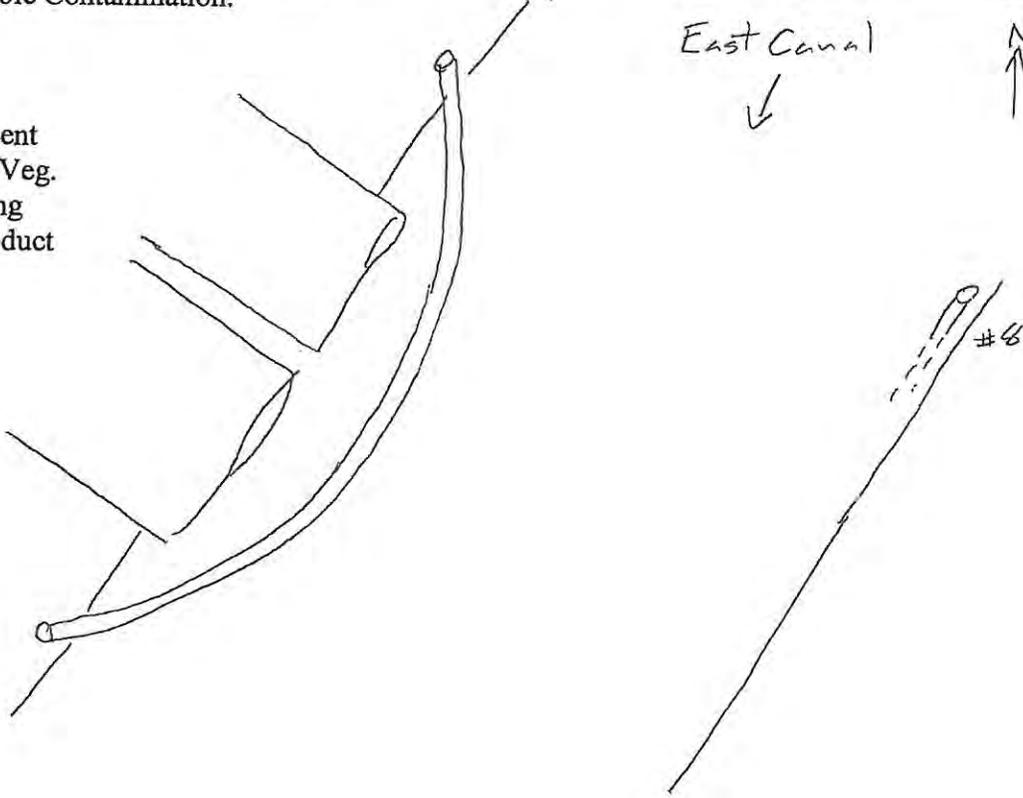
<b>Boom Location: 2</b>	Time/Date: 1418 / 10.16.12
Description of Boom Before Maintenance: UNSATISFACTORY - BOOM OUT OF POSITION DUE TO HIGH WATER LEVELS	Photograph (s) Time/Date Stamp:  1418 / 10.16.12
Boom Repaired (Y/N): Description: MOVED BOOM BACK INTO POSITION ONTO POSTS	Boom Replaced (Y/N) / Number of Sections: Description:
<b>Visual Observations</b> Visible Contamination (Y/N): Iron Staining (Y/N): Oily Sediment/Soil (Y/N): Distressed Vegetation (Y/N):	
Sheen Present on Water (Y/N): Is the Boom Containing the Sheen? (Y/N) Pooled Product (Y/N): If yes, was product removed with sorbent pads?	
Location of Visible Contamination:  <div style="display: flex; justify-content: space-between;"> <div style="width: 30%;"> <p><u>Legend</u></p> <p>//// Sheen</p> <p>\\ \\ Oily Sediment</p> <p>xxx Distressed Veg.</p> <p>RRR Iron Staining</p> <p>● Pooled Product</p> </div> <div style="width: 65%; text-align: center;">

- Expand Booms 2 and 11 by two boom lengths each. Additional boom sections are necessary at Boom 2 to help prevent it from being displaced during high water events in East Canal. The seep at Boom 11 has expanded about 4 feet south of the existing extent of the boom along the shoreline and the surface water sheen is very pronounced. Boom 11 should be expanded to cover the entire length of the seep. Since no seep has been observed at the Booms 9/12, the four boom sections composing the small leg that is right in front of the culverts should be removed. These would provide four boom sections to expand Booms 2 and 11, but not change the total number of boom sections deployed.

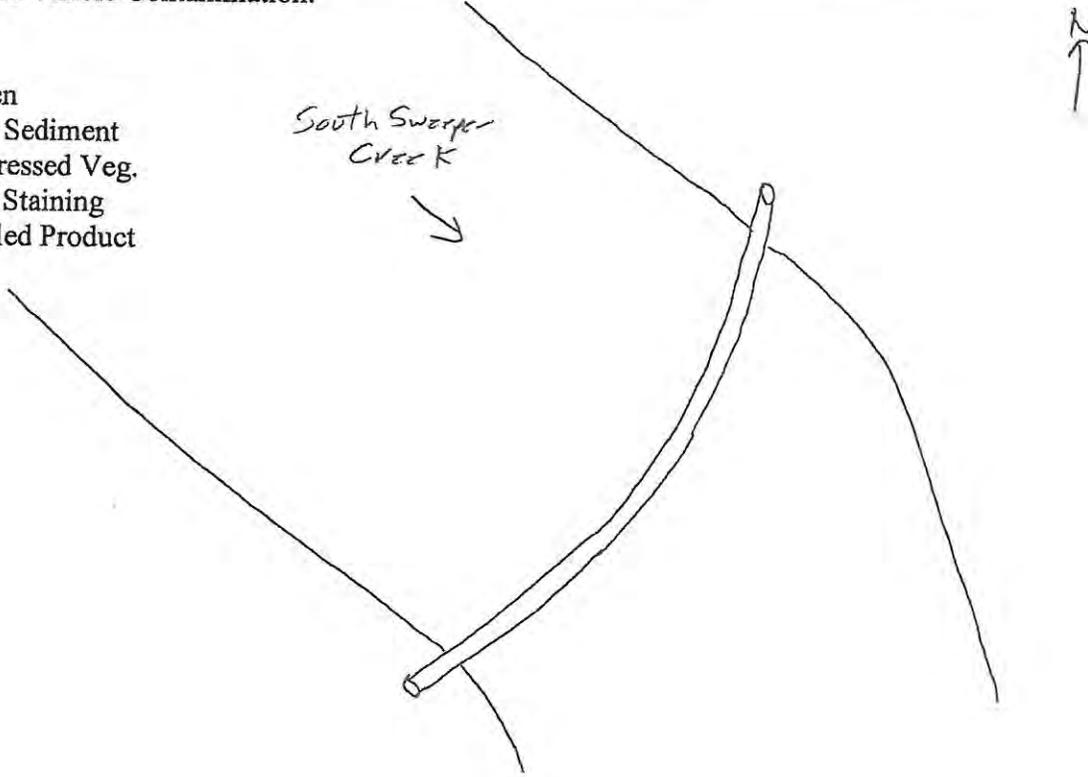
<b>Boom Location: 6</b>	Time/Date: 1508 / 10-16-12		
Description of Boom Before Maintenance: UNSATISFACTORY - (2) BAD SECTIONS	Photograph (s) Time/Date Stamp: 1508 / 10-16-12		
Boom Repaired (Y/N): Description: REPLACED (2) BOOM SECTIONS ON SOUTH END OF BOOM RUN	Boom Replaced (Y/N) / Number of Sections: 2 Description: REPLACED (2) WATER LOGGED SECTIONS		
<p><b>Visual Observations</b></p> <table style="width: 100%; border: none;"> <tr> <td style="width: 50%; border: none; vertical-align: top;">                 Visible Contamination (Y/N):                  Iron Staining (Y/N):                  Oily Sediment/Soil (Y/N):                  Distressed Vegetation (Y/N):             </td> <td style="width: 50%; border: none; vertical-align: top;">                 Sheen Present on Water (Y/N):                  Is the Boom Containing the Sheen? (Y/N)                  Pooled Product (Y/N):                  If yes, was product removed with sorbent pads?             </td> </tr> </table>		Visible Contamination (Y/N): Iron Staining (Y/N): Oily Sediment/Soil (Y/N): Distressed Vegetation (Y/N):	Sheen Present on Water (Y/N): Is the Boom Containing the Sheen? (Y/N) Pooled Product (Y/N): If yes, was product removed with sorbent pads?
Visible Contamination (Y/N): Iron Staining (Y/N): Oily Sediment/Soil (Y/N): Distressed Vegetation (Y/N):	Sheen Present on Water (Y/N): Is the Boom Containing the Sheen? (Y/N) Pooled Product (Y/N): If yes, was product removed with sorbent pads?		
Location of Visible Contamination: <div style="margin-top: 20px;"> <p><u>Legend</u></p> <ul style="list-style-type: none"> <li>//// Sheen</li> <li>\\ \\ Oily Sediment</li> <li>xxx Distressed Veg.</li> <li>RRR Iron Staining</li> <li>● Pooled Product</li> </ul> <div style="text-align: center; margin-top: 20px;">

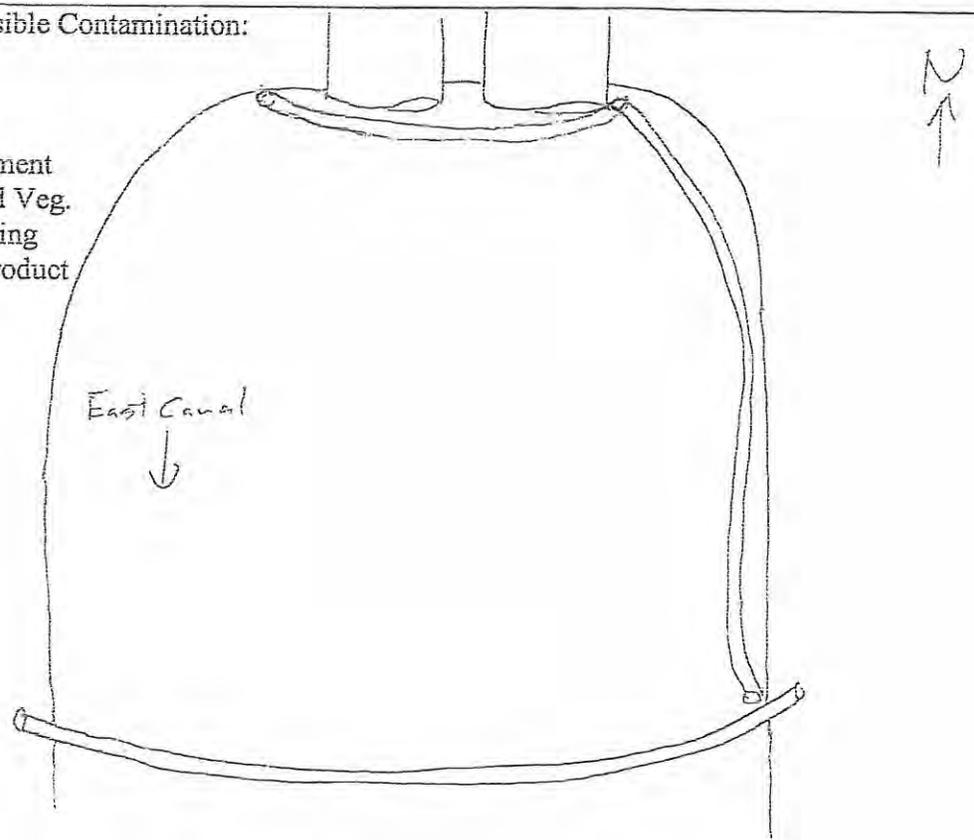
<b>Boom Location:</b> 9/12	<b>Time/Date:</b> 1515/12.4.12
<b>Description of Boom Before Maintenance:</b> UNSATISFACTORY	<b>Photograph (s) Time/Date Stamp:</b> 1103/12.5.12
<b>Boom Repaired (Y/N):</b> Description: MOVED BOOM BACK INTO POSITION ONTO POSTS	<b>Boom Replaced (Y/N) / Number of Sections:</b> Description:
<b>Visual Observations</b> Visible Contamination (Y/N): Iron Staining (Y/N): Oily Sediment/Soil (Y/N): Distressed Vegetation (Y/N):	
Sheen Present on Water (Y/N): Is the Boom Containing the Sheen? (Y/N) Pooled Product (Y/N): If yes, was product removed with sorbent pads?	
<b>Location of Visible Contamination:</b>	
<b>Legend</b> /// Sheen \\\ Oily Sediment xxx Distressed Veg. RRR Iron Staining ● Pooled Product

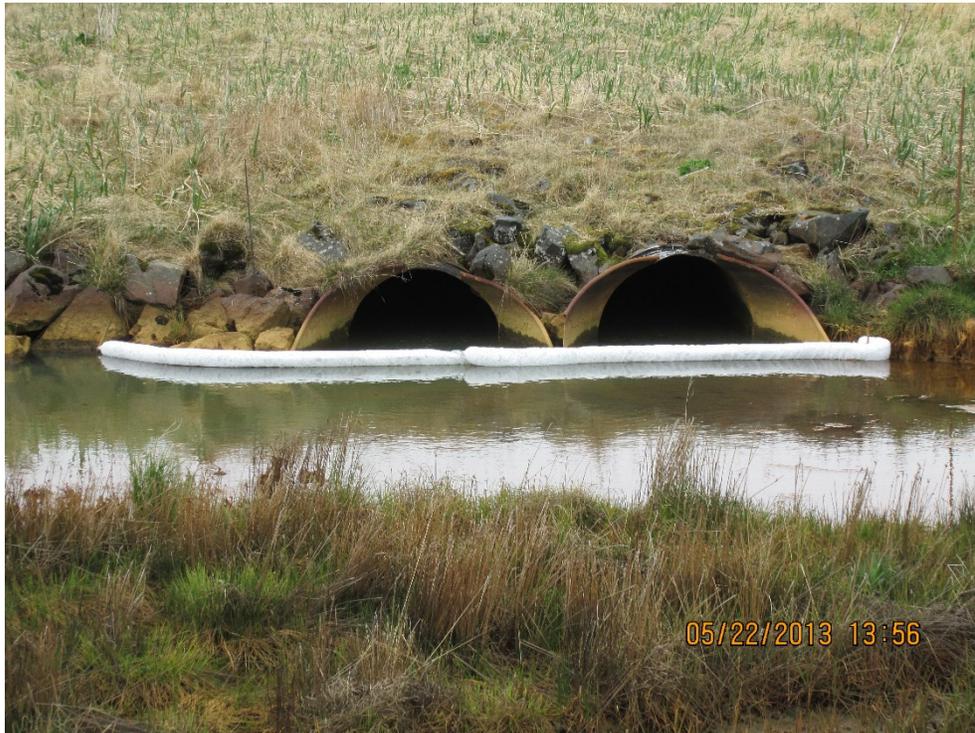
Photo 1 – East Canal Boom 2, May 2013, view west; new boom sections

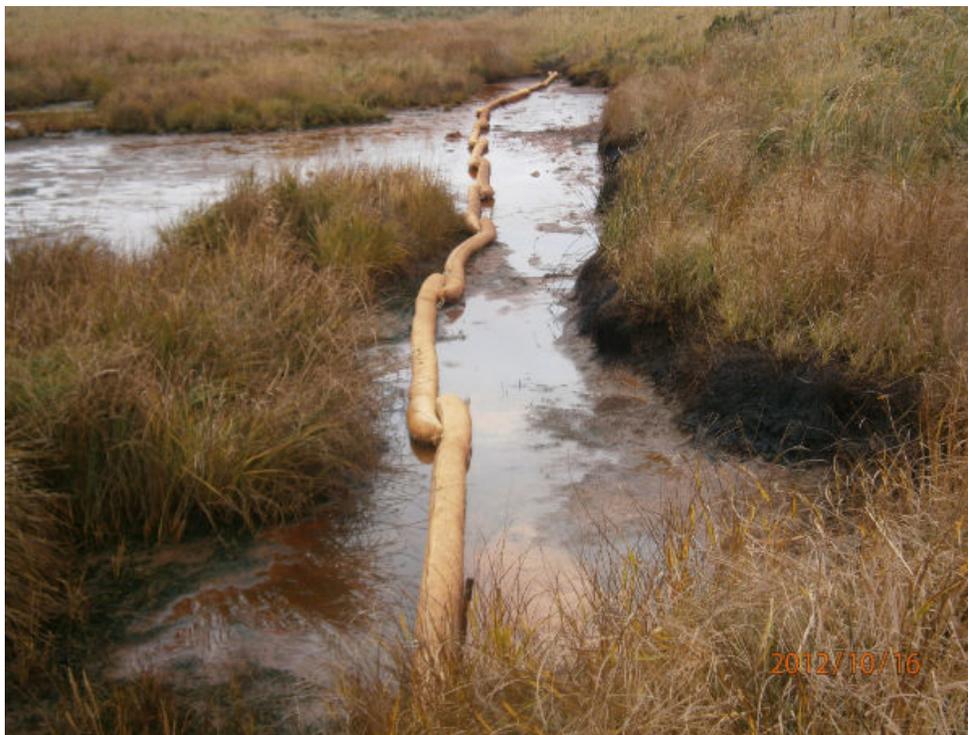
Photo 6 – East Canal Boom 8, October 2012, view north; boom with iron staining visible

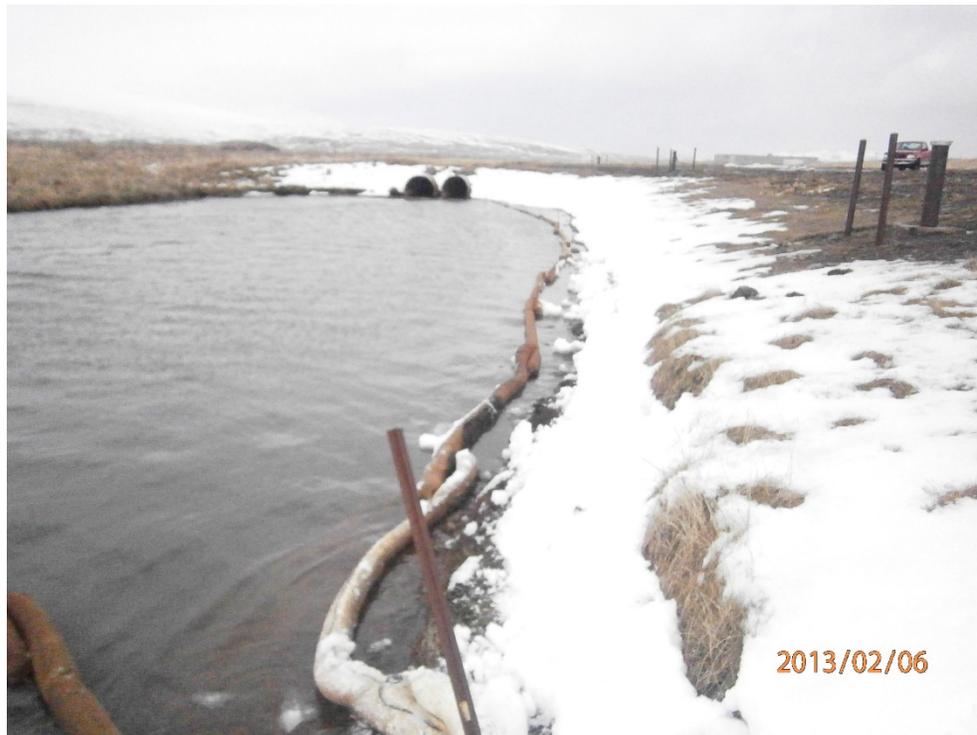
Photo 7 – East Canal Boom 9/12, February 2013, view north; snow along bank

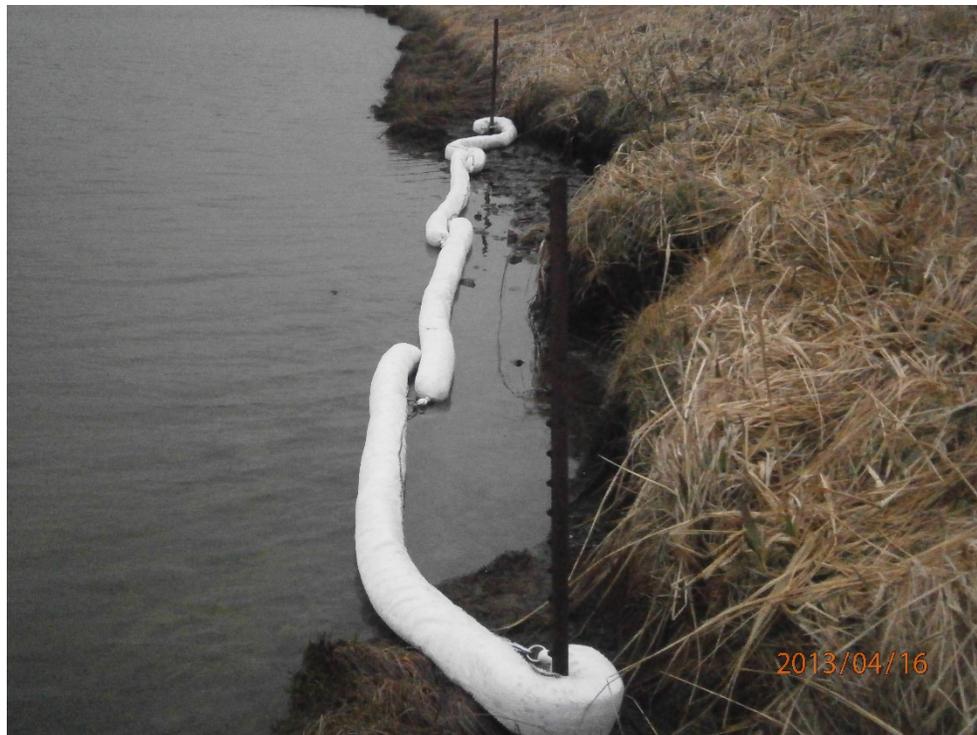
Photo 10 – East Canal Boom 11, April 2013, view north; following replacement
