***FINAL***  
**Long Term Management Plan for  
Non-Time-Critical Removal Action for PCB  
Contamination at  
Installation Restoration Site 29 (Hangar 1) at  
Former Naval Air Station Moffett Field, California**

**AMEC Environment & Infrastructure, Inc.  
9210 Sky Park Court, Suite 200  
San Diego, California 92123  
(858) 300-4300  
Document Control No. AMEC-8816-0005-0132**

**June 2013**

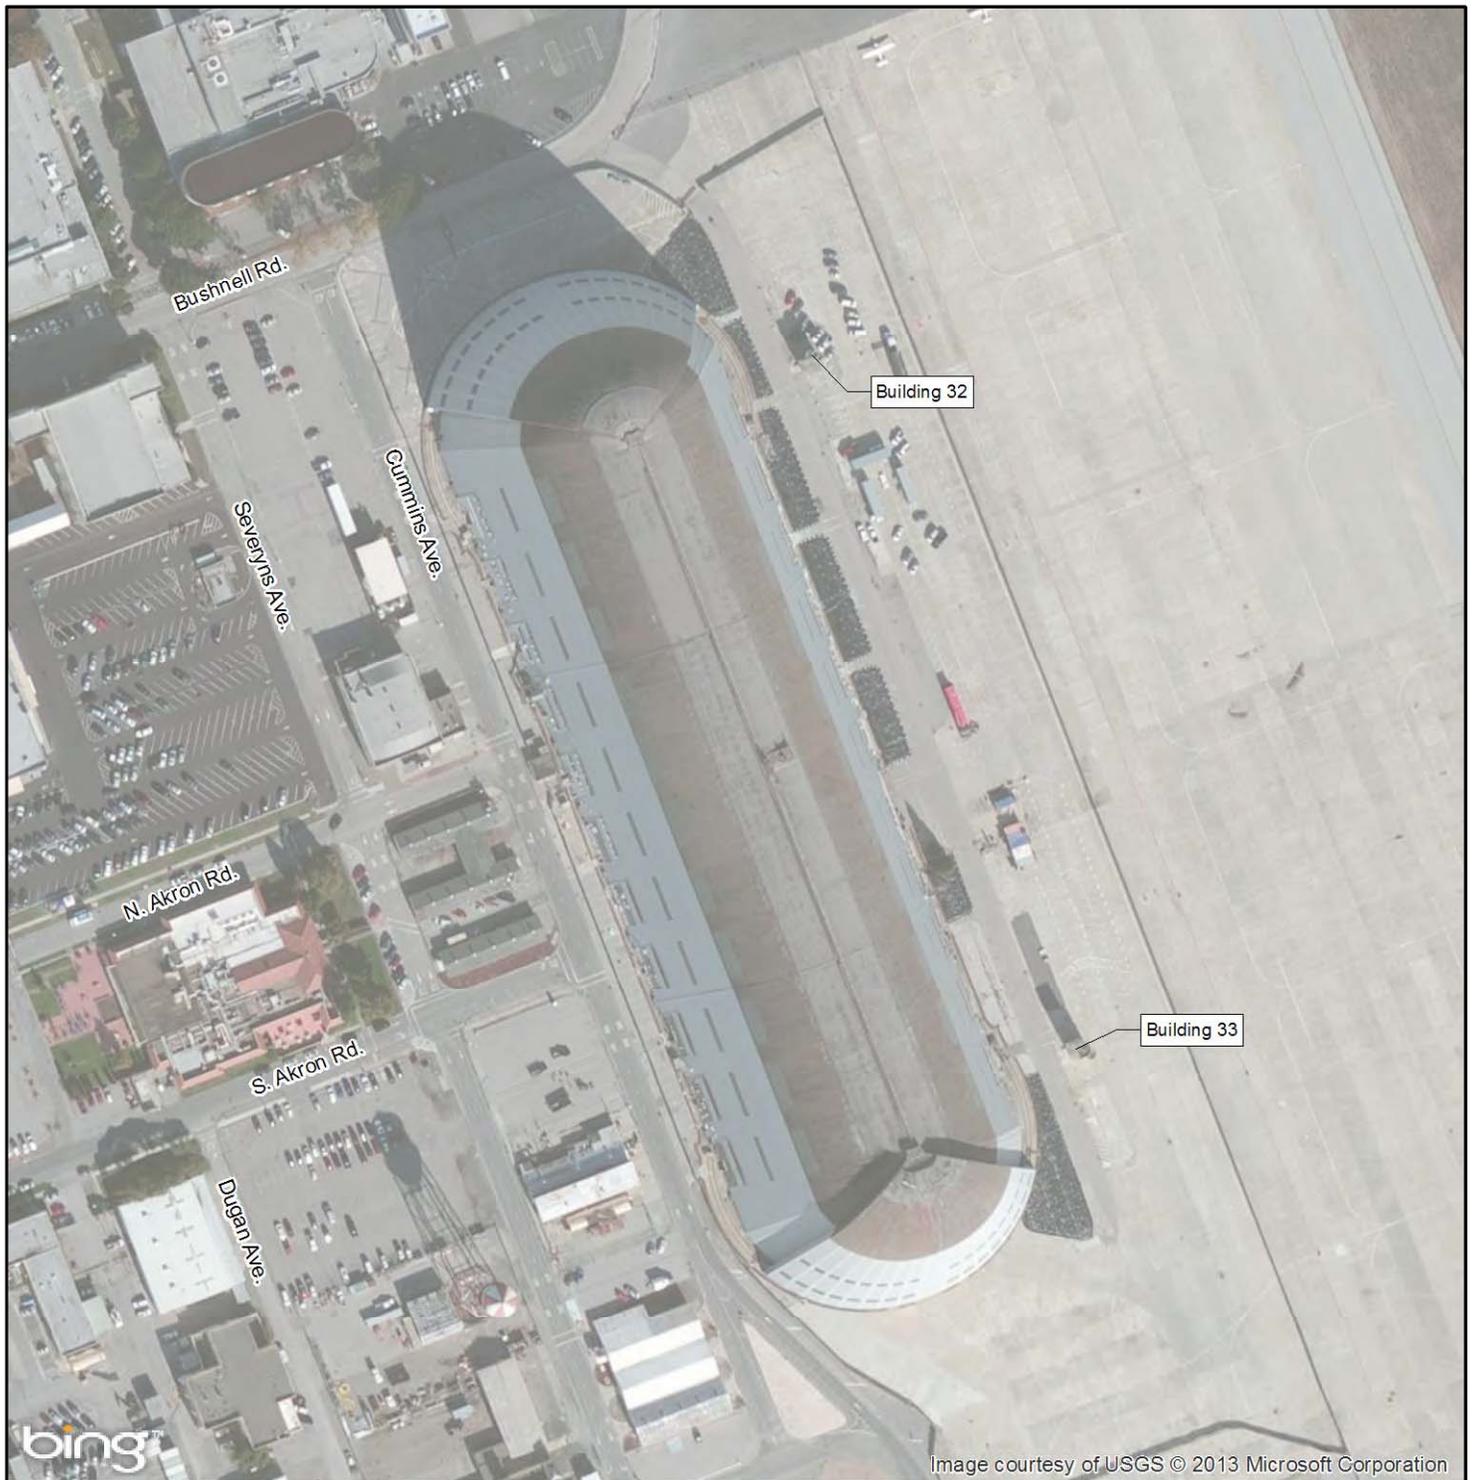
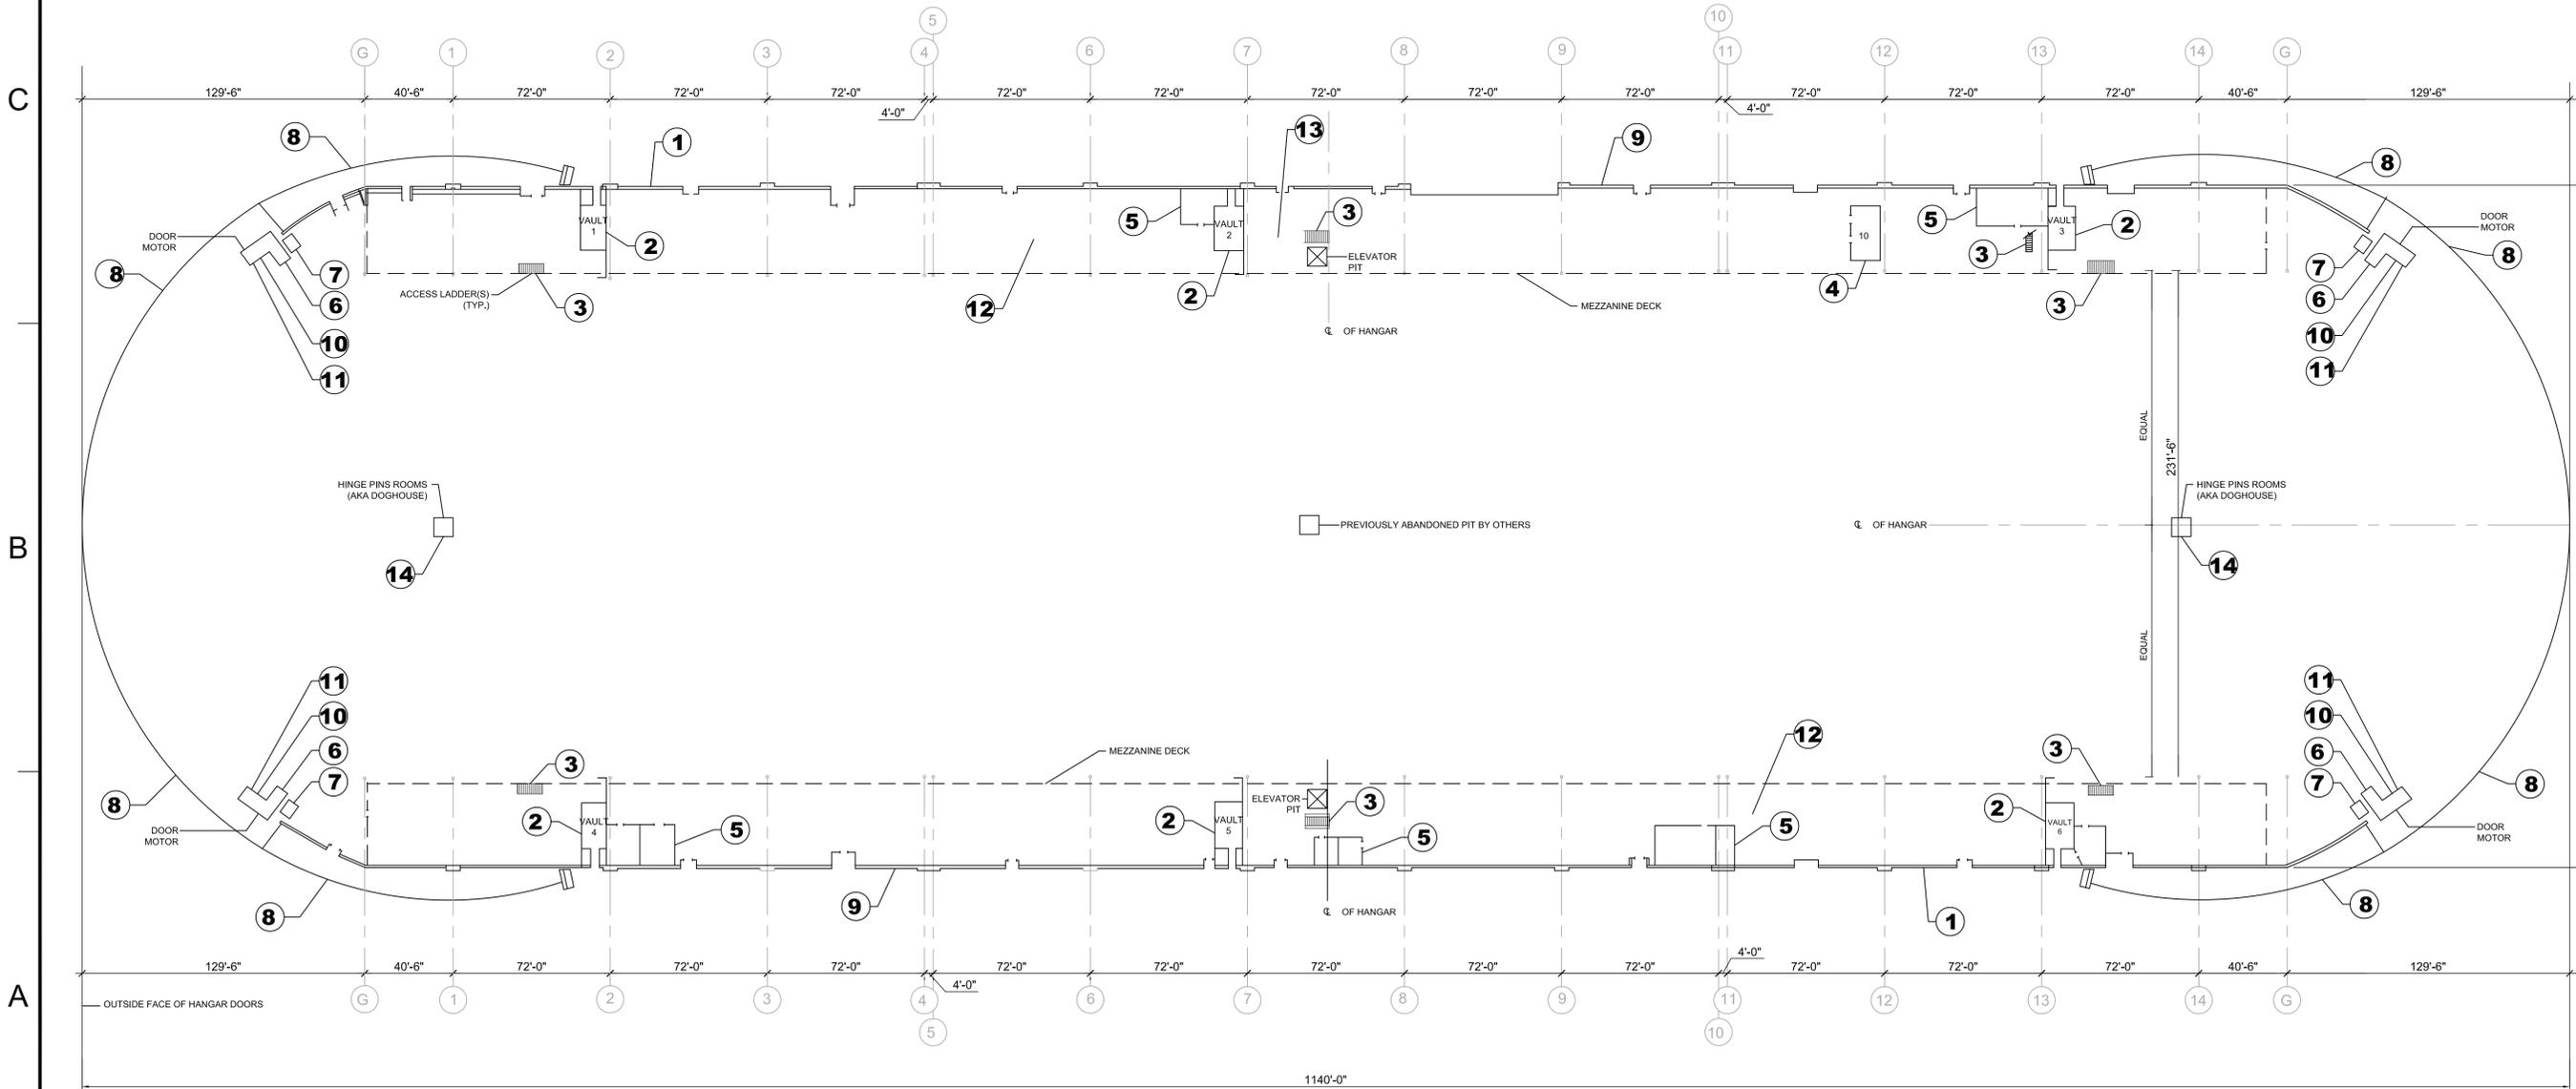
5	FORMER TOILETS	NEW CM15 OVERCOAT ON CMU. ORIGINAL PAINT BENEATH CONTAINS PCBS.	INSPECT AND REPAIR CM15 COATING DURING LTMGMT INSPECTIONS.
6	DOOR MOTOR HOUSING	NEW CM15 OVERCOAT ON STEEL. ORIGINAL PAINT BENEATH CONTAINS PCBS.	INSPECT AND REPAIR CM15 COATING DURING LTMGMT INSPECTIONS.
7	DOOR MOTOR ELECTRICAL VAULT	NEW CM15 OVERCOAT ON STEEL. ORIGINAL PAINT BENEATH CONTAINS PCBS.	INSPECT AND REPAIR CM15 COATING DURING LTMGMT INSPECTIONS.
8	DOOR TRUCKS (BOLSTERS)	NEW CM15 OVERCOAT ON STEEL. ORIGINAL PAINT BENEATH CONTAINS PCBS.	INSPECT AND REPAIR CM15 COATING DURING LTMGMT INSPECTIONS.
9	CONCRETE STEMWALLS SURROUNDING HANGAR PERIMETER	ORIGINAL PAINT REMOVED COMPLETELY. CONCRETE SEALED WITH CARBOGUARD 1340 SEALER.	NO LTMGMT INSPECTIONS NEEDED. OWNER IS RESPONSIBLE FOR MAINTENANCE OF SEALER.
10	DOOR MOTOR DRIVE GEAR (CHAIN AND ROLLERS)	NOT OVERCOATED WITH CM15.	NO LTMGMT INSPECTIONS NEEDED. OWNER IS RESPONSIBLE FOR MAINTENANCE OF DOOR DRIVE GEAR COMPONENTS.

11	DOOR GEAR HOUSING	NEW CM15 OVERCOAT ON STEEL. ORIGINAL PAINT BENEATH CONTAINS PCBS.	INSPECT AND REPAIR CM15 COATING DURING LTMGMT INSPECTIONS.
12	TOP AND BOTTOM SURFACES OF MEZZANINE DECKS	NEW CM15 OVERCOAT ON STEEL. ORIGINAL PAINT BENEATH REMOVED COMPLETELY.	NO LTMGMT INSPECTIONS NEEDED. OWNER IS RESPONSIBLE FOR ROUTINE MAINTENANCE AND TOUCHUP OF THE COATING ON THE MEZZANINE DECKS.
13	ACCESS TO ROOF BETWEEN COLUMNS 7 AND 8	NEW CM15 OVERCOAT ON NEW GALVANIZED STEEL GRIP STRUTS. ORIGINAL PAINT ON HANDRAILS DOES NOT CONTAIN PCBS.	NO LTMGMT INSPECTIONS NEEDED. OWNER IS RESPONSIBLE FOR ROUTINE MAINTENANCE AND TOUCHUP OF THE COATING ON THE ROOF ACCESS.
14	HINGE PIN SYSTEM ON TOP OF ROOF (DOOR PIVOT POINTS)	NEW CM15 OVERCOAT ON STEEL. ORIGINAL PAINT BENEATH CONTAINS PCBS.	INSPECT AND REPAIR CM15 COATING DURING LTMGMT INSPECTIONS.

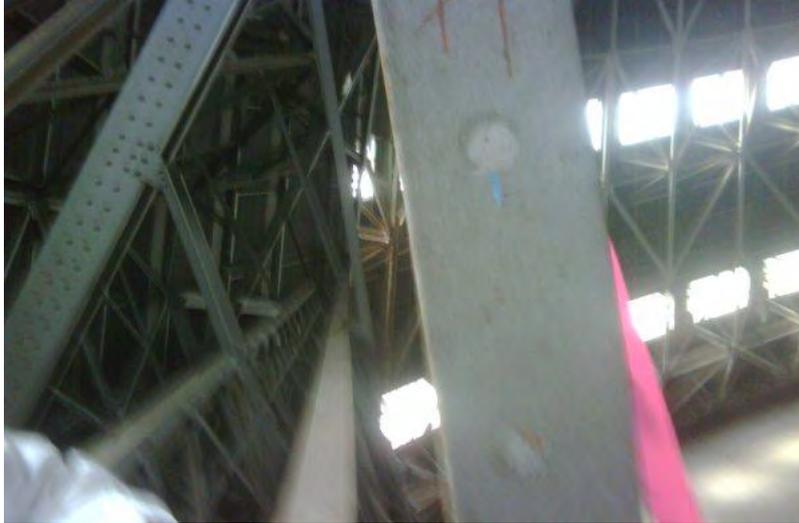
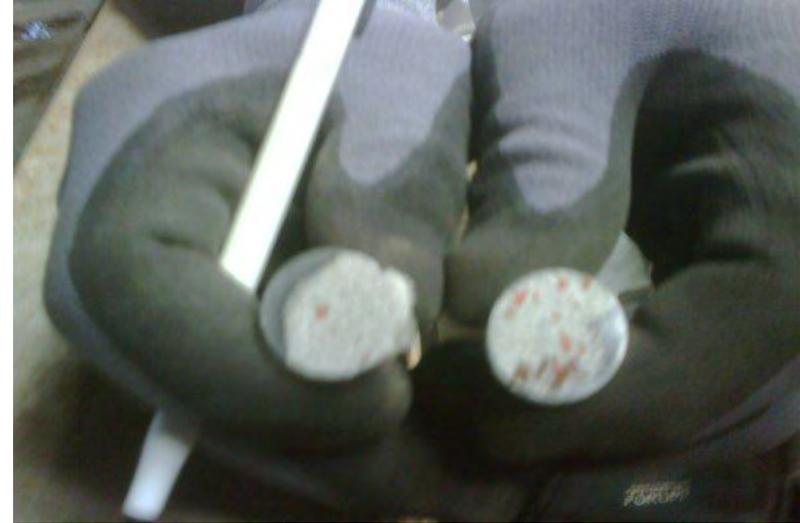
# Column 14 Level 9

Structure Component	Local Environment	Rust ASTM D610	Underfilm Corrosion ASTM D1654	Peeling	Blistering ASTM D714
Column 14 Level 9	Interior Exposure – Dry, dusty	6P	None	0	10

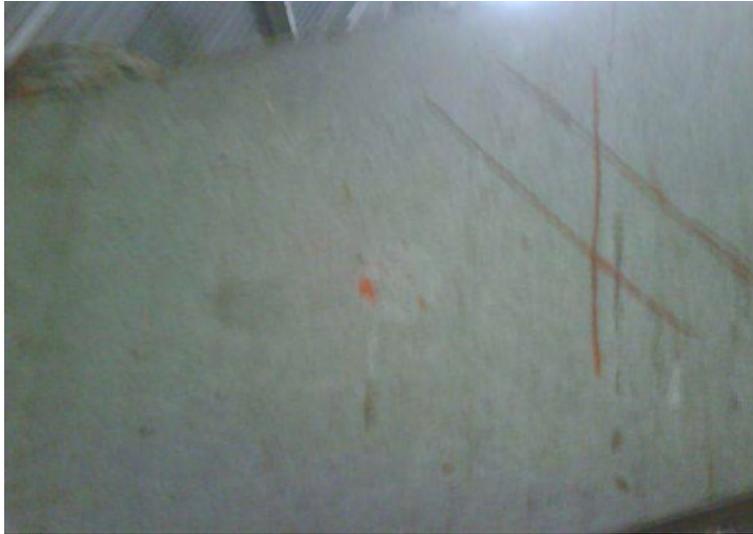
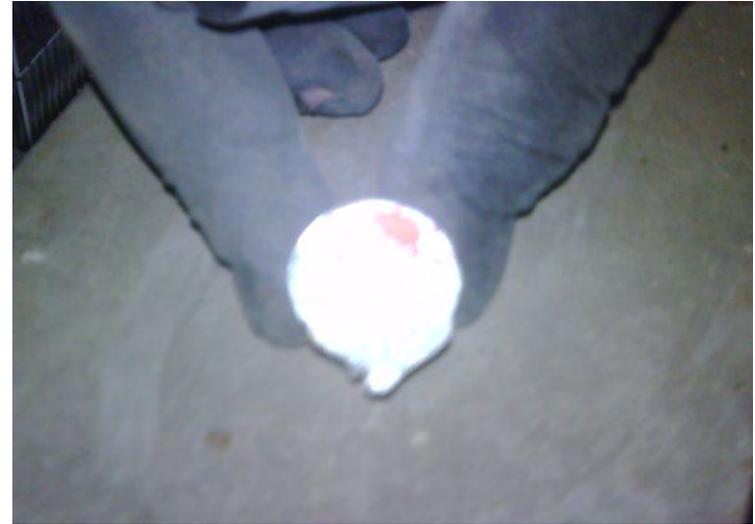
# Column 12 Level 7

Structure Component	Local Environment	Rust ASTM D610	Underfilm Corrosion ASTM D1654	Peeling	Blistering ASTM D714
Column 12 Level 7	Interior Exposure – Dry, dusty	7P	None	0	10

Cracking ASTM D660	Checking ASTM D661	Film Thickness SSPC-PA 2	Adhesion ASTM D3359	Adhesion ASTM D4541	Condition of Underlying Substrate
None	None	6.0 - 7.0 mils (150-175 micrometers)	4A to 3A	Epoxy – 375 psi (2585 kPa)	Adherent mill scale, no rust, no surface profile
				Cyanoacrylate – glue failure

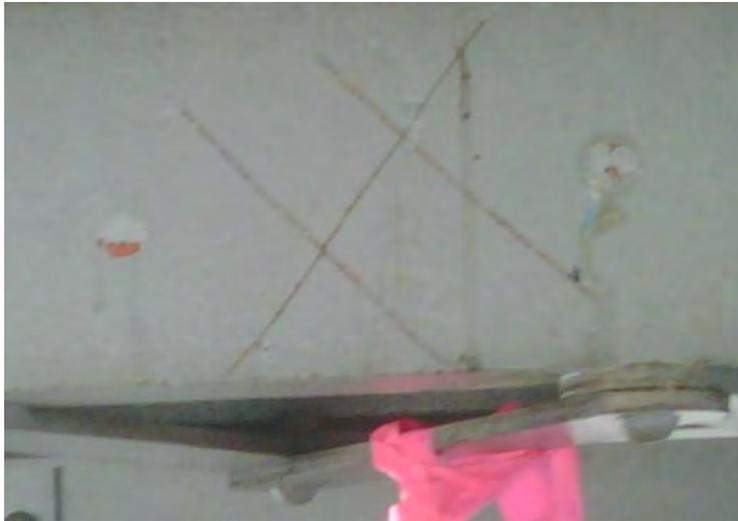
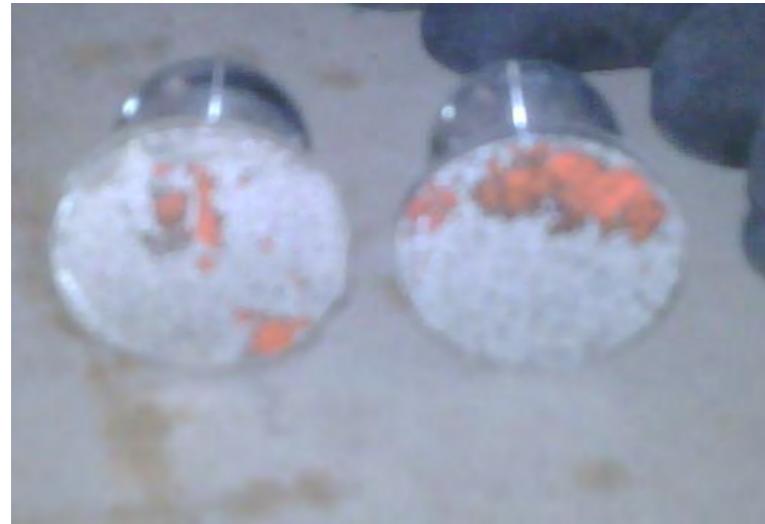
# Column 10 Level 5

Structure Component	Local Environment	Rust ASTM D610	Underfilm Corrosion ASTM D1654	Peeling	Blistering ASTM D714
Column 10 Level 5	Interior Exposure – Dry, dusty	7P	None	0	10

Cracking ASTM D660	Checking ASTM D661	Film Thickness SSPC-PA 2	Adhesion ASTM D3359	Adhesion ASTM D4541	Condition of Underlying Substrate
None	None	5.0 - 6.0 mils (125-150 micrometers)	4A to 3A	Epoxy – 500 psi (2585 kPa)	Adherent mill scale, no rust, no surface profile
				Cyanoacrylate – 700 psi (4826 kPa)

Dollie on the right was adhered using an epoxy adhesive and resulted in a 500 psi pull. Primary adhesive failure was of the existing topcoat to the existing primer and a small percentage of cohesive failure of the existing primer. Approximately 10% of the failure was cohesive failure of the existing primer.

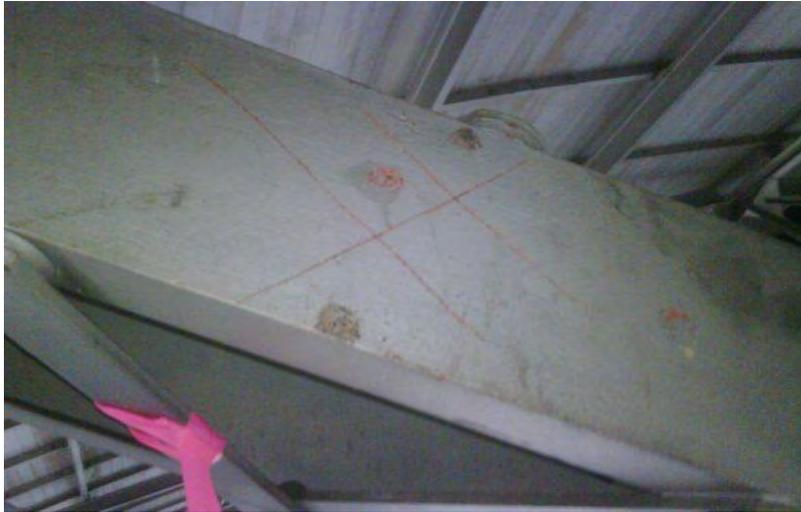
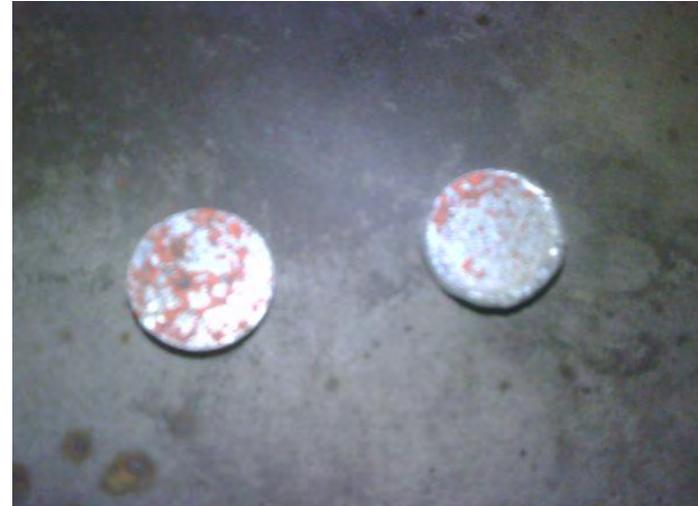
# Column 8 Level 2

Structure Component	Local Environment	Rust ASTM D610	Underfilm Corrosion ASTM D1654	Peeling	Blistering ASTM D714
Column 8 Level 2	Interior Exposure – Dry, dusty	5P	None	0	10

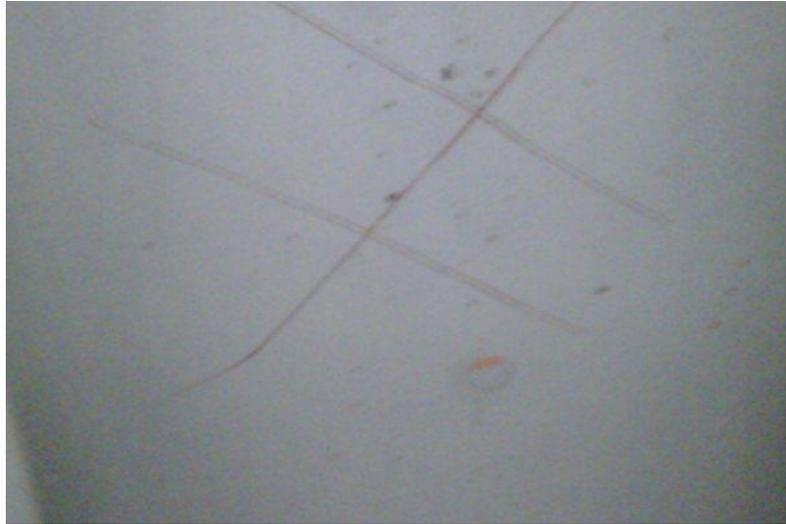
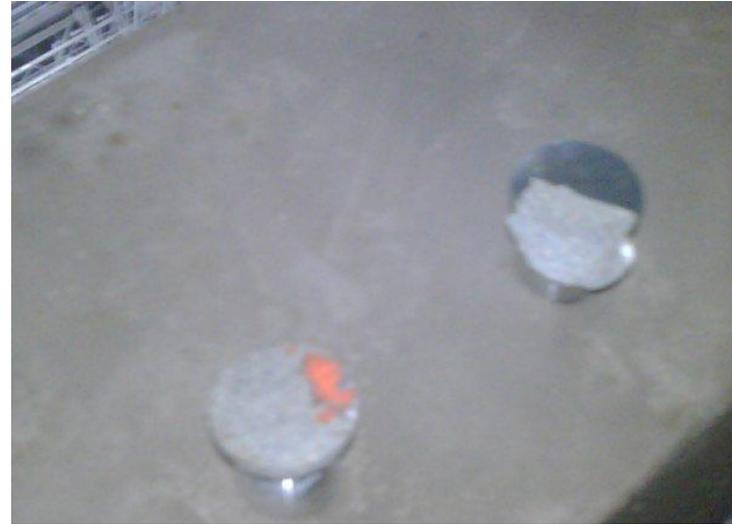
# Column 6 Level 1

Structure Component	Local Environment	Rust ASTM D610	Underfilm Corrosion ASTM D1654	Peeling	Blistering ASTM D714
Column 6 Level 1	Interior Exposure – Dry, dusty	7P	None	0	10

Cracking ASTM D660	Checking ASTM D661	Film Thickness SSPC-PA 2	Adhesion ASTM D3359	Adhesion ASTM D4541	Condition of Underlying Substrate
None	None	3.0 - 4.0 mils (75-100 micrometers)	4A	Epoxy – glue failure	Adherent mill scale, no rust, no surface profile
				Cyanoacrylate – 800 psi (5516 kPa)

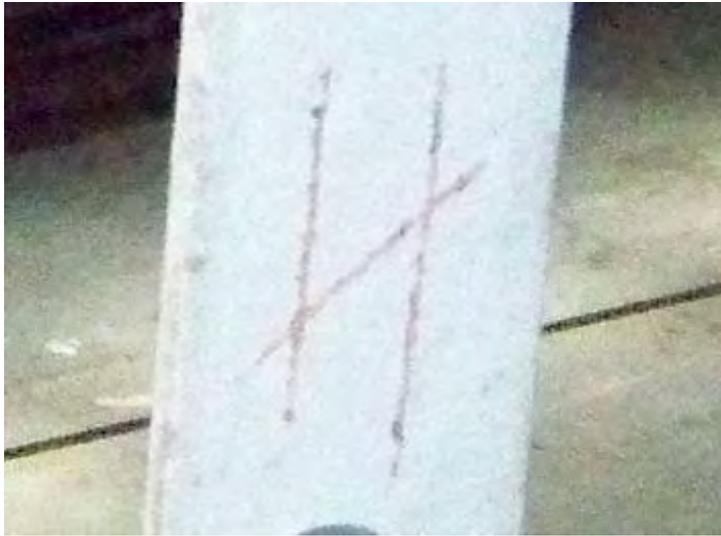
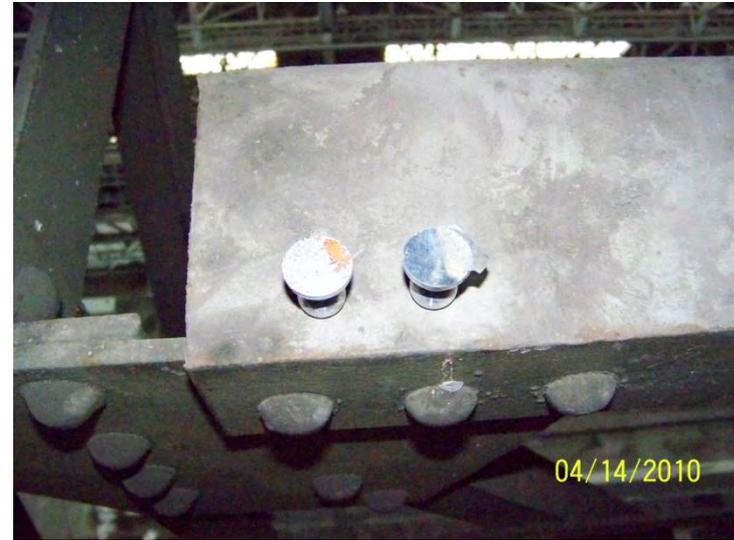
# Column 3 Level 3

Structure Component	Local Environment	Rust ASTM D610	Underfilm Corrosion ASTM D1654	Peeling	Blistering ASTM D714
Column 3 Level 3	Interior Exposure – Dry, dusty	6P	None	0	10

Cracking ASTM D660	Checking ASTM D661	Film Thickness SSPC-PA 2	Adhesion ASTM D3359	Adhesion ASTM D4541	Condition of Underlying Substrate
None	None	7.0 - 9.0 mils (175-225 micrometers)	4A	Epoxy – 300 psi glue failure (2068kPa)	Adherent mill scale, no rust, no surface profile
				Cyanoacrylate – 1000 psi (6895 kPa)

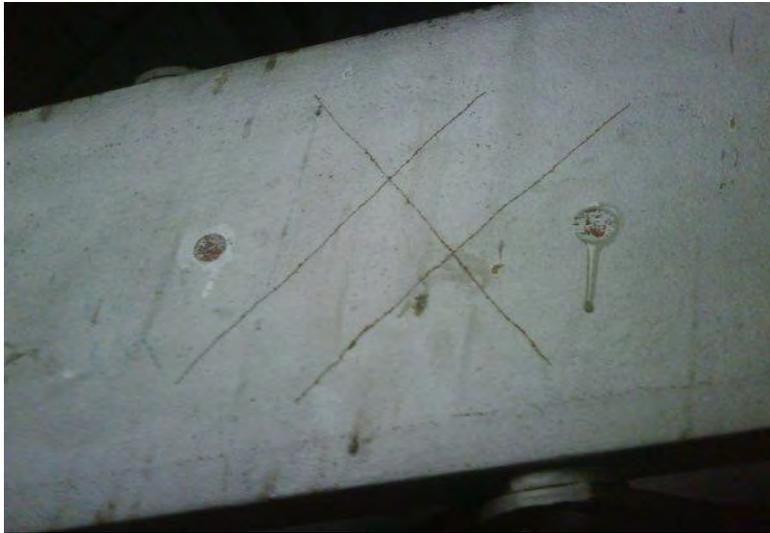
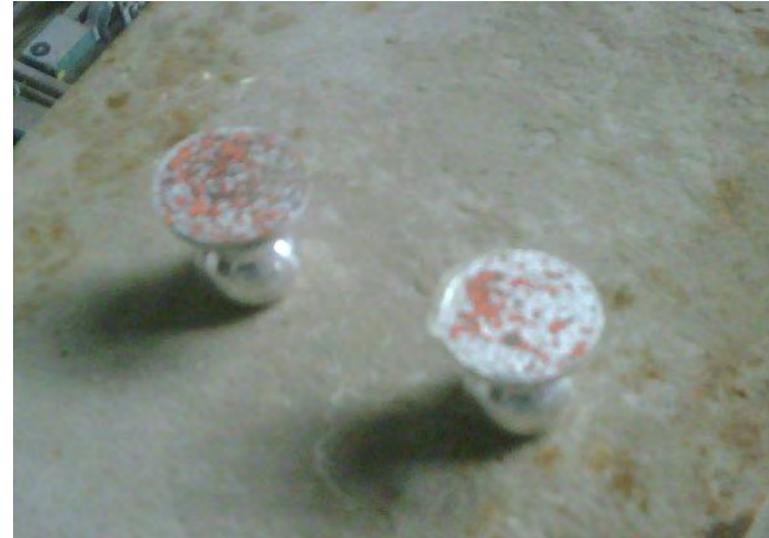
# Column 2 Level 5

Structure Component	Local Environment	Rust ASTM D610	Underfilm Corrosion ASTM D1654	Peeling	Blistering ASTM D714
Column 2 Level 5	Interior Exposure – Dry, dusty	5P	None	0	10

Cracking ASTM D660	Checking ASTM D661	Film Thickness SSPC-PA 2	Adhesion ASTM D3359	Adhesion ASTM D4541	Condition of Underlying Substrate
None	None	4.0 - 7.0 mils (100-175 micrometers)	4A	Epoxy – 800 psi (5516 kPa)	Adherent mill scale, no rust, no surface profile
				Cyanoacrylate – 500 psi (3447 kPa)

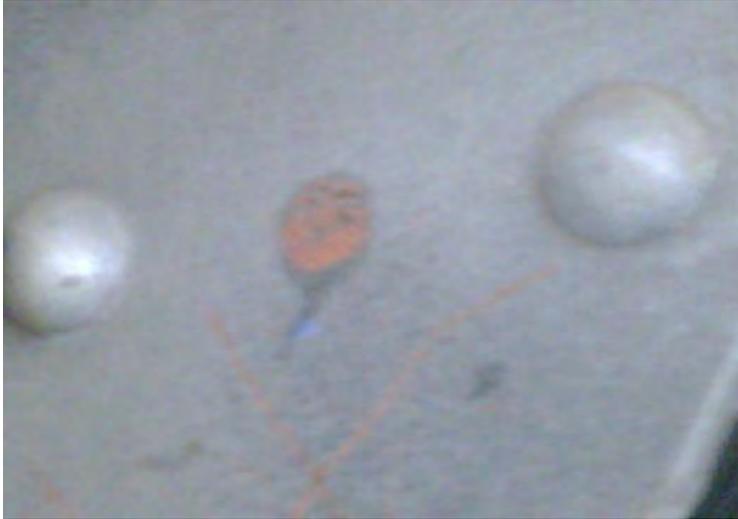
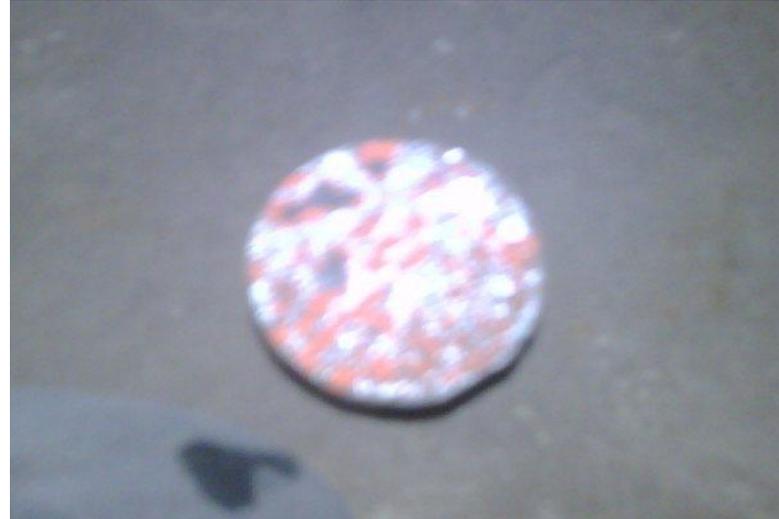
# Column 1-2 Level 7

Structure Component	Local Environment	Rust ASTM D610	Underfilm Corrosion ASTM D1654	Peeling	Blistering ASTM D714
Column 1-2 Level 7	Interior Exposure – Dry, dusty	6P	None	0	10

Cracking ASTM D660	Checking ASTM D661	Film Thickness SSPC-PA 2	Adhesion ASTM D3359	Adhesion ASTM D4541	Condition of Underlying Substrate
None	None	7.0 - 9.0 mils (100-175 micrometers)	3A	Epoxy – dolly lost	Adherent mill scale, no rust, no surface profile
				Cyanoacrylate – 900 psi (6205 kPa)

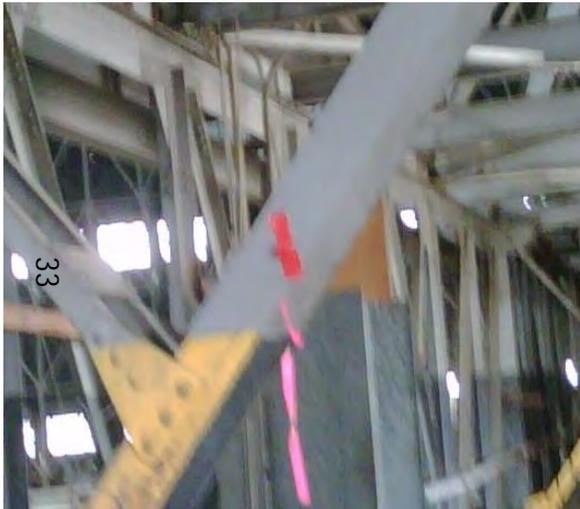
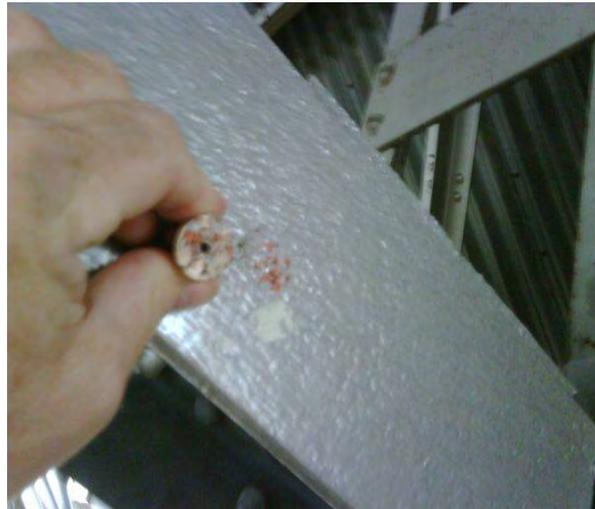
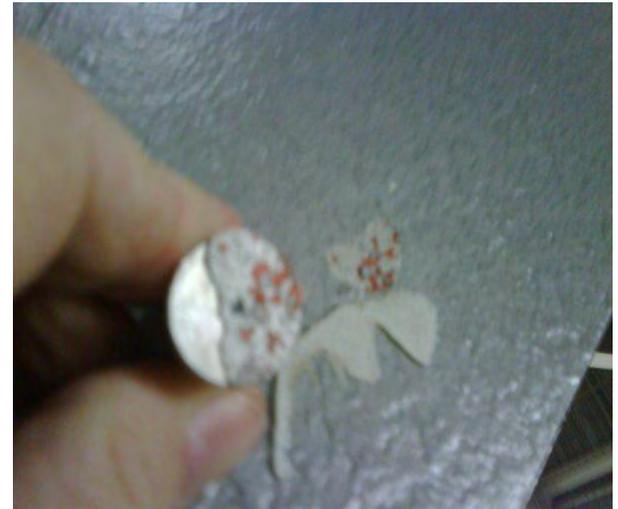
# Overcoating Patch Test Column 7 Grade Level

Surface Preparation: 5,000 psi pressure wash with potable water

Dollie on the right was adhered using an epoxy adhesive and resulted in a 150 psi pull, with primary adhesive failure of the existing topcoat to the existing primer and cohesive failure of the existing primer. In addition there was approximately 40% glue failure. Approximately 5-10% of the failure was cohesive failure of the existing primer.

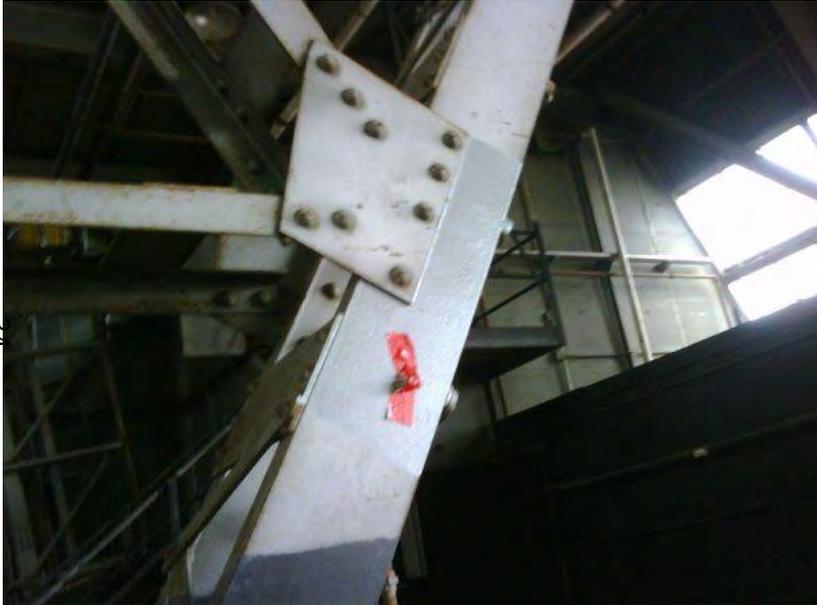
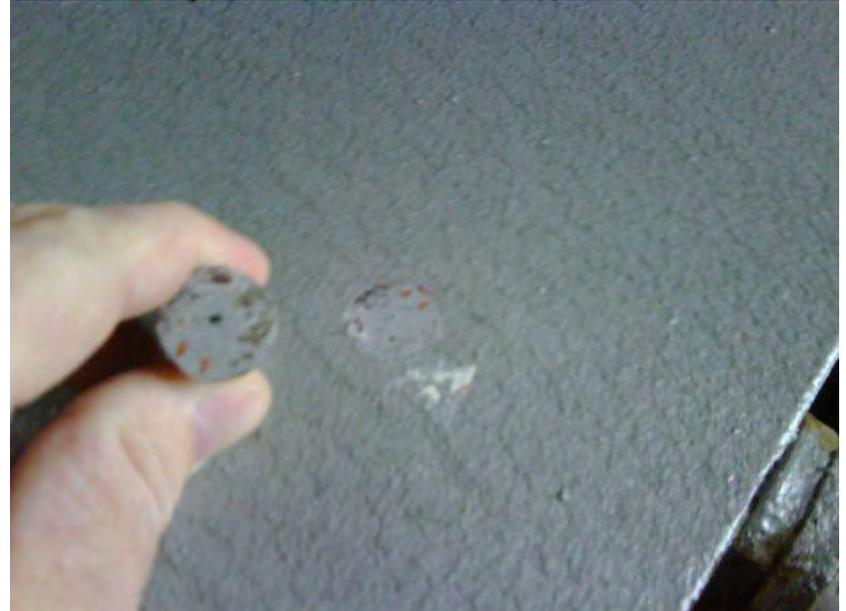
# Overcoating Patch Test Column 8 Grade Level

Surface Preparation: 5,000 psi pressure wash with potable water

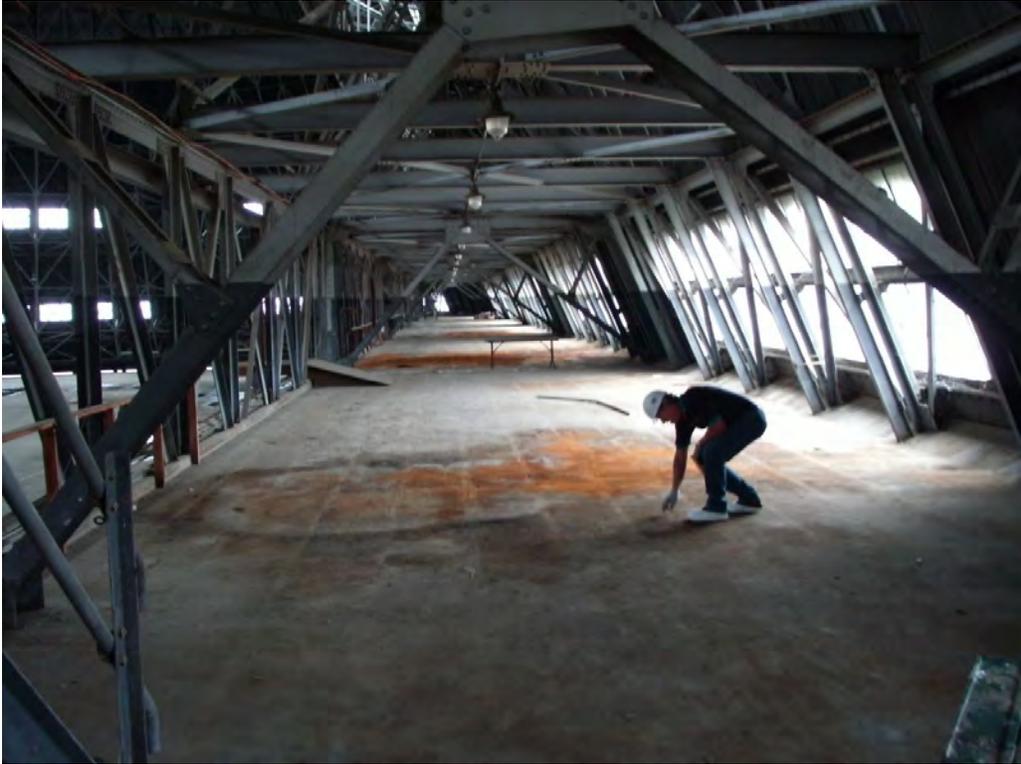
As identified in the Coating Condition Survey (AMEC 2010b), the mezzanine decks on both the east and west sides of the hangar required additional preparation prior to coating because they contained mill scale and they had not been primed during original construction. These decks were abrasive blasted on both the top and bottom side, to completely remove the existing paint, rust, and mill scale. The decks were then coated with one coat of Carbozinc 859<sup>®</sup> rust-inhibiting epoxy primer applied at 3 to 5 mils DFT and one finish coat of CM15 applied at 4 to 8 mils DFT.

**19.1 West Mezzanine – Rusty Deck**

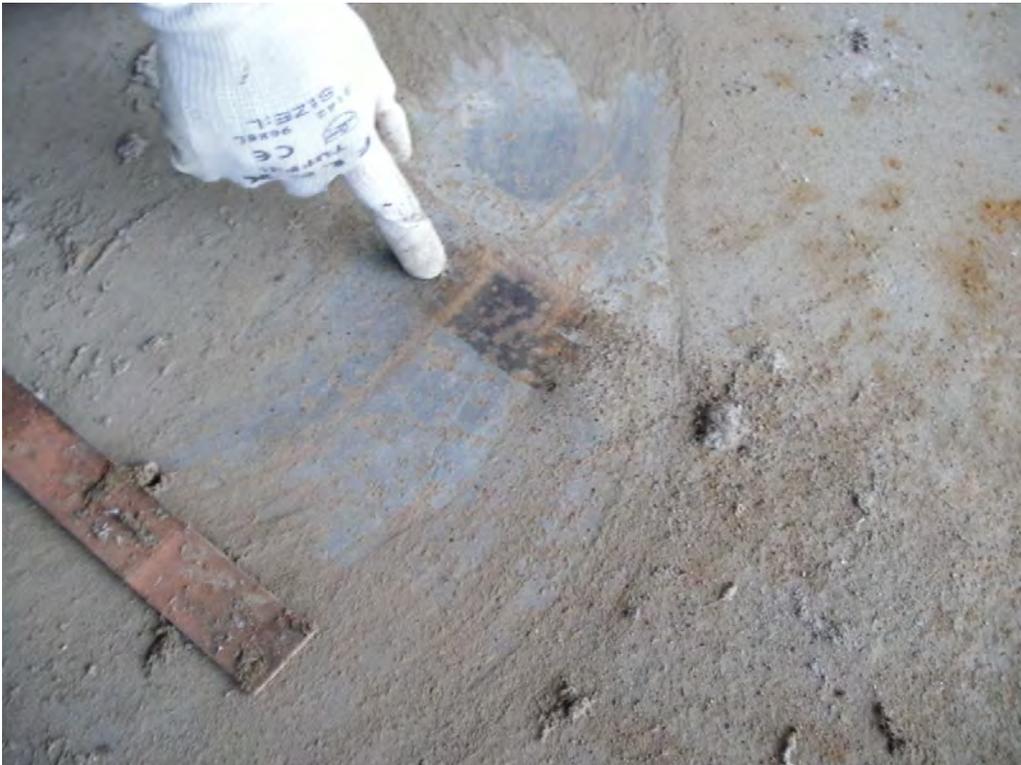
**19.2 West Mezzanine – Scraped Aluminum paint off of deck to show “No Paint” and evidence of “Mill Scale”**

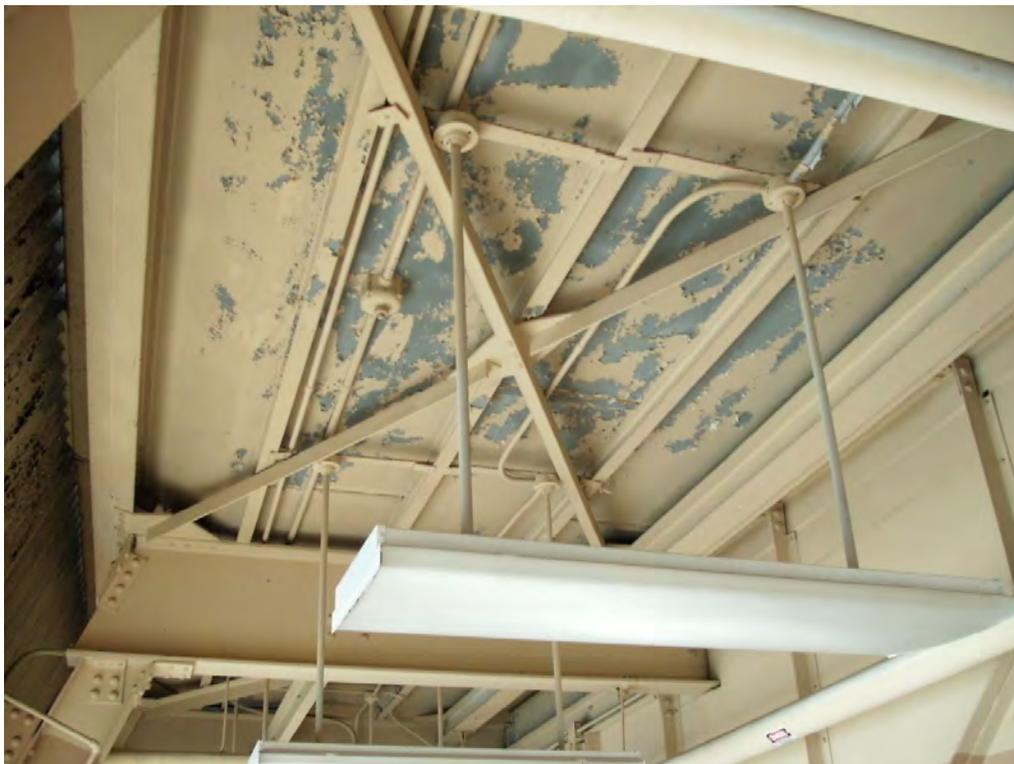
**19.4 Underside of Mezzanine showing the delaminating paint from the Aluminum**

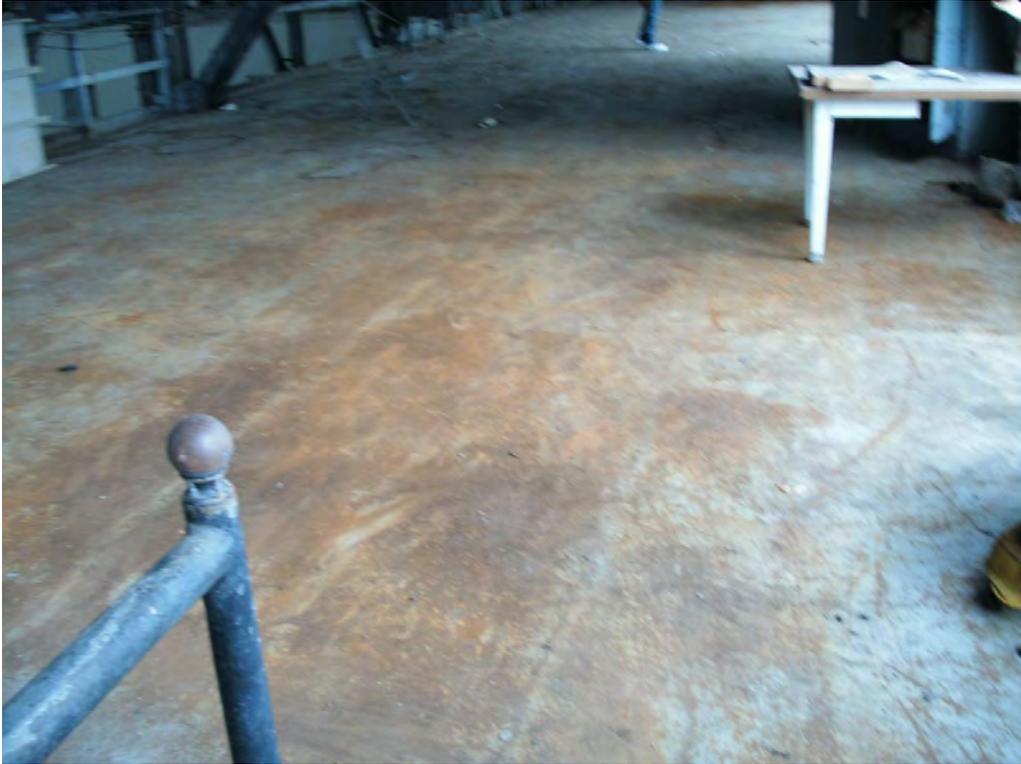
**19.5 Rusty Deck of Mezzanine – East Side**

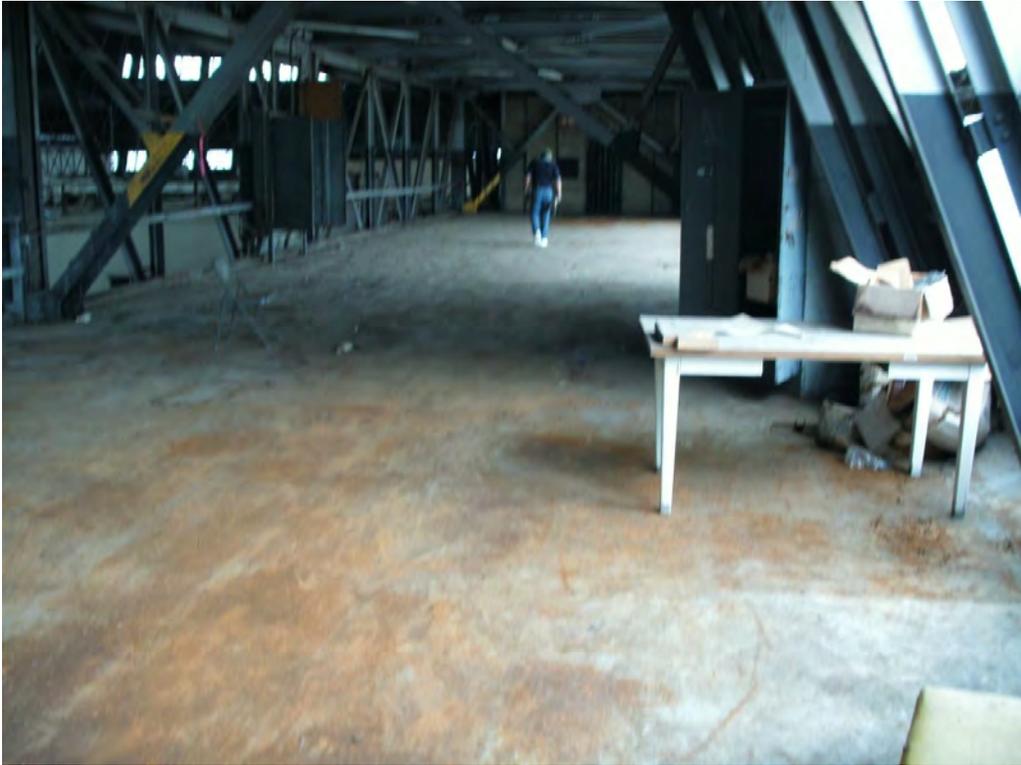
**19.6 Rusty Deck of Mezzanine – East Side**

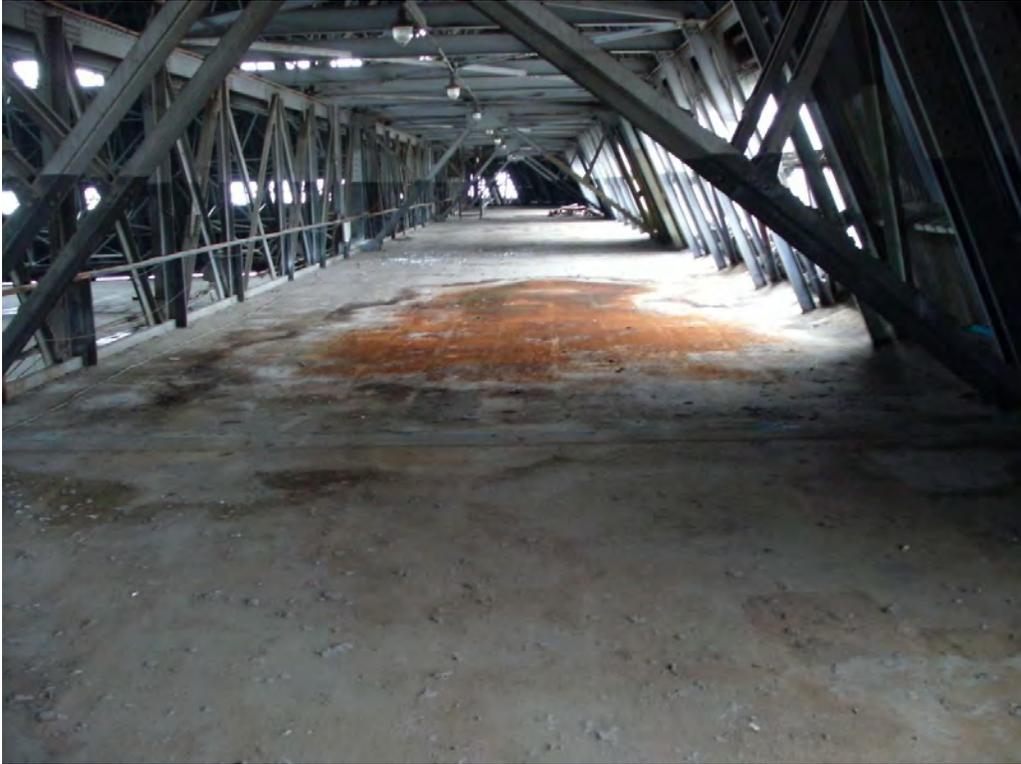
**19.7 Rusty Deck of West Mezzanine**

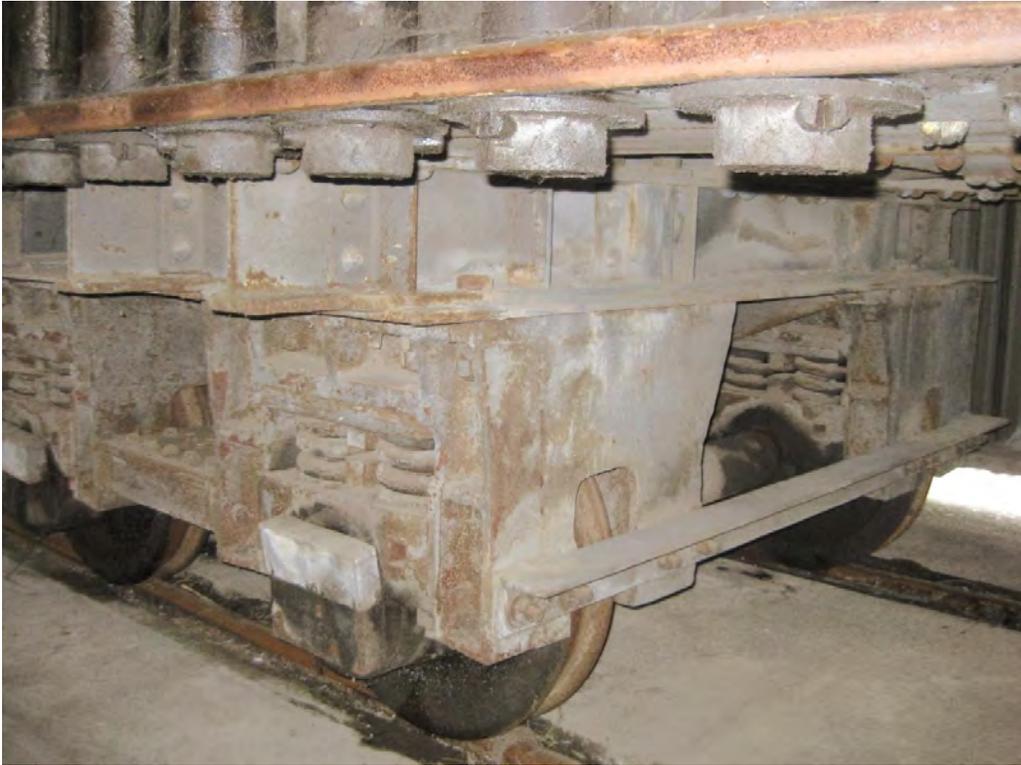
**19.8 Rusty Door Truck at South East Door**
