Former NAS Moffett Field

Hangar 1 Removal Action Update

AMEC Earth & Environmental, Inc.

**July 8, 2010
RAB Meeting**

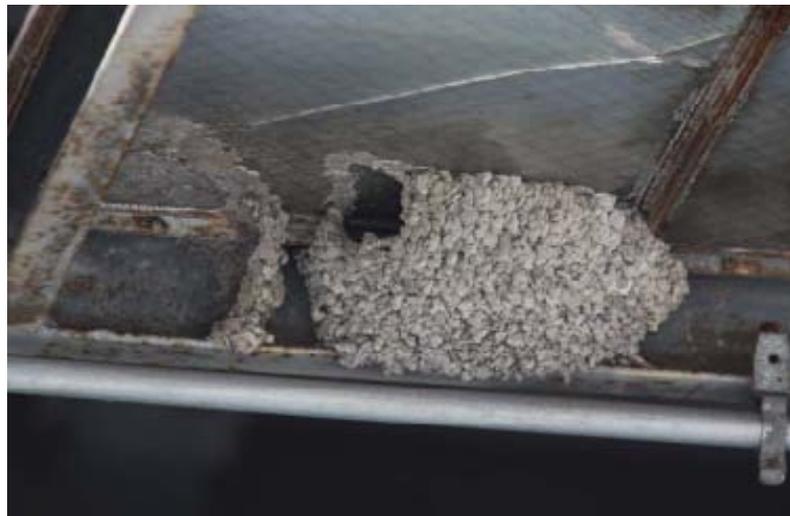
Inactive Cliff Swallow nest

- Recommendations approved by California Department of Fish & Game and US Fish & Wildlife Service
 - Remove inactive nests
 - Protect active Raven nest
 - Periodic nesting surveys
 - Monitor and protect Burrowing Owls

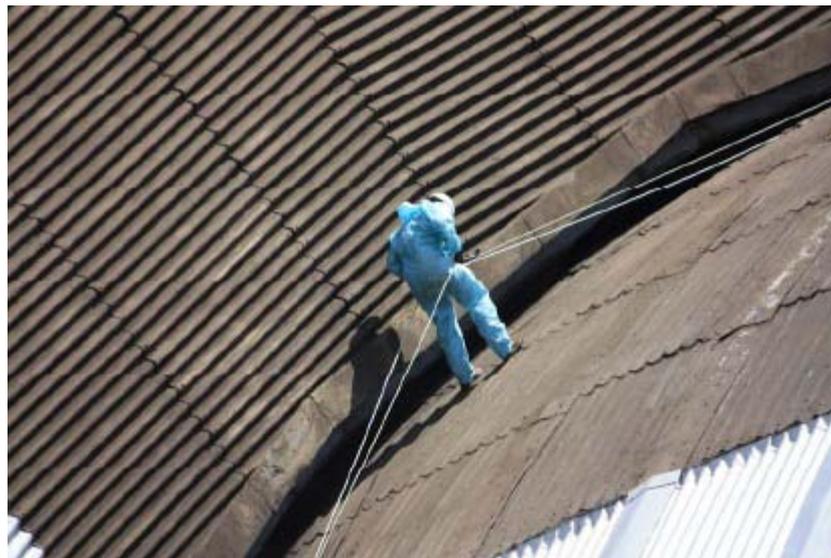
Inspection of clamshell doors for Swift nests

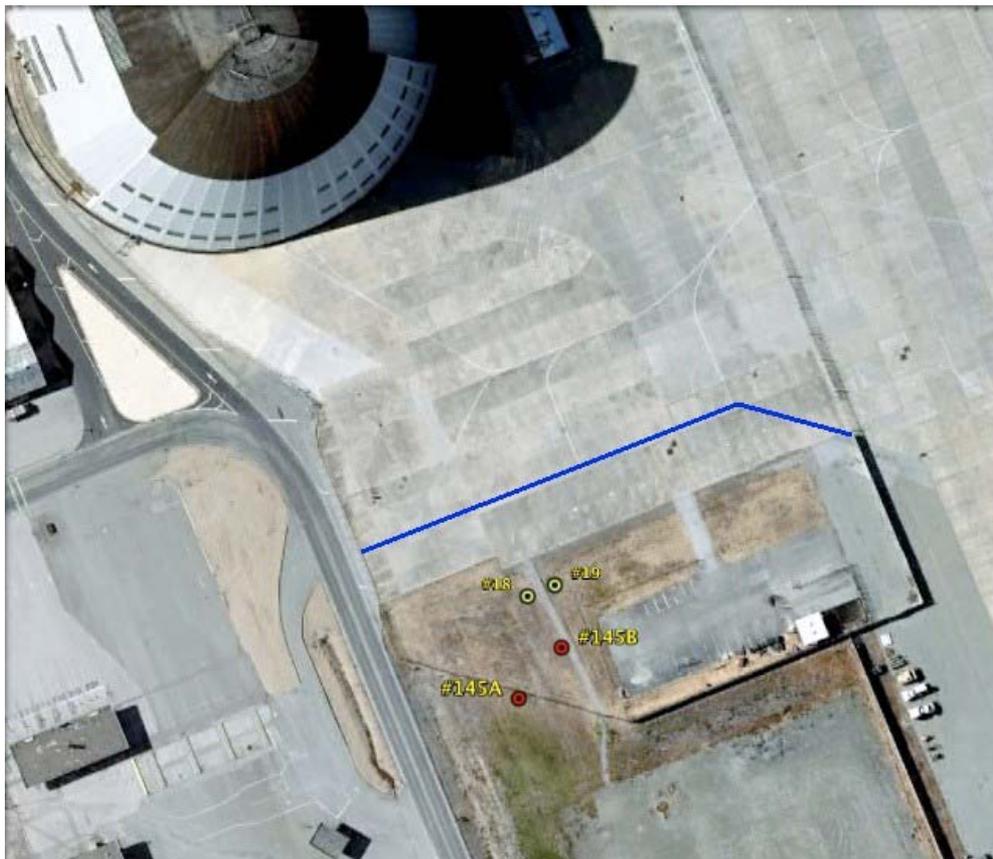
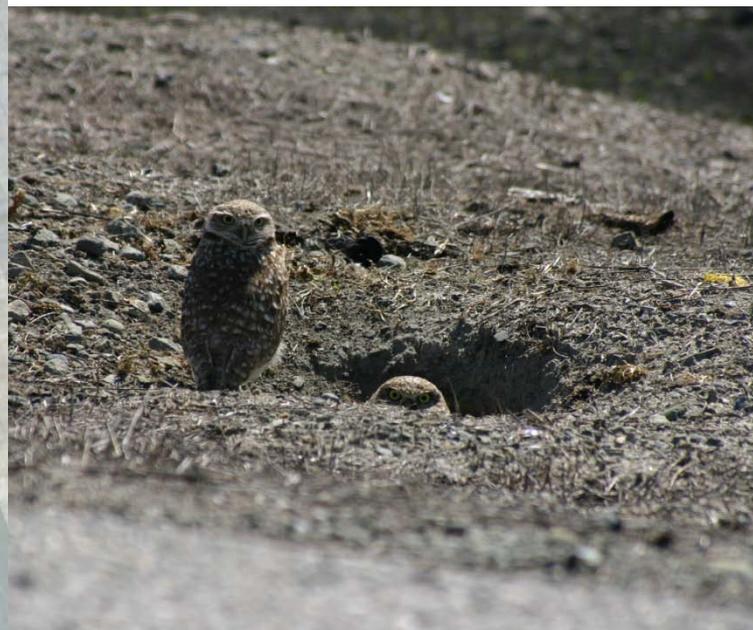
Burrowing Owl Locations

Construction fence approximately 175 Feet north of active burrow

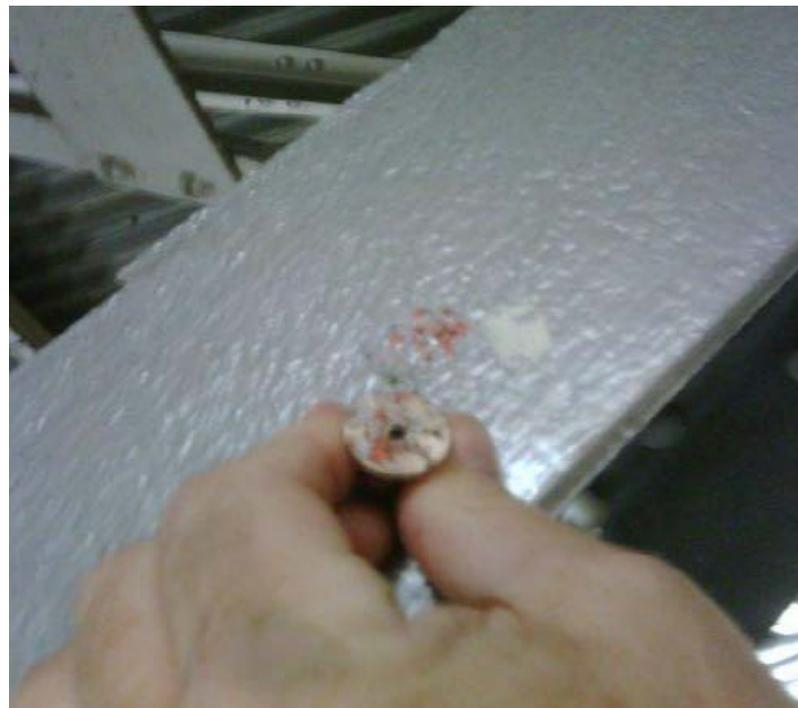
Patch test on new coating

- Adhesion of existing coating very good at all locations tested
 - Average adhesion strength of 603 psi
 - 200 psi is acceptable
- Recommended coating system:
 - Carbomastic 15 (CM15) aluminum epoxy mastic
 - Surface preparation by low-pressure water cleaning and localized abrasive blasting or power tool cleaning
 - Application by spray, brush, or roller at 3 – 10 mils
- Excellent adhesion of CM15 coating system demonstrated in all tests (550 psi – 675 psi)

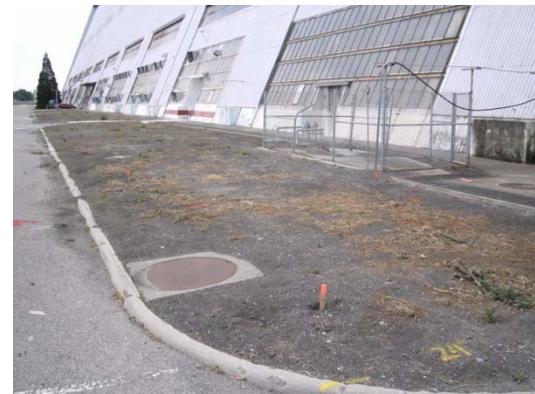
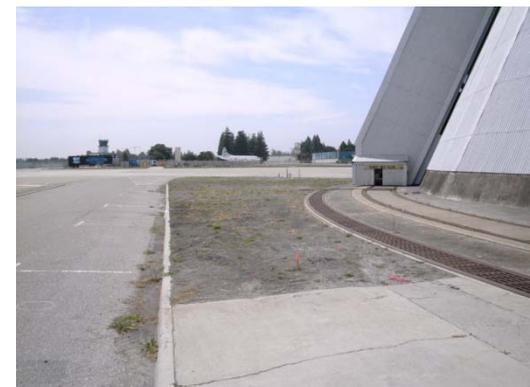
- Soil Areas
 - 110 samples collected from soil areas
 - 20 samples $>1,000 \mu\text{g}/\text{kg}$ PCB action limit
 - PCB contamination restricted to upper 6 inches
 - Contaminated soil will be excavated and disposed off site
- Storm Drain Trench Sediment
 - 4 samples collected from the storm drain
 - All samples exceed PCB action limit
 - Sediment will be removed by vacuum methods and disposed off site

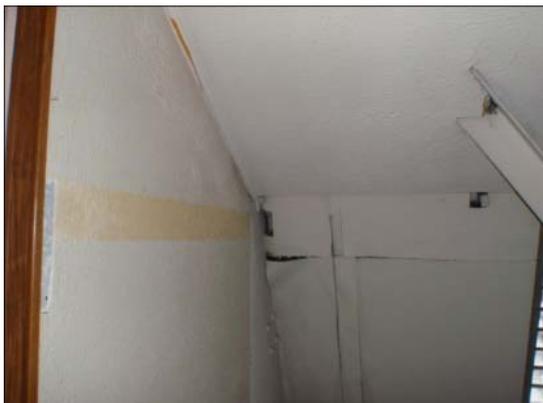
Drywall

- Compliance with OSHA and Cal. Code of Regulations (CCR Title 8)
- Install containment barriers and negative air pressure
- Air monitoring supervised by Certified Industrial Hygienist
- Post abatement inspection and clearance sampling
- All work under direction of California Asbestos Consultant

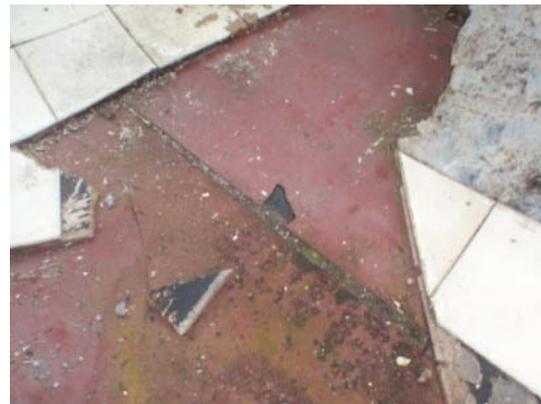
Mastic under flooring

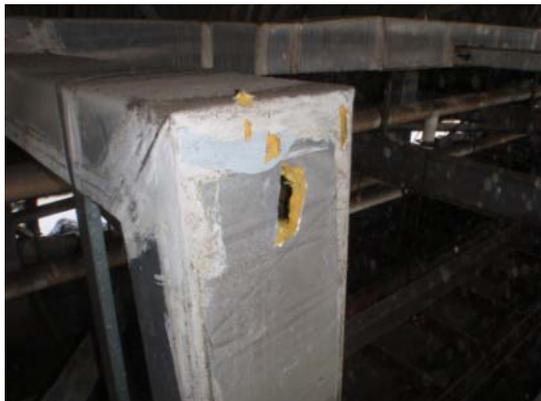
Duct tape and wrap

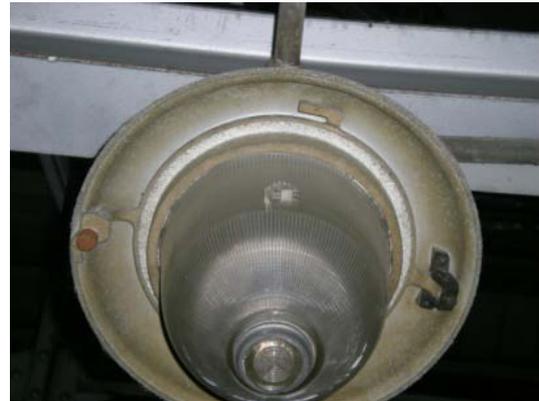
Light fixture gaskets
