Remedial Action Summary Report, Free Product Recovery

SWMU 62 New Housing Fuel Leak Area and Additional Sites

Former Naval Complex

Adak, Alaska

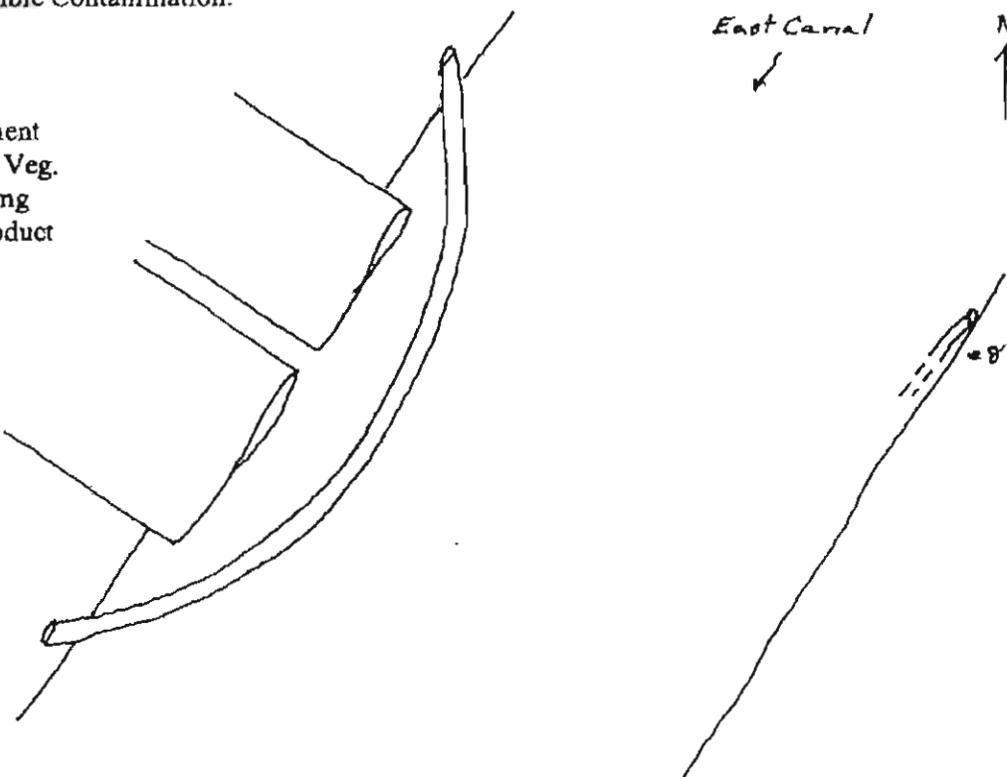
Boom Location: 2	Time/Date: <div style="text-align: right; font-family: cursive;">14:10 / 11-18-11</div>
Description of Boom Before Maintenance: UNSATISFACTORY - BOOM UNDONE FROM POSTS DUE TO HIGH WATER LEVELS + WEATHER	Photograph (s) Time/Date Stamp: <div style="text-align: right; font-family: cursive;">14:10 / 11-18-11</div>
Boom Repaired (Y/N): Description: WELL REPAIR WHEN WATER LEVELS DROP	Boom Replaced (Y/N) Number of sections: Description:
Visual Observations Visible Contamination (Y/N): Iron Staining (Y/N): Oily Sediment/Soil (Y/N): Distressed Vegetation (Y/N):	
Sheen Present on Water (Y/N): Is the Boom containing the Sheen? (Y/N): N/A Pooled Product (Y/N): If yes, was product removed with sorbent pads?	
Location of Visible Contamination: <div style="display: flex;"> <div style="flex: 1;"> <p><u>Legend</u></p> <p>//// Sheen</p> <p>\\\\ Oily Sediment</p> <p>xxx Distressed Veg.</p> <p>RRR Iron Staining</p> <p>● Pooled Product</p> </div> <div style="flex: 2;">

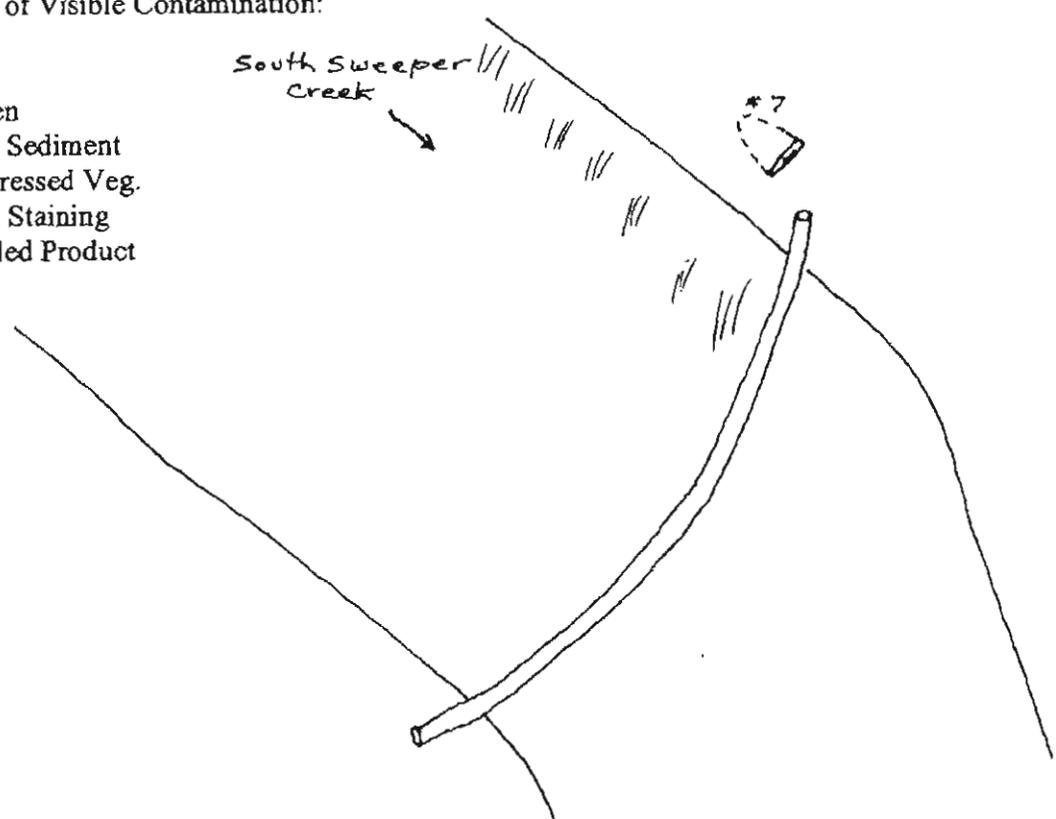
Boom Location: 6	Time/Date: 1100 4-4-12
Description of Boom Before Maintenance: Disconnected in middle	Photograph (s) Time/Date Stamp: 1339 4-5-12
Boom Repaired (Y/N): Description: Boom retied and reconnected.	Boom Replaced (Y/N) Number of sections: 3 Description: 3 middle sections replaced.
Visual Observations	
Visible Contamination (Y/N): * Iron Staining (Y/N): Oily Sediment/Soil (Y/N): Distressed Vegetation (Y/N): Location #6 contained the boom after it was retied and Location #10 could not contain boom until replaced	Sheen Present on Water (Y/N): * Is the Boom containing the Sheen? (Y/N): Pooled Product (Y/N): If yes, was product removed with sorbent pads?
Location of Visible Contamination:	
Legend /// Sheen \\\ Oily Sediment xxx Distressed Veg. RRR Iron Staining ● Pooled Product

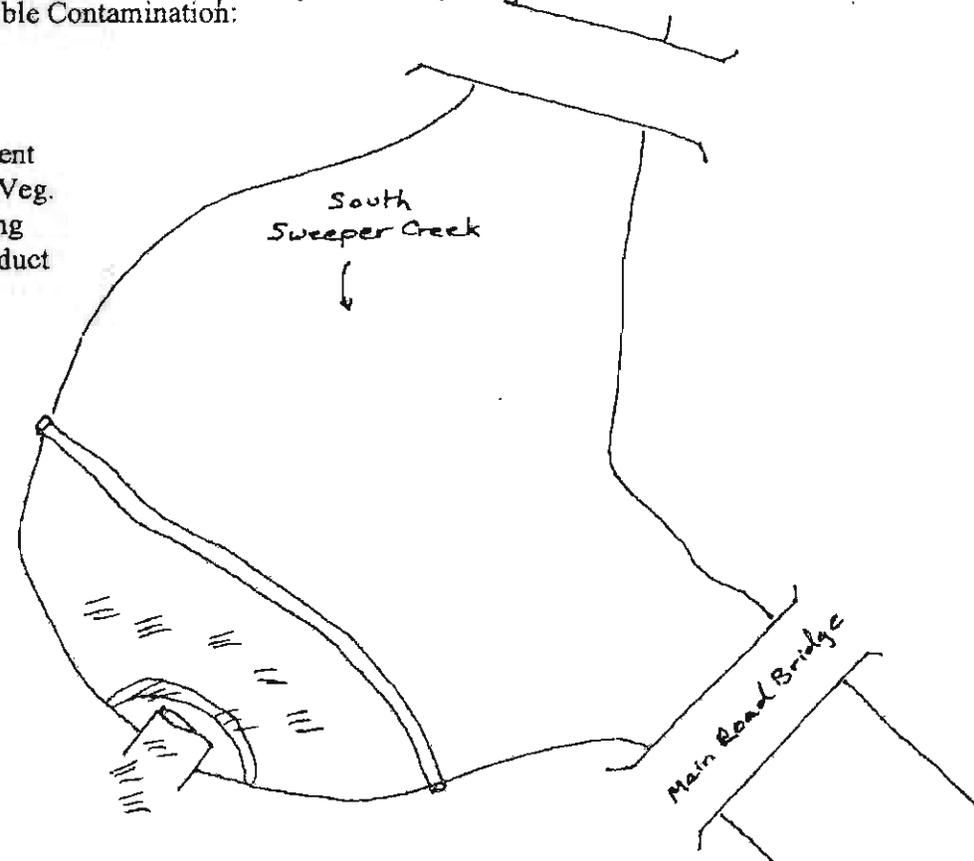
Boom Location: 10	Time/Date: 1100 4-4-12
Description of Boom Before Maintenance: <i>Water logged</i>	Photograph (s) Time/Date Stamp: 1338 4-5-12
Boom Repaired (Y/N): Description:	Boom Replaced (Y/N) Number of sections: 10 Description: <i>Replaced 10 sections</i>
Visual Observations Visible Contamination (Y/N): Iron Staining (Y/N): Oily Sediment/Soil (Y/N): Distressed Vegetation (Y/N):	
Sheen Present on Water (Y/N): Is the Boom containing the Sheen? (Y/N): Pooled Product (Y/N): If yes, was product removed with sorbent pads?	
<i>The culvert had collapsed, leaking into the location</i>	
Location of Visible Contamination:	
<div style="display: flex; justify-content: space-between;"> <div style="width: 30%;"> <p><u>Legend</u></p> <p>//// Sheen</p> <p>\\ \\ Oily Sediment</p> <p>xxx Distressed Veg.</p> <p>RRR Iron Staining</p> <p>● Pooled Product</p> </div> <div style="width: 60%; text-align: center;">

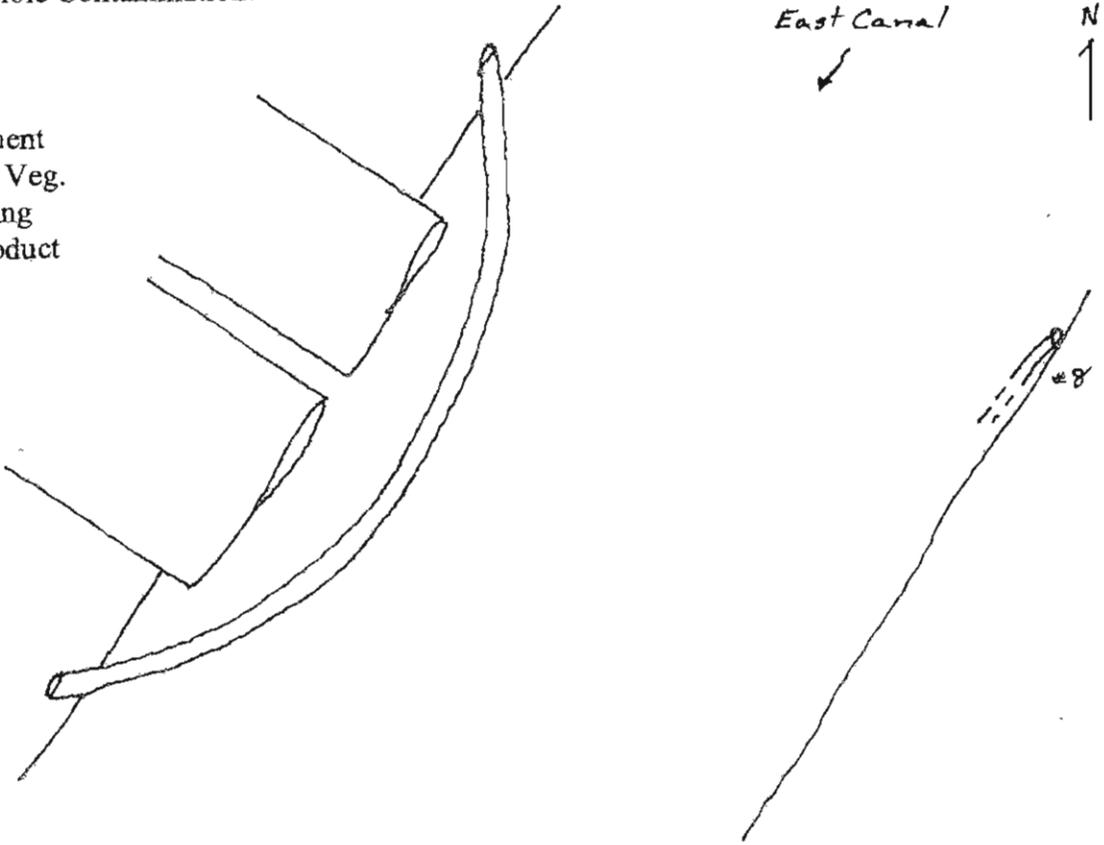
Boom Location: 2	Time/Date: 5-17-12
Description of Boom Before Maintenance: <i>Unsatisfactory, water logged</i>	Photograph (s) Time/Date Stamp: 1502 5-17-12
Boom Repaired (Y/N): Description: <i>Tied boom to new stakes.</i>	Boom Replaced (Y/N) Number of sections: 2 Description: <i>Replaced Both sections</i>
Visual Observations Visible Contamination (Y/N): Iron Staining (Y/N): Oily Sediment/Soil (Y/N): Distressed Vegetation (Y/N): Sheen Present on Water (Y/N): Is the Boom containing the Sheen? (Y/N): Pooled Product (Y/N): If yes, was product removed with sorbent pads?	
Location of Visible Contamination: <div style="display: flex; align-items: flex-start;"> <div style="flex: 1;"> <p><u>Legend</u></p> <p>//// Sheen</p> <p>\\\\ Oily Sediment</p> <p>xxx Distressed Veg.</p> <p>RRR Iron Staining</p> <p>● Pooled Product</p> </div> <div style="flex: 2;">

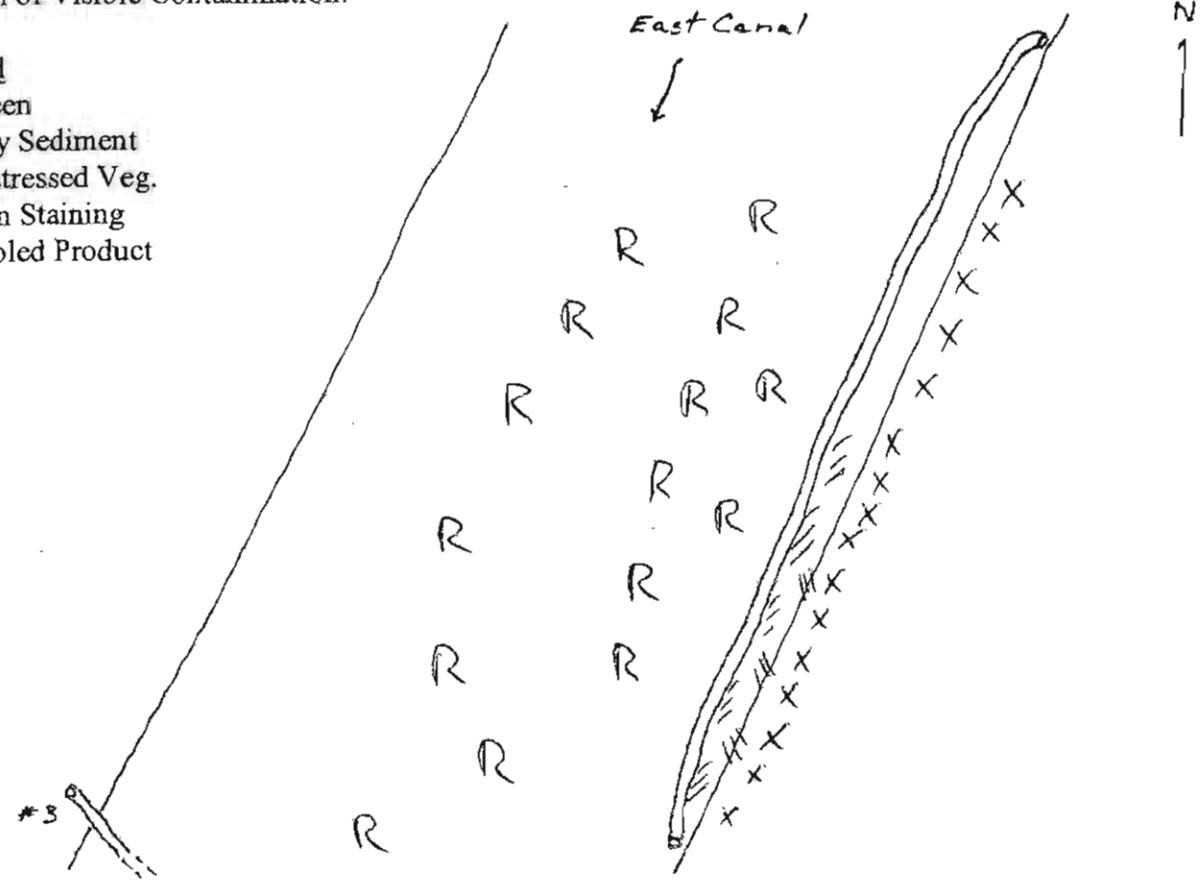
Boom Location: 8	Time/Date: <div style="text-align: center; font-size: 1.2em;">5-17-12</div>
Description of Boom Before Maintenance: <i>Unsatifactory, water logged</i>	Photograph (s) Time/Date Stamp: <div style="text-align: center; font-size: 1.2em;">1503 5-17-12</div>
Boom Repaired (Y/N): Description: <i>Boom Replaced</i>	Boom Replaced (Y/N) Number of sections: 12 Description: <i>Replaced all sections</i>
Visual Observations	
Visible Contamination (Y/N): Iron Staining (Y/N): Oily Sediment/Soil (Y/N): Distressed Vegetation (Y/N):	Sheen Present on Water (Y/N): Is the Boom containing the Sheen? (Y/N): Pooled Product (Y/N): If yes, was product removed with sorbent pads?
Location of Visible Contamination:	
<p><u>Legend</u></p> <p>//// Sheen</p> <p>\\\\ Oily Sediment</p> <p>xxx Distressed Veg.</p> <p>RRR Iron Staining</p> <p>● Pooled Product</p>

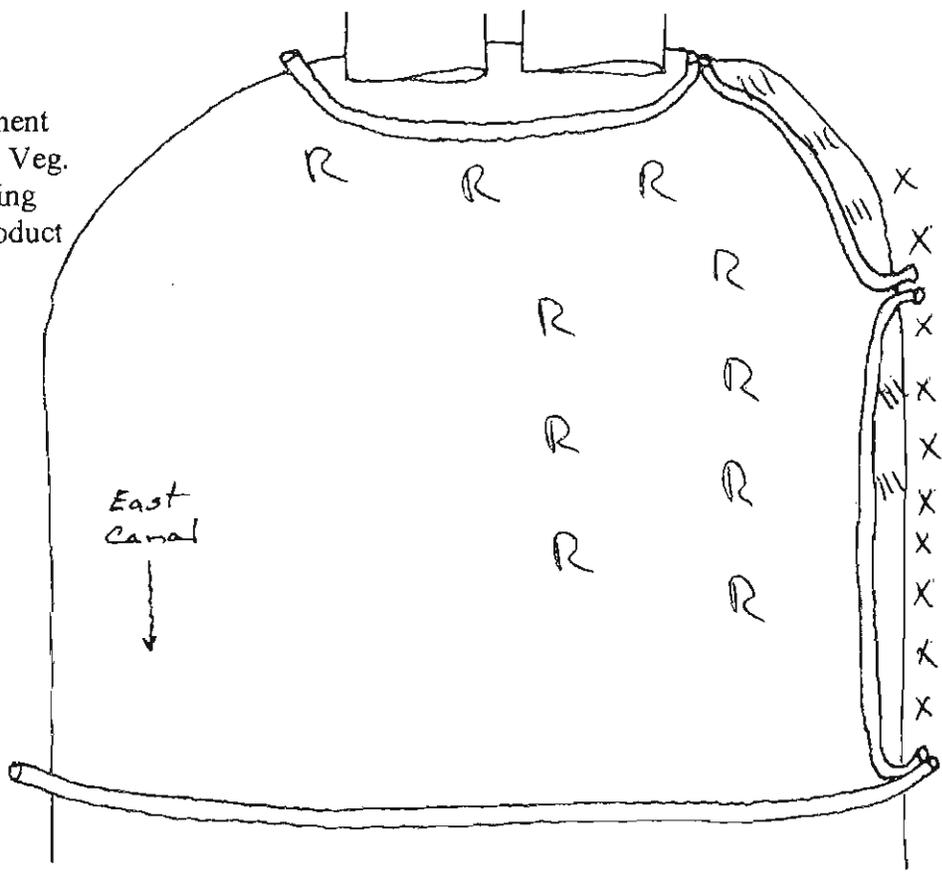
Boom Location: 9/12	Time/Date: 5-17-12
Description of Boom Before Maintenance: Unsat's factory, waterlogged	Photograph (s) Time/Date Stamp: 1505 5-17-12
Boom Repaired (Y/N): Description: Boom Replaced	Boom Replaced (Y/N) Number of Sections: 24 Description: Replaced all sections
Visual Observations	
Visible Contamination (Y/N): Iron Staining (Y/N): Oily Sediment/Soil (Y/N): Distressed Vegetation (Y/N):	Sheen Present on Water (Y/N): Is the Boom containing the Sheen? (Y/N): Pooled Product (Y/N): If yes, was product removed with sorbent pads?
Location of Visible Contamination:	
<p><u>Legend</u></p> <p>//// Sheen</p> <p> Oily Sediment</p> <p>xxx Distressed Veg.</p> <p>RRR Iron Staining</p> <p>● Pooled Product</p>

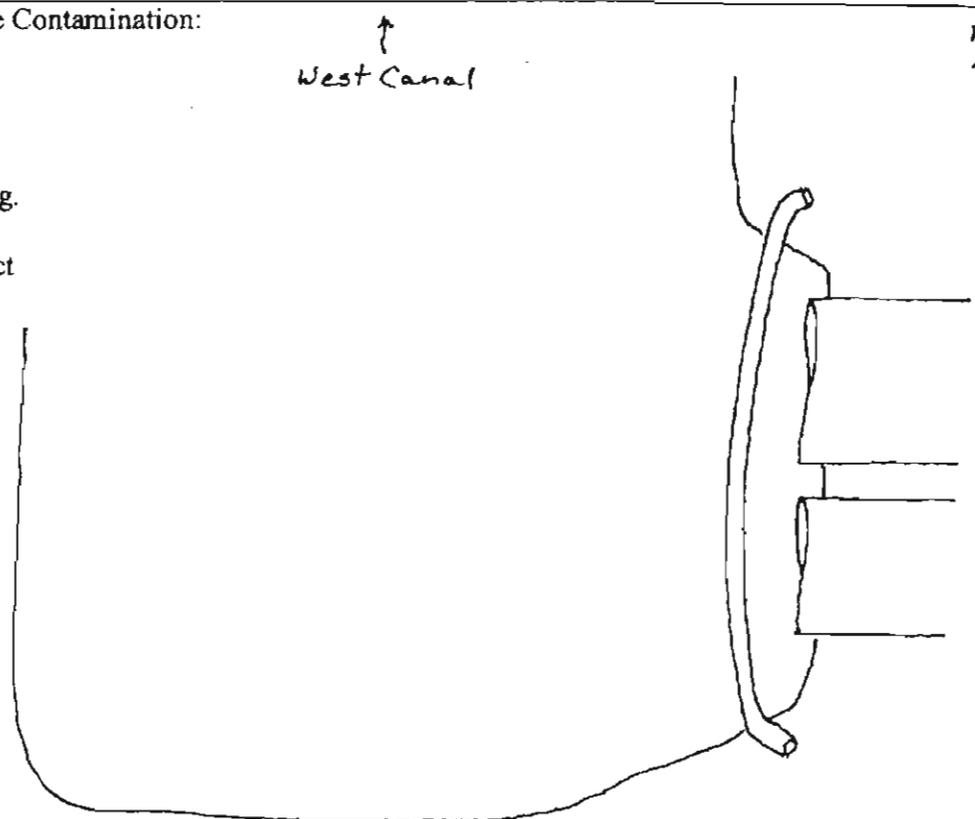
Boom Location: 4	Time/Date: 16:04 8/1/12
Description of Boom Before Maintenance: UNSATISFACTORY	Photograph (s) Time/Date Stamp: 8/1/12
Boom Repaired (Y/N): Description: BOOM WATERLOGGED, REPLACED ALL THREE SECTIONS	Boom Replaced (Y/N) Number of sections: 3 Description: MOVED NEW BOOM INTO POSITION OVER STAKES
Visual Observations Visible Contamination (Y (N)) Iron Staining (Y (N)) Oily Sediment/Soil (Y (N)) Distressed Vegetation (Y (N))	
Sheen Present on Water (Y (N)) Is the Boom containing the Sheen? (Y / N): Pooled Product (Y (N)) If yes, was product removed with sorbent pads?	
Location of Visible Contamination:	
Legend /// Sheen \\\ Oily Sediment xxx Distressed Veg. RRR Iron Staining ● Pooled Product	↑ West Canal

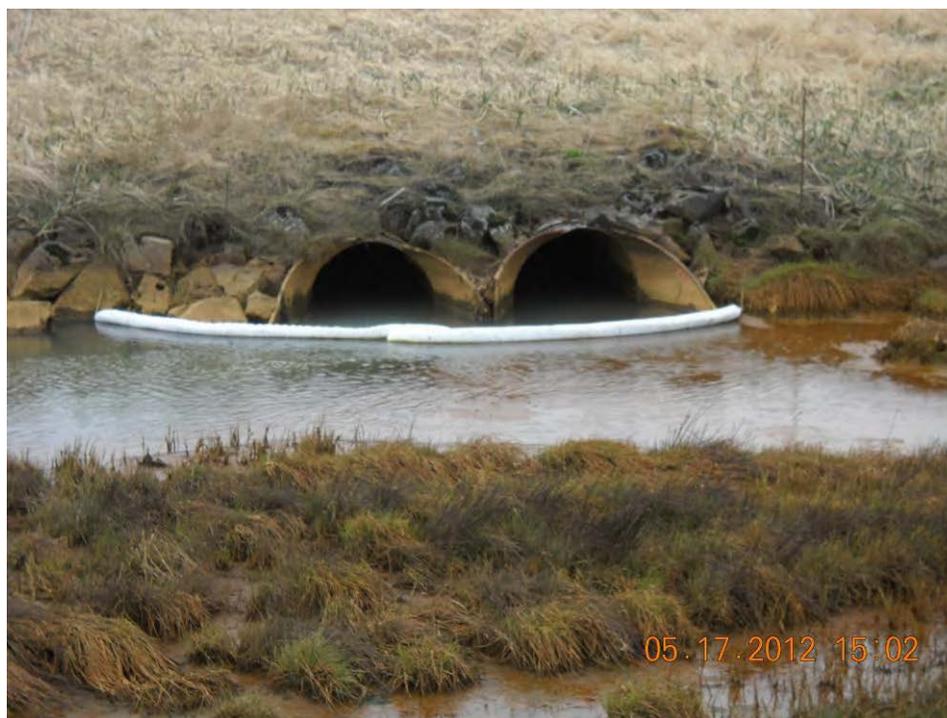
Photo 1 – East Canal Boom 2, May 2012, view west; new boom section with iron staining visible

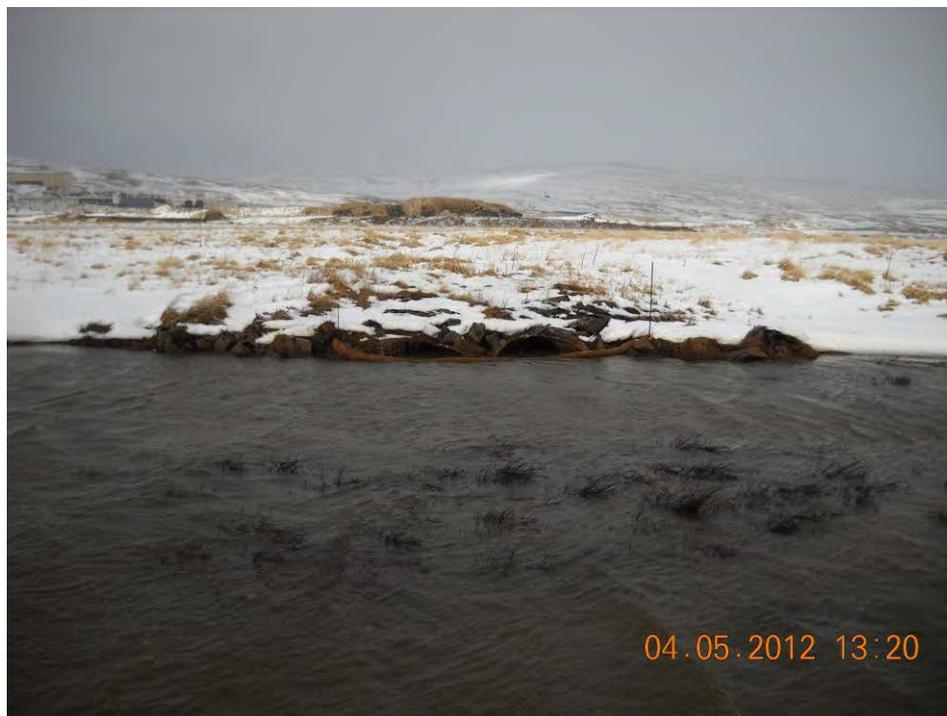
Photo 2 – East Canal Boom 2, April 2012, view west; high water level in canal while the canal pumps were off

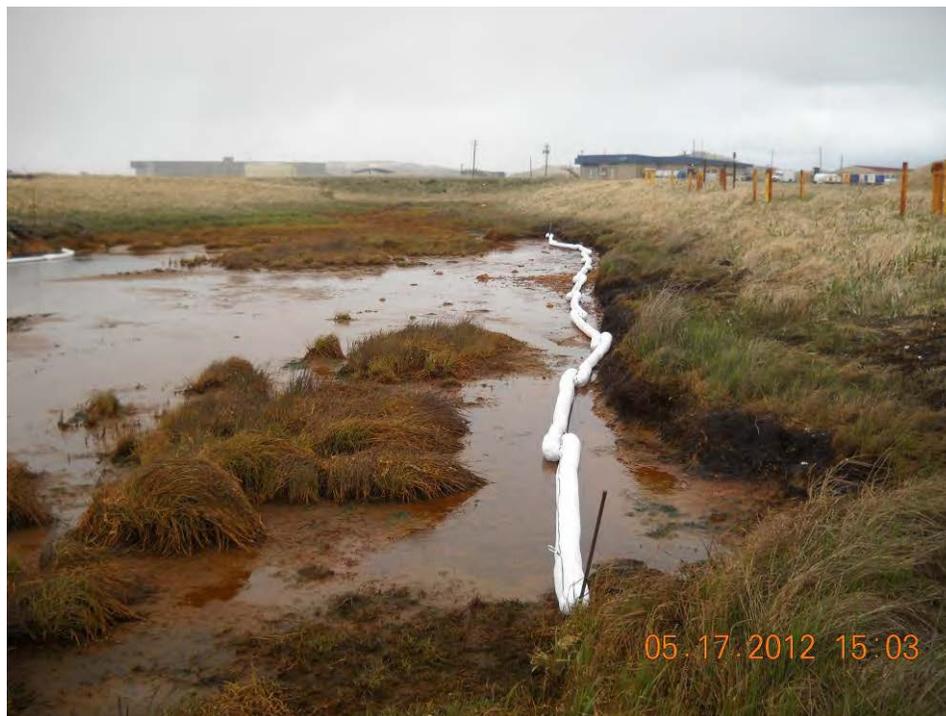
Photo 7 – East Canal Boom 8, May 2012, view north; newly replaced boom with iron staining visible

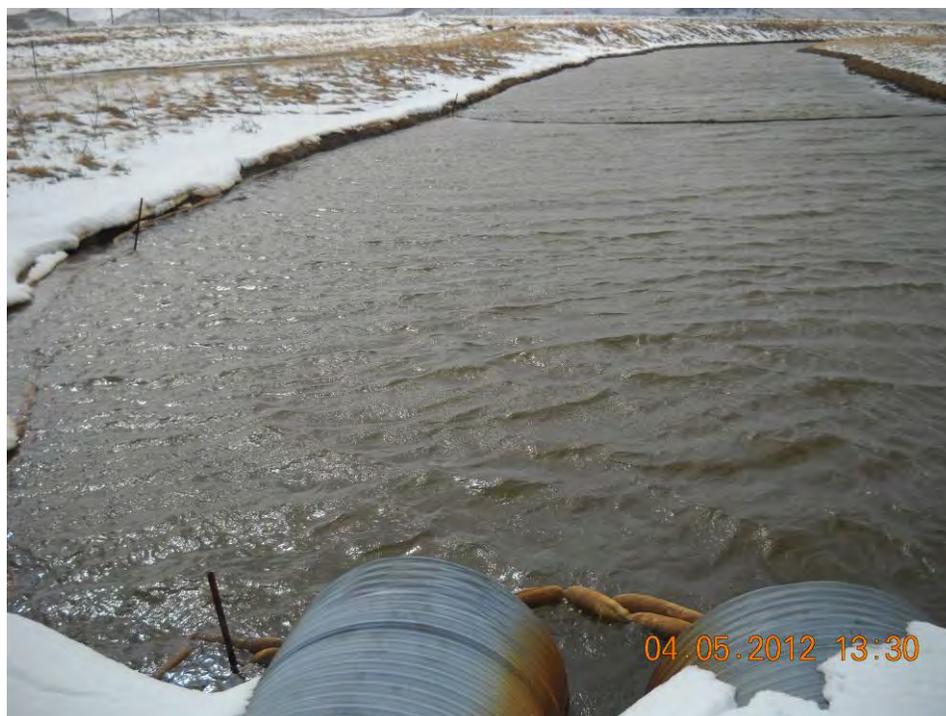
Photo 8 – East Canal Boom 9/12, April 2012, looking south showing partially submerged boom

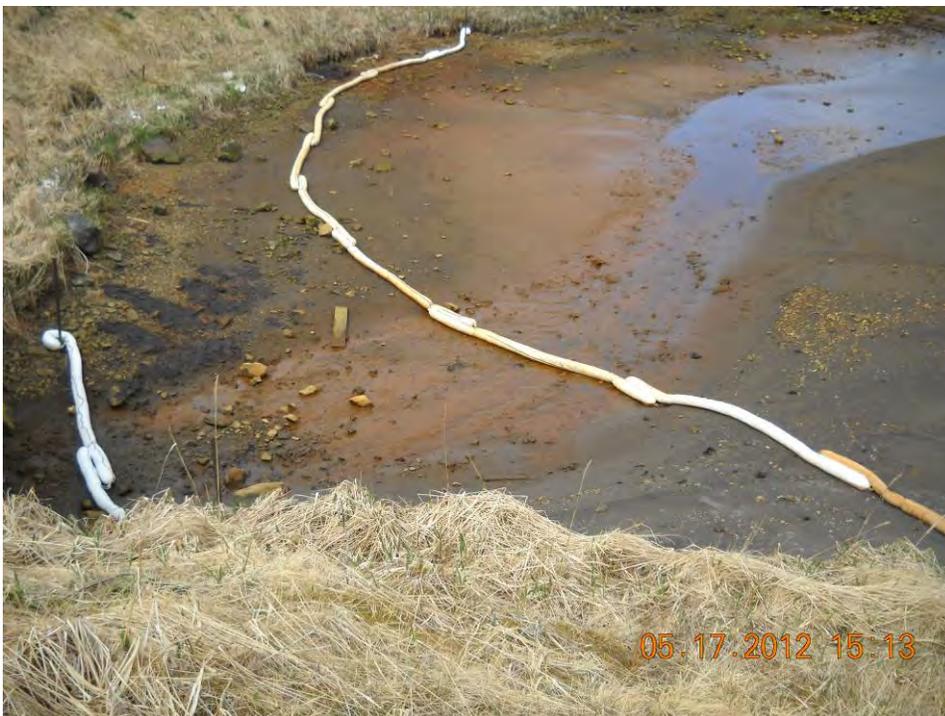
Photo 10 – Sweeper Creek Boom 10, May 2012, looking northwest showing oil and iron staining

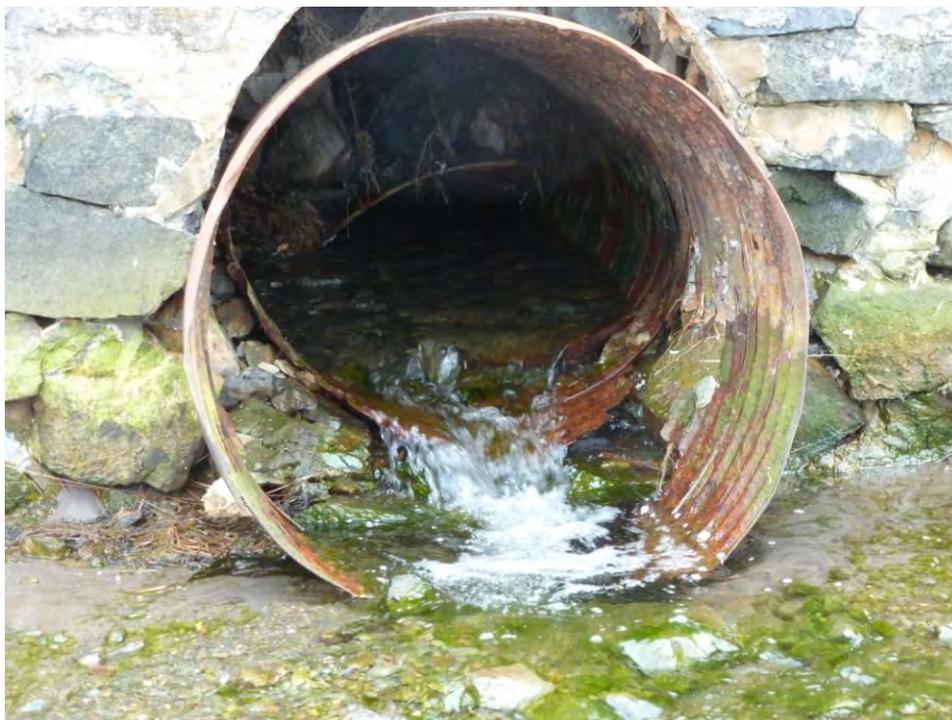
Photo 11 – Sweeper Creek Boom 10, April 2012, looking south showing collapsed culvert

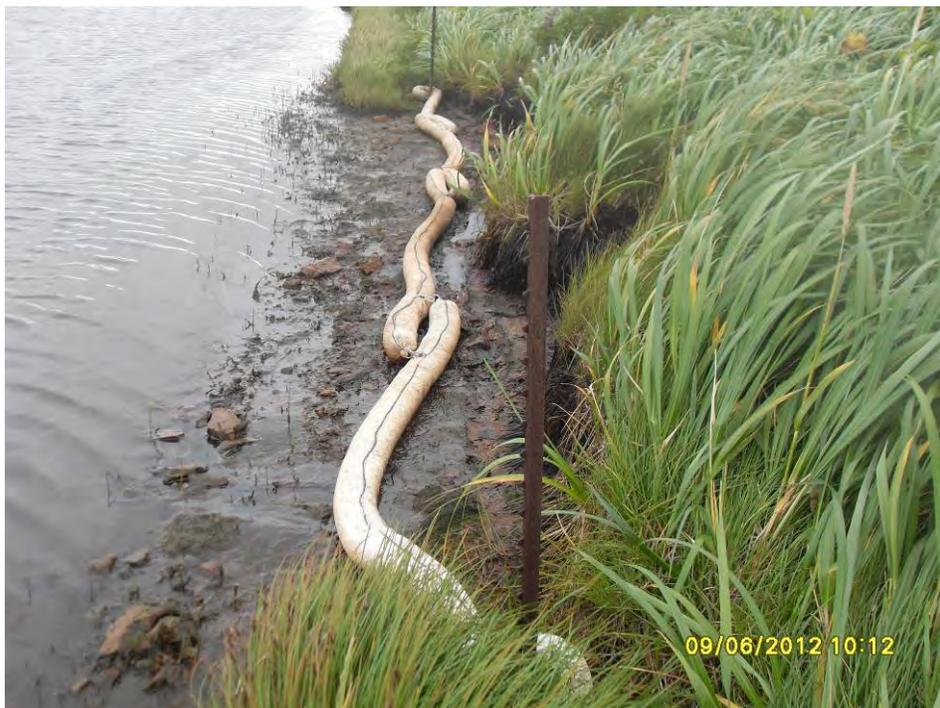
Photo 12 – East Canal Boom 11, September 2012, looking north showing petroleum staining on shoreline
