2012 Institutional Controls Site Inspection Report

Operable Units A and B-1

Former Naval Complex

Adak, Alaska

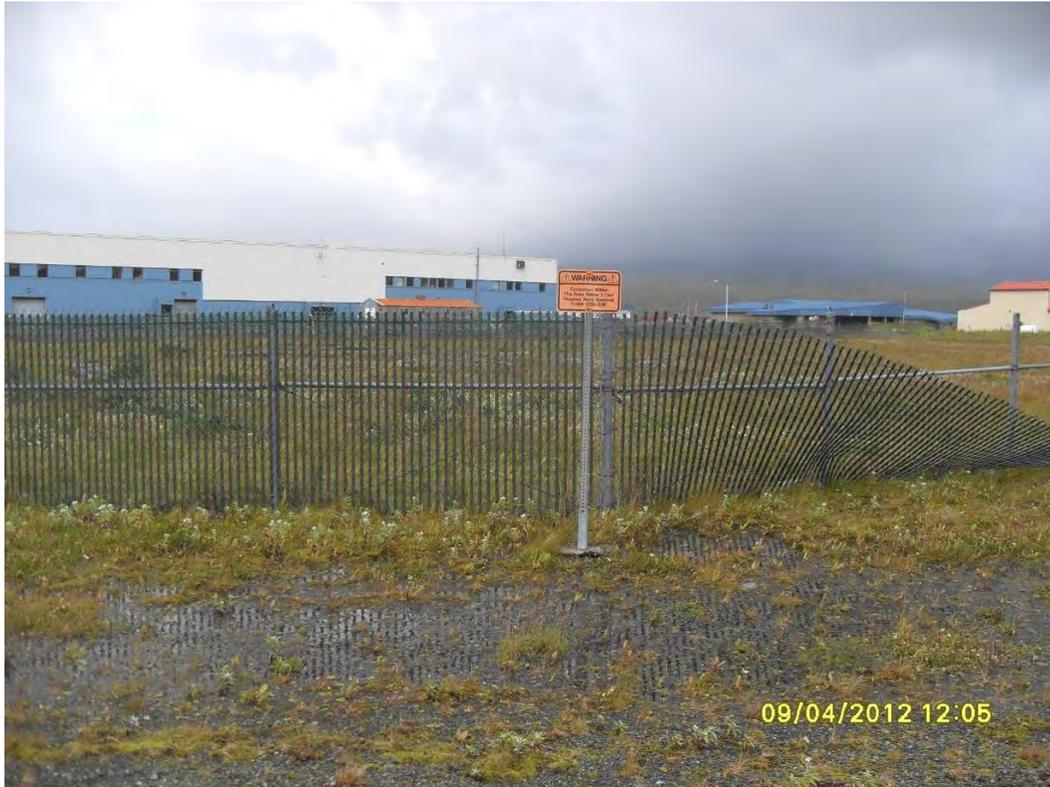
During the September 4, 2012 inspection, no changes to the site were observed compared to the 2011 inspection results. The site appeared to be used as a storage location for cement cinder blocks. No residential construction had occurred at the site (Photograph 2-1).

Photograph 2-1. SWMU 10, Old Baler Building - looking northwest. The fence in the photograph was installed by the land user and is not an IC requirement.

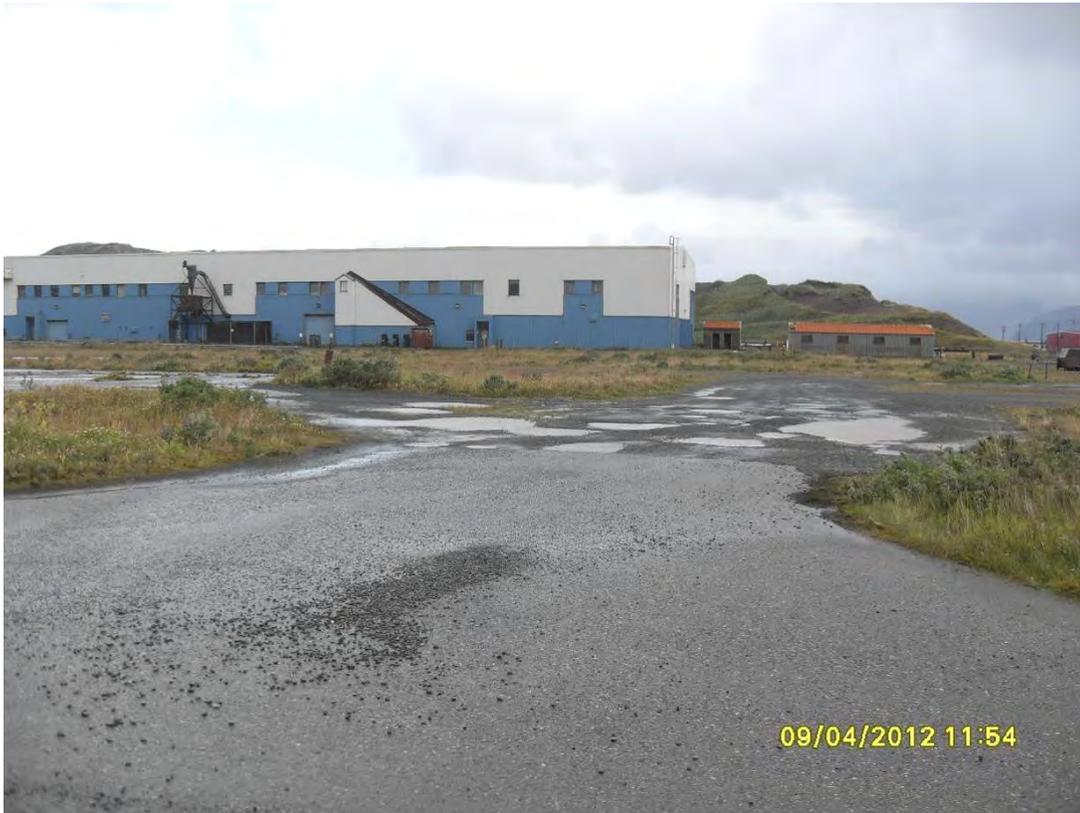
Photograph 2-2. SWMU 14, Old Pesticide Disposal Area – looking east

During the inspection on September 4, 2012, no changes to the site were observed compared to the 2011 inspection results. The site did not appear to be in use. No residential construction had occurred at the site. No indications of groundwater use or excavation activities were found at the site. The ICs required at this location include soil excavation restriction. There were no signs present on the site, but several signs were located in the near vicinity of the site. Therefore, all ICs appear to be functioning as intended.

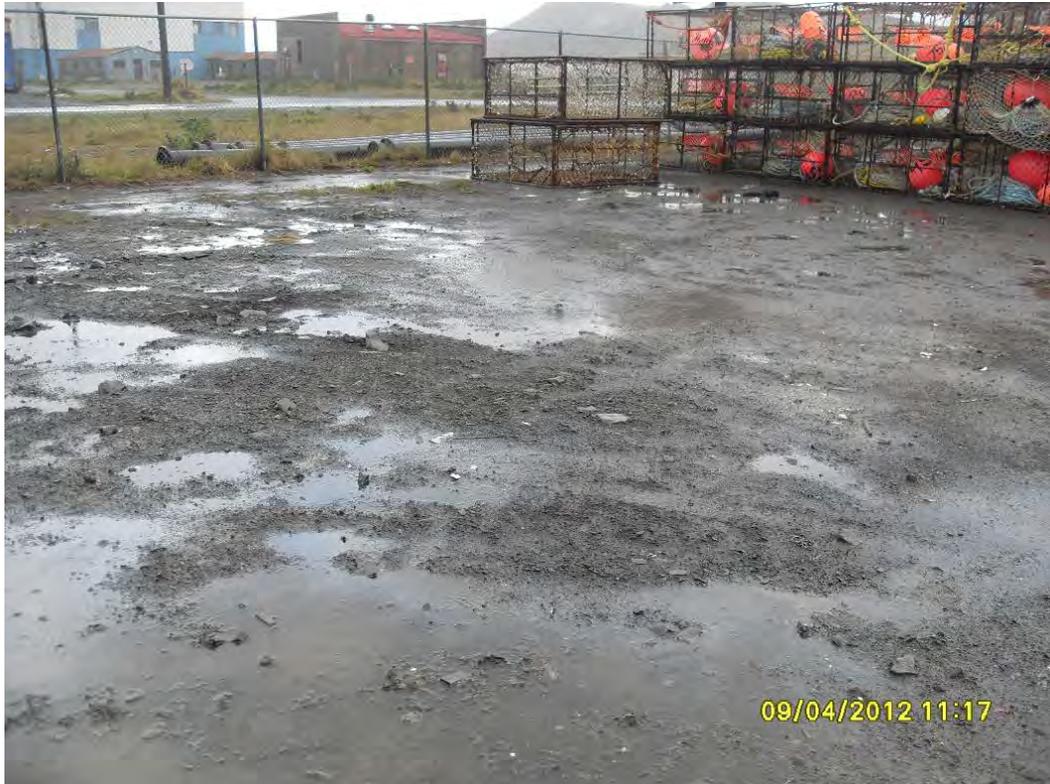
The site is currently being used to store fishing equipment. All 55-gallon drums, debris, and vehicles observed onsite in 2011 and placed there by the current users have been removed from the site. During the inspection on September 4, 2013, puddles of water with slight petroleum sheen were observed in same area as the oily stained areas observed in 2011 (Photograph 2-3). The puddles prevented observing if the petroleum staining remains at this location.

Photograph 2-3. SWMU 15, Future Jobs/Defense Reutilization Marketing Office – looking northeast at the location where drums were stored onsite and staining was observed in 2011. Sheen was observed in the puddles in the foreground.

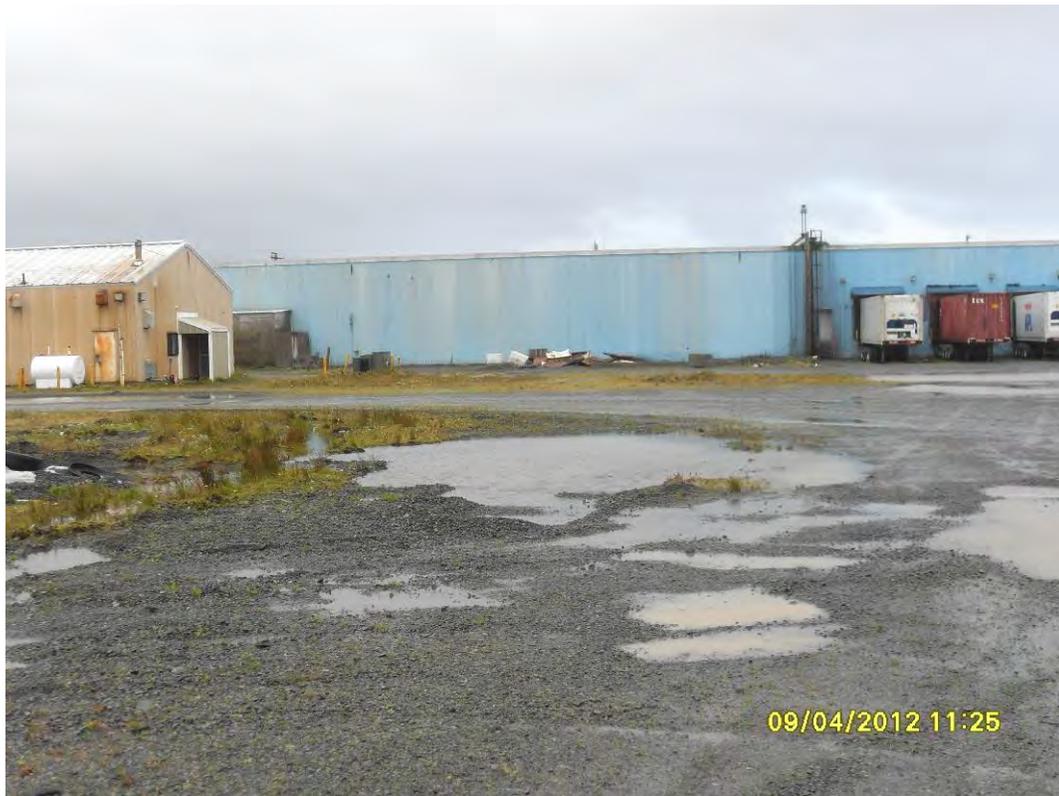
The aboveground storage tank (AST), 55-gallon drums of fuel, and oil-stained soil (not associated with Navy activities) located near well MW15-424 have been removed from the site. A pile of gravel fill covered by poly-sheeting is now located here. There was no obvious area of excavation but new gravel appears to have been spread where the oil-staining was observed last year (Photograph 2-4). The oily stained soil observed at this location during the 2011 inspections was not observed during the 2012 inspection.

Photograph 2-4. SWMU 15, Future Jobs/Defense Reutilization Marketing Office - looking west where the AST, drums and stained soil was located south of site during the 2011 inspection.

Two pallets of 5-gallon containers of unknown contents were observed adjacent to the blue shed northwest of the site (Figure 2-1). The excavation restriction sign installed in 2010 is missing, and it is recommended that it be replaced. No indications of groundwater use or excavation activities were found. Housekeeping practices onsite are improved and appear adequate. However, potentially contaminated soil remaining onsite may be impacting underlying groundwater. It is recommended that housekeeping practices continue to be monitored at this site.

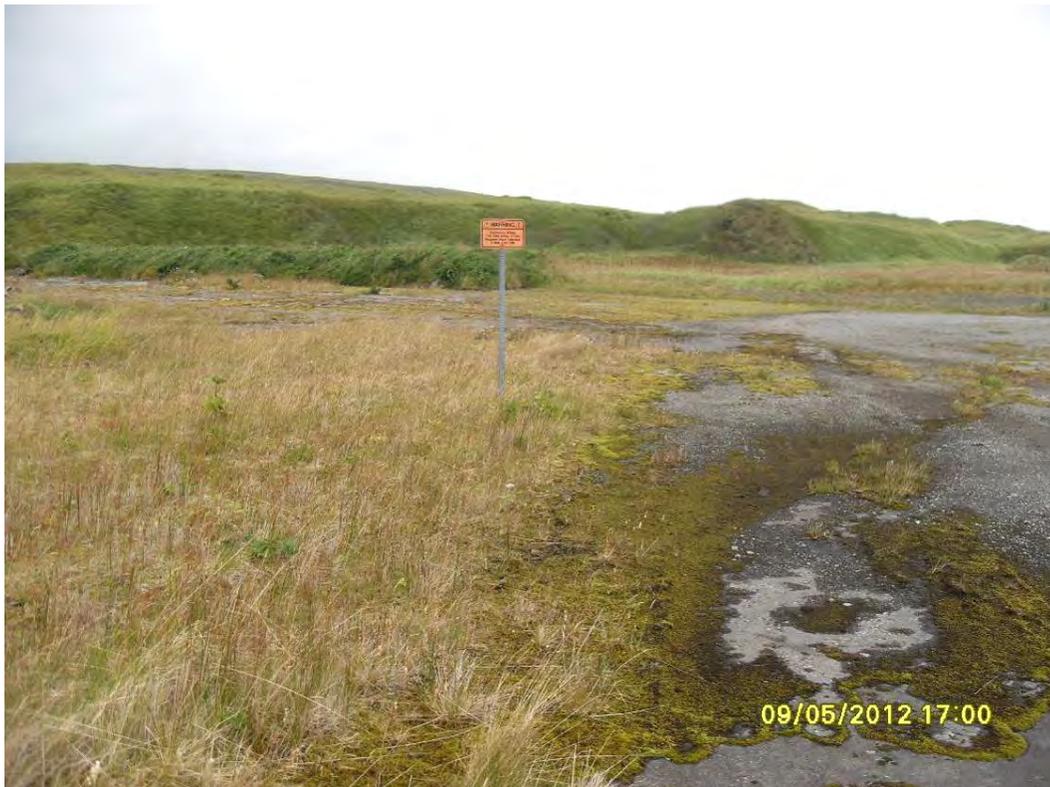
During the September 5, 2012 inspection, no changes to the site were observed compared to the 2011 inspection results. The site did not appear to be in use. No residential construction had occurred at the site. No indications of groundwater use or excavation activities were found. The sign is located approximately 100 feet from the road and is legible (see Photograph 2-5). The ICs appear to be functioning as intended in the OU A ROD to protect human receptors from exposure to contaminated soil or groundwater.

Photograph 2-5. SWMU 16, Former Firefighting Training Area – looking northwest

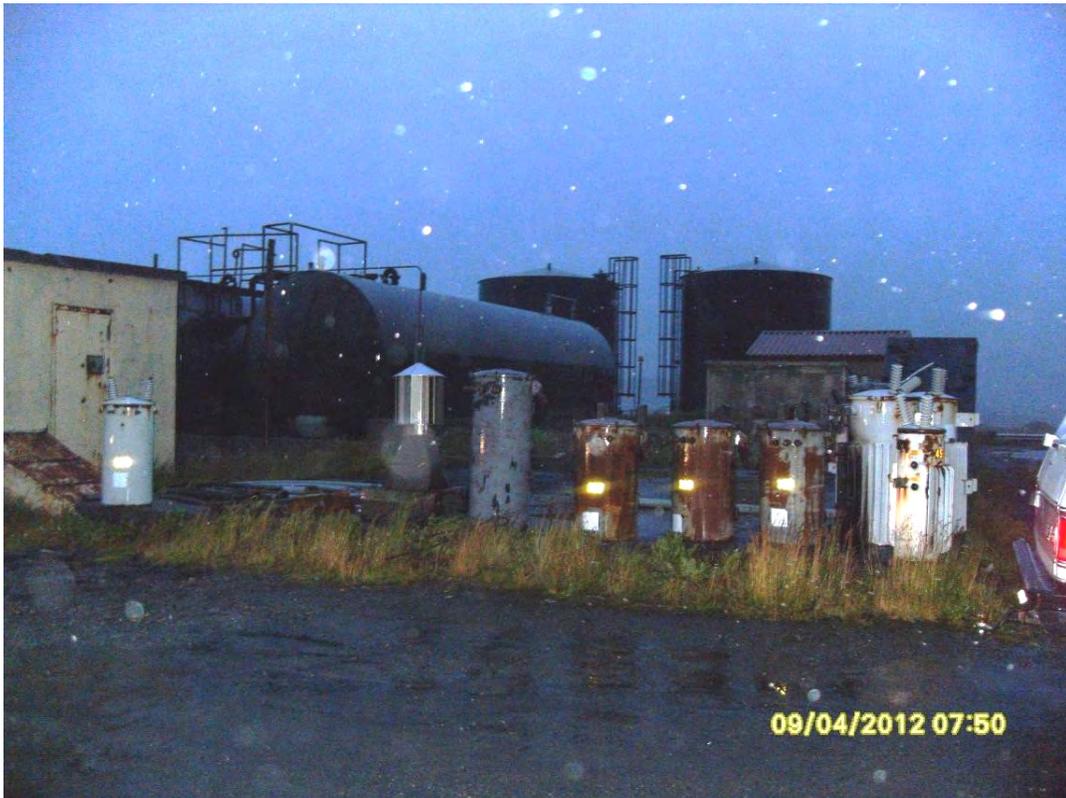
Photograph 2-6. SWMU 17, Power Plant No. 3 Area – looking east at transformers stored next to AST secondary containment.

The oily soil approximately 6 feet in diameter that was observed during the 2011 inspection and located west of the AST secondary containment was not observed in 2012. Large pieces of equipment were staged in this area preventing a complete inspection. The 150 crushed drums and two large transformers observed in the AST secondary containment in 2011 were again observed in 2012. Seven additional large transformers (approximately 50 gallons) were observed staged on a concrete pad adjacent and south of the secondary containment. All of these transformers were observed to have "No PCBs" stickers (Photograph 2-6, Figure 2-2).

Housekeeping practices have improved at this site but should continue to be monitored. It is recommended that the Treatment Plant Operator be notified to properly remove and dispose of the crushed drums and transformers. It is further recommended that the City be notified of the permit excavation requirement and that the open excavation observed at the site be filled in.

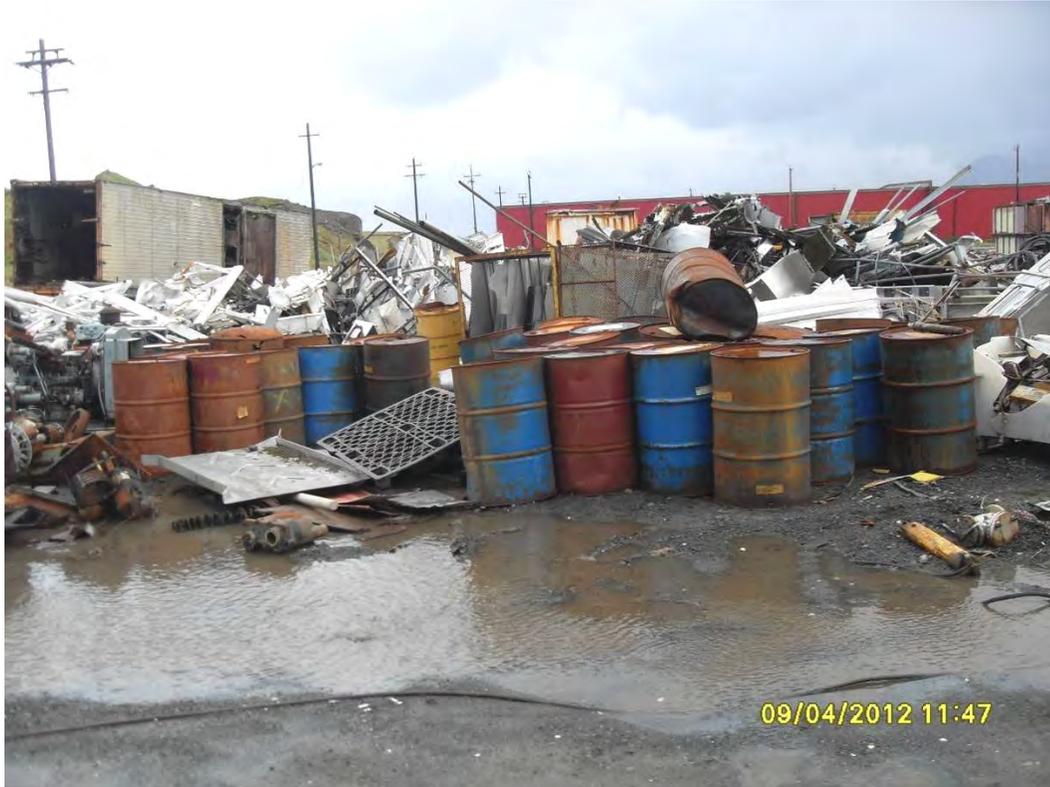
have been more segregated by material type (i.e., wood, metal, electronics, vehicles, etc.). TAC is currently in the process of shipping metal off island for recycling. Due to recent rain, standing water was observed throughout the site and a slight sheen was observed where drums and soil staining was observed during the 2011 inspection (Photograph 2-8, Figure 2-3).

Photograph 2-8. SWMU 55, Public Works Transportation Department Waste Storage Area - looking at numerous 55-gallon drums, ponded water, and debris

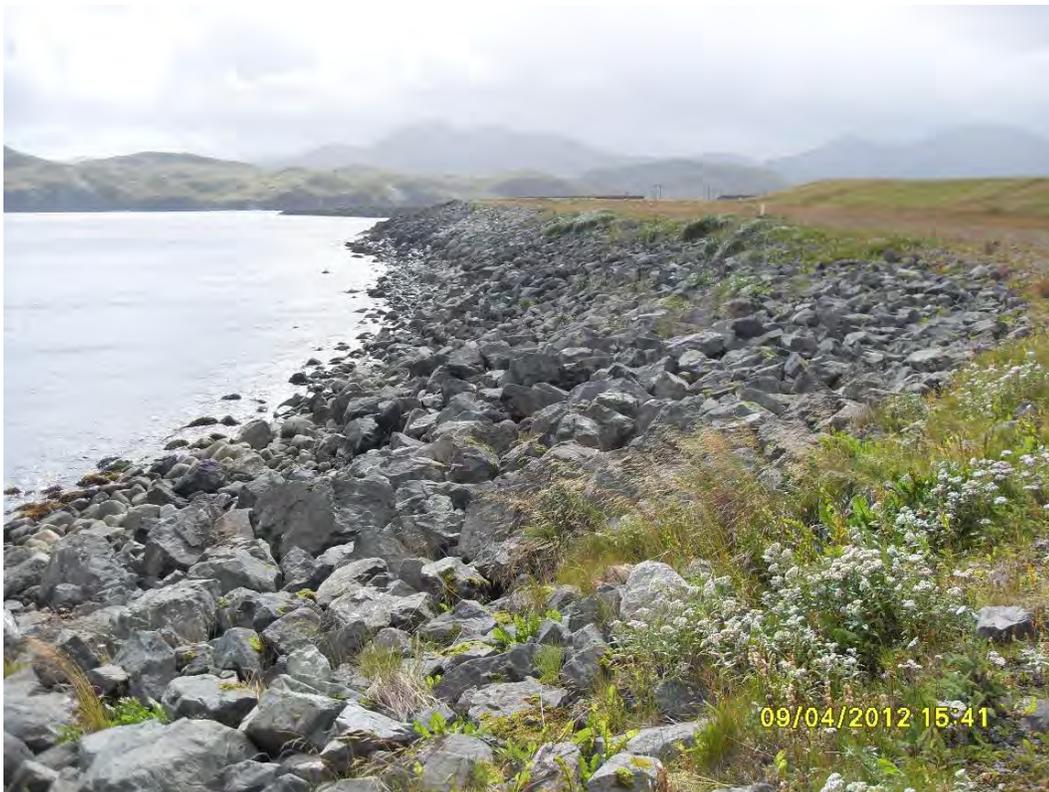
Photograph 2-12. SWMU 13, Metals Landfill – looking south along the landfill armor wall

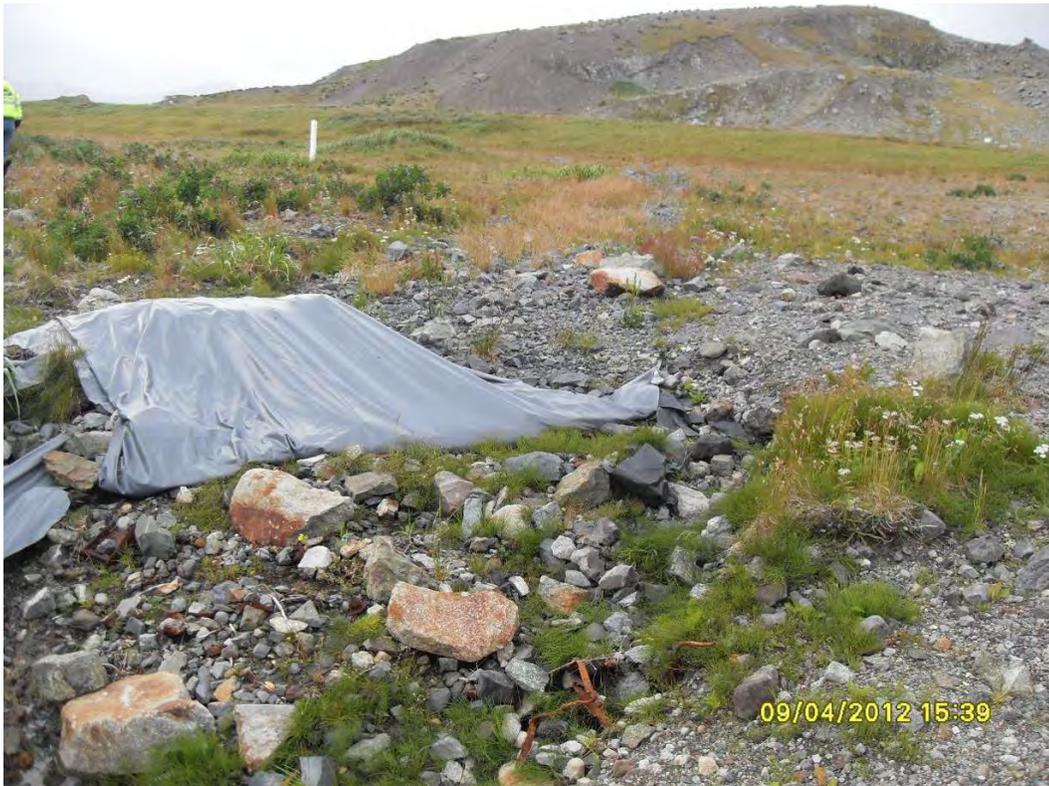
Photograph 2-13. SWMU 13, Metals Landfill – looking northwest at erosion and damaged Swale 6

The northern-most swale, Swale 7, is eroding at the cliff and the liner is exposed. As observed in 2011, Swale 6 north of monitoring well 13-2 is eroding at the cliff, and the liner is exposed and torn (Photograph 2-13, Figure 2-4). The remaining swales were observed to be in good condition. Small amounts of metal debris were visible throughout the armor wall

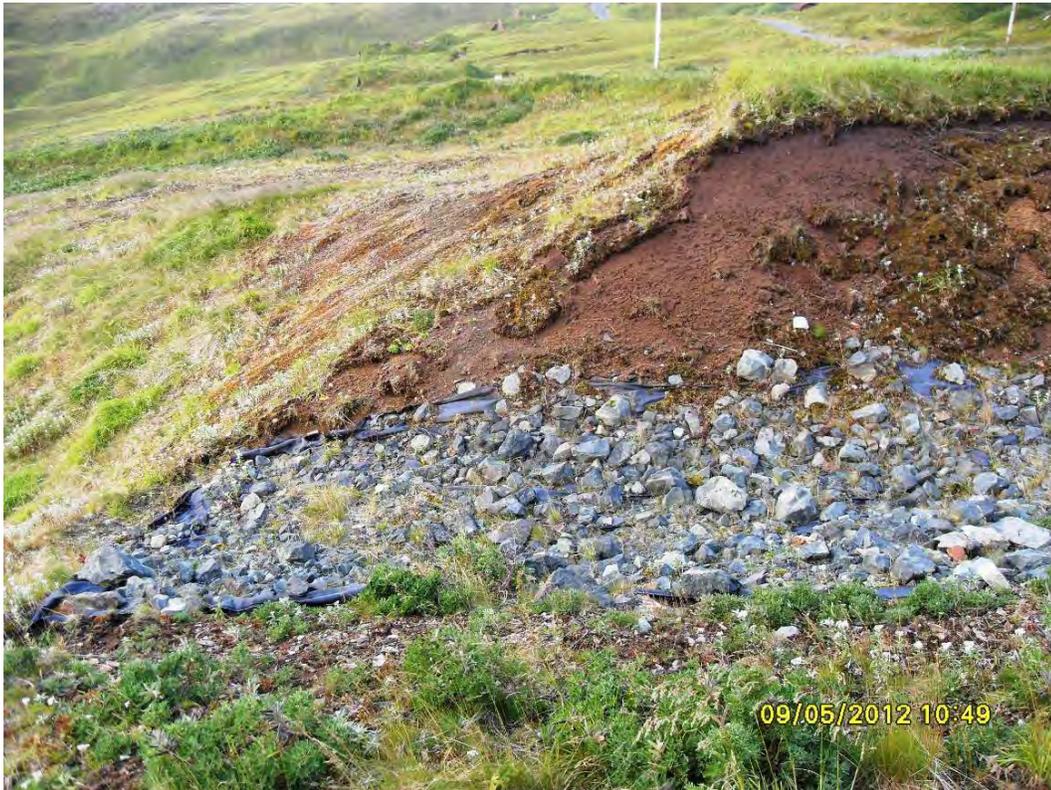
During the 2009 through 2011 inspections, a large, sparsely vegetated area was noted in the central portion of the landfill. Vegetation in this area shows improvement in that the vegetation was generally thicker and taller than in previous inspections (Photograph 2-14). The two sparsely vegetated areas in the southern portion of the landfill were not observed during the September 5, 2012 inspection. In general, the remainder of the vegetative cap appears adequate.

Photograph 2-15. SWMU 25, Roberts Landfill – looking northwest at sparsely vegetated area near swales

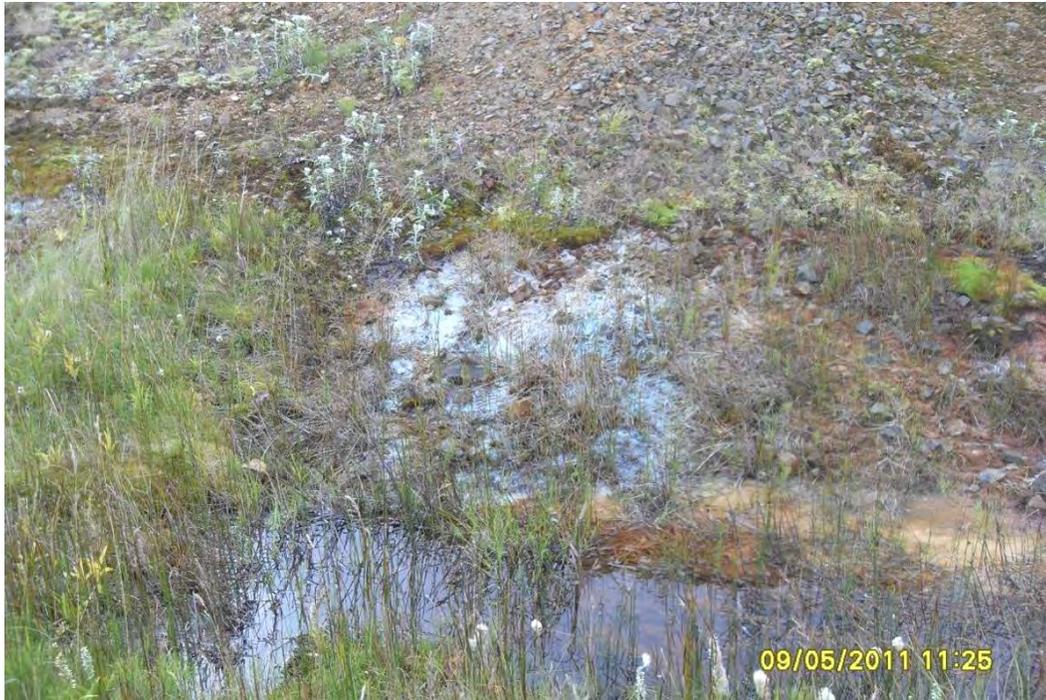
Photograph 2-16. SWMU 25, Roberts Landfill – looking southeast at the blue and white groundwater seep northwest of the landfill

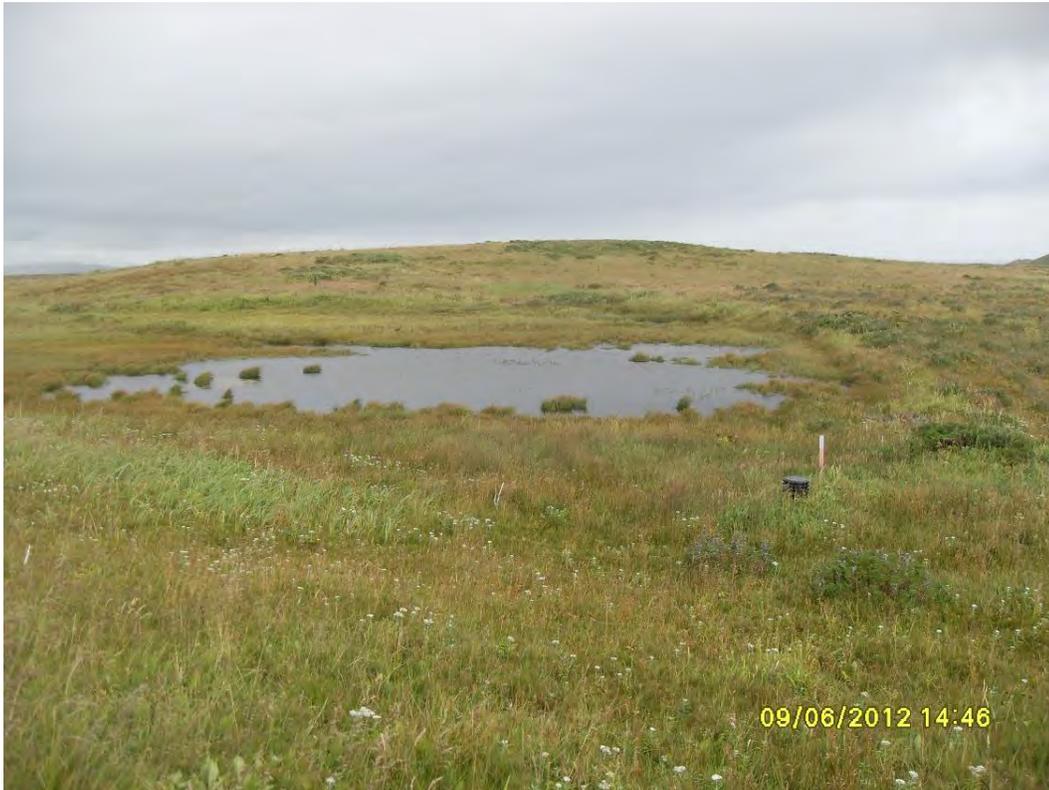
The pond located on the southern portion of the landfill near the gates that was observed during the 2009, 2010, and 2011 inspections was still present during the September 5, 2012 site inspection. The pond footprint is approximately 70 feet in diameter and water levels were elevated compared to 2011 levels due to recent wet weather. As previously determined, the pond is not thought to be located on the landfill cap or impacting its integrity.

Photograph 2-17. SWMU 25, Roberts Landfill – looking northeast at the pond and PVC drainage pipe

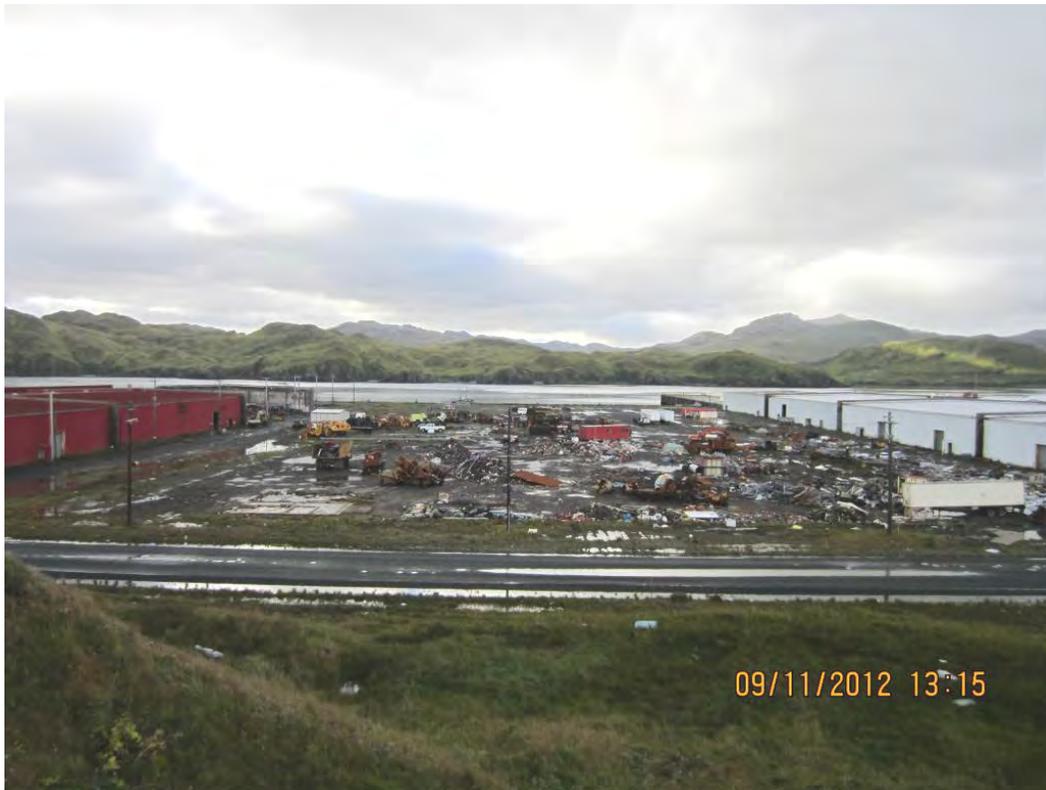
contained a large quantity of containers was no longer present during the 2012 inspection. The pink connex box containing 5-gallon containers and underlying stained soil still remains at the site. There is no restricted access or soil barrier at the site. While no evidence of excavation was noted during the inspection, the large amount of debris at the site prevented certain confirmation that unauthorized excavation has not occurred.

Photograph 2-18. SWMU 24, Hazardous Waste Storage Facility – looking south

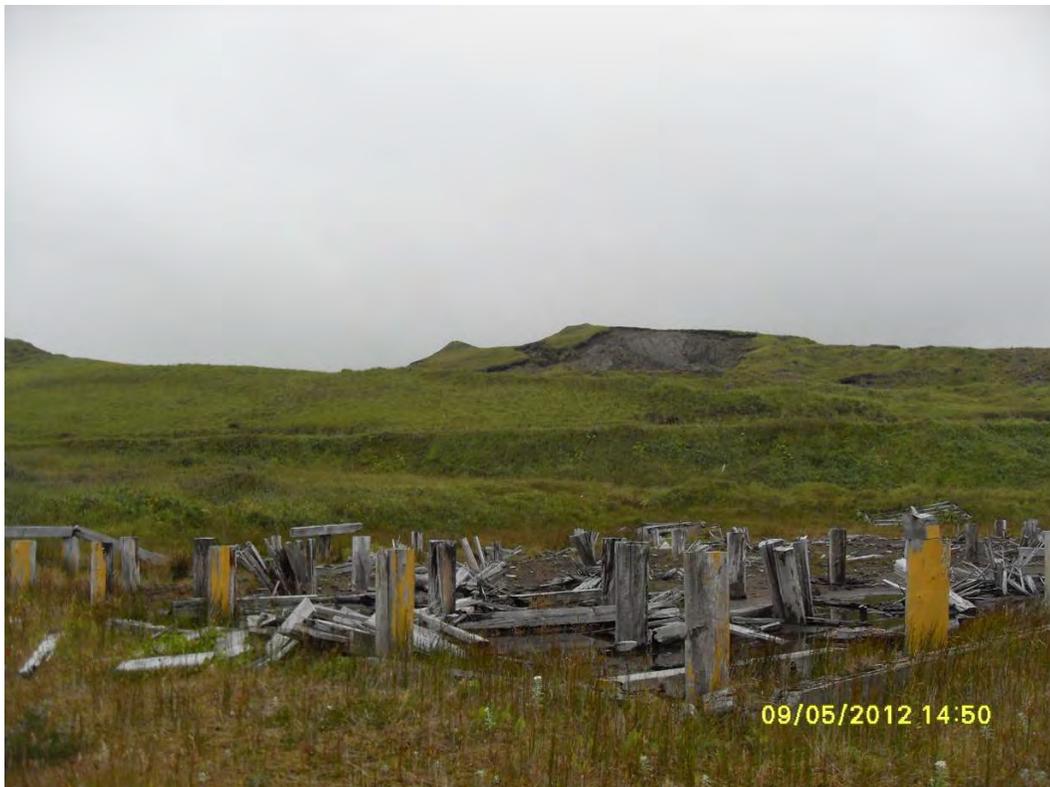
Photograph 2-26. SWMU 60, Tank Farm A - looking west at removed truck fueling platform

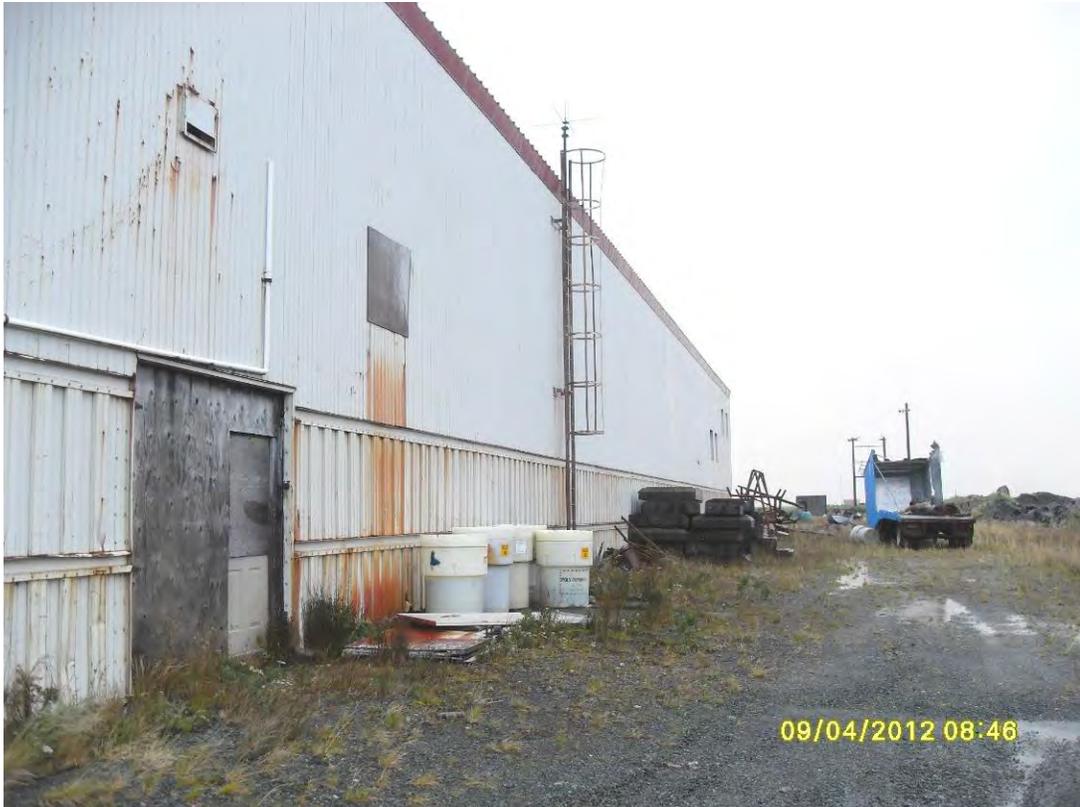
Photograph 2-30. NMCB Building Area – looking east toward drums stored on the south side of the building

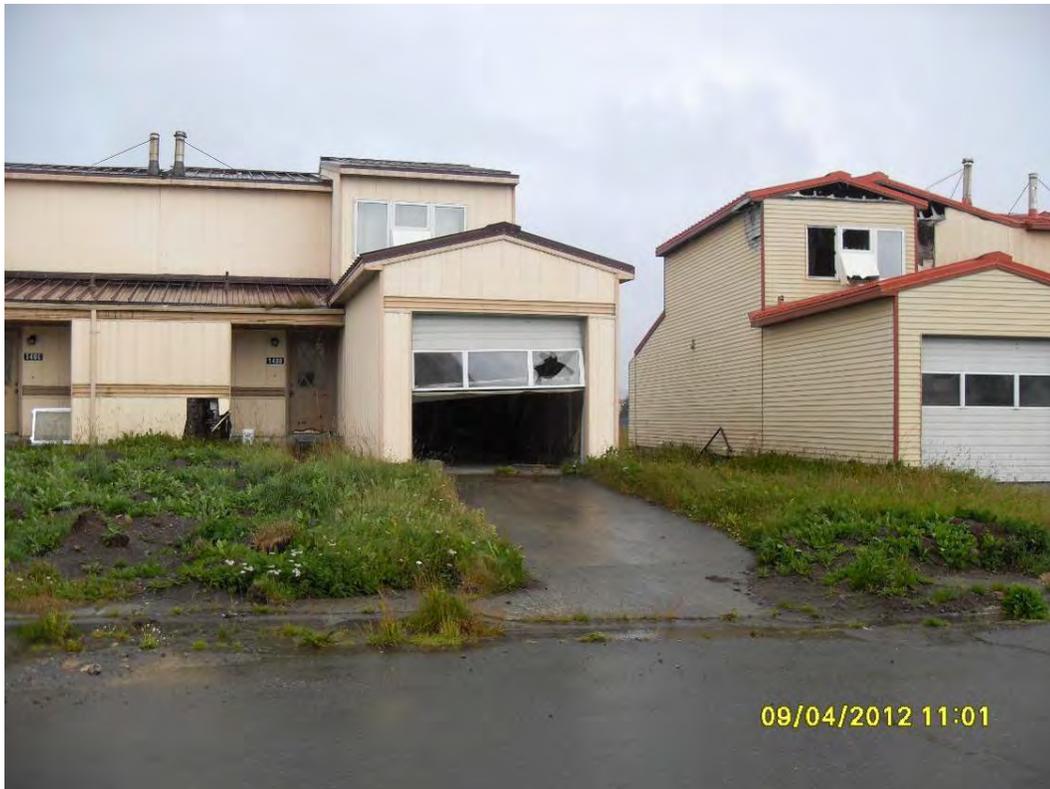
Photograph 2-33. SWMU 62, New Housing Fuel Leak – Housing unit 140D with excavated areas looking west

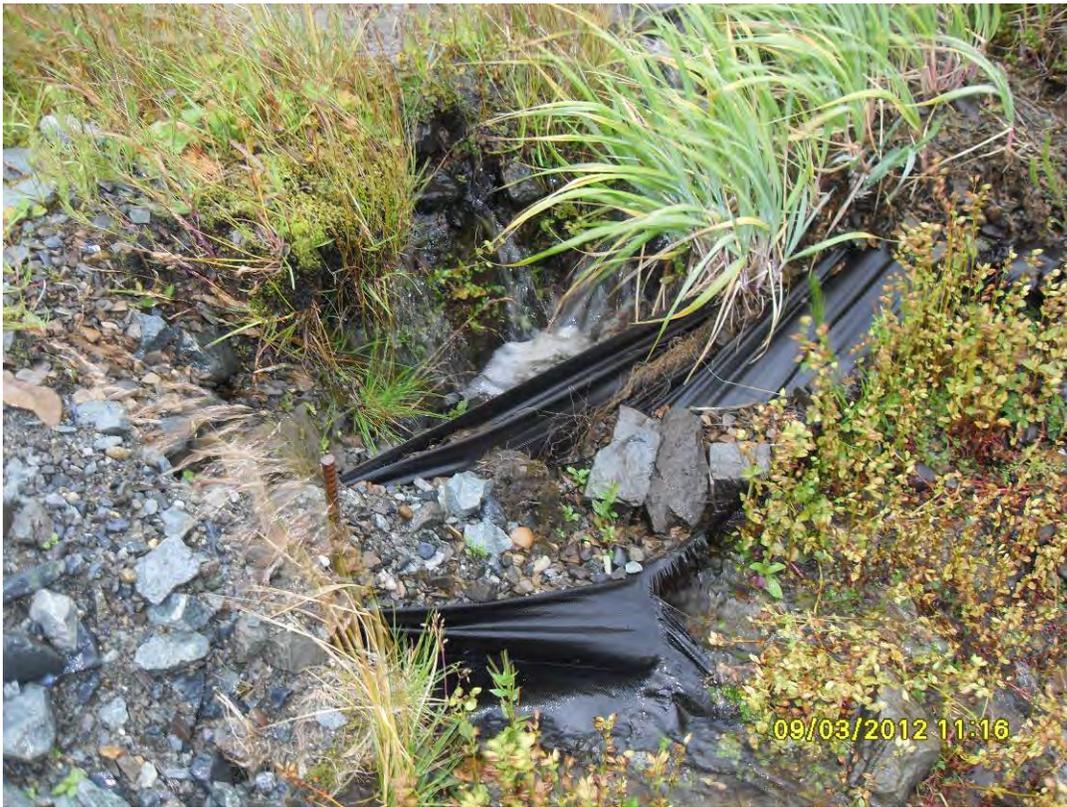
Photograph 3-7. SWMU 4, South Davis Road Landfill - looking northwest at west end of northern swale erosion

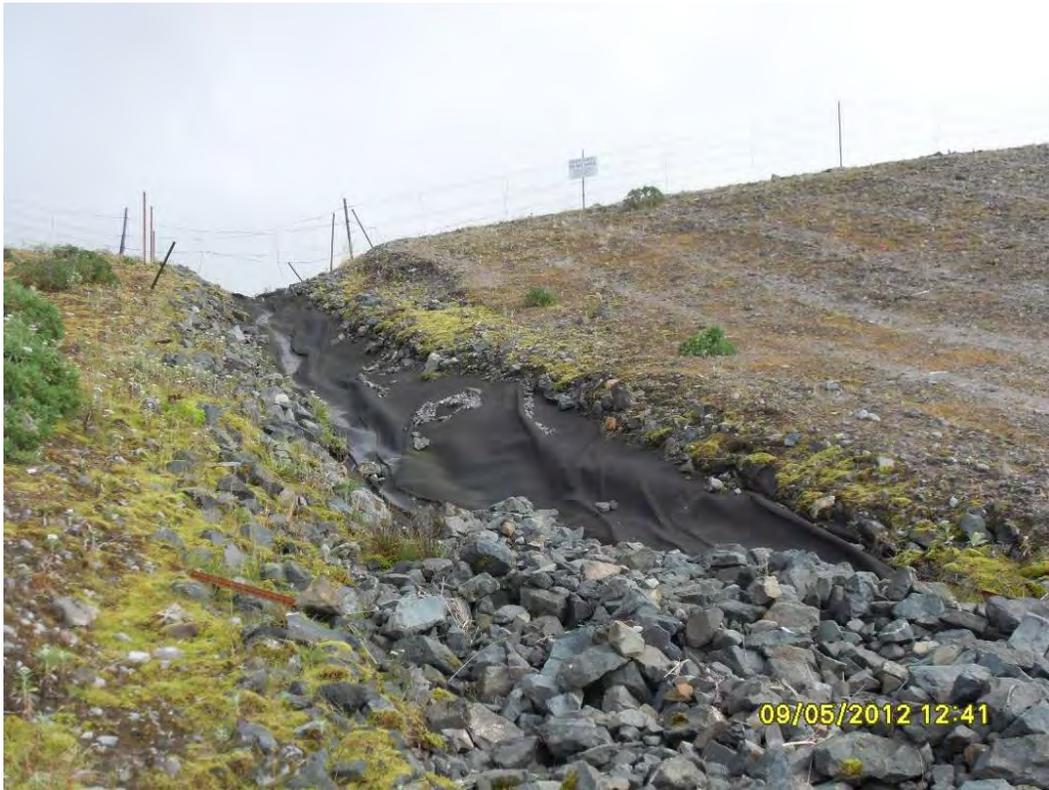
Photograph 3-9. SWMUs 18 and 19, White Alice Landfill – looking north at southern swale with exposed liner

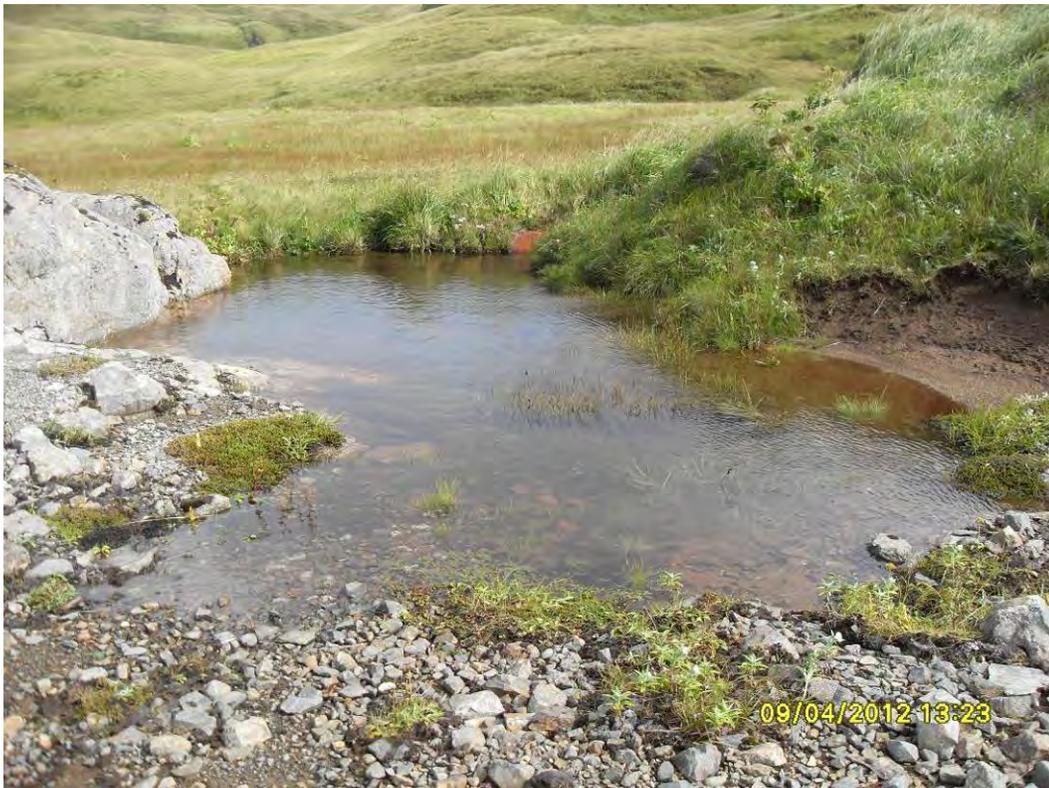
Photograph 3-11. SWMU 29, Finger Bay Landfill – ponded water with debris on central portion of landfill

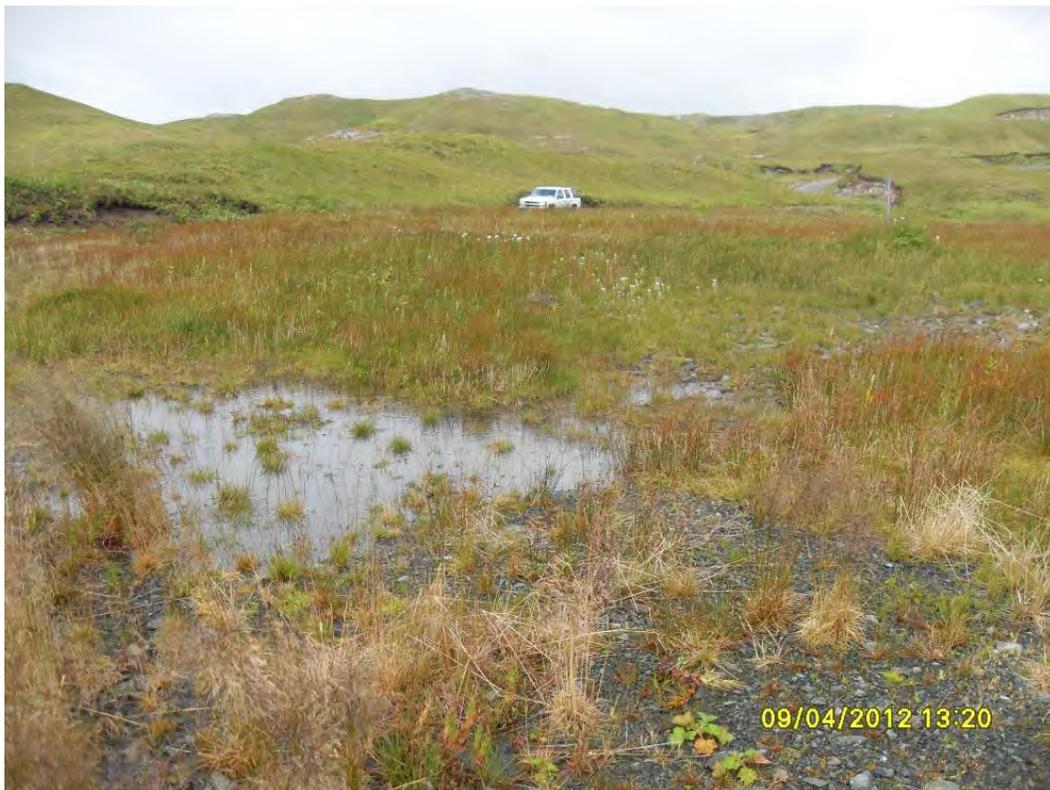
Photograph 3-12. SWMU 29, Finger Bay Landfill – looking west at the former seep location

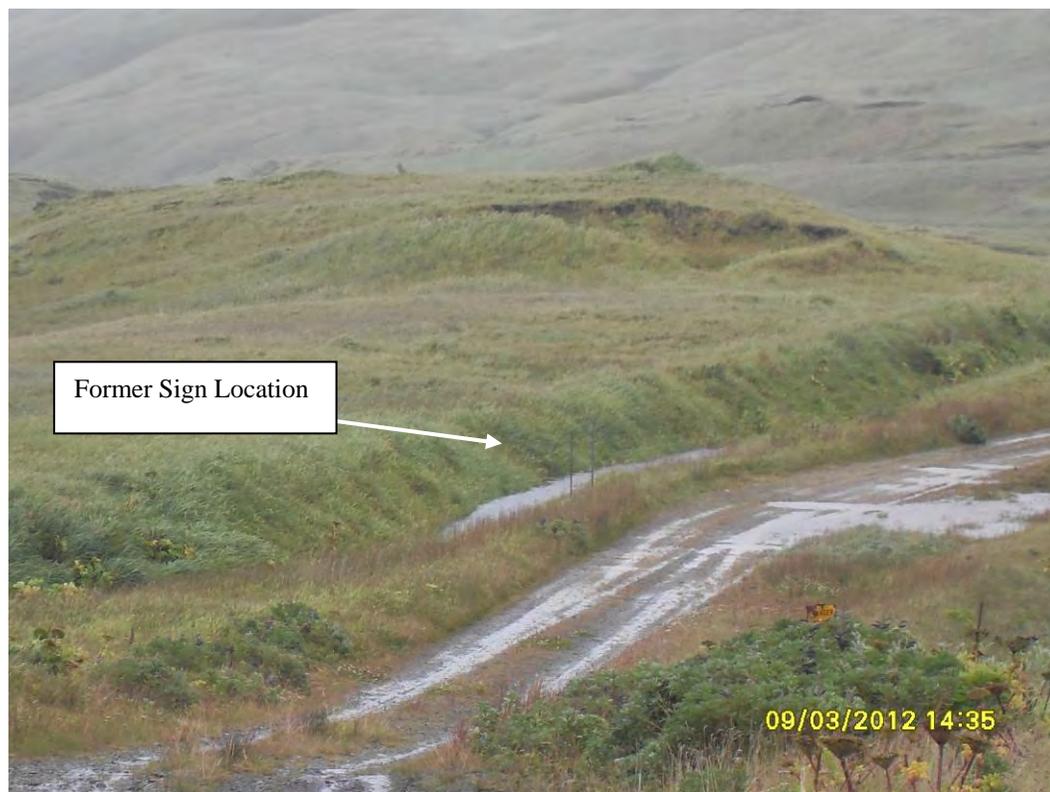
Photograph 3-24. SWMU 1, Andrew Lake Waste Ordnance Demolition Range (Parcel 4) – south entrance road looking north towards missing UXO warning sign
