# **Remedial Action Summary Report Free Product Recovery**

SWMU 62 New Housing Fuel Leak Area,  
Area 303, and Additional Sites

## **Former Naval Complex**

Adak, Alaska

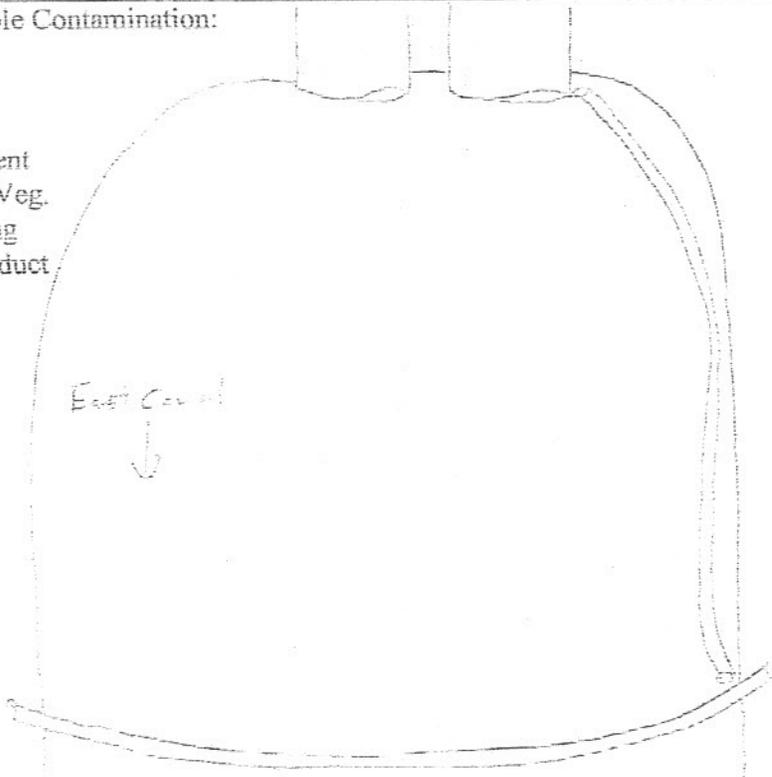
Boom Location: 9/12	Time/Date: 1530/3-7-14
Description of Boom Before Maintenance: SATISFACTORY. (2) CLIP UNDONE IN CENTER. WILL BE REPAIRED OR REPLACED IN APRIL EVENT	Photograph (s) Time/Date Stamp: 1530/3-7-14
Boom Repaired (Y (N)) Description:	Boom Replaced (Y (N)) / Number of Sections: Description:
<p><b>Visual Observations</b></p> <p>Visible Contamination (Y (N))</p> <p>Iron Staining (Y (N))</p> <p>Oily Sediment/Soil (Y (N))</p> <p>Distressed Vegetation (Y (N))</p> <p>Sheen Present on Water (Y (N))</p> <p>Is the Boom Containing the Sheen? (Y / N)</p> <p>Pooled Product (Y (N))</p> <p>If yes, was product removed with sorbent pads?</p>	
<p>Location of Visible Contamination:</p> <p>Legend</p> <p>/// Sheen</p> <p>\\ \\ Oily Sediment</p> <p>xxx Distressed Veg.</p> <p>RRR Iron Staining</p> <p>● Pooled Product</p>

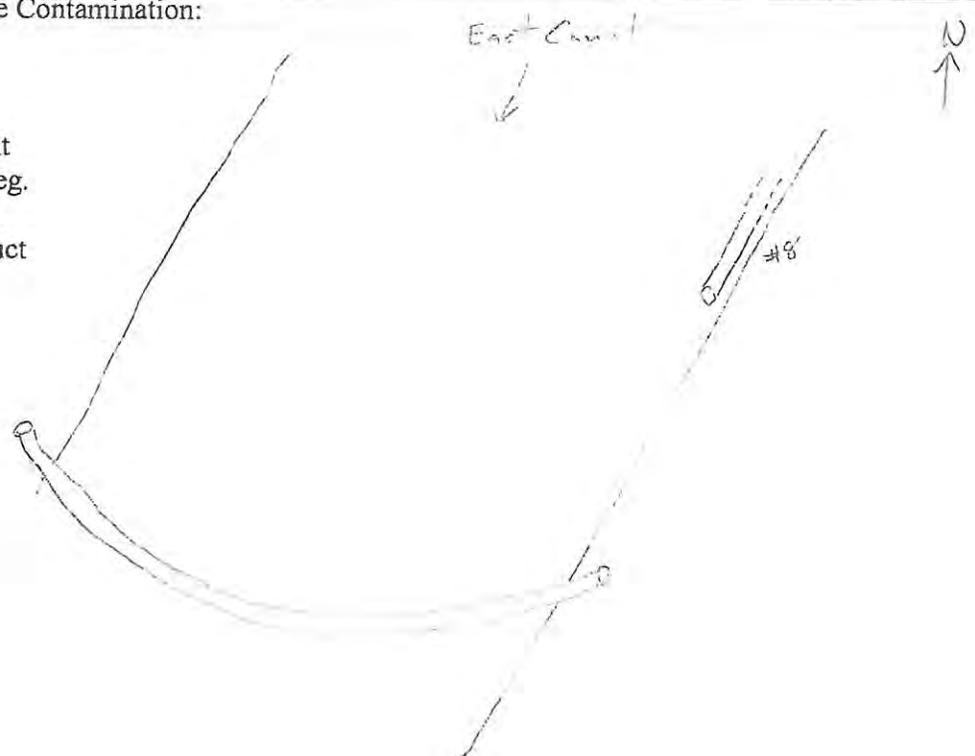
Boom Location: 3	Time/Date: 1021 / 4-9-14
Description of Boom Before Maintenance: UNSATISFACTORY	Photograph (s) Time/Date Stamp: 1021 / 4-9-14
Boom Repaired (Y/N): Description: INSTALLED NEW SECTIONS	Boom Replaced (Y/N) / Number of Sections: 8 Description: REPLACED ALL SECTIONS FOR ANNUAL MAINTENANCE
<b>Visual Observations</b> Visible Contamination (Y/N): Iron Staining (Y/N): Oily Sediment/Soil (Y/N): Distressed Vegetation (Y/N):	
Sheen Present on Water (Y/N): Is the Boom Containing the Sheen? (Y/N) Pooled Product (Y/N): If yes, was product removed with sorbent pads?	
Location of Visible Contamination:  <div style="display: flex; align-items: flex-start;"> <div style="flex: 1;"> <p><u>Legend</u></p> <p>//// Sheen</p> <p>\\ \\ Oily Sediment</p> <p>xxx Distressed Veg.</p> <p>RRR Iron Staining</p> <p>● Pooled Product</p> </div> <div style="flex: 2;">

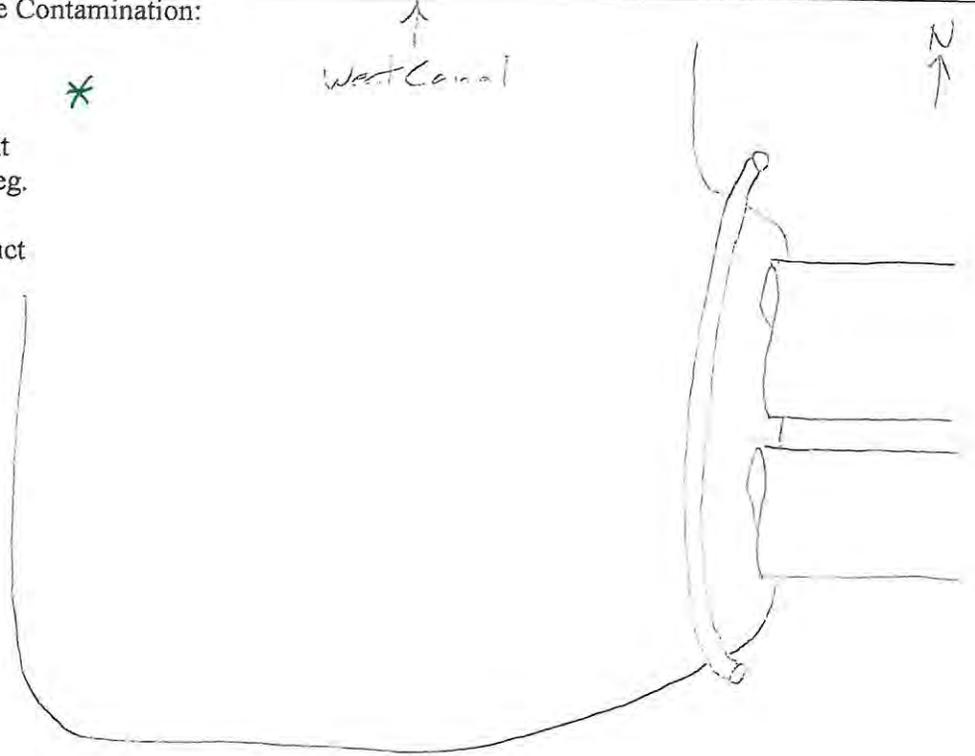
Boom Location: 4	Time/Date: 10 <sup>33</sup> / 4-9-14
* Description of Boom Before Maintenance: REMOVED (3) SECTIONS PERMANENTLY PER NAVY APPROVAL	Photograph (s) Time/Date Stamp: 10 <sup>33</sup> / 4-9-14
Boom Repaired (Y (N)): Description:	Boom Replaced (Y (N)) / Number of Sections: Description:
<p><b>Visual Observations</b></p> <p>Visible Contamination (Y (N))</p> <p>Iron Staining (Y (N))</p> <p>Oily Sediment/Soil (Y (N))</p> <p>Distressed Vegetation (Y (N))</p> <p>Sheen Present on Water (Y (N))</p> <p>Is the Boom Containing the Sheen? (Y / N)</p> <p>Pooled Product (Y (N))</p> <p>If yes, was product removed with sorbent pads?</p>	
<p>Location of Visible Contamination:</p> <p>Legend</p> <ul style="list-style-type: none"> <li>//// Sheen *</li> <li>\\ \\ Oily Sediment</li> <li>xxx Distressed Veg.</li> <li>RRR Iron Staining</li> <li>● Pooled Product</li> </ul>

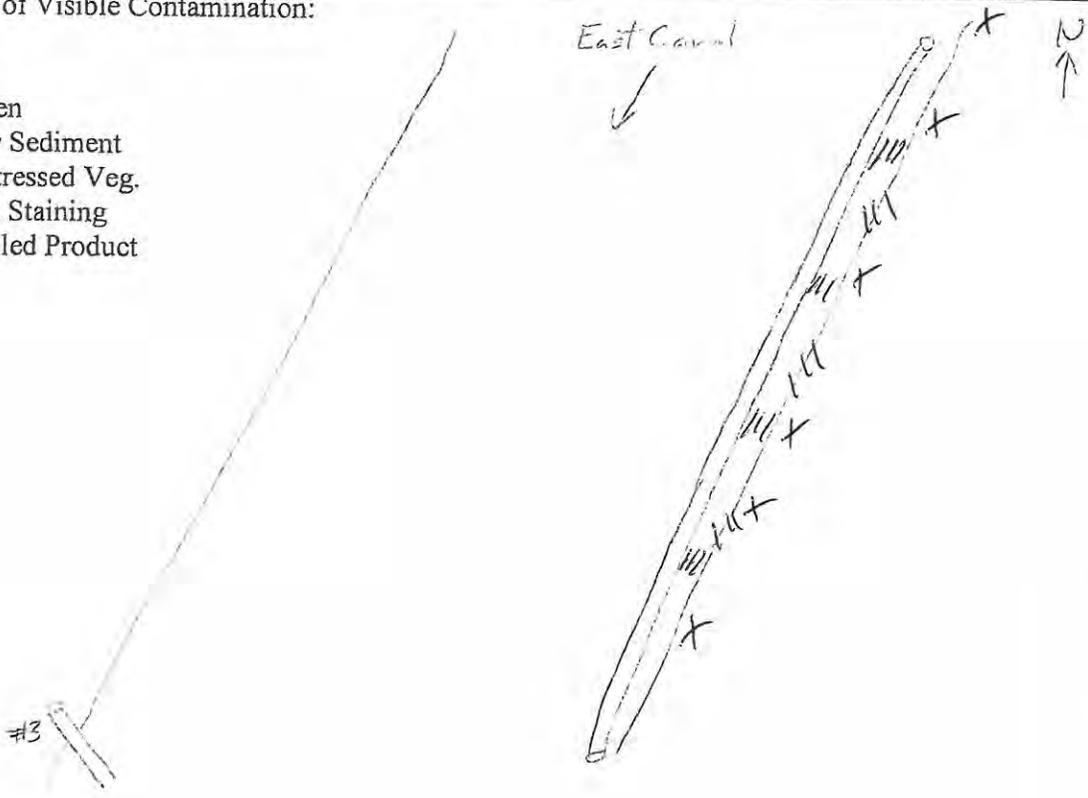
<b>Boom Location: 8</b>	<b>Time/Date:</b> 1021 / 4-9-14
<b>Description of Boom Before Maintenance:</b> UNSATISFACTORY	<b>Photograph (s) Time/Date Stamp:</b> 1021 / 4-9-14
<b>Boom Repaired (Y/N):</b> (Y) <b>Description:</b> INSTALLED NEW SECTIONS	<b>Boom Replaced (Y/N) / Number of Sections:</b> (Y) 12 <b>Description:</b> REPLACED ALL SECTIONS FOR ANNUAL MAINTENANCE
<b>Visual Observations</b>	
<b>Visible Contamination (Y/N):</b> (Y) <b>Iron Staining (Y/N):</b> (Y) <b>Oily Sediment/Soil (Y/N):</b> (Y) <b>Distressed Vegetation (Y/N):</b> (Y)	<b>Sheen Present on Water (Y/N):</b> (Y) <b>Is the Boom Containing the Sheen? (Y/N)</b> (Y) <b>Pooled Product (Y/N):</b> (N) <b>If yes, was product removed with sorbent pads?</b>
<b>Location of Visible Contamination:</b>	
<b>Legend</b> /// Sheen \\\ Oily Sediment xxx Distressed Veg. RRR Iron Staining ● Pooled Product

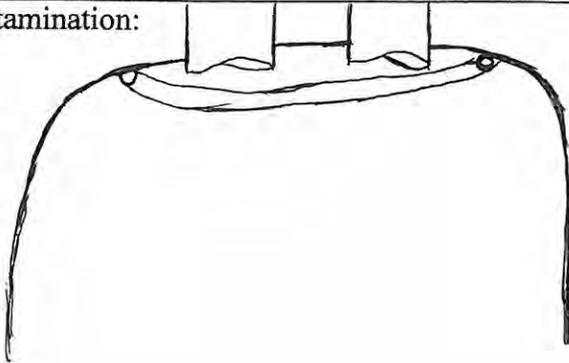
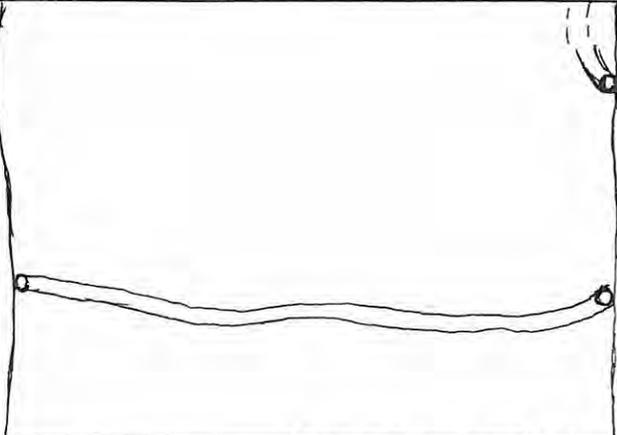
<b>Boom Location:</b> 912	<b>Time/Date:</b> 10 <sup>14</sup> 10 <sup>17</sup> / 4-9-14
<b>Description of Boom Before Maintenance:</b> UNSATISFACTORY	<b>Photograph (s) Time/Date Stamp:</b> 10 <sup>14</sup> /10 <sup>17</sup> / 4-9-14
<b>Boom Repaired (Y/N):</b> Description: MODIFIED LOCATION AND INSTALLED NEW SECTIONS AND RESTAKED	<b>Boom Replaced (Y/N) / Number of Sections:</b> 13 Description: REPLACED ALL SECTIONS FOR ANNUAL MAINTENANCE AND MODIFICATION.
<b>Visual Observations</b> Visible Contamination (Y/N): Iron Staining (Y/N): Oily Sediment/Soil (Y/N): Distressed Vegetation (Y/N):	
Sheen Present on Water (Y/N): Is the Boom Containing the Sheen? (Y/N) Pooled Product (Y/N): If yes, was product removed with sorbent pads?	
<b>Location of Visible Contamination:</b>	N ↑
<b>Legend</b> /// Sheen \\\ Oily Sediment xxx Distressed Veg. RRR Iron Staining ● Pooled Product

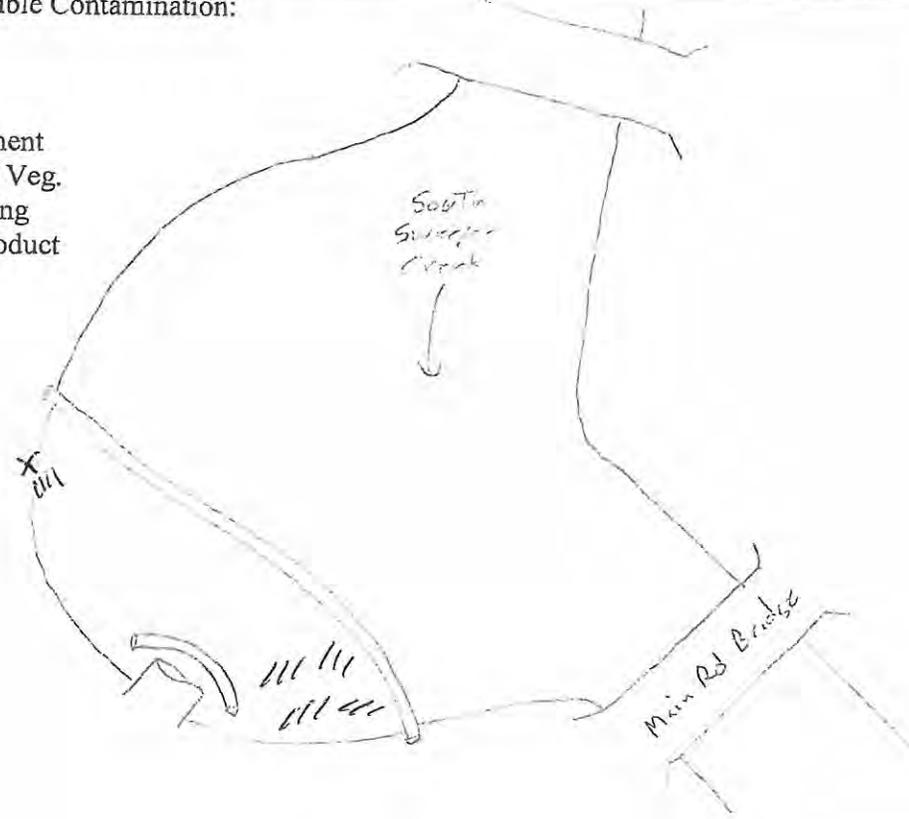
<b>Boom Location: 10</b>	<b>Time/Date:</b> 1026 / 4-9-14
<b>Description of Boom Before Maintenance:</b> UNSATISFACTORY	<b>Photograph (s) Time/Date Stamp:</b> 1026 / 4-9-14
<b>Boom Repaired (Y/N):</b> (Y) <b>Description:</b> INSTALLED NEW SECTIONS	<b>Boom Replaced (Y/N) / Number of Sections:</b> (Y) / 12 <b>Description:</b> REPLACED ALL SECTIONS FOR ANNUAL MAINTENANCE
<b>Visual Observations</b>	
<b>Visible Contamination (Y/N):</b> (Y) <b>Iron Staining (Y/N):</b> (N) <b>Oily Sediment/Soil (Y/N):</b> (Y) <b>Distressed Vegetation (Y/N):</b> (Y)	<b>Sheen Present on Water (Y/N):</b> (Y) <b>Is the Boom Containing the Sheen? (Y/N):</b> (Y) <b>Pooled Product (Y/N):</b> (N) <b>If yes, was product removed with sorbent pads?</b>
<b>Location of Visible Contamination:</b>	
<div style="display: flex;"> <div style="flex: 1;"> <p><b>Legend</b></p> <ul style="list-style-type: none"> <li>//// Sheen</li> <li>\\ \\ Oily Sediment</li> <li>xxx Distressed Veg.</li> <li>RRR Iron Staining</li> <li>● Pooled Product</li> </ul> </div> <div style="flex: 2;">

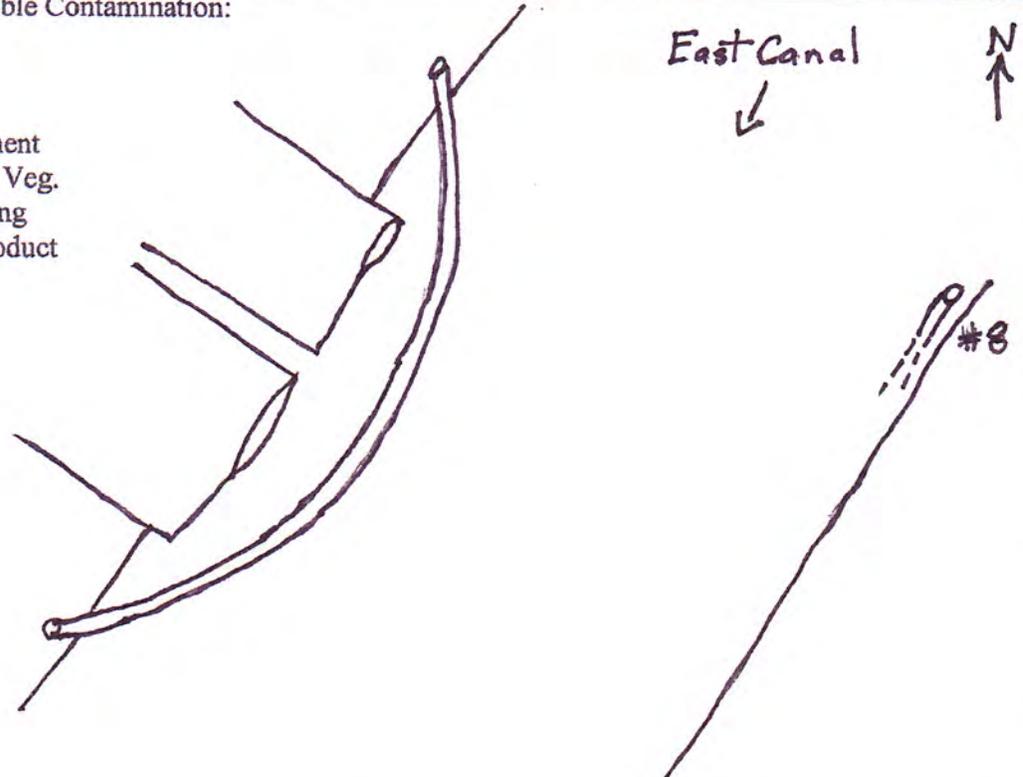
<b>Boom Location: 2</b>	<b>Time/Date:</b> 0952 / 7-9-14
<b>Description of Boom Before Maintenance:</b> UNSATISFACTORY	<b>Photograph (s) Time/Date Stamp:</b> 0952 / 7-9-14
<b>Boom Repaired (Y/N):</b> Description: REATTACH SOUTH END ONTO STAKE DUE TO HIGH WATER LEVELS AND DIKE PUMPS NOT ON REGULARLY	<b>Boom Replaced (Y/N) / Number of Sections:</b> Description:
<b>Visual Observations</b> Visible Contamination (Y/N): Iron Staining (Y/N): Oily Sediment/Soil (Y/N): Distressed Vegetation (Y/N):	
Sheen Present on Water (Y/N): Is the Boom Containing the Sheen? (Y/N): Pooled Product (Y/N): If yes, was product removed with sorbent pads?	
<b>Location of Visible Contamination:</b>  <b>Legend</b> /// Sheen \\\ Oily Sediment xxx Distressed Veg. RRR Iron Staining ● Pooled Product

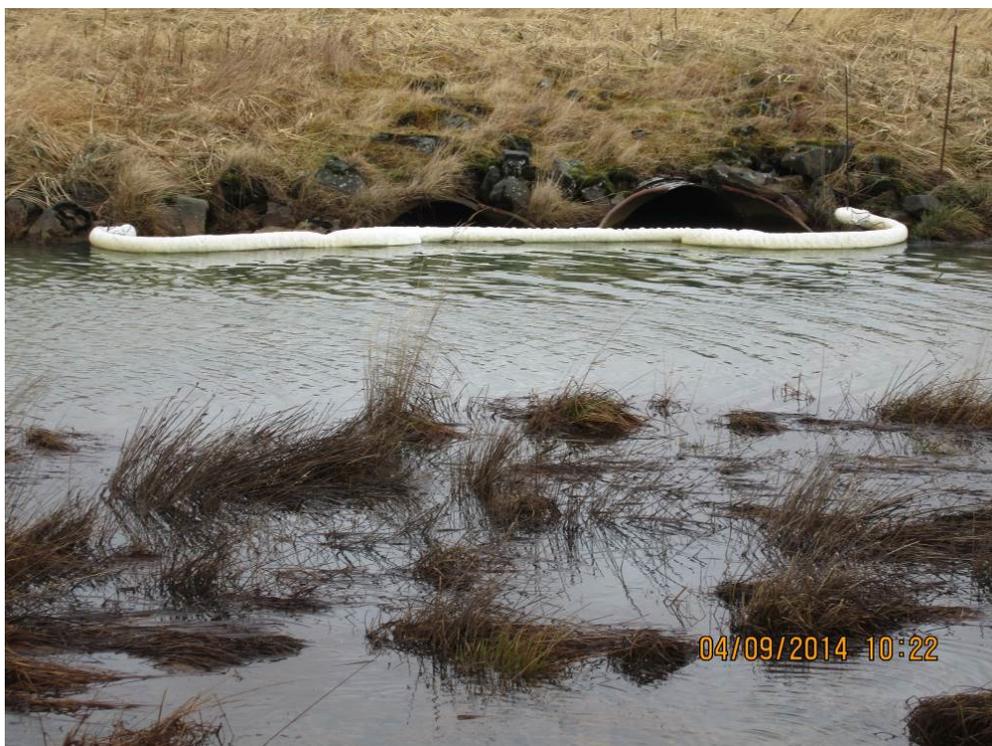
Photo 2. – East Canal Boom 2, April 2014, view west; high water level in canal while the canal pumps were off.

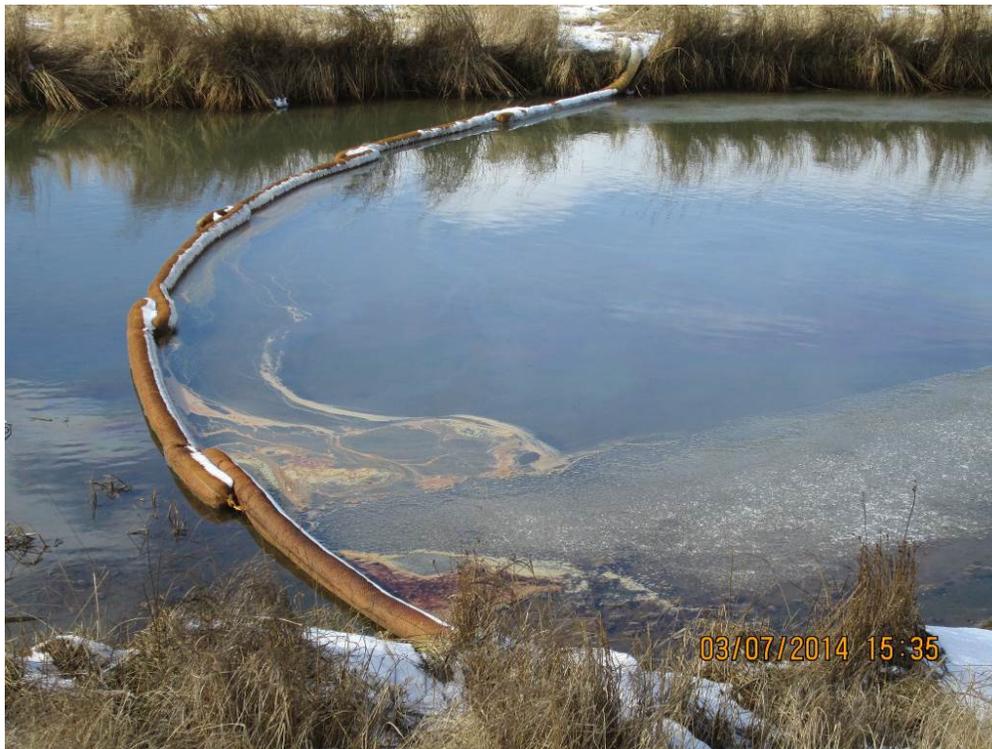
Photo 3. – West Canal Boom 3, March 2014, view west; visible free product behind boom.

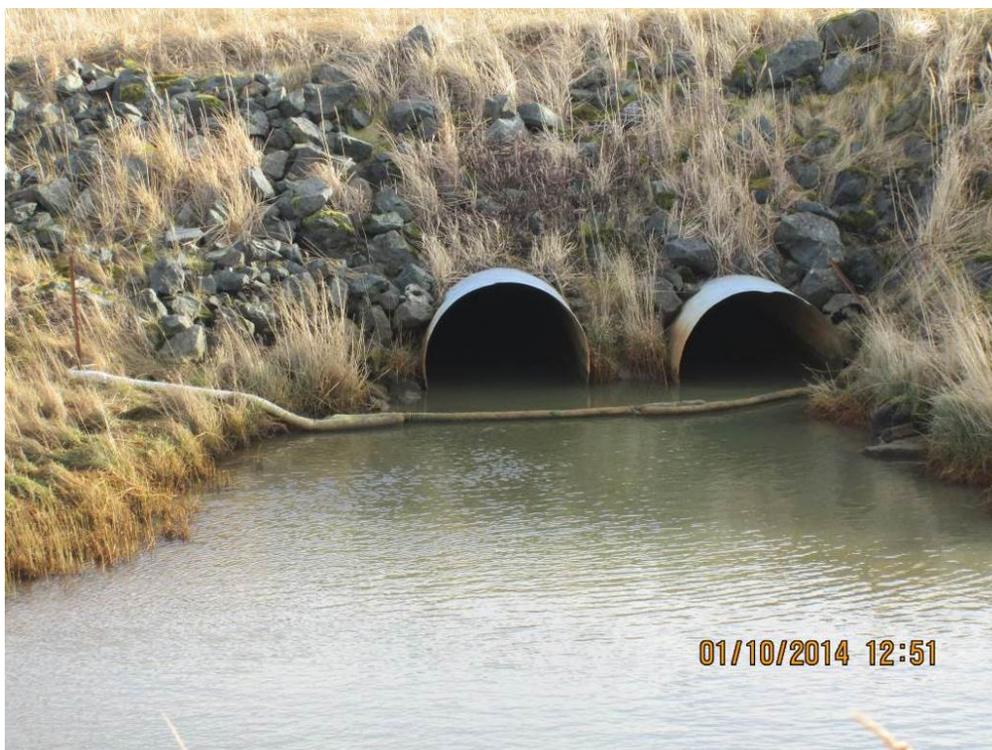
Photo 4. – West Canal Boom 4, January 2014, view east (boom was removed in April 2014).

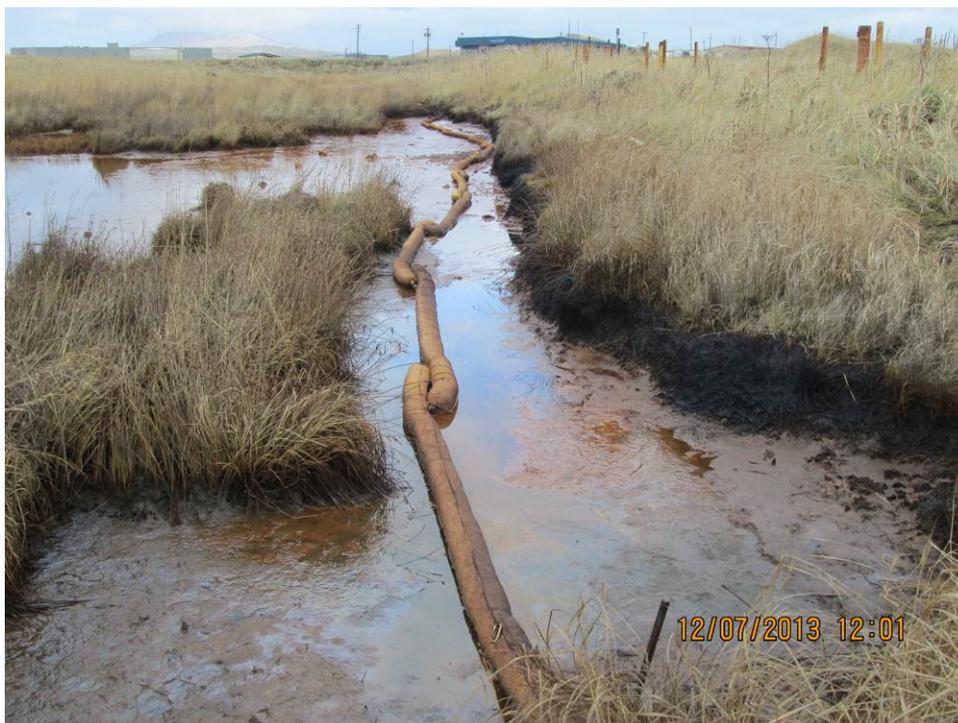
Photo 6. – East Canal Boom 8, December 2013, view north; boom with oil sheen visible.

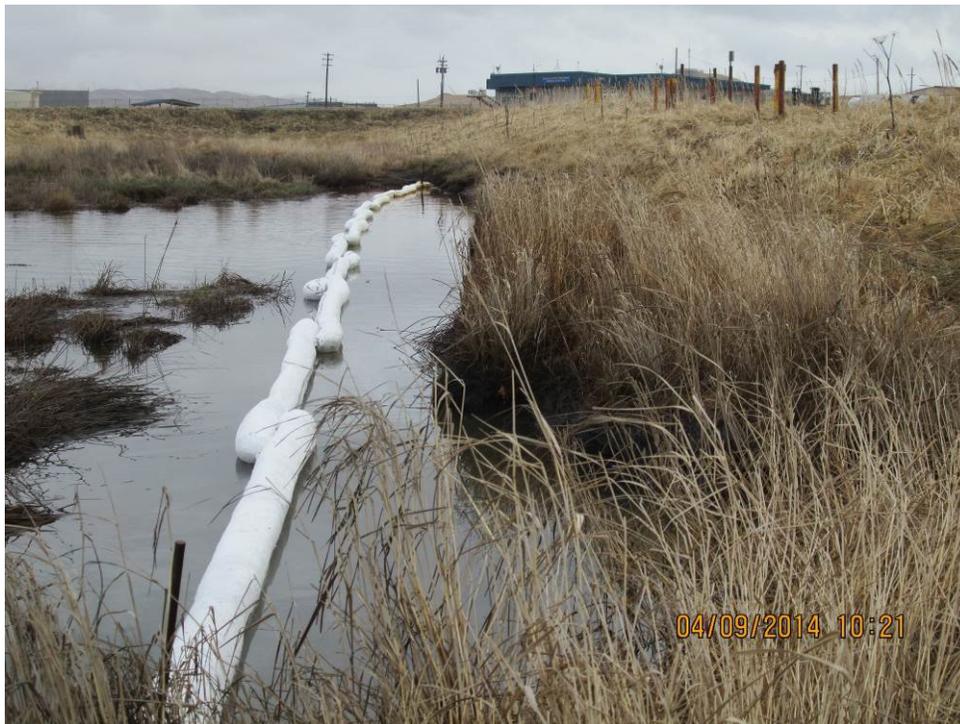
Photo 7. – East Canal Boom 8, April 2014, view north; with replaced boom.

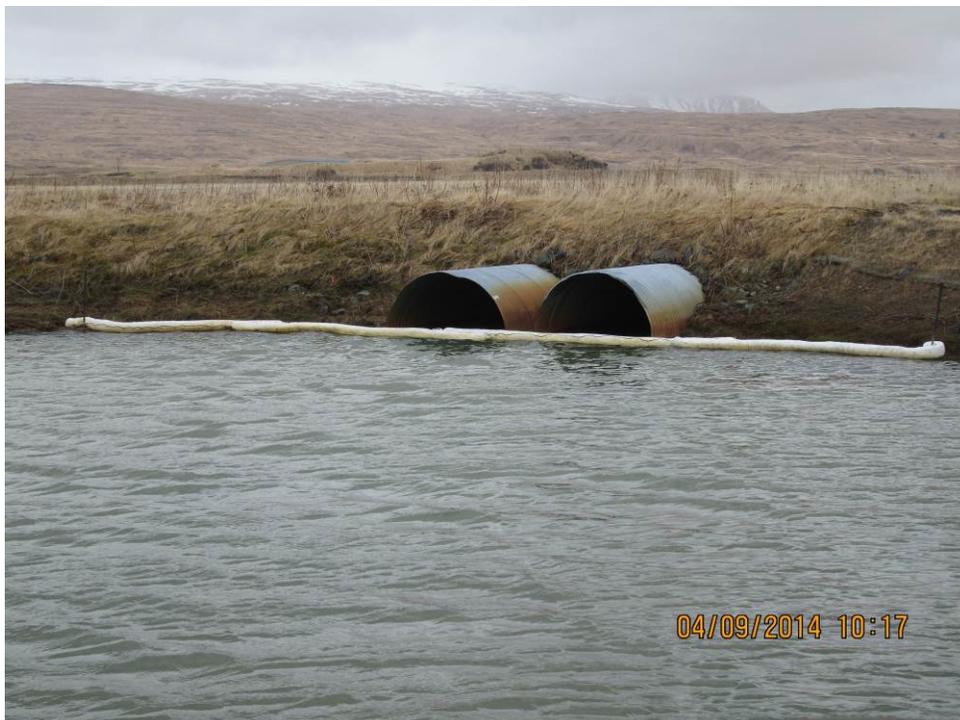
Photo 10. – East Canal Boom 9, April 2014, view north; revised location.

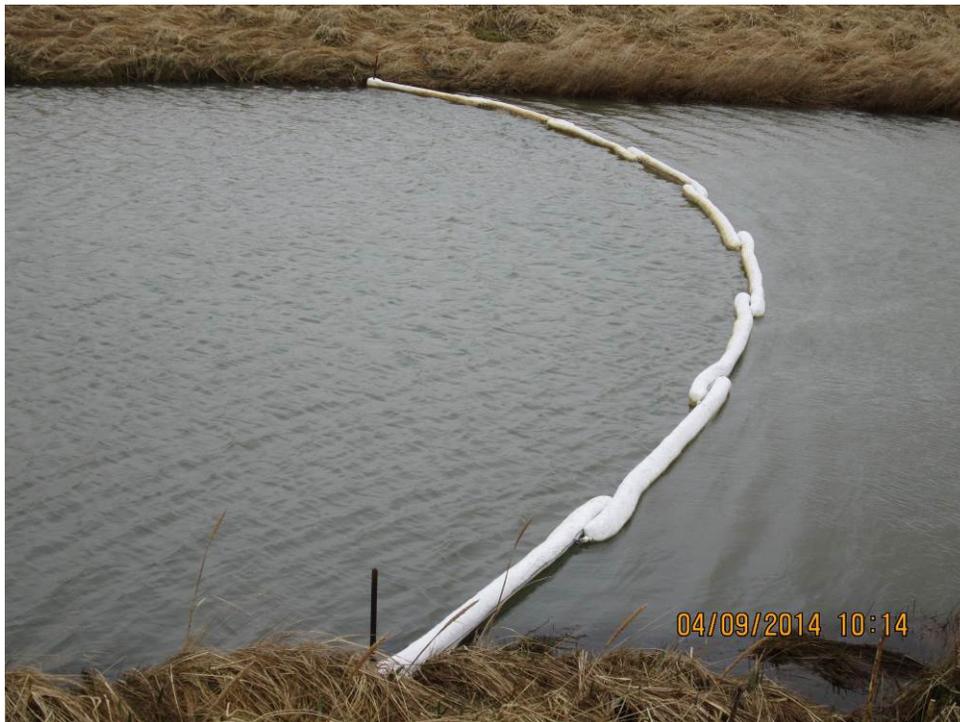
Photo 11. – East Canal Boom 12, April 2014, view west; revised location downstream of Boom 11.

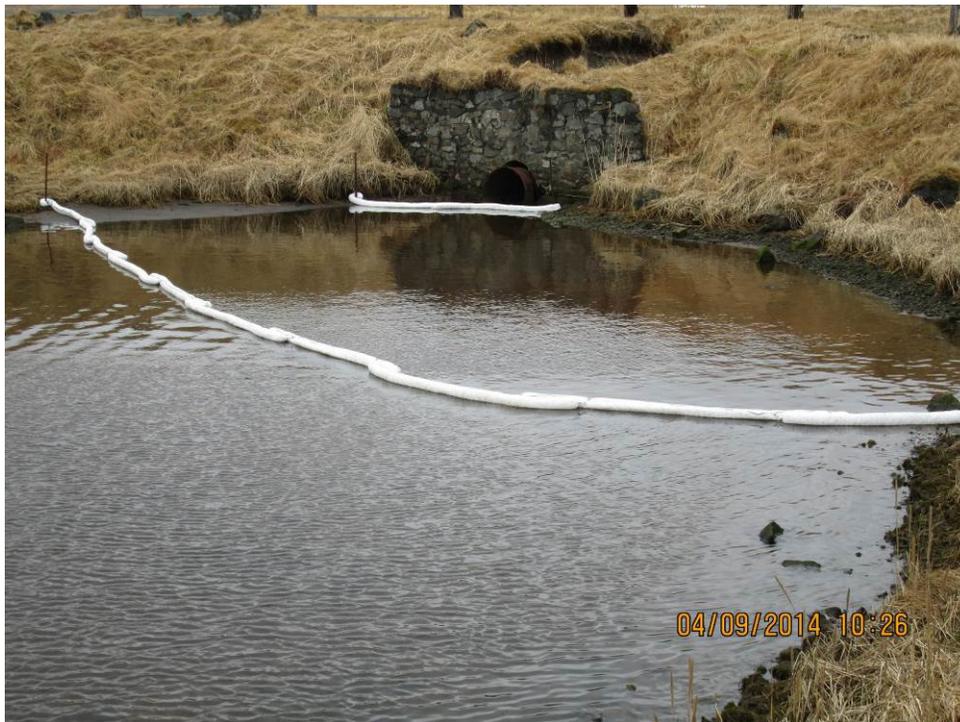
Photo 13. – Sweeper Creek Boom 10, February 2014, view southeast; new boom at high tide.
