Final FORMER MARINE CORPS AIR STATION (MCAS) El Toro 114th Restoration Advisory Board (RAB) Meeting Summary

Meeting Date/Time: 26 April 2016/6:35 p.m. to 7:47 p.m.

- Hangar 296 and Associated Piping Draft Radiological Site Inspection Report, Former Marine Corps Air Station El Toro, Irvine, CA

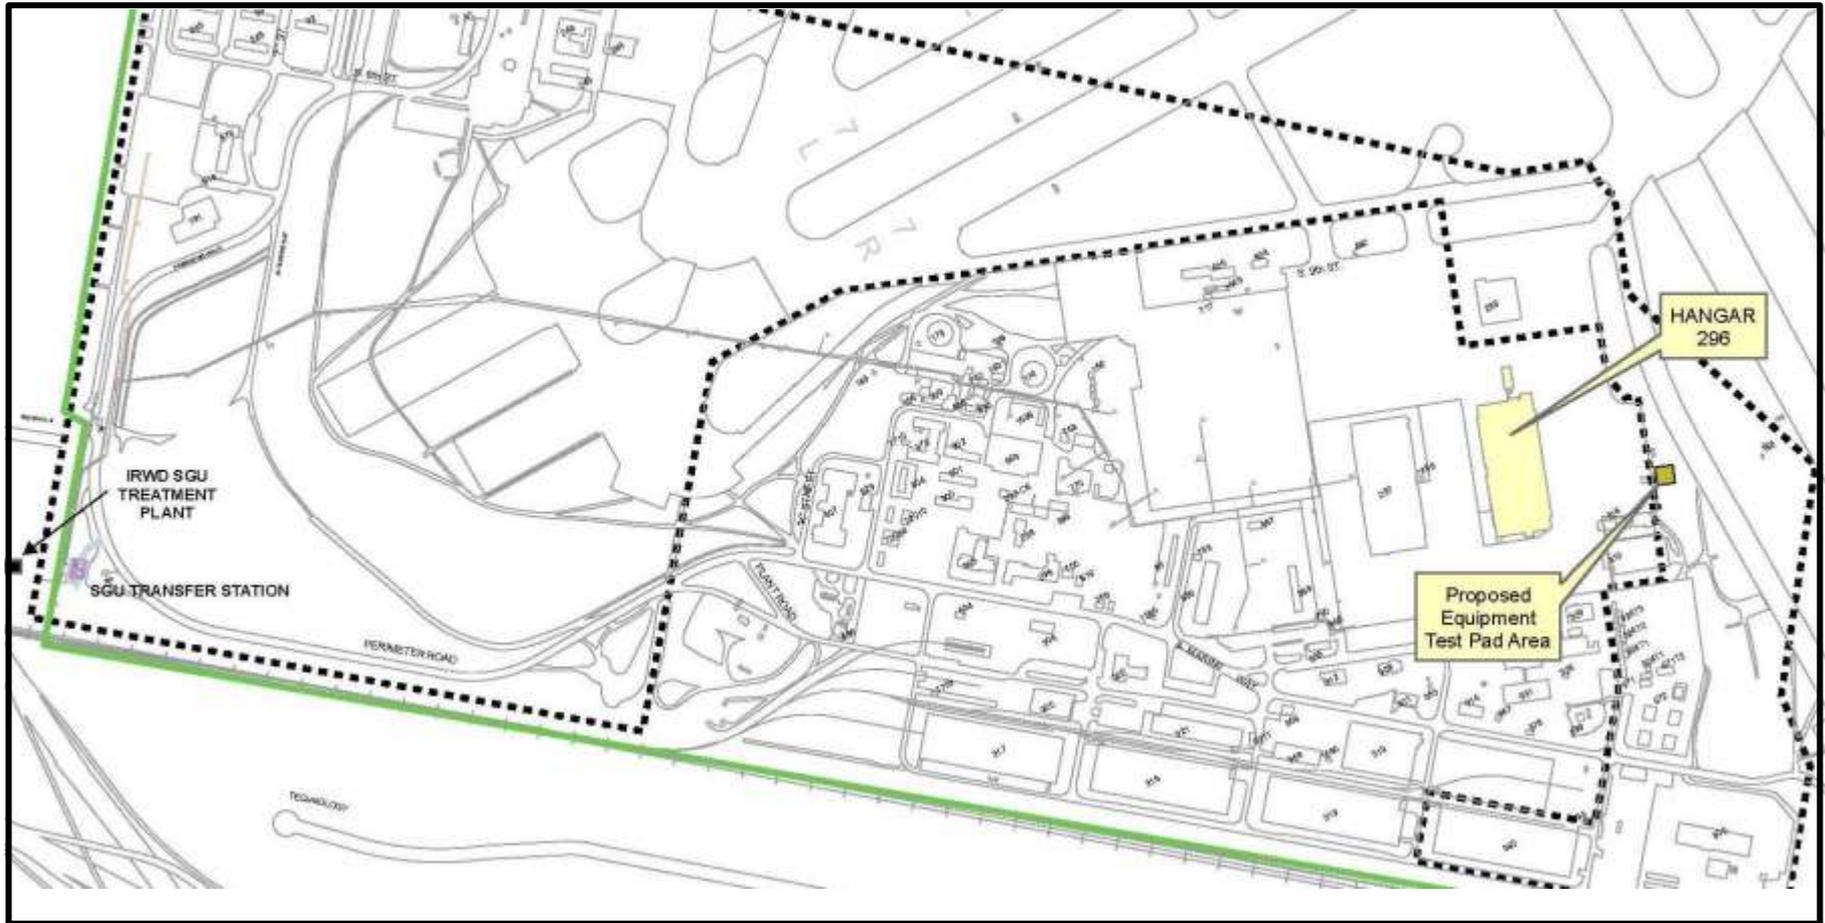
BACKGROUND – Hangar 296 Location

Slides 3 and 4 – Present a site location map for Former MCAS El Toro (Slide 3) and a map of where Hangar 296 is located within the industrial portion of Former MCAS El Toro (Slide 4).

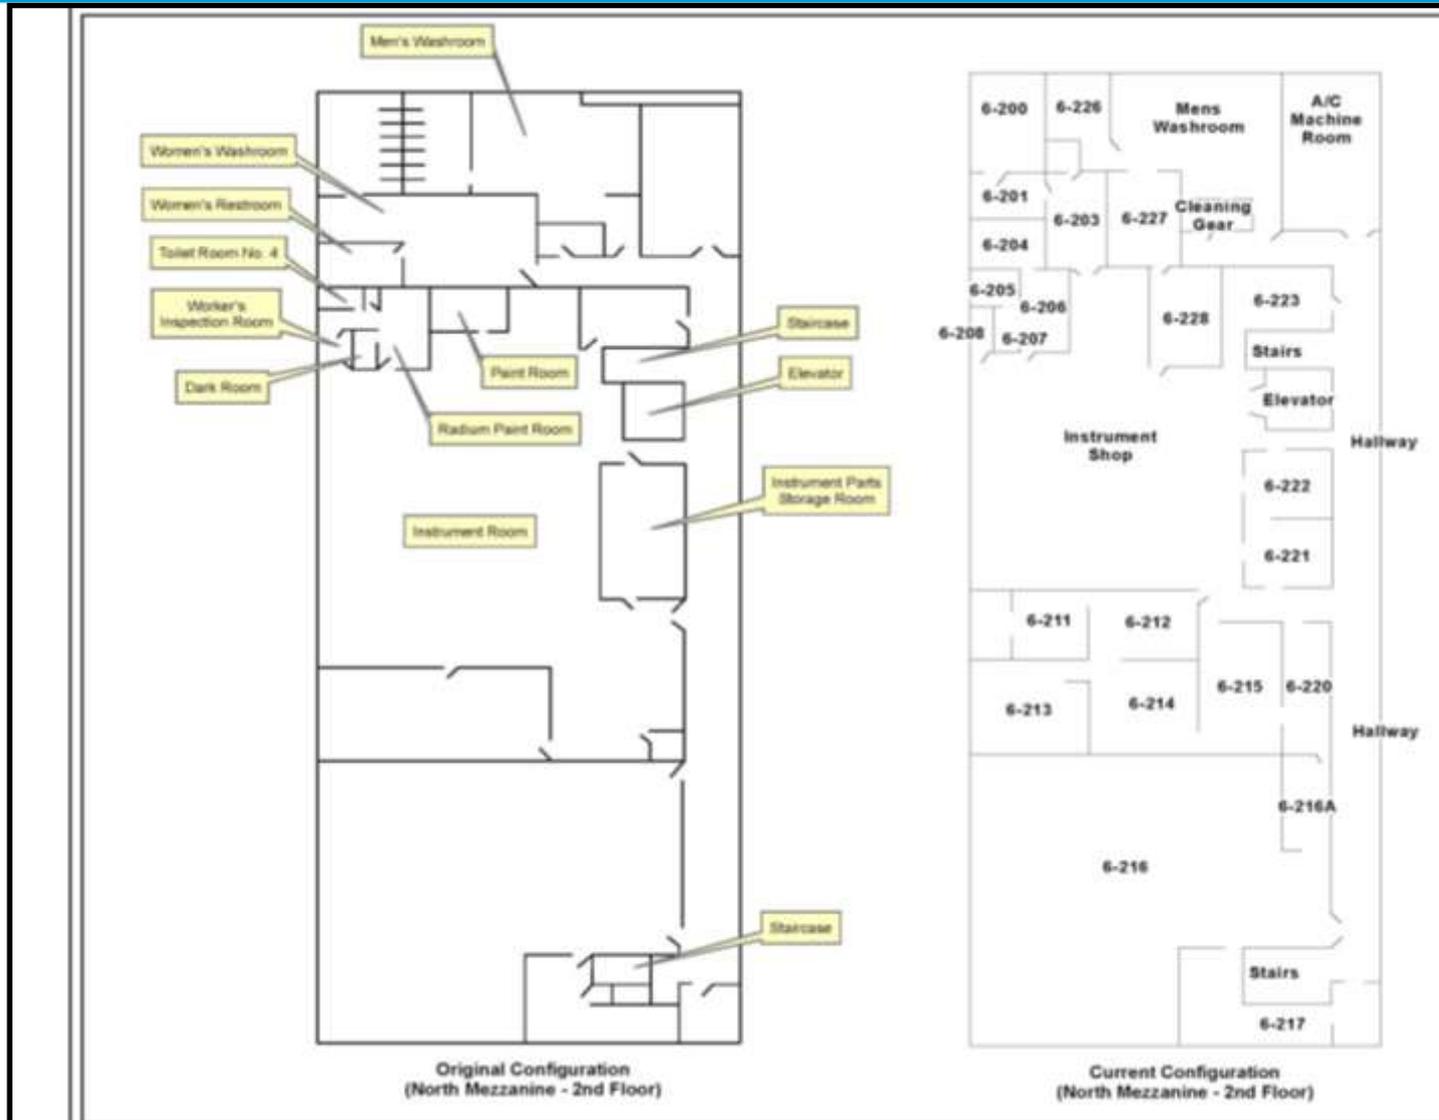
BACKGROUND – Location of Former Radium Paint Room

Slide 6 – Shows the location of the former Radium Paint Room. The figure shows two different views (one old and one more recent) of the interior of Hangar 296. He explained that activities in the former Radium Paint Room were limited to refurbishment of aircraft parts and that they occurred from about April 1949 to December 1950 (approximately 19 months).

explained that with respect to the size of Hangar 296, activities that took place in the former Radium Paint Room were limited to the northeastern corner of the hangar. Further, he noted that Hangar 297 was used during this investigation as a background or reference area.

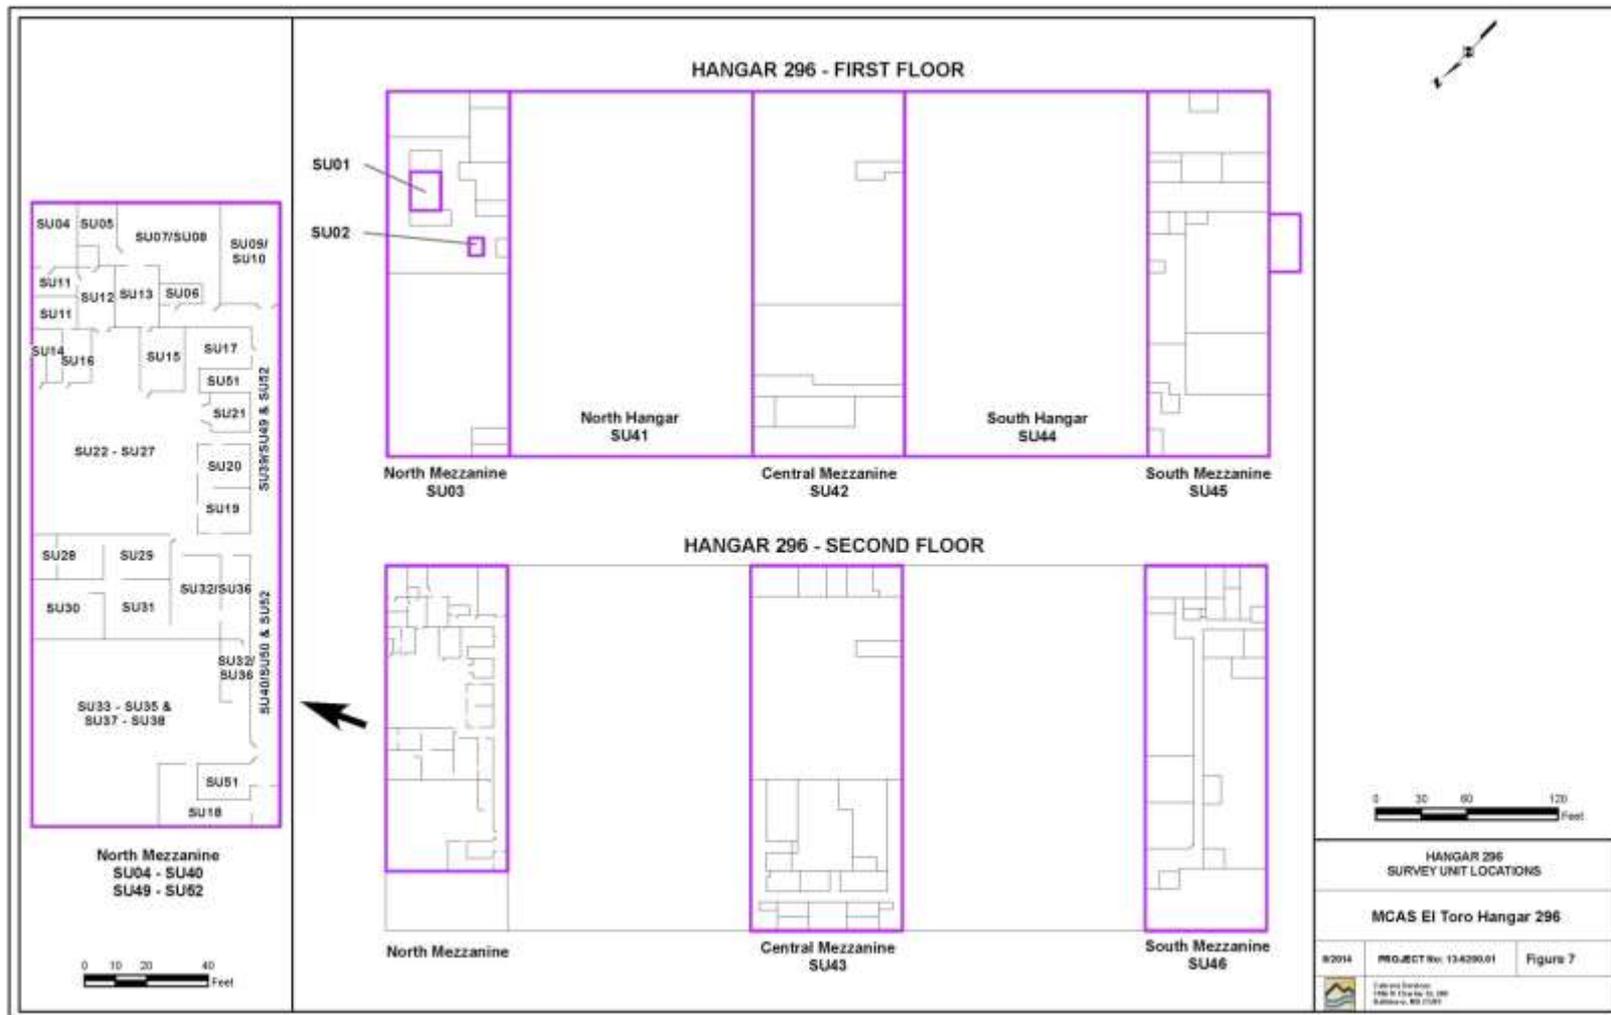
SURVEY UNIT LOCATIONS

Slide 13 – Presents the 52 survey units (outlined in purple) investigated in Hangar 296. Mr. Hay explained that each survey unit was treated as a separate survey and the same number of samples were collected at each survey unit.

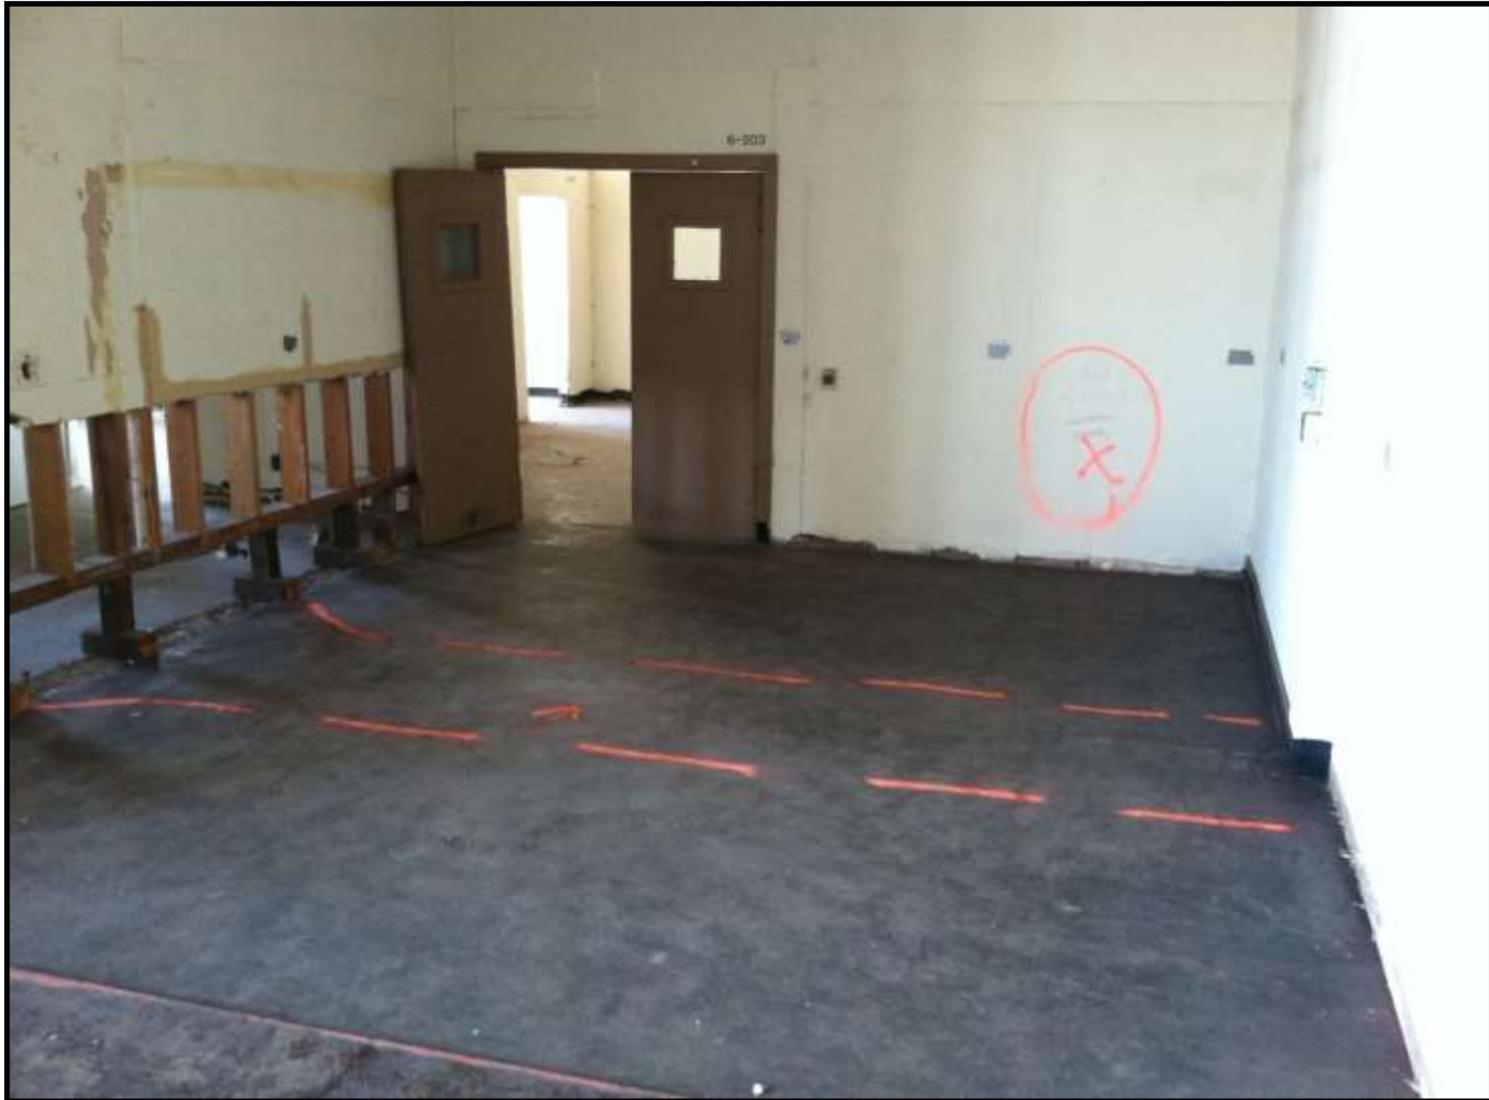
FORMER RADIUM PAINT ROOM

Slide 14 – Presents a photograph showing the footprint of a former wall in the former Radium Paint Room. The dashed red lines on the photograph show the boundary of the former wall, which had previously been removed.

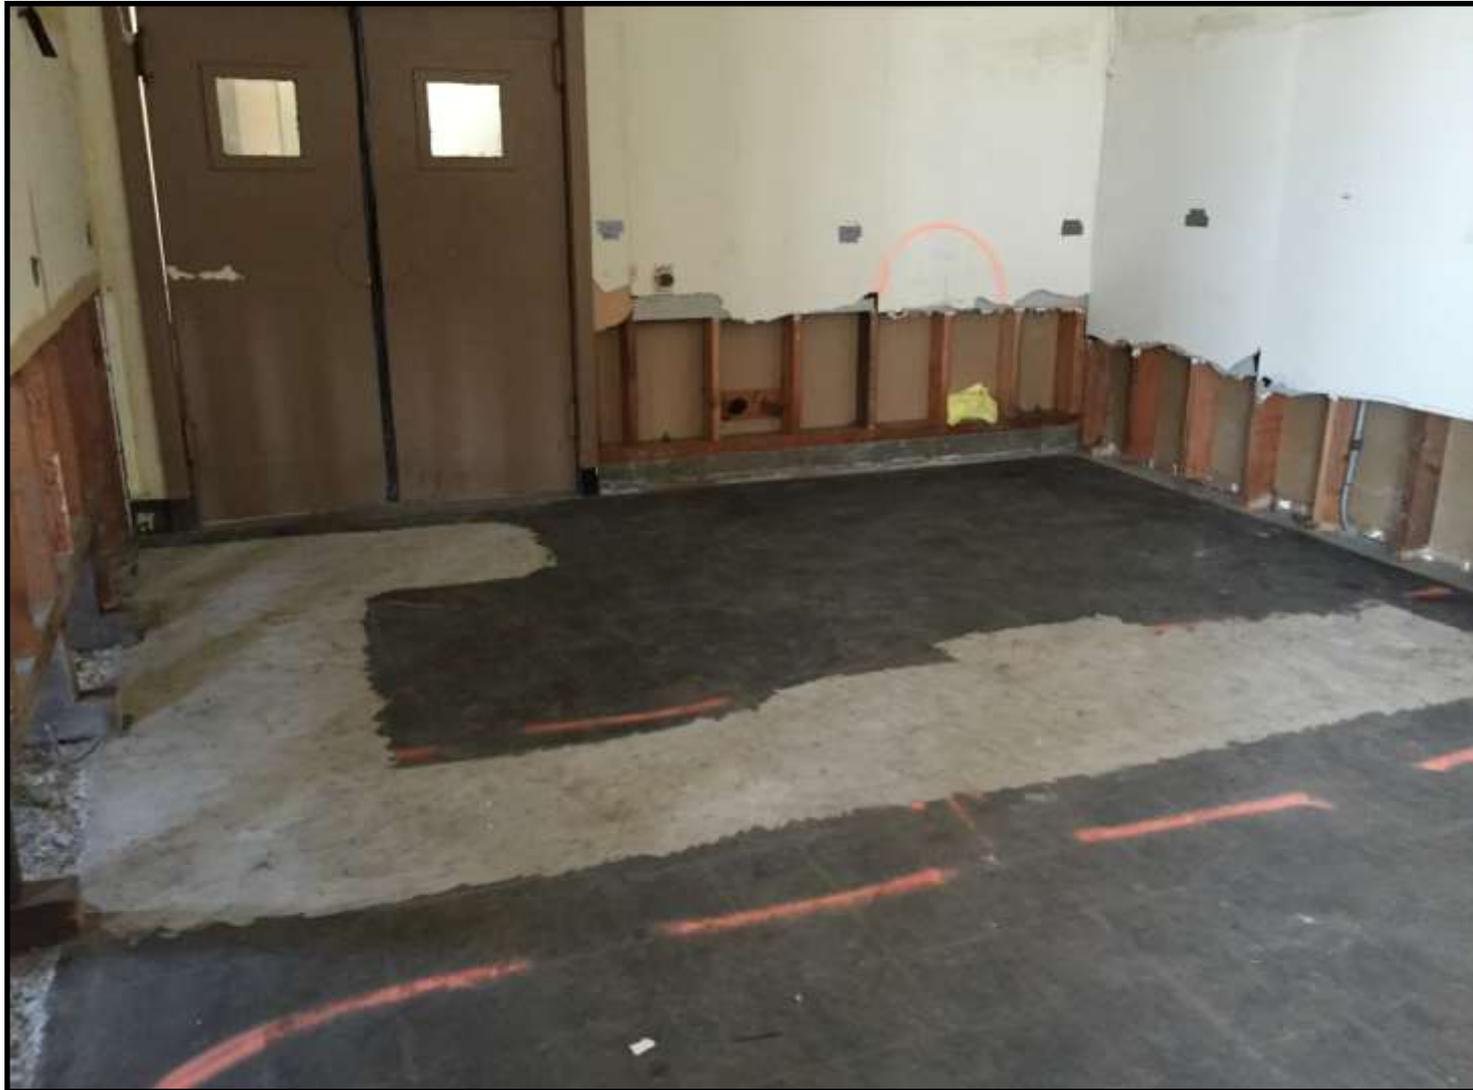
POST-REMEDIAL FLOOR AND WALLS IN FORMER RADIUM PAINT ROOM

Slide 15 – Presents a photograph of the post-remedial floor and walls in the former Radium Paint Room. Radiologically impacted wallboard was removed. To determine the depth of the radiological impacts in the concrete floor, a thin layer (about 1/8 inch) was scabbled (scraped off). The photo shows the cut-out portion of the wall and the area on the concrete that was scabbled. He noted that all radiologically impacted materials (floor tiles, wallboard, scabbled concrete) were transported off site for disposal as low-level radioactive waste.

- Limited scabbling conducted in former Radium Paint Room
- FSS measurements showed radioactivity was comparable to background
- No unacceptable levels of radiation were identified on building surfaces throughout the hangar

- NFA and URR are recommended for the entirety of Hangar 296 building surfaces

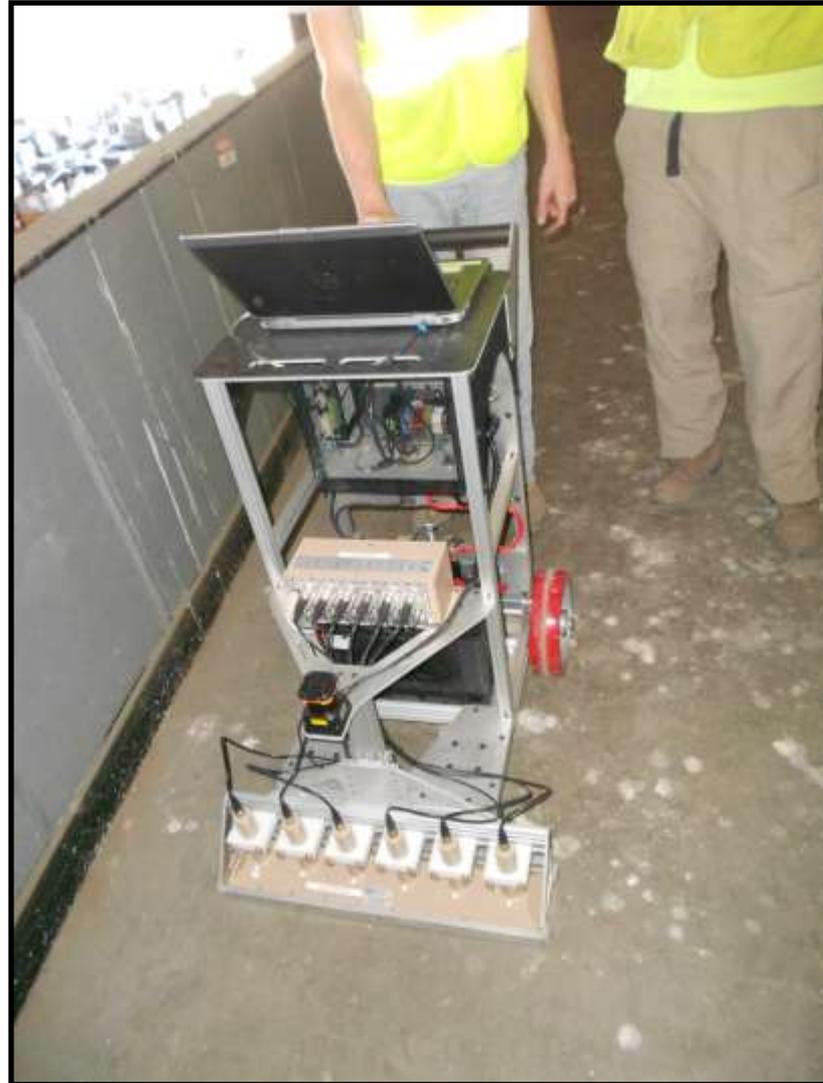
System 2: Three-Dimensional Indoor Survey System (3-DISS) Automated Floor Scanning System

Slide 16 – Presents a photograph of the Three-Dimensional Indoor Survey System (3-DISS) with six detectors at its base. This instrument was used during the investigations at Hangar 296.

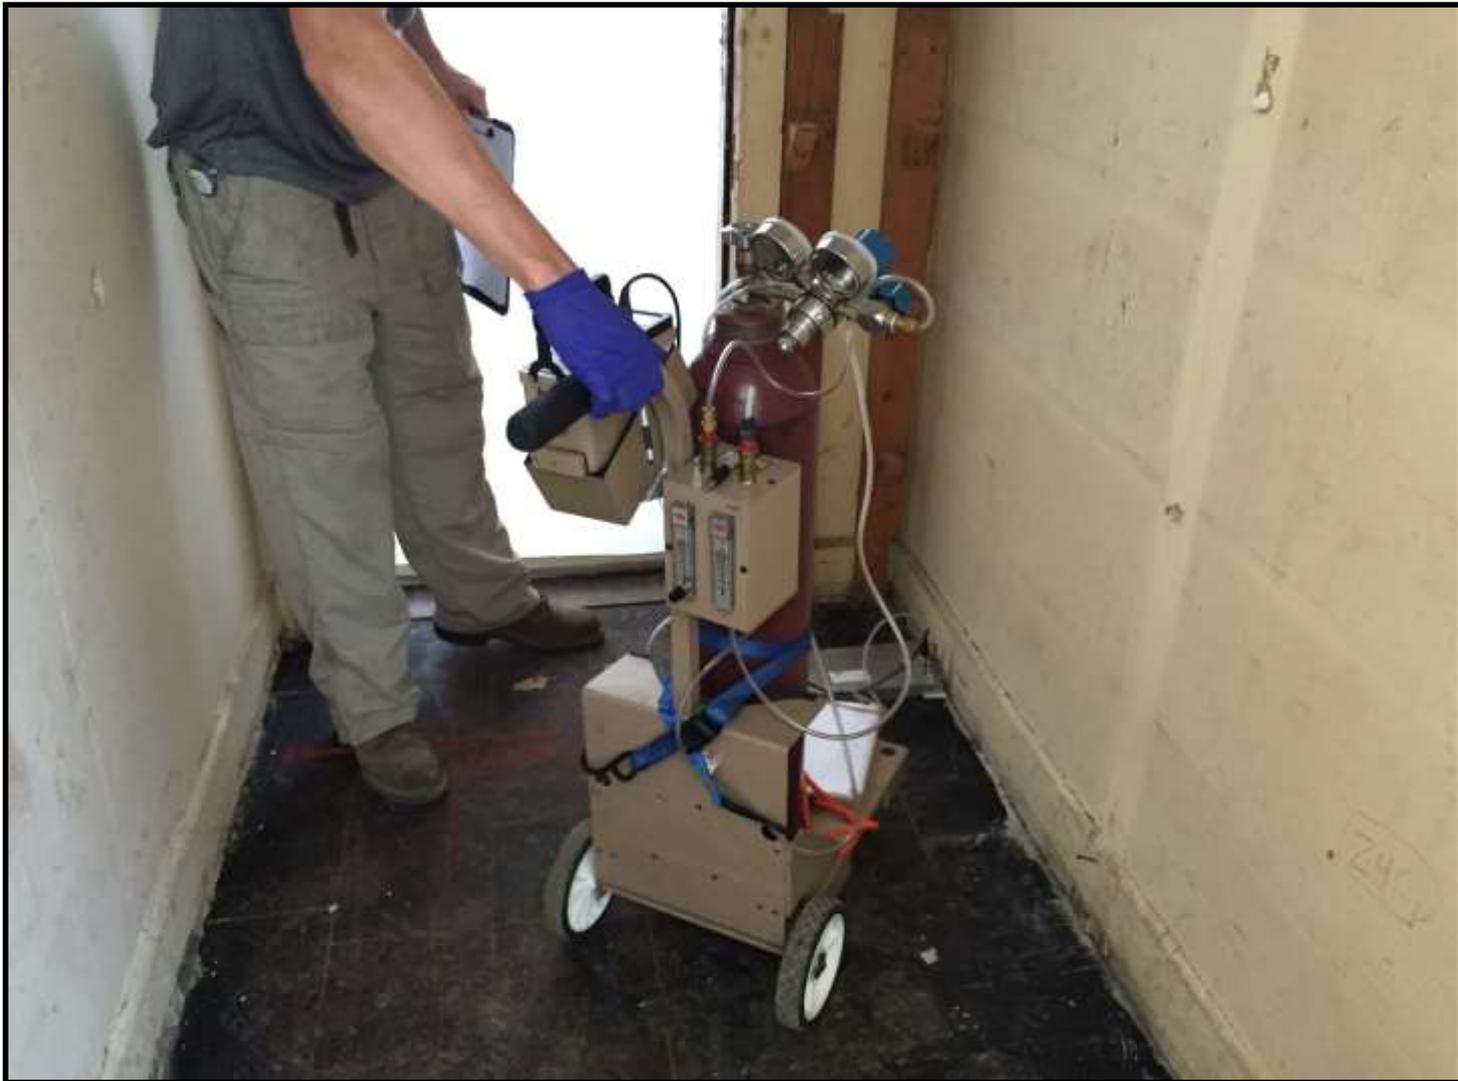
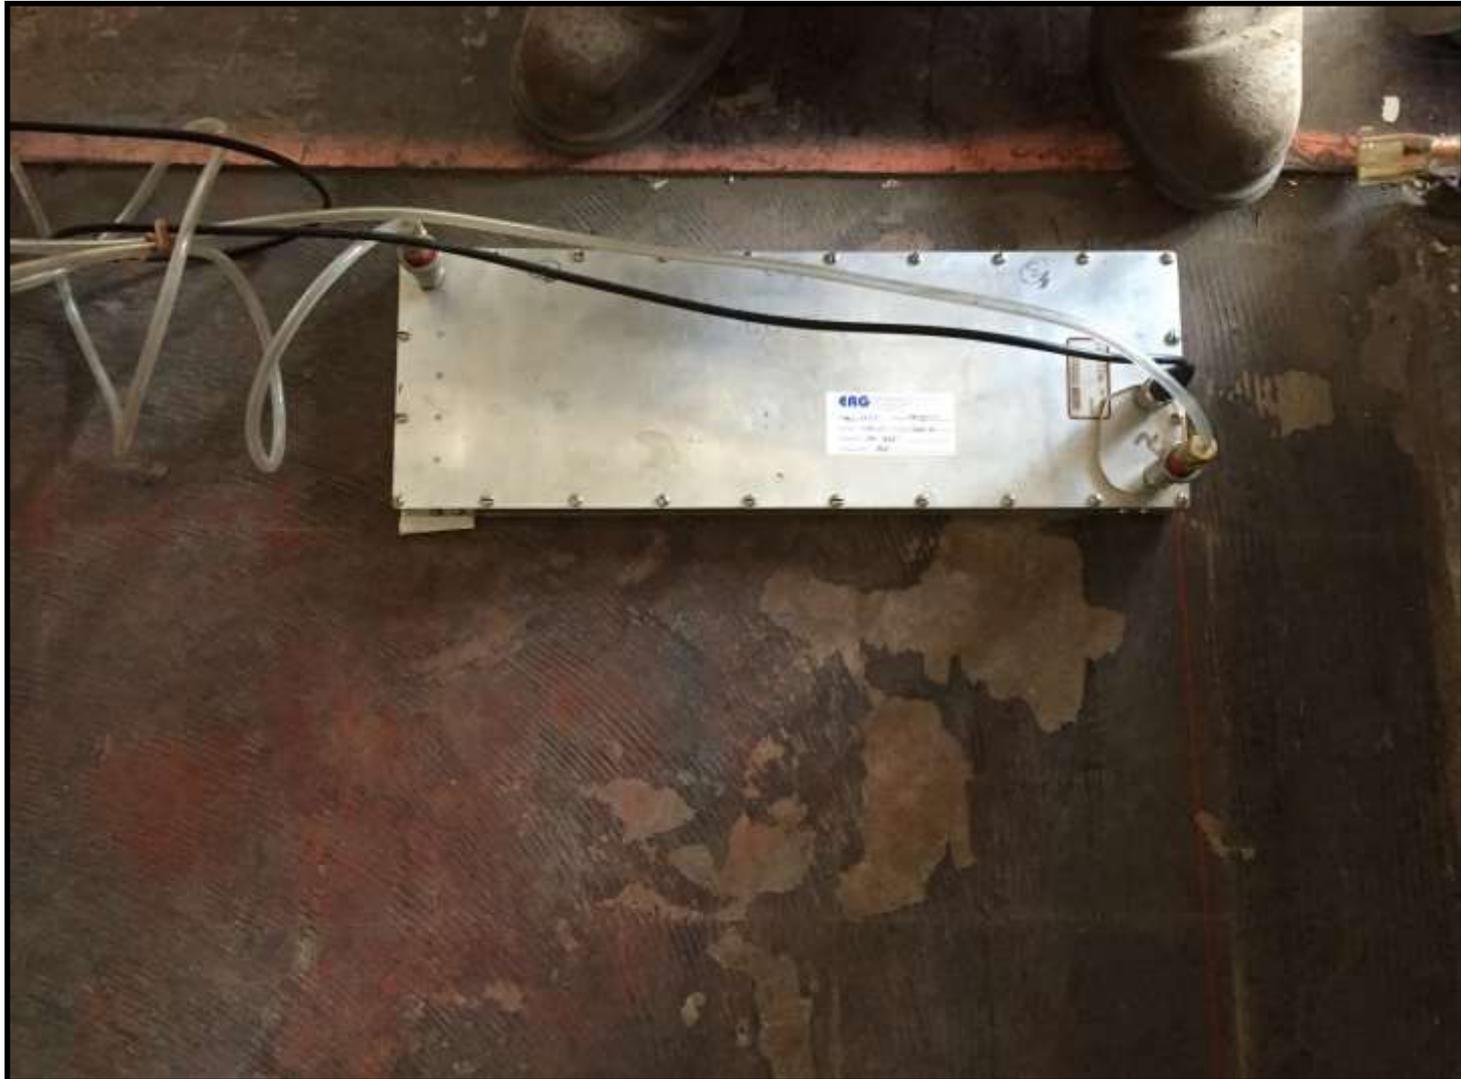
FINAL STATUS SURVEY SCANS (cont.)

Slides 17 and 18 – Present photographs of another piece of equipment used for scanning in smaller areas and a close-up of the detector, respectively.

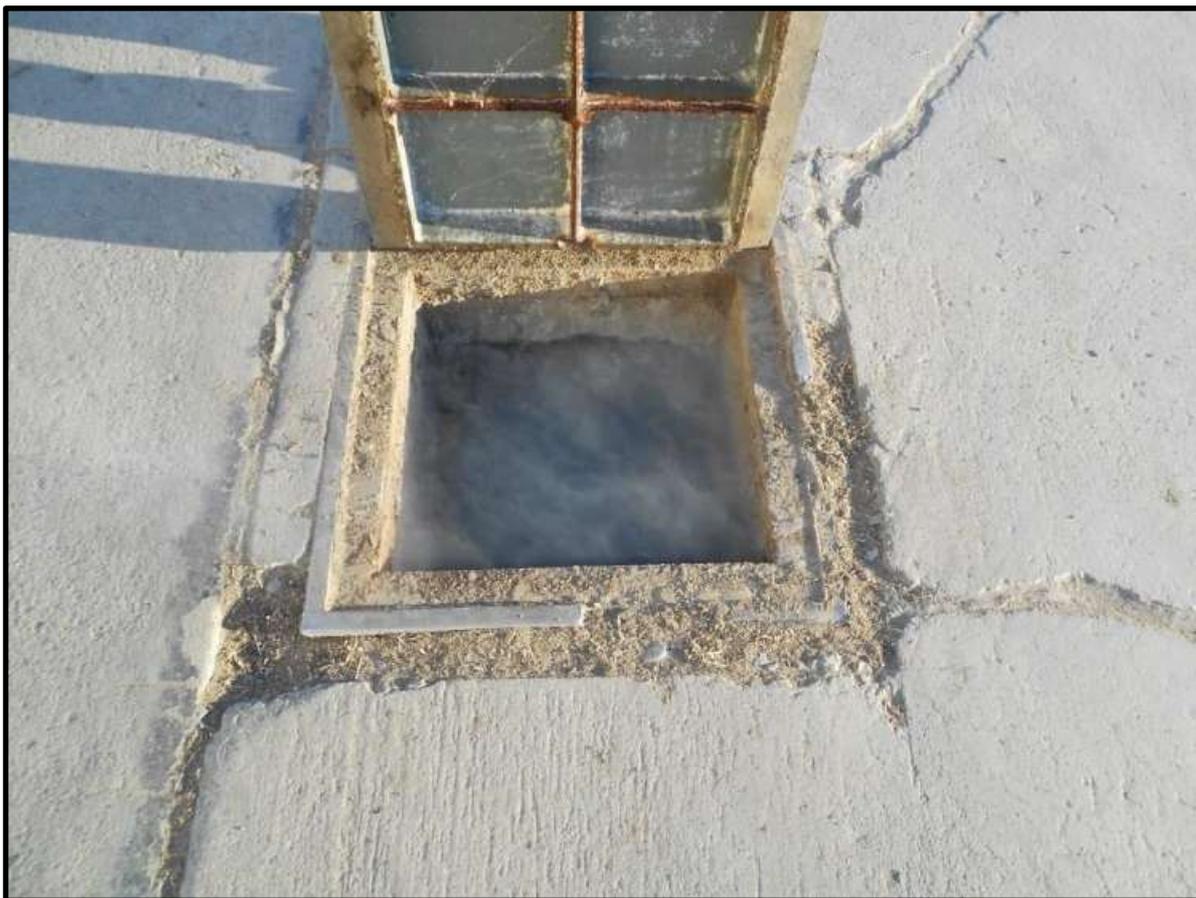
Slide 21 – Presents a photograph of the smoke test conducted to verify whether the former piping from Hangar 296 connected to the SSL or the IWP. Mr. Hay explained that they used a video camera to visually inspect the piping at Hangar 296. In addition, smoke was pumped through the pipeline originating from Hangar 296 and it was visually confirmed that it connected to the SSL.

- Confirmed connection of lateral from former Radium Paint Room to SSL using a smoke test.

Slide 22 – Presents the conclusions and recommendations derived upon completion of the smoke tests and remote imaging via video camera. The tests confirm that the piping is connected to the SSL. The Navy's recommendation was to evaluate the SSL downstream of Hangar 296.

- The connection of the interior piping from the former Radium Paint Room to the SSL was confirmed using a video camera and visually following removal of underground piping
- The locations of manholes up- and downstream from the Hangar 296 SSL connection were confirmed by smoke testing
- Investigated and removed underground piping from the interior of the building to where the piping connects to the SSL outside of the building

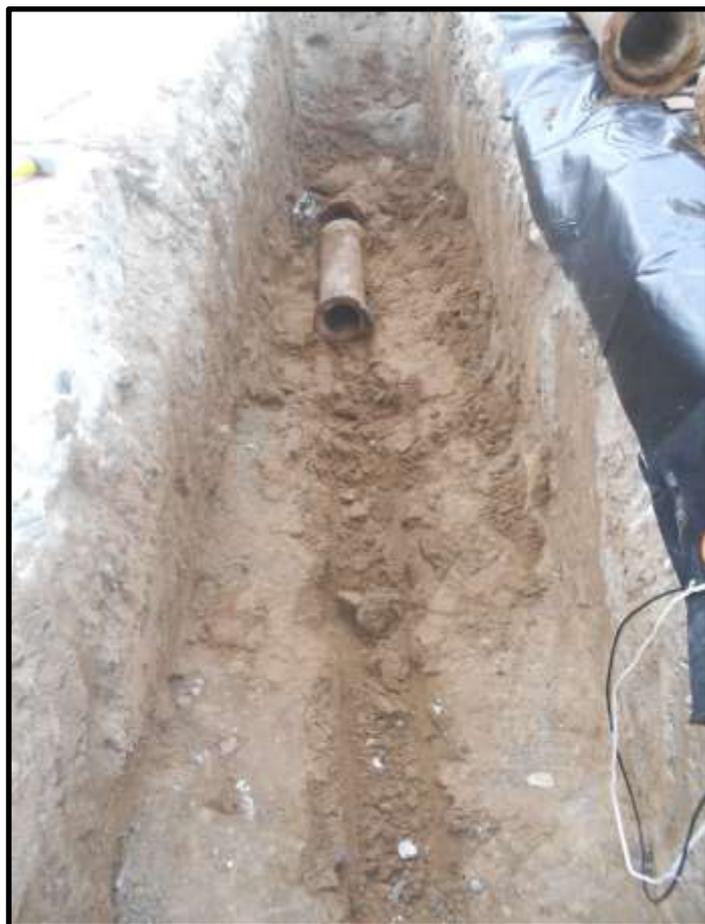
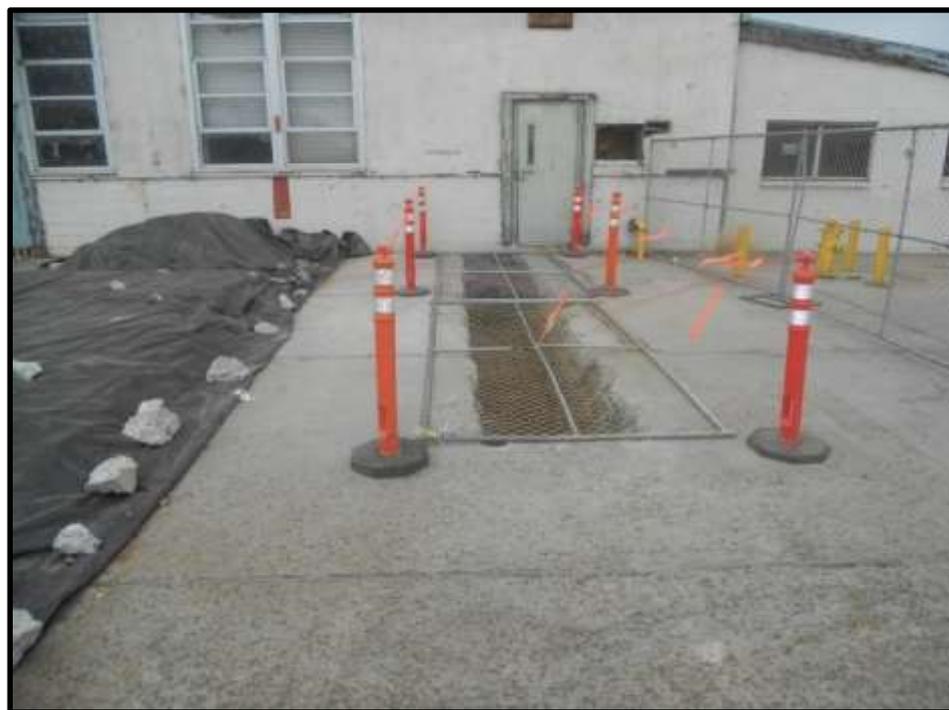
Slide 25 – Presents a photograph of the fieldwork conducted to investigate the belowground pipe outside Hangar 296. Mr. Hay explained that there was residual radiation inside the piping itself. An accumulation of residual radiation was detected where the vertical pipe, originating from the second floor, connected to the horizontal pipe located on the first floor.

- Investigated soil surrounding belowground pipe outside Hangar 296 connected to SSL

- No piping associated with the former Radium Paint Room remains within Hangar 296
- FSS measurements of the soil removed from the pipe trench are comparable to background
- No unacceptable levels of radioactivity were identified in any soil samples

- NFA and URR are recommended for subsurface soils associated with former piping from the former Radium Paint Room to the main SSL lateral connection

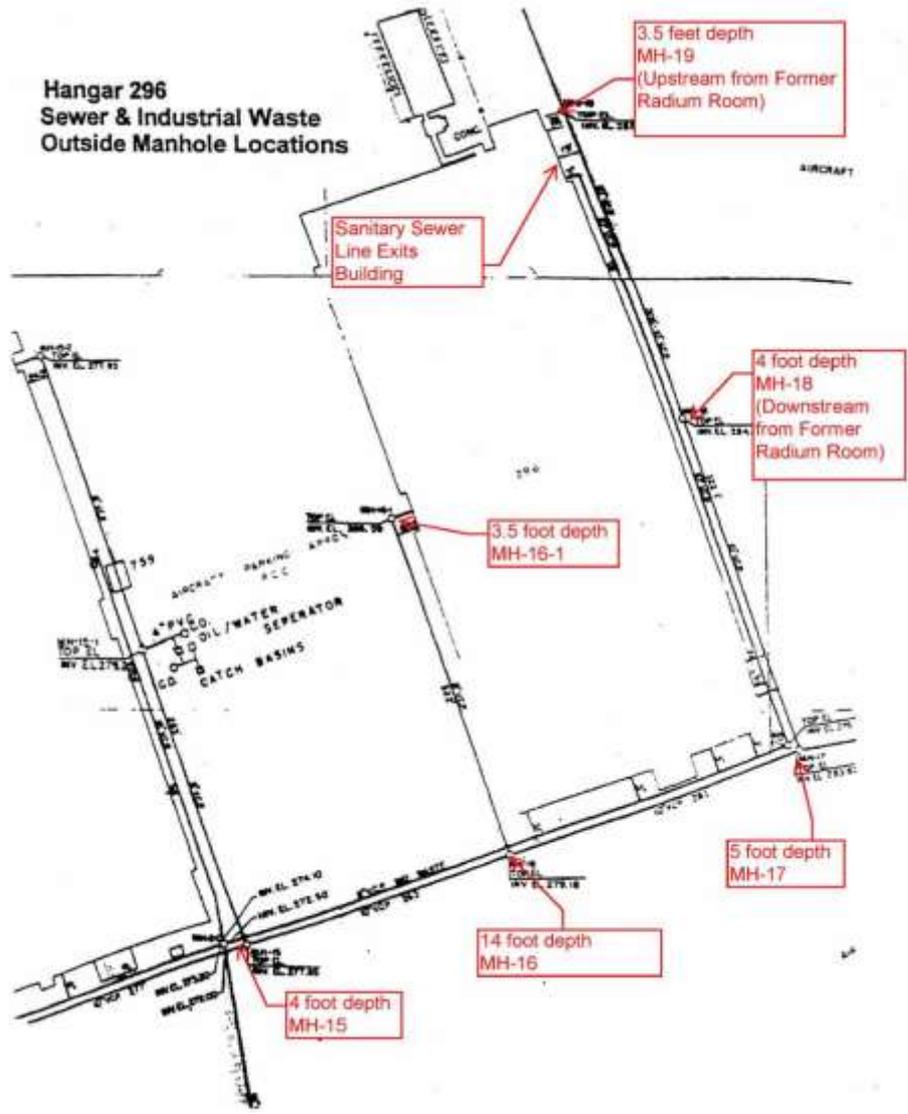
WORK PERFORMED TO MEET OBJECTIVE #4 (cont.)

Slides 28 and 29 – Presents the work performed to meet Objective #4 and a figure showing the layout of the manholes that were connected to Hangar 296.

- Performed radiological surveys and collected samples from four manholes downstream from Hangar 296 SSL connection.
- Collected background measurements in manhole MH-19, located upstream of Hangar 296 SSL connection.

- ^{226}Ra concentrations in manholes downstream from Hangar 296 were comparable to background
- No unacceptable levels of ^{226}Ra were identified in the SSL downstream of Hangar 296

- NFA and URR are recommended for the SSL downstream of the Hangar 296 SSL connection
