Basewide Assessment Update NAS South Weymouth Restoration Advisory Board Meeting July 20, 2006

Environmental Sites at NAS South Weymouth

- Update the RAB on the progress of the Navy's Basewide Assessment, specifically including:
 - ❖ Geochemical Evaluation (Floc Assessment)
 - ❖ Hydrogeological Evaluation
 - ❖ Human Health Risk Assessment
 - ❖ Ecological Risk Assessment

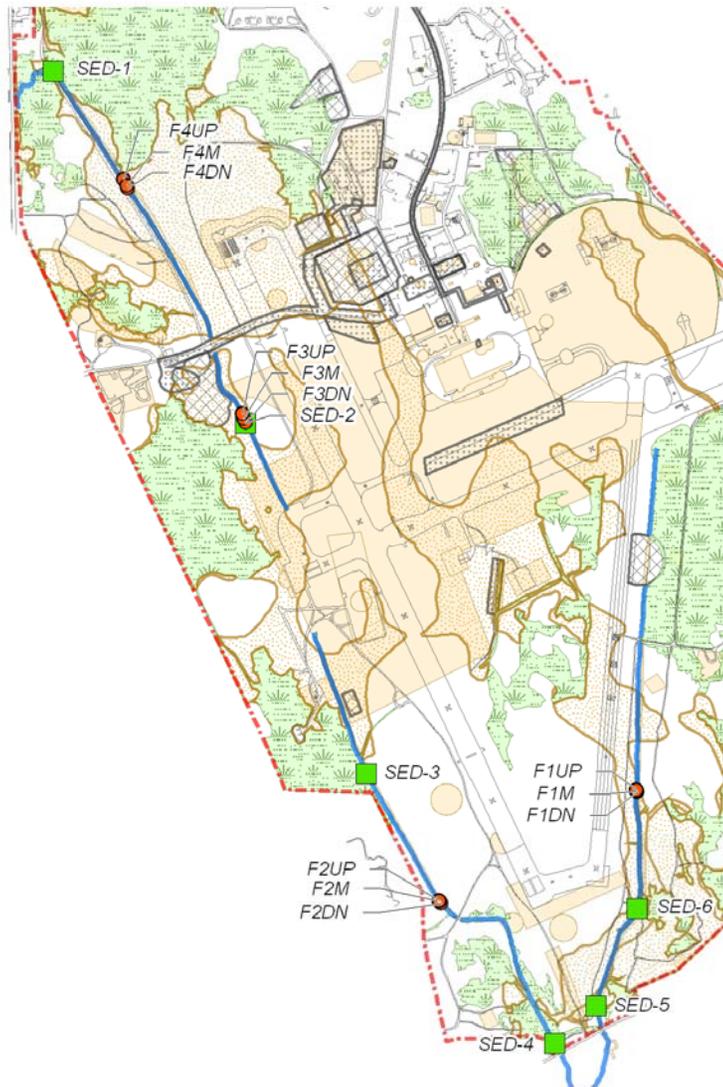
Floc and Sediment Sampling Locations

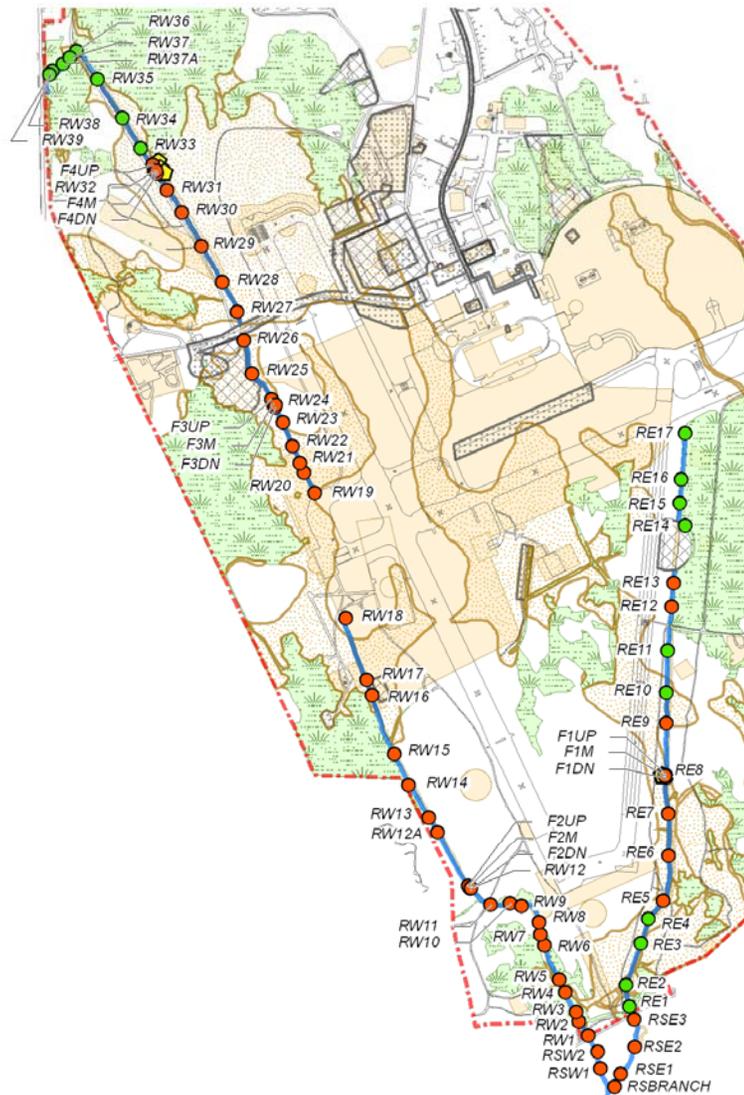
December 2005 Floc Recon Results

**December 2005 Floc Survey
French Stream
Former NAS South Weymouth
Weymouth, MA**

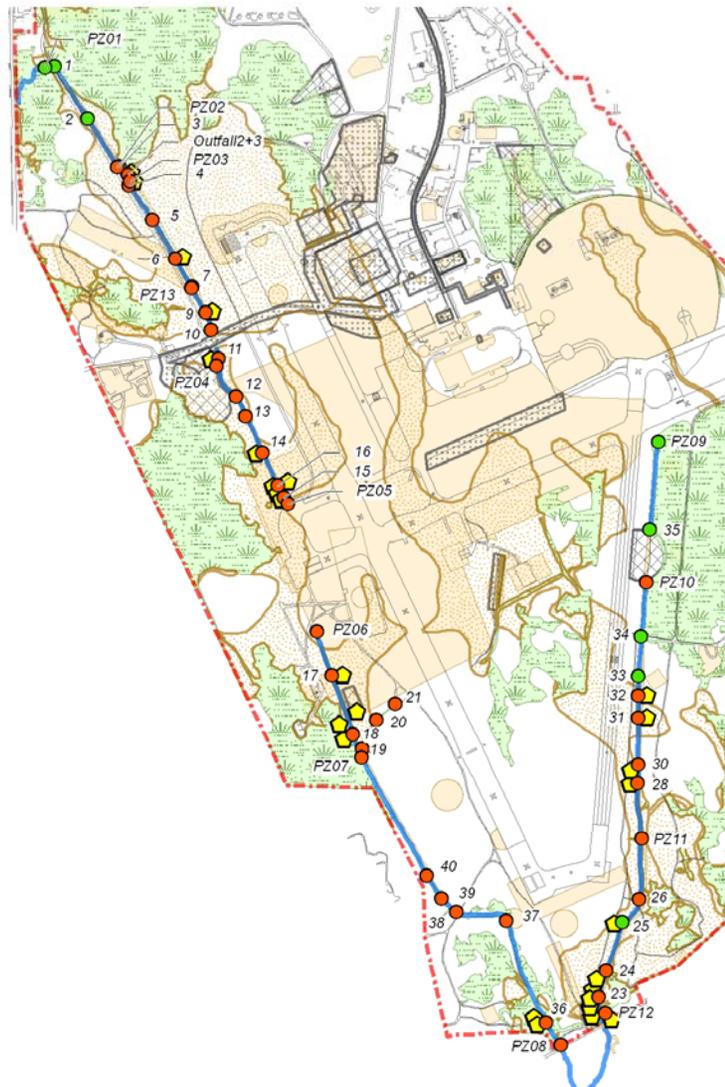
March 2006 Floc Survey Results

March 2006 Floc Survey
French Stream
 Former NAS South Weymouth
 Weymouth, MA

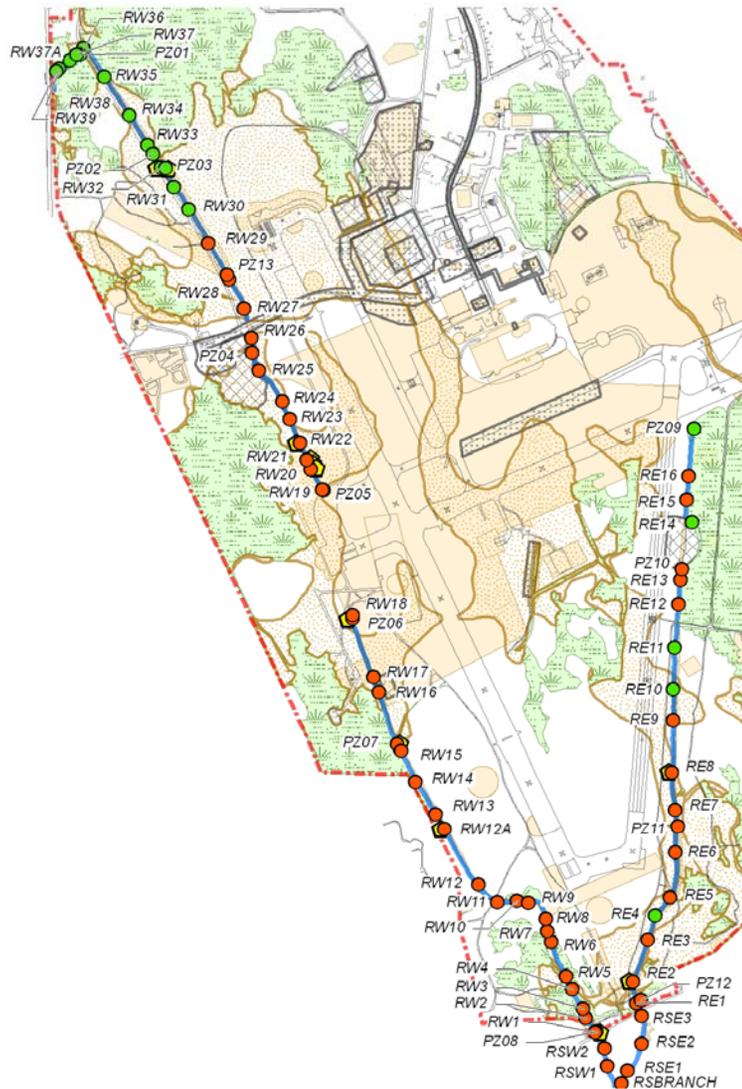
May 2006 Floc Recon Results

May 2006 Floc Survey
French Stream
 Former NAS South Weymouth
 Weymouth, MA

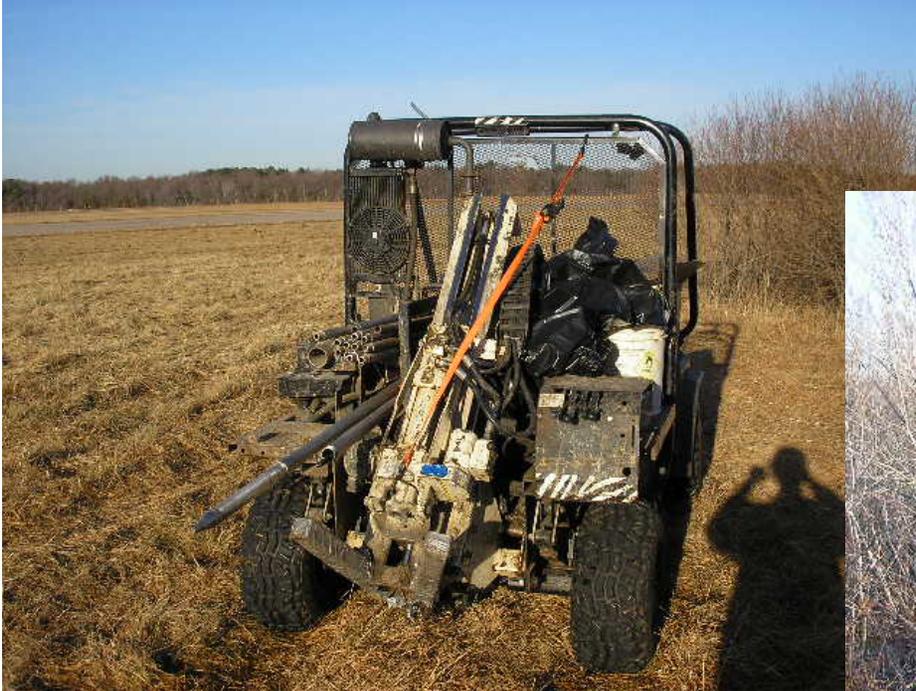
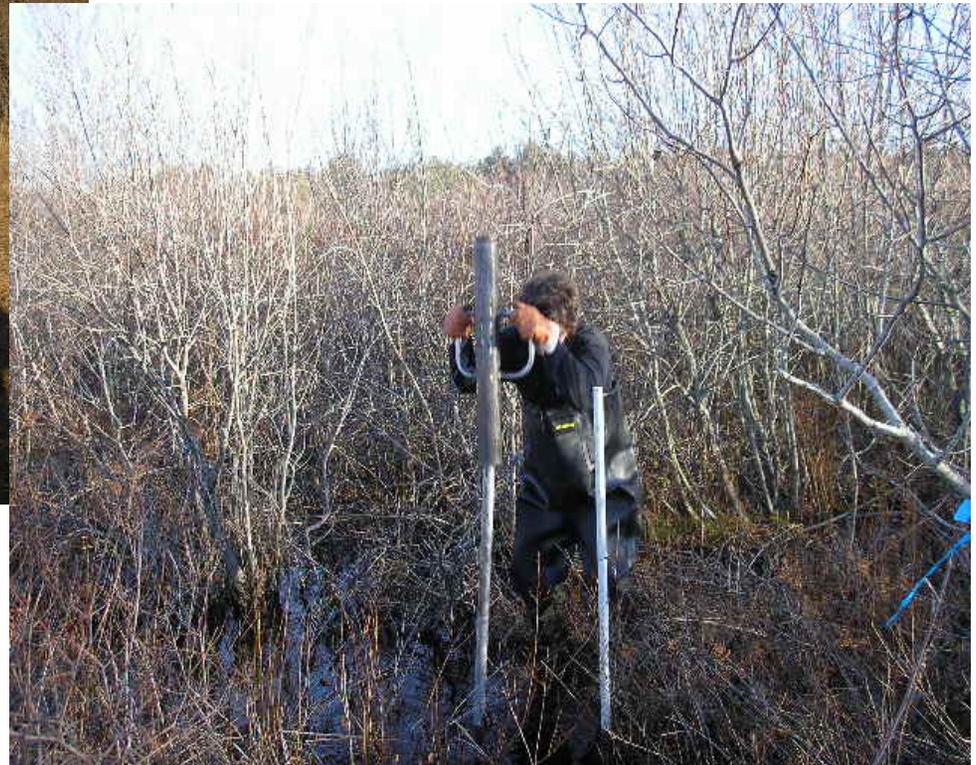
Drill Rig

Shallow Piezometer Installation

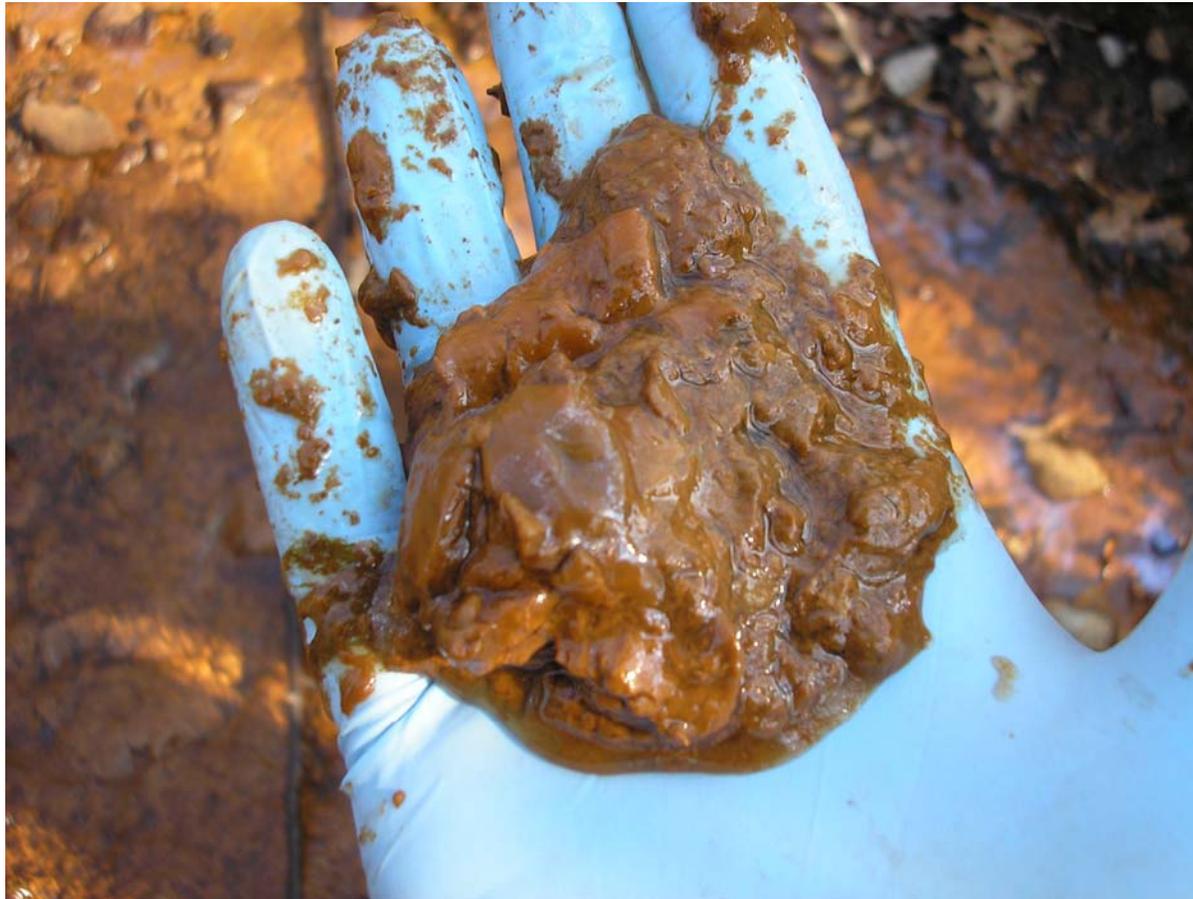
Gelatinous material located at a seep (March 2006)

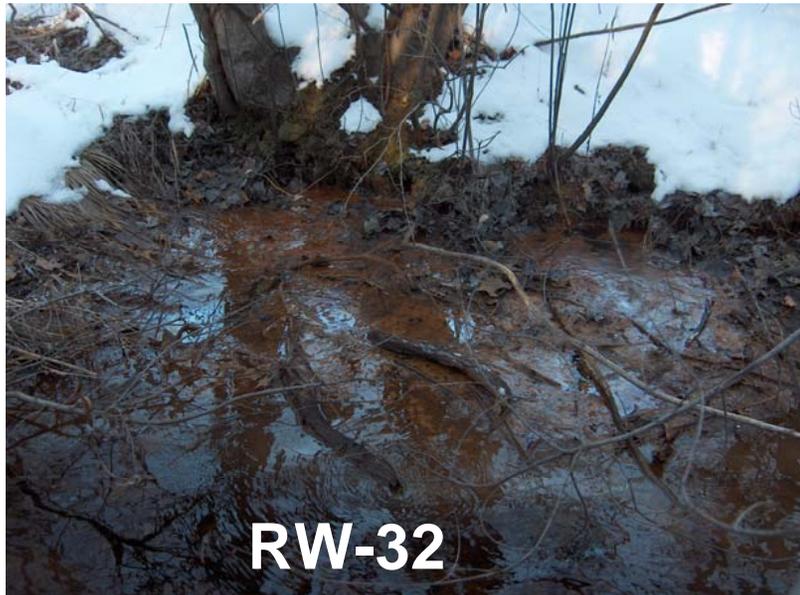
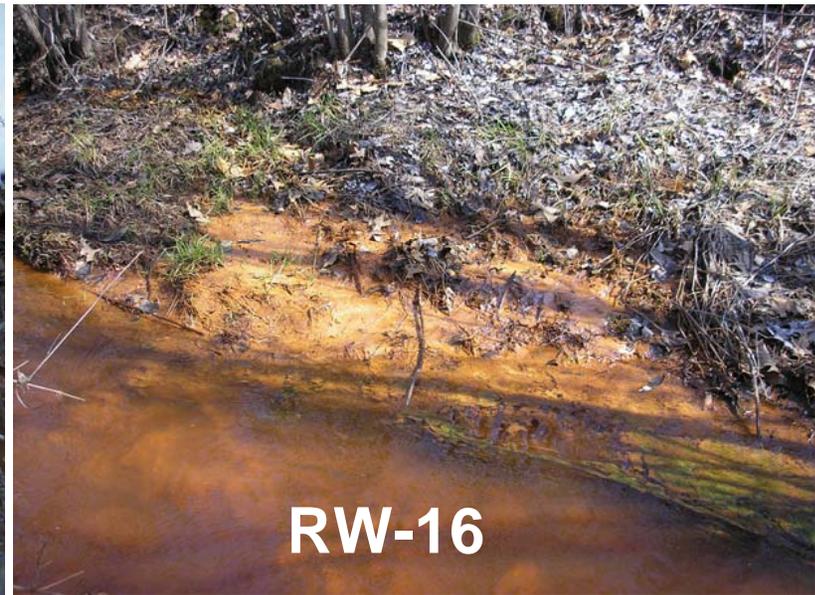
Gelatinous material located at seeps

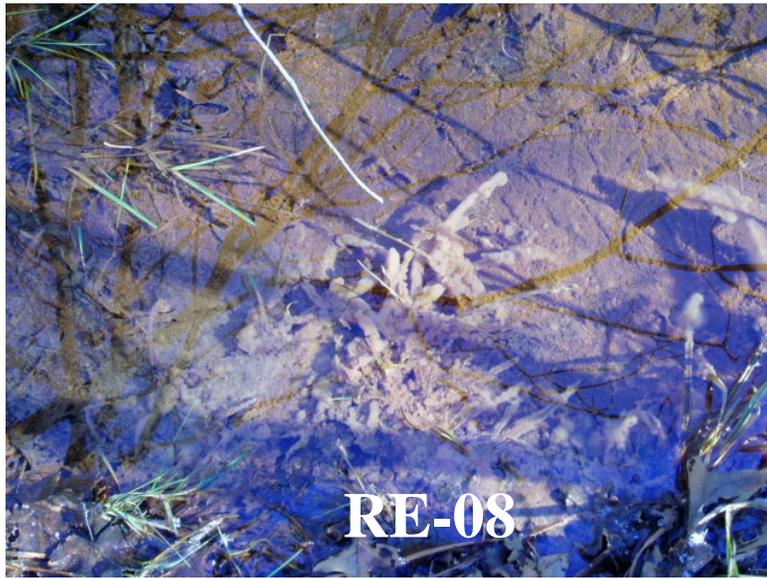
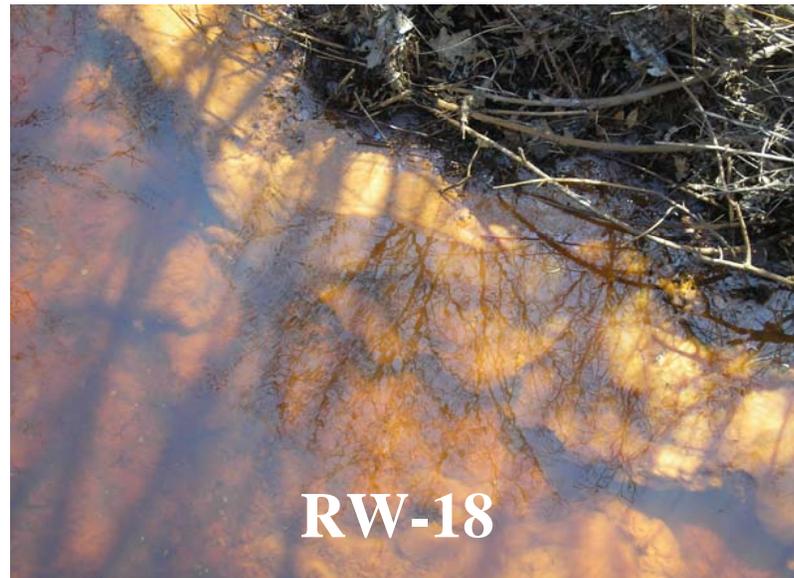
Floc deposits on woody debris

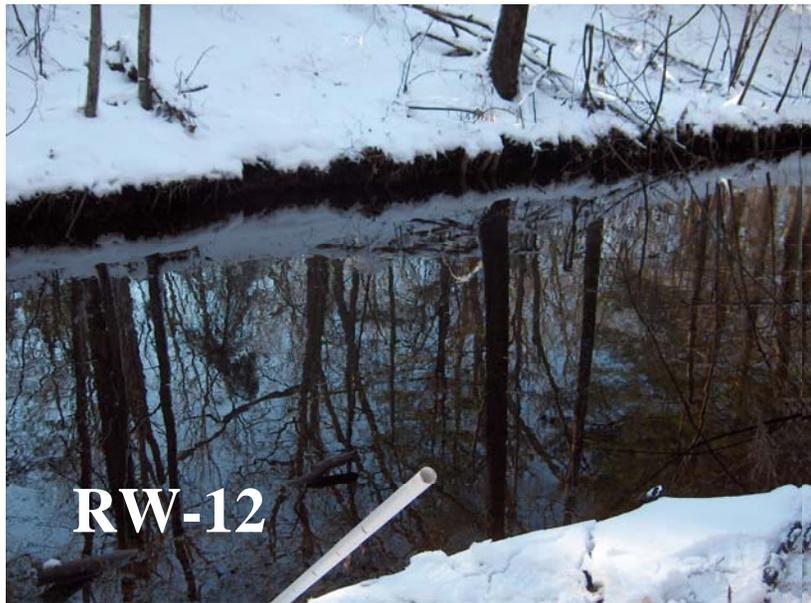
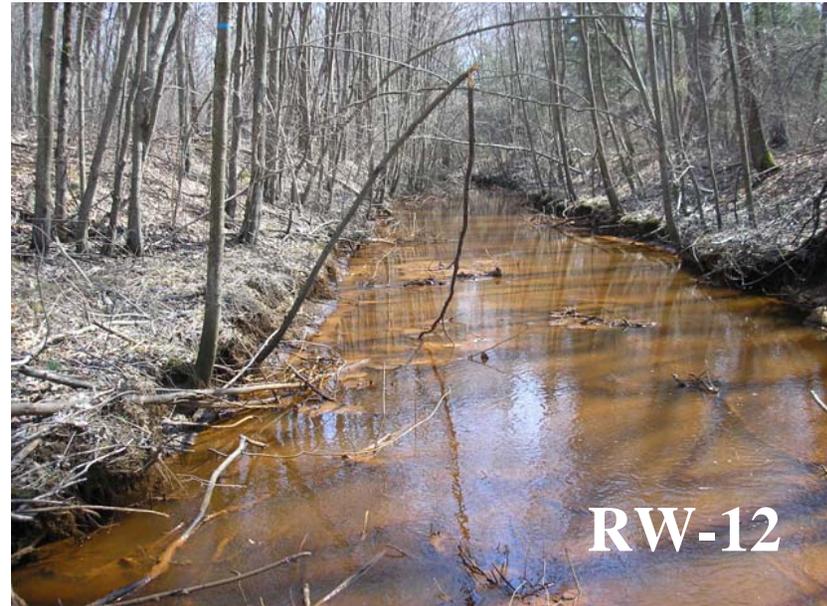
flaky Floc deposits in water column

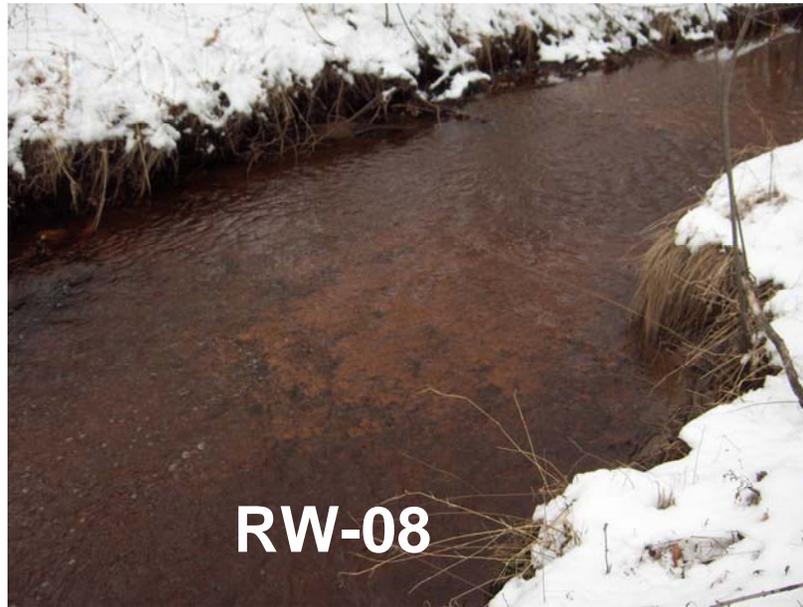
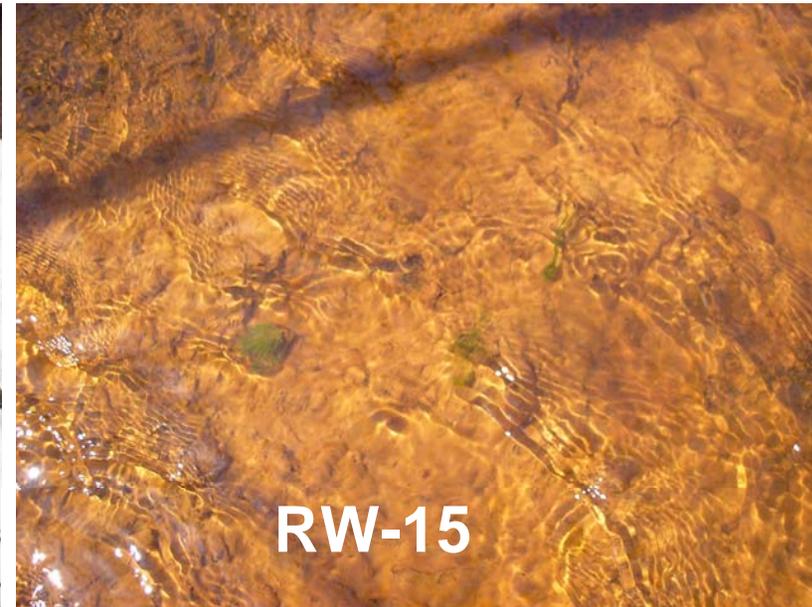
Slimy Floc deposits on stream substrate

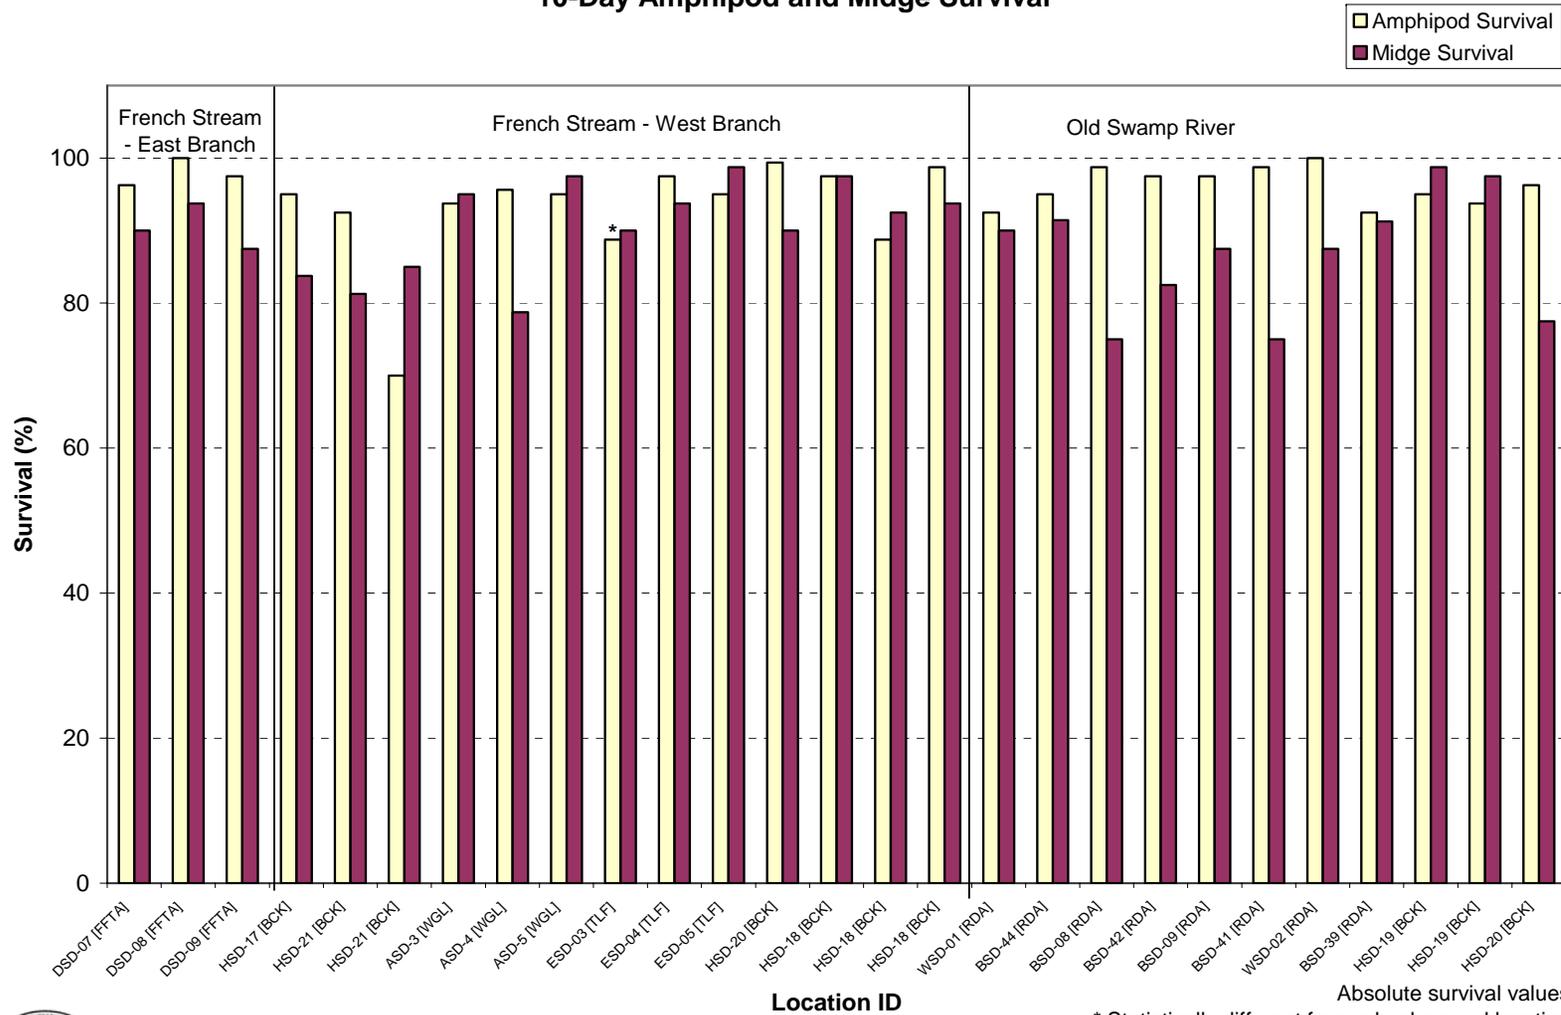
10-Day Amphipod and Midge Survival

* Statistically different from a background location
