Site Management Plan Fiscal Year 2015

**Former Naval Air Station
Joint Reserve Base (NAS JRB)
Willow Grove, Pennsylvania**

**Naval Facilities Engineering Command
Mid-Atlantic**

October 2015

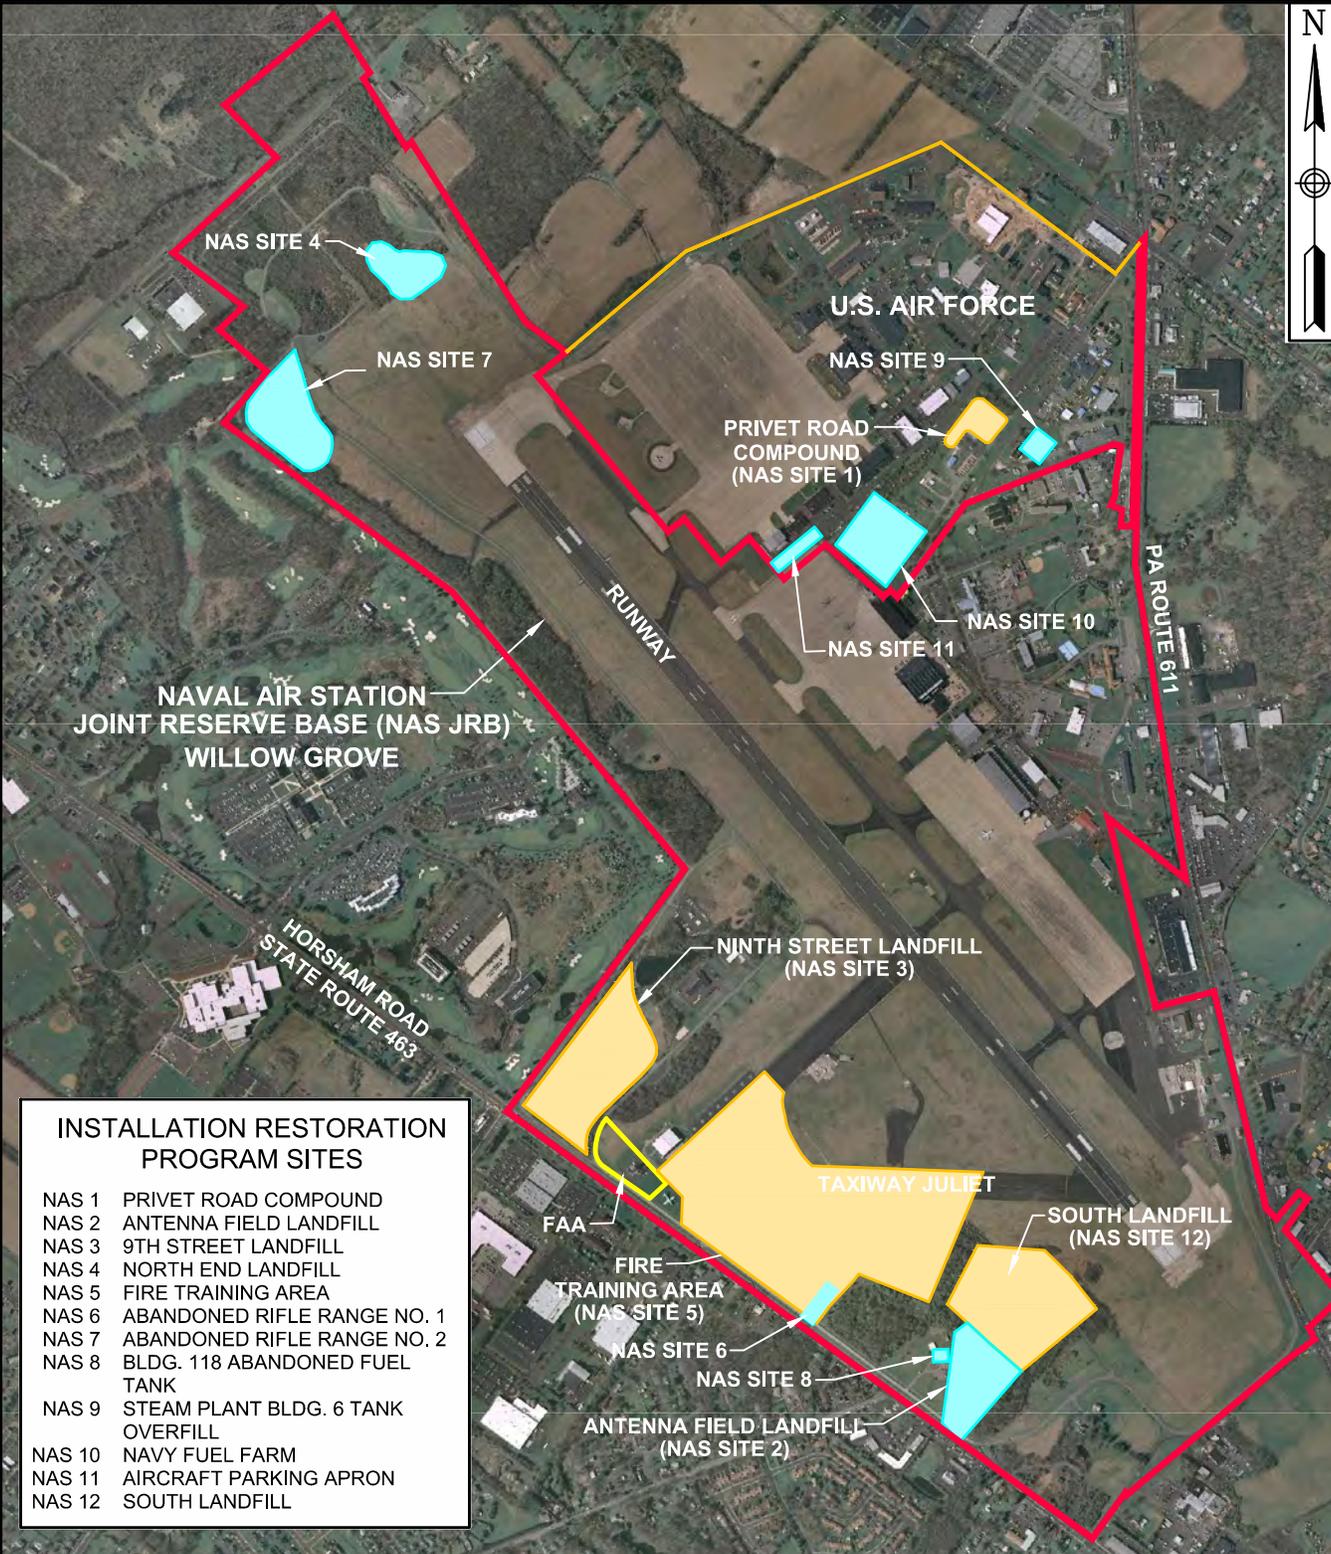
SCALE AS NOTED	
FILE 112G02014BM01-1	
REV 0	DATE 06/14/13
FIGURE NUMBER FIGURE 3-1

INSTALLATION RESTORATION PROGRAM SITES	
NAS 1	PRIVET ROAD COMPOUND
NAS 2	ANTENNA FIELD LANDFILL
NAS 3	9TH STREET LANDFILL
NAS 4	NORTH END LANDFILL
NAS 5	FIRE TRAINING AREA
NAS 6	ABANDONED RIFLE RANGE NO. 1
NAS 7	ABANDONED RIFLE RANGE NO. 2
NAS 8	BLDG. 118 ABANDONED FUEL TANK
NAS 9	STEAM PLANT BLDG. 6 TANK OVERFILL
NAS 10	NAVY FUEL FARM
NAS 11	AIRCRAFT PARKING APRON
NAS 12	SOUTH LANDFILL

**LOCATION OF IR SITES
NAS JRB WILLOW GROVE
WILLOW GROVE, PENNSYLVANIA**

The Ninth Street Landfill site is located at the western boundary of the facility, immediately north of Ninth Street (Figure 3-1). Disposal operations at the 9-acre site were initiated as a replacement for the Antenna Field Landfill in 1960. Wastes were burned and then buried in excavated trenches. Wastes were similar to those at Site 2, and included general wastes, bulk items, paint waste, asbestos, and sewage sludge (NEESA, 1986). Transformers containing PCBs were also stored and serviced in a salvage yard established on the landfill after the landfill's closure in 1967 (EA Engineering, 1990). Figure 3-4 shows the site layout.

The Fire Training Area is located in the south-central portion of NAS JRB, approximately midway between Runway 10/28 and State Route 463 (Figure 3-1). The site is located immediately south of Taxiway Juliet and covers an irregularly shaped area of approximately 1.25 acres, as shown on Figure 3-6. The training area was used from 1942 to 1975 for large-scale firefighting exercises, which included the disposal and burning of flammable liquid wastes generated by the Naval Air Station. Wastes, including solvents, paint chemicals, xylenes, toluene, and various petroleum compounds, were consumed at the rate of up to 4,000 or more gallons per year in these firefighting exercises. The area was also reportedly used for the drum storage of these flammable materials during the periods between burning exercises.

The site is located in the northwestern corner of the facility, west of the north end of Runway 15/33 (Figure 3-1). Construction and operation of the range were similar to Site 6, and consisted of a 1-acre earthen rampart to collect fired rounds of ammunition. The range operated from 1965 until 1977, when the current range located in Building 176 at the Army Reserve Compound was constructed. The rampart, along with the spent ammunition, was regraded in 1977. This area was subsequently used as a landfill for inert materials including clean fill, broken concrete, asphalt, and cinderblocks. In addition, dry wastewater treatment sludge and emulsified oil and grease from on-site oil/water separators were reported to have been buried at the site (NEESA, 1986). Figure 3-8 presents an aerial view of the site.

The site consists of a former underground 500-gallon heating fuel tank located approximately 50 feet north of Building 118 (Figure 3-1). The tank was placed in service in 1959, and was abandoned in place in 1980 when it was replaced with a 290-gallon above ground tank. The tank contained only No. 2 heating fuel and serviced Building 118. In 1980, oil was observed seeping into the basement of Building 118. This occurred on an intermittent basis, and the oil was removed after each occurrence. The tank was investigated as a result of the seepage. The tank was empty and soils in the excavation around the tank did not indicate the presence of released materials; however, the fill and riser pipes were removed and the tank was buried in place (NEESA, 1986). Figure 3-9 presents an aerial view of the site.

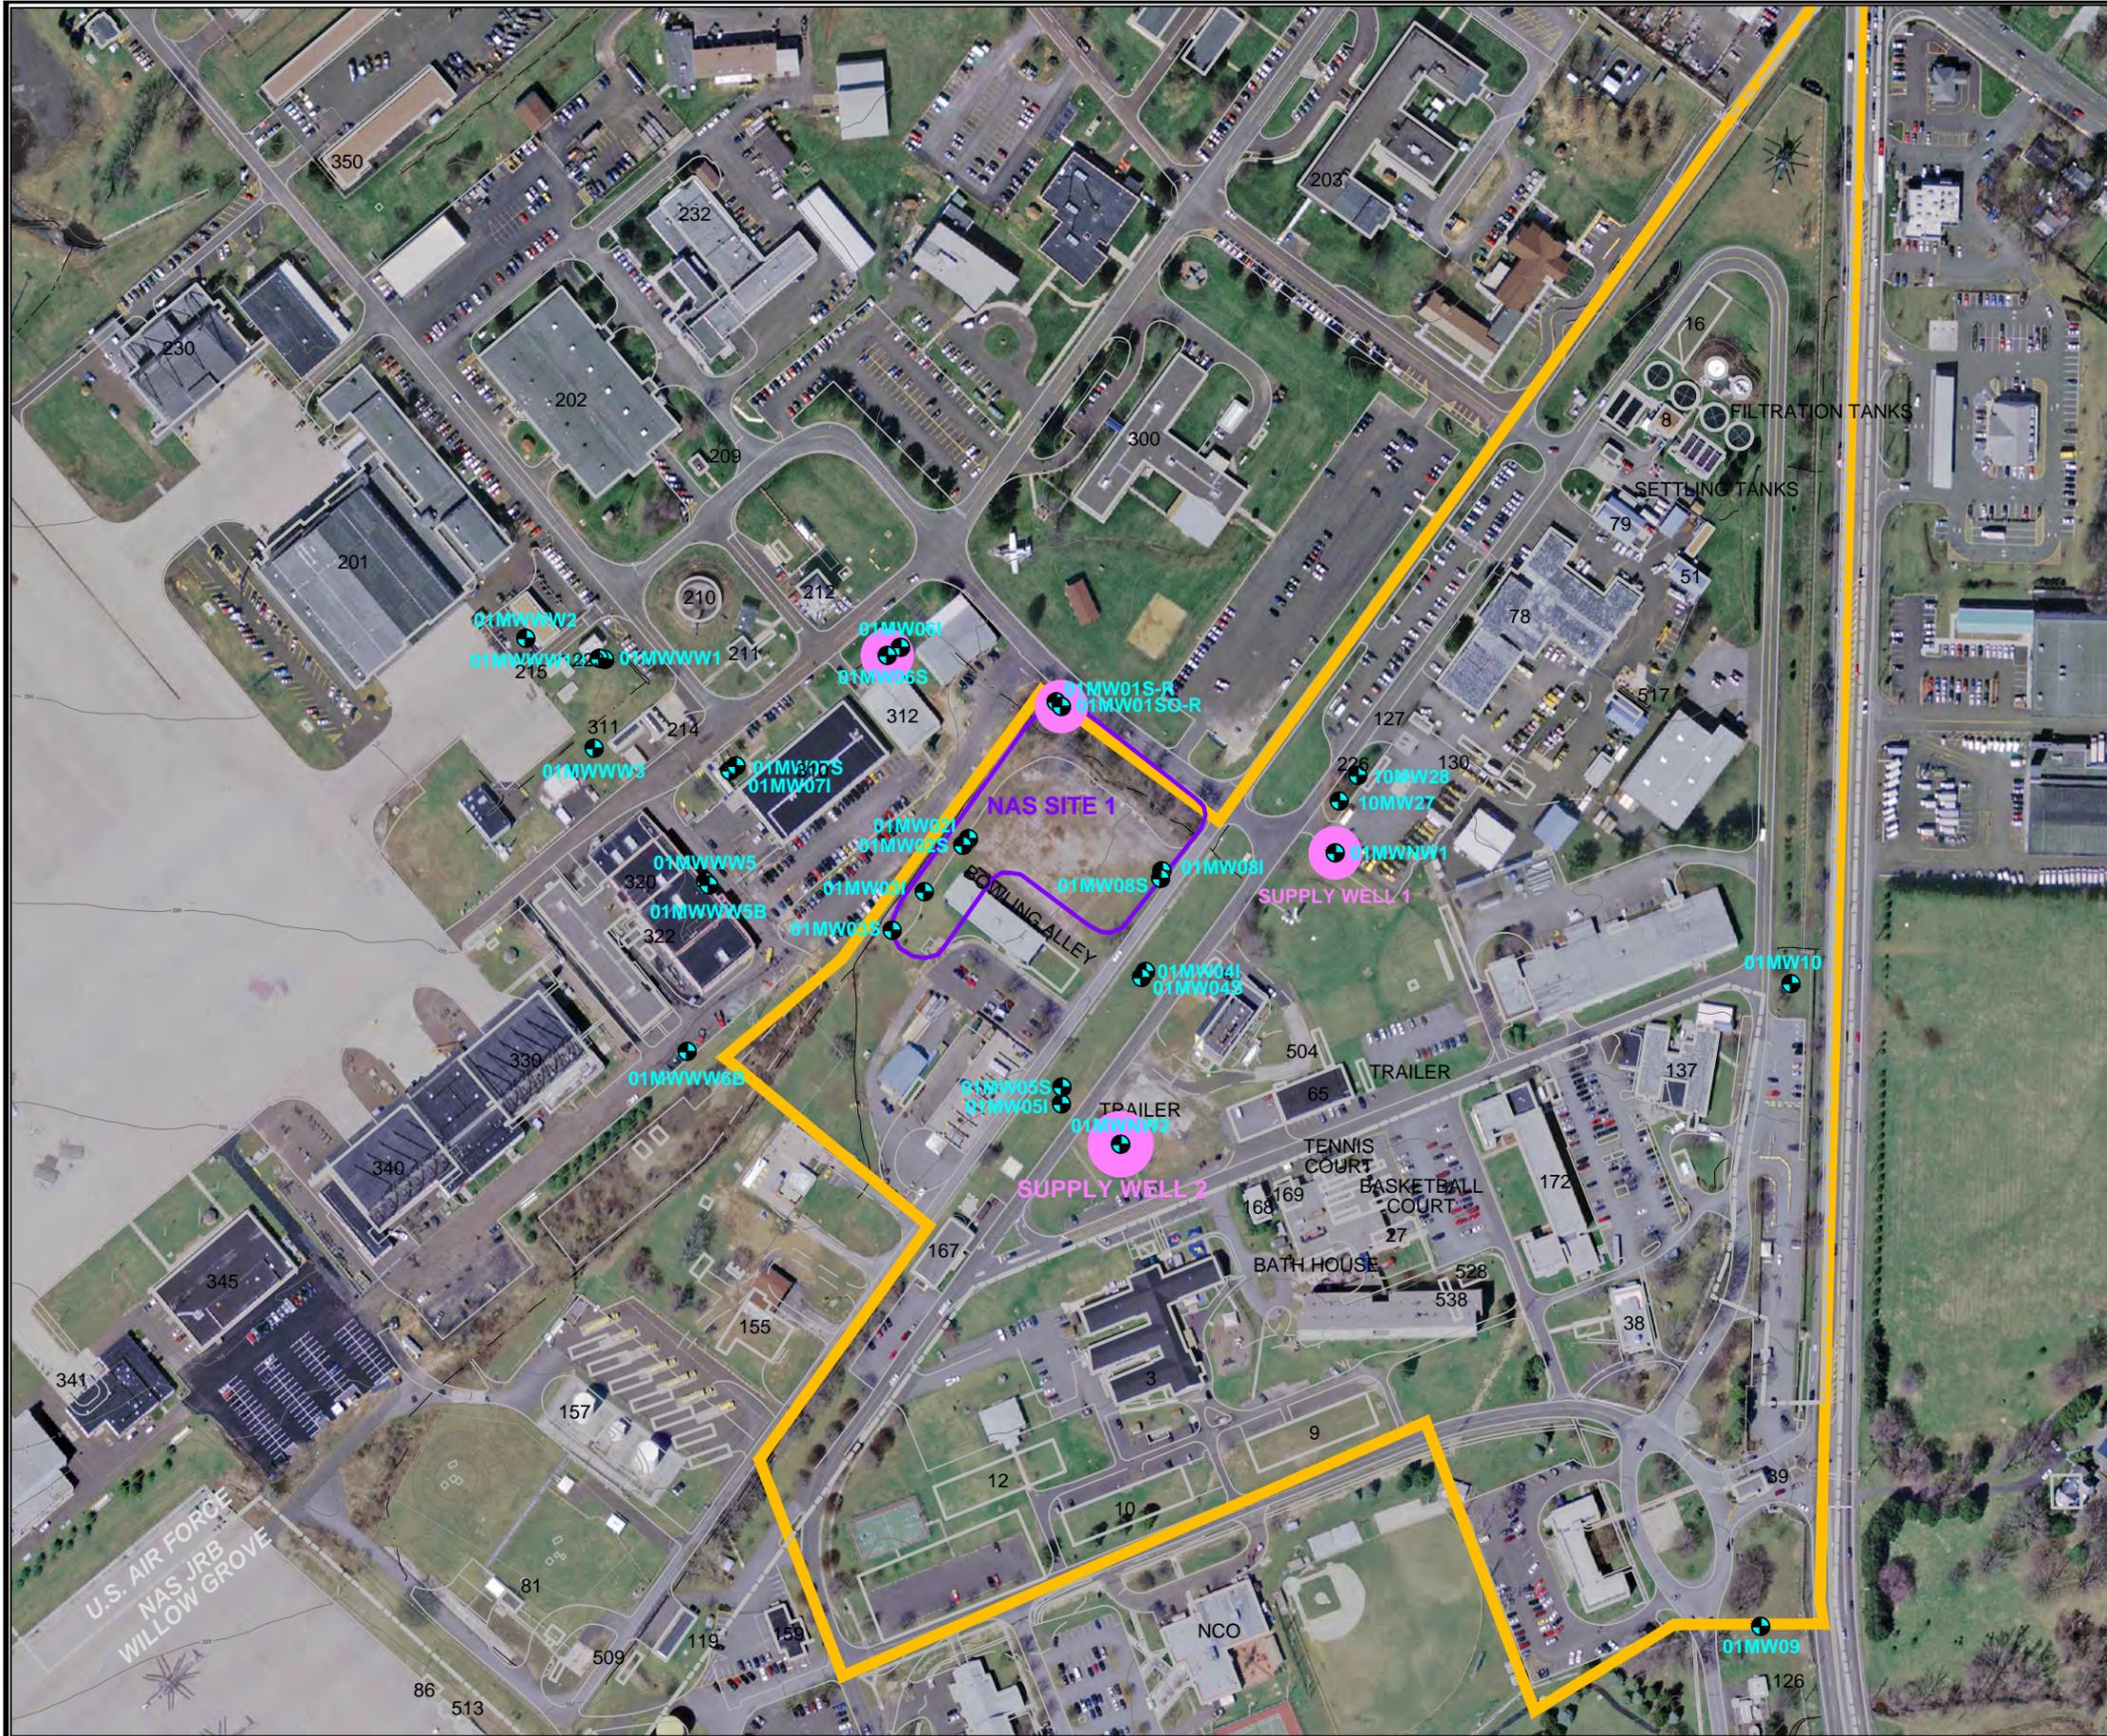
FILE 112G02014GM01-1	SCALE AS NOTED
FIGURE NUMBER FIGURE 3-2	REV DATE 0 06/13/13

SITE LAYOUT
 SITE 1 – PRIVET ROAD
 NAS JRB WILLOW GROVE
 WILLOW GROVE, PENNSYLVANIA

The former Privet Road Compound is located west of Privet Road, across from the steam plant (Building No. 6). Figure 3-2 shows the current Site 1 layout. The entire site area was approximately 2 acres and consisted of a bowling alley, parking lot, and a 0.5-acre fenced area. Trash handling operations at the Privet Road Compound began in 1967 when the Ninth Street Landfill (Site 3) was closed. To replace the landfill, regular trash pickup and off-site disposal were initiated. The Privet Road Compound site was used to process wastes from 1967 to 1975. A fence was erected around the compound area in 1972 to control waste disposal and handling within the compound. The suspected waste handling area, however, is believed to have extended throughout Site 1, including the area where the Bowling Alley and parking lot were located.

The Privet Road Compound was constructed as a transfer station to handle materials not accepted by the trash pickup service. During operations at the compound, wastes were temporarily stored on site to await off-site disposal or were burned and/or buried on site. Burning and burial ceased by 1975; however, stored waste material was not completely removed from the site until 1977 (NEESA, 1986).

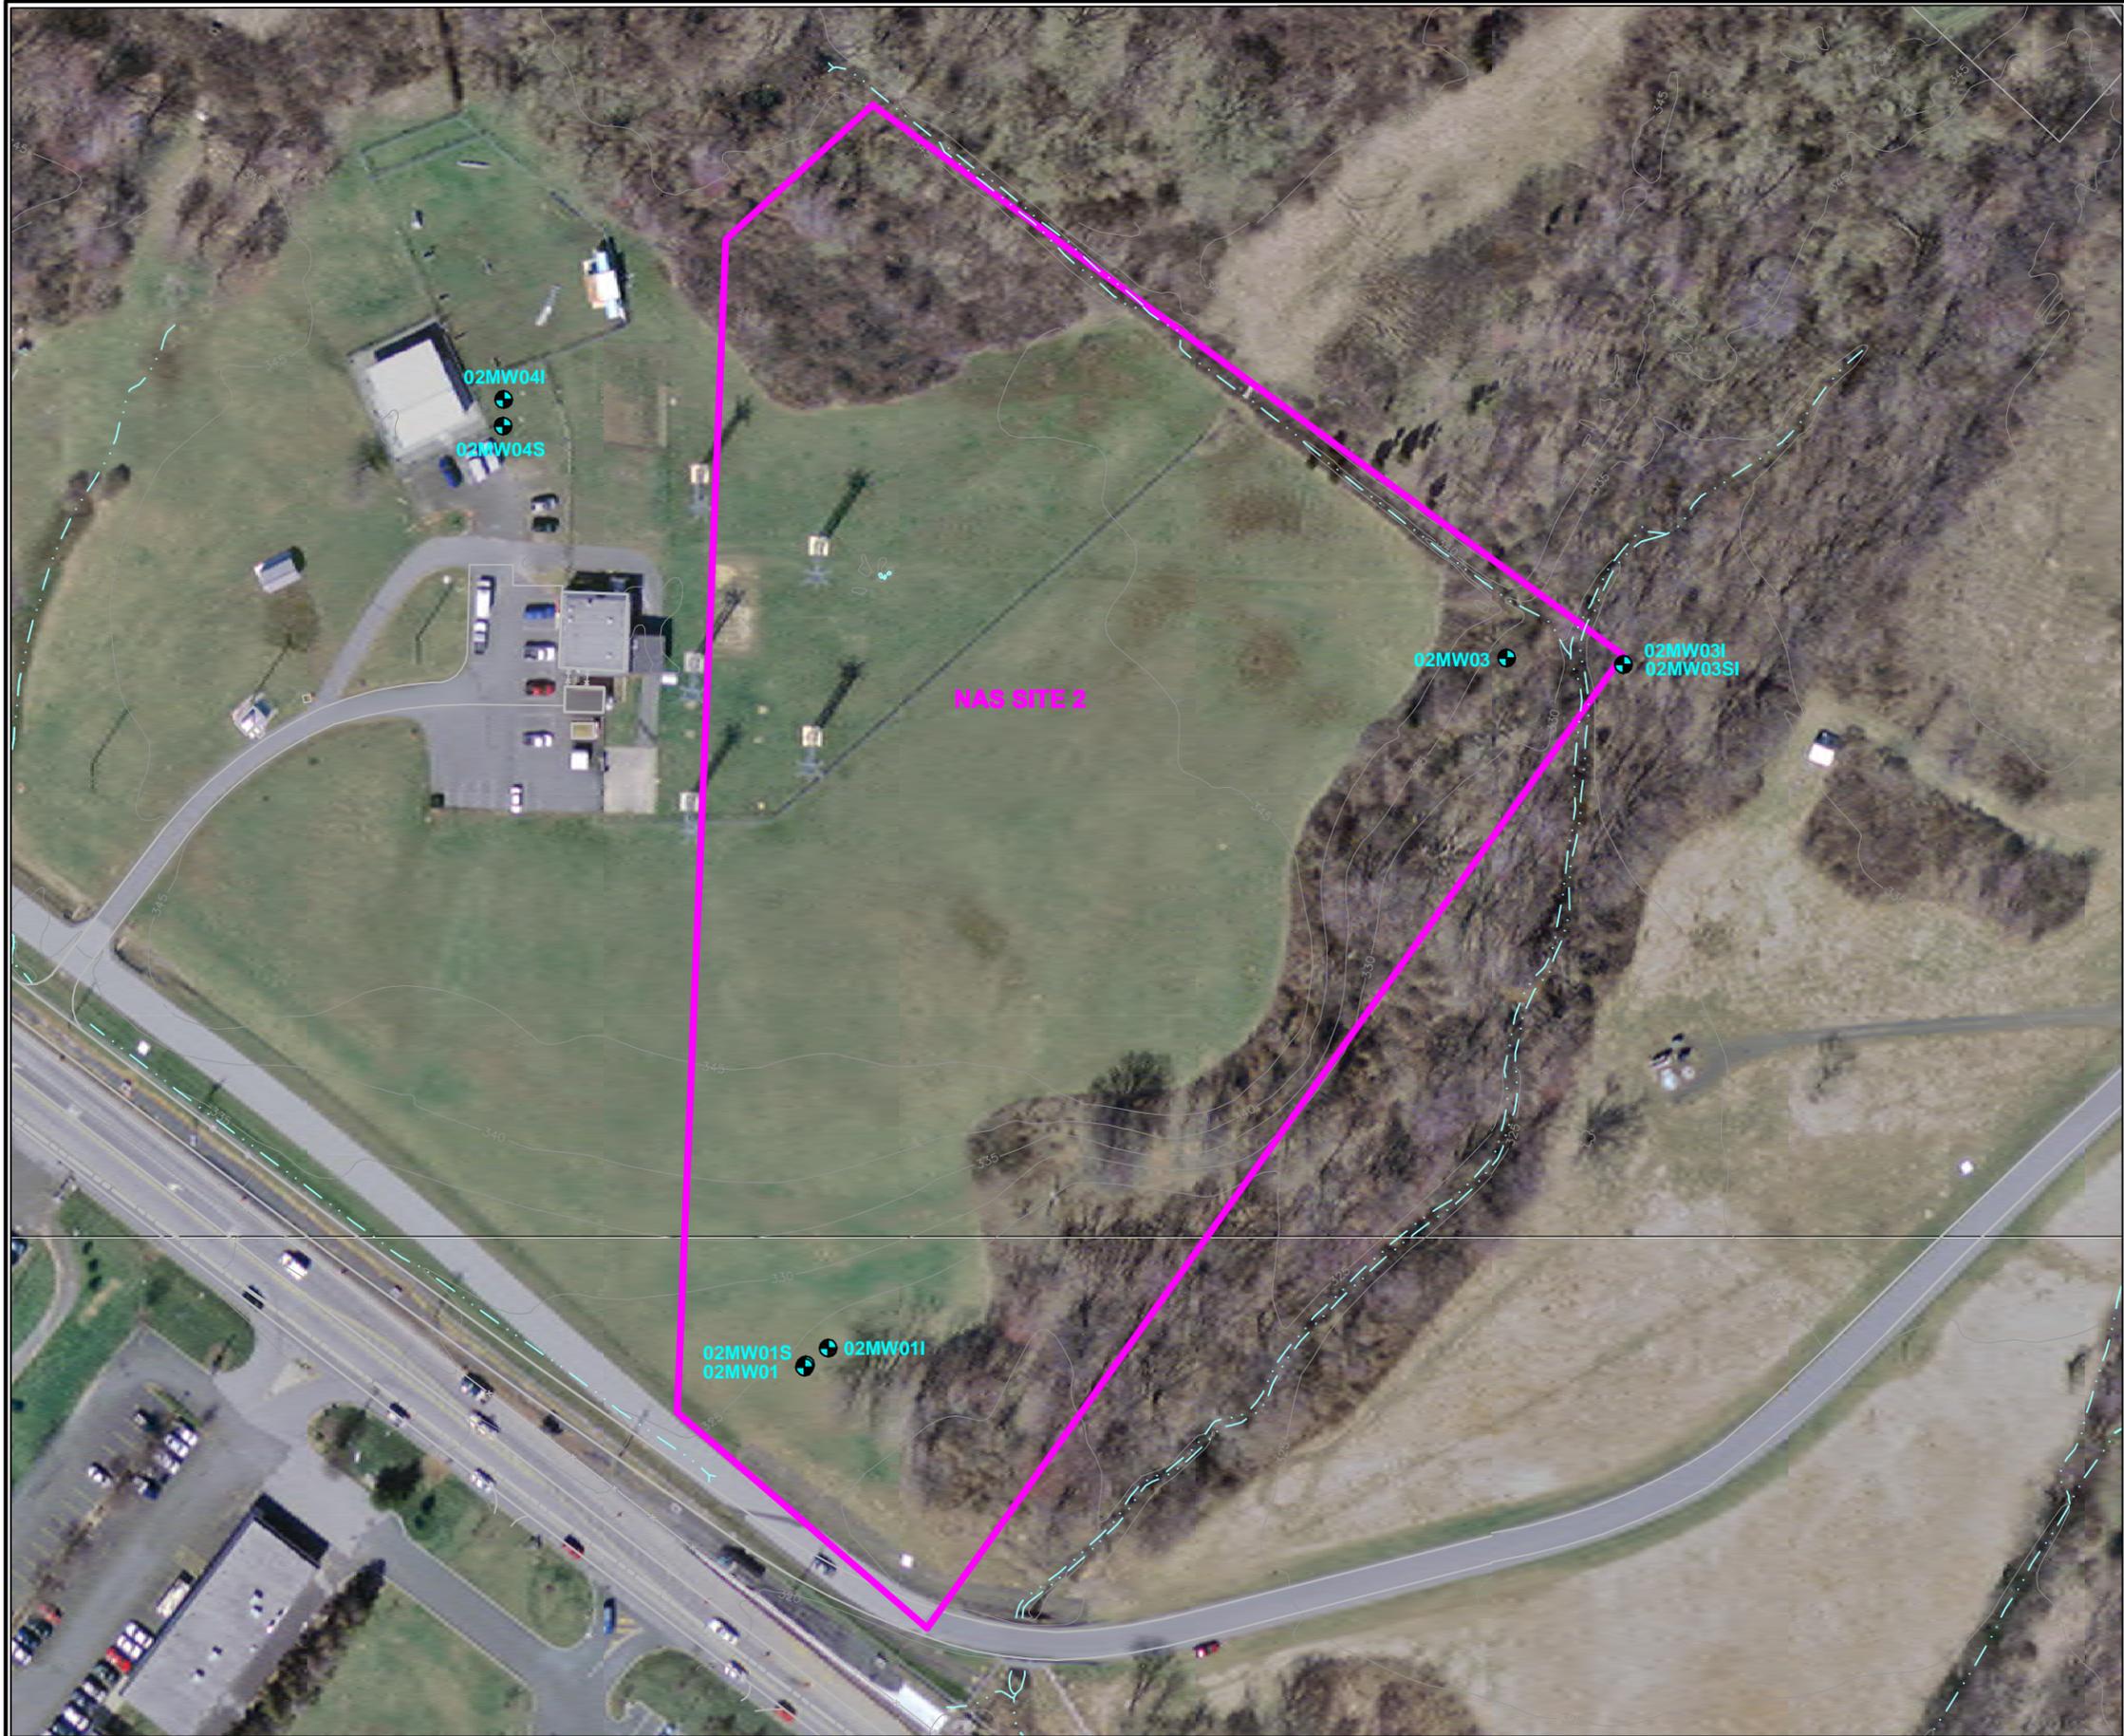
FILE 112G02014GM01-2	SCALE AS NOTED
FIGURE NUMBER FIGURE 3-3	REV DATE 0 06/26/12

SITE LAYOUT
 SITE 2 – ANTENNA FIELD LANDFILL
 NAS JRB WILLOW GROVE
 WILLOW GROVE, PENNSYLVANIA

The landfill was used between 1948 and 1960 as the principal disposal area for solid waste generated by the facility. Waste disposal activities included the excavation of trenches where wastes were subsequently burned and/or buried. In addition to general wastes, bulk items such as furniture, tires, and shingles were disposed. Paint wastes and sewage sludge were also reportedly disposed (NEESA, 1986).

In the mid 1990's, an antenna array consisting of five antennae was constructed at the site to replace an older antenna array.

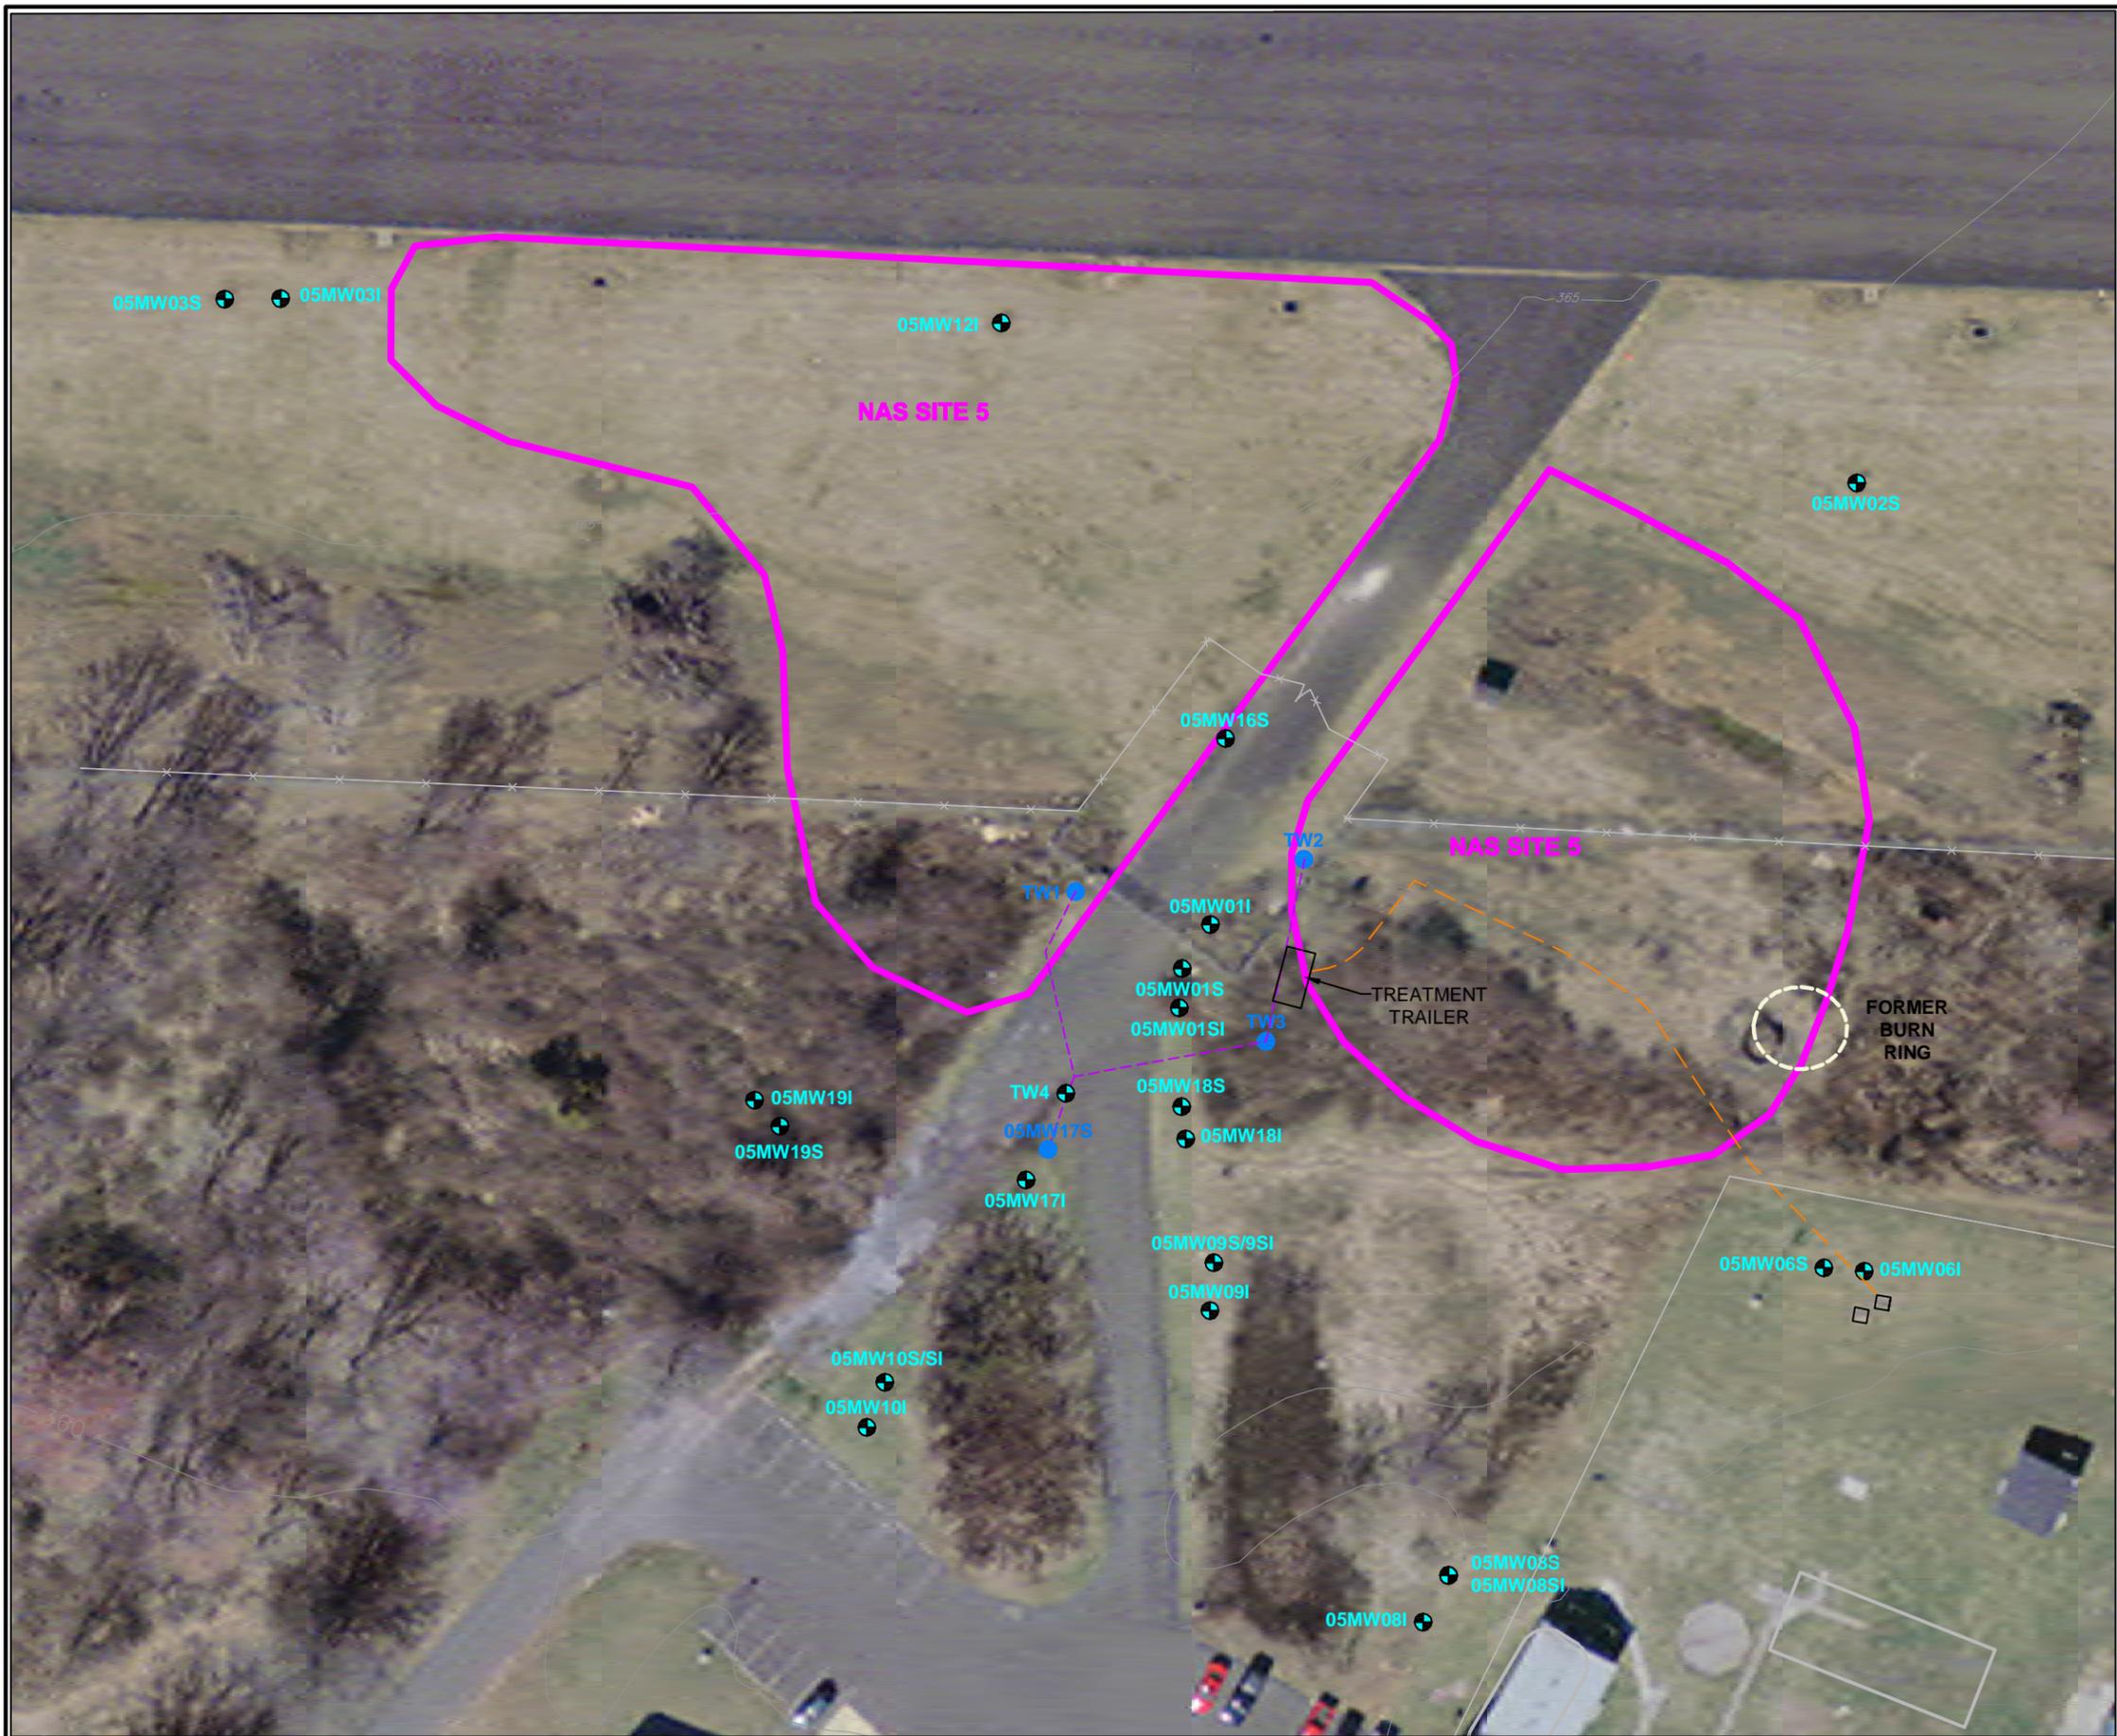
FILE 112G02014GM01-5	SCALE AS NOTED
FIGURE NUMBER FIGURE 3-6	REV DATE 0 06/26/12

- MONITORING WELL LOCATION
- INJECTION/EXTRACTION WELL LOCATION
- - - UNDERGROUND ELECTRIC AND WATER LINE
- - - UNDERGROUND ELECTRIC LINE
- SITE BOUNDARY
- INSTALLATION BOUNDARY

SITE LAYOUT
SITE 5 – FIRE TRAINING AREA
NAS JRB WILLOW GROVE
WILLOW GROVE, PENNSYLVANIA

The Fire Training Area is primarily covered by grasses, with some woody and brushy vegetation present within the southern portion of the area. The burn area consisted of a "burning ring" that was actually a section of a partially buried steel tank, wide open at the top with an intact bottom below the surrounding grade, which was located in the south-central portion of the site (Tetra Tech, 2002c).

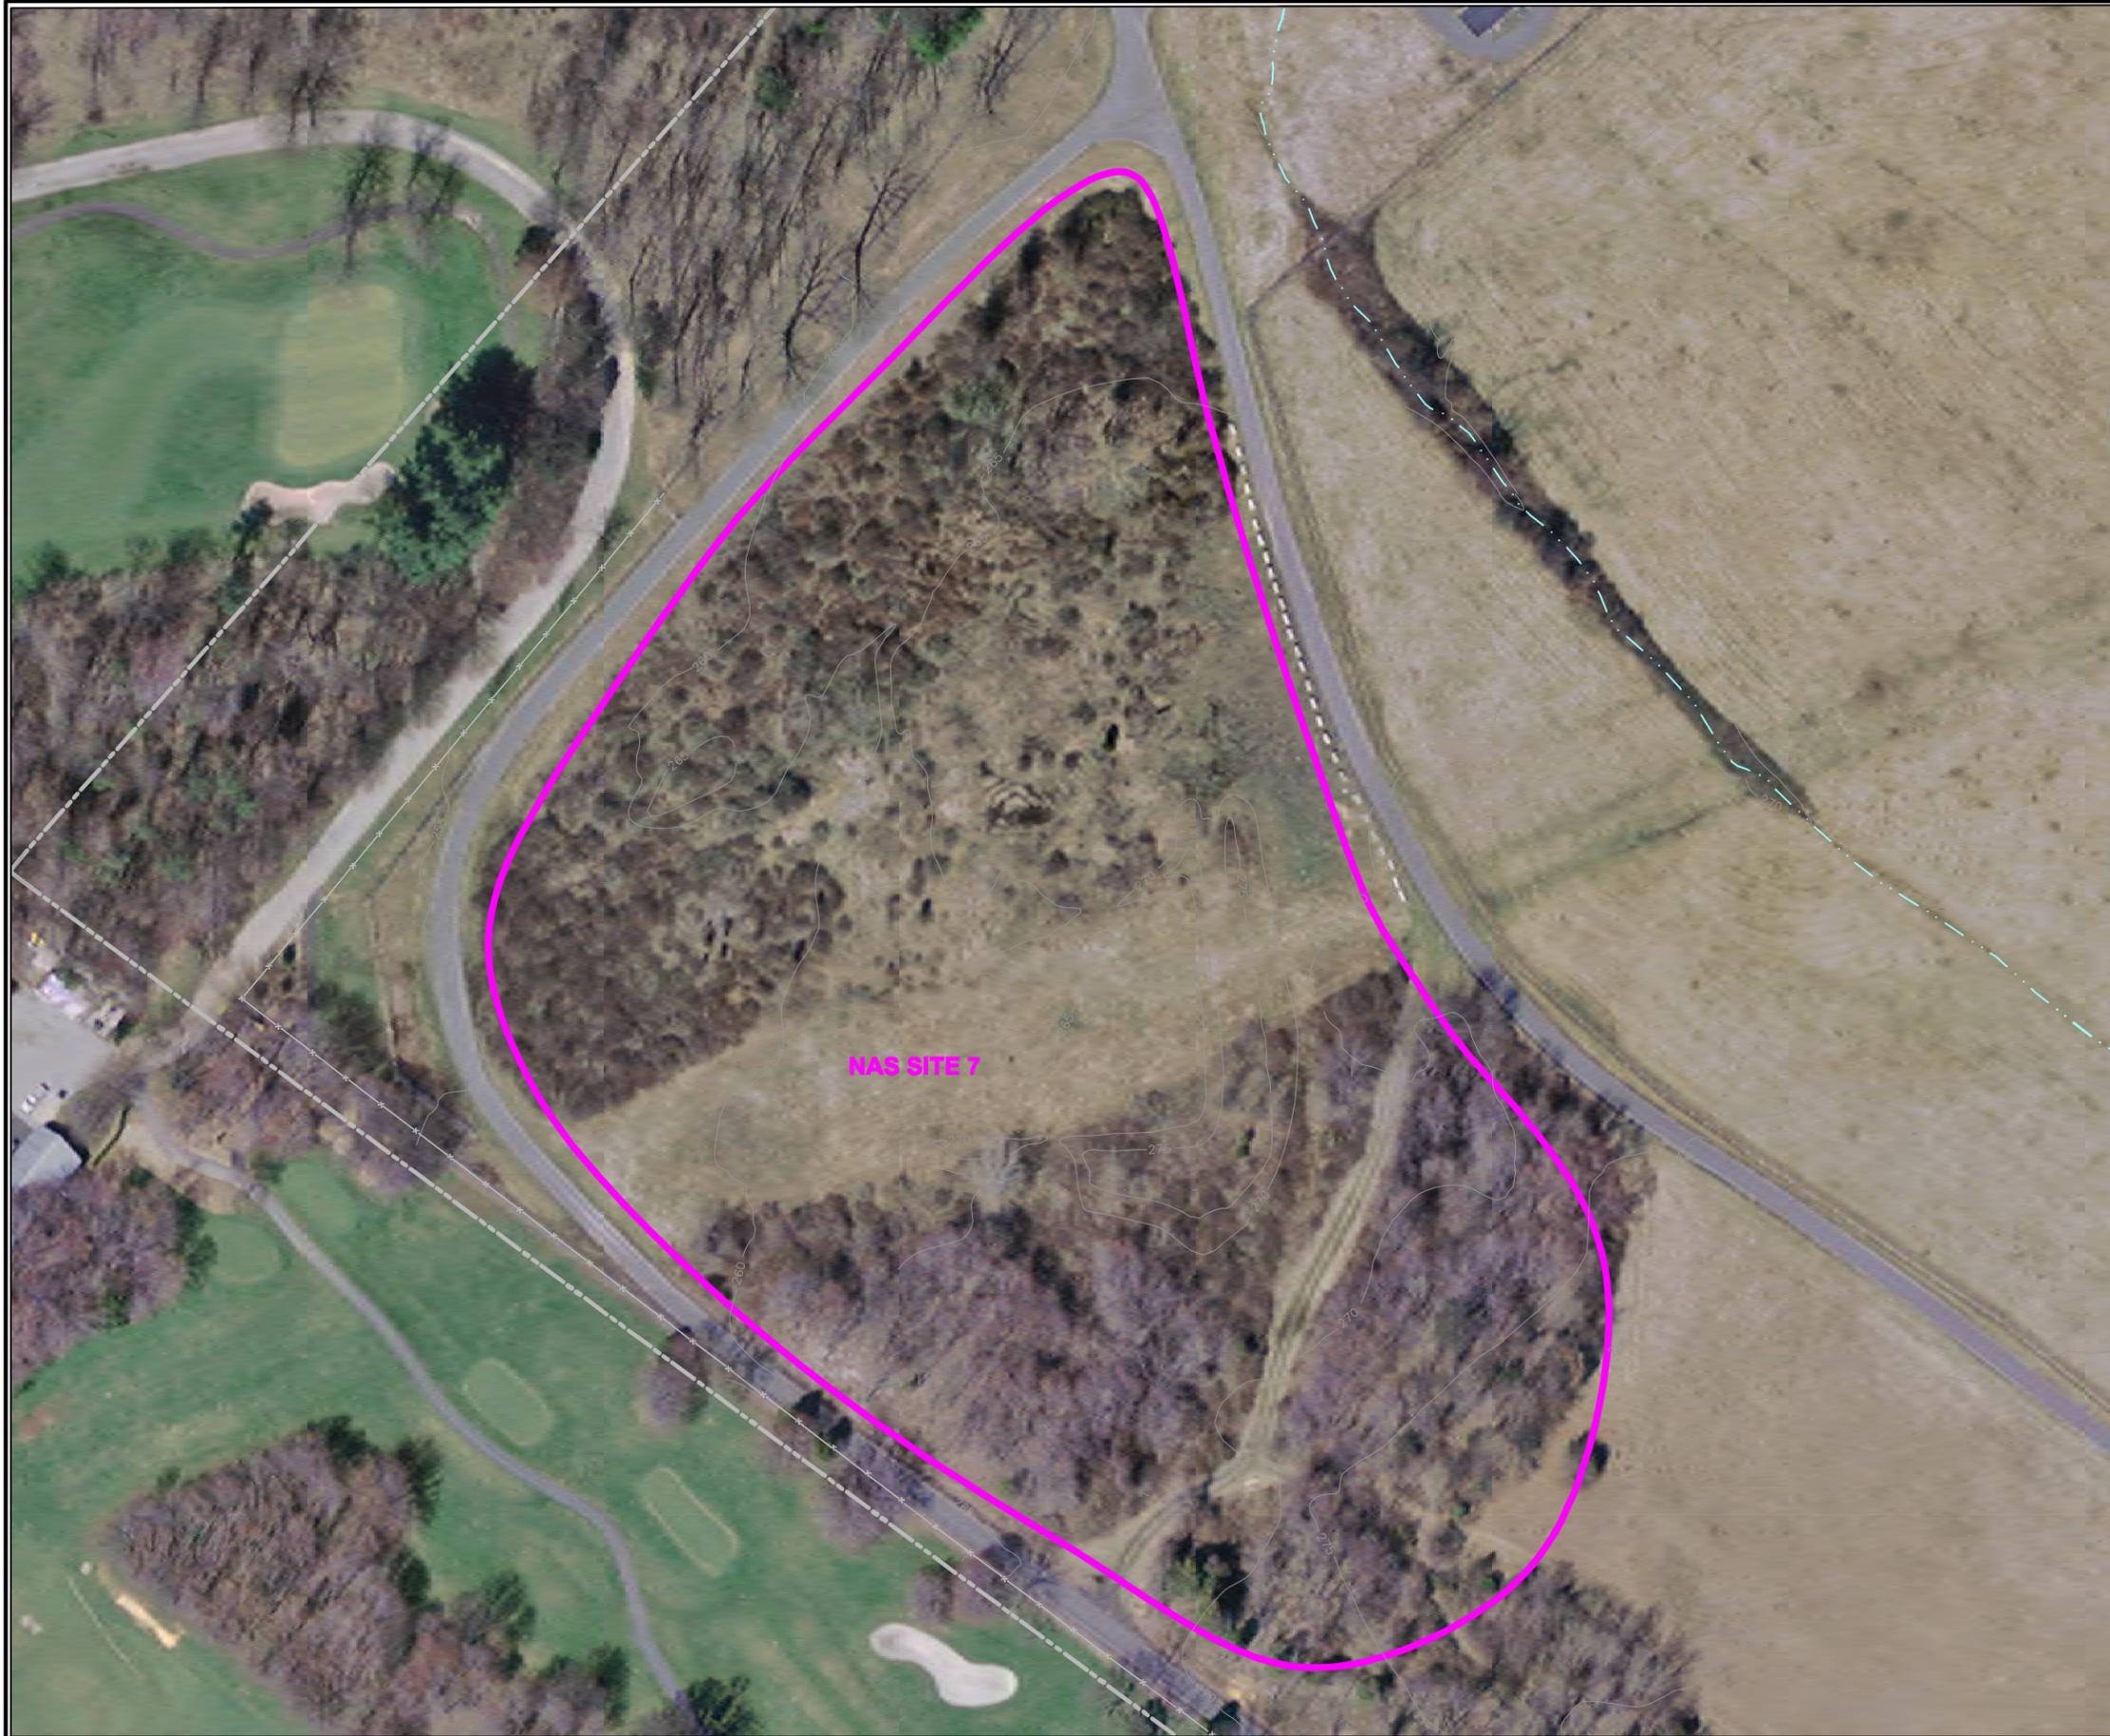
FILE 112G02014GM01-7	SCALE AS NOTED
FIGURE NUMBER FIGURE 3-8	REV DATE 0 06/26/12

SITE LAYOUT
 SITE 7 – ABANDONED RIFLE RANGE 2
 NAS JRB WILLOW GROVE
 WILLOW GROVE, PENNSYLVANIA

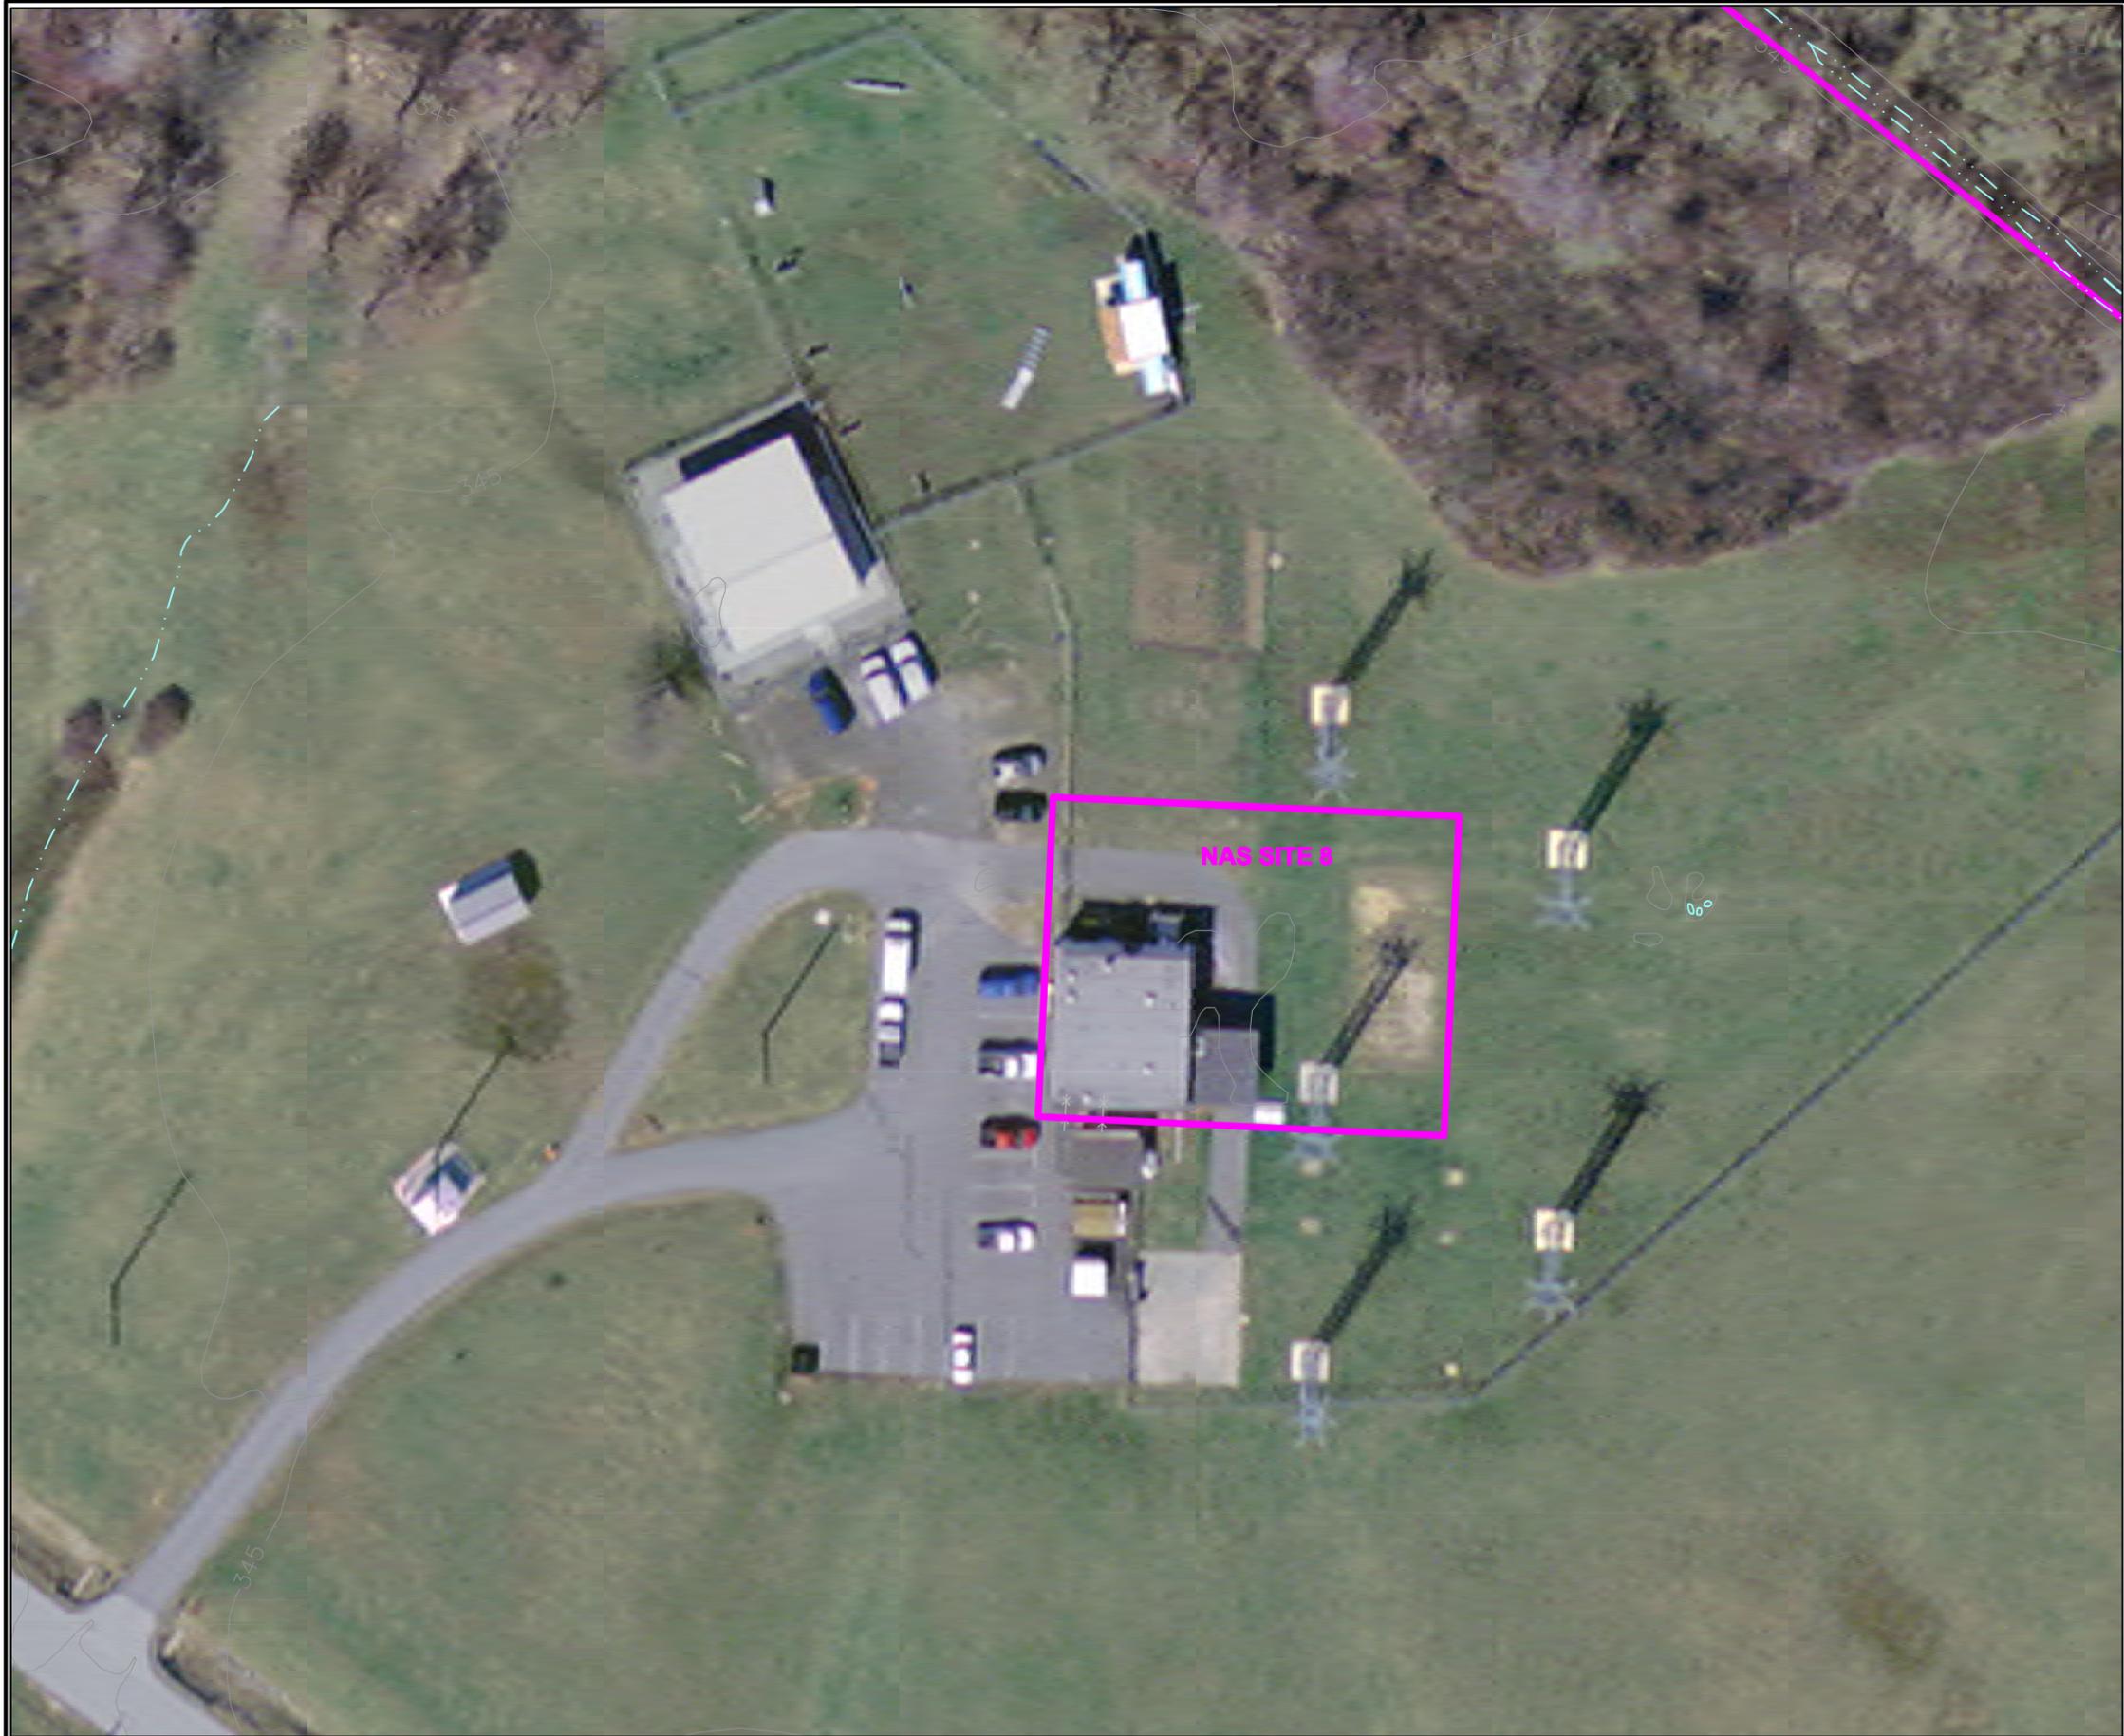
FILE 112G02014GM01-8	SCALE AS NOTED
FIGURE NUMBER FIGURE 3-9	REV DATE 0 06/26/12

SITE LAYOUT
 SITE 8 - BUILDING 118
 ABANDONED FUEL TANK
 NAS JRB WILLOW GROVE
 WILLOW GROVE, PENNSYLVANIA
