Site Management Plan Fiscal Year 2015

**Former Naval Air Station
Joint Reserve Base (NAS JRB)
Willow Grove, Pennsylvania**

**Naval Facilities Engineering Command
Mid-Atlantic**

October 2015

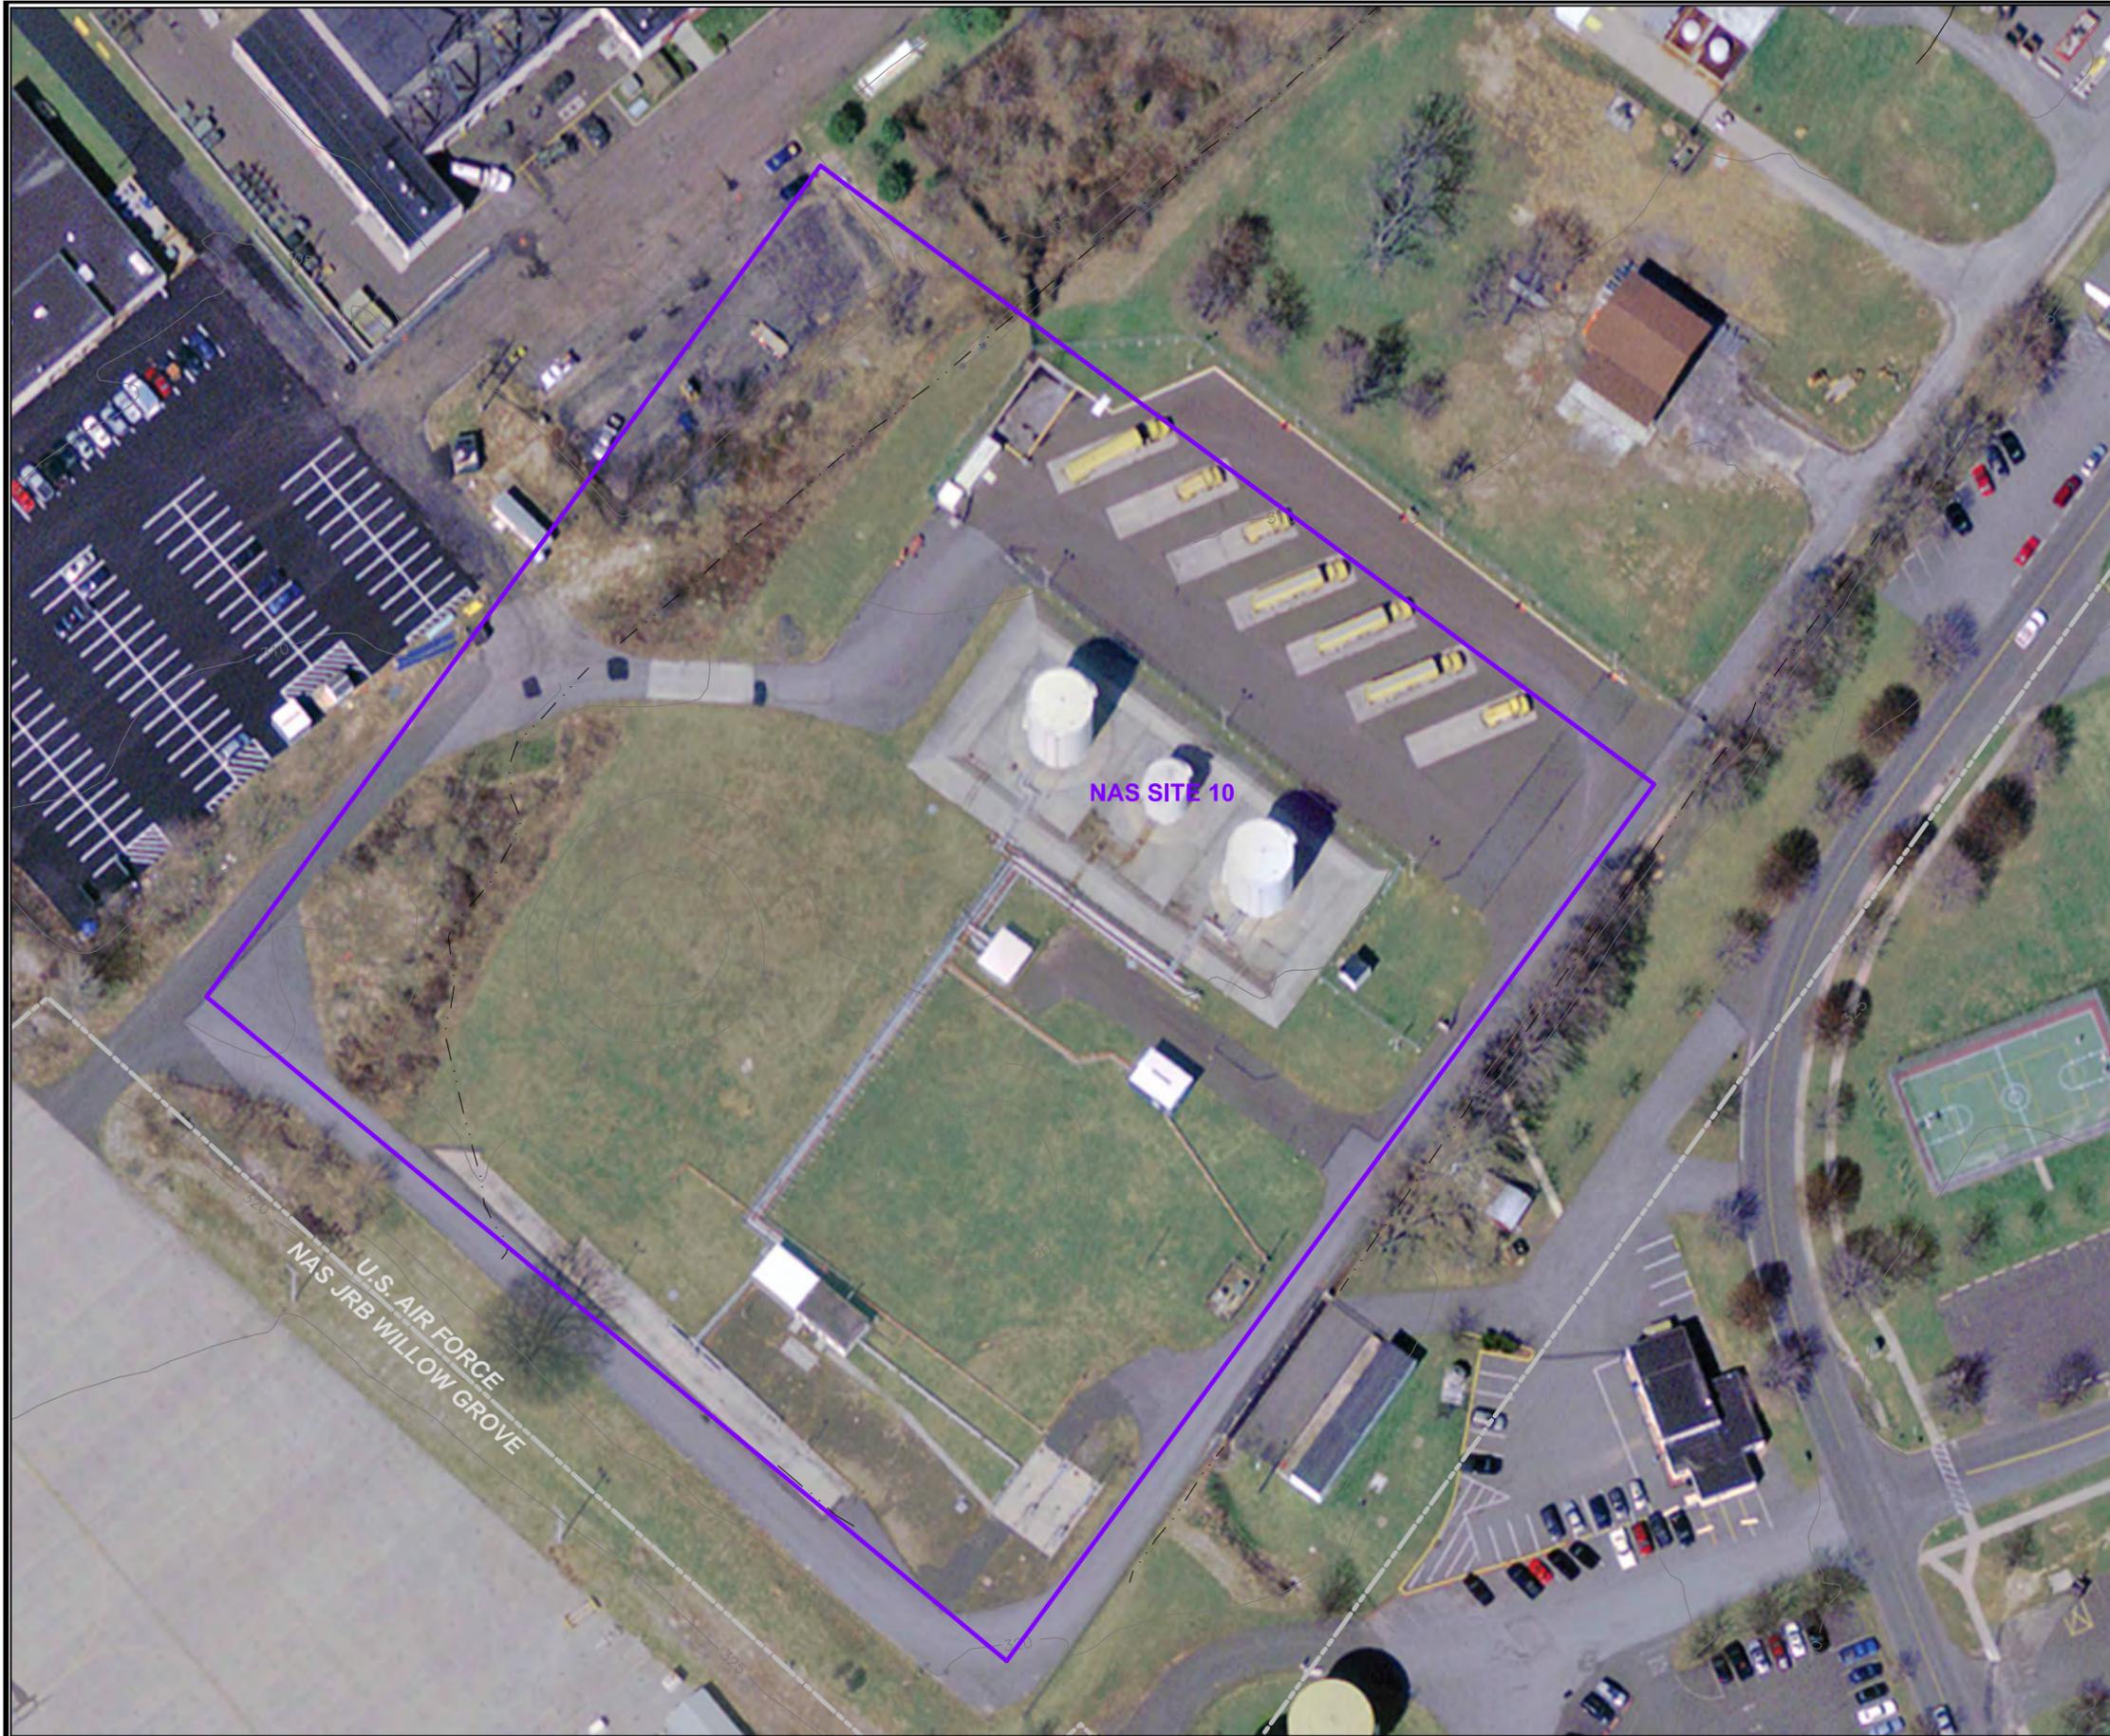
FILE 112G02014GM01-9	SCALE AS NOTED
FIGURE NUMBER FIGURE 3-10	REV DATE 0 06/13/13

SITE LAYOUT
 SITE 9 – BUILDING 6
 STREAM PLANT TANK OVERFILL
 NAS JRB WILLOW GROVE
 WILLOW GROVE, PENNSYLVANIA

When the main steam plant (Building 6) was converted from coal to oil in 1969 through 1970, spill containment for the fuel oil tank was not constructed. In 1978, a fuel oil supplier delivered No. 2 fuel oil to a filled tank while leaving the delivery truck unattended. The fuel backed up through the vent pipe, and approximately 3,000 to 5,000 gallons of fuel oil were released. The spill was located in the area between Building 6 and Building 114 (Figure 3-1). This area is now bermed to contain spills resulting from fuel delivery. An aerial view of the site is presented on Figure 3-10.

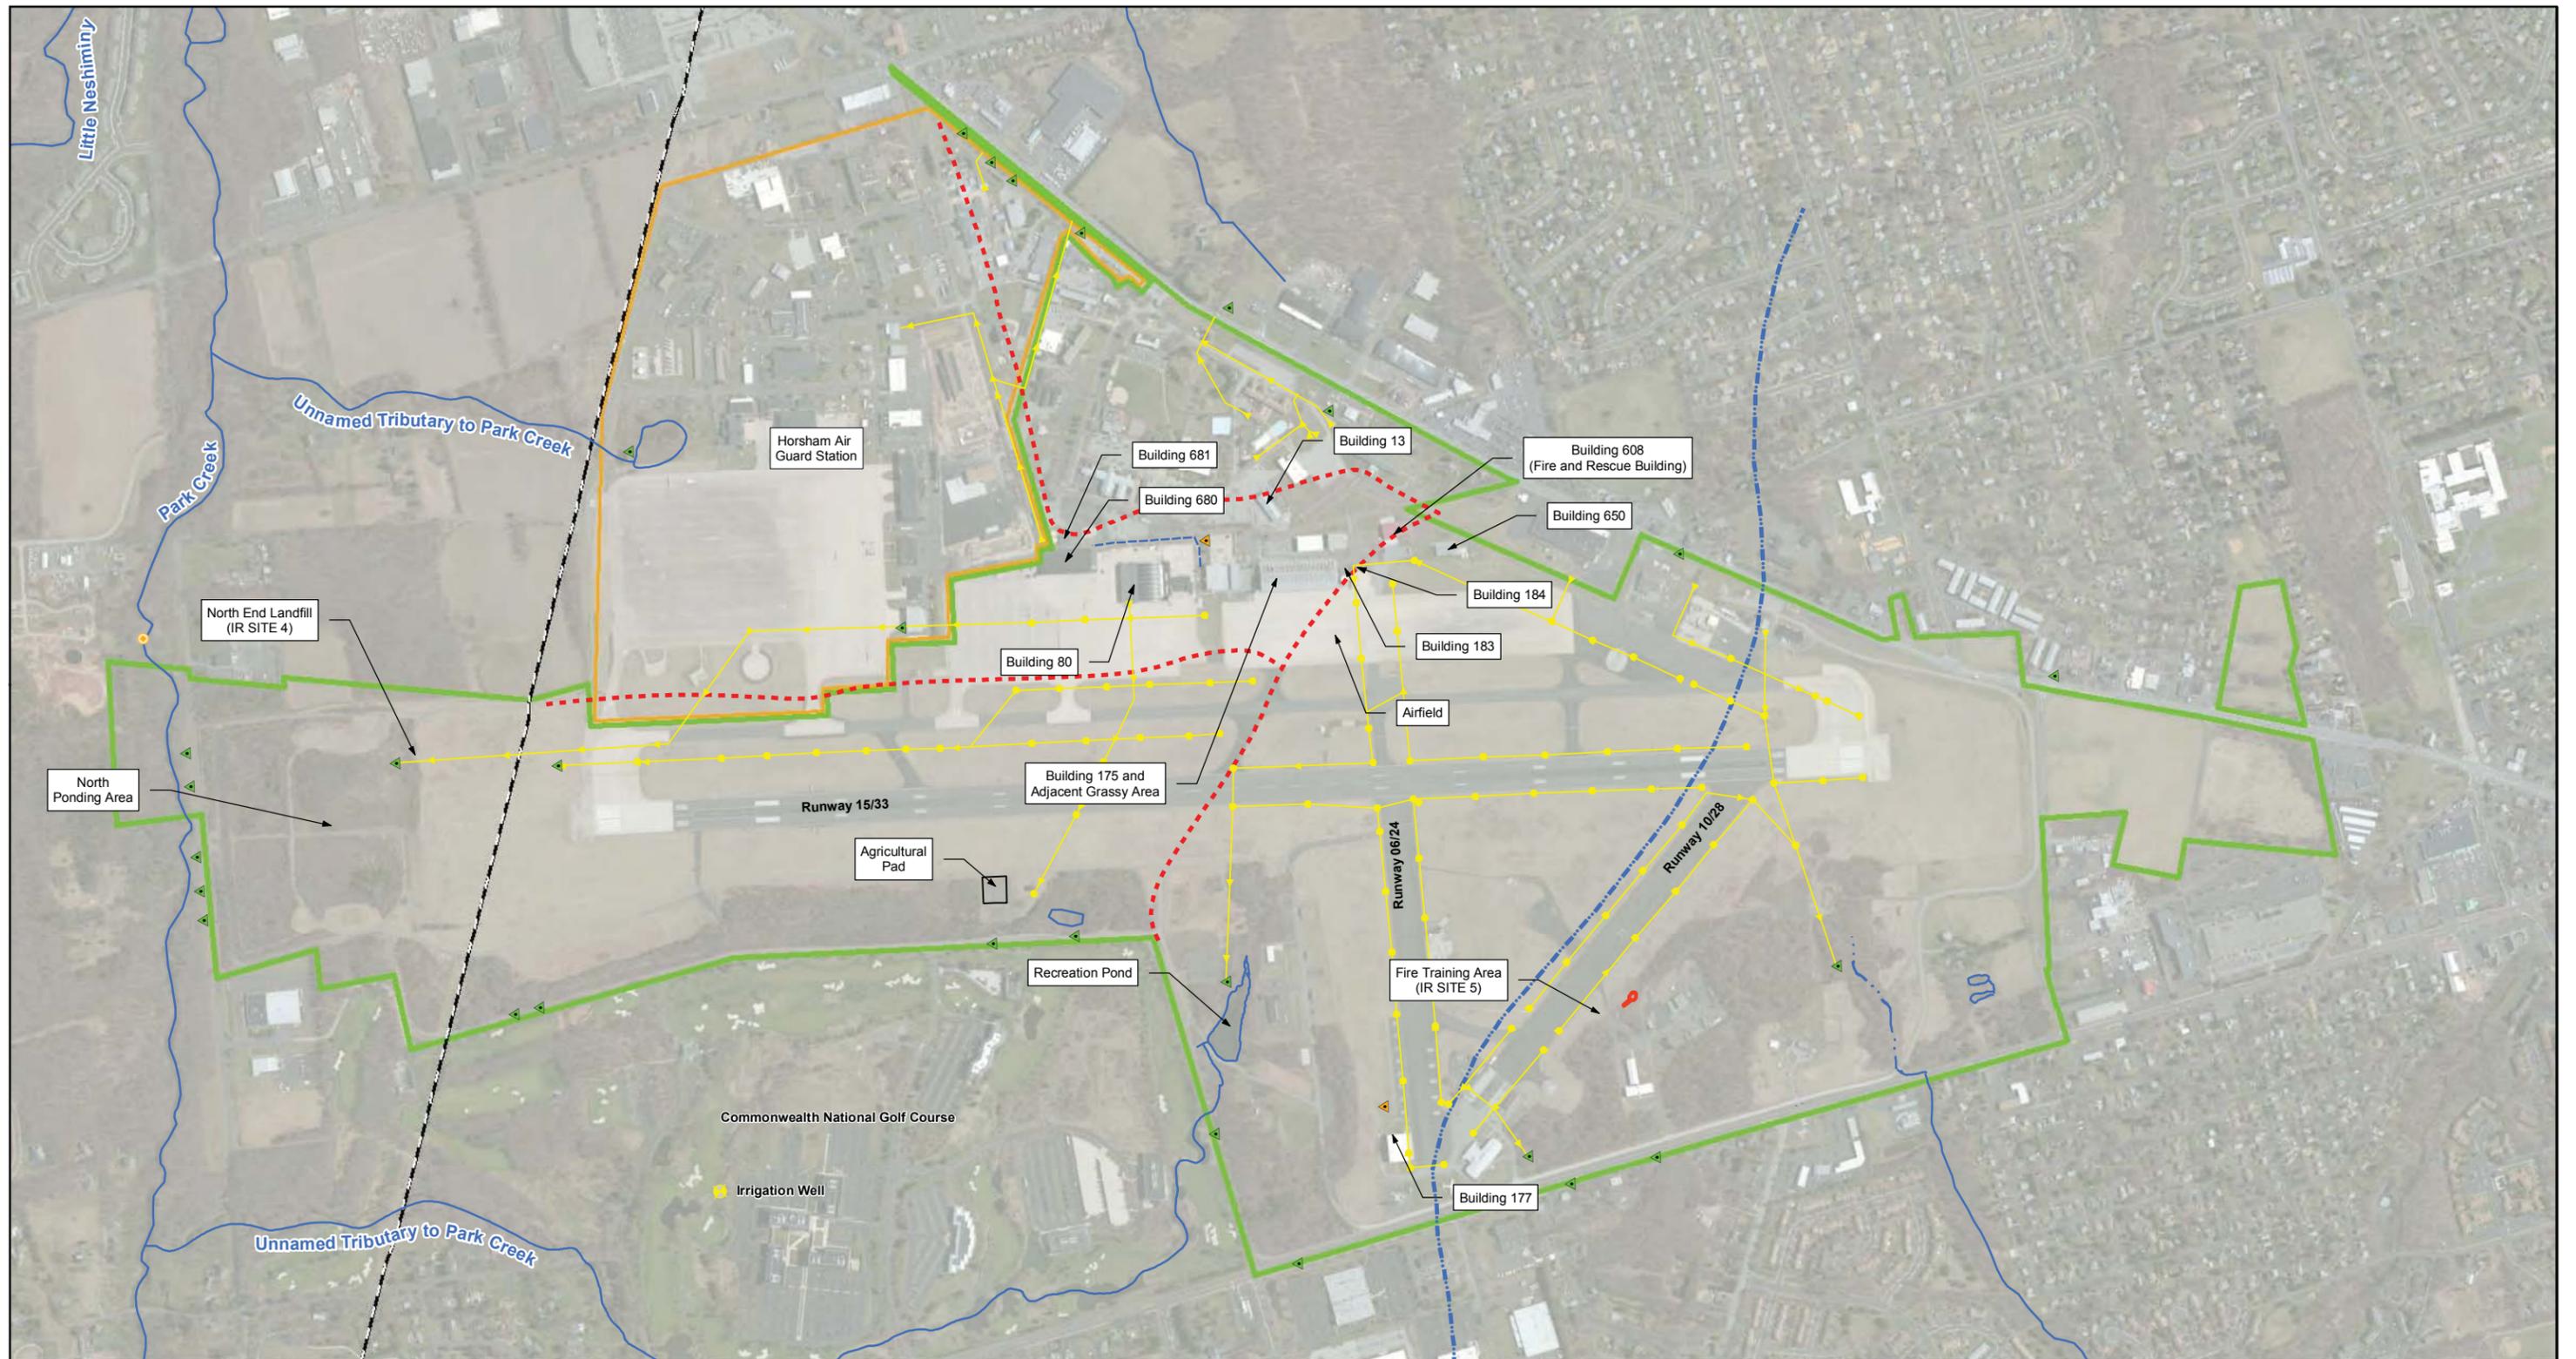
Legend	
	NAS JRB Willow Grove Boundary
	Horsham Air Guard Station Boundary
	Outfall
	Recovery Tank Outfall
	Wastewater Treatment Plant NPDES Discharge
	Irrigation Well
	Williams Pipeline
	Culvert
	Surface Water
	Intermittent Stream
	Storm Sewer
	Watershed - Divide
	Drainage - Divide
	Fire Ring

Soils at the former NAS JRB Willow Grove property have not been tested for PFCs; therefore, it is unknown whether PFCs are present in soils at the installation. However, if PFOS and PFOA have been found in groundwater, they may also be present in subsurface soil in certain areas. In their anionic forms, PFOS and PFOA are water-soluble and can migrate readily from soil to groundwater. The EPA has not established action levels for PFOS and PFOA in soil. The primary exposure pathway for PFOS and PFOA would be the ingestion of contaminated drinking water.
