**Remedial Action Completion Report
Installation Restoration Program
Sites 2 and 17**

**FORMER MARINE CORPS AIR STATION
EL TORO, CALIFORNIA**

March 2009

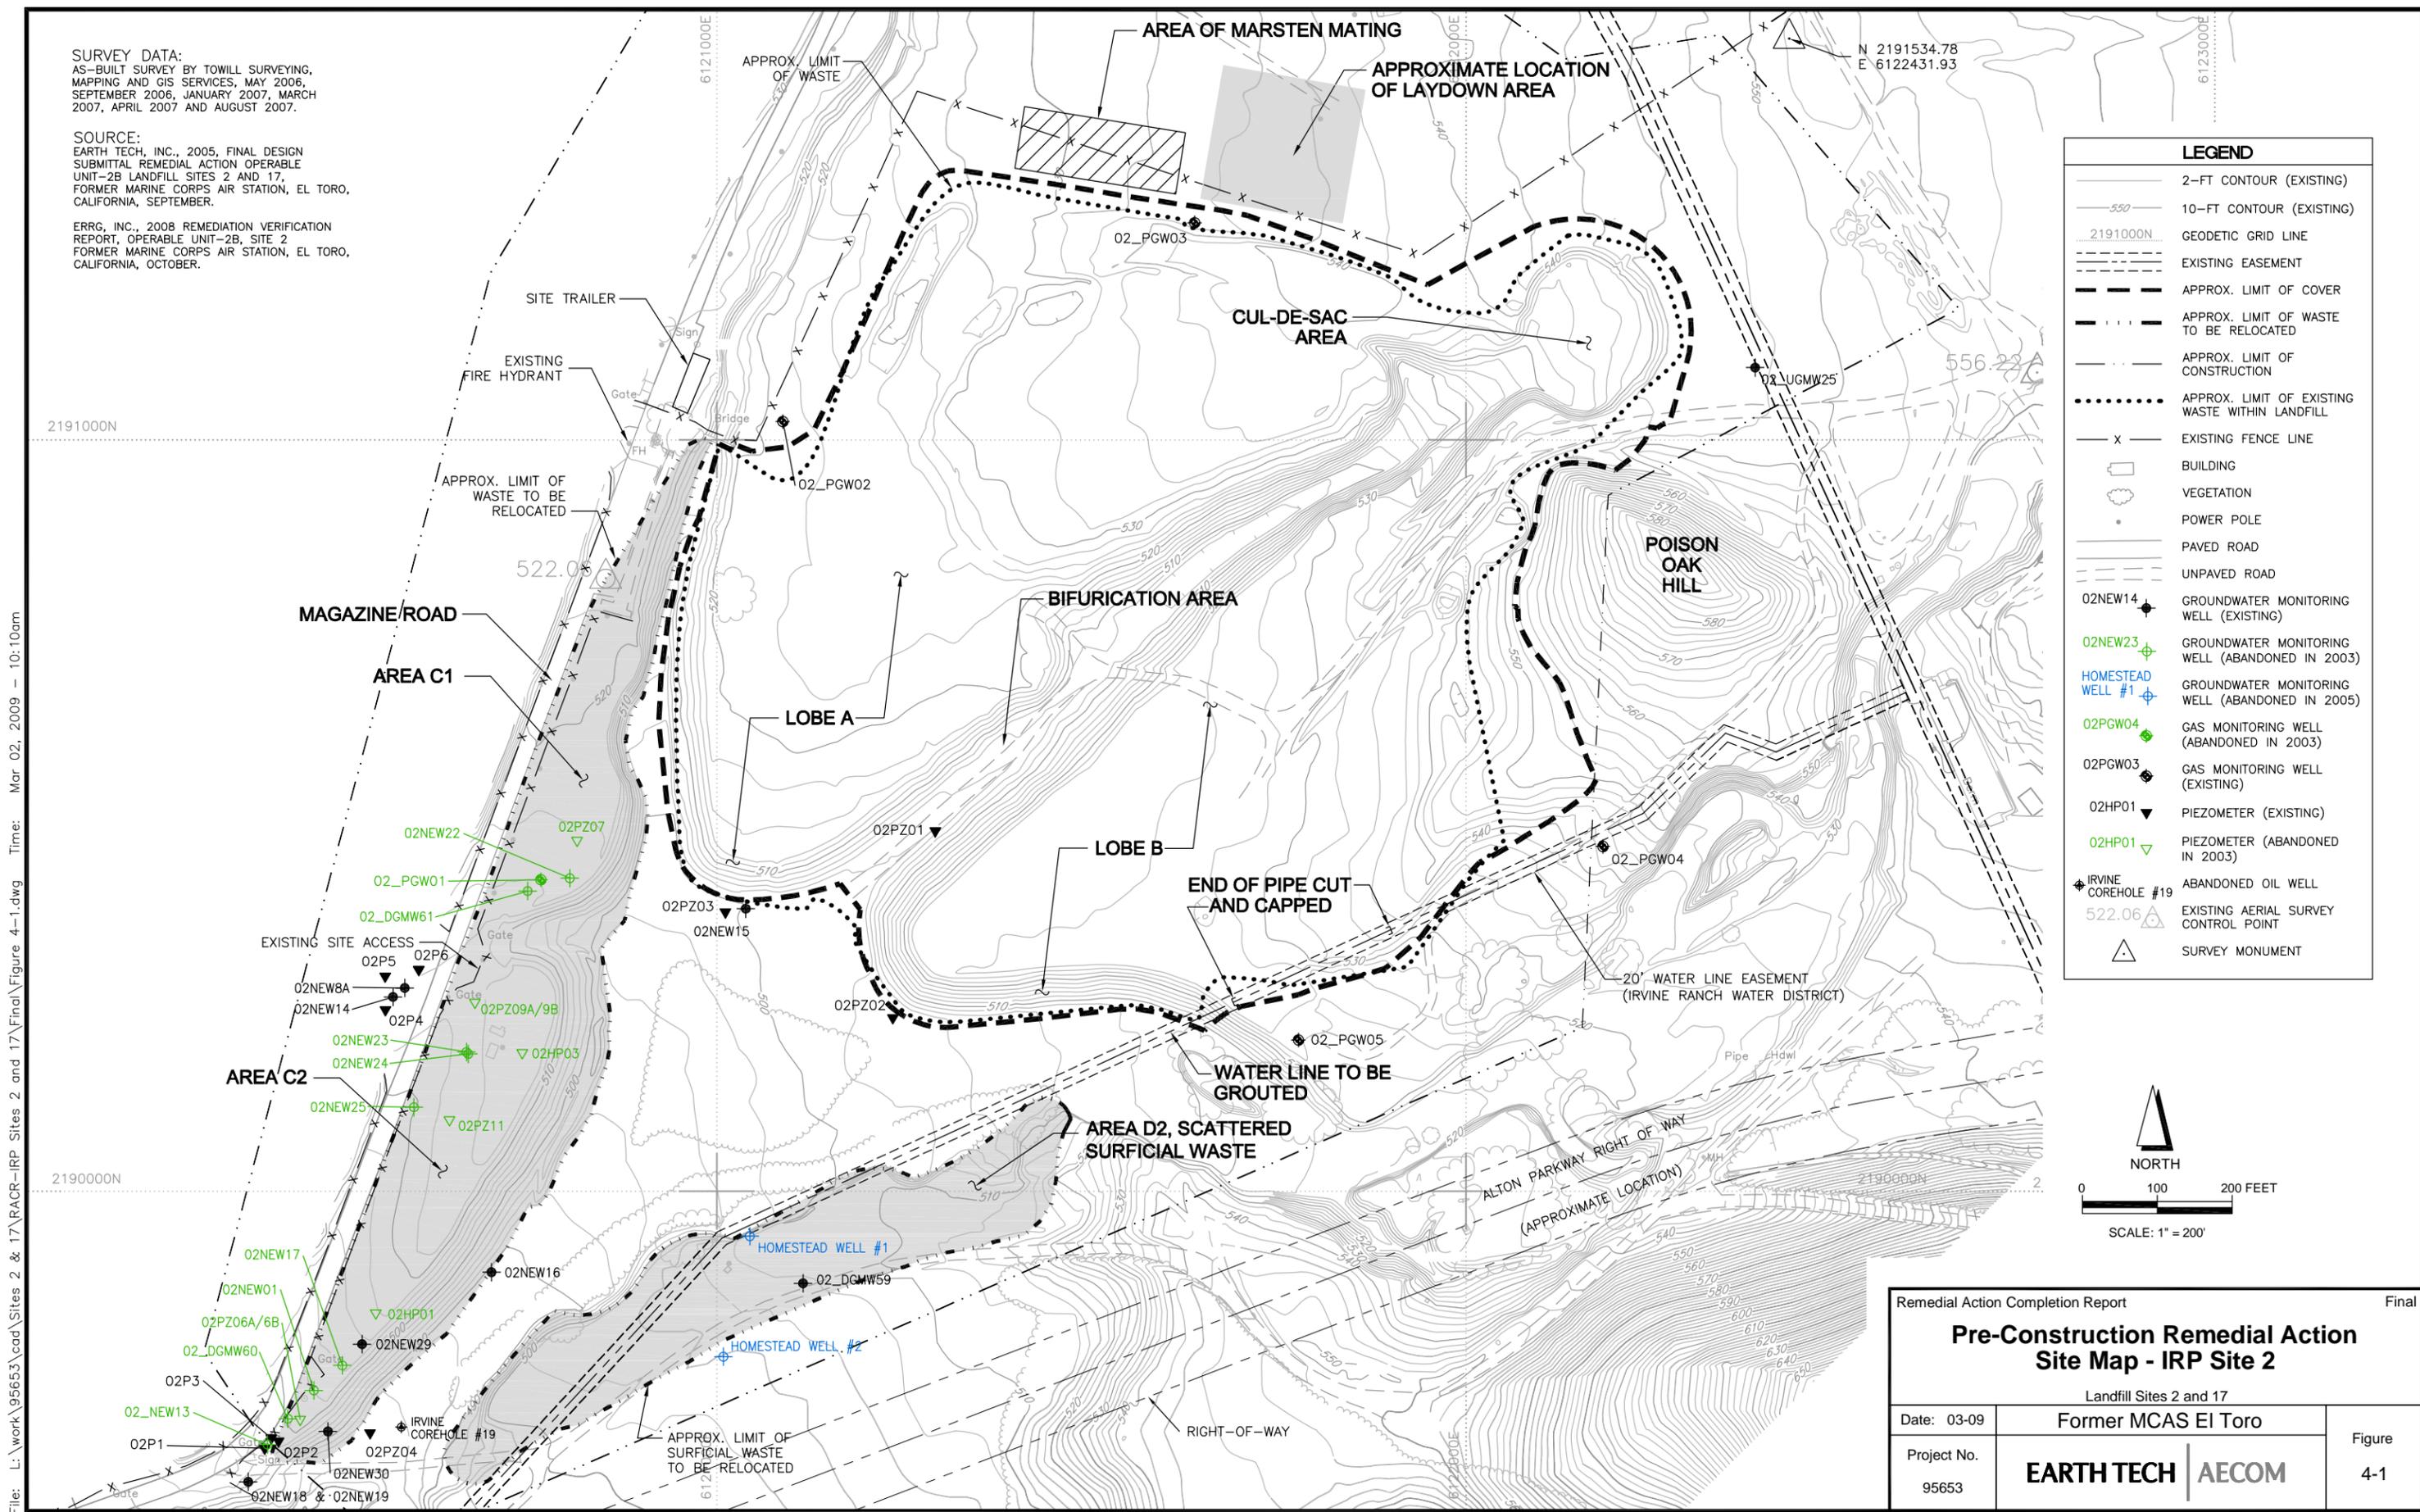
File: L:\work\95653\cad\Sites 2 & 17\RACR-IRP_Sites 2 and 17\Final\Figure 4-1.dwg Time: Mar 02, 2009 10:10am

Pre-construction site surveys were conducted at IRP Sites 2 and 17 in December 2005 and November 2007, respectively. During these surveys, pre-construction site grades and surface conditions were surveyed. Additional surveying was conducted upon the start of grading operations at both sites and is discussed in Section 4.1.2.3. Figures 4-1 and 4-2 show pre-construction maps of IRP Sites 2 and 17 respectively.

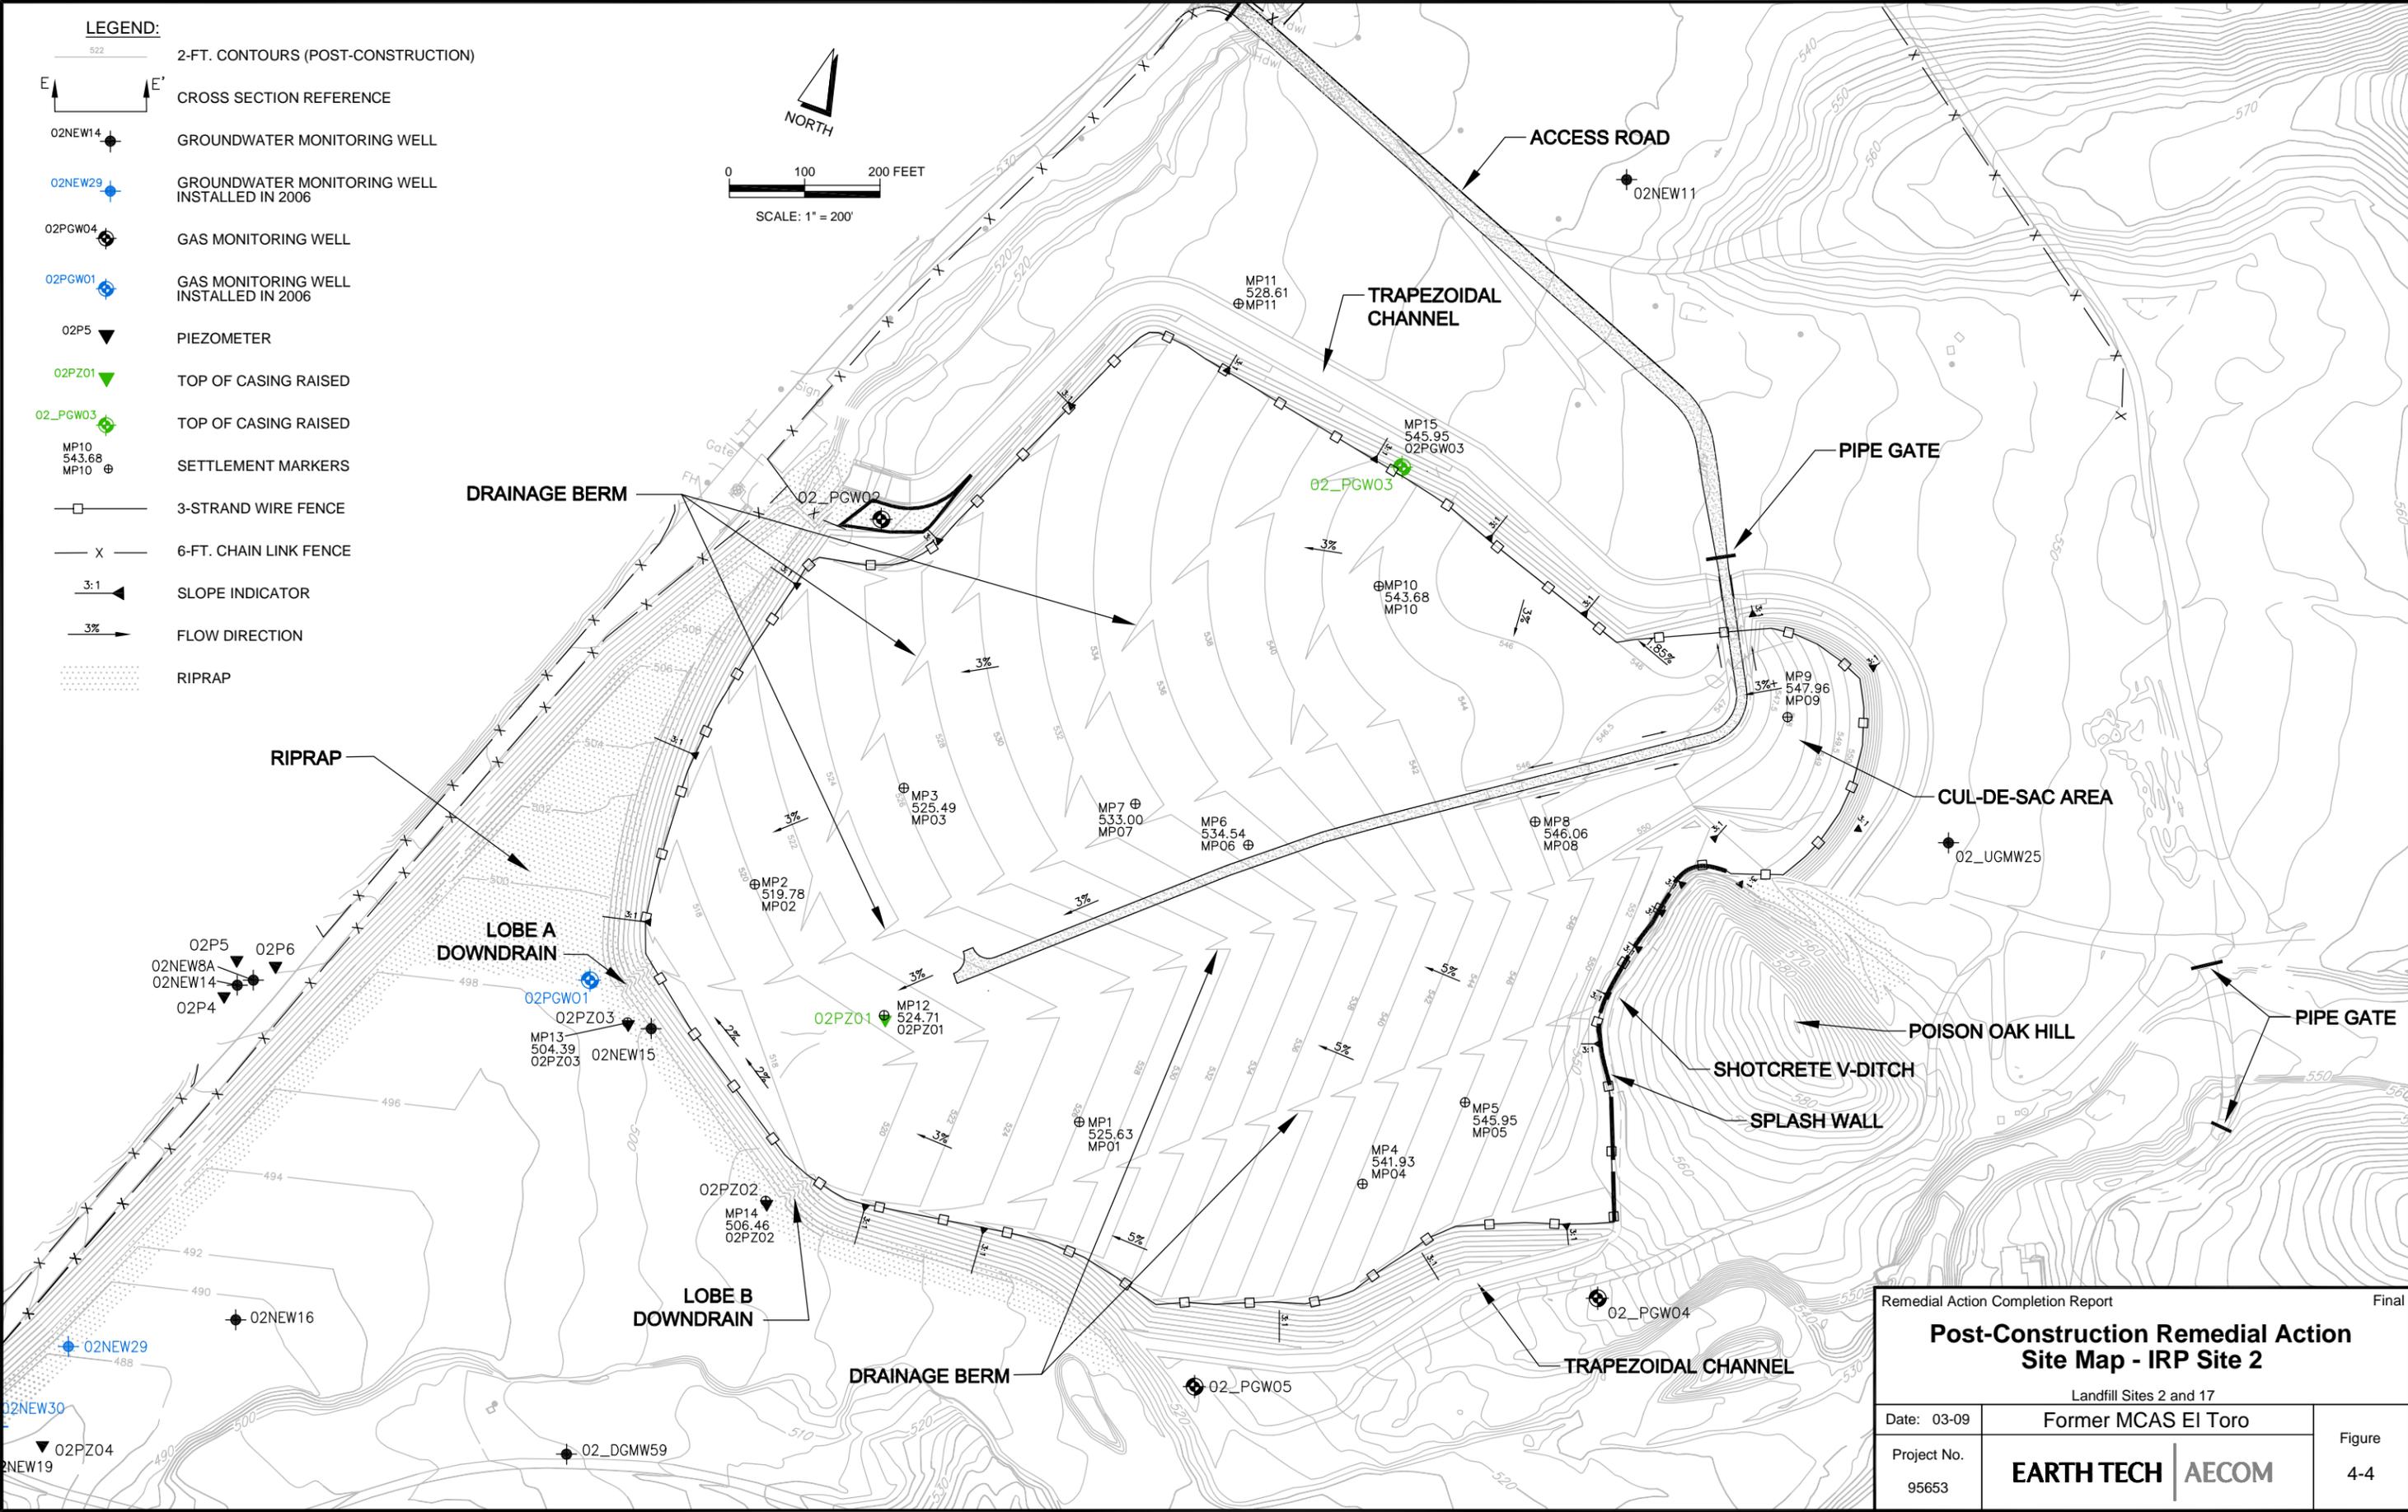
File: L:\work\95653\cad\Sites 2 & 17\RACR-IRP_Sites 2 and 17\Final\Figure 4-4.dwg Time: Mar 02, 2009 - 10:11am

The two gabion downdrains located at the south ends of Lobes A and B shown on Figure 4-4 were modified to accommodate the change in the bifurcation design. The entrance areas funneling the surface flow to the downdrains was expanded. The perimeter of the landfill crown was raised slightly to slope surface runoff inward and toward the downdrains.

After a heavy storm that occurred in late December 2007, the Lobe A downdrain sustained some damage. The rip rap and gabion baskets area was immediately covered with plastic and the entrance to the downdrain was widened to prevent any further degradation of the downdrain before the next rain event. The temporary repair withstood several rain events over the forthcoming months until the Lobe A downdrain underwent repair in early March 2008. As part of the repair, the downdrain entrance was lowered and the apron leading into the downdrain was widened. Also, the entire downdrain was lined with 80-mil HDPE in lieu of requiring 4-feet of ET cover over the waste material beneath the downdrain.

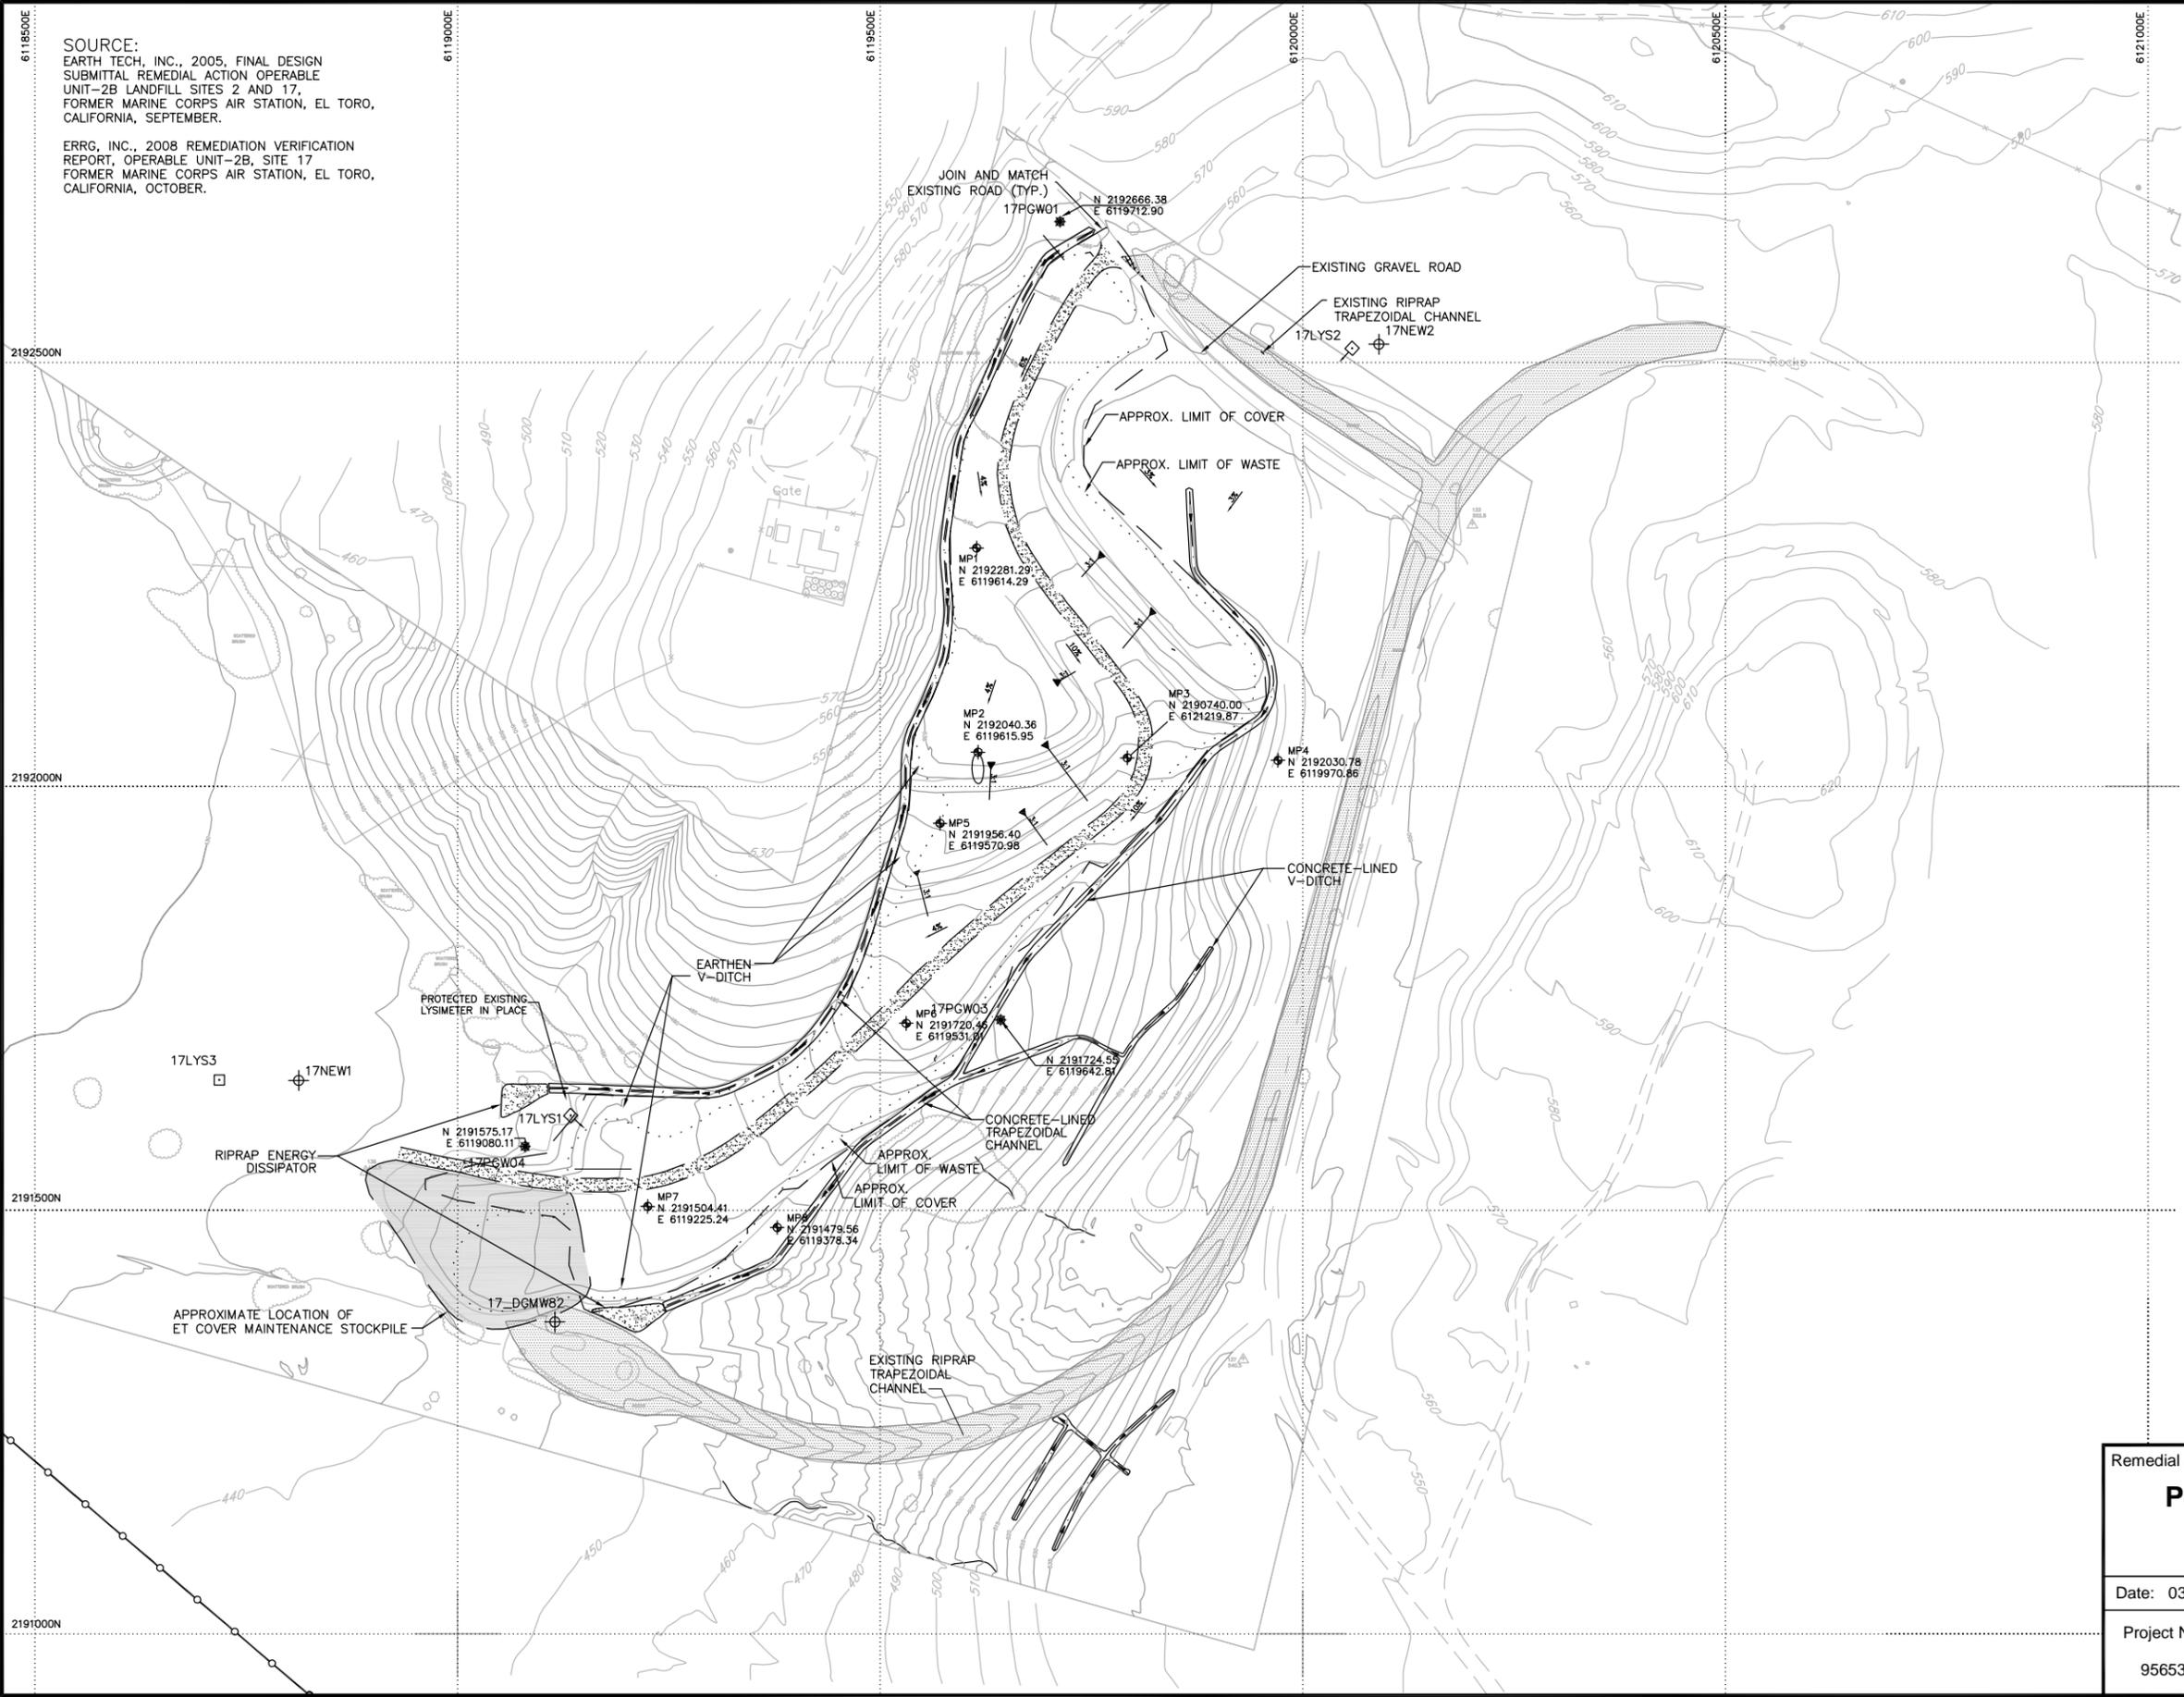
Landfill perimeter gas wells 17PGW01, 17PGW03, and 17PGW04 were installed near the proposed locations identified in the Remedial Design Submittal (Earth Tech 2005a), as shown on Figure 4-5. A 12-inch protective galvanized steel casing with three pipe bollards was constructed around each landfill perimeter well to protect them from potential damage. A 3-foot by 3-foot by 6-inch reinforcement concrete pad was installed around each well. Detailed descriptions of the individual well installations, including boring logs, abandonment activities, and a copy of wells installation permit #08-05-09 are presented in *Well Installation Report - Permit 08-05-09, Former MCAS El Toro, Site 17* (ERRG 2008b), which are included in Appendix B of IRP Site 17 RVR (ERRG 2009b).

NOTES:
 1. FINAL CONTOURS SHOWN ARE ELEVATIONS AFTER PLACEMENT OF FOUNDATION LAYER AND EVAPOTRANSPIRATION SOIL COVER OVER PREPARED SUBGRADE.

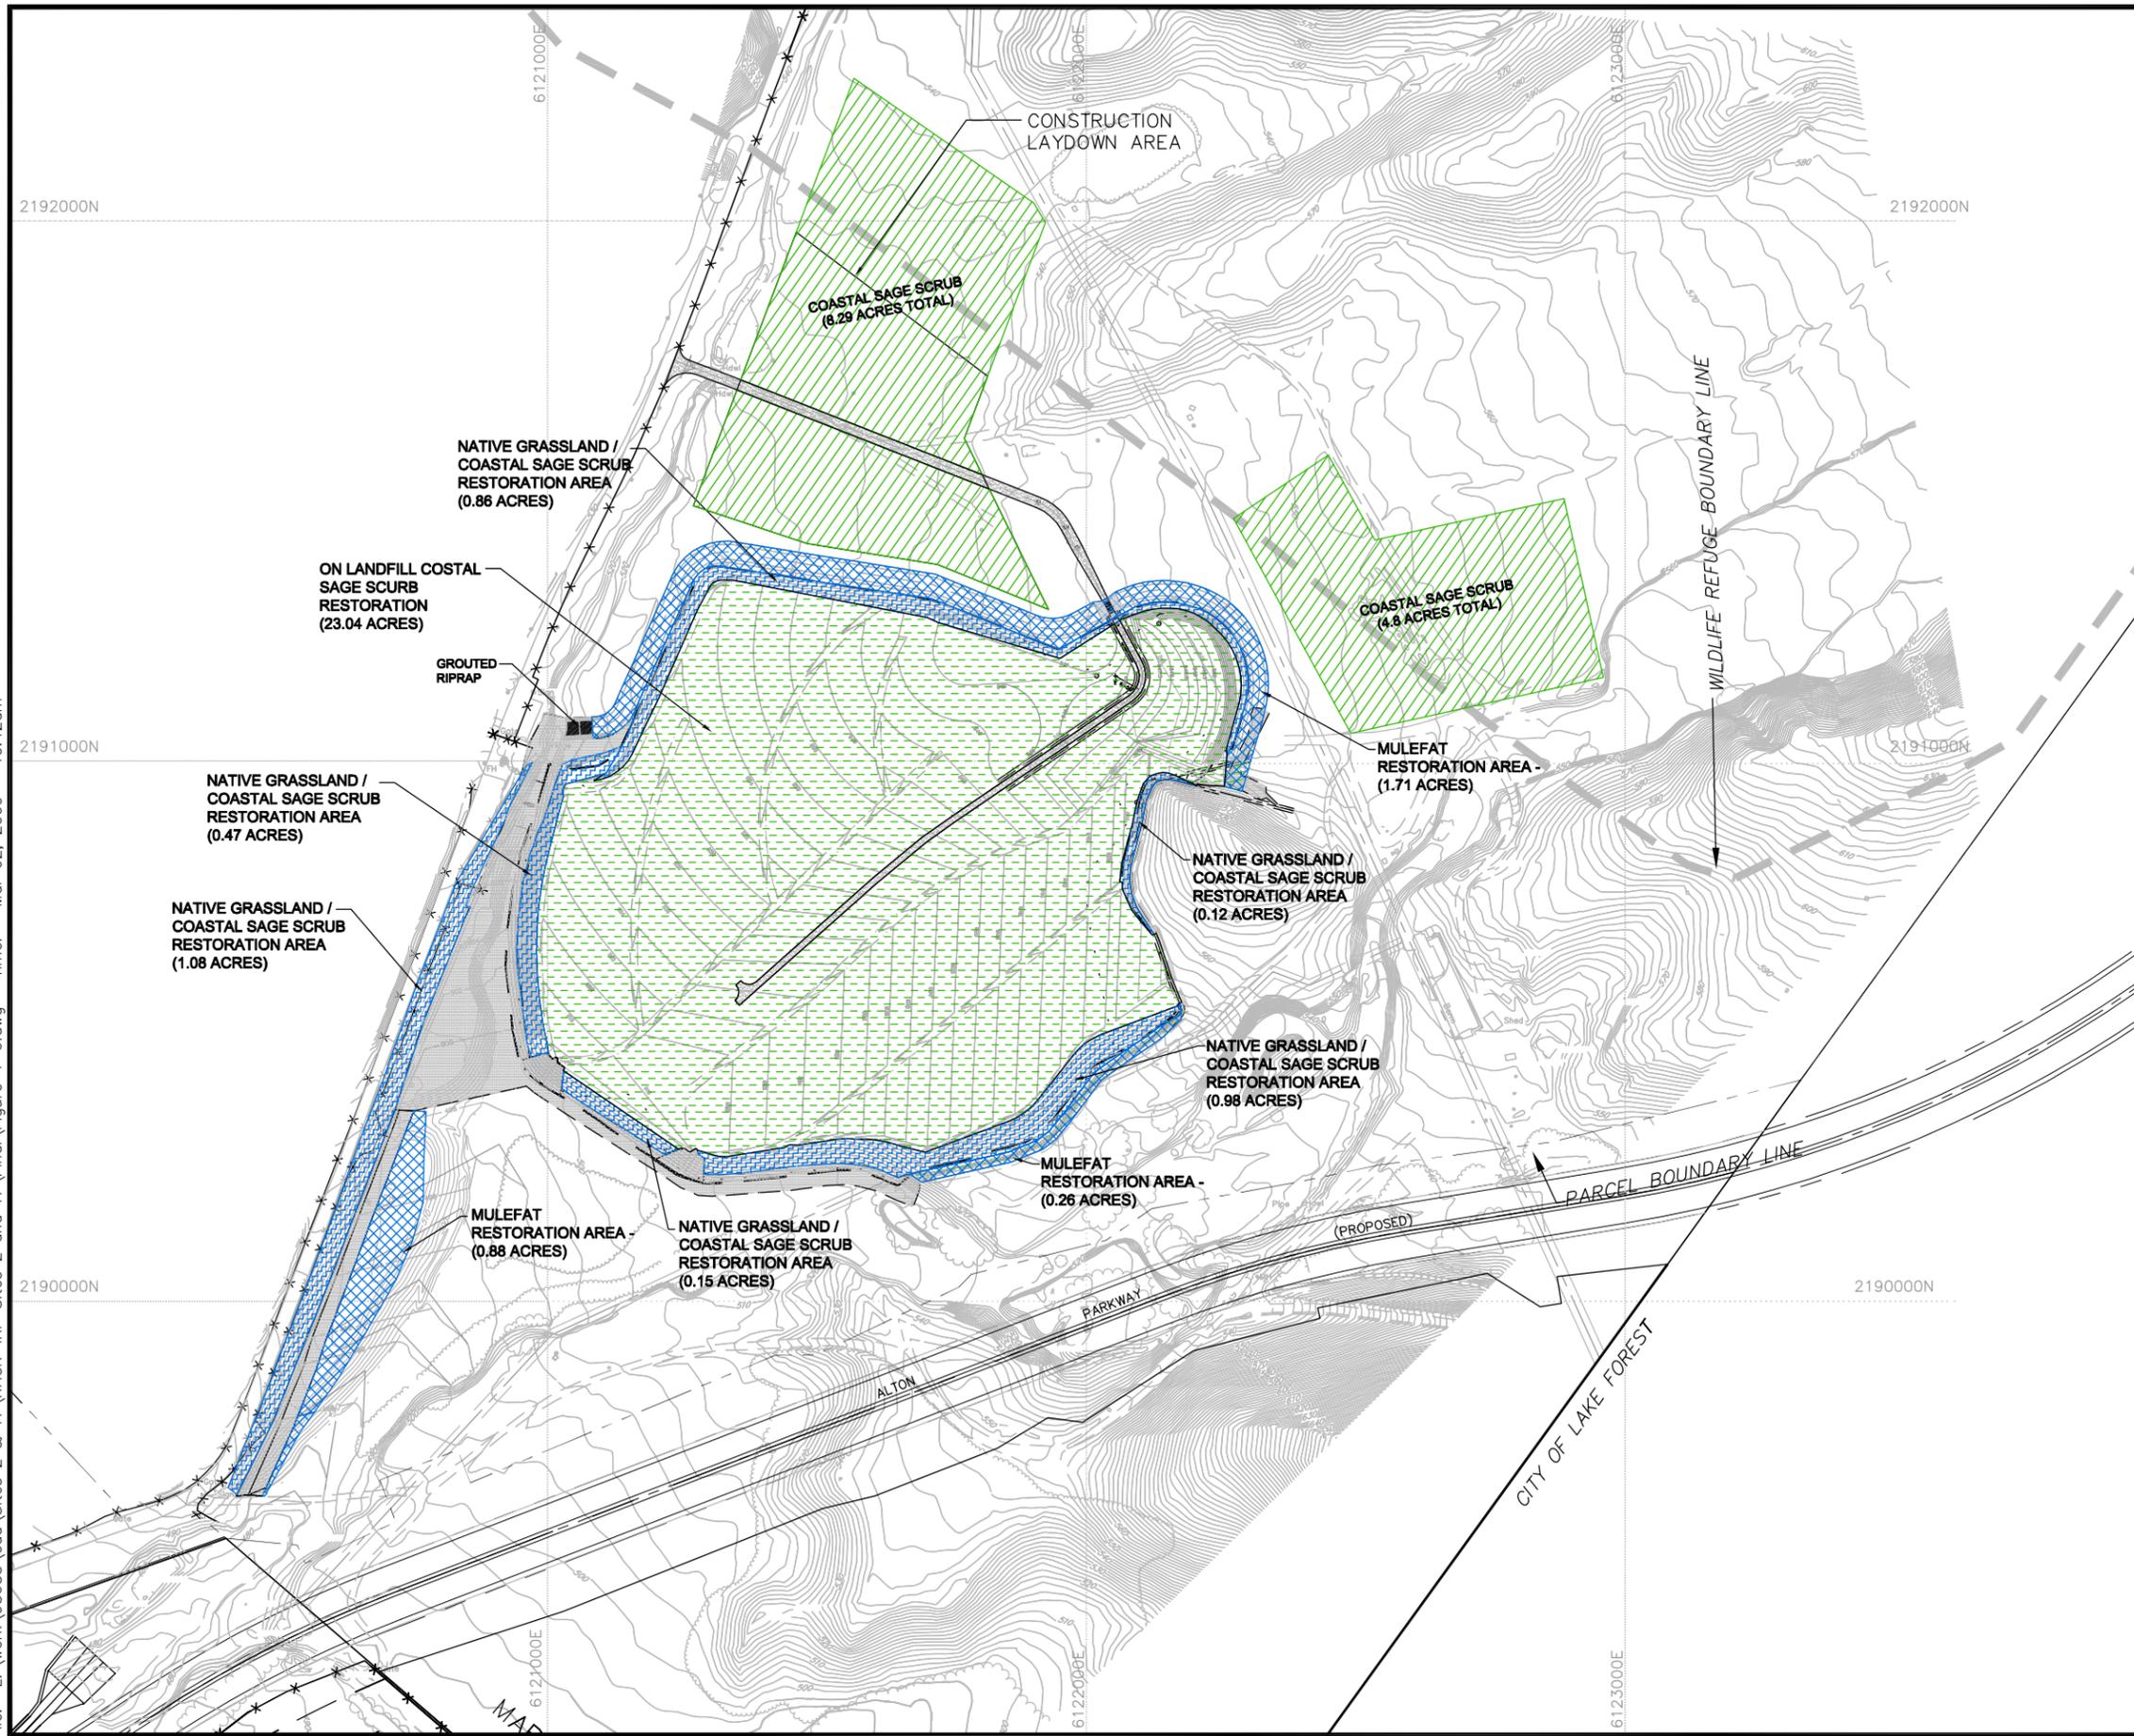
File: L:\work\95653\cad\Sites 2 & 17\RACR-IRP_Sites 2 and 17\Final\Figure 4-6.dwg Time: Mar 02, 2009 - 10:12am

- MULEFAT RESTORATION AREA - 2.85 ACRES TOTAL
- NATIVE GRASSLAND / COASTAL SAGE SCRUB RESTORATION AREA - 3.66 ACRES TOTAL
- ON LANDFILL COASTAL SAGE SCRUB RESTORATION AREA - 23.04 ACRES TOTAL
- OFF LANDFILL COASTAL SAGE SCRUB RESTORATION AREA - 13.09 ACRES TOTAL
- 2-FT CONTOUR (FINISH GRADE)
- 10-FT CONTOUR (FINISH GRADE)
- 2192000N GEODETIC GRID LINE
- ACCESS ROAD
- SETTLEMENT MONUMENT
- FENCE LINE
- EXISTING BUILDING
- VEGETATION
- CONSTRUCTION LAYDOWN AREA
- WILDLIFE REFUGE BOUNDARY

- Earthguard at 8 gallons per acre
- Eco Fiber at 2,000 pounds per acre (lbs/acre)
- Seed for small six-weeks grass (*Vulpia microstachys*) (2 lbs/acre)
- Purple needlegrass (*Nassella pulchra*) (1 lb/acre)
- Fascicled tarweed (*Deinandra fasciculata*) (2 lbs/acre)
- Coast golden brush (*Isocoma menziesii*) (0.5 lbs/acre)

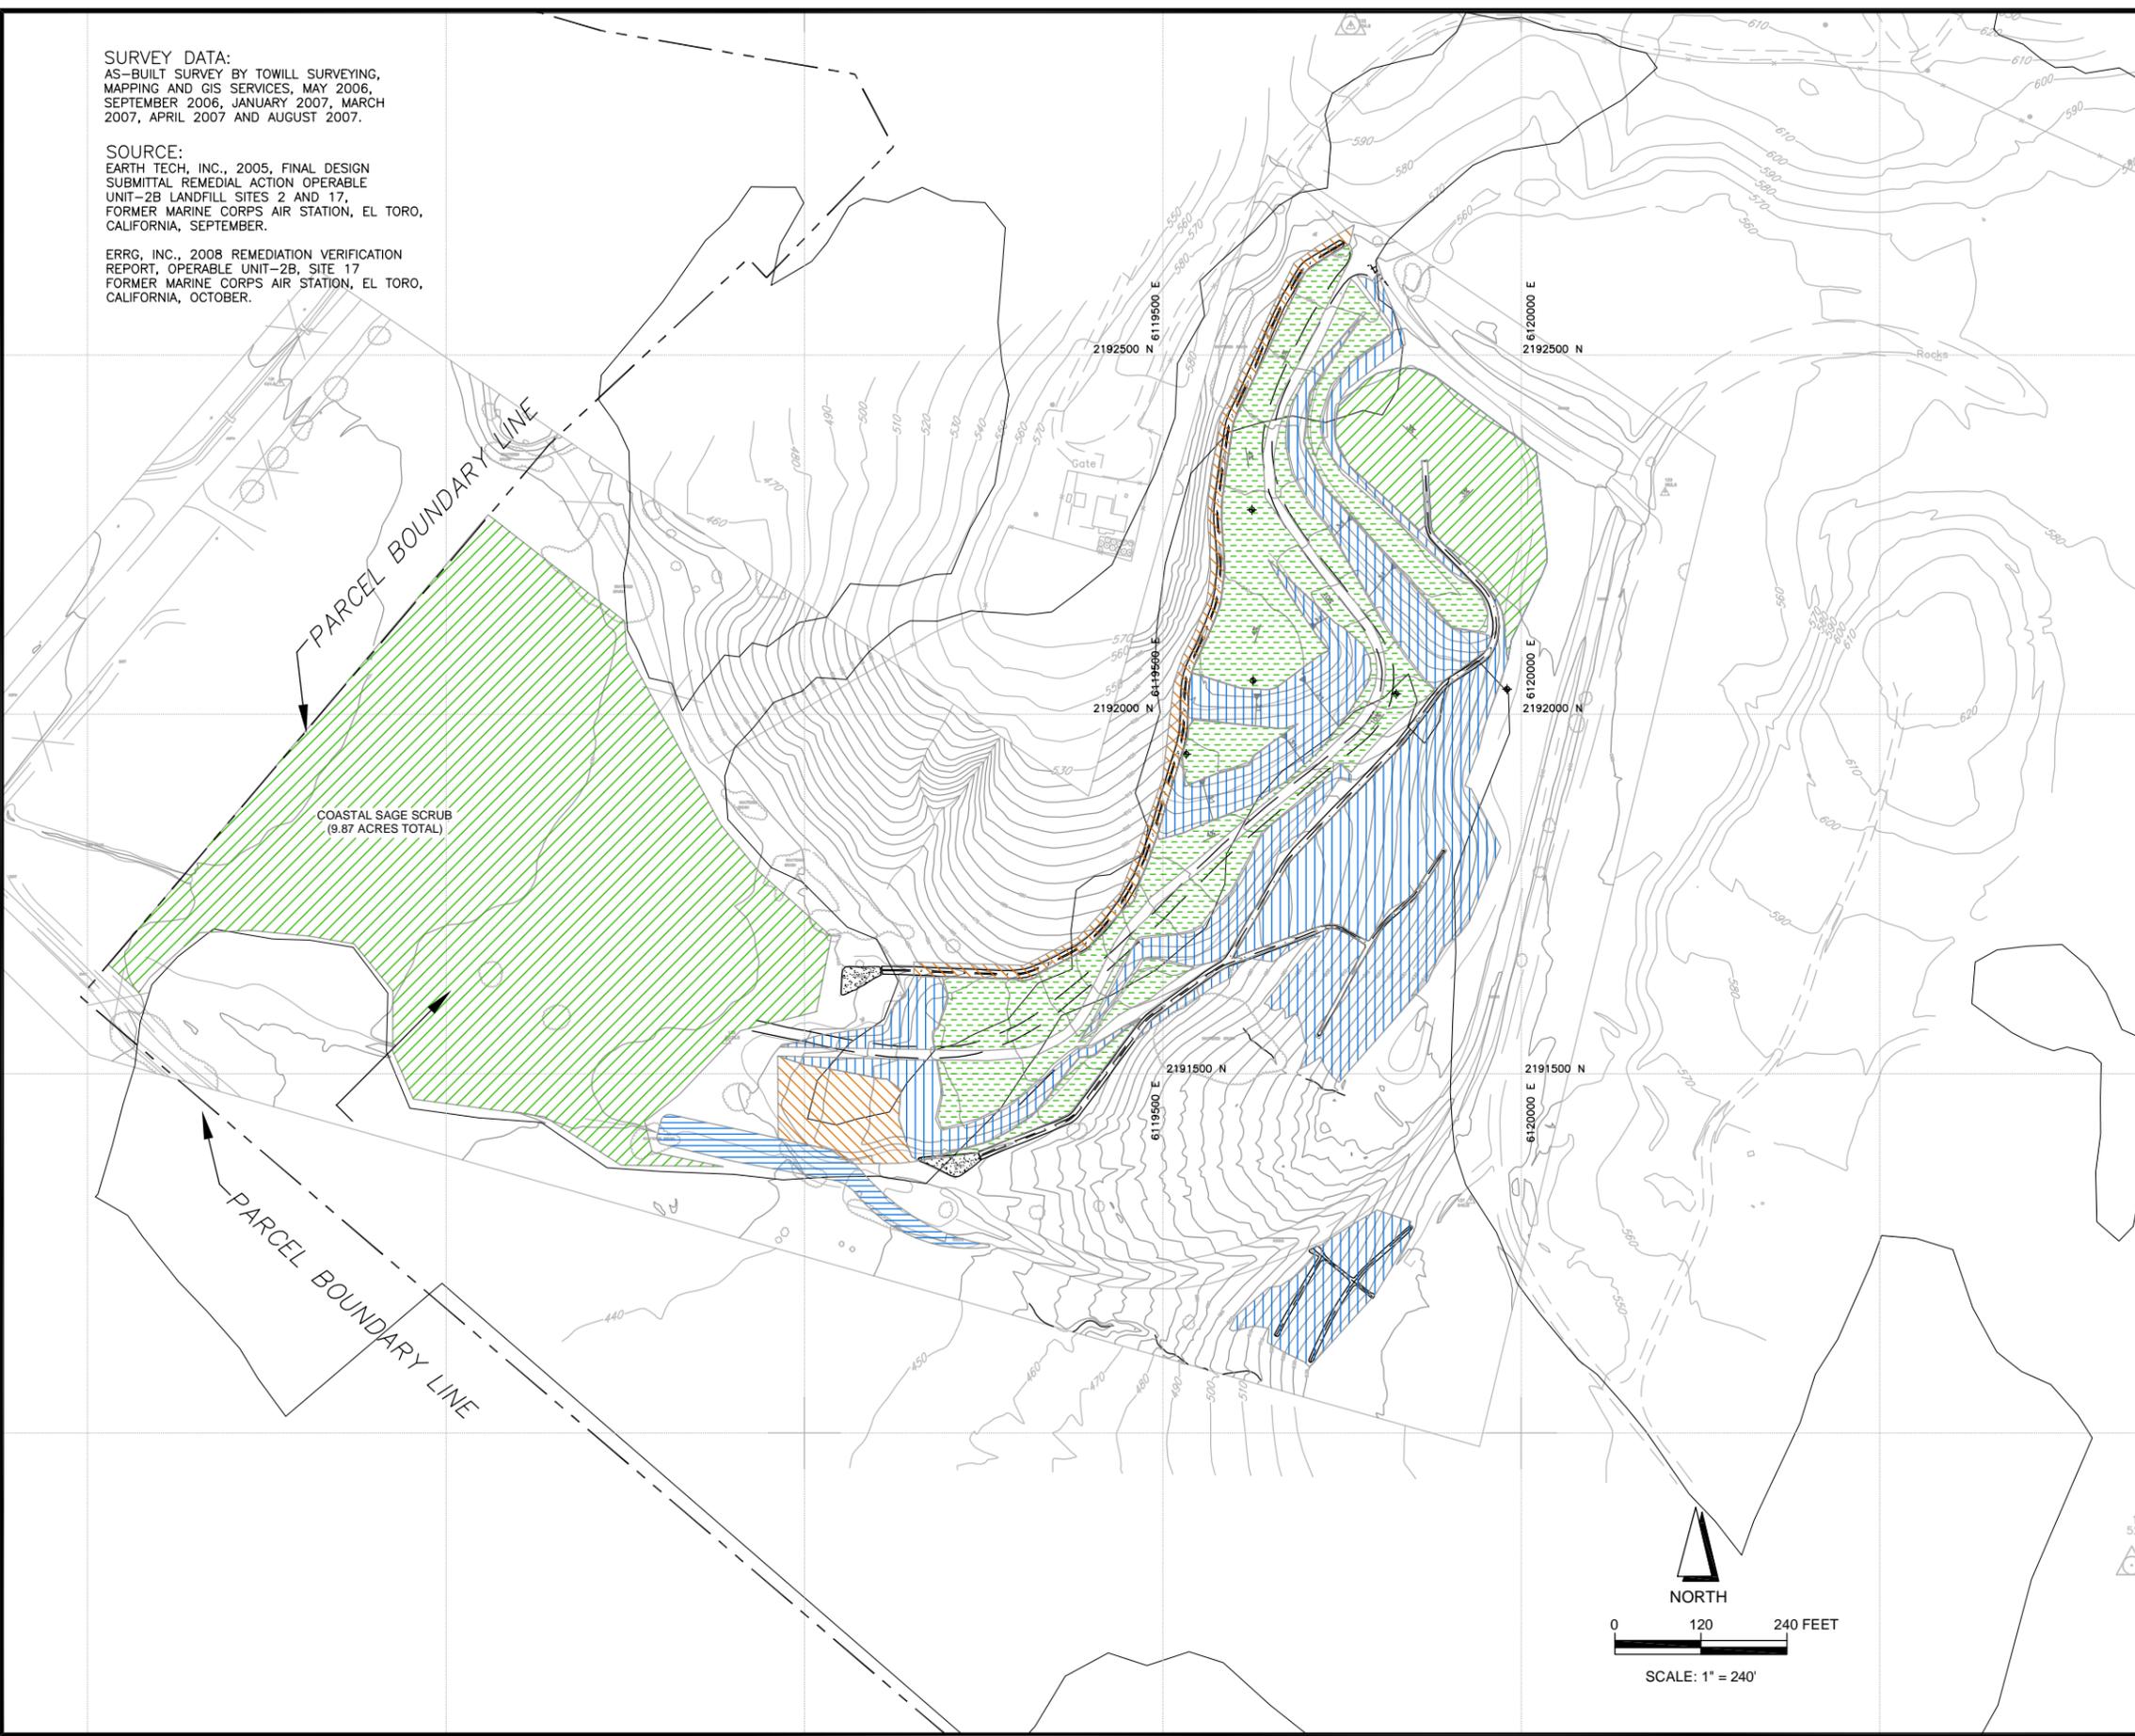
- MULEFAT RESTORATION AREA - 0.37 ACRES TOTAL
- NATIVE GRASSLAND / COASTAL SAGE SCRUB RESTORATION AREA - 5.34 ACRES TOTAL
- ON LANDFILL COASTAL SAGE SCRUB RESTORATION AREA - 3.76 ACRES TOTAL
- OFF LANDFILL COASTAL SAGE SCRUB RESTORATION AREA - 11.19 ACRES TOTAL
- HYDROSEED FOR EROSION CONTROL ONLY
- 2-FT CONTOUR (EXISTING/SUBGRADE)
- 10-FT CONTOUR (EXISTING/SUBGRADE)
- 2-FT CONTOUR (FINAL GRADE)
- 10-FT CONTOUR (FINAL GRADE)
- GEODETIC GRID LINE
- ACCESS ROAD
- SHOTCRETE V-DITCH
- TRAPEZOIDAL CHANNEL
- EXISTING RIPRAP
- SETTLEMENT MONUMENT
- FENCE LINE
- EXISTING FENCE LINE
- EXISTING BUILDING
- VEGETATION
- POWER POLE
- SLOPE (HORIZONTAL TO VERTICAL)
- SLOPE AND FLOW DIRECTION
- EXISTING GROUNDWATER MONITORING WELL
- EXISTING LYSIMETER DRILLED AT 30° ANGLE (SHOWS ANGLE DIRECTION)
- CONSTRUCTION LAYDOWN AREA
