FACT SHEET

Time-Critical Removal Action

Installation Restoration Program Site 1

Former Marine Corps Air Station El Toro

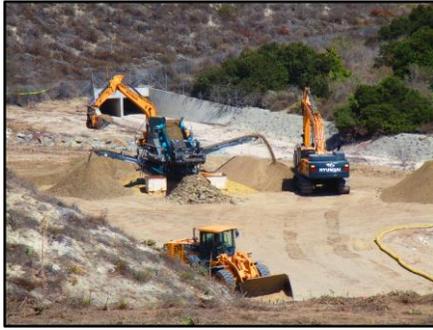
Soil Screening Plant Operations

Within Area B (TCRA) and Area C, an approximately 12-inch layer of topsoil was removed from all areas and mechanically screened for munitions. Screened soil was then scanned with analog equipment (i.e., handheld metal detectors). DGM was used to survey the new soil surface in these areas to identify items for the intrusive investigation. DTSC did not require soil excavation and screening prior to the DGM survey in the ACRB.

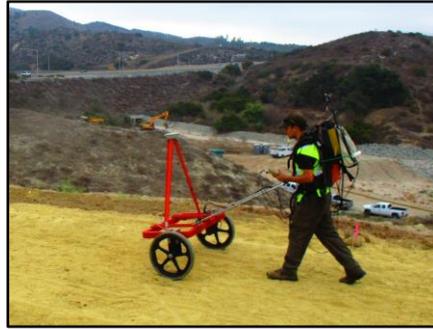
Digital Geophysical Mapping

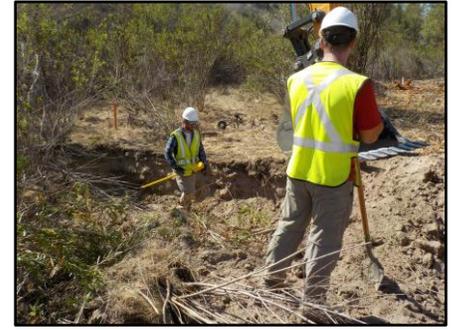
Subsurface Clearance Activities
