FORMER MARINE CORPS AIR STATION (MCAS) El Toro 102nd Restoration Advisory Board (RAB) Meeting Minutes

Meeting Date/Time: 26 January 2011/6:30pm - 7:45pm

INSTALLATION RESTORATION PROGRAM (IRP) OPERABLE UNIT 2C SITE 3 – ORIGINAL LANDFILL SITE 5 – PERIMETER ROAD LANDFILL

PROJECT UPDATE

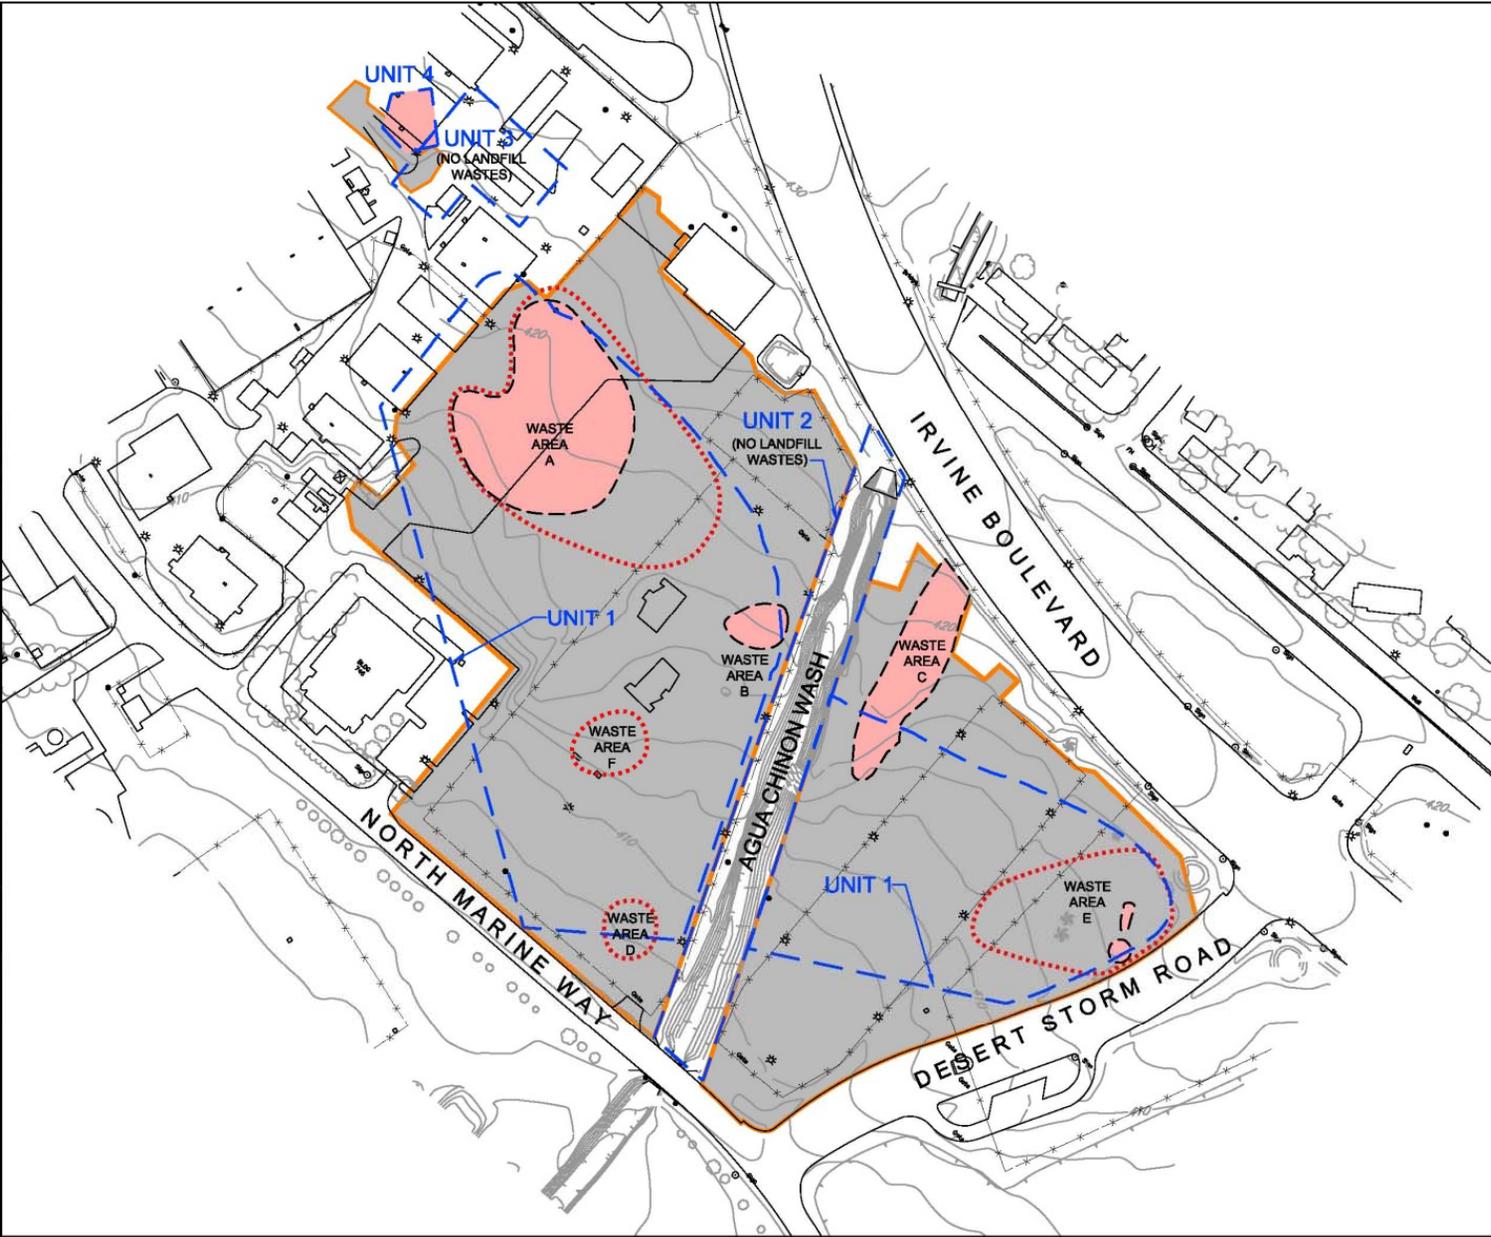
ORIGINAL SITE PLAN
 SITE 3 - ORIGINAL LANDFILL
 SITES 3 & 5
 FORMER MARINE CORPS AIR STATION
 EL TORO, CALIFORNIA

- Active from 1943 to 1955
- Encompasses Approximately 11 acres
- Unlined Channel (Agua Chinon Wash) bisects the Site
- Original landfill at Base - Operated as a Cut-and-Fill Disposal Facility
- Types of Waste Included Metals, Incinerator Ash, Solvents, Paint, Residues, Hydraulic Fluids, Engine Coolants, Oily Wastes, Municipal Solid Waste, and Inert Solid Wastes
- Several Waste and Debris Areas (Areas B – F) Exist Outside of the Main Landfill Area (Area A)

Waste placement boundary shown is based on Trenching Locations (August - September 2002, November - December 2003)

Slide 5 presents a detailed map of IRP Site 3, the Main Landfill and the outlying waste areas. The outlying waste areas were excavated and consolidated into the Main Landfill footprint.

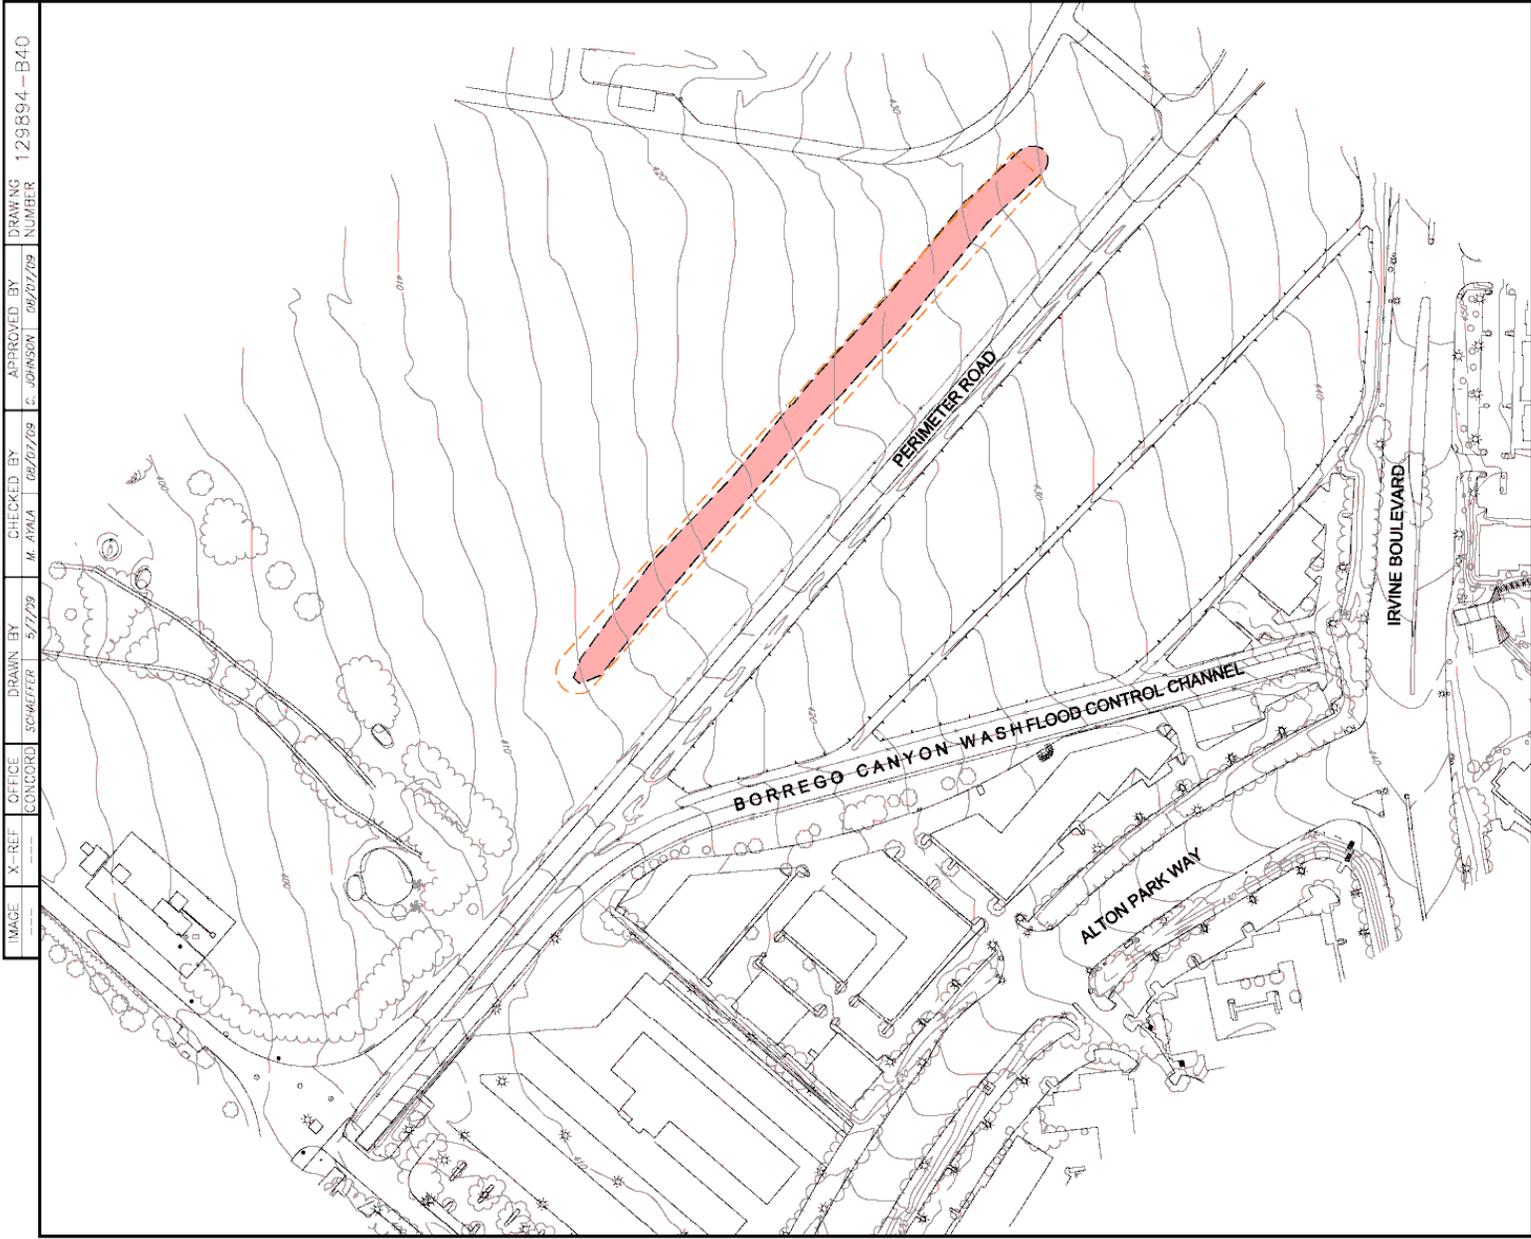
- Active from 1955 to the late 1960s
- Encompasses Approximately 1.8 acres
- 300 feet Northwest of Borrego Canyon Wash
- Operated as a Cut-and-Fill Disposal Facility
- Types of Waste Included Burnable Trash, Municipal Solid Waste, Cleaning Fluids, Scrap Metals, Paint Residues, and Unspecified Fuels, Oils, and Solvents

Note:
 Waste placement boundary shown is based on Tronching Locations (August - September 2002)

Slide 6 presents a brief background of IRP Site 5, Perimeter Road Landfill. This Landfill operated as a cut-and-fill facility that had a very long and narrow shape. Slide 7 shows the map of the IRP Site 5 Landfill.

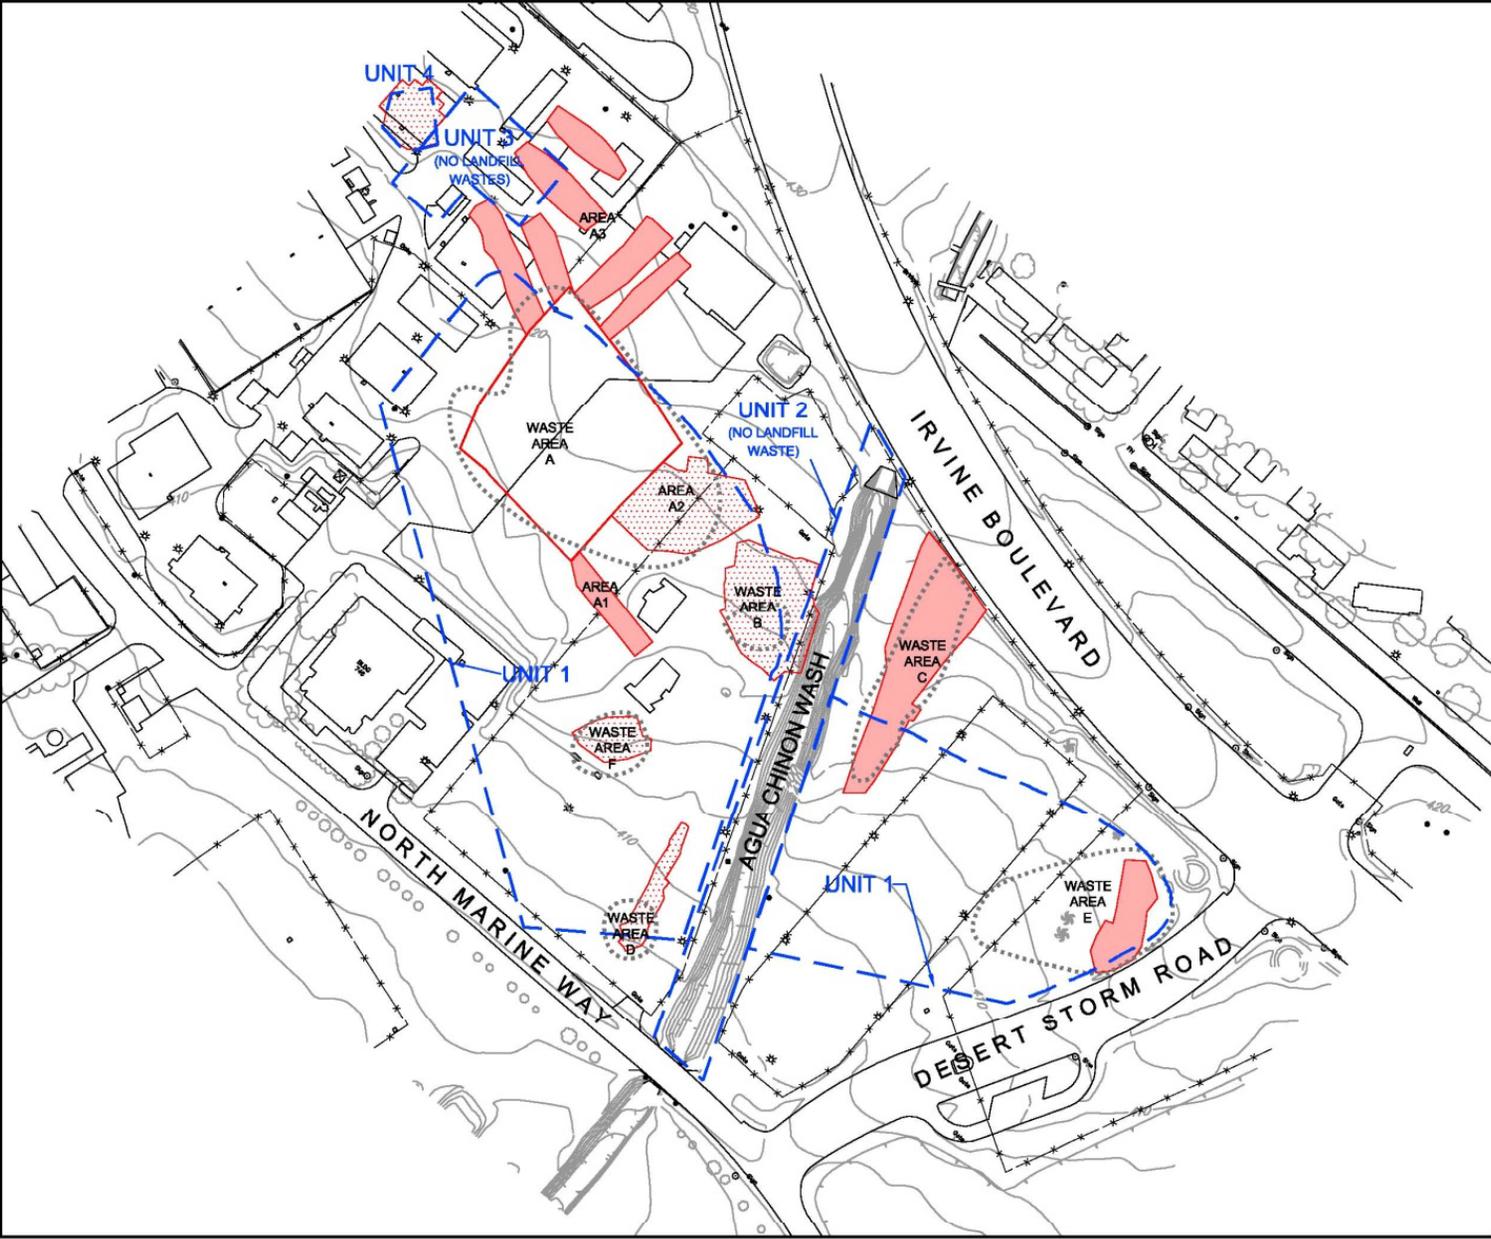
- Waste from a total of nine areas has been consolidated into the Main Landfill
- The areas were classified into two categories based on the types of material discovered:
 - Areas with incinerator waste and/or debris
 - Areas with only miscellaneous construction debris
- In the areas with only miscellaneous construction debris; no radiological items were identified in these areas
- In the areas with incinerator waste/debris; radiological items were identified, segregated, and properly disposed off-site

Slide 11 is a figure showing the current site plan for IRP Site 3 that includes the Main Landfill footprint (Waste Area A) and the surrounding consolidated waste areas. Mr. Johnson identified the locations of the two types of wastes identified in the outlying trenches. The maps color-coded the two waste types.

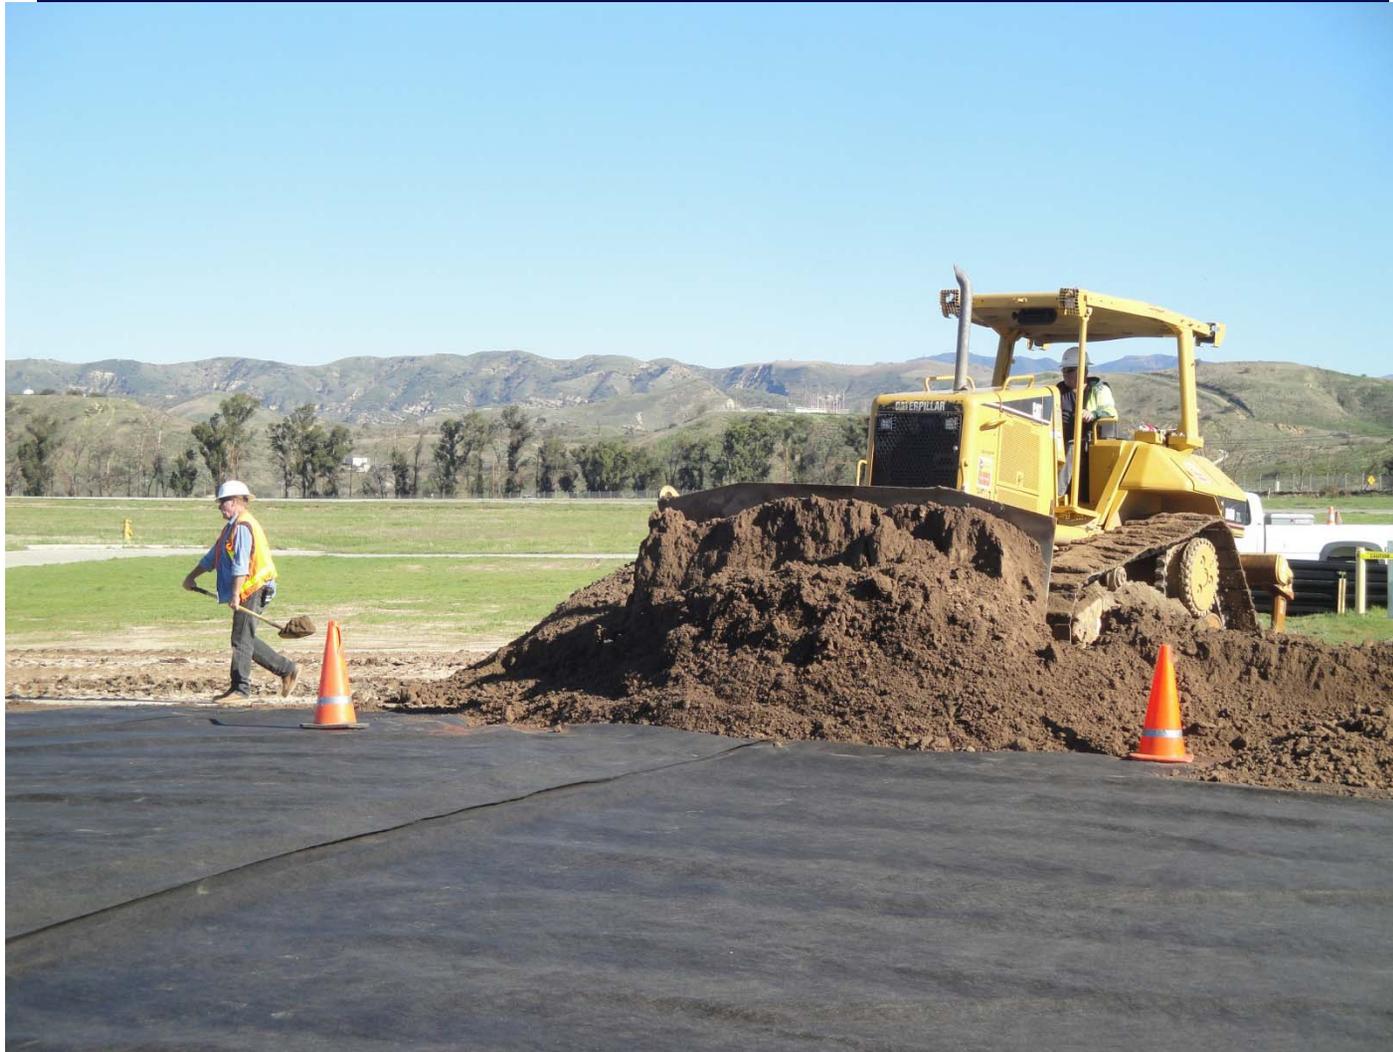
Placing protective cover soil over the geomembrane liner at IRP Site 5.

Slide 13 is a photograph of the protective soil cover being placed over the flexible membrane liner that was completed at IRP Site 5. The cover placement at IRP Site 5 was ahead of IRP Site 3. The cover is sloped to allow drainage away from the landfill.

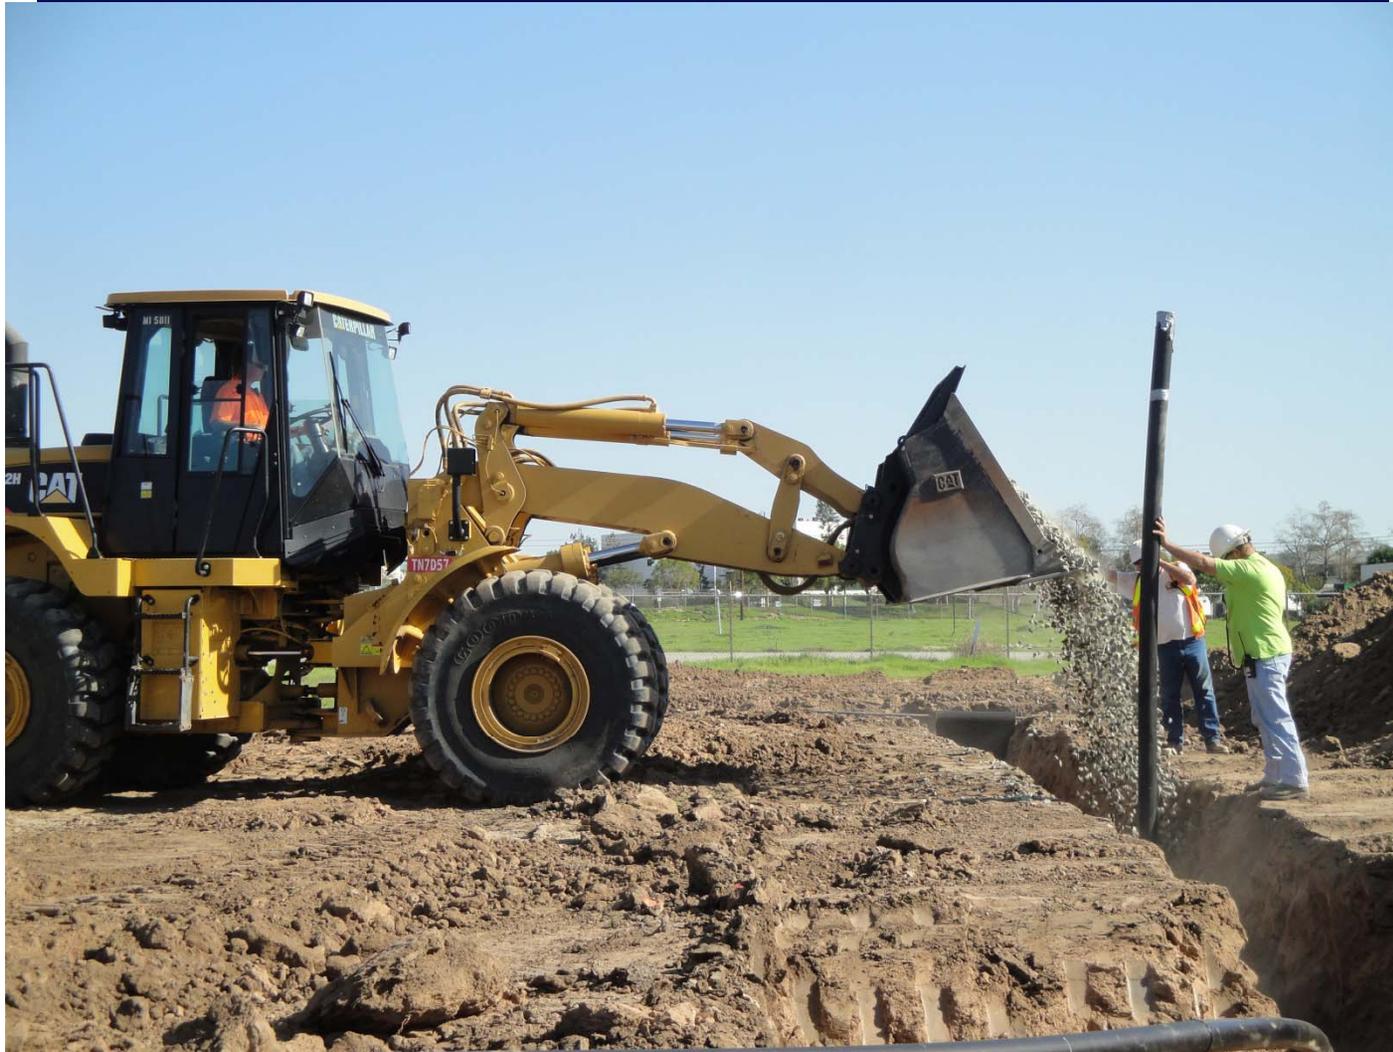
Placing 1-1/2 inch crushed rock over passive LFG vent piping surrounding IRP Site 5. Geotextile was placed on top of rock as a silt barrier prior to backfilling.

Slides 14 and 15 are photographs showing installation of the landfill gas venting/collection system used at IRP Site 5. The system is composed of passive vents at the perimeter of the landfill (Slide 14). The perimeter vent trench is about 25 feet away from the landfill perimeter. No landfill gas was detected during the monitoring completed in September or December 2010.

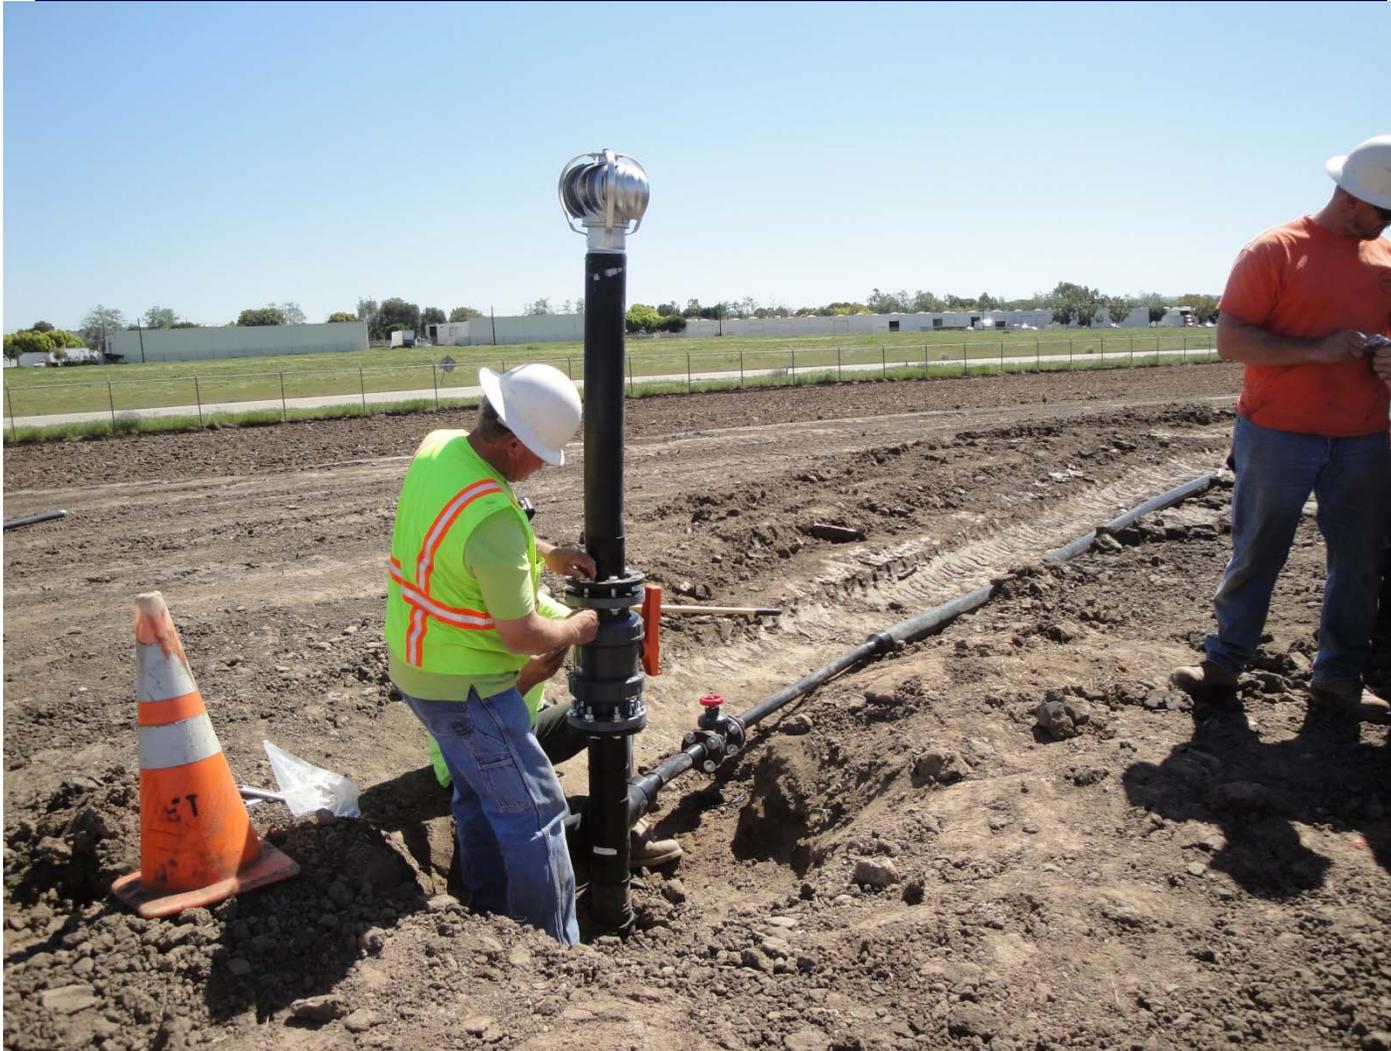
Installing 05_LFG01 well to LFG header system at IRP Site 5.

Mr. Johnson explained he was jumping ahead to describe the landfill gas trenches and collection system at the landfill. The main activity (Slide 15) was installing a landfill gas venting/collection well within the landfill. This is shown on Slide 15 where the vertical pipe is shown and the horizontal collection pipe is visible.

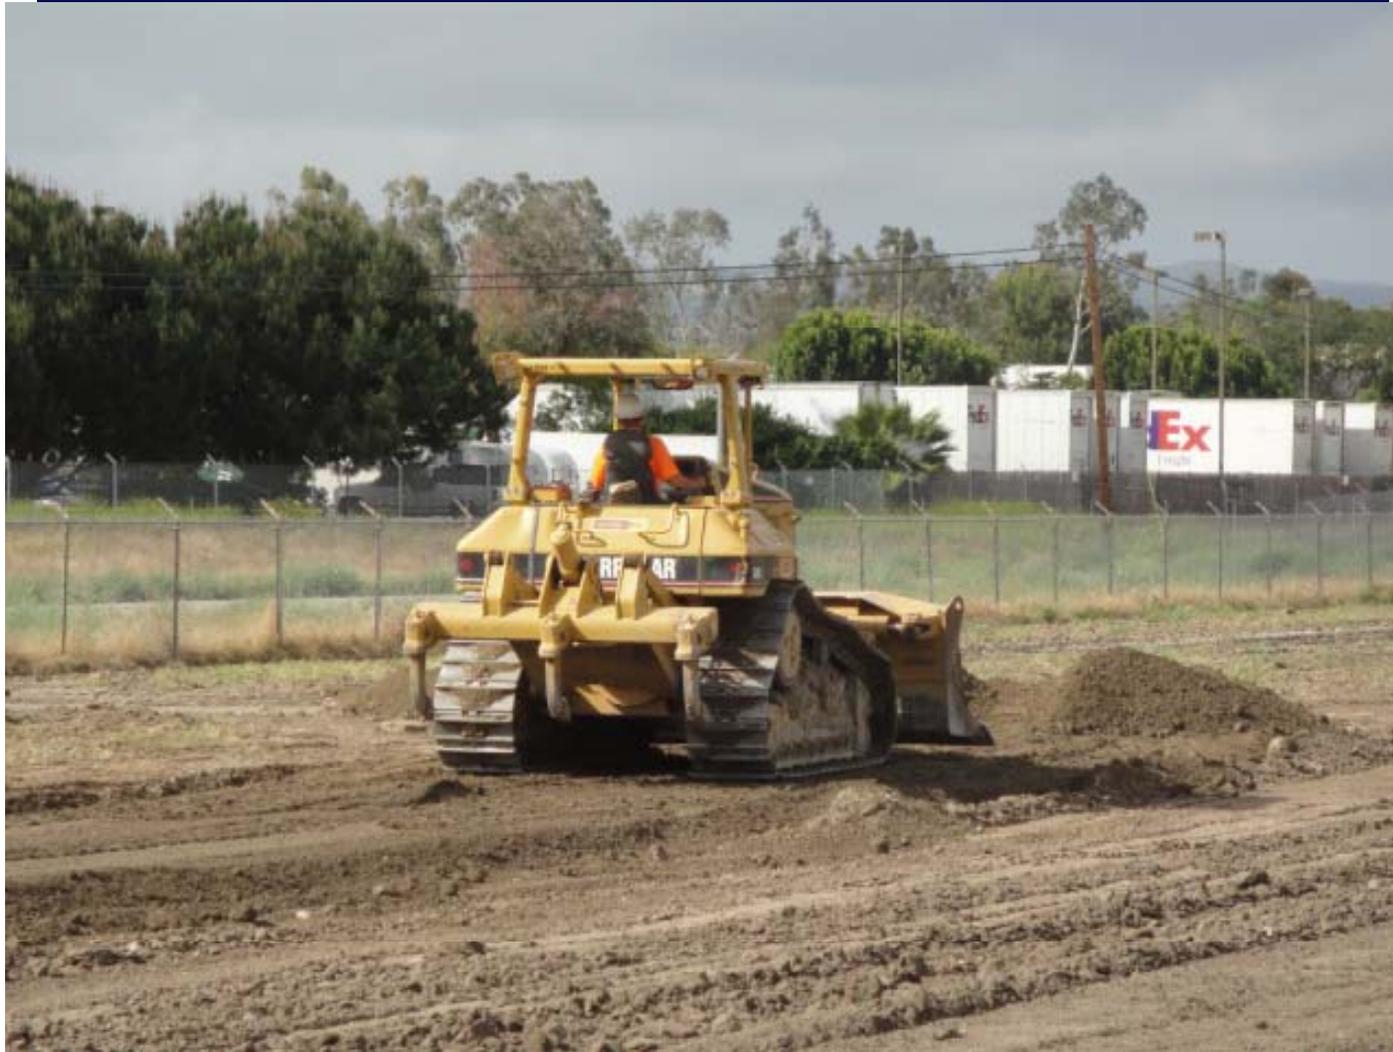
Installing the access road at IRP Site 5.

Slide 16 is a picture of the gravel access road being constructed at IRP Site 5 for monitoring and inspections.

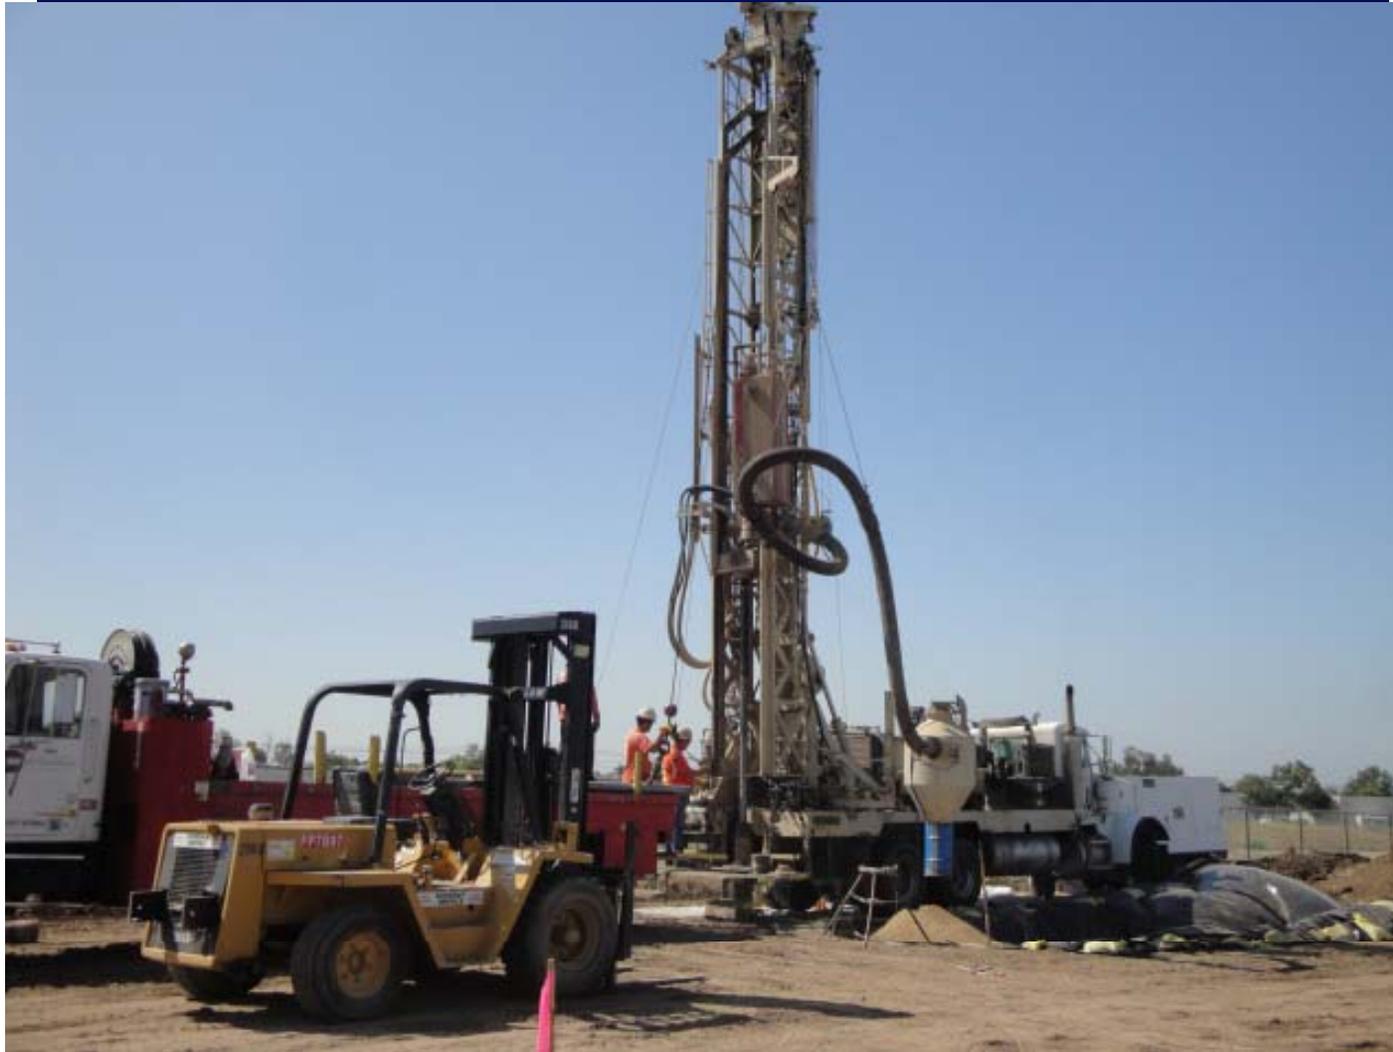
Installing additional groundwater monitoring wells at IRP Site 5.

Slide 17 is a picture of installing a groundwater monitoring well at IRP Site 5. These wells were installed to replace previously installed well to provide for an effective monitoring network.

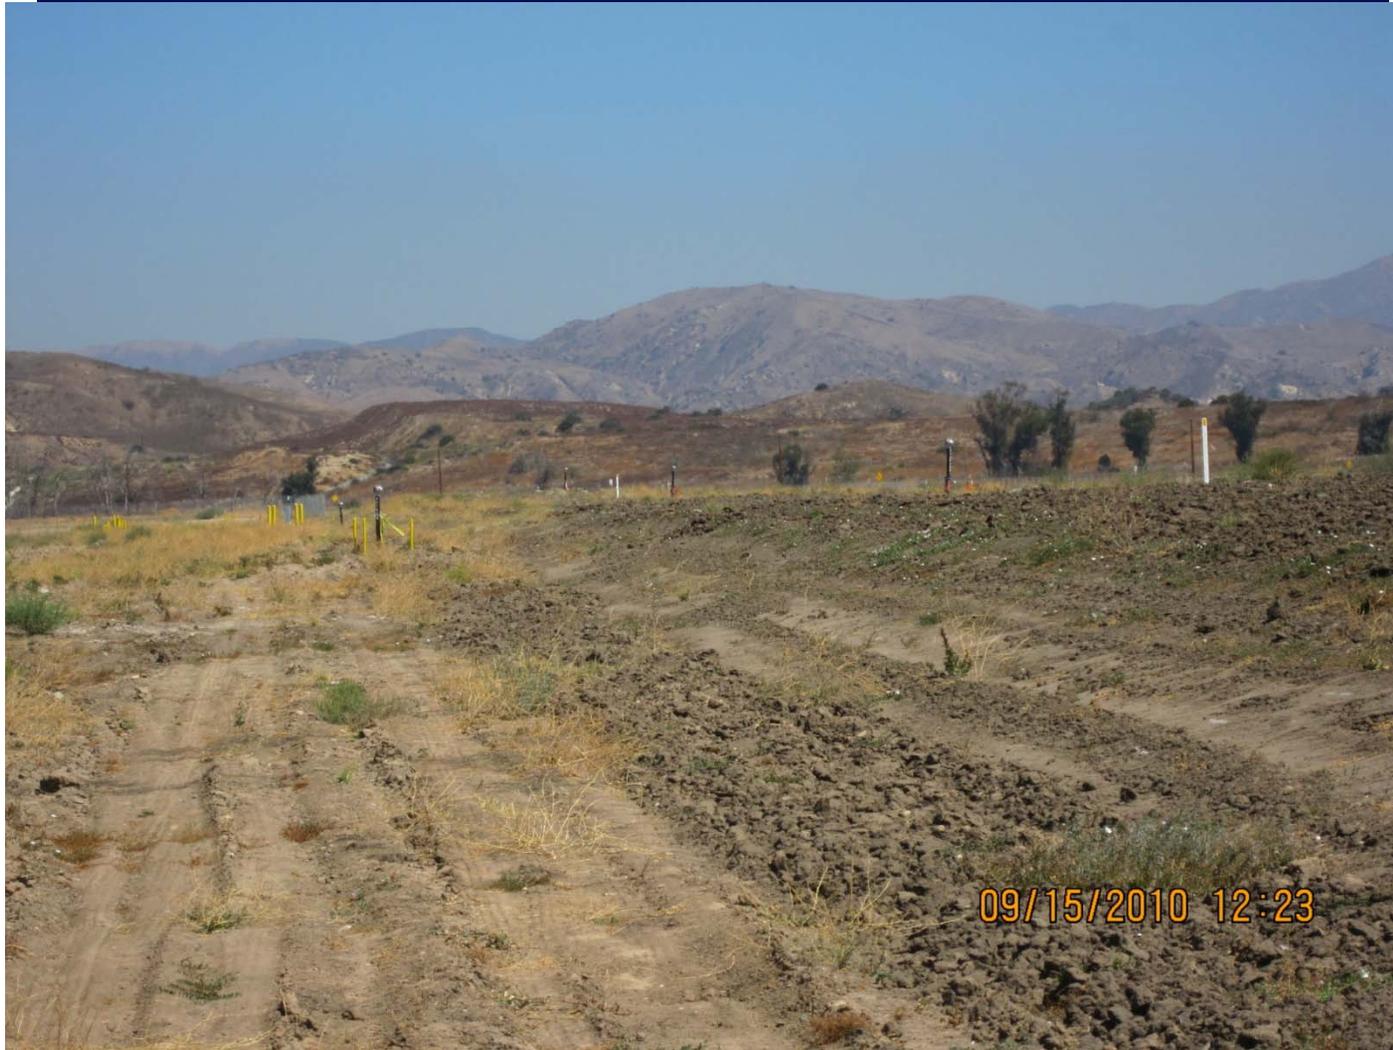
Final surface at IRP Site 5.

Slide 18 is a photograph of the final surface at IRP Site 5 and shows the slope away from the landfill area. The photograph was taken before the hydroseeding was completed in December 2010. The approximate location of the liner and the gas vent risers were pointed out.

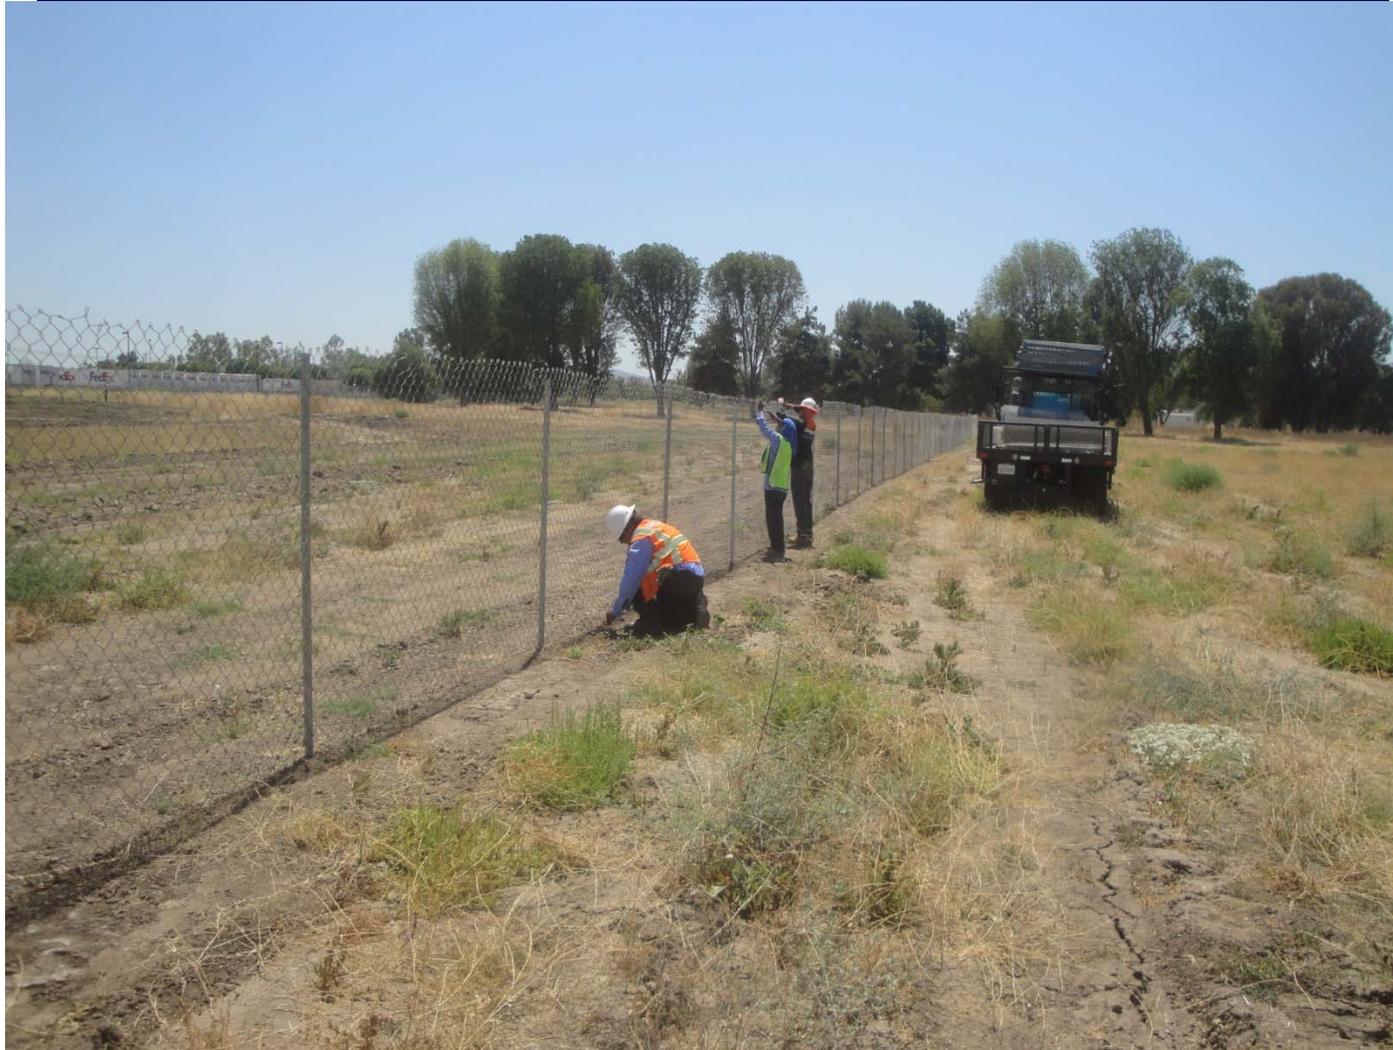
Installing fencing at IRP Site 5.

Slide 19 is a picture of the crew installing the IRP Site 5 fence, completed in September 2010, for security and access control.

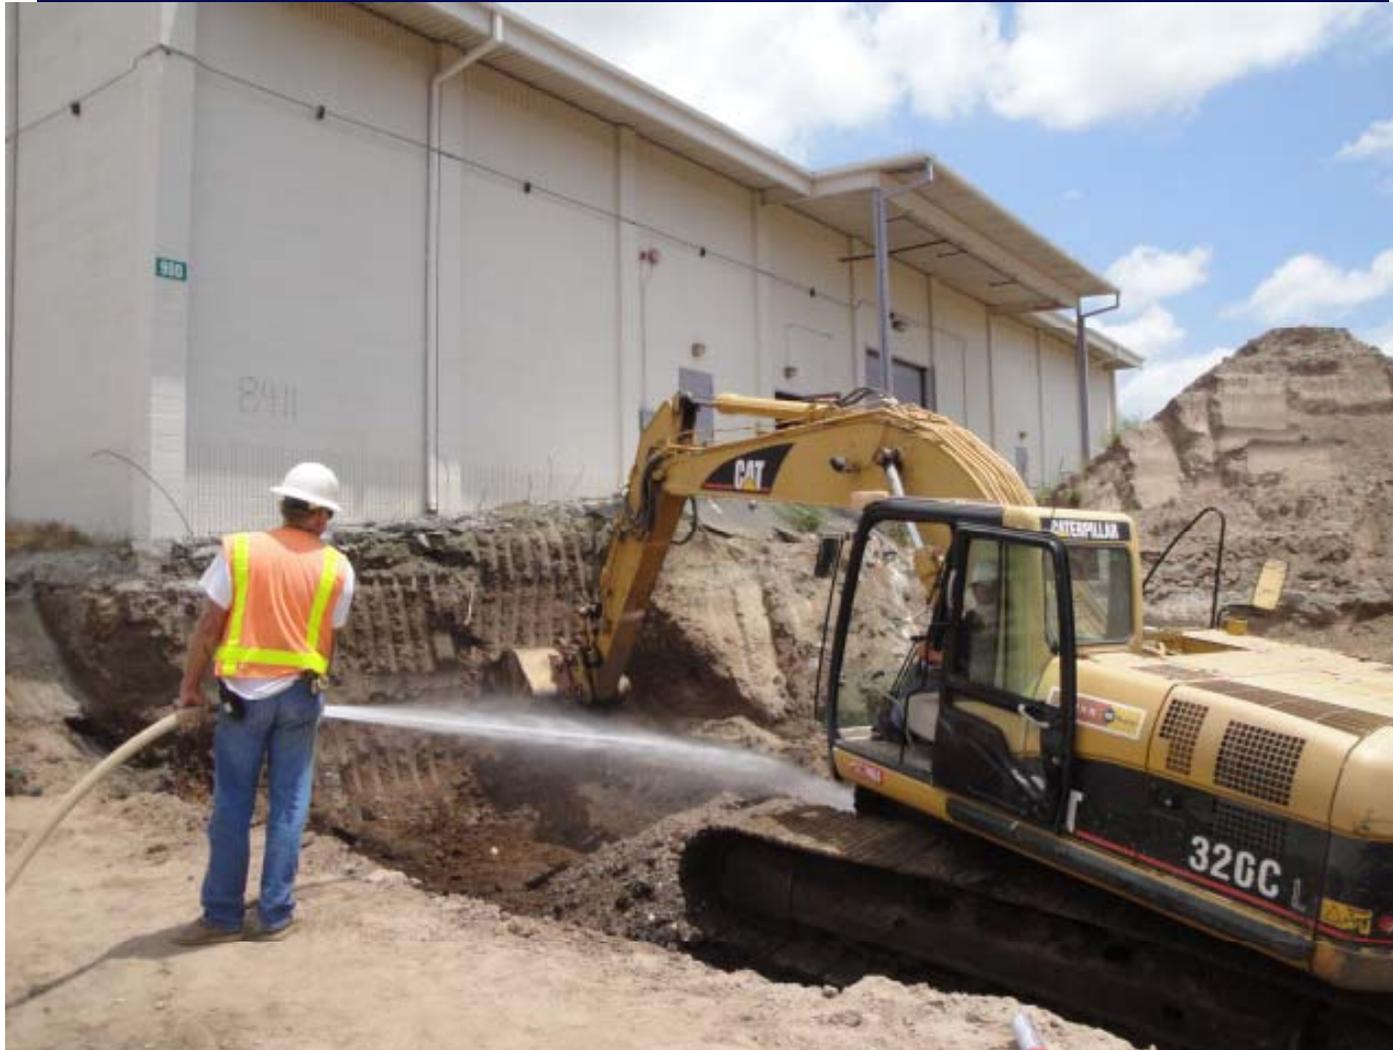
Excavating incinerator waste/debris from Area A3 adjacent to Building 900 at IRP Site 3. Incinerator waste/debris extended beneath the building.

Slide 20 is a photograph of excavating waste from Area A3 adjacent to Building 900 at IRP Site 3. This excavation determined that incinerator wastes extended beneath the adjacent Building 900. Study and evaluations determined that the best resolution was to demolish Building 900 so waste could be economically and safely removed.

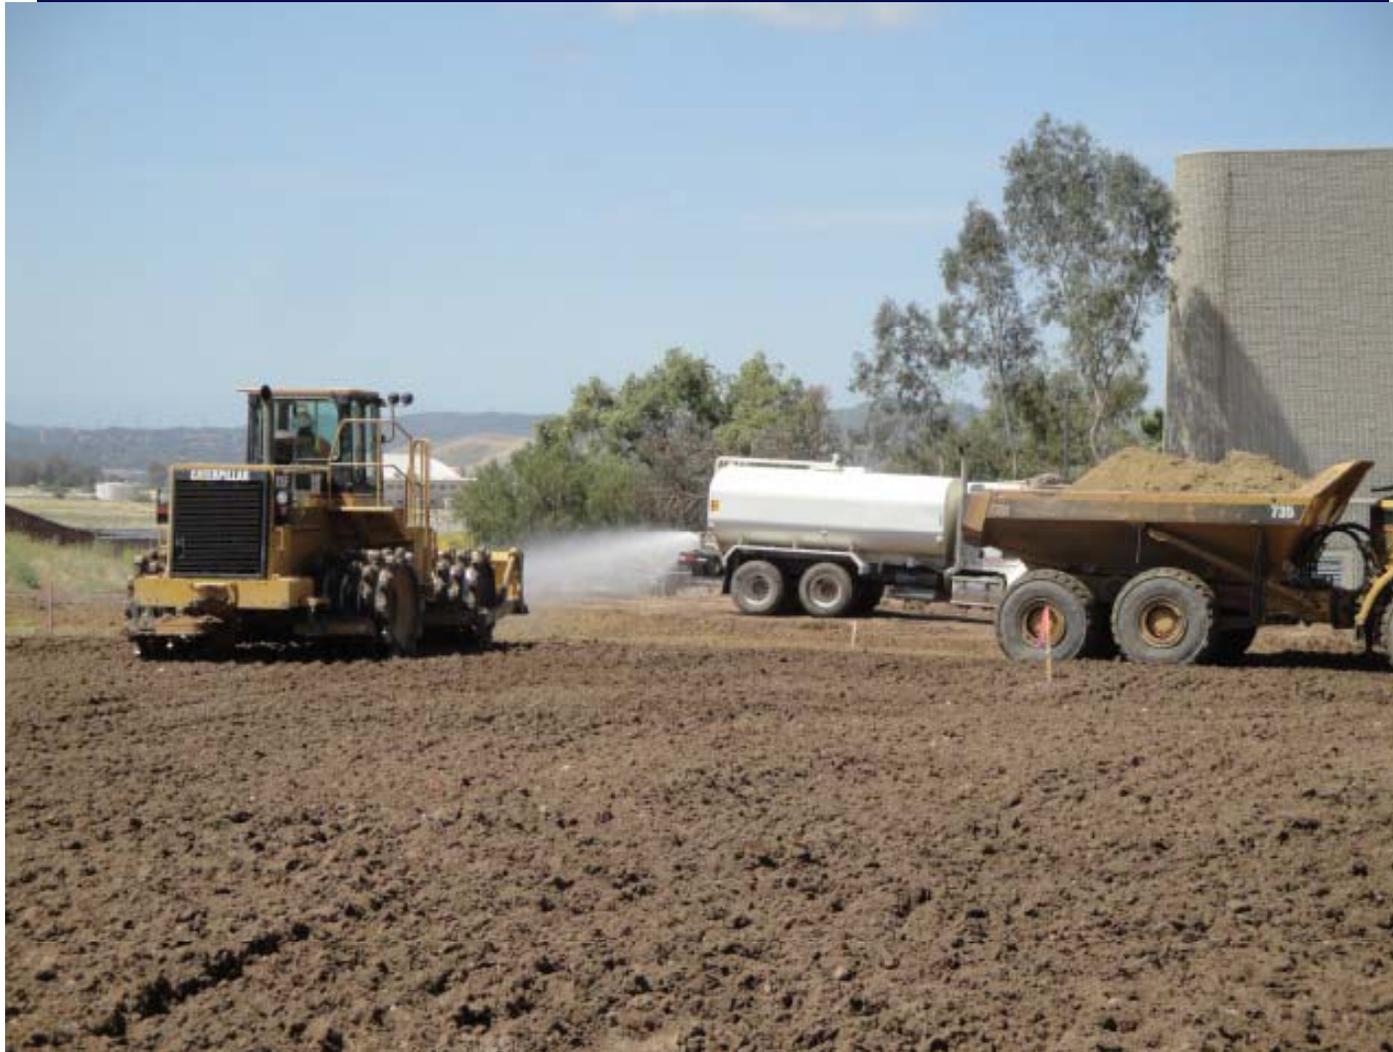
Placing foundation layer material at IRP Site 3.

Slide 21 is a photograph of placing and compacting the foundation soil at IRP Site 3.

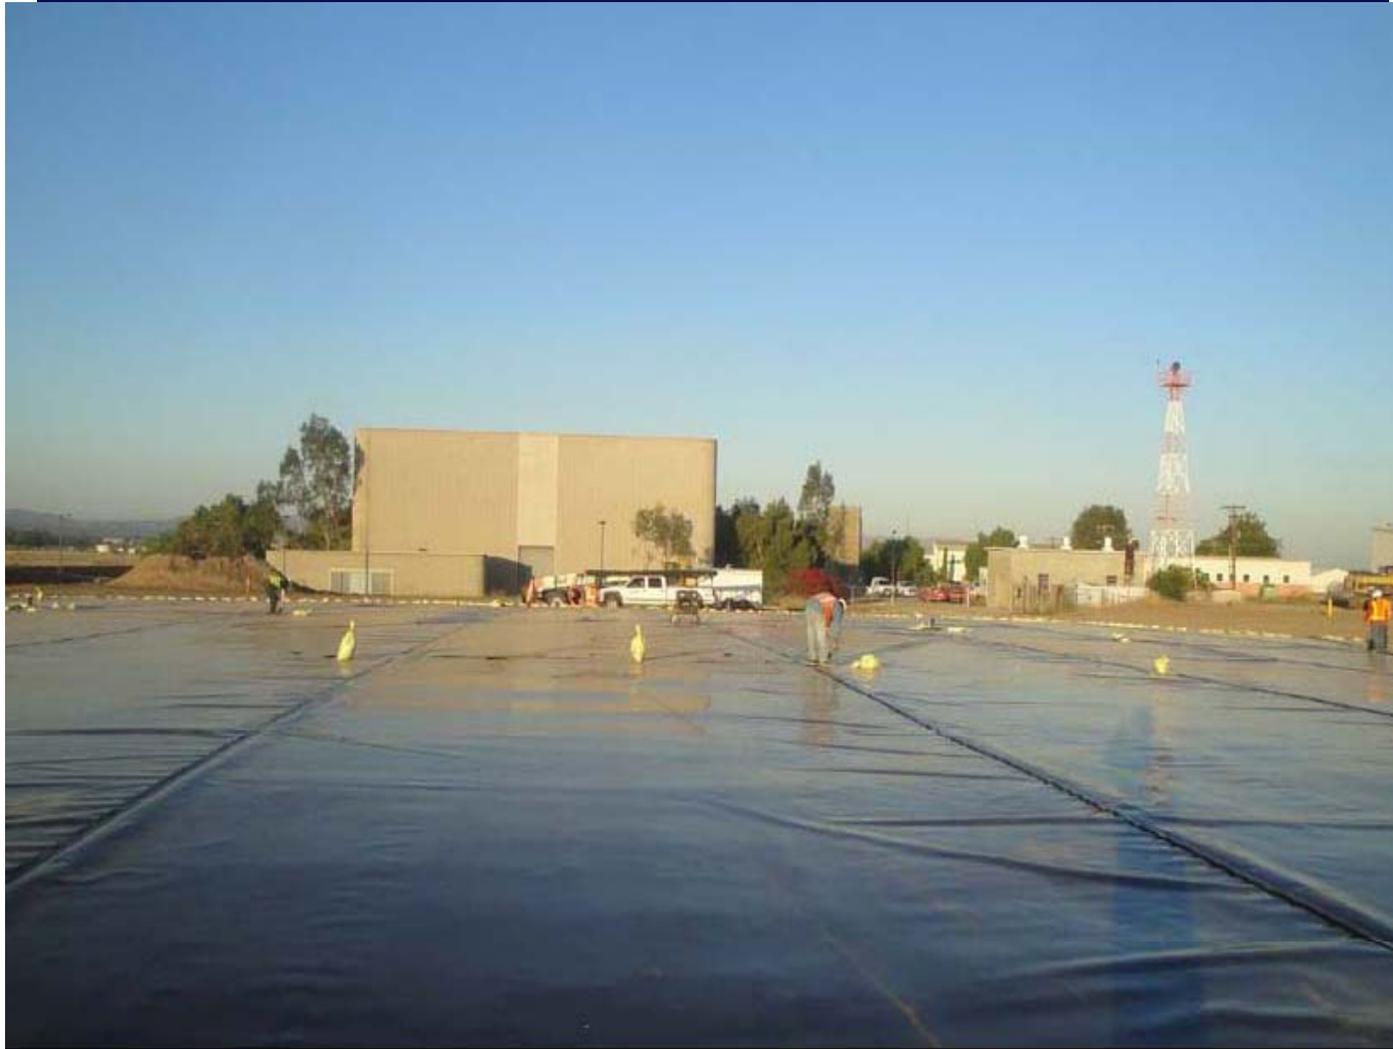
Installing flexible geomembrane liner at IRP Site 3.

Slide 22 is a photograph of the flexible membrane liner being placed and seams welded at IRP Site 3. The old flight simulator building in the background is at approximately 250 feet from the outer edge of the landfill. Monitoring points are between the landfill and the building.
