FORMER MARINE CORPS AIR STATION (MCAS) El Toro 102nd Restoration Advisory Board (RAB) Meeting Minutes

Meeting Date/Time: 26 January 2011/6:30pm - 7:45pm

INSTALLATION RESTORATION PROGRAM (IRP) OPERABLE UNIT 2C SITE 3 – ORIGINAL LANDFILL SITE 5 – PERIMETER ROAD LANDFILL

PROJECT UPDATE

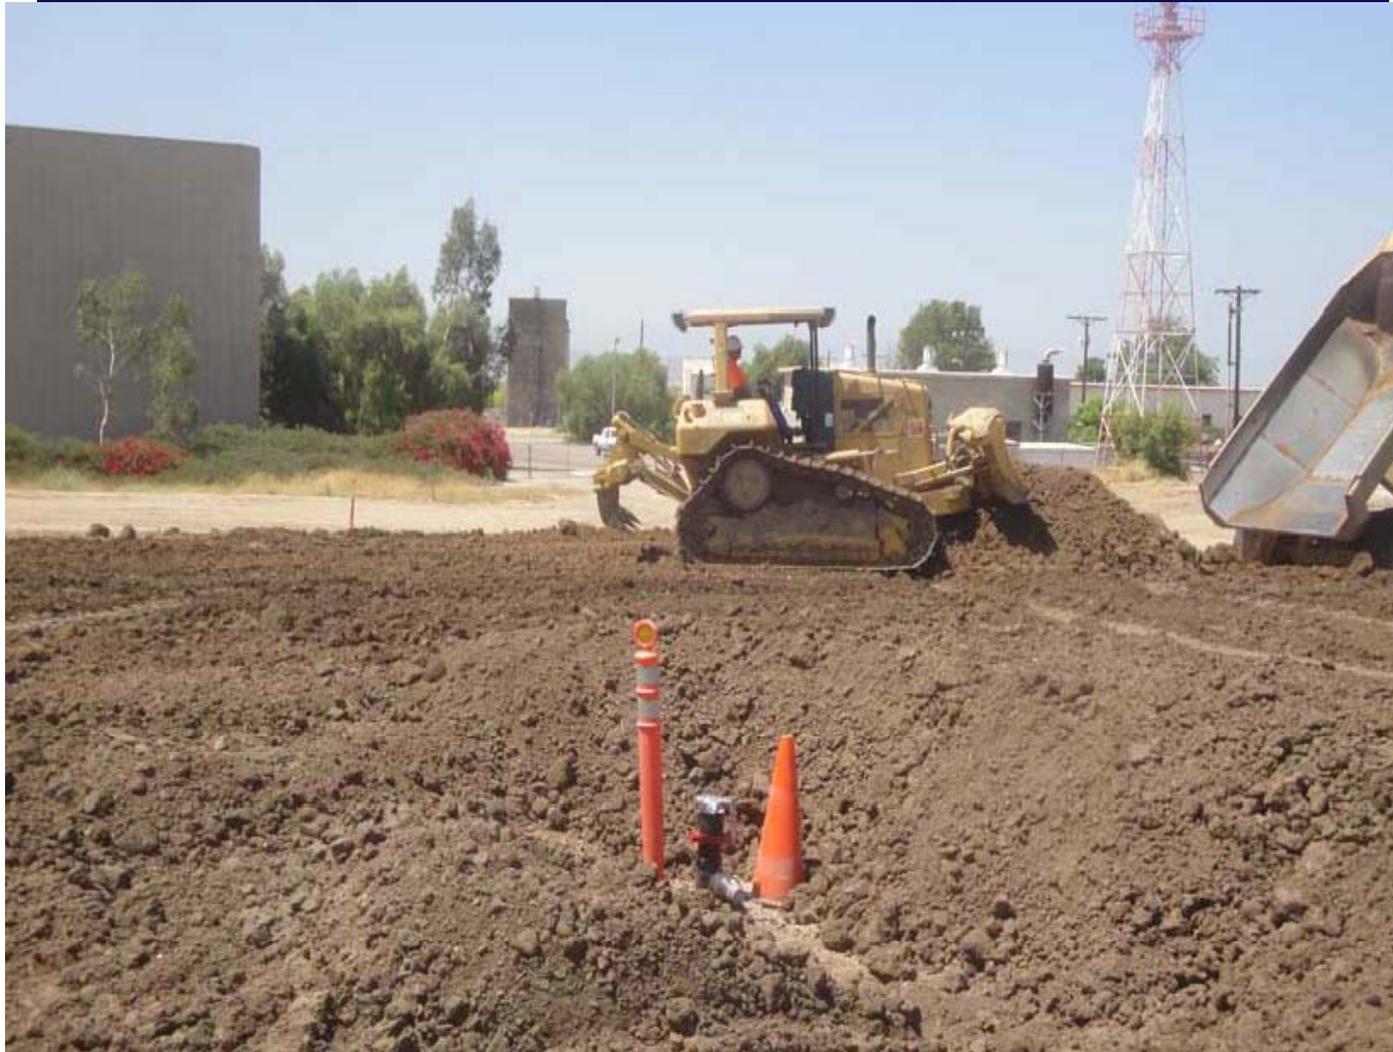
Placing protective cover soil over the geomembrane liner at IRP Site 3.

Slide 23 is a photograph of the protective cover placement over the membrane liner at IRP Site 3. The landfill gas well is shown and will be connected to a riser pipe, valve box, and manifold when completed.

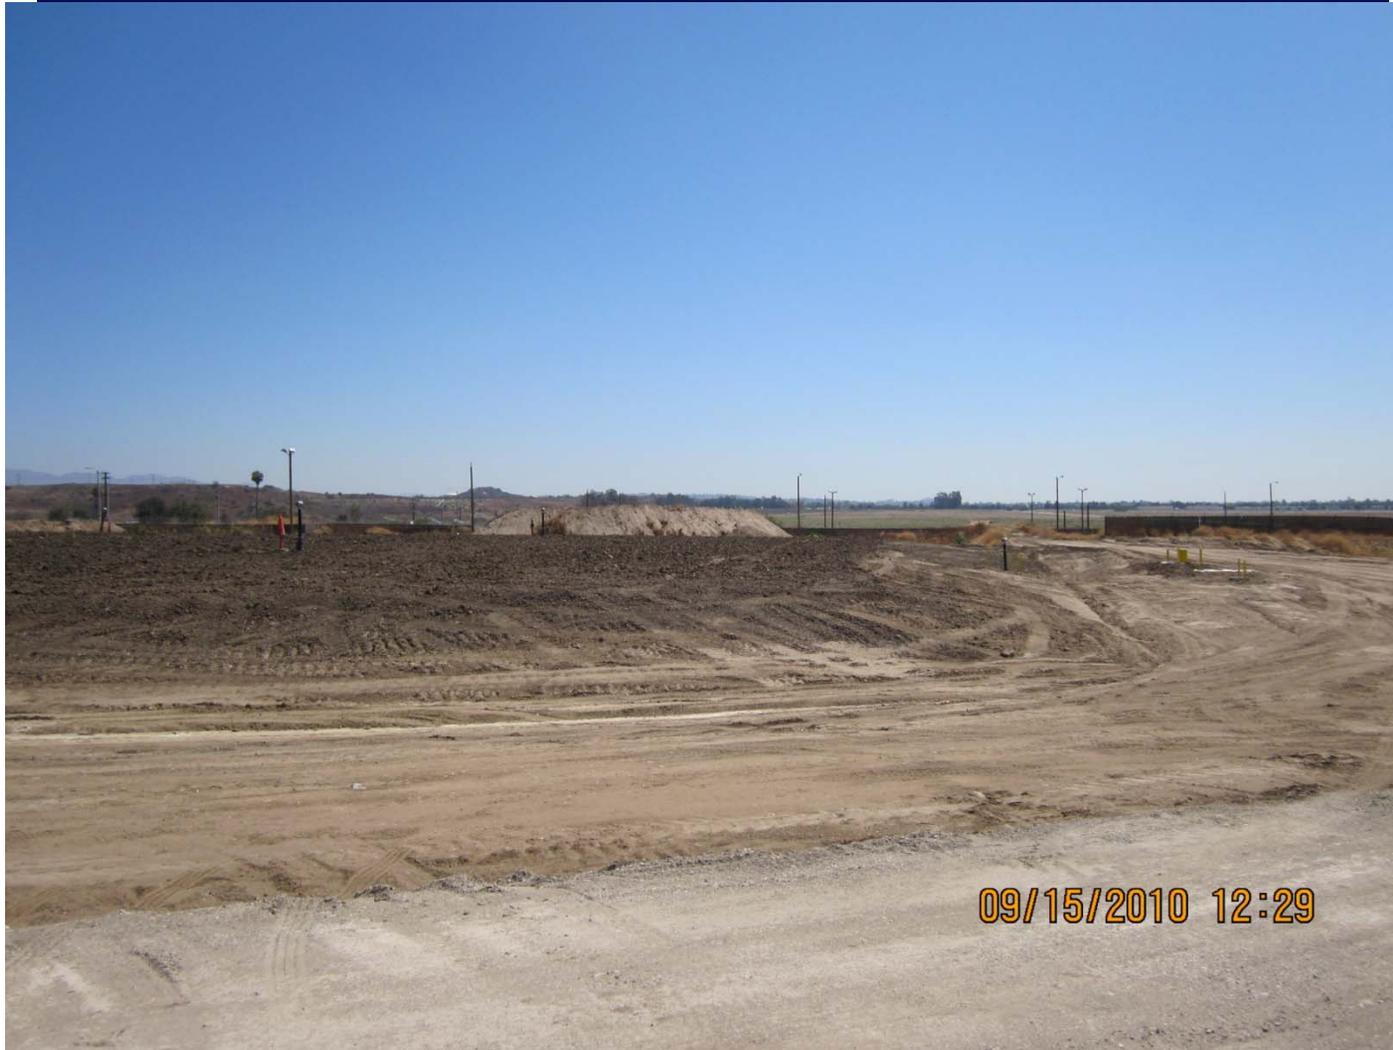
Final surface at IRP Site 3.

Slide 24 is a photograph of the final cover surface at IRP Site 3. This shows the sloped surface.

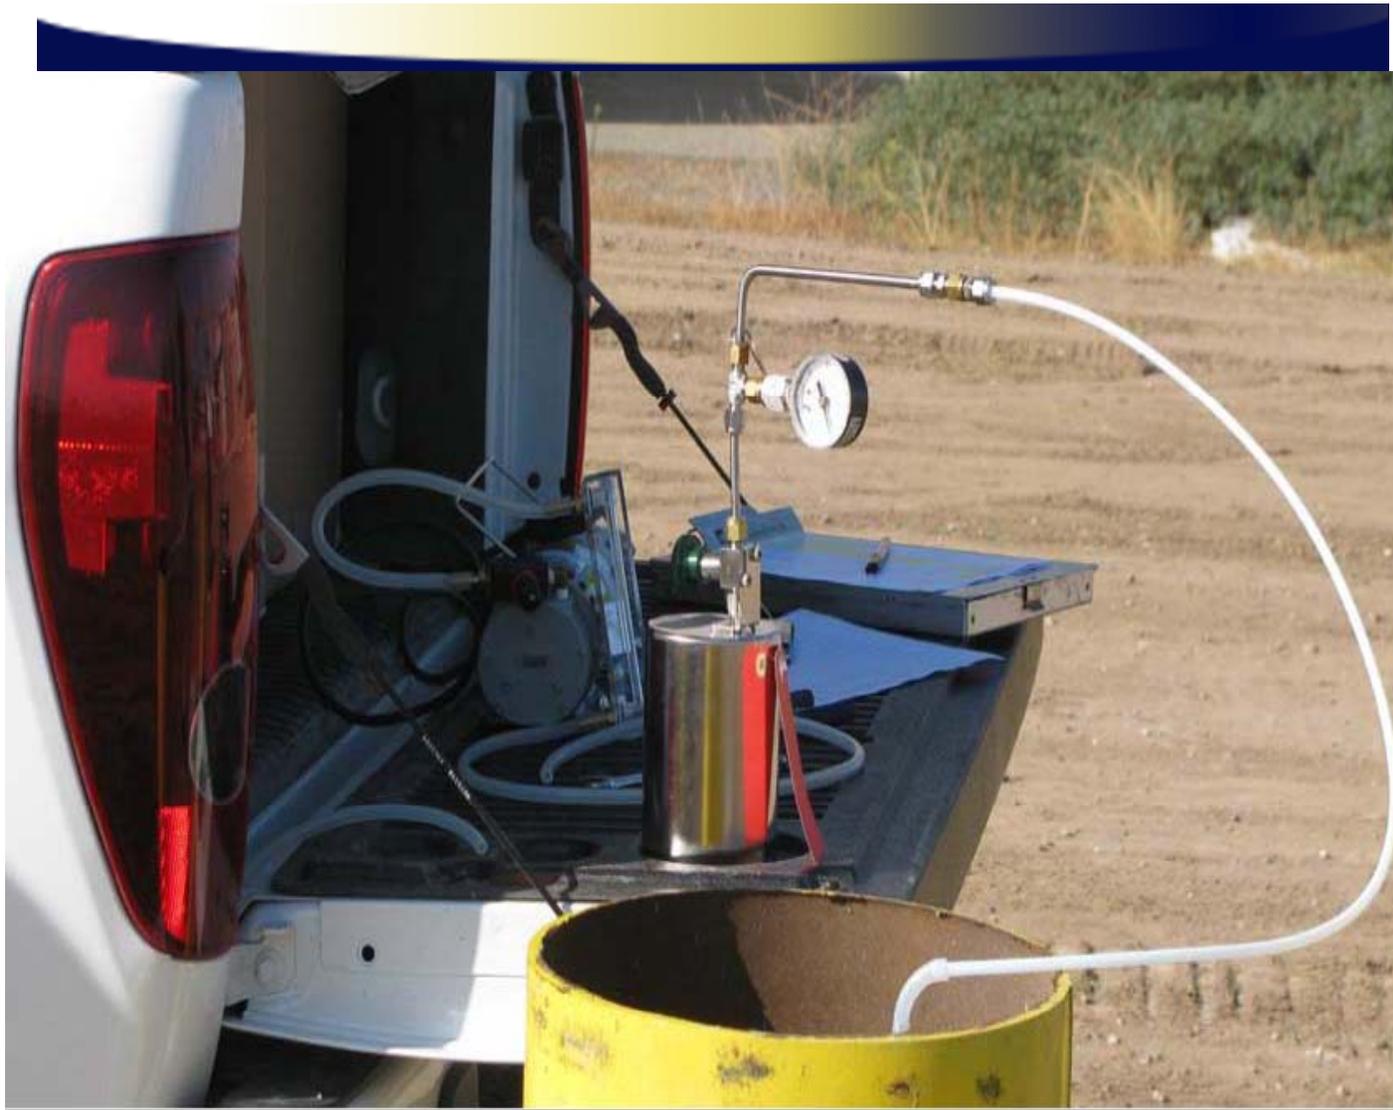
Collecting a vapor sample from a perimeter LFG well at IRP Site 3 during the 1st Quarterly sampling event.

Slide 25 is a photograph of a landfill gas sample being collected from one of the interior landfill gas wells. This is from the first quarterly sampling event at IRP Site 3 in September 2010. Another sampling round was completed in December 2010. Monitoring results show no landfill gas (methane).

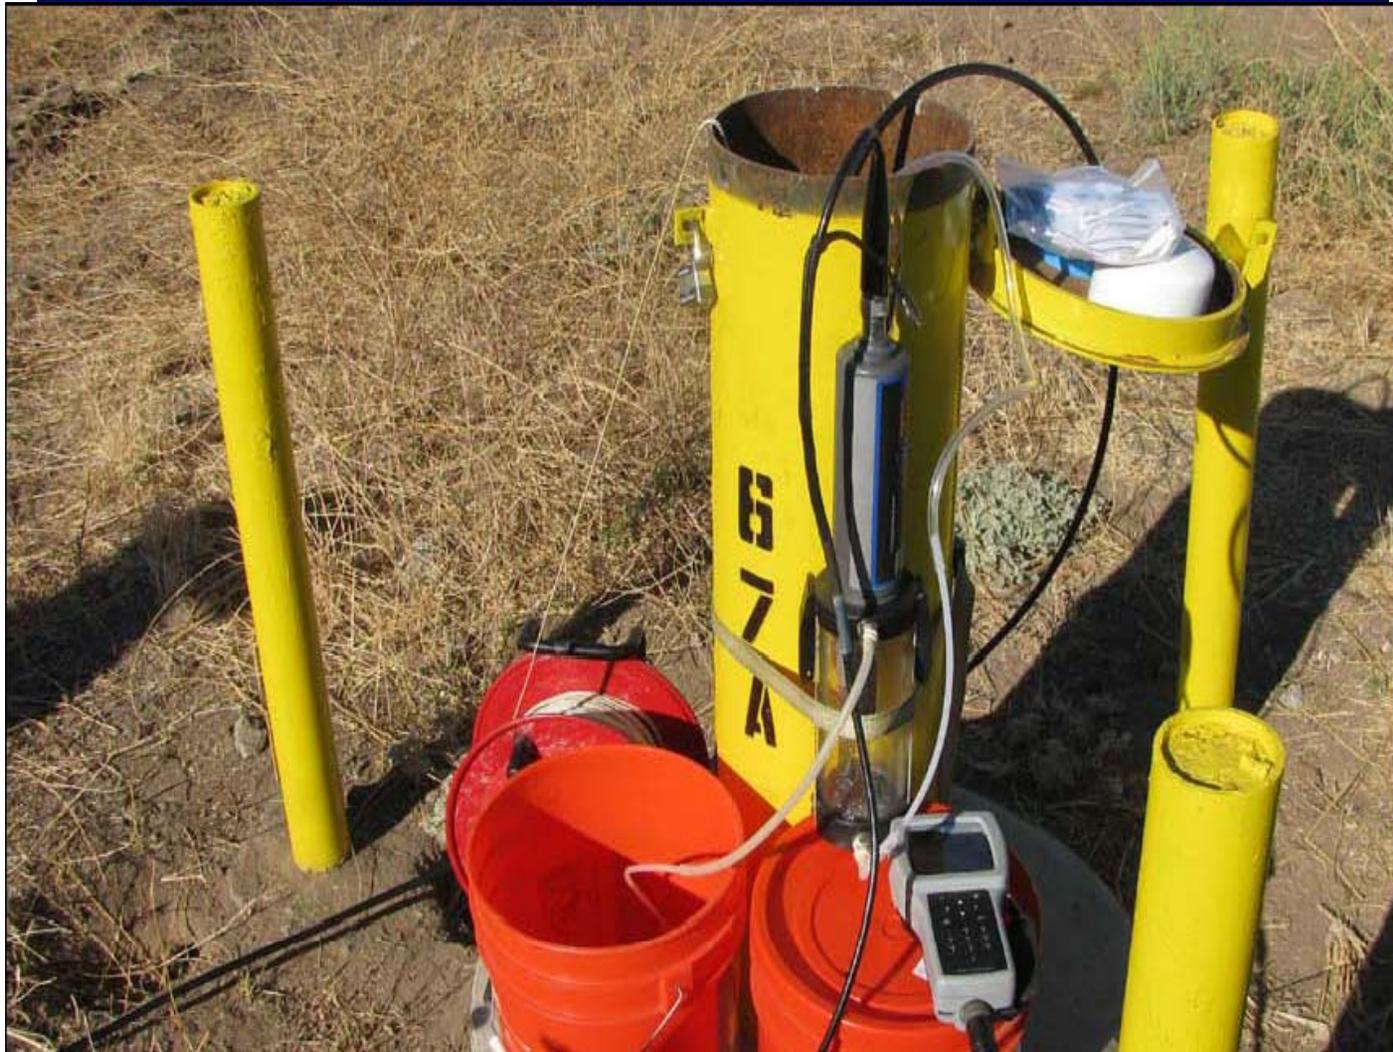
Collecting a groundwater sample from a downgradient groundwater well at IRP Site 5 during the 1st Quarterly sampling event.

Slide 26 is a photograph of a groundwater sample being collected, using low flow equipment, from an IRP Site 5 well during the first quarterly sampling round.

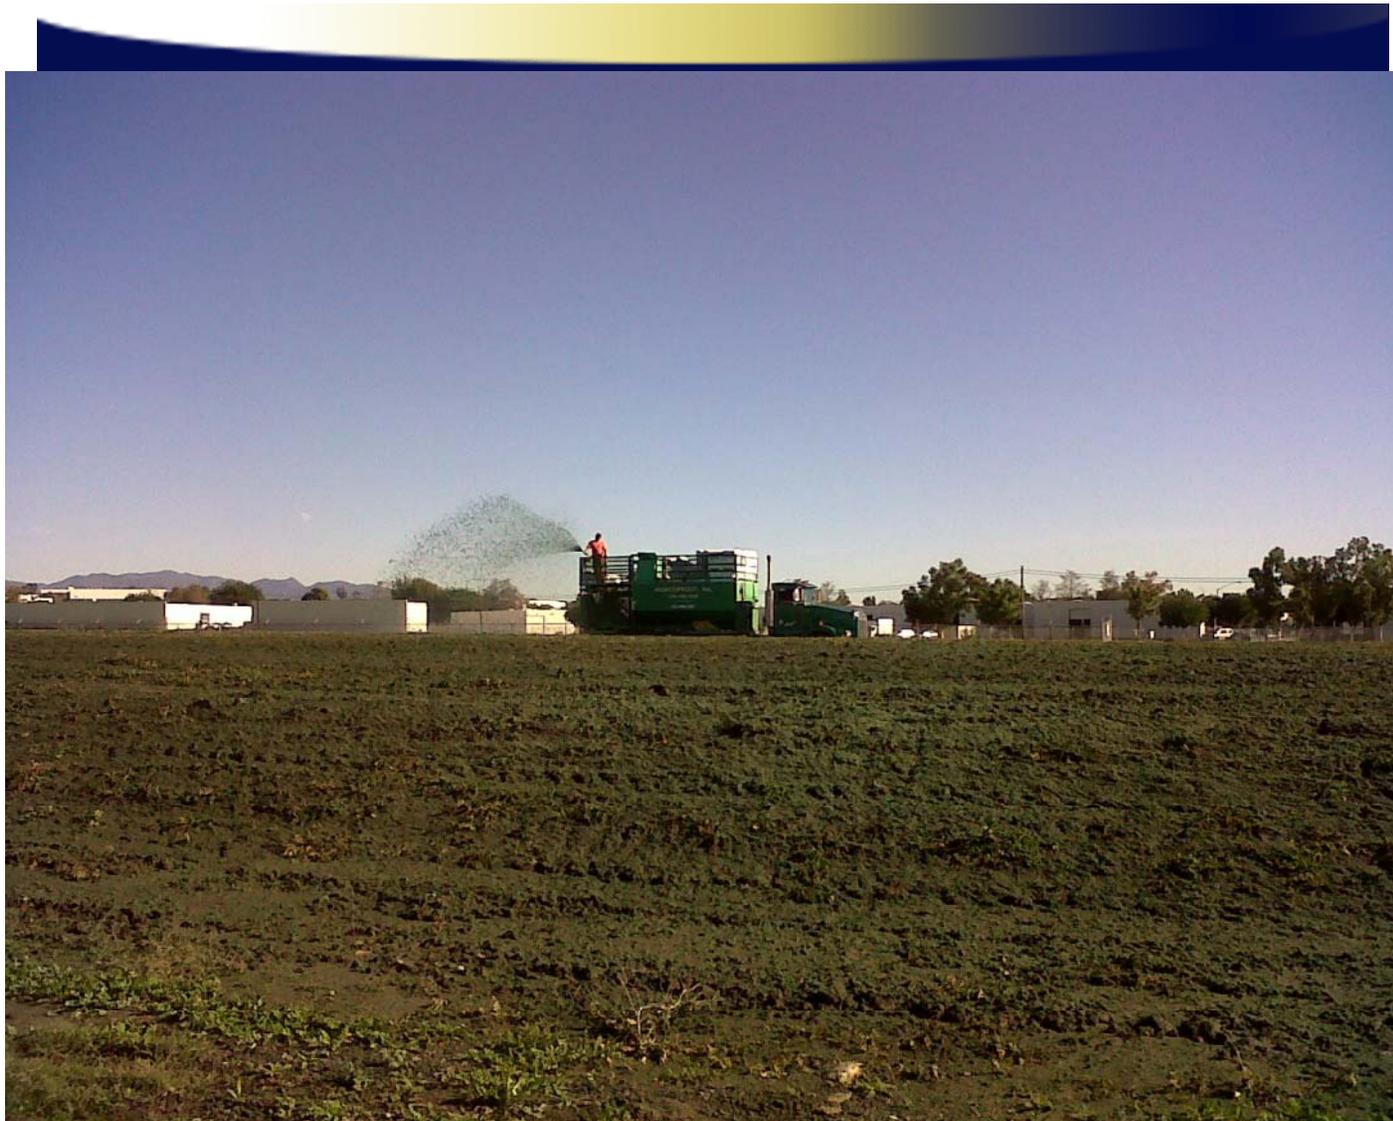
Installation of vegetative cover (hydroseeding) at IRP Site 5.

Slide 27 is a photograph of hydroseeding at IRP Site 5. Both landfill covers were hydro seeded at the end of December 2010 after the rainstorms.
