Final FORMER MARINE CORPS AIR STATION (MCAS) El Toro 112th Restoration Advisory Board (RAB) Meeting Summary

Meeting Date/Time: 25 February 2015/6:38 p.m. to 8:40 p.m.

- Project Update, Installation Restoration Program (IRP) Site 1 Soil and IRP Sites 1 and 2 Groundwater, Former MCAS El Toro
- Installation Restoration Program Second Five-Year Review Summary, Former MCAS El Toro
- Subsurface Delineation of Waste Area C1 at Installation Restoration Program (IRP) Site 3, Former Marine Corps Air Station El Toro, Irvine, CA

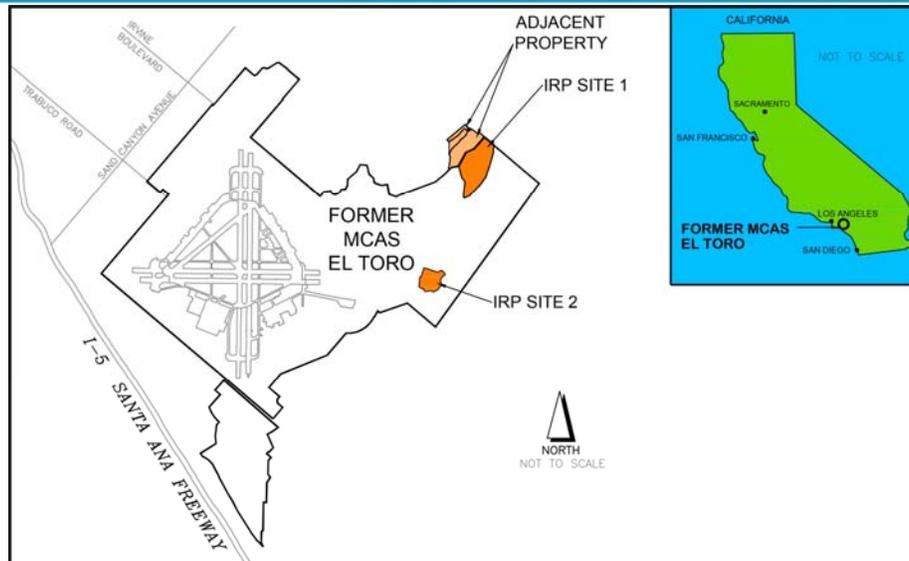
Site Locations

Slide 3 – Presents a site location map of IRP Sites 1 and 2 relative to Former MCAS El Toro. The map shows the location of IRP Site 2 to be downgradient from IRP Site 1. Mr. Smits explained that IRP Site 2 is shown on the figure because the groundwater between IRP Sites 1 and 2 is connected and the contamination is comingled at IRP Site 2.

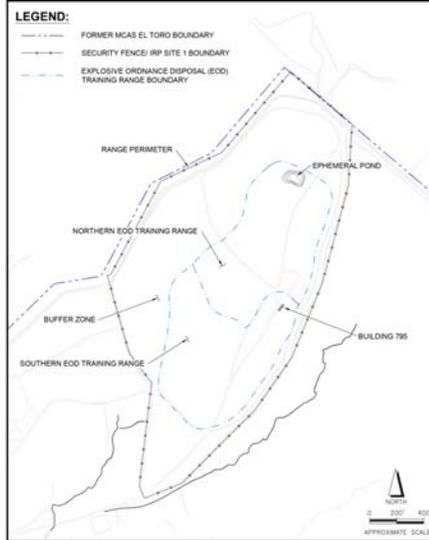
IRP Site 1

Slide 5 – Presents a site map of IRP Site 1. The map shows the different areas of the EOD range.

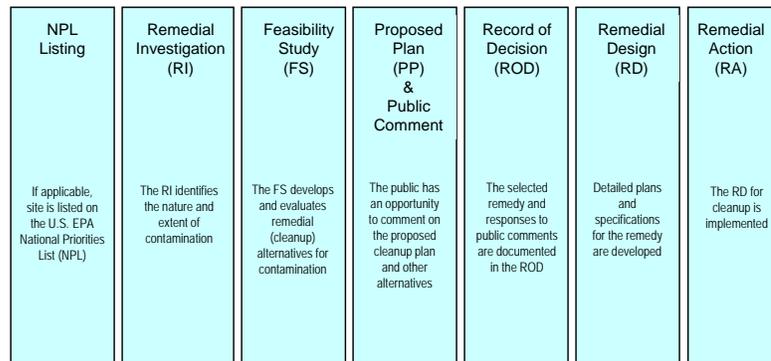
CERCLA Process

Slide 6 – Shows the current status of IRP Site 1 and IRP Site 2 in the CERCLA cleanup process. Mr. Wanyoike explained that the cleanup to address IRP Sites 1 and 2 Groundwater was further along in the CERCLA process than the cleanup to address IRP Site 1 Soil. Currently, IRP Site 1 Soil is in the FS phase where remedial (cleanup) alternatives are being evaluated to address the hazards/contaminants in

soil. He noted that IRP Sites 1 and 2 Groundwater is currently in the Remedial Action (RA) phase of the CERCLA process because cleanup actions to address contamination in groundwater have been implemented at these sites.

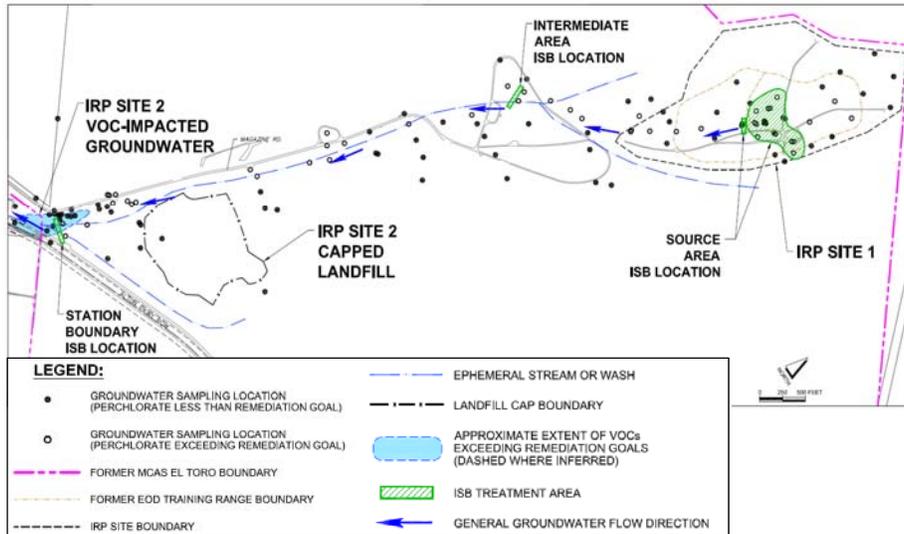
IRP Site 1 and 2 Groundwater

Slide 9 – Presents a site map of IRP Sites 1 and 2 relative to one another.

Mr. Wanyoike reminded the RAB that the remedy selected for IRP Site 1 Groundwater is in-situ bioremediation (ISB), performance monitoring, and institutional controls (ICs) and that monitored natural attenuation and ICs was the remedy selected for IRP Site 2.

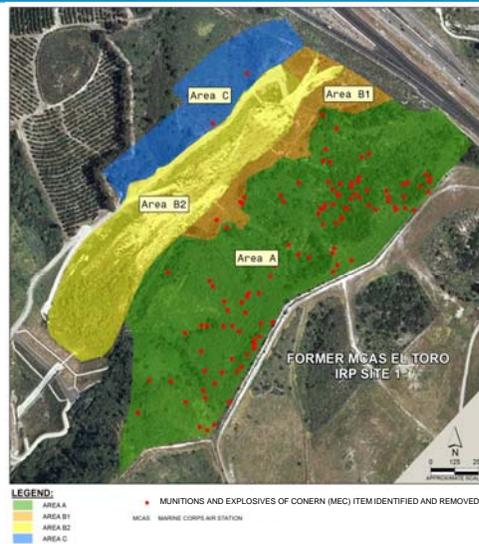
Slide 12 – Presents an aerial photograph of the IRP Site 1 Vadose Zone/ Adjacent Property. The figure shows the Adjacent Property currently owned by the Irvine Company (Area A shown in green and Area C shown in blue), and the Orange County Flood Control District (Area B2 shown in yellow). The figure also shows the locations where MEC, composed mainly of 20-millimeter projectiles, was identified and removed from the Adjacent Property during the TCRA conducted in 2010.

- Adjacent Property Area Investigation
 - Additional Munitions Characterization was conducted in 2008
 - Time Critical Removal Action (TCRA) was implemented in 2010 to address the immediate munition hazard on the Adjacent Property
 - Removal Action Report was issued in August 2011
 - Results from the TCRA were incorporated into the IRP Site 1 Soils Feasibility Study

Mr. Wanyoike clarified that the TCRA was focused on these areas (Areas A, B1, and C) due to the higher probability of finding items within these areas. Area B2 has a lower probability since it is a retarding basin where the likelihood of finding items is much lower due to ongoing operations in this area. Mr. Zweifel asked why there are MEC detections found in Area C. Mr. Wanyoike replied there are only a few locations in Area C where MEC was detected. Mr. Chris Crompton, RAB member, reminded the Navy that one of comments made by the Orange County Flood District was to be cognizant of the fact that Area B2 is an area that is maintained by Orange County Flood District personnel. He noted that personnel access the area to maintain the as-built design of the flood retardant basin. Mr. Smits replied that the comment was considered when developing and evaluating alternatives in the FS. Mr. Wanyoike noted that various stakeholders, including the Irvine Company and the Orange County Flood District, were provided copies of the FS and have remained engaged in the review process.

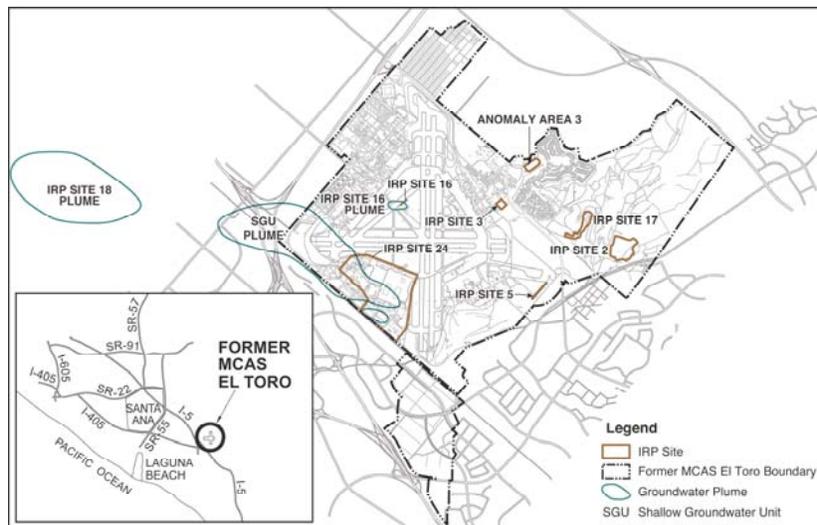
Sites - Locations

Slide 4 – Presents a site map showing locations of the IRP sites included in the Second Five-Year Review relative to Former MCAS El Toro.

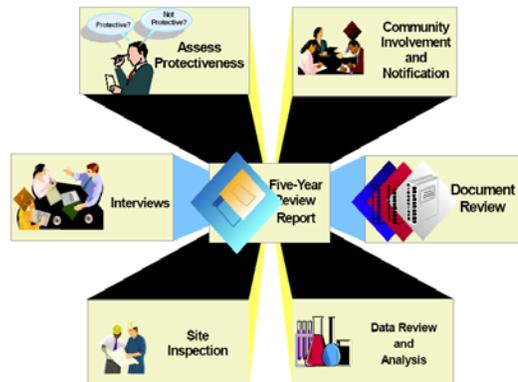
Figure 1: Components of the Five-Year Review Process

Slide 5 – Presents the components of the Five-Year Review, including community involvement and notification, document review, data review and analysis, site inspections, interviews, and creation of protectiveness statements.

The fundamental purpose of a Five-Year Review is to determine whether the remedy at a site remains protective of human health and the environment.

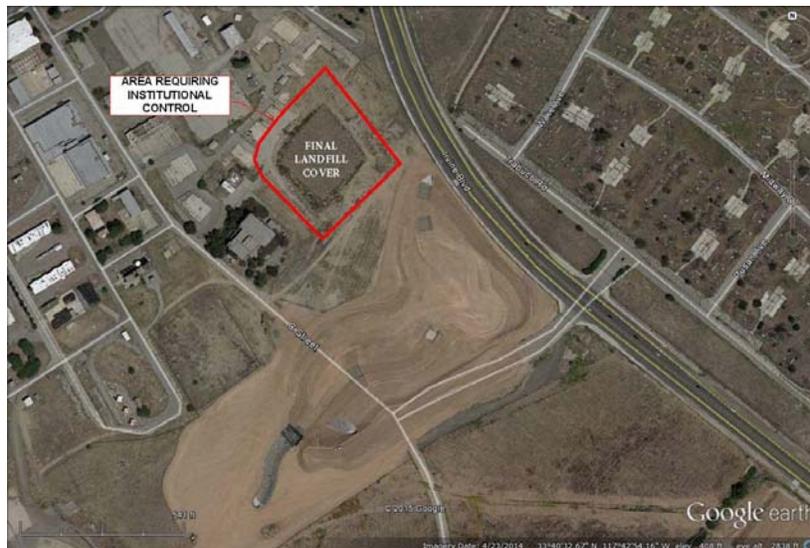
BACKGROUND IRP SITE 3 – SITE PLAN

- Consolidated waste into the Main Landfill at IRP Site 3
- Installed a synthetic flexible membrane liner (FML)
- Placed a 2-foot soil cover over the FML
- Constructed surface water drainage systems along the boundary of the landfills
- Placed hydroseed on the landfill covers to promote growth of native grass for erosion control

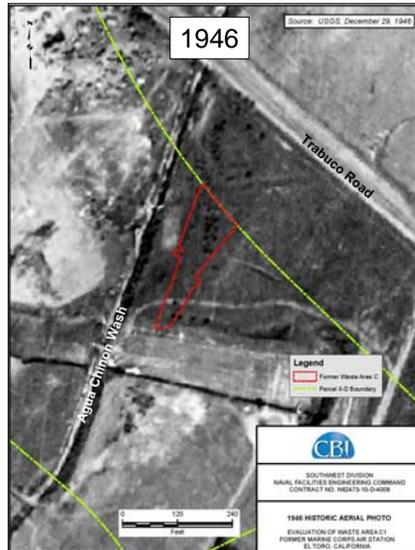
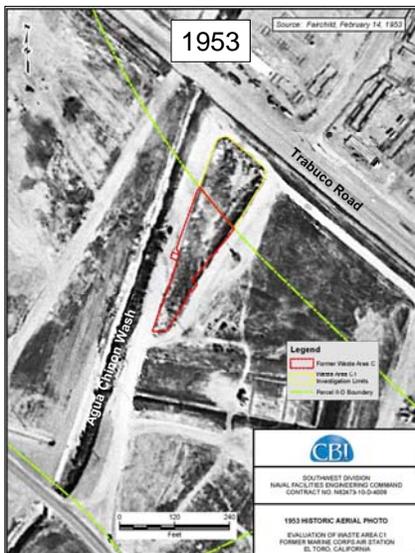
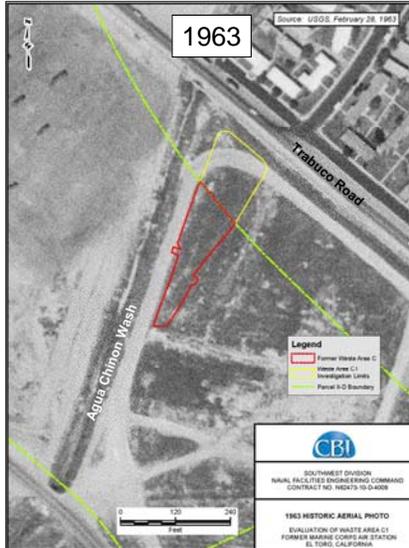
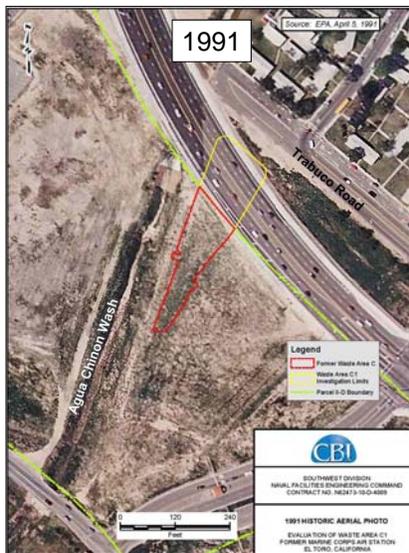
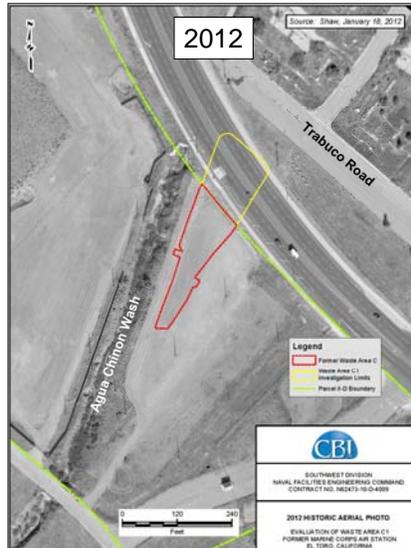
HISTORICAL AERIAL PHOTOGRAPHS

Slide 6 – Presents a summary of the comprehensive document review conducted for Waste Area C1. Mr. Johnson explained that the most useful information was derived from what was observed in aerial photographs dating back to 1946.

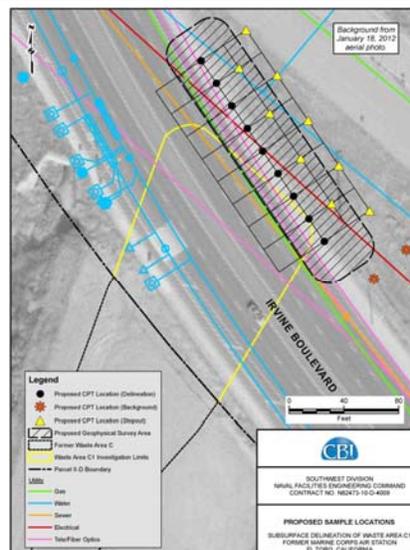
PLANNED FIELD ACTIVITIES PROPOSED GEOPHYSICAL AREA/CPT TEST LOCATIONS

- The objective of this work is to conduct subsurface delineation activities at Waste Area C1 to determine the extent of waste, if any, along the northeast edge of Irvine Boulevard
- The scope of work will include the following tasks:
 - Conduct traditional utility clearance activities to evaluate the presence of subsurface utilities prior to any intrusive activities
 - Conduct ground-penetrating radar (GPR) and an electrical resistivity survey to provide an initial evaluation of waste, if any, along the northeast edge of Irvine Boulevard
 - Conduct cone penetration technology (CPT) testing to determine the extent of waste, if any, along the northeast edge of Irvine Boulevard

Slide 16 – Presents a summary of CPT and the advantages of this technology for use at Waste Area C1. Mr. Johnson explained that CPT would provide real-time data, which would allow the Navy to step-out to another location while crews are onsite. In addition, he noted that CPT eliminates drill cuttings and the need to address investigation derived waste (IDW).
