# **Disposition of Dredge Spoils to Build Former Runway Areas**

## **Alameda RAB Meeting Alameda Point**

Naval Radiological Affairs Support Office

January 9, 2014

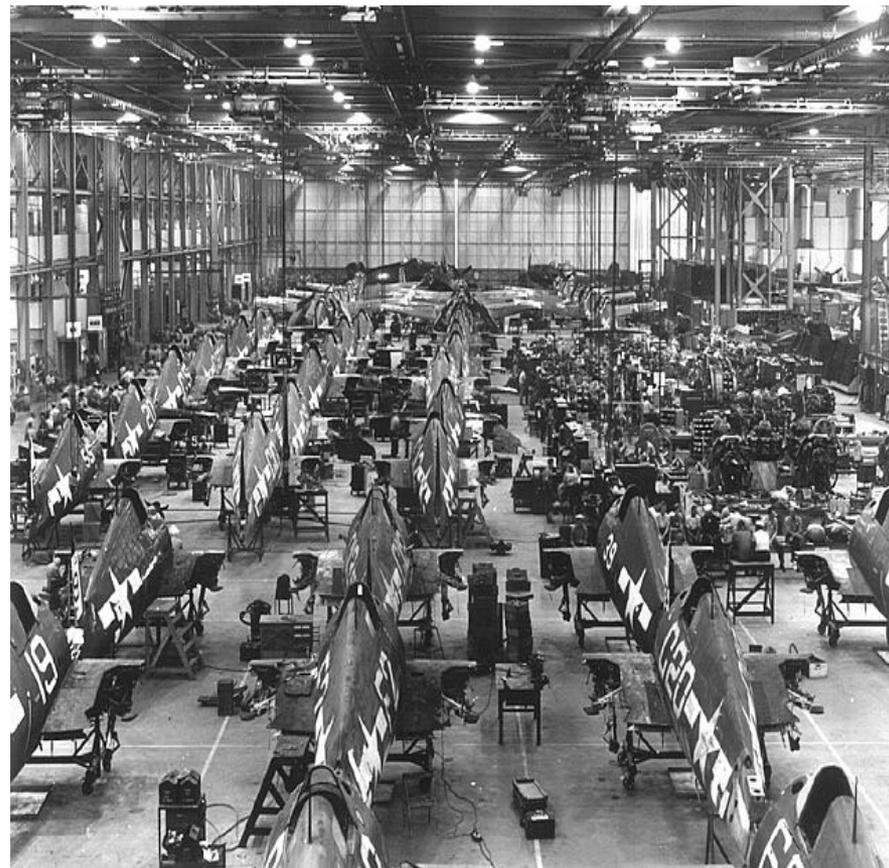
- Paint applied to allow instruments to glow in the dark
- Application/Removal of Radium Paint
  - Building 5 1941-~1950's
  - Building 400 1950's -1970's
- Liquid waste disposed via Storm Drain System.
- Drain lines from the instrumentation shops in Buildings 5 and 400 discharge into Seaplane Lagoon via Storm Drain Line F
- Data collected from Line F and Seaplane Lagoon confirmed radium contamination

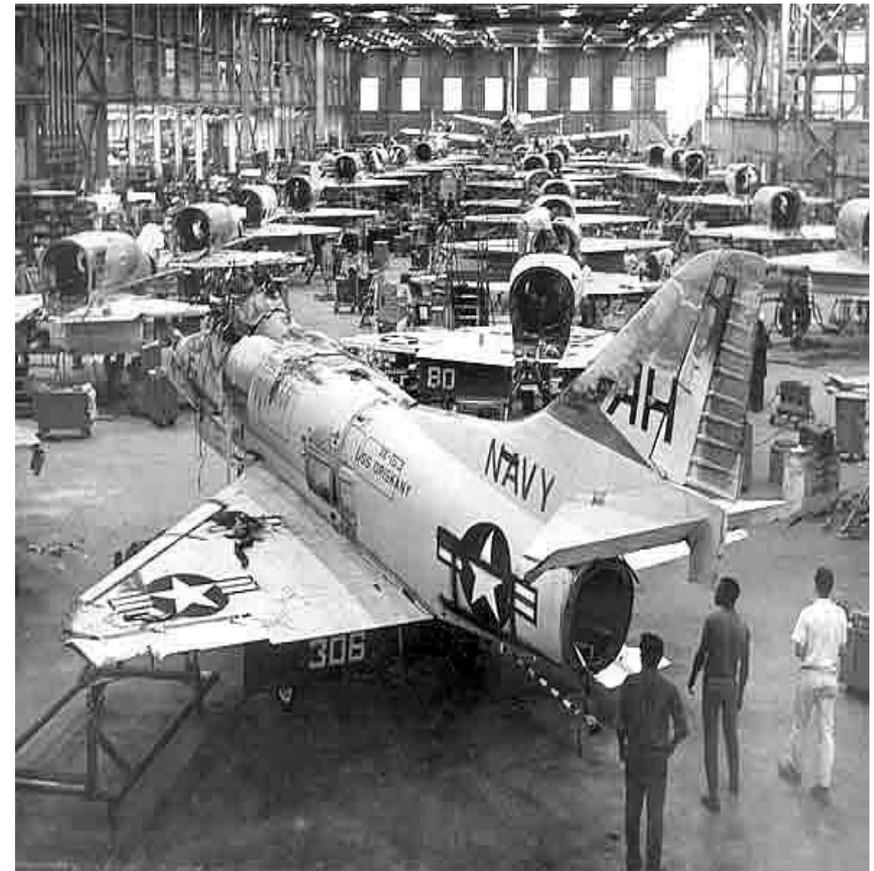
- Lines A and B discharge into Oakland Inner Harbor
- Connect to Building 5A
- Building 5A built 1945
- Lines A and B not connected to Instrument Shop in Buildings 5 or 400
  - Not suspected as being source or radium contamination from radium painting operations
- Samples collected in the Fed Parcel 1A (surface and to depth) did not indicate elevated radium contamination

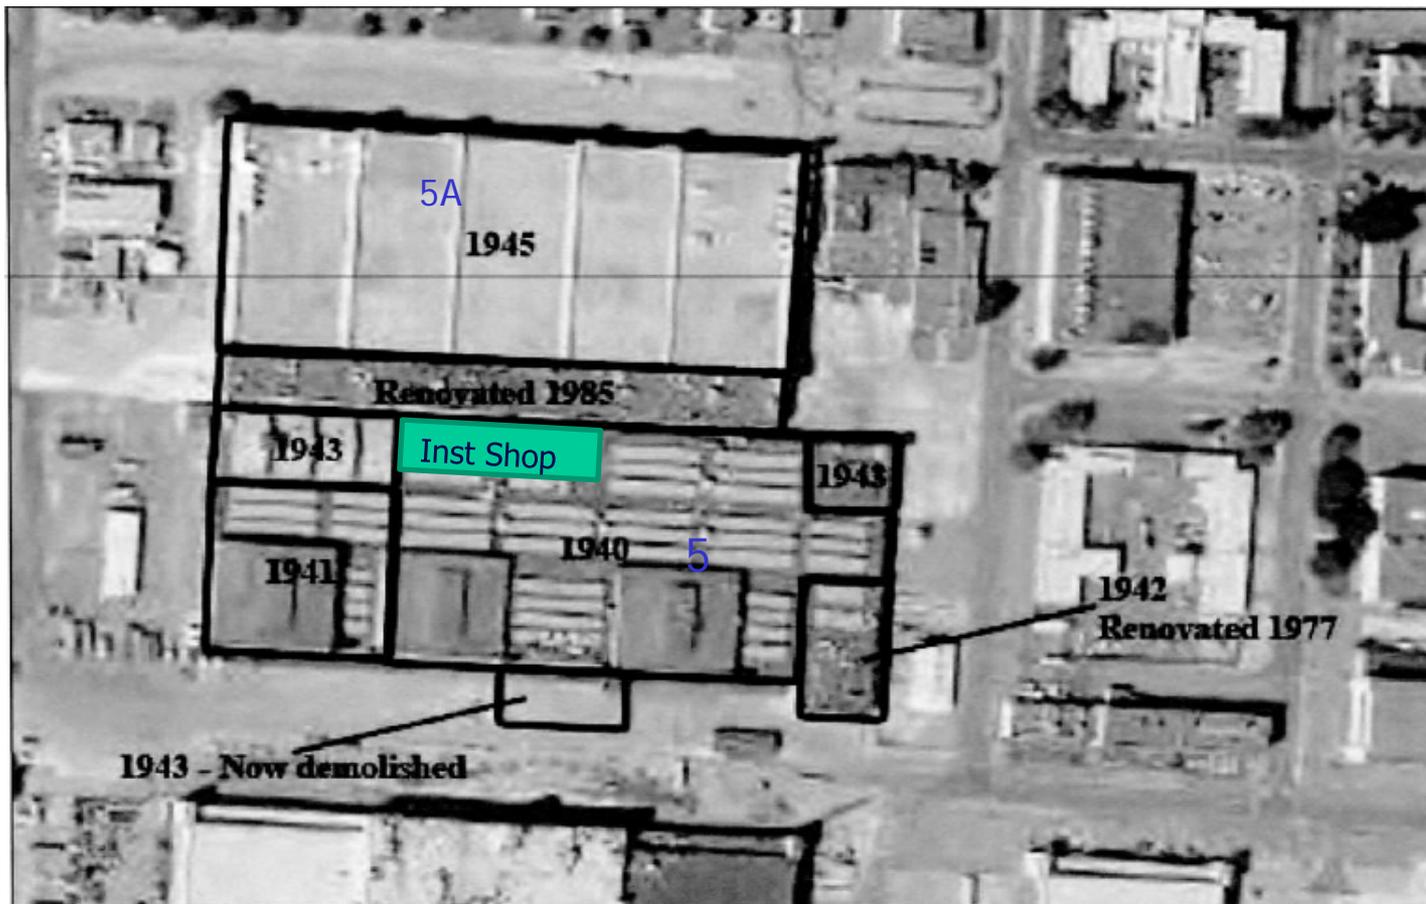
# Building 5/5A Construction Dates

**Diagram:** Showing the development of Building 5 and 5A. Construction dates for each section is given.

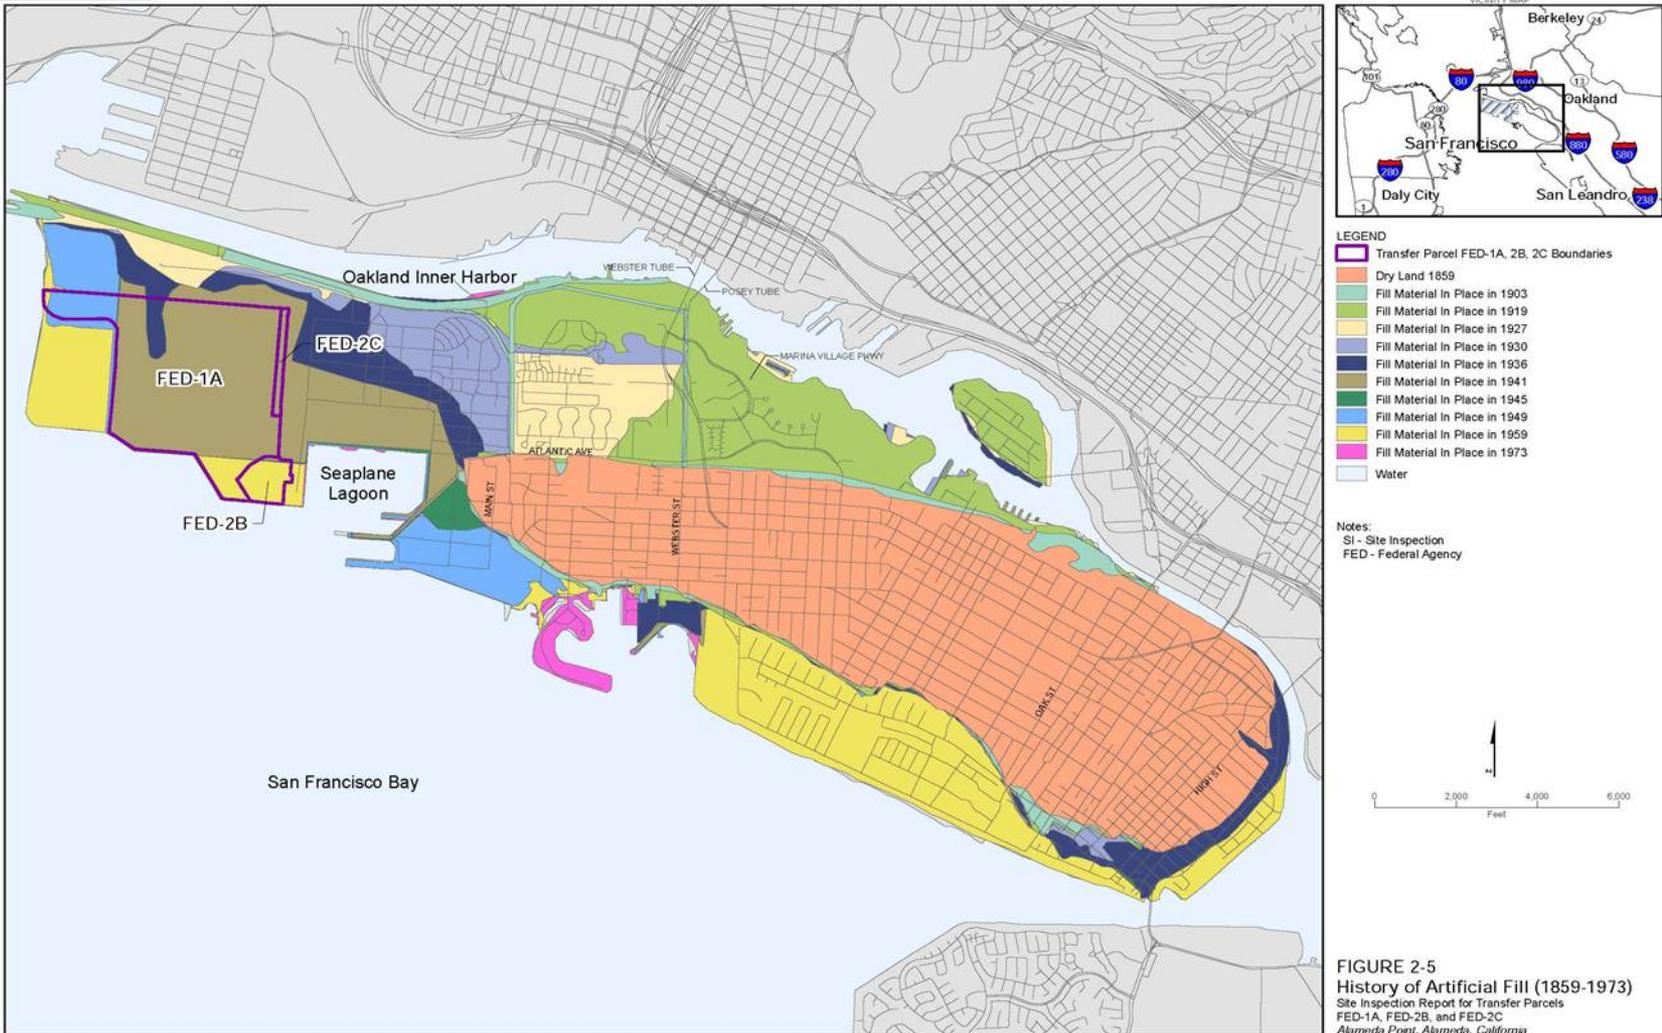
**FIGURE 2-5**  
 History of Artificial Fill (1859-1973)  
 Site Inspection Report for Transfer Parcels  
 FED-1A, FED-2B, and FED-2C  
 Alameda Point, Alameda, California

# History of Artificial Fill (1859-1973)
