Hunters Point Shipyard

FINAL **HISTORICAL** **RADIOLOGICAL ASSESSMENT**

History of the Use of General Radioactive Materials
1939 – 2003

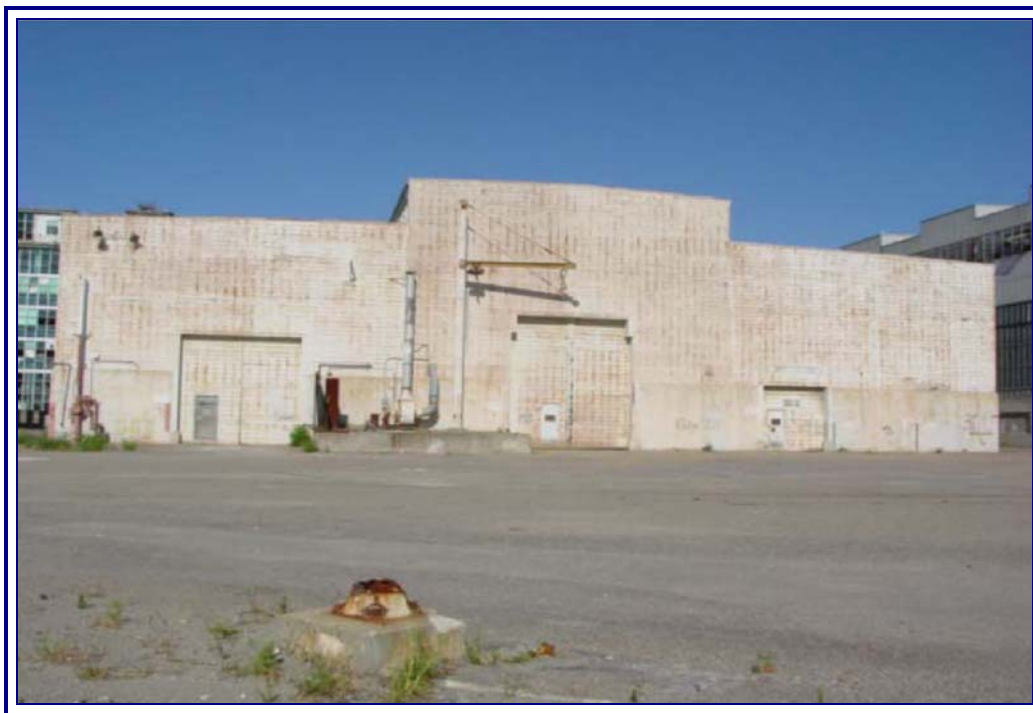
8.3.3.3 *Building 211*

Site Description: Building 211 is a three-story concrete-framed, curtain-walled building that was built in 1942 ([HRA-1118, p 92](#)). It is a large warehouse-type building, with a large gantry for craning materials to the upper stories. Building 211 is attached to Building 253 ([HRA-1118, p 94](#)). A building site plan is provided in [Figure 8.3.3.2](#) above.

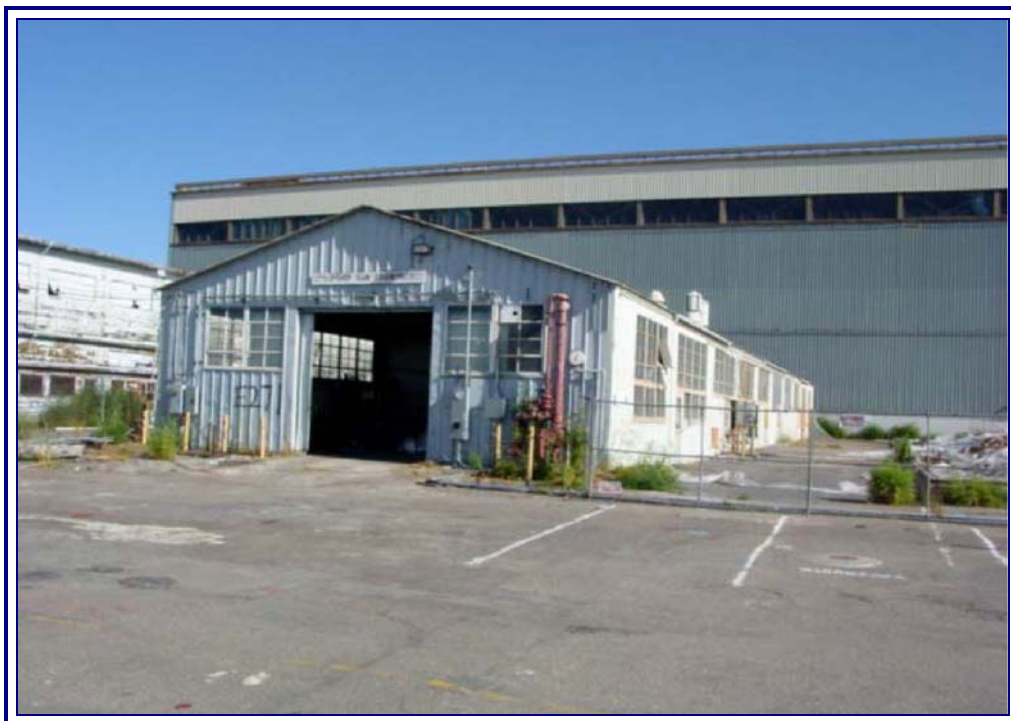
8.3.3.8 *Building 271*

Site Description: Building 271 is a single-width, metal-sided shop building that was built in 1947 and manufactured by the Butler Company or in the manner of Butler Company buildings. This prefabricated, standard building was used on military bases due to limited budgets ([HRA-1118, p 106](#)). A building site plan is provided in [Figure 8.3.3.8](#).

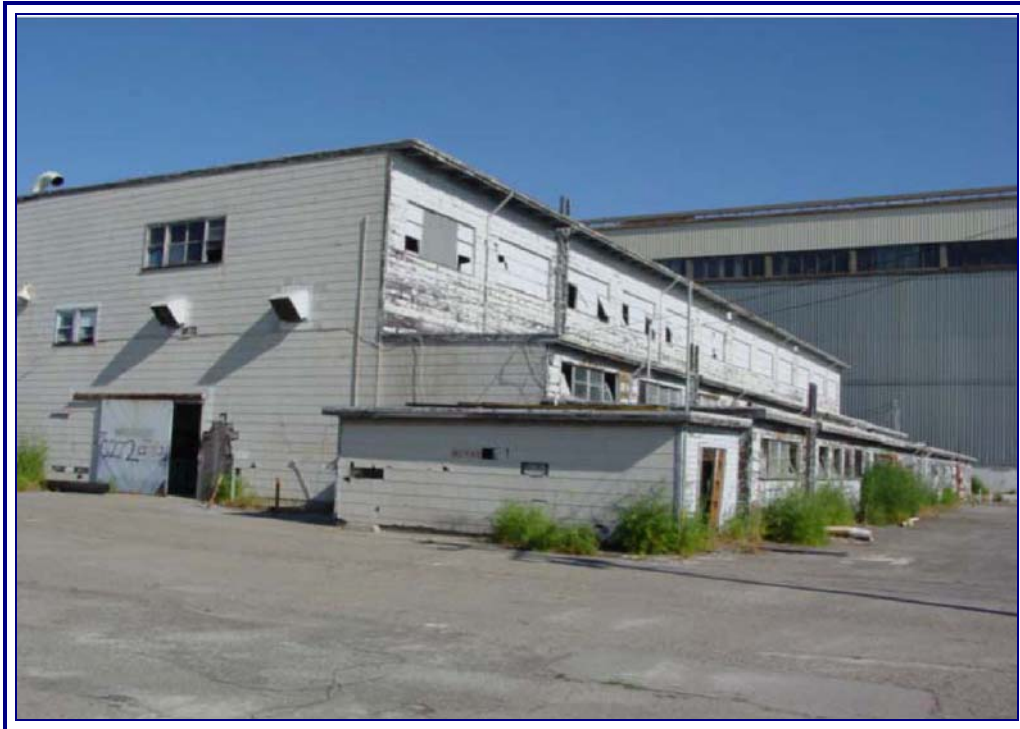
Site Description: Building 272 is a large wood-framed shop building that includes a shallow, almost flat, gabled roof with monitors and with shallow shed-roofed forms at either side. A building site plan is provided in [Figure 8.3.3.8](#) above.

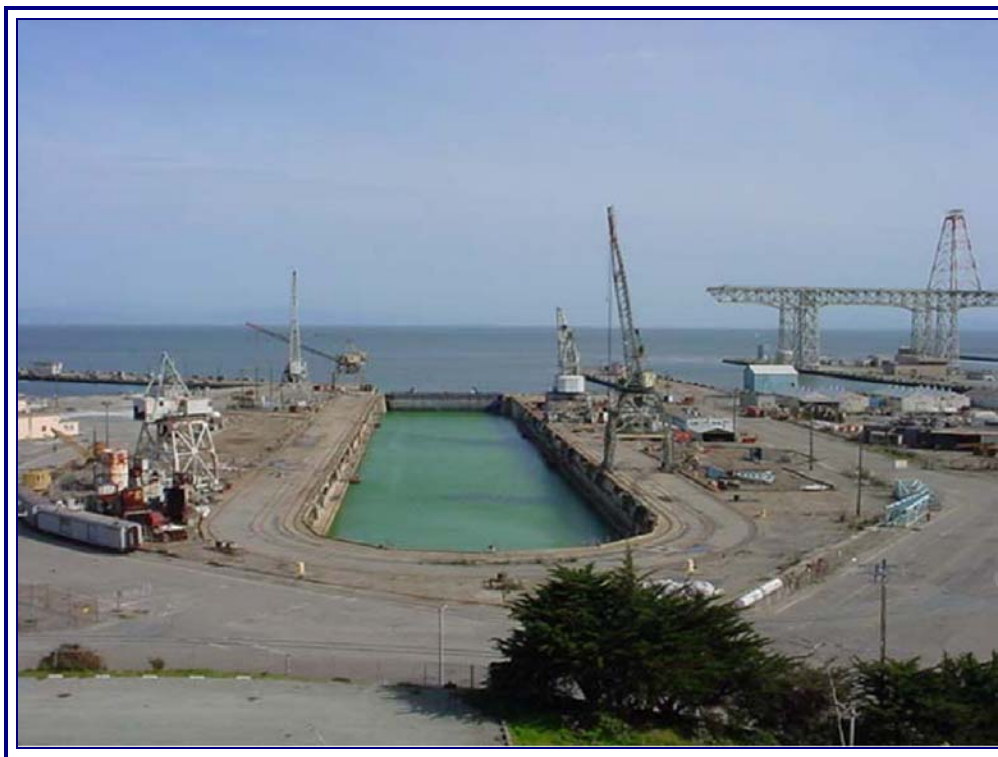
Site Description: Drydock 4 is a 1,092-by-143 foot, 53-foot-deep concrete graving drydock, with a rounded northwest end. Access steps are recessed into the wall, and the floor is flat, while the walls are slightly sloping. The drydock is outlined by a crane track that permits access to ships in the dock from all angles. Two or more smaller ships could be docked for servicing at the same time ([HRA-1117, pp 157-160](#)). A drainage system from the southeast corner of the drydock runs eastward to the Bay ([HRA-4691](#)). A drydock site plan is provided in [Figure 8.3.3.12](#).

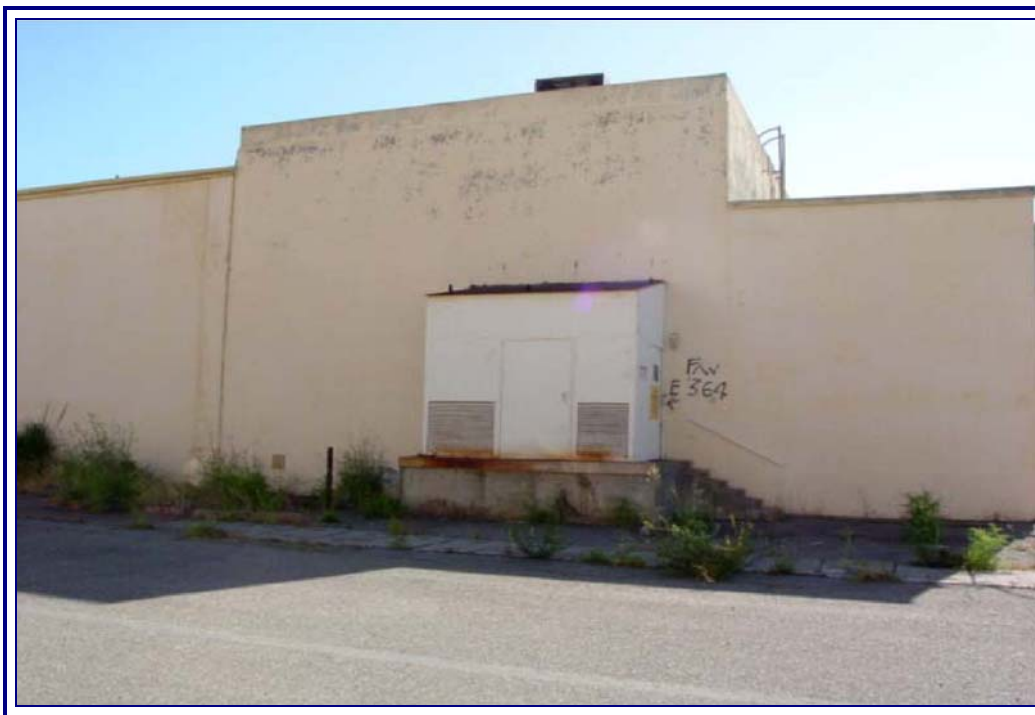
Site Description: Building 364 measures approximately 40 feet by 50 feet. A liquid radioactive waste collection area to the rear of the building contained a subsurface sump with a pumphouse on a concrete pad and two holding tanks. A building site plan is provided in [Figure 8.3.4.4](#) above, and a floor plan is provided in [Figure 8.3.4.8FP](#).

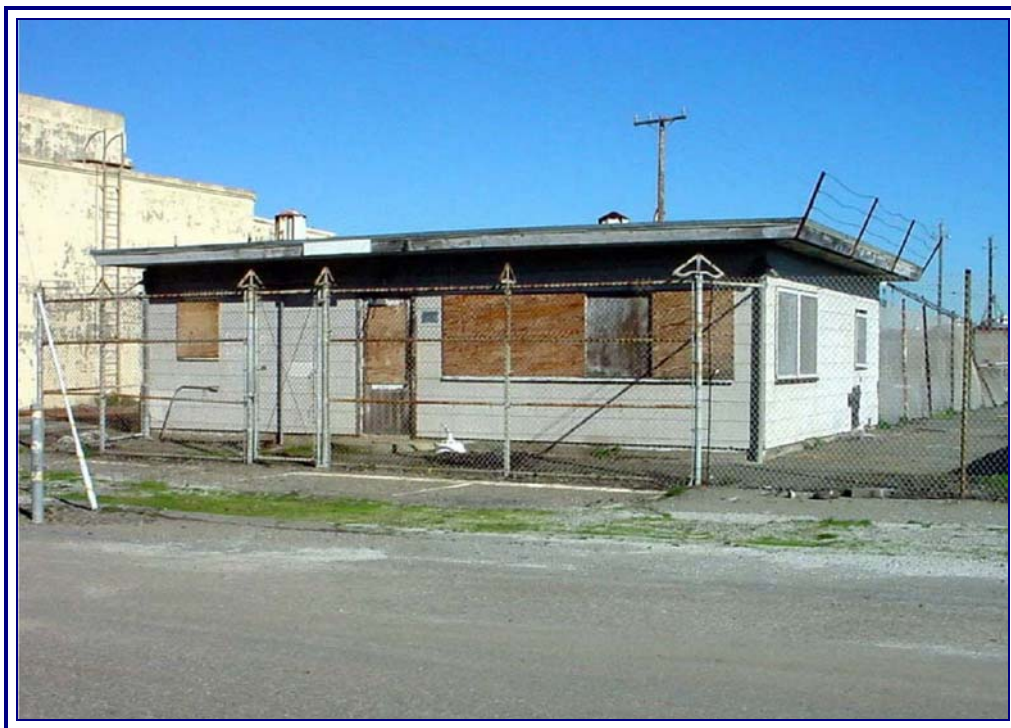
Site Description: Building 365 is a one-story wooden structure with a concrete foundation and measures 30 feet by 40 feet. A building site plan is provided in [Figure 8.3.4.4](#) above.

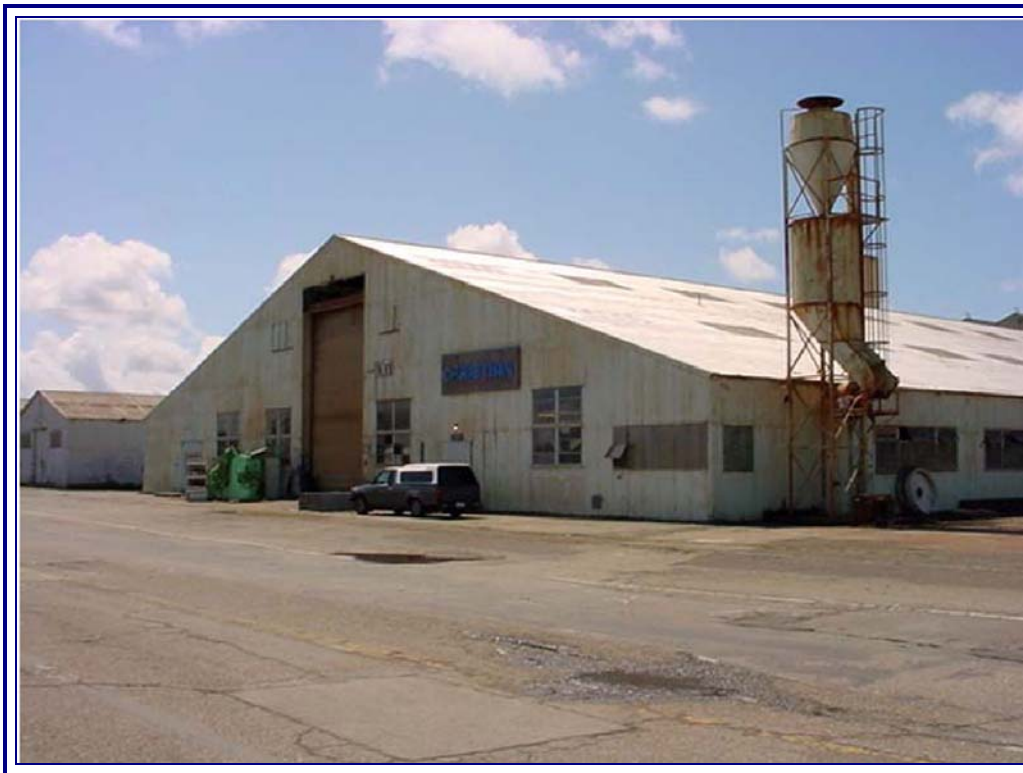
Site Description: Building 366 is a large corrugated metal, gable-roofed Butler-type structure, measuring approximately 280 feet by 130 feet. A building site plan is provided in [Figure 8.3.4.10](#).

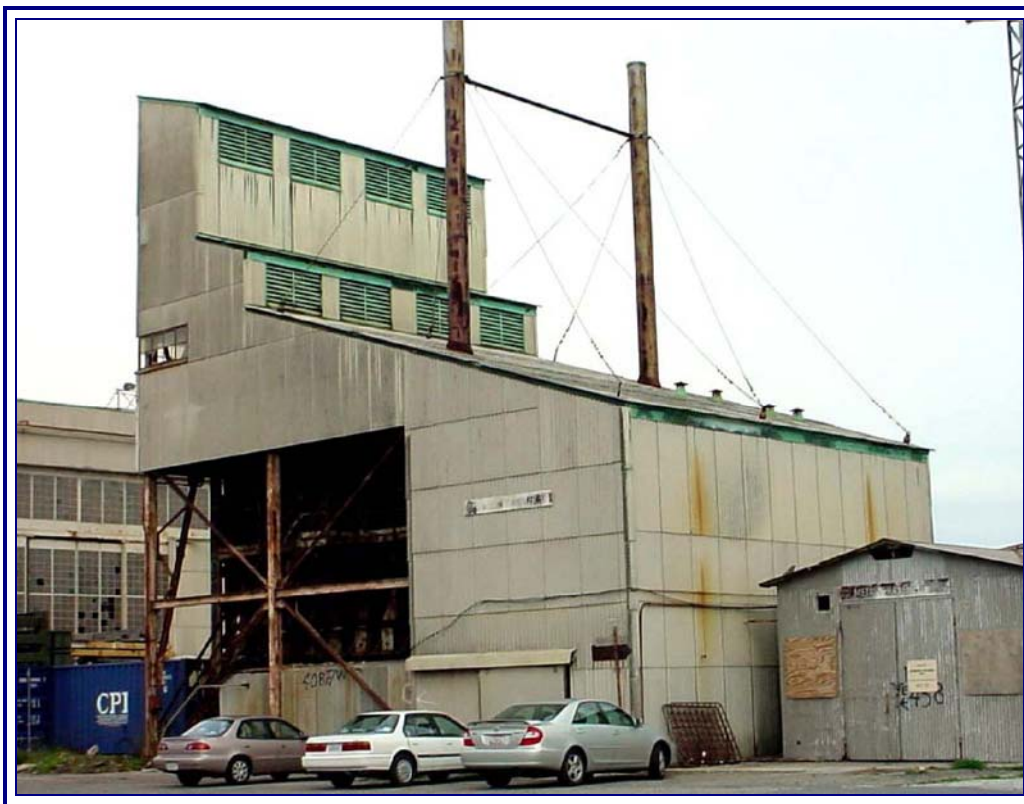
Site Description: Building 408 houses a furnace/smelter that was constructed in 1947. The building is the equivalent of three stories at its northern side, dropping to one story at the south. It is open-sided on the north. Most of the east and west sides are sided in transite, a corrugated asbestos-concrete material. A firebrick-lined hearth occupies most of the open area at the north. Natural gas burners exist on the east and west sides of the hearth. A pair of smokestacks extends from the lower rear segment of the building. A building site plan is provided in [Figure 8.3.4.12](#).

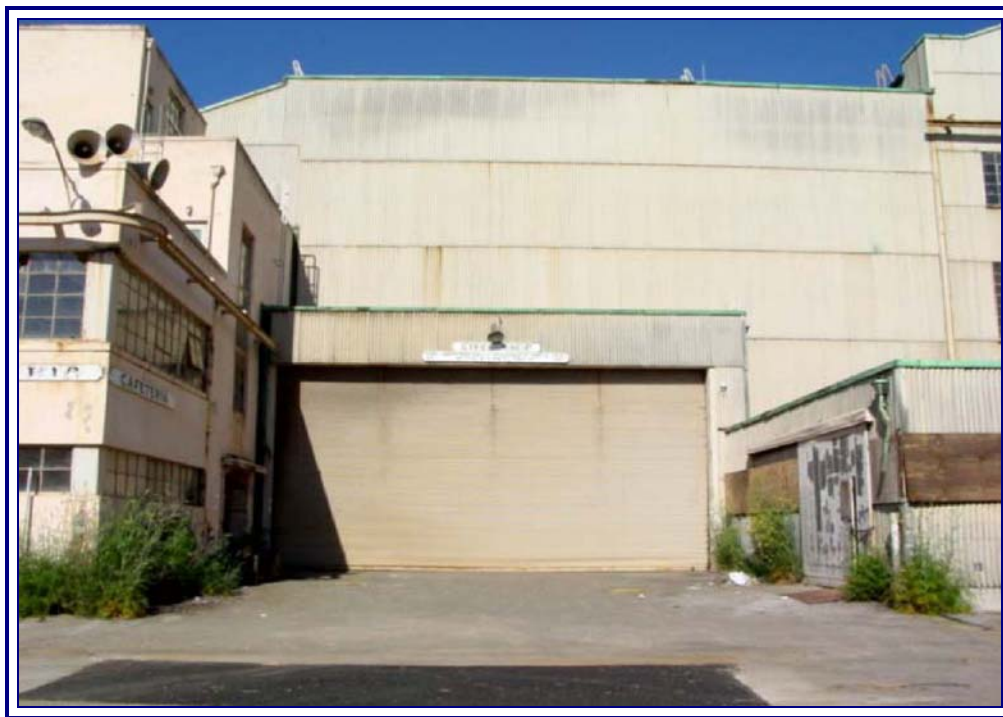
Site Description: Building 411 is a large curtain-walled, steel-framed building with a flat roof, located in the southern waterfront area. The building includes a saw-toothed series of rooftop monitors as well as bands of steel industrial sash and large glazed industrial doors. The building has two levels, with a taller segment to the north ([HRA-1118, pp 143-145](#)). A building site plan is provided in [Figure 8.3.4.12](#) above.

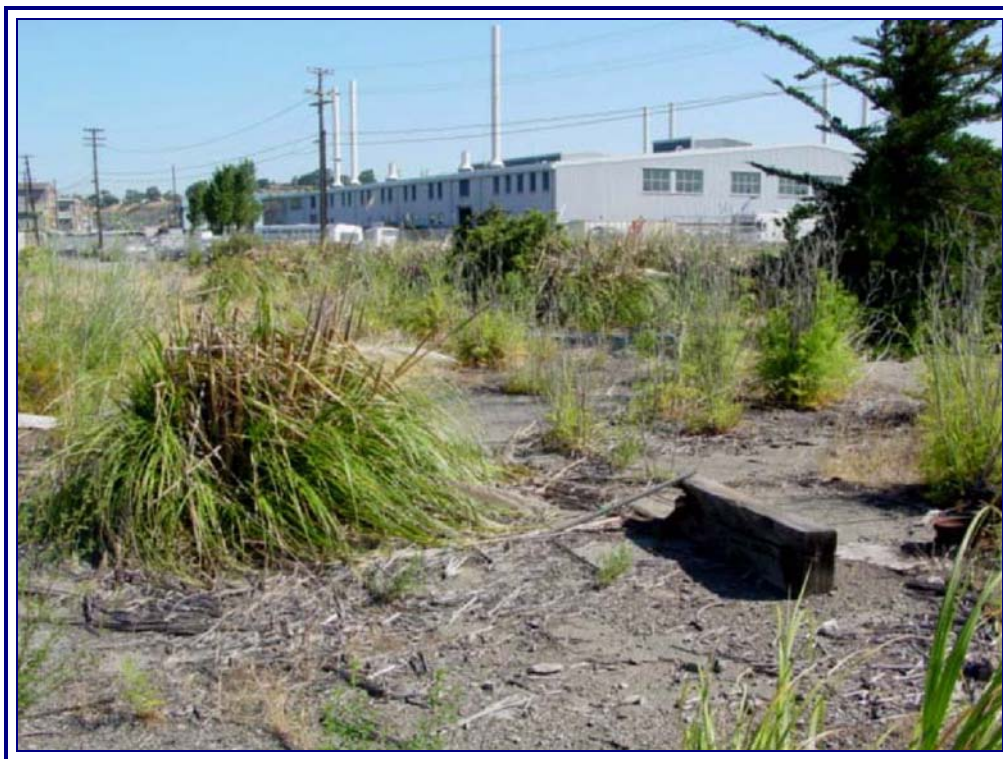
Site Description: From correlations of available historical maps, the former Building 506 was irregular in construction and measured 9,375 square feet at the foundation. A site plan is provided in [Figure 8.3.5.3](#) above, and a floor plan is provided in [Figure 8.3.5.4FP](#).

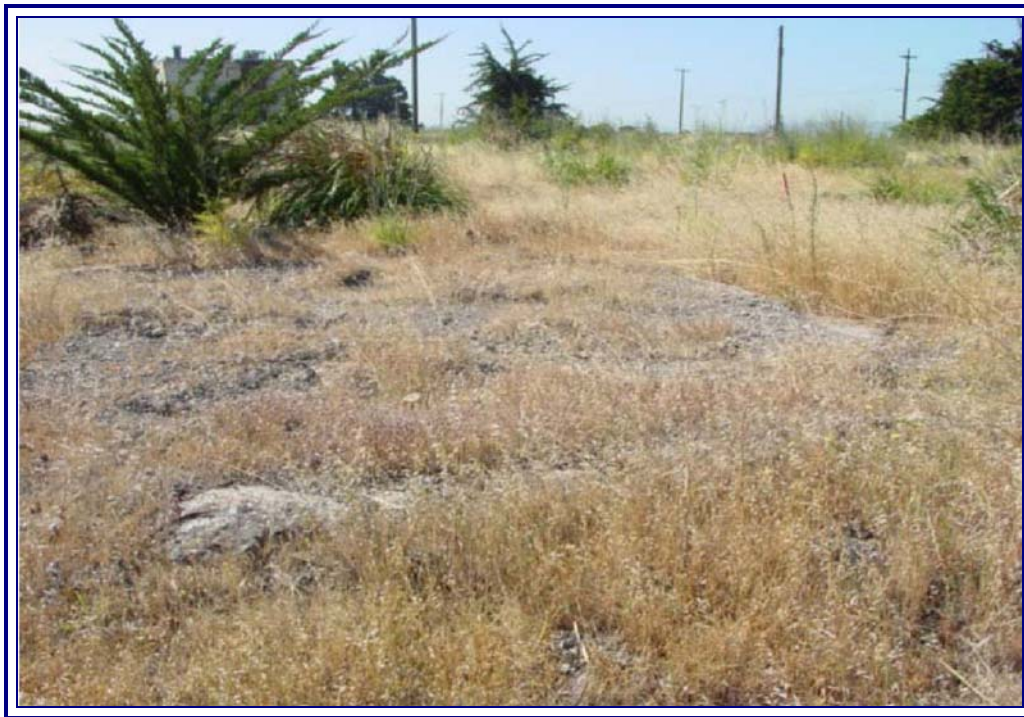
Site Description: The original Building 529 measured 17 feet by 29.5 feet. It included an underground isotope storage vault and waste sump. A site plan is provided in [Figure 8.3.5.3](#) above, a floor plan is provided in [Figure 8.3.5.13FP](#), and a plot plan is provided in [Figure 8.3.5.13PP](#).

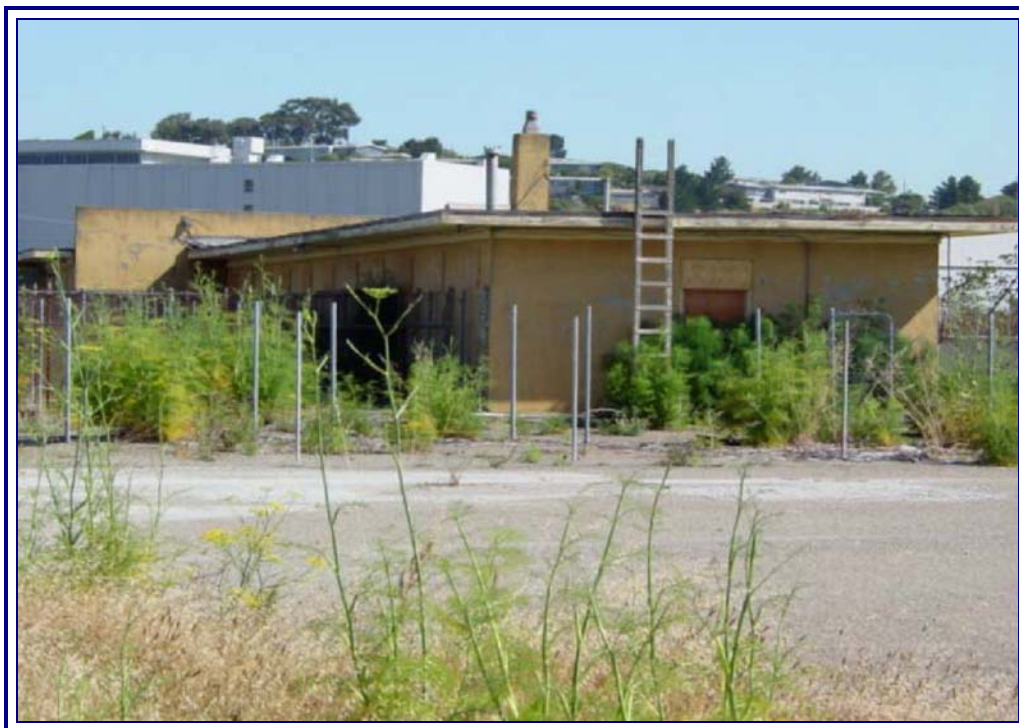
Site Description: Building 707 is irregular in construction and measures approximately 13,000 square feet, including kennels. A site plan is provided in [Figure 8.3.5.15](#) above, and a floor plan is provided in [Figure 8.3.5.17FP](#).

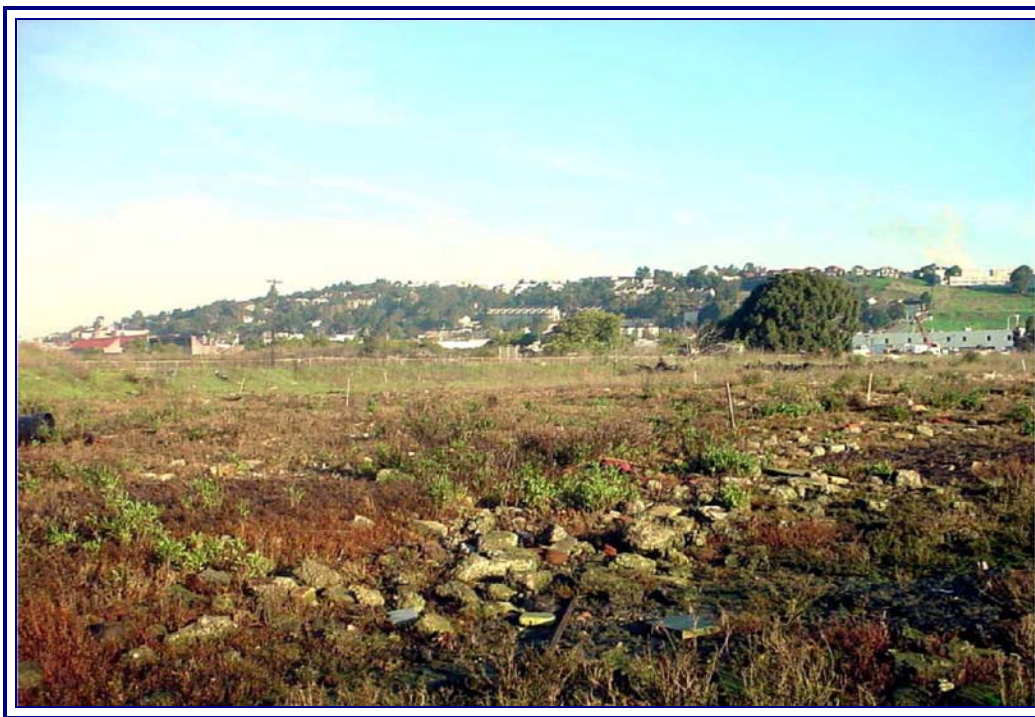
Site Description: An open field area located on the southwest end of IR-01/21 (HRA-4506). The site has three parts: a fan-shaped, post-exposure reflection/refraction field, measuring 150 feet in radius; a 60-by-35-foot site designated Area A; and a 60-by-50-foot area designated Area B. Site was enclosed on the west side by a soil berm (HRA-26, p 11). It was also known as the South Gate Range. A site plan is provided in Figure 8.3.5.27.

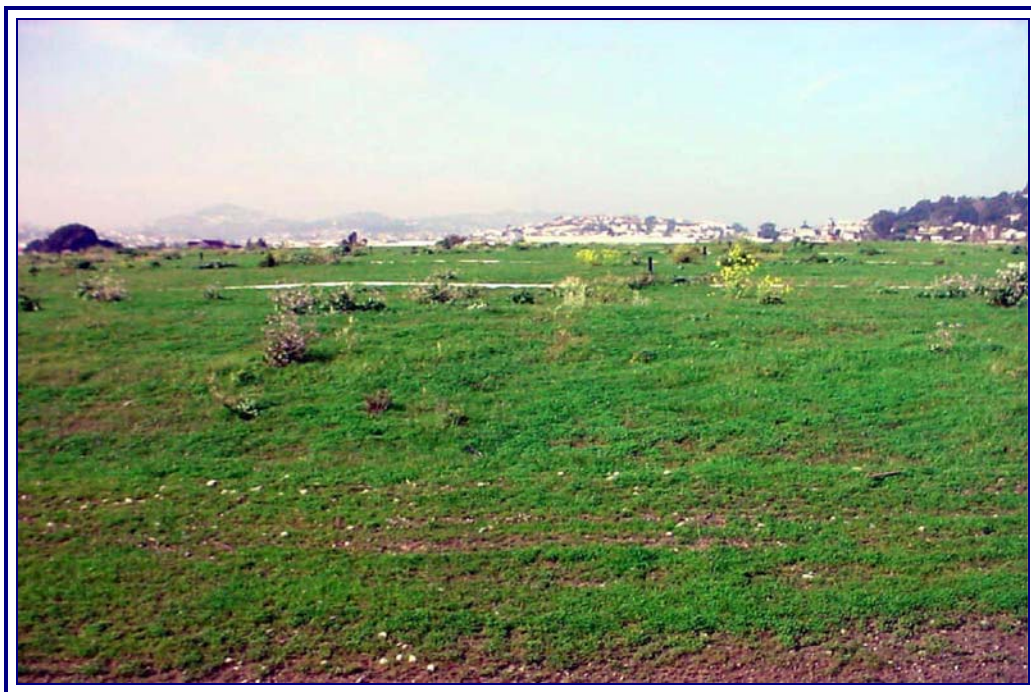
Site Description: Irregular land area, measuring approximately 1,525,000 square feet, 120 feet southeast of Building 820, 80 feet south of Building 830, 150 feet southwest of Building 810, and immediately west and adjacent to IR-02. A site plan is provided in [Figure 8.3.5.28](#).

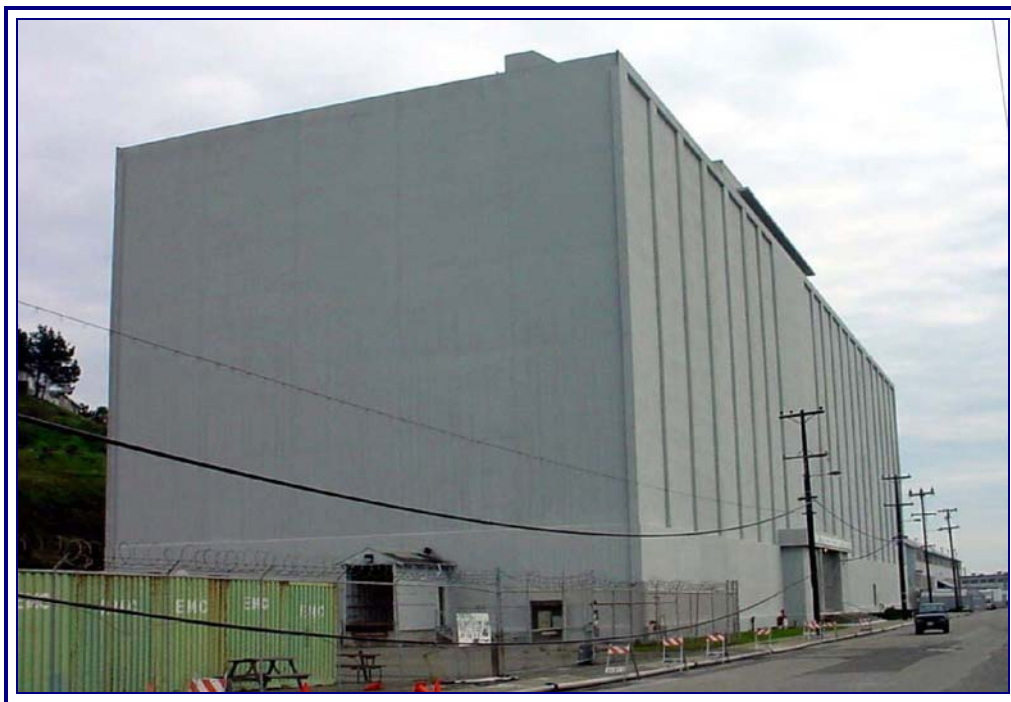
Site Description: A seven-story flat-roofed steel and concrete structure built in the early 1950s as NRDL's main research facility and headquarters ([HRA-1633](#); [HRA-2036, p 1](#)). NRDL occupied the building from 1955 ([HRA-235](#); [HRA-2427](#); [HRA-2466](#)) through its closure in 1969 ([HRA-413](#); [HRA-2918, p 1](#)). The entire building was classified as a restricted area. Generally, each floor of the facility was occupied as follows ([HRA-599, p 2](#); [HRA-2772, pp 4-9](#); [HRA-2910](#); [HRA-2918, p 2](#); [HRA-2927](#)):
