Hunters Point Naval Shipyard Radiological Program Update

HPS CAC Meeting September 11, 2017

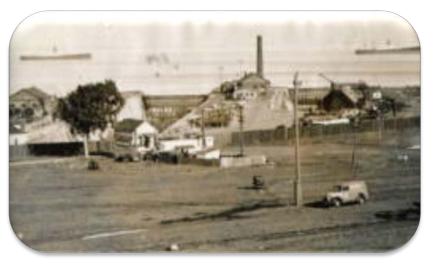
HPNS dry docks (1940)

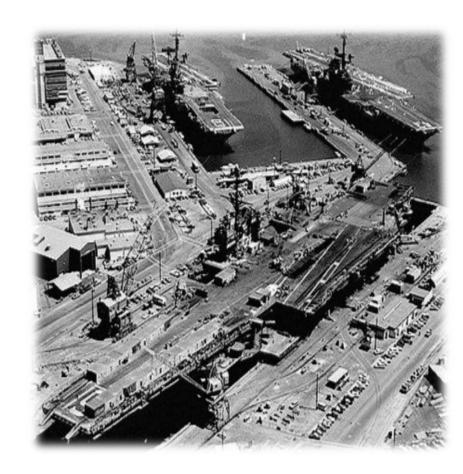
Where are the potentially contaminated areas at HPNS?

- Buildings with historical radiological use
- Sanitary sewer and storm drain lines (removed)
- Former disposal/burial areas
- Piers and ship berths
