Parcel E (Site 03) Treatability Study and Parcel C Remedial Action

Hunters Point Naval Shipyard

**Community Meeting
December 3, 2014**

Parcel E, Site 03 Treatability Studies

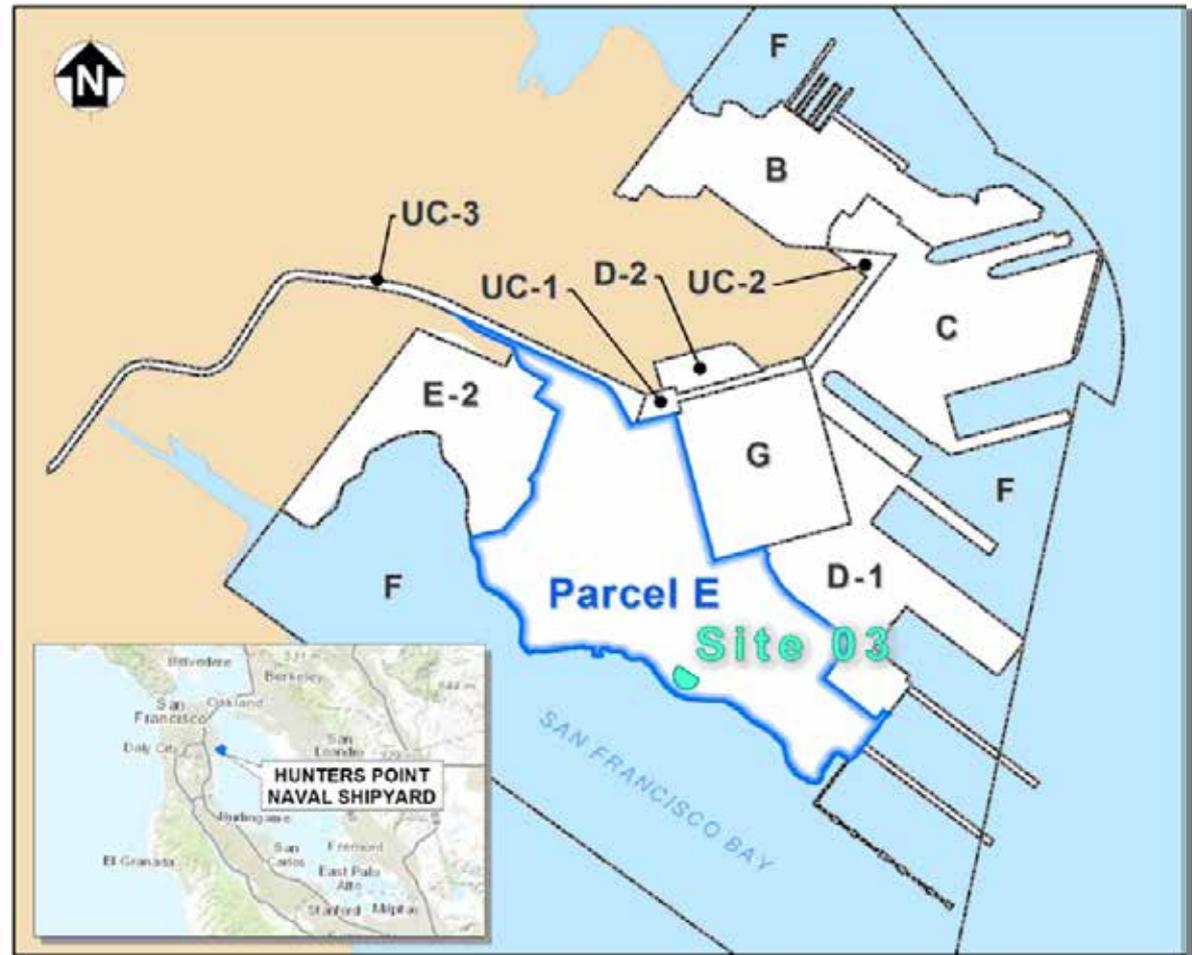
Location of Site 03

- Site 03 is part of Parcel E
- Located in the southwest part of Hunters Point Naval Shipyard
- Includes about 1 acre
- 30 feet from the SF Bay

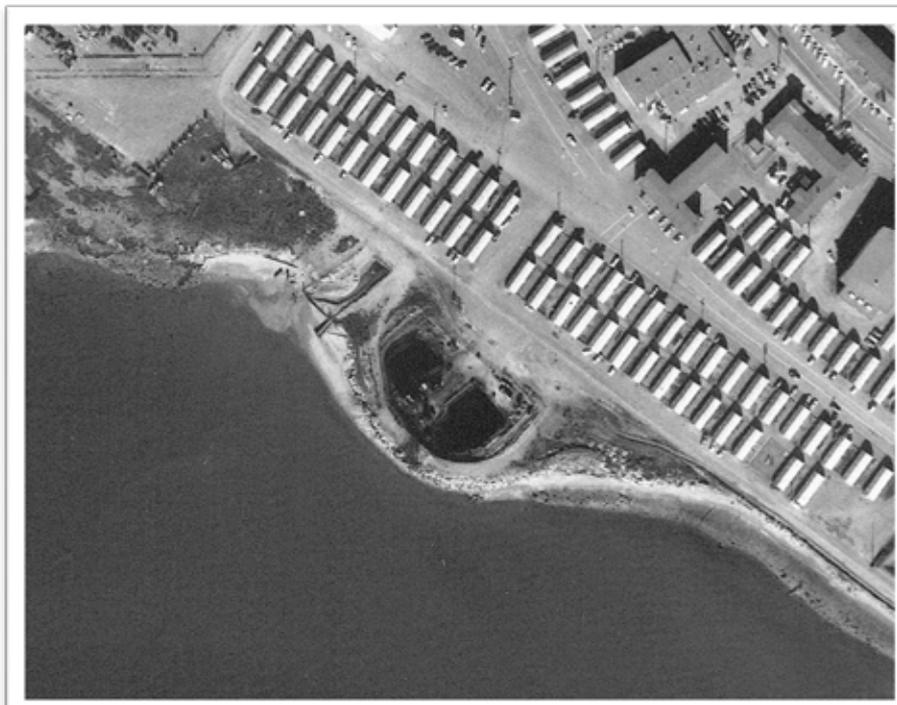
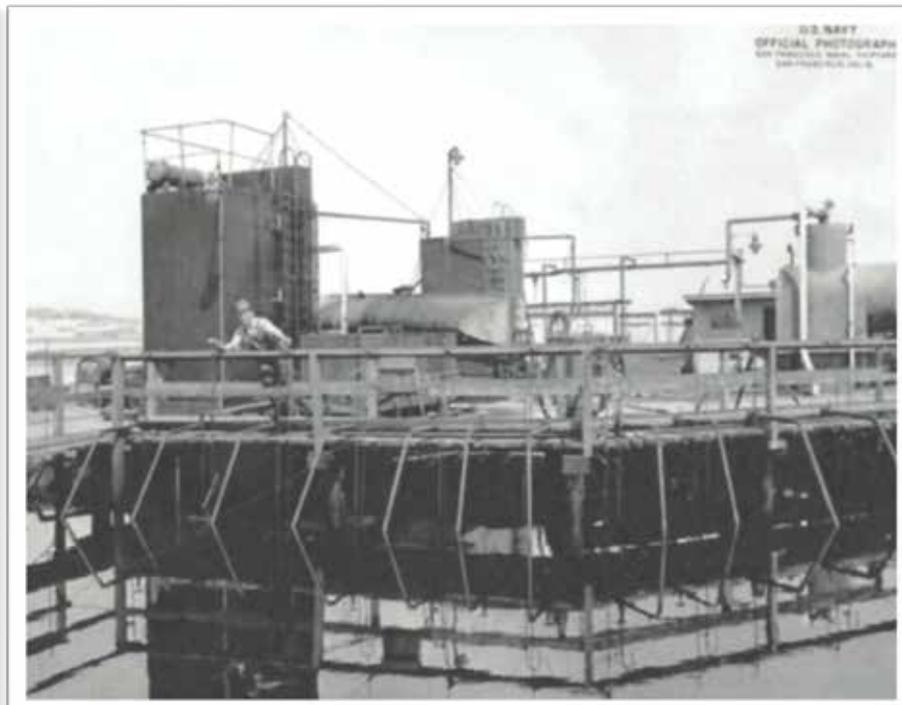
History of the Site 03

- Operation of Oil Reclamation Ponds from 1944 to 1974
- Two unlined ponds with a combined capacity of 440,000 gallons
- Filled in with soil after the recycling operations ended

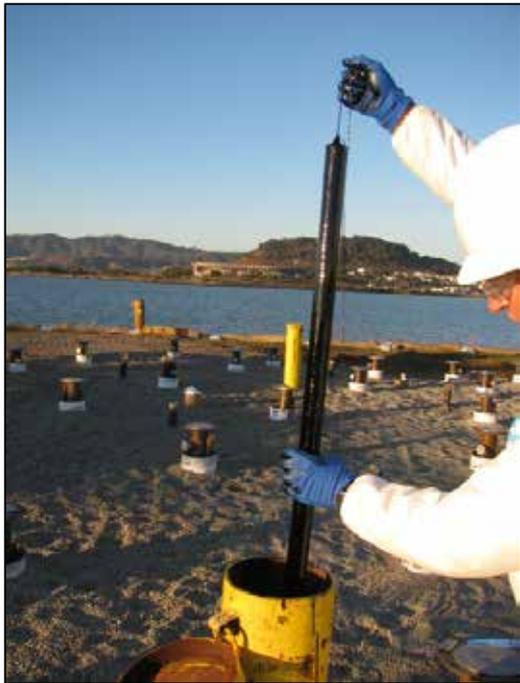
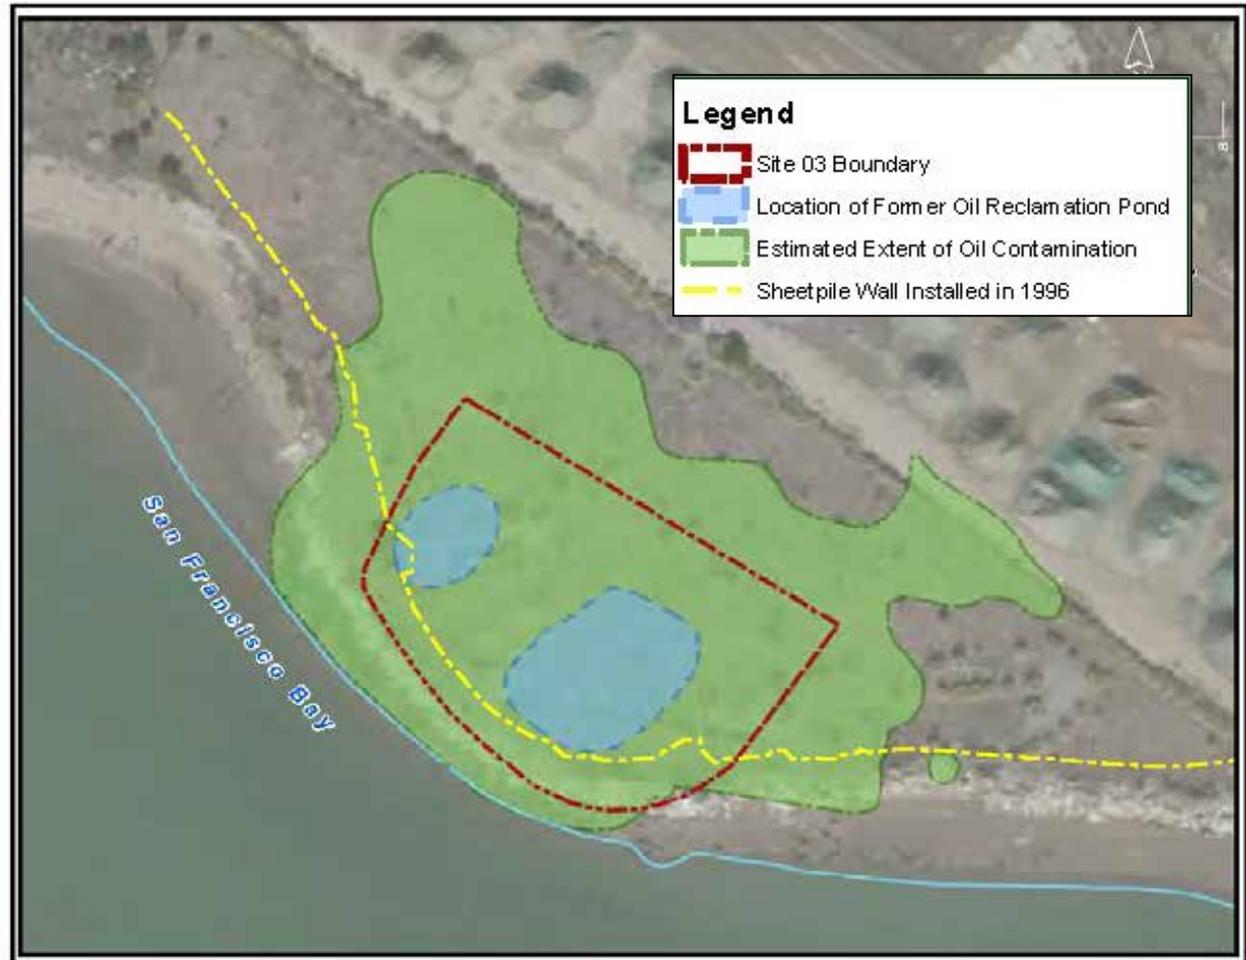
Oil Contamination at Site 03

- Oil leaked from the ponds, contaminating soil and groundwater

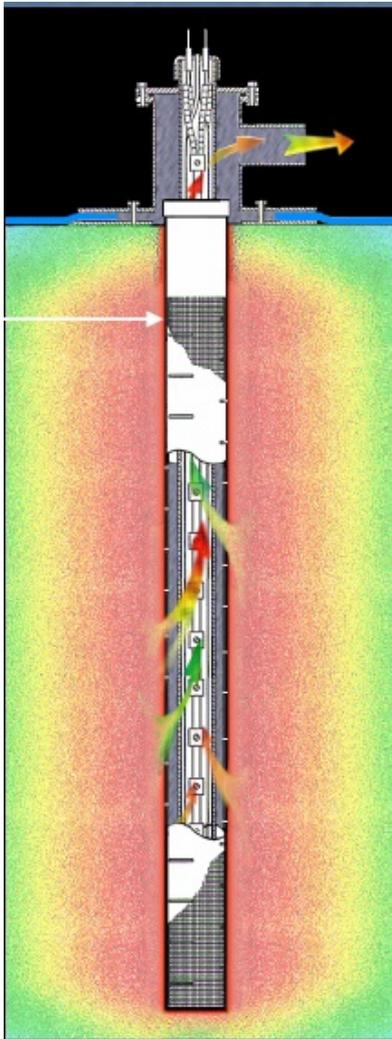
Thermal Remediation

- **Oily Waste is too thick to remove at normal temperatures**
- **Heating to 100°C makes the oily waste more fluid**
- **Contamination is collected and treated above ground**

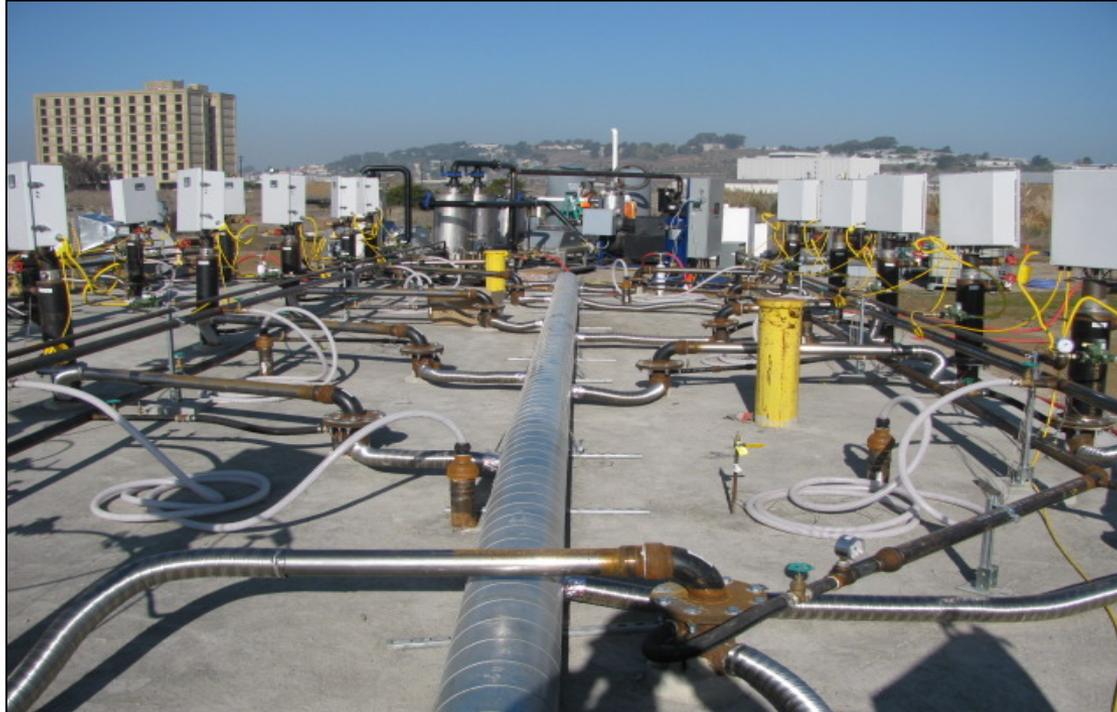
Thermal Remediation Treatability Study

- **46 Heater Wells**
- **14 Groundwater Extraction Wells**
- **46 Vapor Extraction Wells**
- **7 Groundwater Injection Wells**
- **10 Temperature/Pressure Monitoring Points**

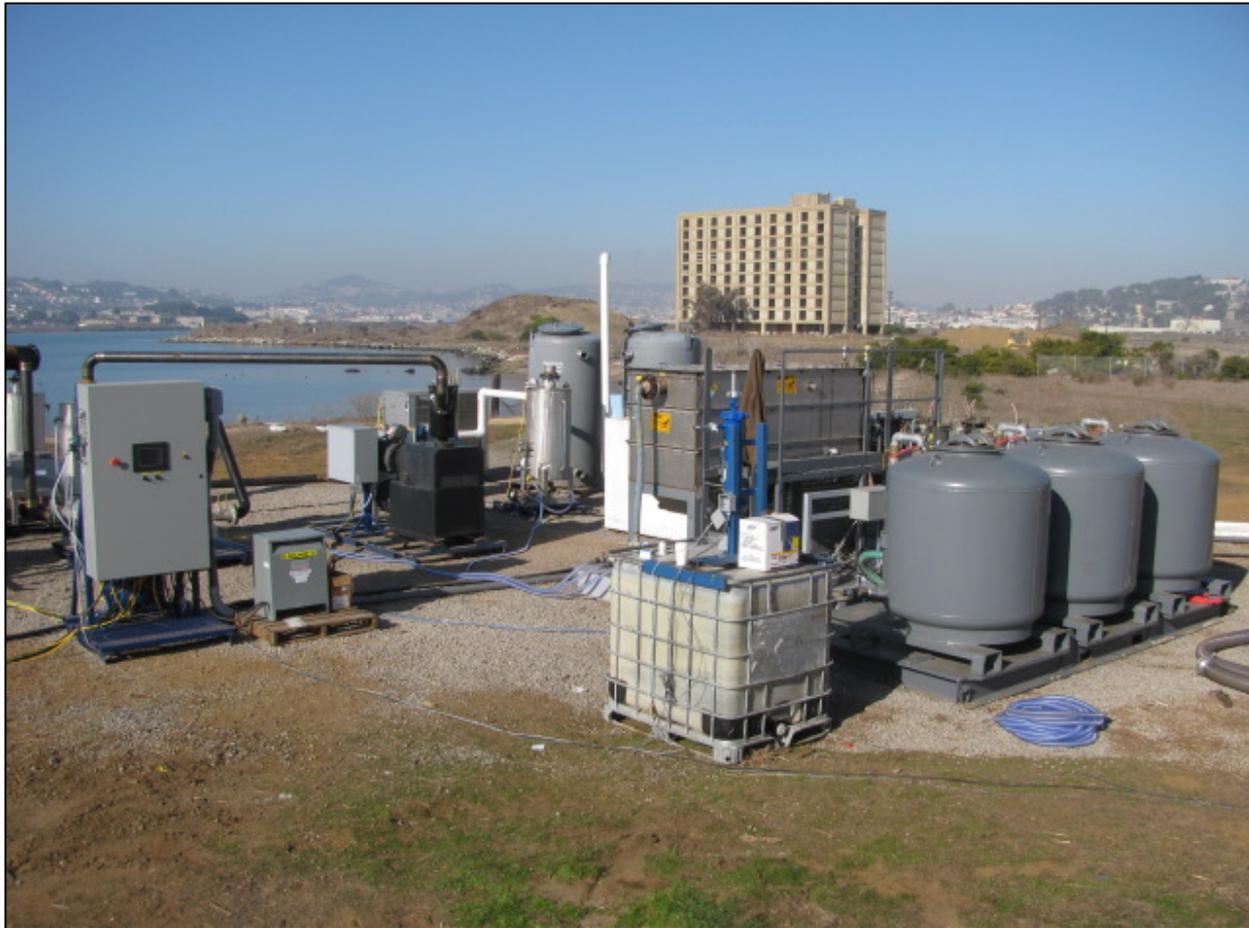
Thermal Remediation Treatability Study

Groundwater and vapor was collected and treated above ground

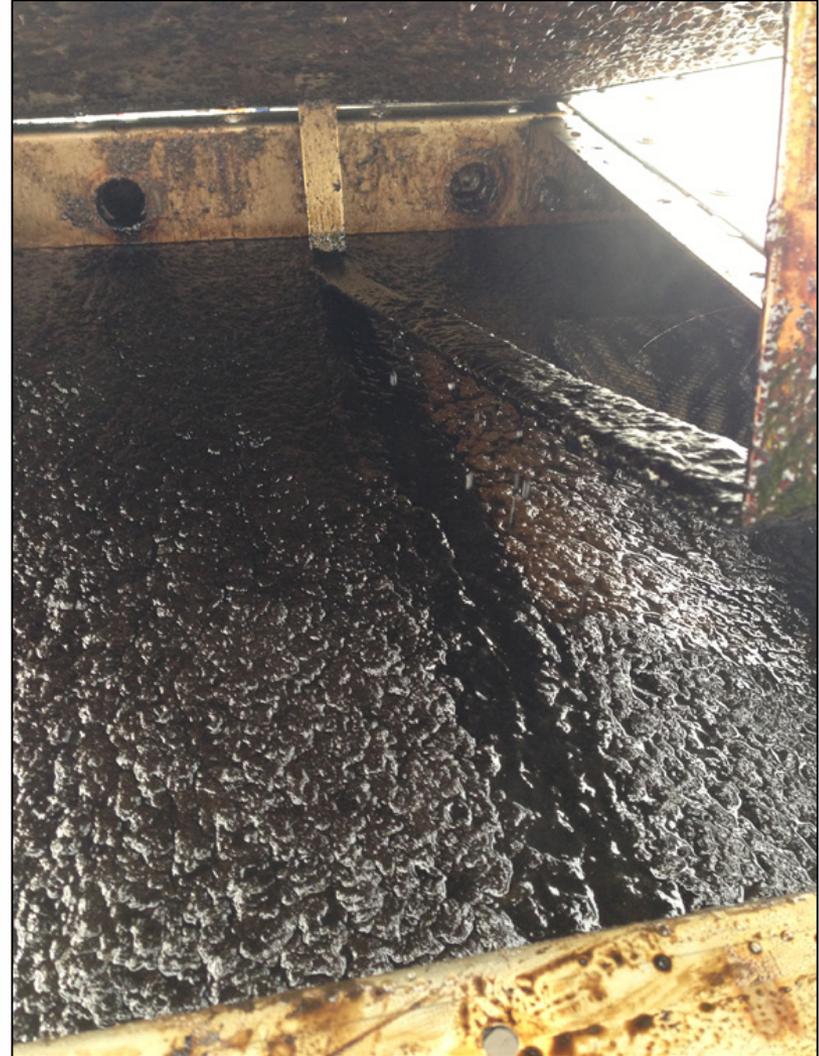
Thermal Remediation Treatability Study

- **Operations lasted 5 months**
- **Recirculated more than 800,000 gallons of groundwater**
- **Collected 2,400 gallons of oily waste**

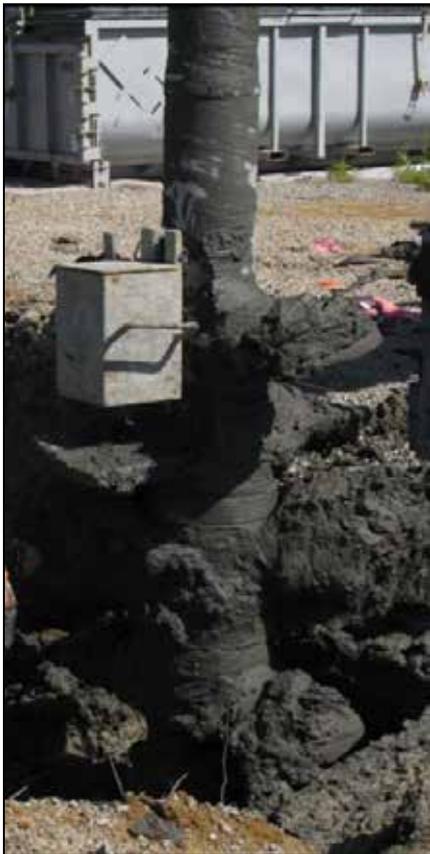
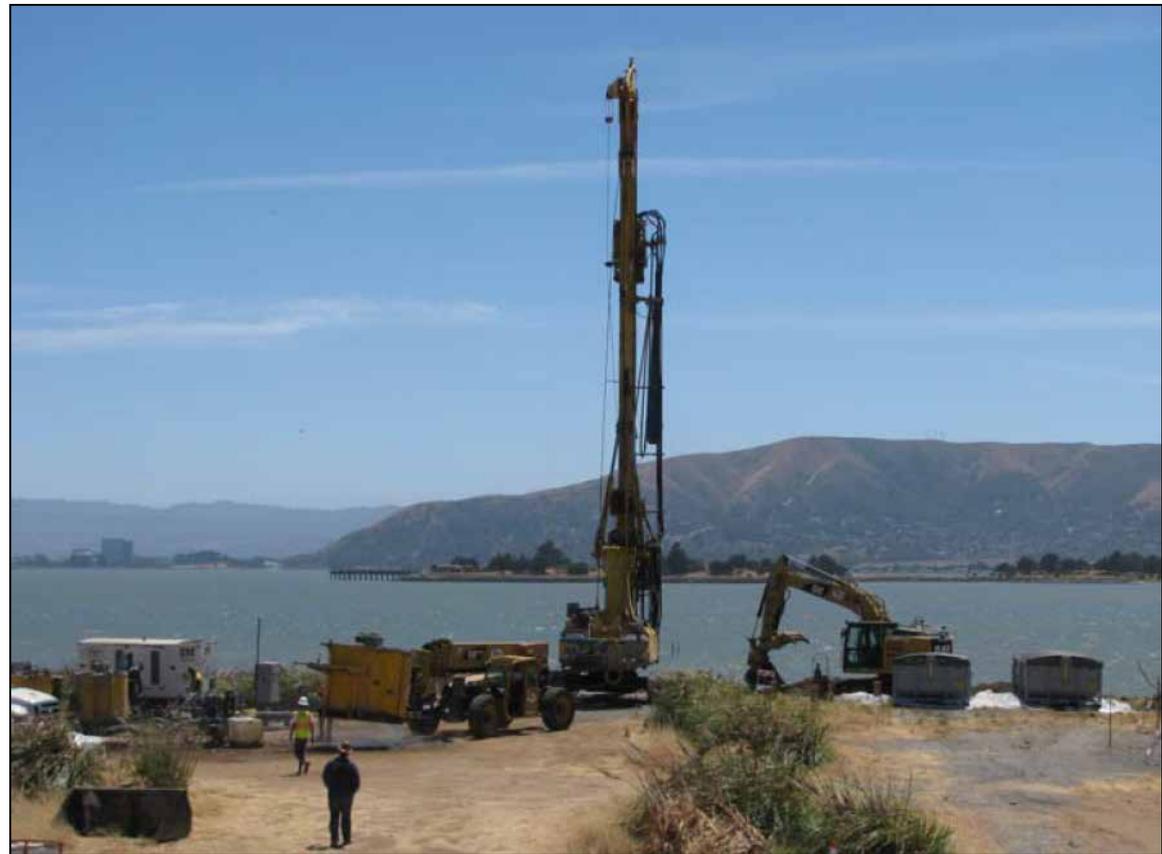
Solidification/Stabilization Treatability Study

- Mixed mud, bentonite and cement to trap oil in place
- Installed 5 columns, each 3 feet in diameter

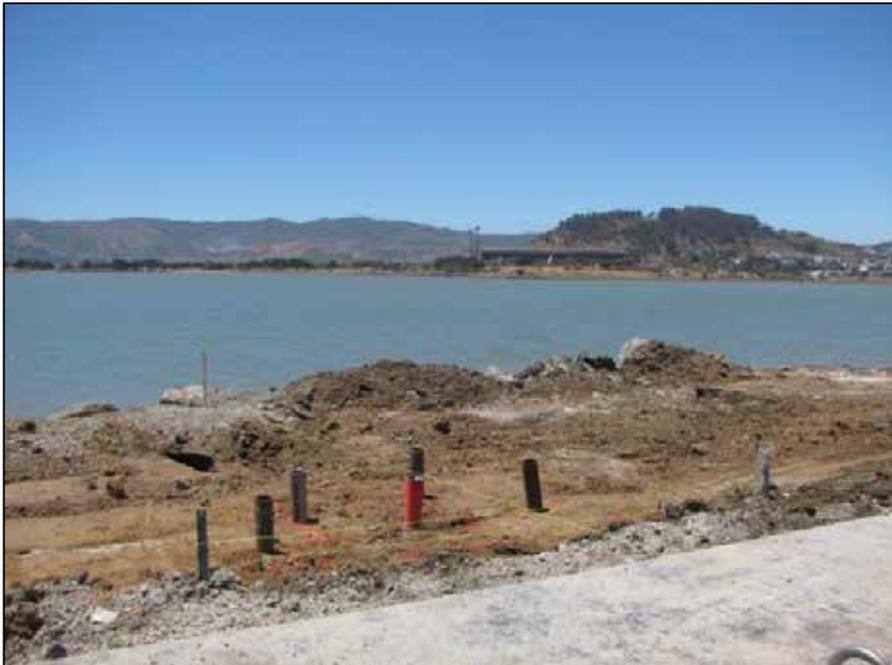
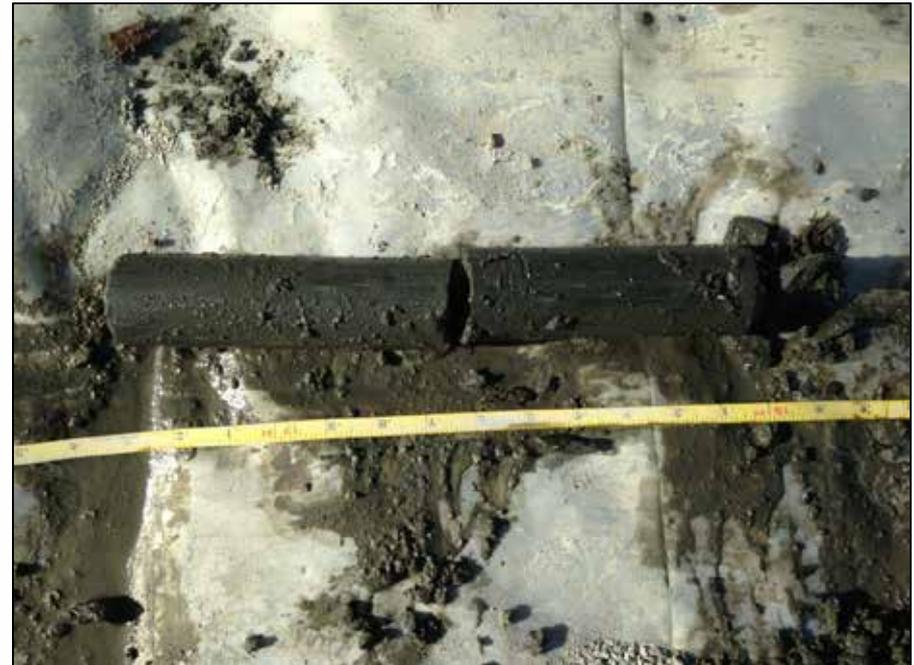
Solidification/Stabilization Treatability Study

- **Completely mixed contaminated soil with a cement mixture**
- **Columns extend to 44 feet below ground surface**
