# **FINAL MARE ISLAND NAVAL SHIPYARD Restoration Advisory Board (RAB) Meeting Minutes**

**HELD THURSDAY, March 24, 2016**

## **II. PRESENTATION (Nicholas Shih [Navy]) *Paint Waste Area and Vicinity Remedial Investigation Results***

# Presentation Overview

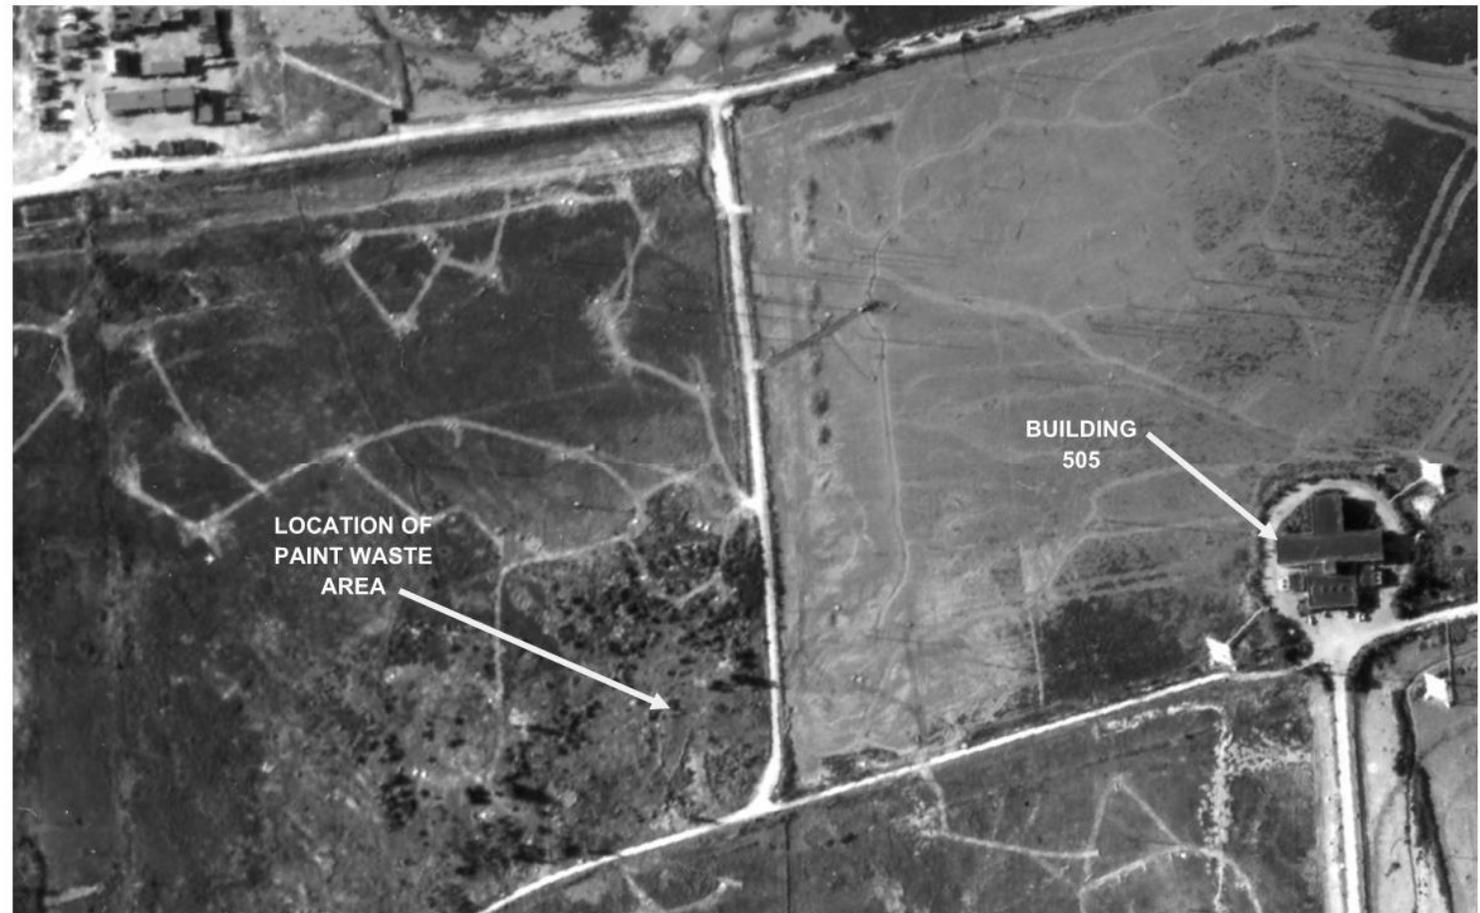
- 2002 US Fish and Wildlife Service survey led to discovery of paint waste area
- Paint waste area most likely a result from dumping by shipyard personnel from nearby paint manufacturing facility (Building 503)
- 1949 aerial photograph shows disturbed/upland area
- Landfill opened in the late 1940s

This aerial photograph was taken in 1949. You can see the paint waste area looks a lot different from the surrounding area, and has indications that it looks disturbed, and that it may even look topographically higher than the surrounding area.

The reason why it may look like this is that the area could have been built up by deposition of material creating an upland area. It is also important to note that at the time when the photograph was taken in the late 1940's, the site landfill was in its initial stages of use; so it could be deduced that the site appears overgrown with vegetation because waste was no longer being deposited at the site as the landfill site became available.

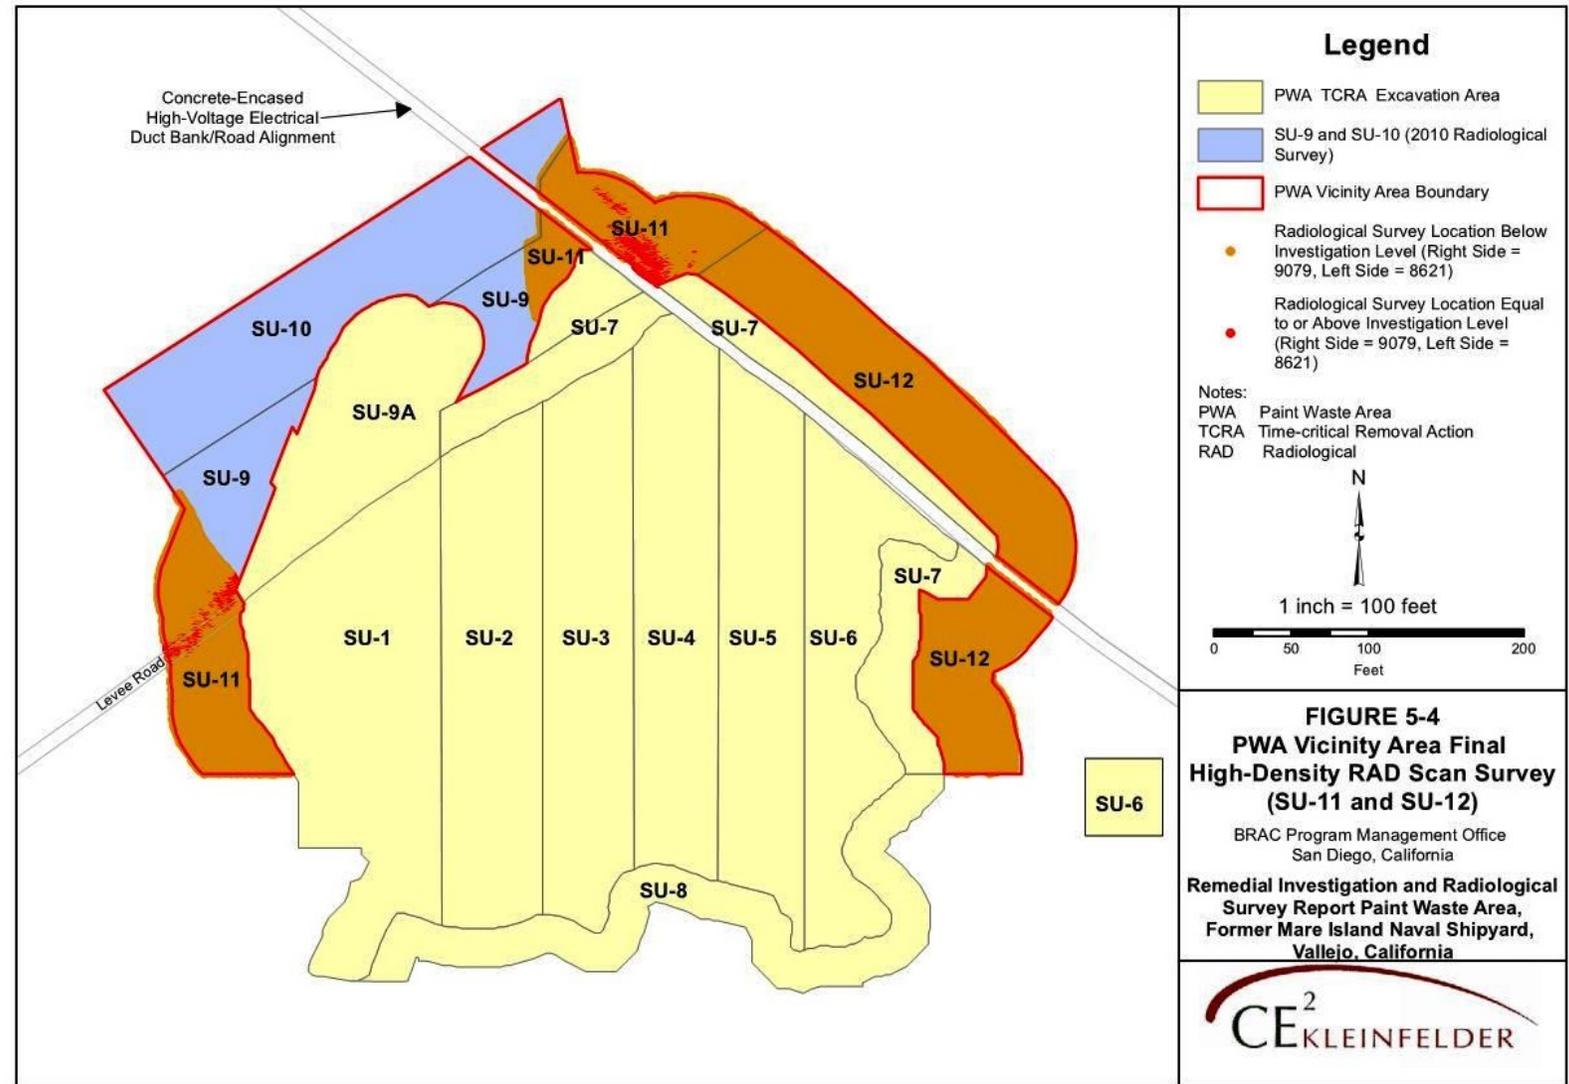
- No radiological items were encountered in survey units 11 and 12 or in the subsurface trenches
- Radiation survey measurements in the subsurface trenches were below the investigation level
- Naturally occurring potassium isotope K40 is present
- Radioactive elements were not detected above the project action limit in any of the 30 soil samples

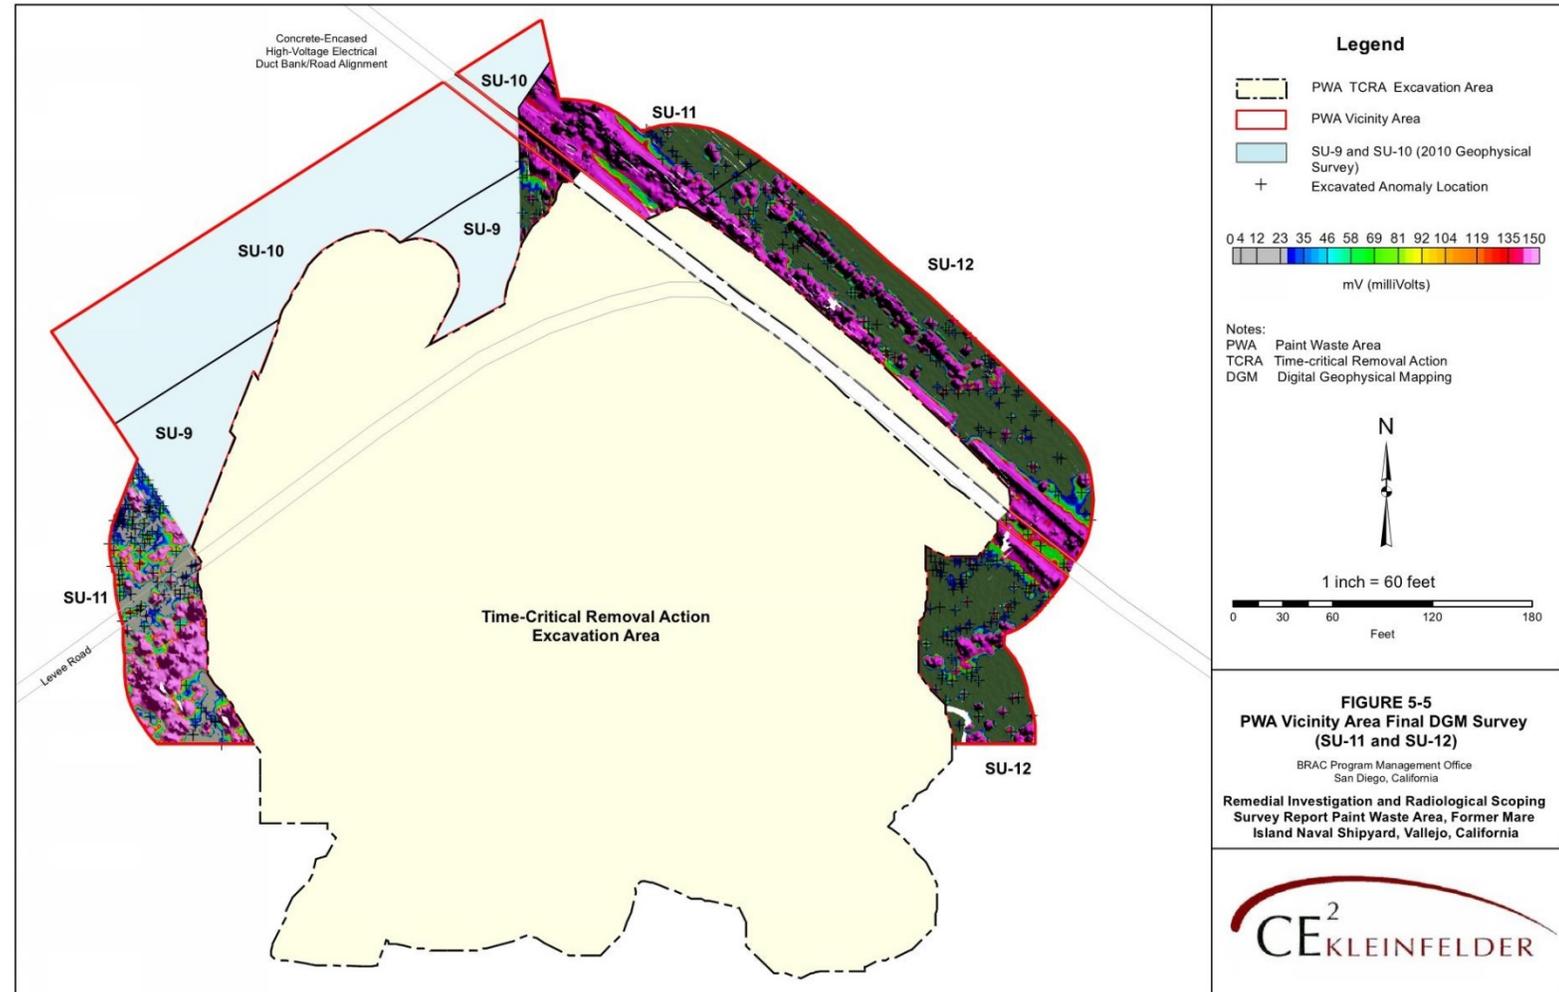
- No munitions and explosives of concern or material designated as safe were recovered in survey units 11 and 12 or in the subsurface trenches
- All anomalies investigated as a result of the digital geophysical mapping survey results were scrap metal debris (nuts, bolts, wire, nails)

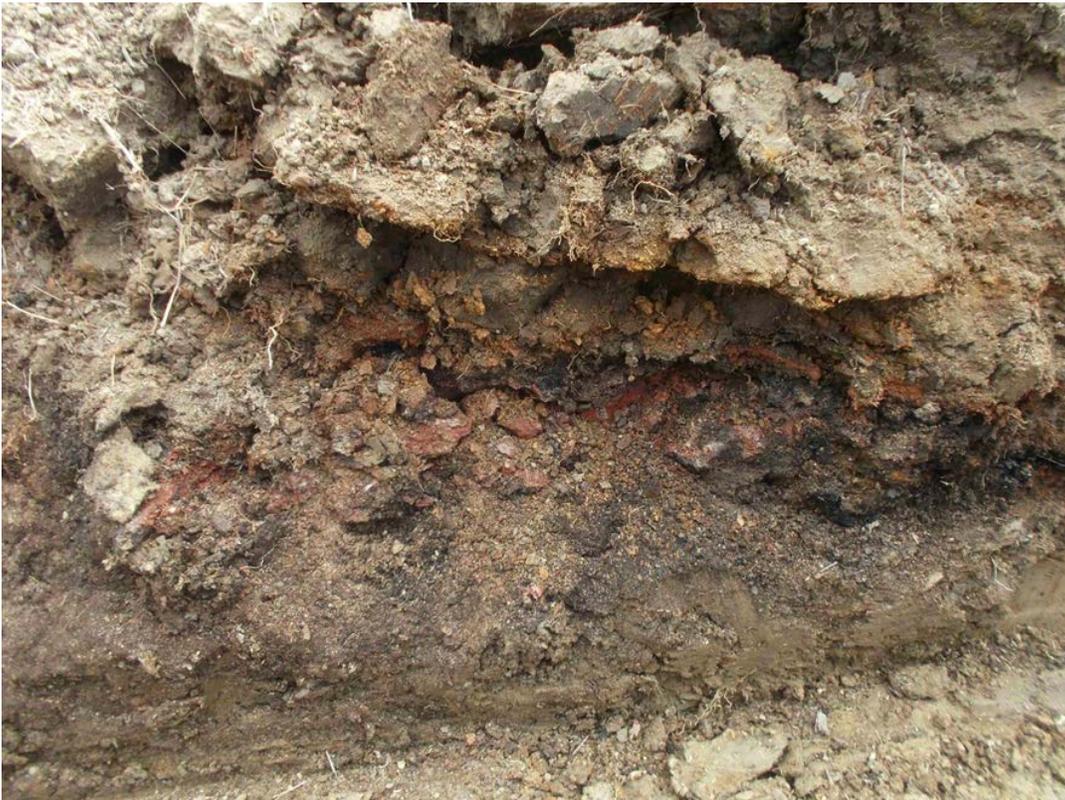
Paint waste observed in Trench 1

Residual paint waste was observed in trench one, trench eight, and two anomaly excavation potholes, at depths ranging from one foot to three feet below ground surface.

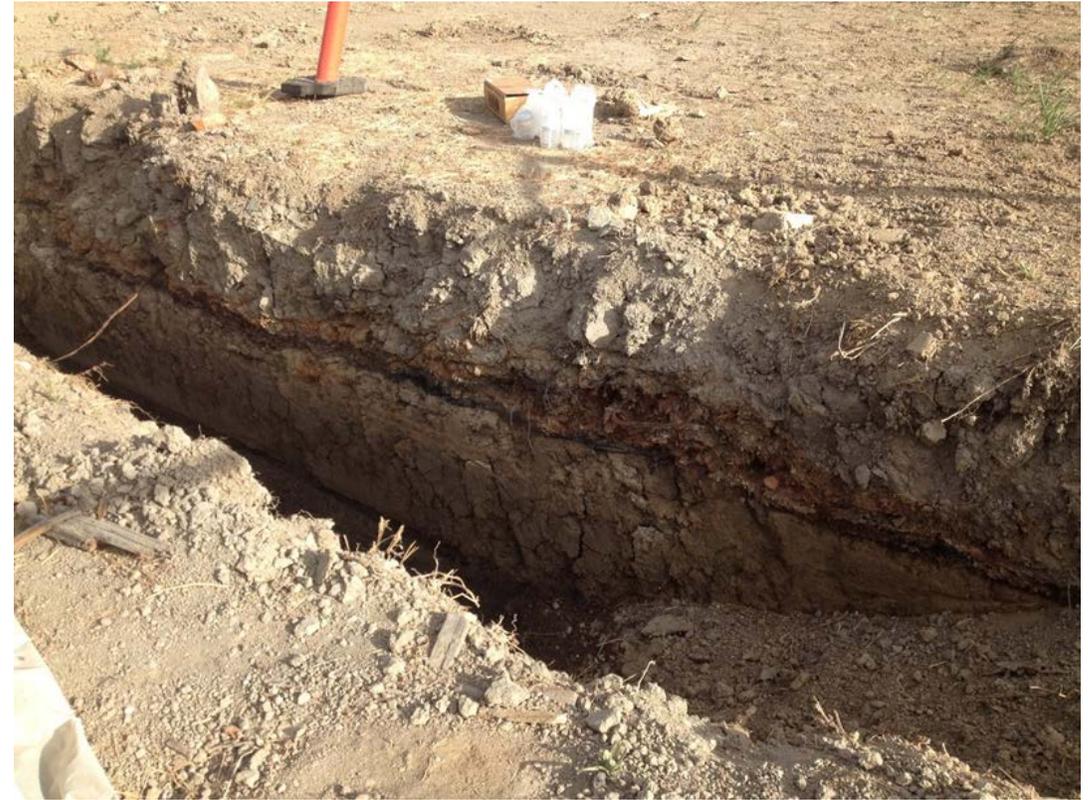
Paint waste observed in Trench 8

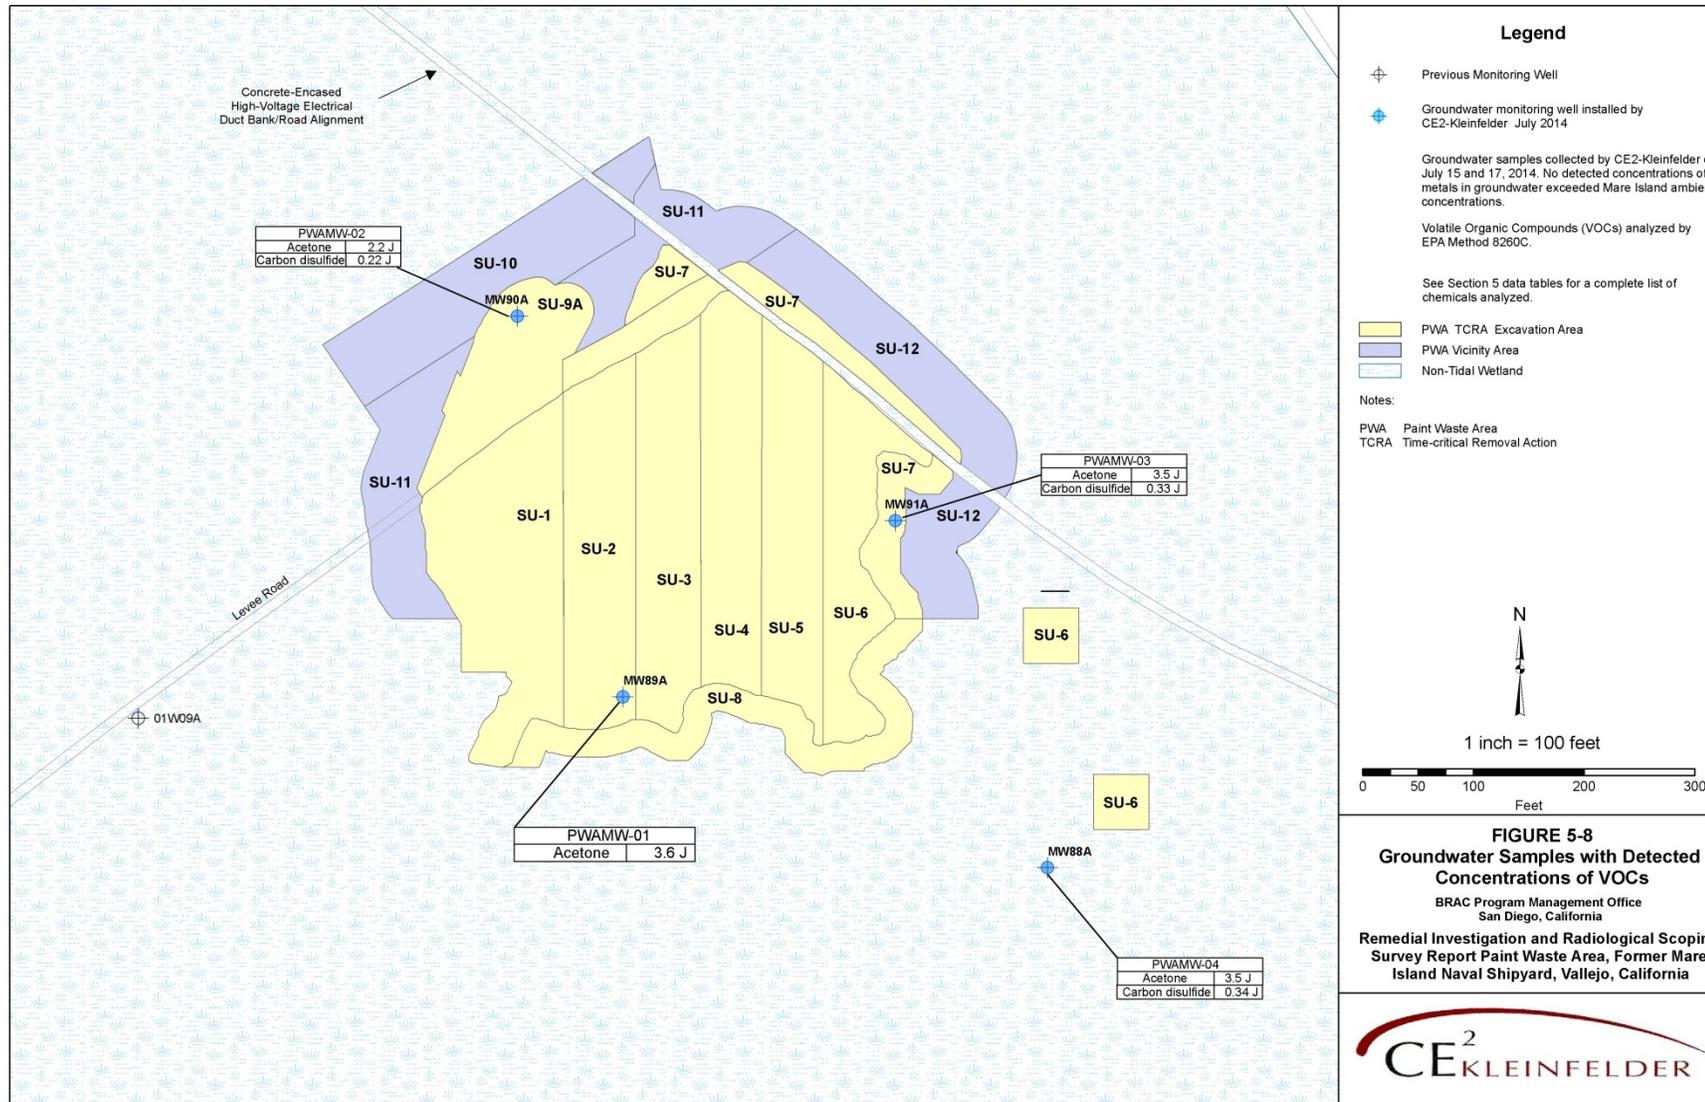
# Groundwater Sampling Results

- Groundwater total cancer risk and non cancer risk hazard exceed criteria for hypothetical residents using groundwater as potable water; however risk is overestimated because metals concentrations (primarily arsenic and chromium) detected in groundwater are consistent with ambient concentrations.
- The Navy determined that shallow groundwater beneath the site meets the criteria for an exception to the State Sources of Drinking Water Policy based on high concentrations of total dissolved solids. The Regional Water Board concurred with this determination in May 2015. Domestic water on Mare Island is supplied by the City of Vallejo. Ingestion of shallow groundwater is not considered a complete exposure pathway.

This slide summarizes the risk results for groundwater. Groundwater total cancer risk and non-cancer hazard risk exceed criteria for hypothetical residents using groundwater as potable water. However, risk is overestimated because metals concentrations, primarily arsenic and chromium, detected in groundwater are consistent with ambient concentrations.

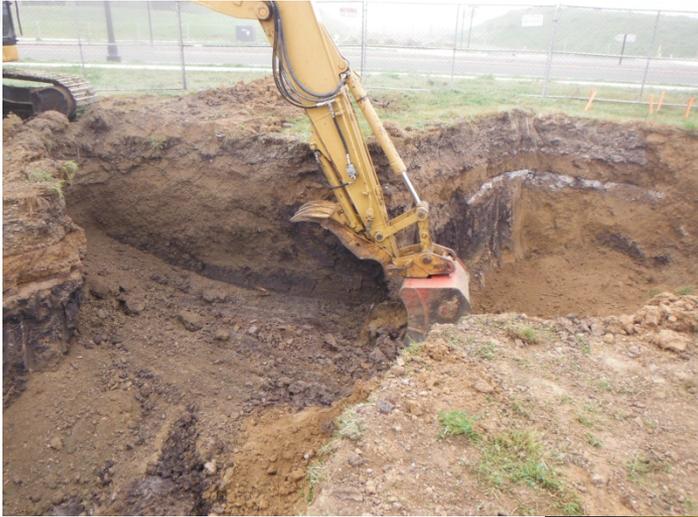
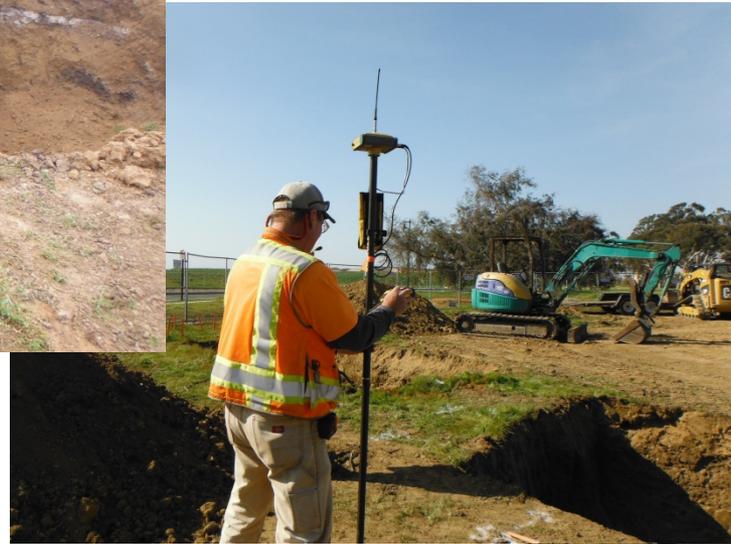
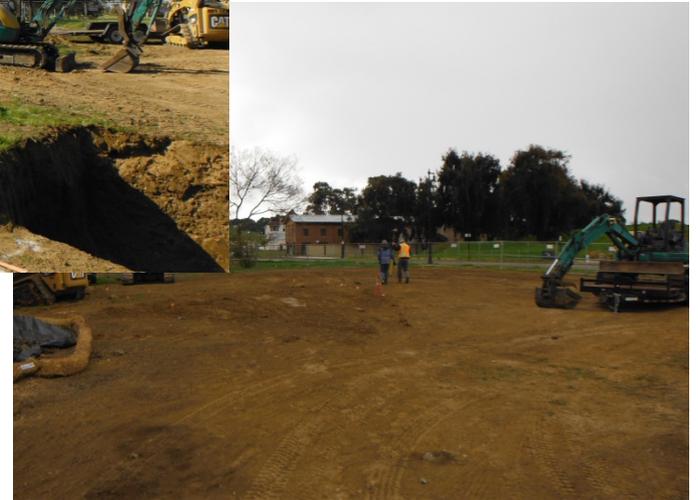
# UST M57 and FOPL E3/VAR/M57 – 2012 Remedial Action

- **Only One Site Remains with Constituents-of-Concern Above Unrestricted Land Use Criteria**
  - UST M57 and FOPL Segment E3/VAR/M57
- **2012 Remedial Activities**
  - Eight (8) Excavations to Remove Constituents-of-Concern Above Residential Tier 2 Screening Levels
  - One Unknown Condition Encountered – Green Sand in One Excavation
  - Collect Verification Samples – Soil and Soil Vapor
  - Dispose of Excavated Materials Offsite at Appropriate Disposal Facility
  - Backfill Excavations
  - Collected Soil Vapor Samples
  - Requested No Further Action – Unrestricted Land Use

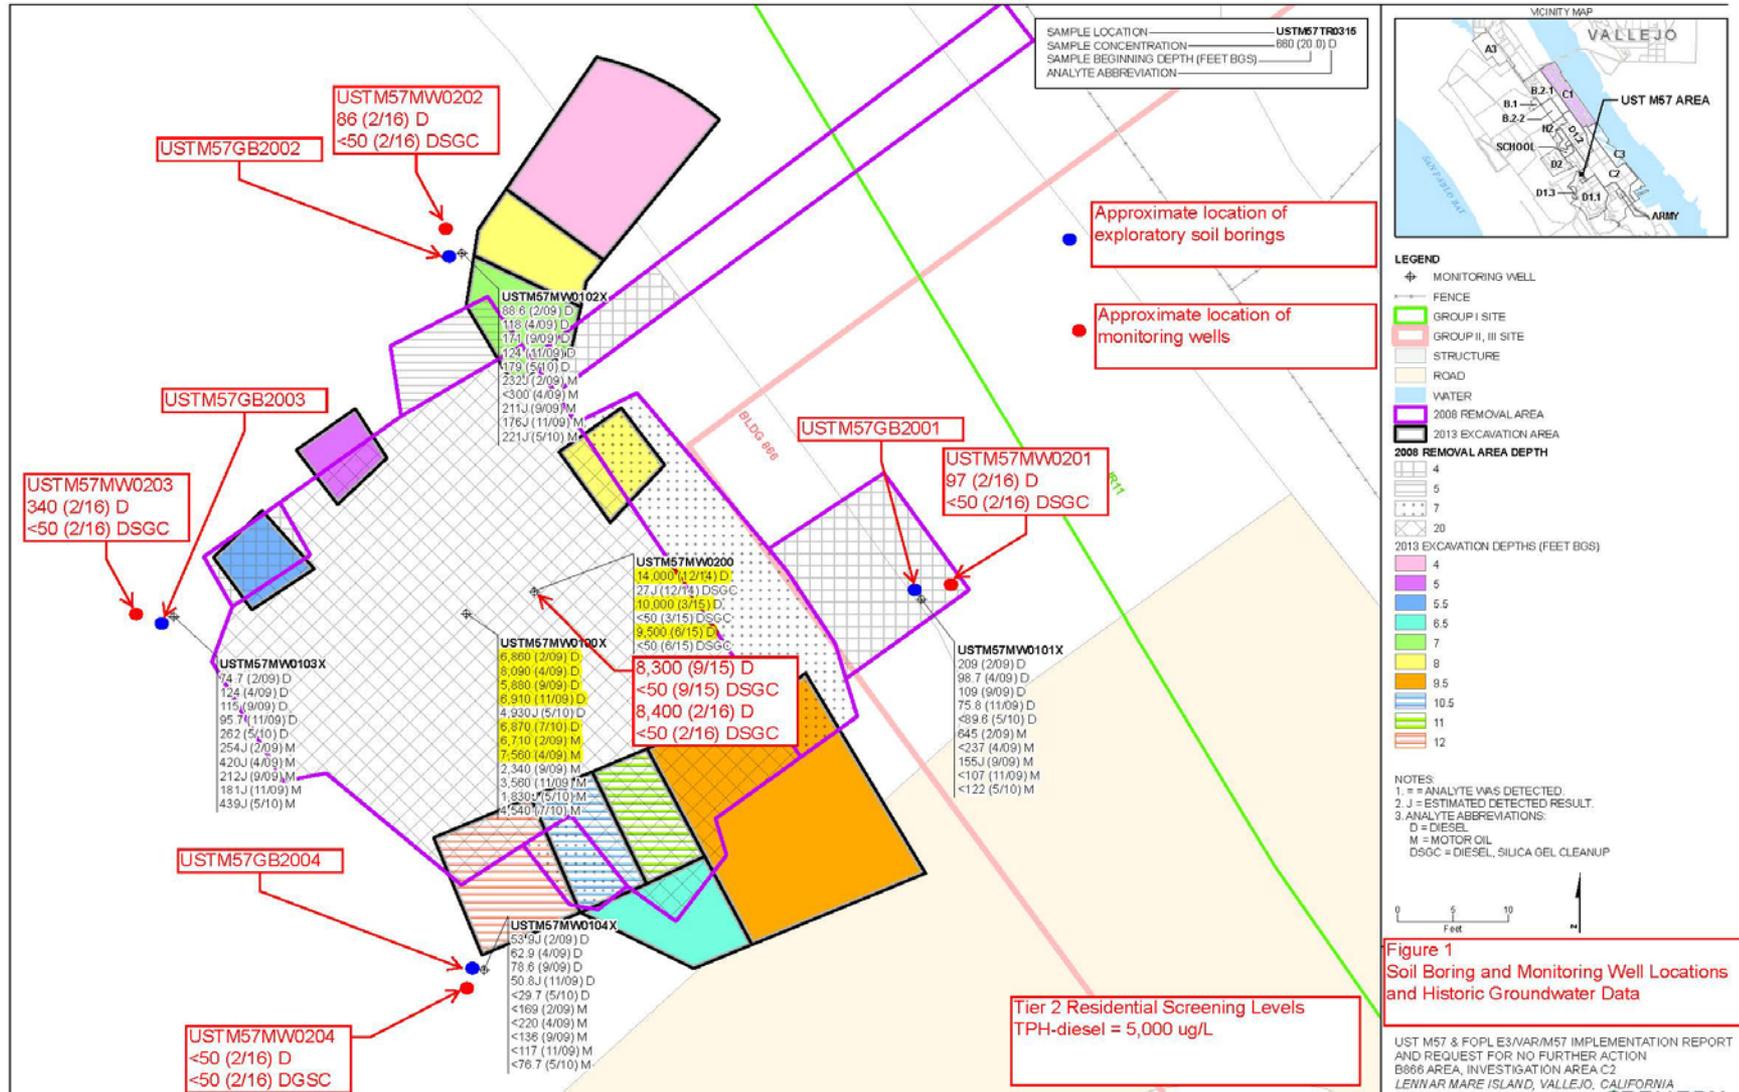
**Figure 1**  
Soil Boring and Monitoring Well Locations and Historic Groundwater Data

- **Installed and Sampled Additional Groundwater Monitoring Wells Around Excavation**
  - Four (4) Wells Installed in January 2016 and Sampled in February 2016
  - Collected Groundwater Samples – Original Well and Newly Installed Wells
    - ❖ TPHd Concentrations in Original Well - 8,400 µg/L
    - ❖ Newly Installed Wells
      - ✓ Ranged from < 50 µg/L to 340 µg/L

But in those wells you can see the total petroleum hydrocarbons as diesel ranges from, you know, non-detect, which is below 50 micrograms per liter, to only 340 micrograms per liter. So this is a very localized condition, very localized in that area.

Put wells real close to the other four wells around the corners. These wells are within 30 feet of this. This is a very localized condition. We can probably get closure for it, but because we're going to be putting single-family homes on this we don't want to chance anything.

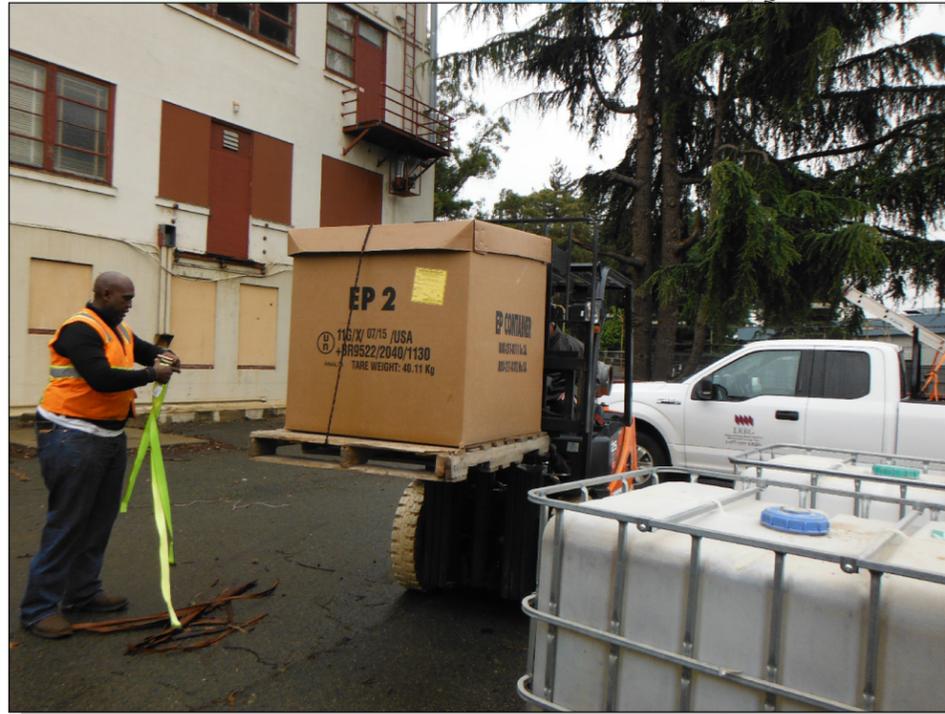
**Removal of Solid and Liquid Waste from Building 746 PCB Site UL#01, Investigation Area C2**
