Historical Radiological Assessment – Supplemental Technical Memorandum

**Naval Station Treasure Island
San Francisco, California**

August 6, 2012

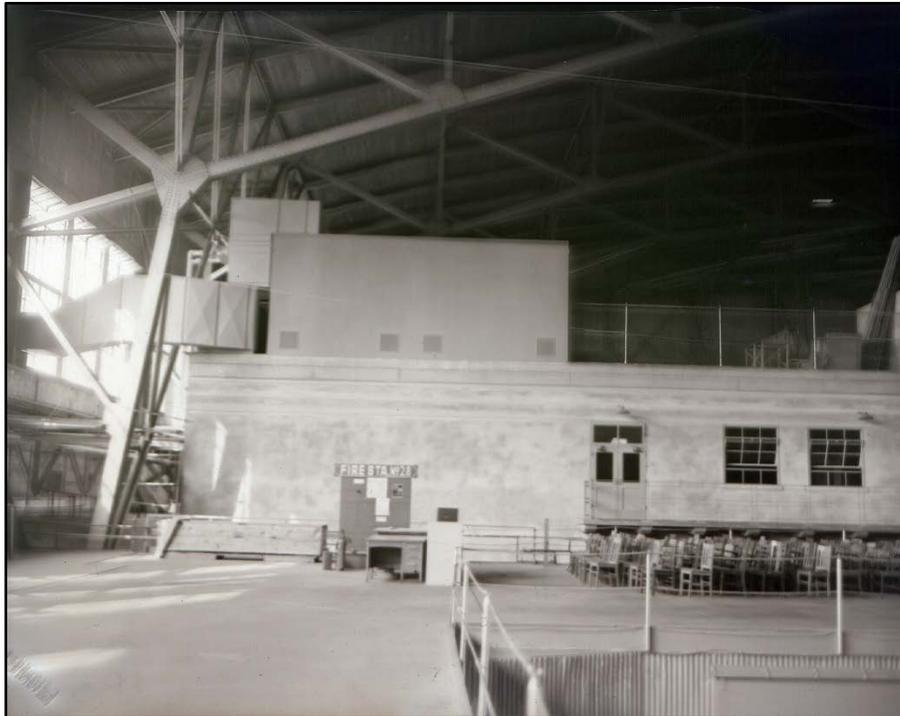
Photo 1: Interior of Hanger 2, 1953, showing radar building

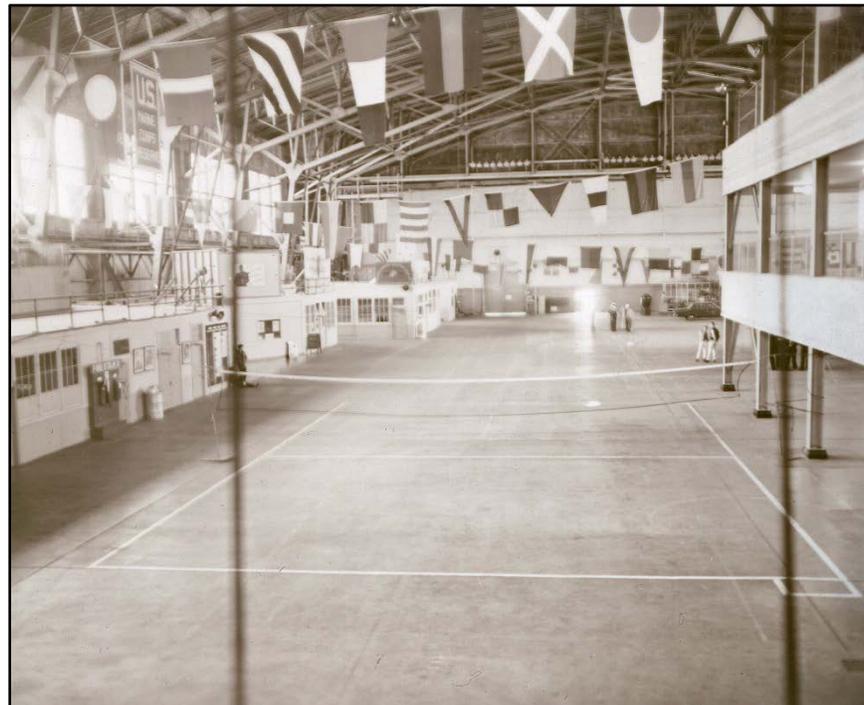
Photo 2: Interior of Hanger 2, 1963, label on photo states "Naval Reserve"

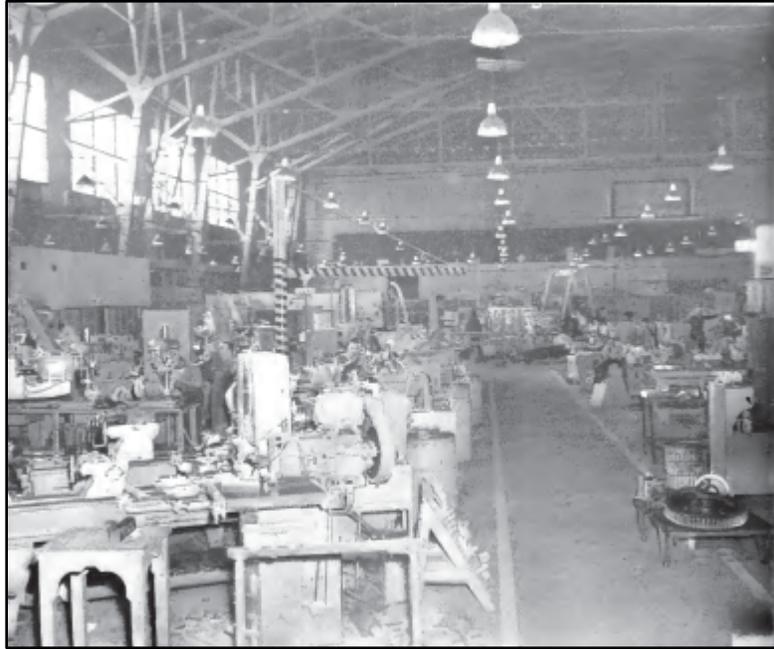
Hanger 3 was the Palace of Fine and Decorative Arts during the GGIE. It is evident from the records reviews and Photo 3 that Building 3 was configured to conduct significant inside shop work associated with the repair activities associated with the "Section/Frontier Base" operations. Building 3 has been designated as radiologically impacted in this HRASTM because of the potential for those historical ship repair activities to have involved radioactive deck markers and gauges. Evidence was found regarding the potential for an optical shop associated with the "Section/Frontier Base" on NAVSTA TI (Navy Undated). Former Navy optical shops at other bases have been found to contain residual radium contamination. The optical shop was on the roof of Building 3 as shown on Photo 4. The plan elevation and details show the presence of sinks and drains in the optical shop and these drains are considered impacted from the point of origin in the shop to the pump station on Photo 5. It is apparent that the 6-inch sanitary sewer line shown on Photo 5 was added sometime after 1943 as it is not shown in earlier drawings and, therefore it was likely added in association with the construction of the optical shop (Navy 1944). As noted in the handwritten note on the plan elevation and details, the optic shop was demolished in 1969. Part of the drain line serving the shop was removed along with the shop, but the majority of the line leading to the pump station remains. There were a number of ship repair piers and two floating dry-docks by the war's end that were dedicated to this activity (see Figure 3, 20 February 1945 aerial photograph). Ship repair activities appear to have ceased sometime in the 1950s; however, it is not clear exactly when these activities ceased.

Photo 3: Interior of Hanger 3 during WWII repair shop for Frontier Base

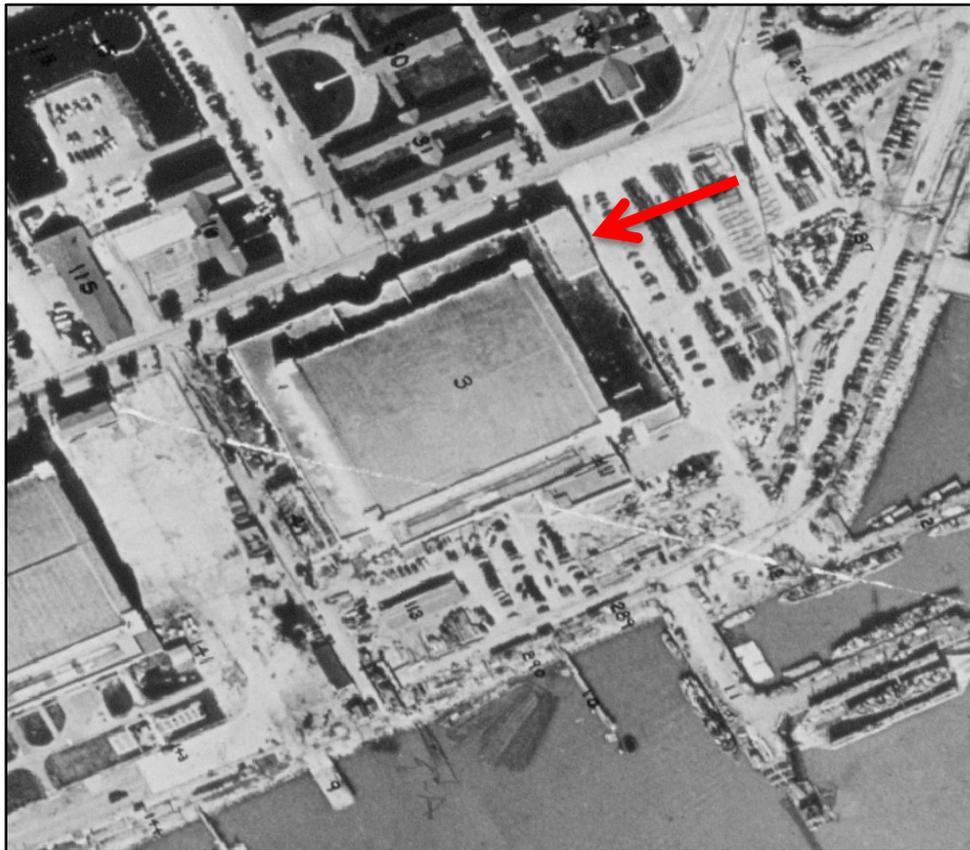
- Research identified the presence of an optical shop in Building 3. The presence of such a shop is notable, as these shops have historically been found to have radium and thorium contamination associated with their operations on other bases. Radium and thorium were used for their radioluminescent properties in optical sighting devices and rangefinders during the WWII period.

Photo 4: 1945 photo showing the presence of the optical shop on the north corner of the Building 3 roof

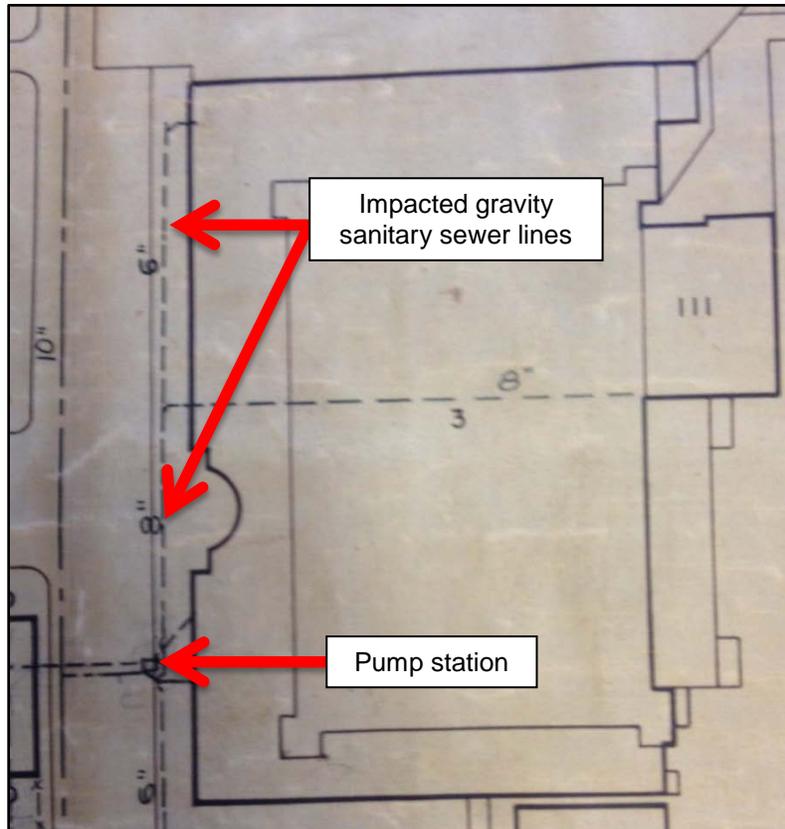
Photo 5: Showing sanitary sewer line in 1946 drawing

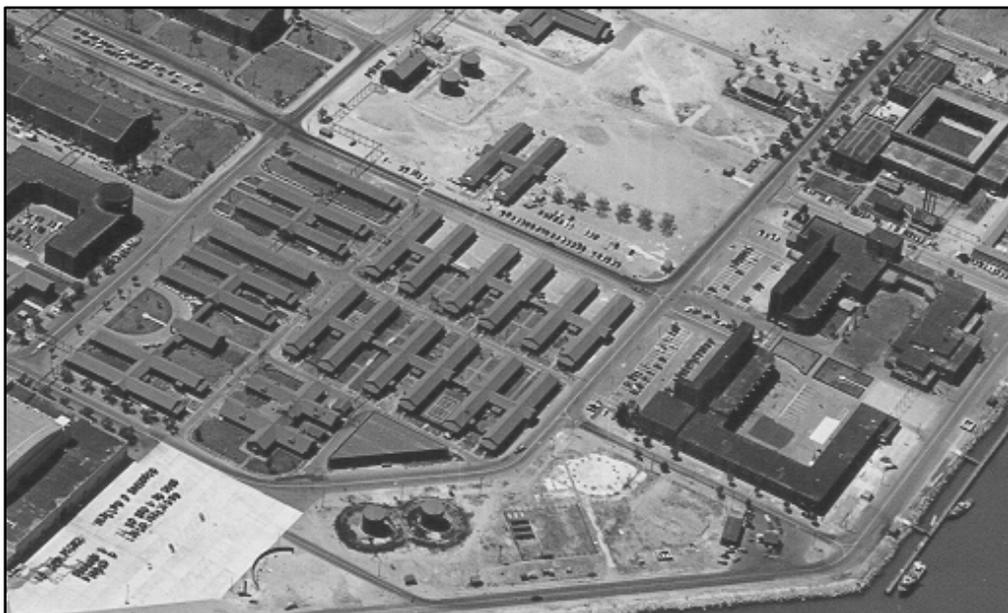
Photo 7: Early 1942 oblique aerial photo of AOI 2

AOI 2 is shown in [Figure 4](#) and is composed of three general areas; the hospital area, an open area associated with piers 15 and 16; and the waterfront (Federal Building area). Except for the Federal Building, the GGIE structures in this area ([Photo 6](#)) were demolished prior to 1942. By early 1942, the Lake of the Nations had been filled in and construction of the hospital buildings was nearing completion (see [Photo 7](#) and [Figure 4](#)). Because the Lake of the Nations was filled in before Navy operations began; and, because the footprint of the entire area was developed early in the war and before other Navy operations were expanded on the island, there is little likelihood that any debris associated with Navy operations would have been disposed of in this area or that any debris would have contained radioactive items associated with those later Navy operations. The Waterline Replacement Area, Site 33, ([Figure 4](#)) is currently undergoing additional investigation, including radiological surveys, and the work to-date has not identified the presence of radioactive materials above established background levels for TI. All data associated with the work will be published in a Remedial Action Completion Report after the work is done.

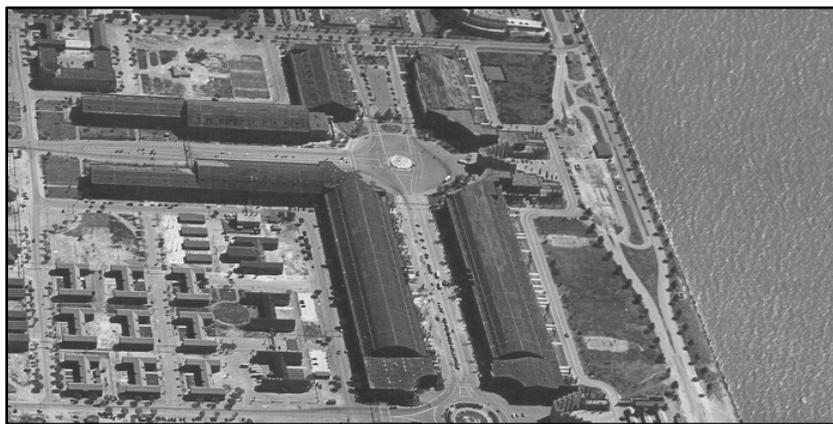
Photo 9: 1943 photo of AOI 3

During Navy operations, AOI 3 ([Figure 5](#)) was historically composed of barracks and administrative areas (Buildings 117, 118, 137, 139, 147, 148, 149, 150, 151, 152, 170, 171, 172, 173, 174, 175, 177, 178, and 179). The area was dominated by four large L-shaped halls during the GGIE ([Photo 8](#)). These halls were used as barracks, Buildings 452 and 453, during WWII, and additional barracks and other classroom room and administrative facilities were built around them during the war (see [Photo 9](#) and 1942 and 1947 aerial photographs on [Figure 5](#)). Following the war, the halls were demolished and the land was unused until the star barracks were built in the late 1960s. Available aerial photographs do not show the former footprint of the GGIE halls being used for laydown areas or debris disposal areas during the period from hall demolition until construction of the star barracks. This is to be expected as these open areas were surrounded by barracks and administrative areas during this period, making it unlikely that such debris disposal would occur in an active area of the base.

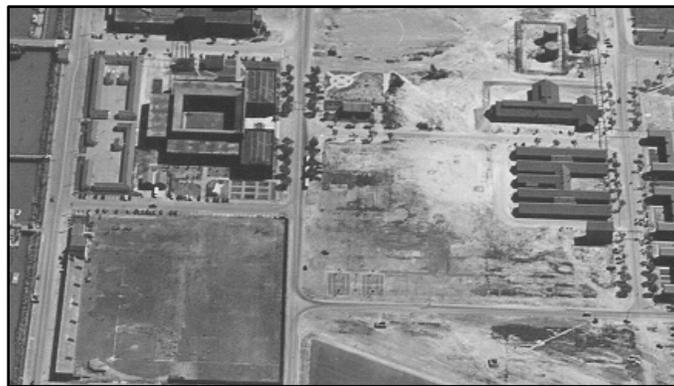
Photo 11: 1942 photograph of AOI 4

AOI 4 is shown on [Figure 6](#). Immediately following the GGIE, the Lake of the Nations and all GGIE structures in this AOI were demolished, except the former Hall of Western States and U.S. Army Encampment facilities ([Photos 10](#) and [11](#)). During Navy operations, the area was historically composed of community related functions such as barracks, classrooms, athletic fields, tennis courts, a Navy Exchange, gymnasium, theatre, library, laundry, Enlisted Men’s club, Chief Petty Officer club and a heating plant. A large supply warehouse, Building 260, dominated the site ([Figure 6](#)).

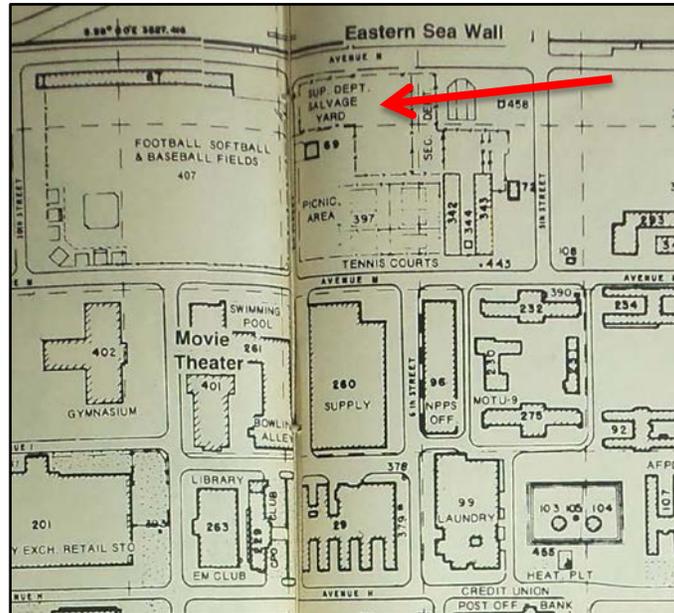
Because this area was used as a salvage yard and due to the lack of any other radiological information associated with this site, this HRASTM identifies this salvage yard (Lot 69) as impacted based on the fact that salvage yards are often linked with the potential for disposal of unregulated radiological commodities.

Photo 12: 1969 base map showing the Supply Department Salvage Yard

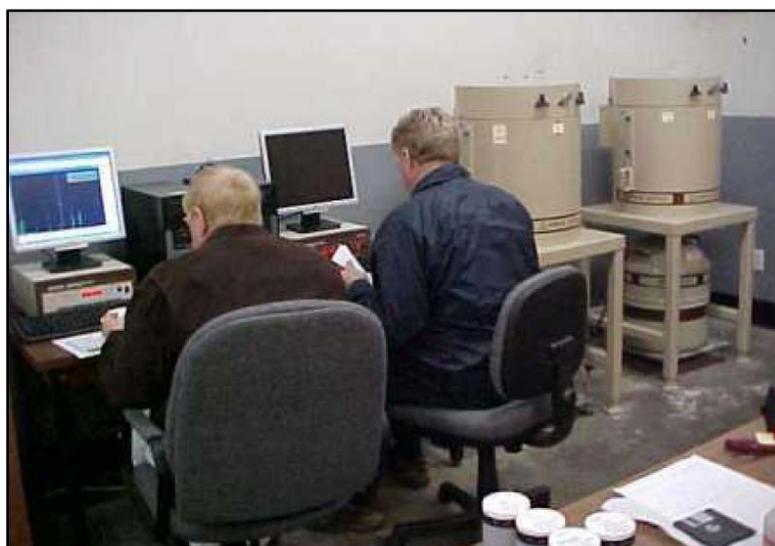
Photo 14: Portable gamma spectrometers in Building 570

Building 570 and the surrounding fenced yard was designated as impacted in this HRASTM as result of the handling and storage of radiologically contaminated items and soil samples (collected from other impacted TI sites) in the building and fenced yard area. The radiological subcontractor, New World Technology of Livermore, California, mobilized two gamma spectrometers to Building 570 in 2007 (Photo 14 above). These spectrometers were used for quick turnaround laboratory analysis of soil samples and radioactive commodities found in the Site 12 solid waste disposal areas (SWDA). The radioactive commodities and soil samples are stored in a conex box (storage or shipping container) in the fenced compound surrounding Building 570. The use of this area for the storage of radiological materials continues in association with the non-time-critical removal action (NTCRA) in the Site 12 SWDAs.

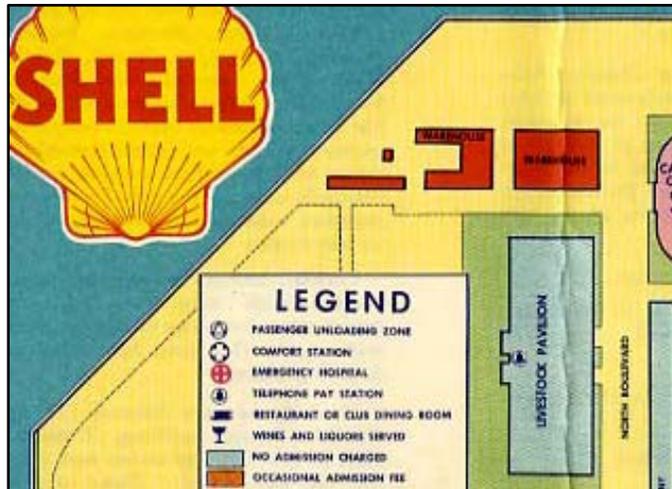
AOI 6 is shown on Figure 8 and Photo 15. The GGIE structures shown on Photo 15 were demolished immediately following the GGIE except for the warehouse (Building 62) shown in the upper right side of Photo 15, which is still there. As discussed in the HRA, the USS *Pandemonium* Site II (NE) was in AOI 6 after the USS *Pandemonium* was moved there in 1969 from the west side of the island (USS *Pandemonium* Site I, AOI 8). The HRA concluded that Site II (NE) was not impacted because:

Photo 15: Vicinity of AOI 6 during the GGIE

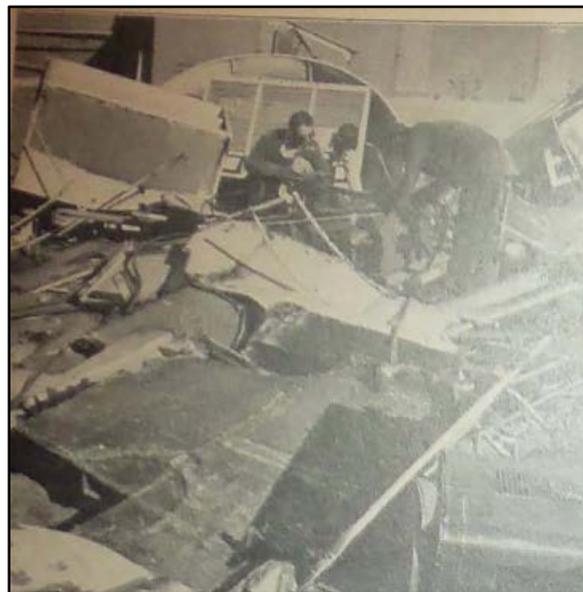
As noted in [Section 2.2](#), significant ship repair activities were ongoing throughout WWII. Those activities generated significant amounts of scrap metal as evidenced by a *Masthead* article that referred to the amount of scrap metal from repair activities as 200,000 pounds per month ([Navy 1945a](#)). This same article contained a photograph ([Photo 16](#)) showing in progress salvage operations for scrap metal. Salvage yards are typically a concern at ship repair facilities as there is a potential for impacted sites from the processing of waste containing unregulated radioisotopes such as Ra-226. While it is not clear exactly where the salvage area was, it is likely that the area would have been in the open area just to the south of Building 327 that was identified as a "Salvage Building" in the HRA. [Photo 17](#) is a 1945 aerial photograph of this area and suggests that the area south of Building 327 is likely the pictured salvage yard based on the presence of the buildings in the background of [Photo 16](#). Therefore, this area has been designated as impacted in this HRASTM. As shown on [Figure 8](#), Building 327 was demolished in the 1960s and the impacted salvage yard area is now in the footprint of the sewage treatment plant that was constructed in 1984.

Photo 16: *Masthead* photo showing welders cutting up scrap metal for salvage

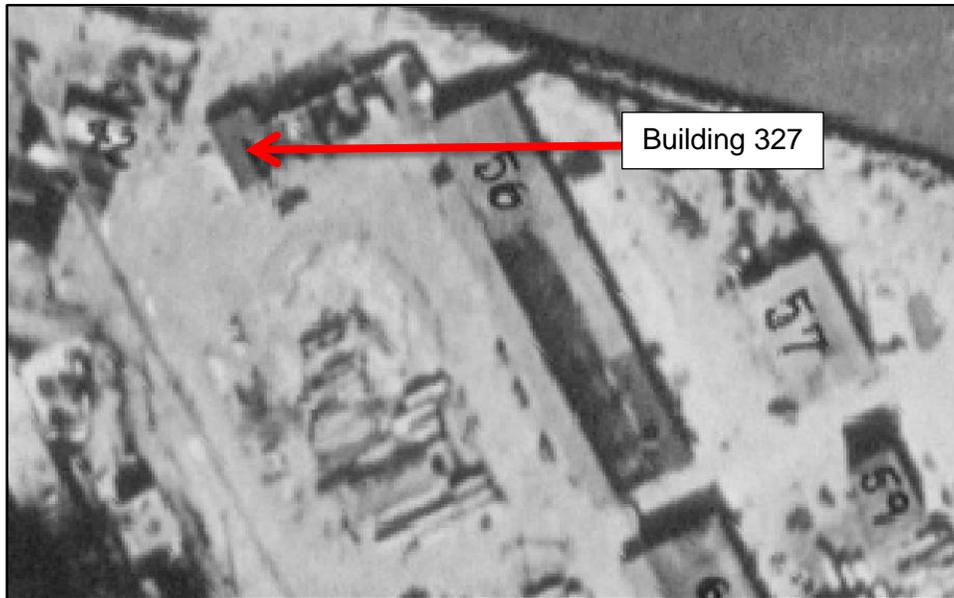
Photo 17: Building 327 and probable salvage yard directly to the south

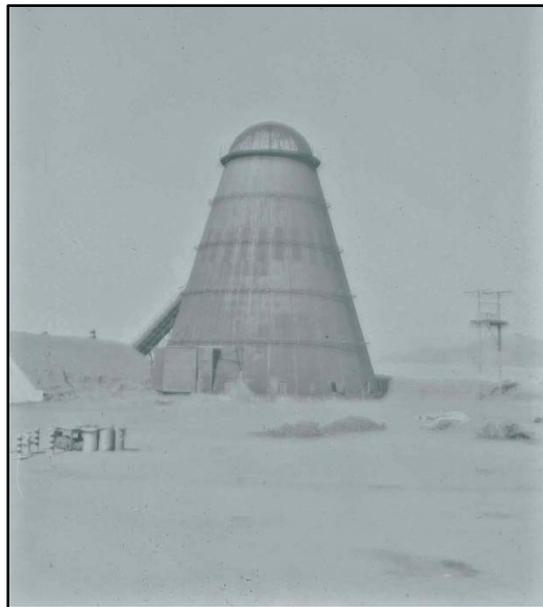
In addition to the ammunition bunkers, the other important features in this area of IR Site 12 include an incinerator (Photo 19), burn pits, and SWDAs that were discussed in the HRA. Playing fields and a storage/salvage yard were in AOI 7. The playing fields were in the southeastern corner and remained in use until housing was constructed in 1969 (see 1947 and 1968 aerial photographs on Figure 9) making it unlikely that any disposal activity would have taken place on the playing fields. In 2009, the Navy conducted a gamma walkover survey of the common area in the North Point Drive housing loop (Navy 2009). All gamma readings during the survey were within background levels, except at one location between Buildings 1244 and 1246. A metallic object about 4 inches round and 1.5 inches deep was thought to be a radioactive gauge and was discovered between the housing units, in the footprint of the former ball field. The discovery of this gauge is likely from an anomalous transport of the item from a SWDA during construction activities associated with the housing area.

Photo 19: Photograph of incinerator

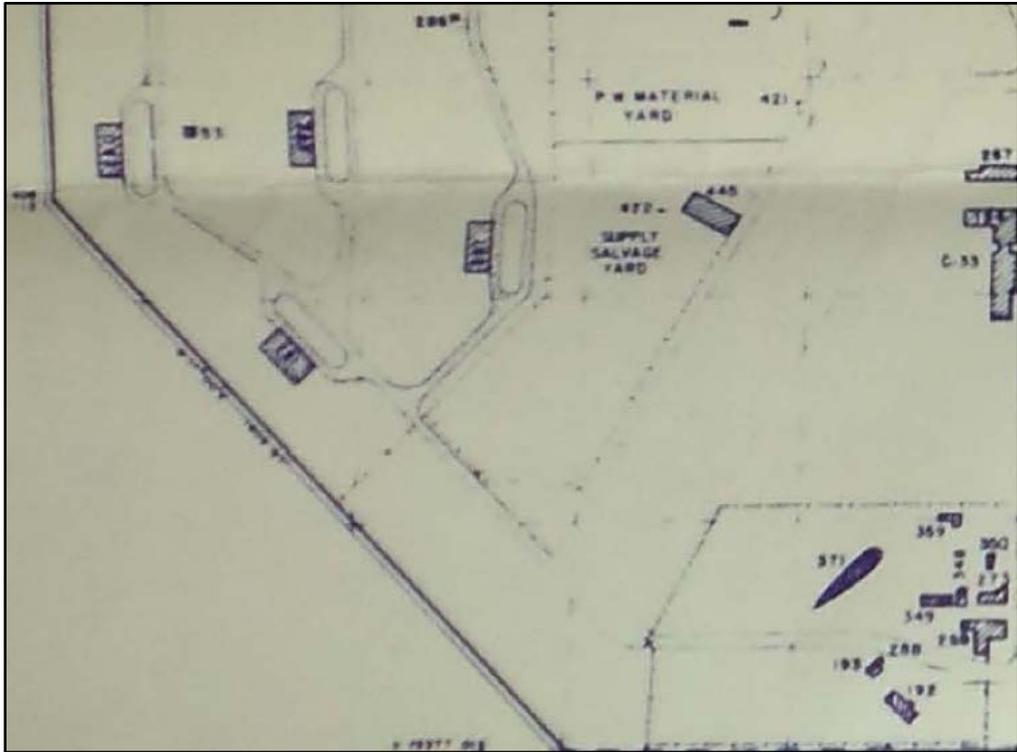
The storage/salvage yard was in the southwestern corner of AOI 7 and remained in use until housing was constructed in 1966 (see 1947 aerial photograph on [Figure 9](#)). The 1947 aerial photo shows this storage/salvage yard being used for storage; a 1962 base map, clearly labels it as a “Supply Salvage Yard” ([Photo 20](#)). As discussed in a *Masthead* news article the salvage yard would “receive large, prefabricated sections of steel decking, gun platforms, etc., from the repair and overhaul work at the Industrial Shops.” in addition to other scrap steel ([Navy 1945a](#)). Salvage yards are typically a concern at ship repair facilities as there is potential for impacted sites from the processing of waste containing unregulated radioisotopes such as Ra-226. No records could be found to suggest this area served as a salvage yard during the period when ship repair activities were ongoing (i.e., WWII). This is evidenced by the fact that the salvage yard pictured during the WWII period had a structure in the immediate background ([Photo 16](#)), and there were no such structures in the area of this storage/salvage yard during the WWII period ([Figure 9](#), 1947 photo inset).

Photo 20: Supply Salvage Yard shown in 1962 base map

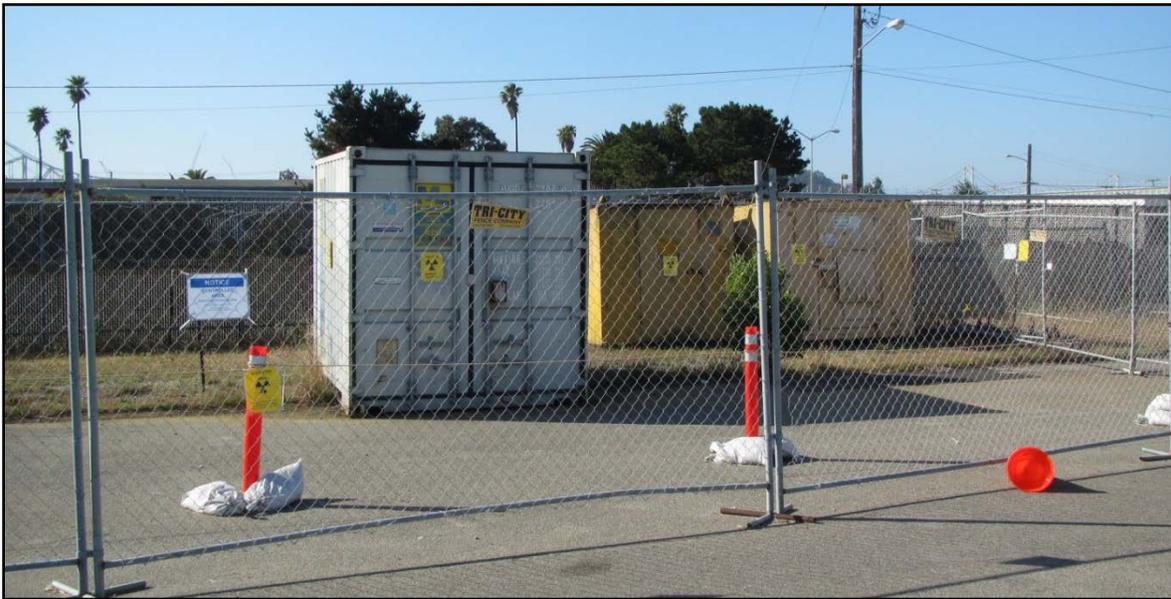
Building 570 was not identified in the HRA as a radiologically impacted or non-impacted site. Building 570 has been used as an office trailer and laydown area by a Navy contractor (Shaw Environmental Inc.) in association with remedial activities on NAVSTA TI, including those at Site 12. Building 570 and the surrounding storage yard is now designated as radiologically impacted as discussed in [Sections 2.2.5](#) and [5.2.3](#), because removal in the Site 12 SWDAs that occurred after the HRA involved radiological commodities and radiologically contaminated soil. Soil samples were stored and counted in the Building 570 area and radiological commodities were stored in conex boxes in the smaller fenced yard of Building 570 ([Photo 25](#)).

Photo 25: Conex boxes used for storage of radiological commodities in the Building 570 compound

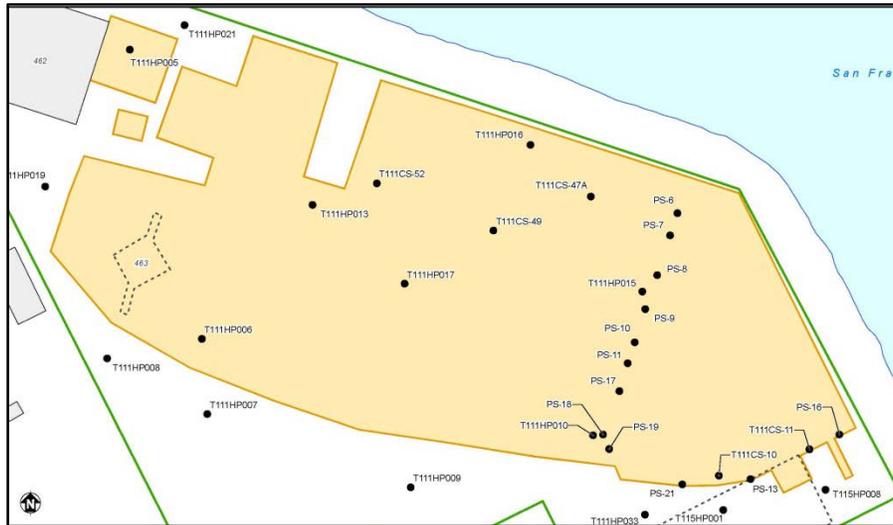
After the HRA, a remedial investigation (RI) report for Site 32 recommended a feasibility study (FS). A PCB remediation under the Toxic Substances Control Act (TSCA), an interim removal action that also addressed arsenic, was done at Site 32 in March 2010. During this removal, the bulk of the remaining USS *Pandemonium* (NE) infrastructure was removed and significant portions of the site were excavated between 2 and 12 feet deep ([Photo 26](#)). Radioactive isotopes were not chemicals of concern; however, during the course of excavation work and as a health and safety procedure at that time, the contractor did periodic radiological scans on the hands and feet of personnel, and on rubber tires of heavy equipment demobilizing from the site. All scans were done with a Ludlum Model 3 survey meter with a Ludlum 449 or Eberline HP-260 probe. No elevated radiation was detected ([Shaw 2011a](#)).

Photo 26: Site 32 excavation footprint

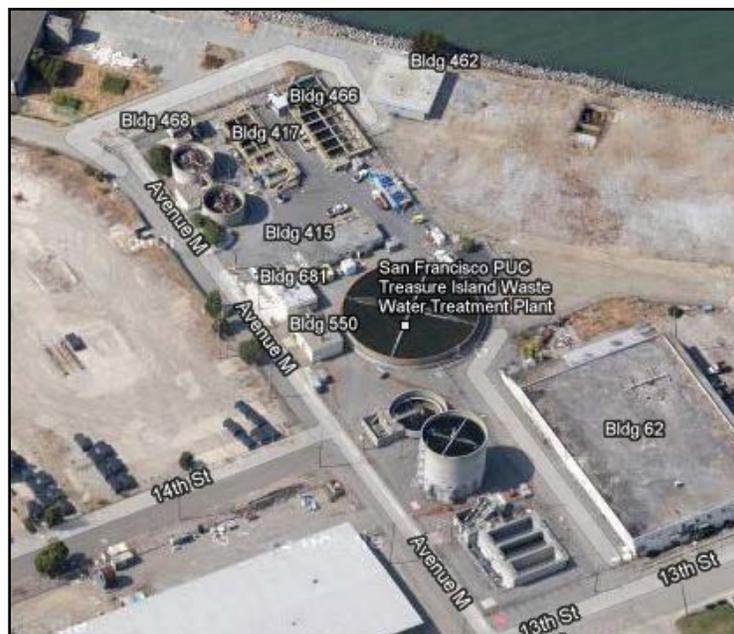
The Former Salvage Yard was not identified in the HRA as a radiologically impacted or non-impacted site. No radiological related or other IRP work has been conducted at the Former Salvage Yard site (Figure 8) since the HRA. The site is considered radiologically impacted due to the historic propensity for former salvage yards that handled industrial debris to be radiologically contaminated. The former WWII era salvage yard is in the footprint of the current waste water treatment plan as shown in Photo 28.

Photo 28: Current photo of TI waste water treatment plant

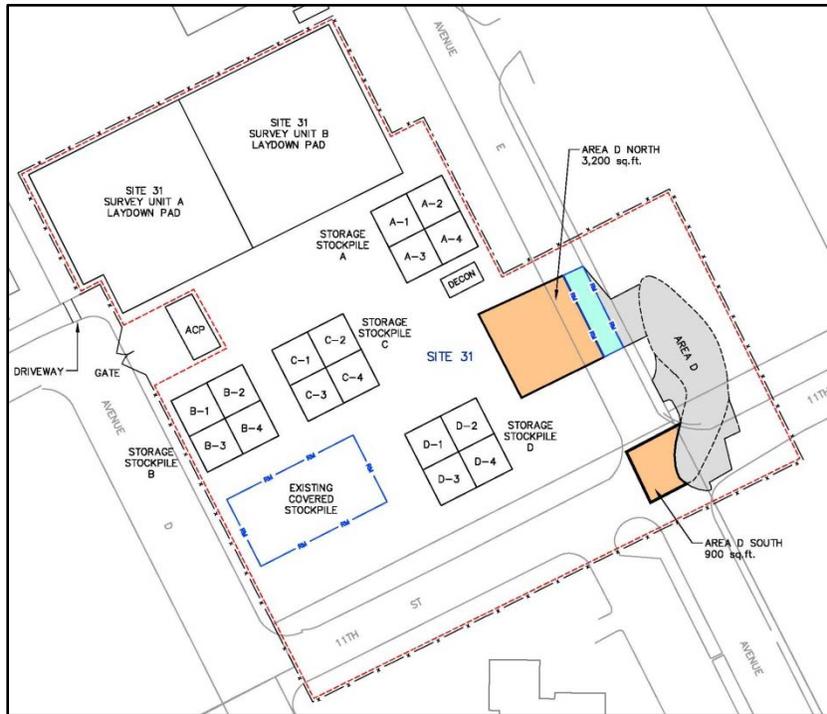
For Site 31, the FS report was finalized in March 2007. The proposed plan/draft remedial action plan was finalized on September 18, 2008, and the public meeting was held on October 7, 2008. The record of decision/remedial action plan was finalized on August 5, 2009. A final soil remediation work plan was submitted January 28, 2010. The soil remediation field work (referred to as Phase I) began in February 2010 and continued through July 2010. This work involved removing soil in the footprints shown in [Photo 29](#). The site is considered radiologically impacted due to the historic propensity for former salvage yards that handled industrial debris to be radiologically contaminated. Elevated radioactivity above background was discovered in the remedial excavation. Laboratory testing confirmed the presence of non-naturally occurring Ra-226, possibly from a deteriorated metal gauge. The Navy is currently doing the Phase II soil remediation for Site 31 that includes further radiological characterization of in situ soil as well as existing soil stockpiles.

Photo 29: Site 31 excavation areas (colored portions)

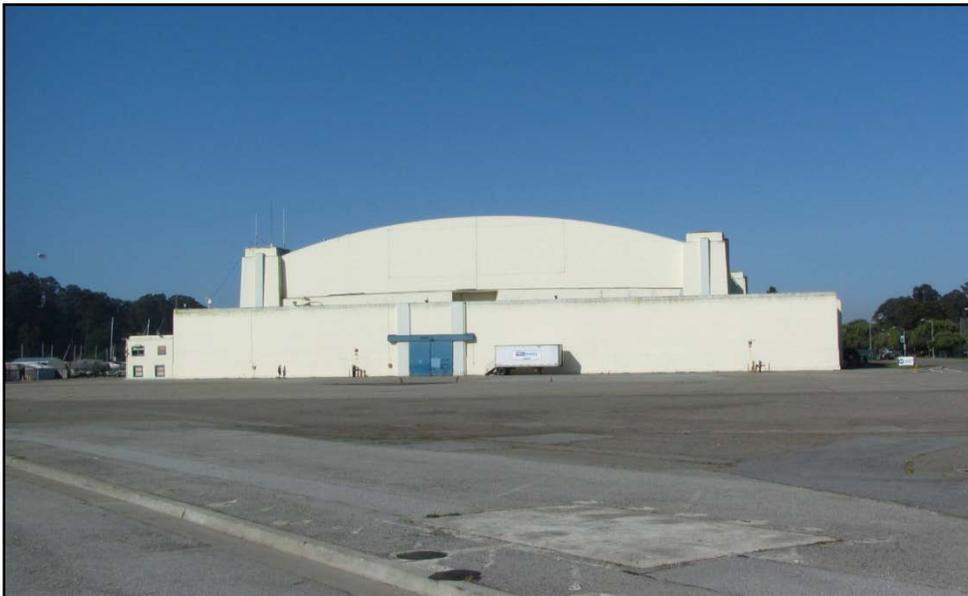
report was completed in March 2011. Groundwater monitoring is currently in progress. The Site 21 work is not expected to have affected the radiological status of this building. Building 3 has now been designated as radiologically impacted due to the extensive repair activities that occurred in the building during WWII and the presence of the optical shop on the northeastern corner of the roof.

Photo 30: Northeast side of Building 3

Recommended Actions – Scoping survey of floor spaces and sanitary sewer drains associated with former optical repair shop out to the first pump station.

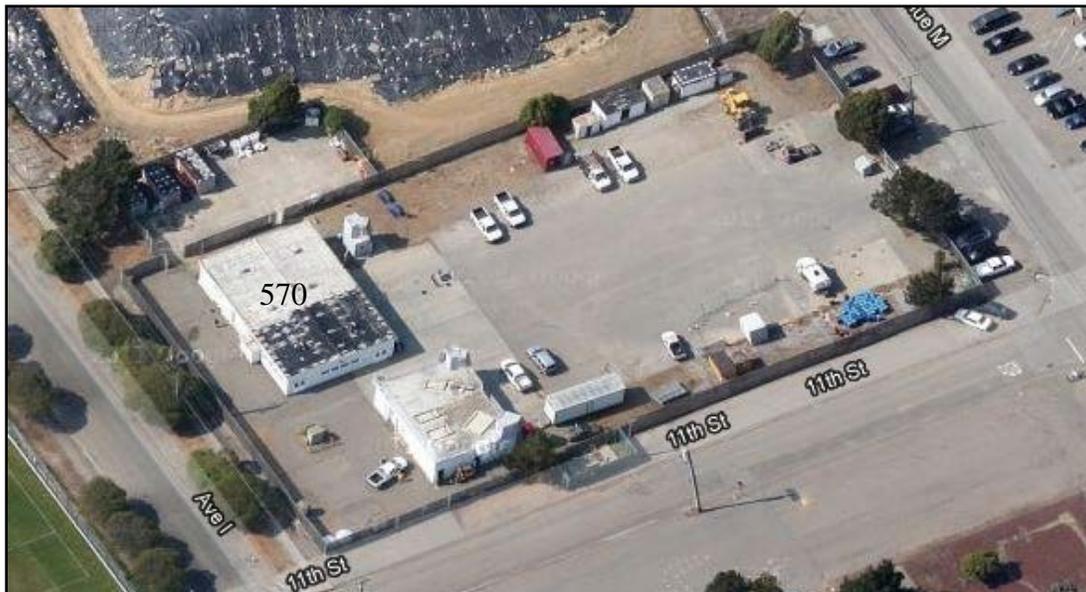
Photo 32: Building 570 area and location

Site Description – Building 570 was constructed in 1988. It is a single story slab-on-grade metal building. The building covers approximately 3,000 square feet. This area was not identified as radiologically impacted in the HRA.

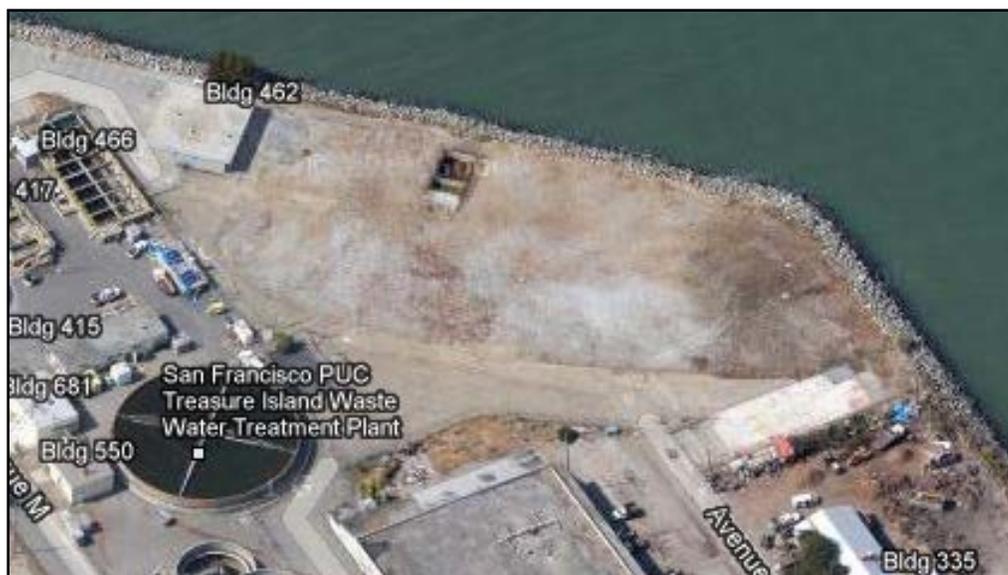
Photo 33: USS Pandemonium Site II (NE)

Recommended Actions – Complete a scoping survey of the concrete holding tanks, structures, and ground surface in the former training area.

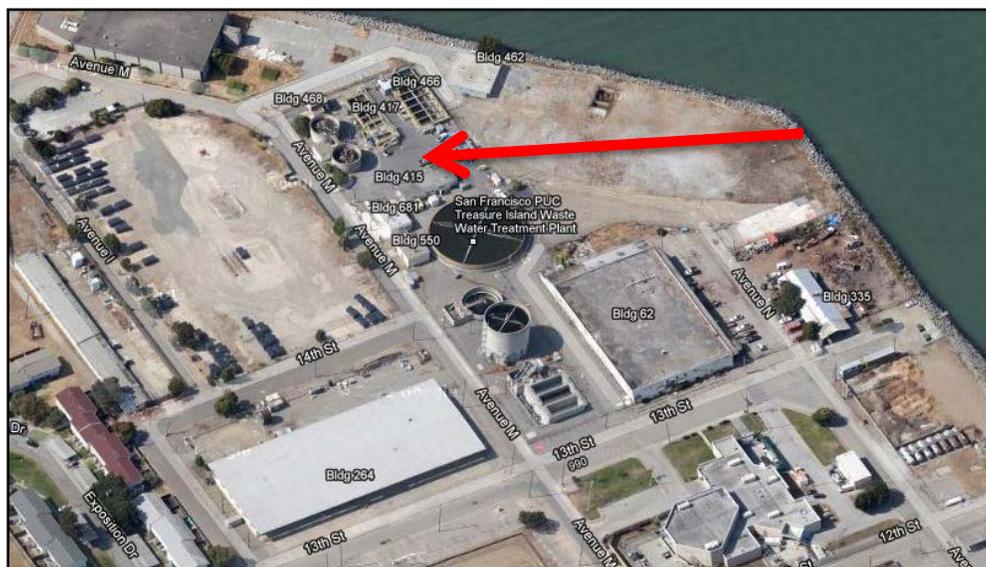
Photo 35: Location of Former Salvage Yard

Site Description – As noted in [Section 2.2](#), significant ship repair activities were ongoing throughout WWII. Those activities generated significant amounts of scrap metal, which was potentially processed in the open area and south of Building 327 that was identified as a Salvage Building in the HRA. Building 327 was demolished in the 1960s and the radiologically impacted area is now beneath the footprint of the sewage treatment plant that was constructed in 1984. This area was not identified as radiologically impacted in the HRA.

Recommended Actions – Complete a scoping survey of the ground surface in the sewage plant area.

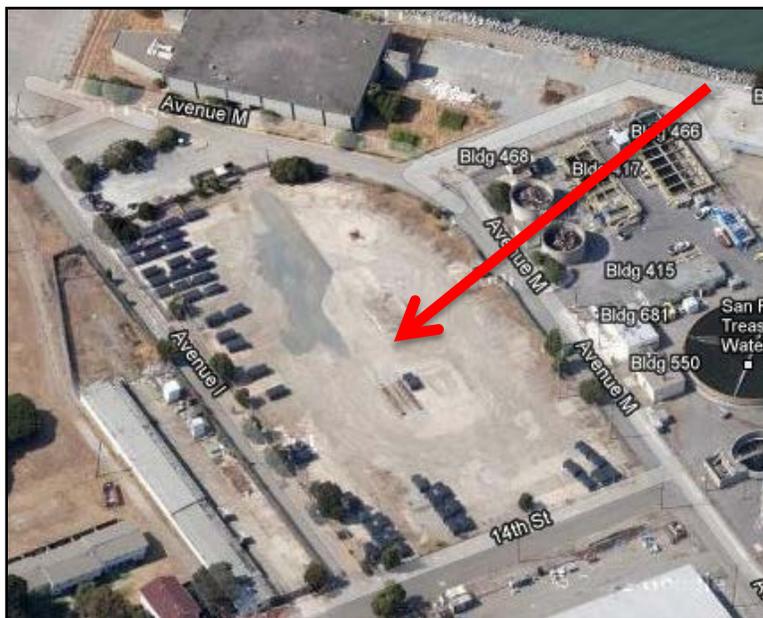
Photo 36: Waste and Clean Soil Stockpile/Loading and Decontamination Site

Site Description – The Waste and Clean Soil Stockpile/Loading and Decontamination Site is an open area in AOI 6 (Figure 8) and shown in Photo 36 above. This area was not identified as radiologically impacted in the HRA.

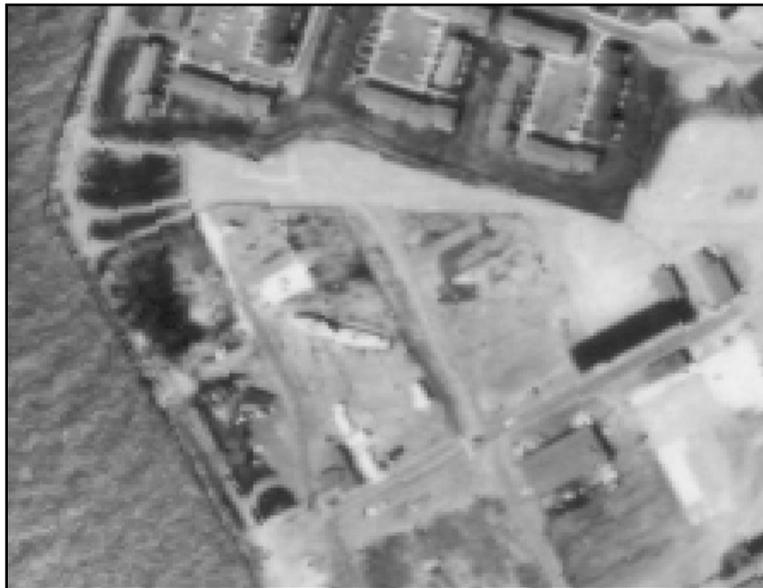
The USS *Pandemonium* Site I (NW) was designated as non-impacted in the HRA. Since the time of the HRA, radiological intrusive work has been done in the portion of SWDA A and B that overlie the USS *Pandemonium* Site I (NW) ([Figure 10](#)). The entire USS *Pandemonium* Site I (NW) is now considered radiologically impacted due to a more conservative estimate of the potential for contamination to have resulted from unlicensed instrument check sources or failure to comply with procedures.

Photo 37: USS Pandemonium Site I (NW)

Recommended Actions – Complete a scoping survey of the former holding tanks, structures, and ground surface in the USS *Pandemonium* Site I (NW) area and a gamma walkover survey of the roadways and areas not previously subject to gamma walkover surveys.

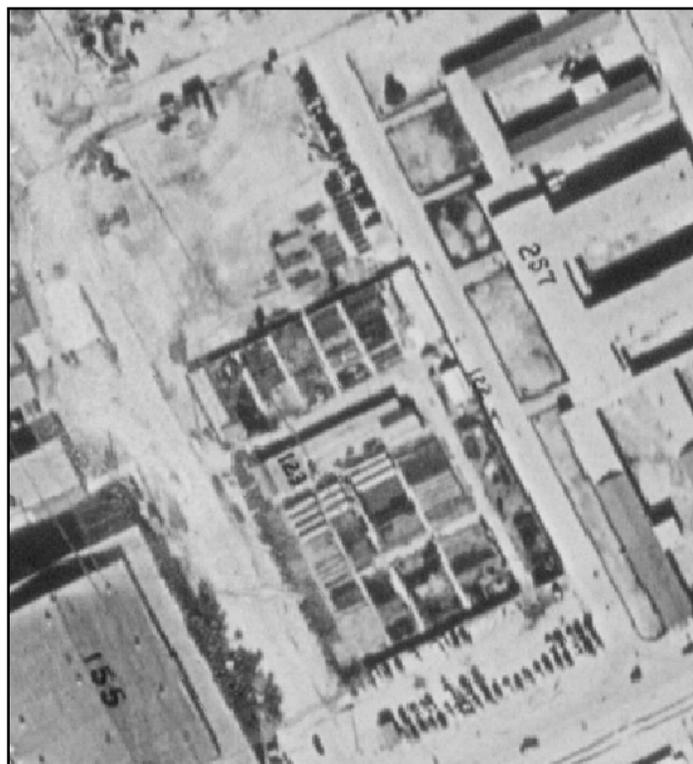
Photo 39: Storage yard area circa 1945

Recommended Actions – Complete a characterization survey and remediate known areas of contamination. Complete an FSS after remediation is completed.

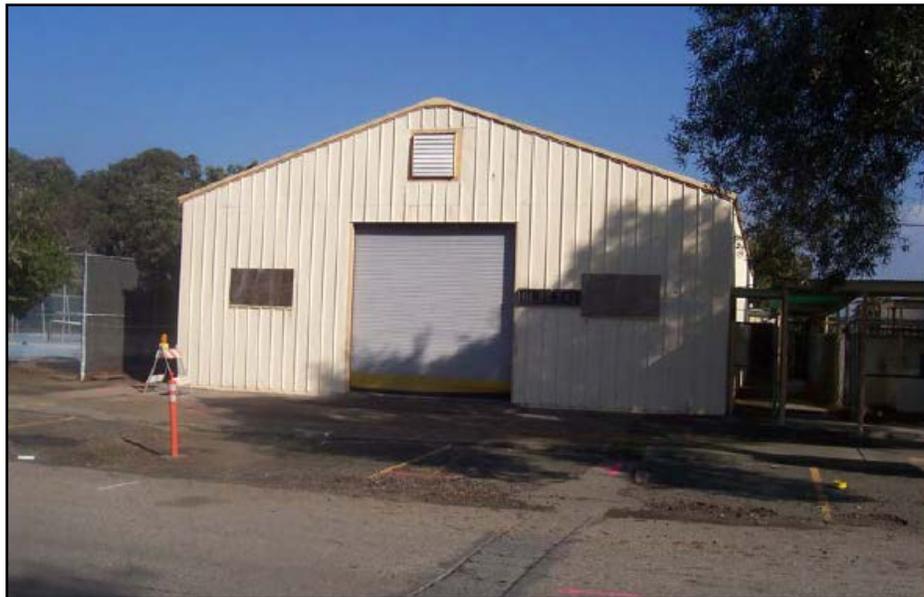
Photo 41: Building 342 area

Site Description – Building 342 was constructed in 1951. It is a single story slab-on-grade approximately 8,000-square-foot metal building. This area was not identified as radiologically impacted in the HRA. The 1972 license description states that “Building 342 houses two labs belonging to RADIAC Maintenance School and one lab that belongs to Underway Replenishment School. Lab #1 is not in use. Lab #2 contains RADIAC storage spaces, a workshop and a counting lab. Lab #3 contains equipment

Recommended Actions – Do a scoping and an FSS of the structure, and a scoping survey of the sanitary sewer line that services the building out to the nearest sump.

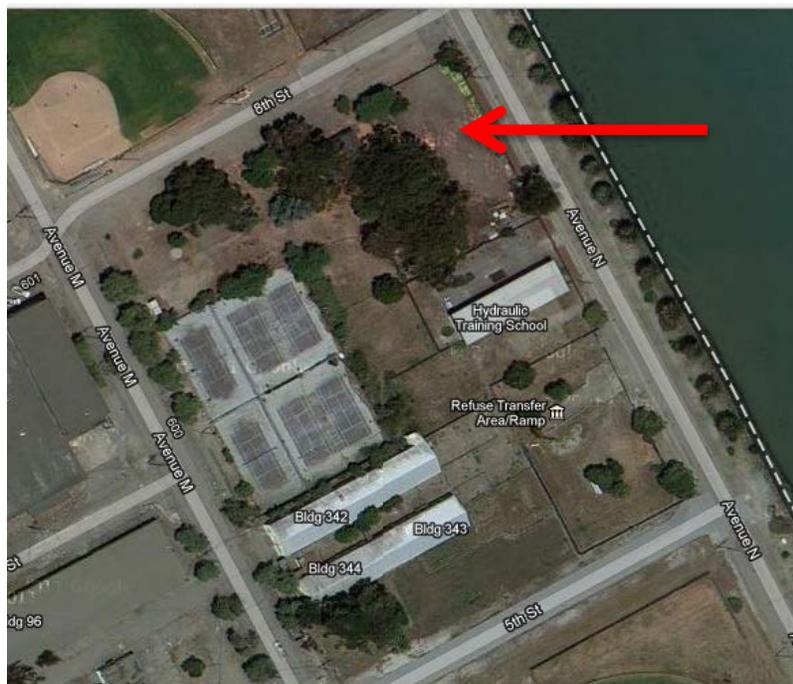
Photo 42: Location of Former Salvage Yard (Lot 69)

Site Description – As noted in [Section 2.2](#), sometime between 1962 and 1968, a Supply Department Salvage Yard was established east of the tennis courts (see above [Photo 42](#) and [Figure 6](#)). By 1996, this salvage yard area was referred to as Lot 69 and was listed as a Hazardous Waste Accumulation Area in the Spill Prevention, Control, and Countermeasures plan. The northern, larger part of Lot 69 was the non-hazardous storage or staging area for furniture and non-hazardous tools waiting to be disposed of by the DRMO. South of the lot there is a transfer station for solid waste. A general inventory of waste stored in the hazardous waste accumulation area consisted of waste oils, flammables, corrosives, and other regulated materials like rags, latex paints, empty paint and flammable containers. Because this area was used as a salvage yard and due to the lack of any other radiological information associated with this site, this HRASTM identifies this salvage yard (Lot 69) as impacted based on the fact that salvage yards are often linked with the potential for disposal of unregulated radiological commodities.

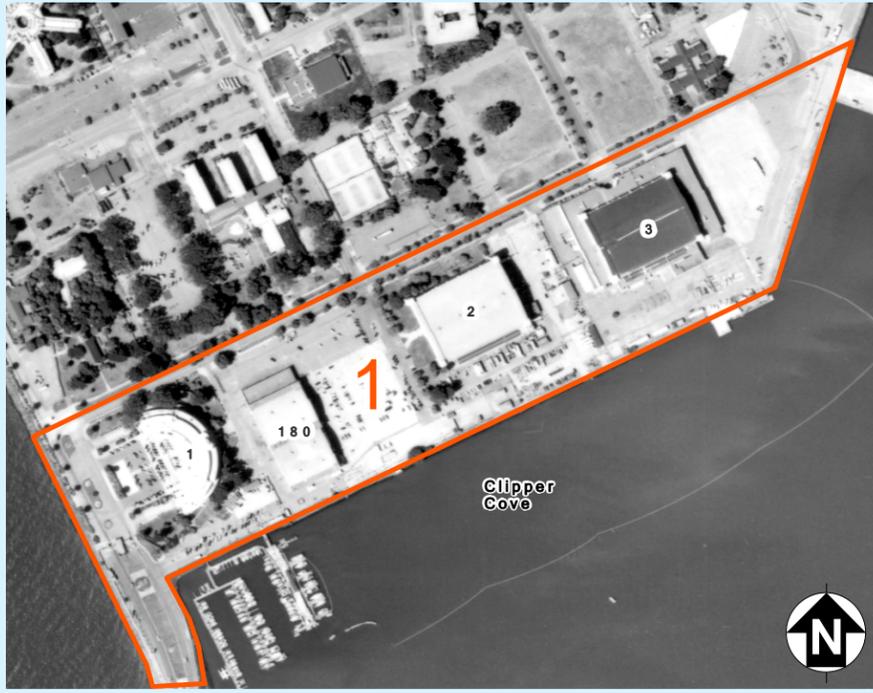
Seaplane Lagoon Area of Interest
15 August 2000 (not to scale)

- In addition, an optical shop which likely handled radioactive materials was located on the roof of Building 3.
- Oil storage tanks on southeast corner of Treasure Island were removed shortly after the end of the WWII.
