Historical Radiological Assessment – Supplemental Technical Memorandum

**Naval Station Treasure Island
San Francisco, California**

August 6, 2012

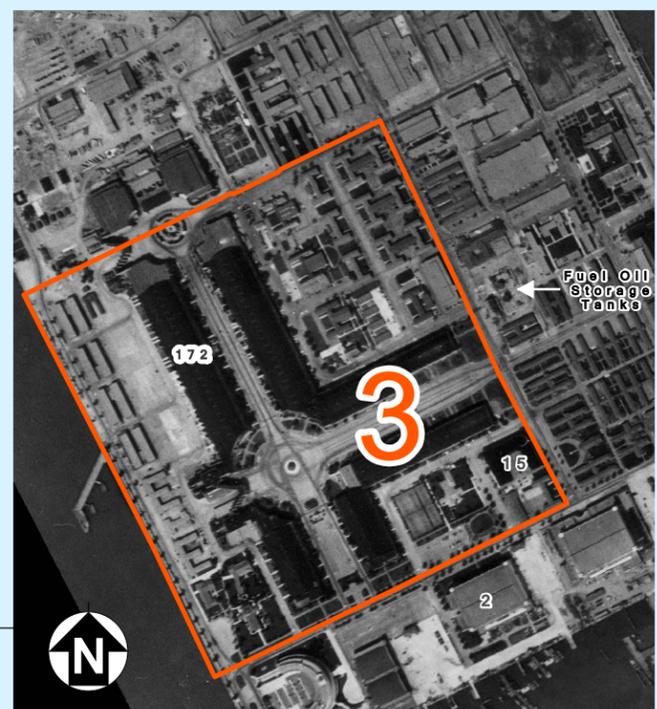
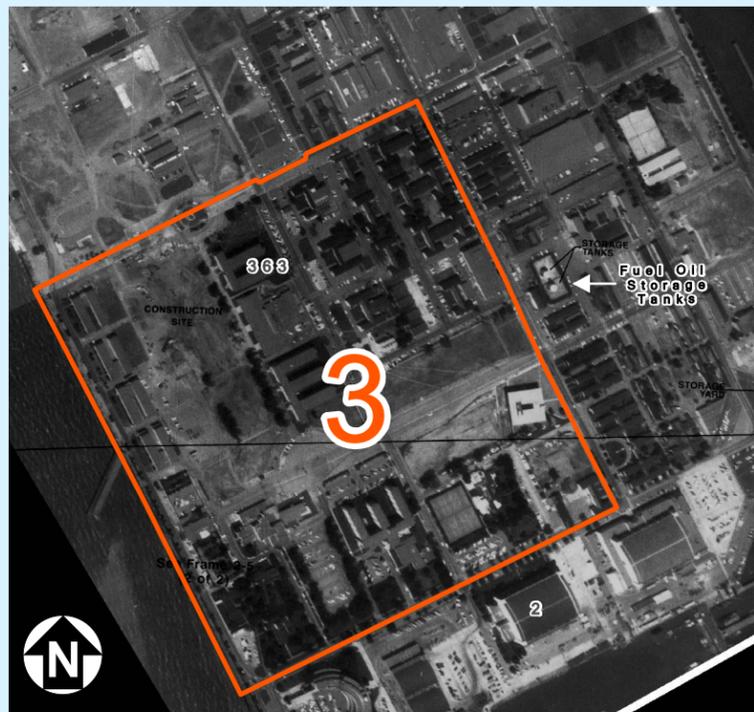
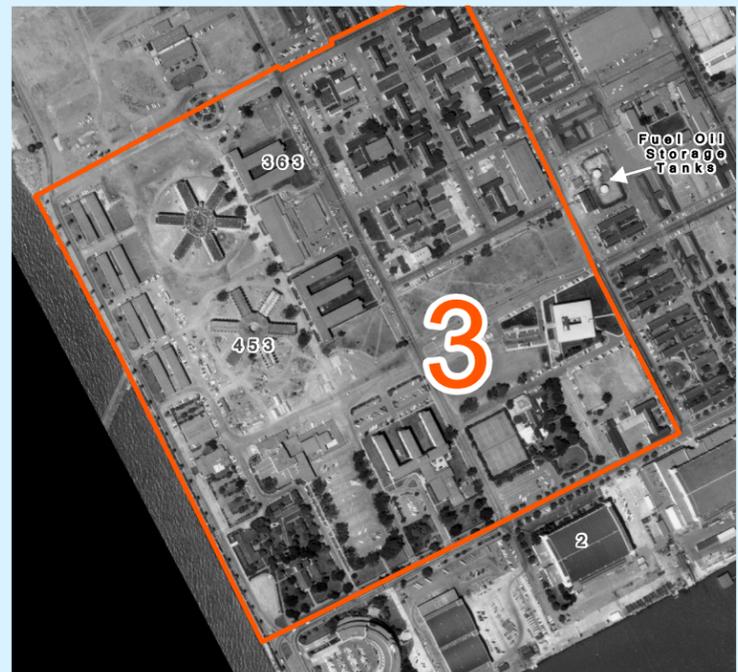
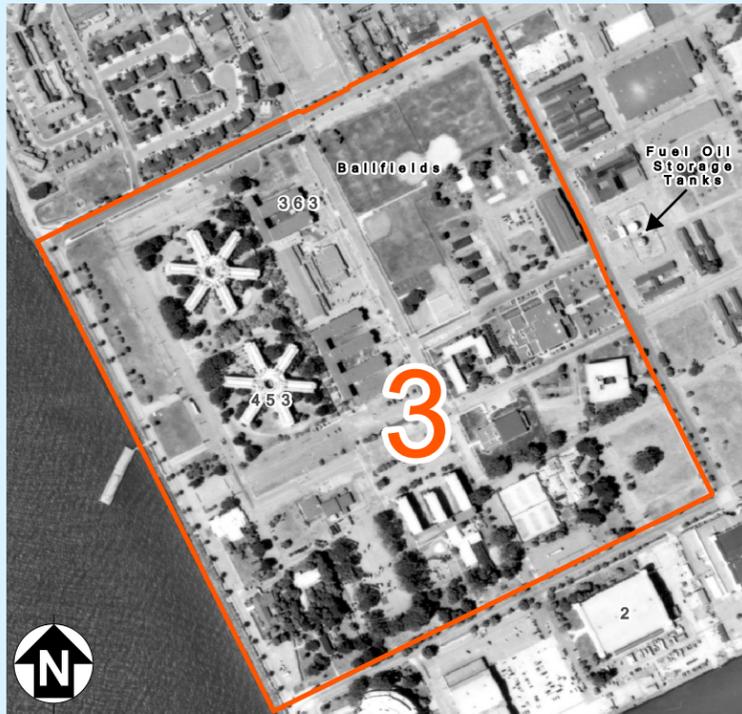
FIGURE 3
SEAPLANE LAGOON
AREA OF INTEREST 1

NOTES:
Area of Interest 3 has no radiologically impacted areas:
1) No evidence of radiological work has been found in this area;
2) Buildings in the area primarily served as barracks and support facilities and there is no evidence of industrial activities in this area;
3) There is no evidence of industrial lay down areas having been present in this area from review of available documents.

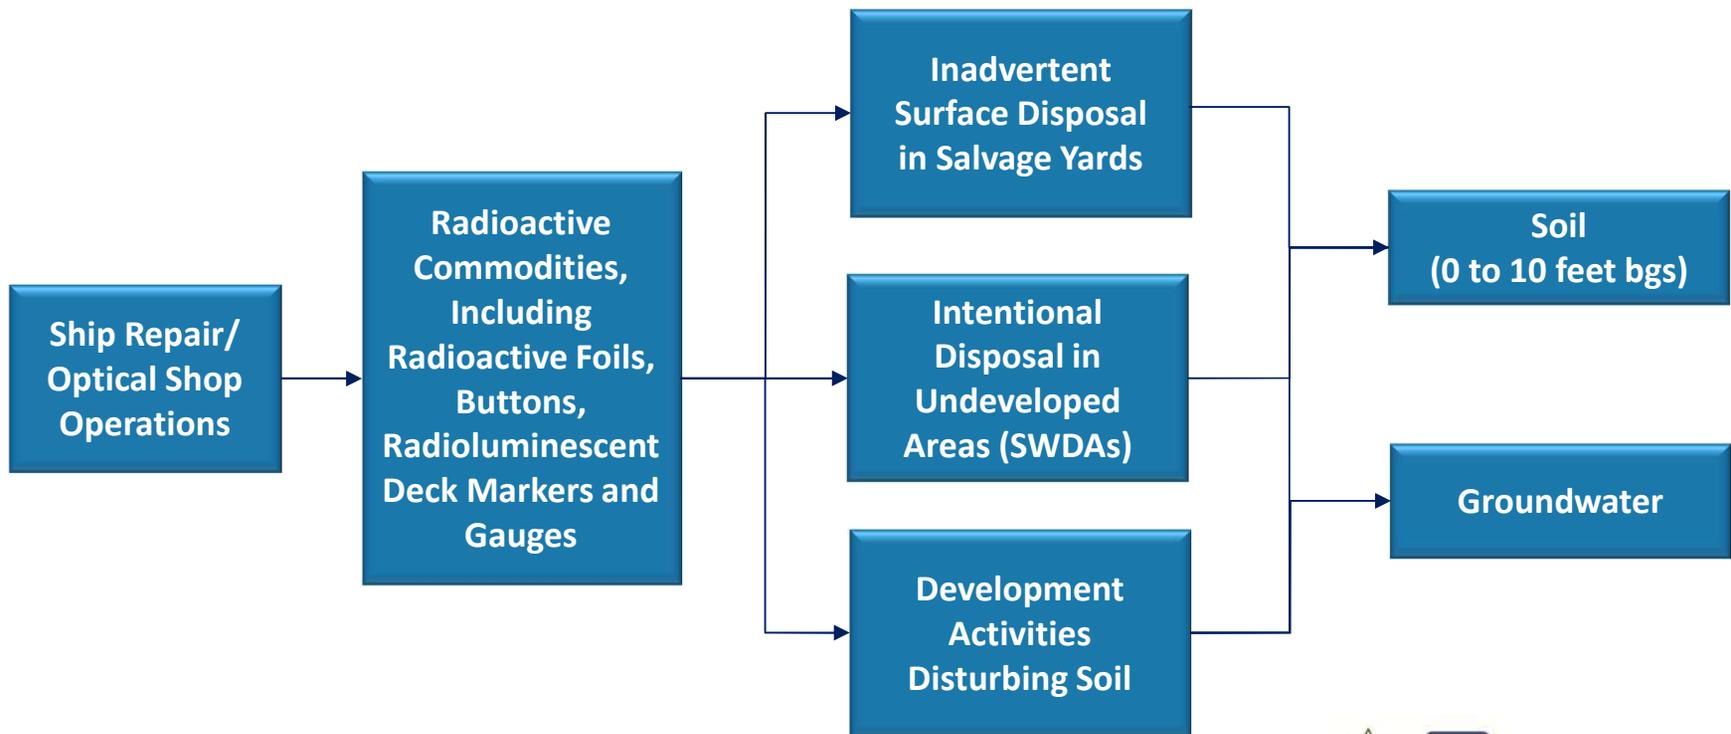
FIGURE 11
REPAIR/SOLID WASTE DISPOSAL
OPERATIONS –
CONCEPTUAL SITE MODEL

Contaminated Media
