Former NAS Brunswick

Restoration Advisory Board Meeting 14 June 2012

HISTORICAL RADIOLOGICAL ASSESSMENT (HRA) FORMER NAVAL AIR STATION BRUNSWICK BRUNSWICK, MAINE

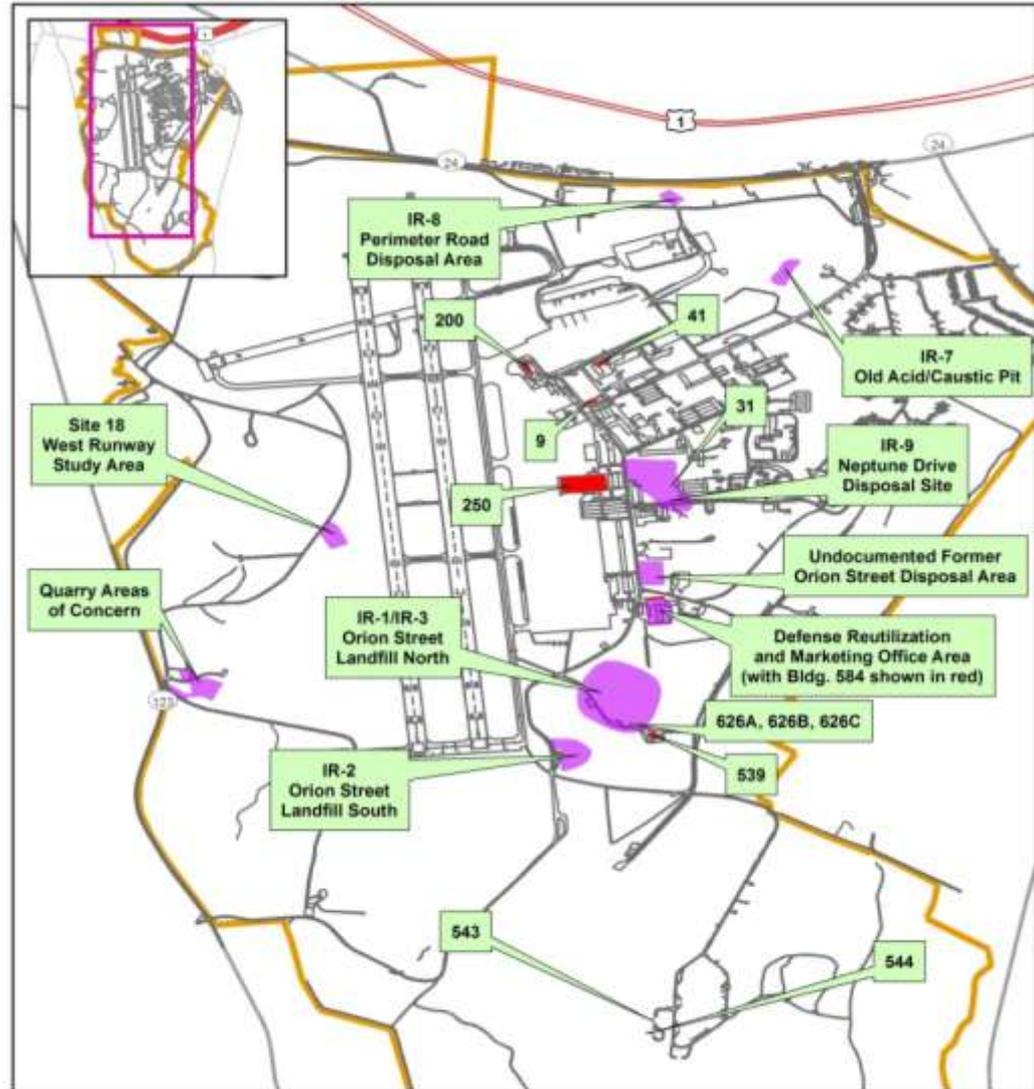
Building 9

- This approximately 8,900 ft² building was originally built in 1943 as a laundry facility and later housed the Electronic and Ordnance Shop (1950s - 1960s) and the Patrol Squadron Special Unit (VPU) (1970s-1980s)
- As an Electronics and Ordnance Shop, this building was used in the maintenance and repair of electronic components
- The building was impacted because aircraft components, electronics, and instrumentation that potentially contained radioactive material were stored and maintained in the building

Recommended Action: **scoping survey** of building structure and drains (if present)

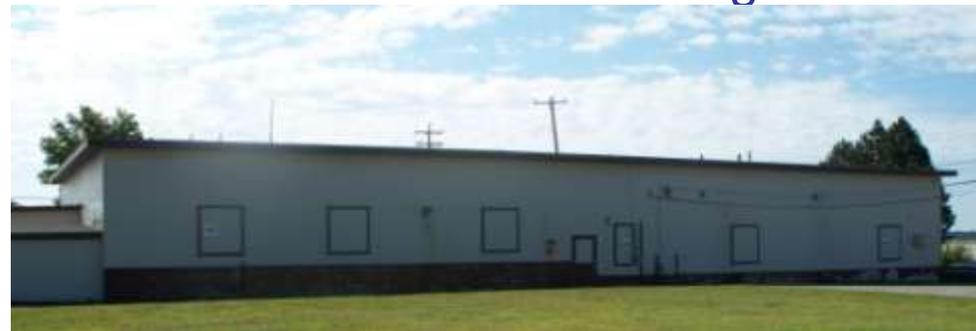
Building 41

- This approximately 10,500 ft² single story structure with below ground utility area was constructed prior to 1944
- A portion of the building housed the parachute maintenance operations until those activities were moved to Building 250 in the 1980s
- This building was impacted because of the maintenance of survival vests which were equipped with compasses and personnel markers containing radioluminescent material

Recommended Action: **scoping survey** of building structure and drains (if present)

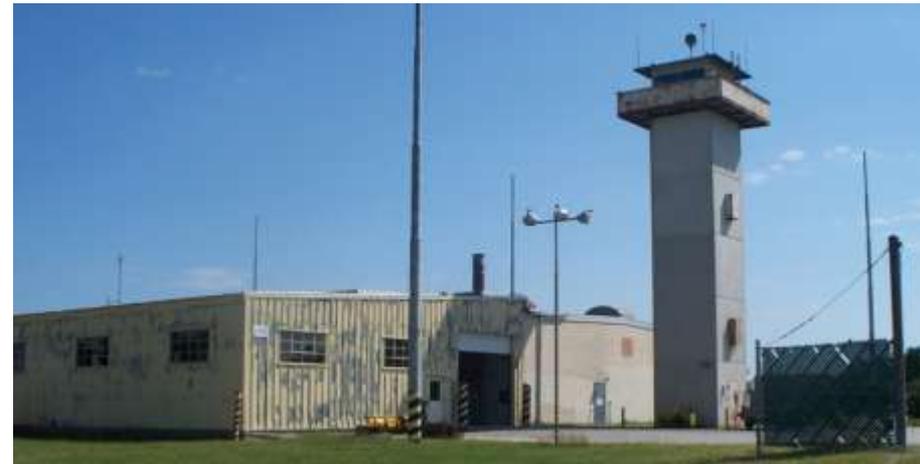
Building 584/DRMO

- The DRMO Area consists of Building 584 (DRMO) and the adjacent DRMO yard. Building 584 was built in 1965. The square footage of the building is 7,200 ft²
- The DRMO yard was a paved, fenced enclosure that is approximately 84,000 ft²
- The DRMO coordinated sale or disposal for the Navy's surplus materials and hazardous waste.
- Building 584 and the DRMO laydown yard were impacted due to the handling and storage of materials that may have contained radioactive material

Recommended Action: **scoping survey** of building structure and drains (if present)

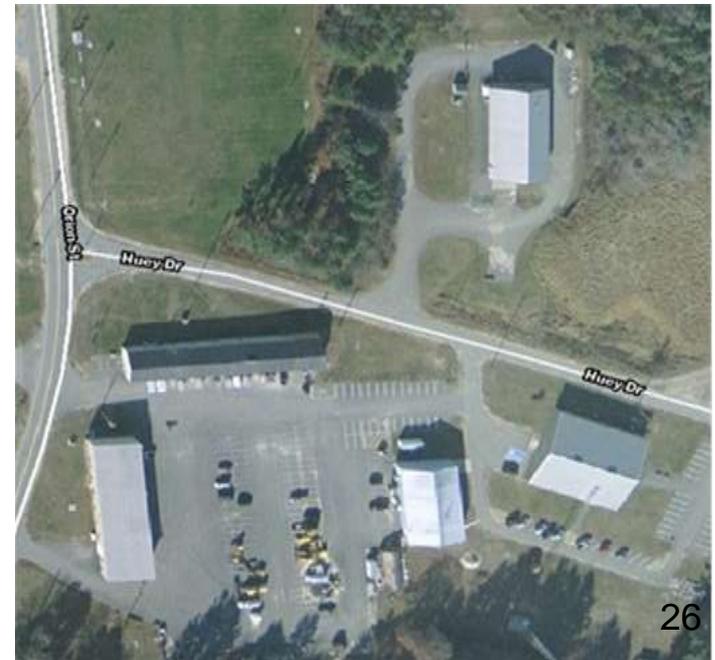
Building 543 & 544

- Building 543 is a 1,200 ft² weapons magazine and Building 544 is a 2,300 ft² weapons magazine that were built in 1958
- The magazines have a history of use as AUW facilities and would likely have stored the weapons inventory
- Building 543 was impacted due to the potential for weapons containing radioactive material having been stored there

Recommended Action: **scoping survey** of building structure

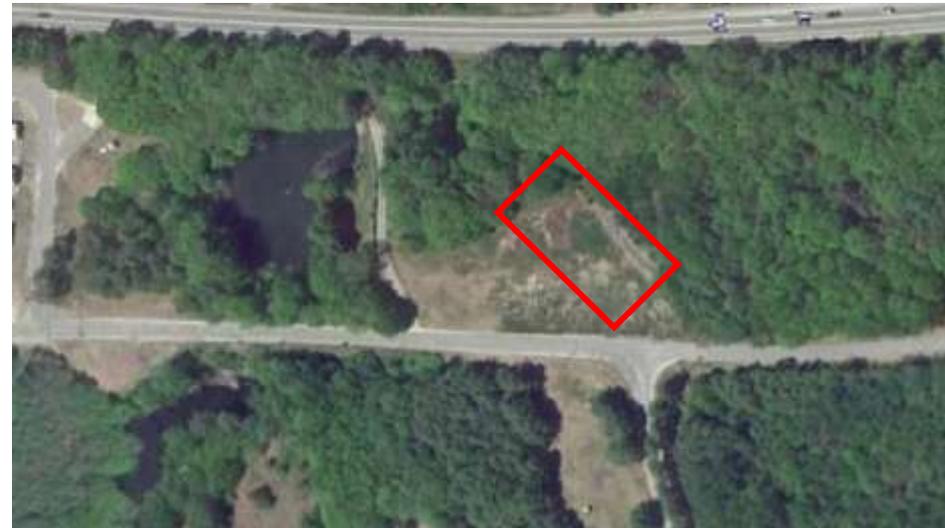
IR Site 8

- The Perimeter Road Disposal Site (IR Site 8) is an approximately 1 acre located along the northern boundary of the installation (south of Bath Road), in a wooded area adjacent to Building 634
- The site was believed to have been used to dispose of demolition debris (as well as construction material and solvents) from 1964 to 1974
- The Site is impacted due to the potential for items containing radioactive material being disposed of within its boundaries

Recommended Action: **scoping survey** of the area

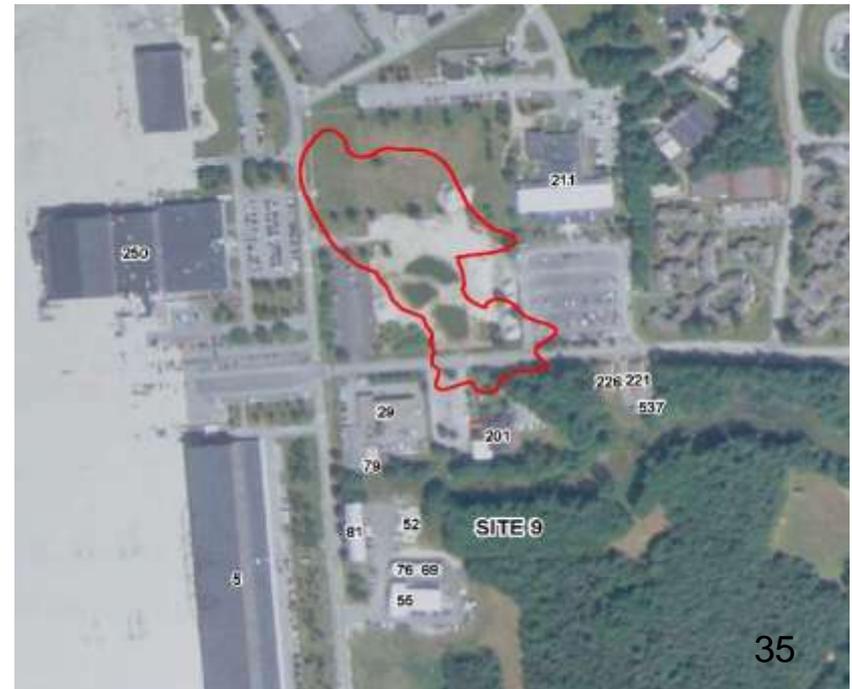
IR Site 9

- The Neptune Drive Disposal Area (IR Site 9) is a partially remediated hazardous waste disposal area occupying approximately 20 acres in the central portion of the base
- Between 1943 and possibly 1953, solid hazardous waste was reportedly burned in the adjacent incinerator and ashes were disposed of in trenches at Site 9
- Since there was the potential that the debris that was incinerated contained radioactive material, there is a possibility that the ash may also have been radiologically contaminated
- The Site was impacted due to the potential for items containing radioactive material being disposed of within its boundaries

Recommended Action: Review (and revise as necessary), the Land Use Control Implementation Plan for applicability to radiological issues and conduct **scoping** surveys of the area

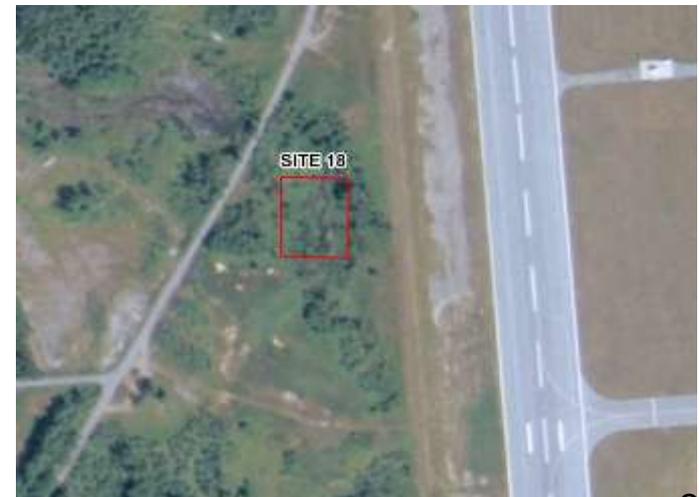
IR Site 18

- The West Runway Site (IR Site 18) is an approximately 0.8 acre area located just to the west of the outbound runway and is partially included in the Former Munitions Bunkers area
- During excavation of test pits in 1993, fill material and metallic debris were uncovered and removed
- Because it is unknown what type of debris was disposed of in this area, there is a possibility that radiologically contaminated debris, radioluminescent devices, and electronics containing radioisotopes could have been disposed at this site
- The Site was impacted due to the potential for items containing radioactive material being disposed of within its boundaries

Recommended Action: **scoping survey** of the area

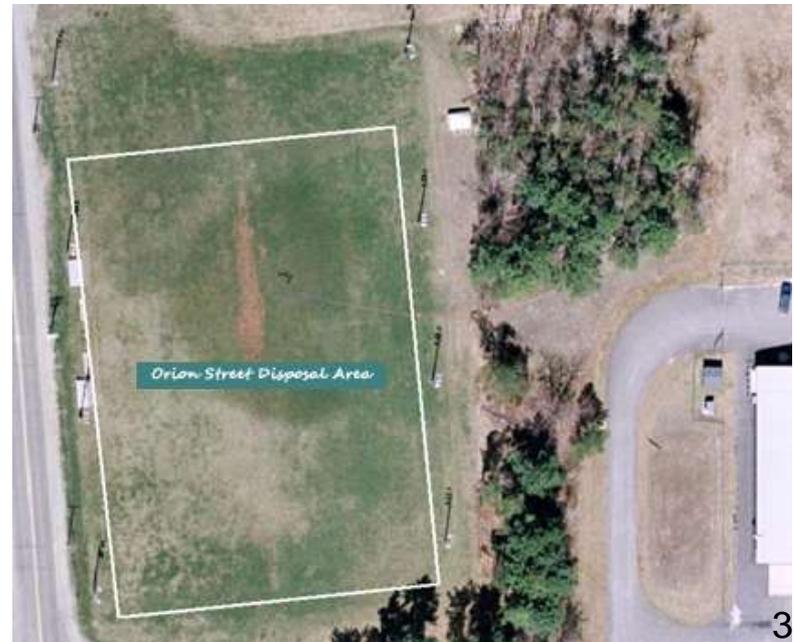
- The Undocumented Former Orion Street Disposal Area is located at the corner of Orion Street and Merriconeag Drive and the exact size of the area is unknown
- The site was identified by a former Navy electronics technician as an open disposal area where the GEMD disposed of defective electronics components, including electron tubes containing radioactive material
- The Undocumented Orion Street Disposal Area is impacted due to the potential for items containing radioactive material being disposed of within its boundaries

Recommended Action: **scoping survey** of the area
