ADAK RESTORATION ADVISORY BOARD

Monday, 30 September 2019
5:00 pm Adak: Community Room
and via Teleconference

ADAK Restoration Advisory Board (RAB) Meeting Materials

ADAK MMRP PROJECT UPDATE

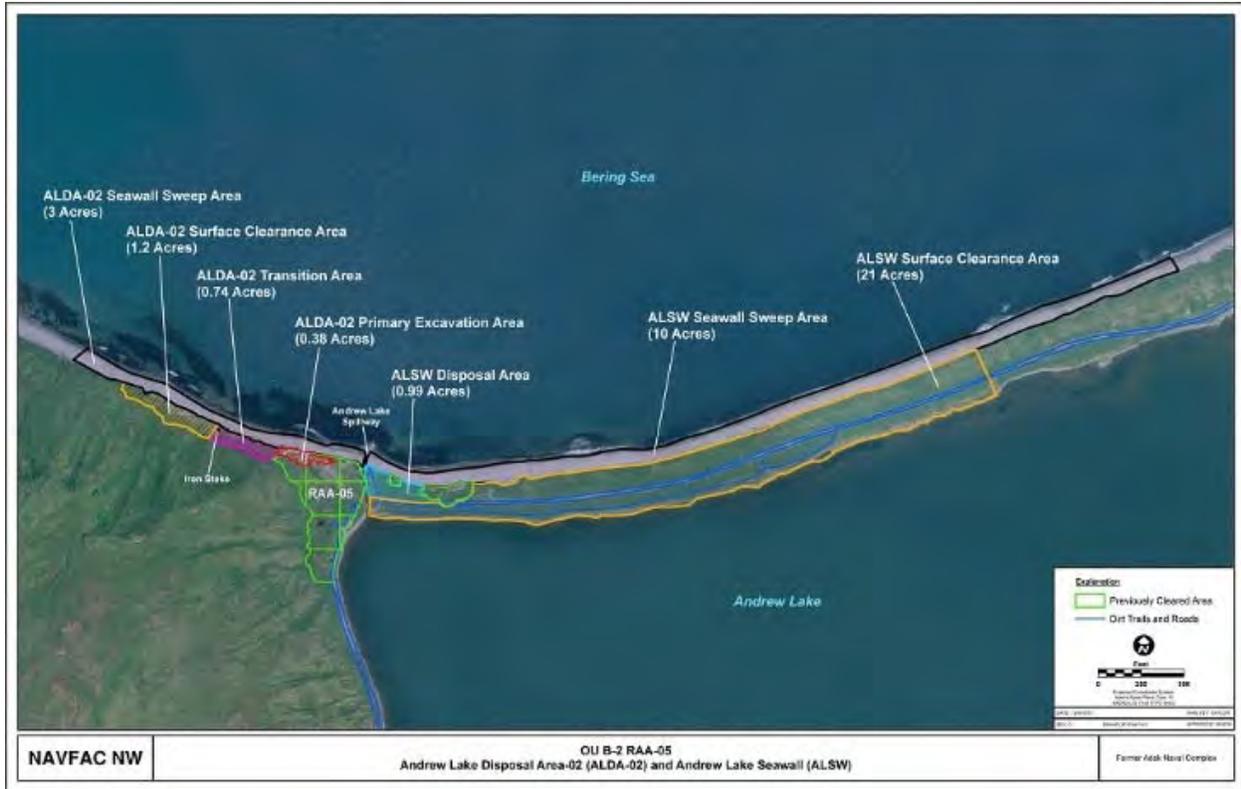
Aptim is midway through their current contract to continue work on the NTCRA through 2020. Work areas shown on the graphic below.

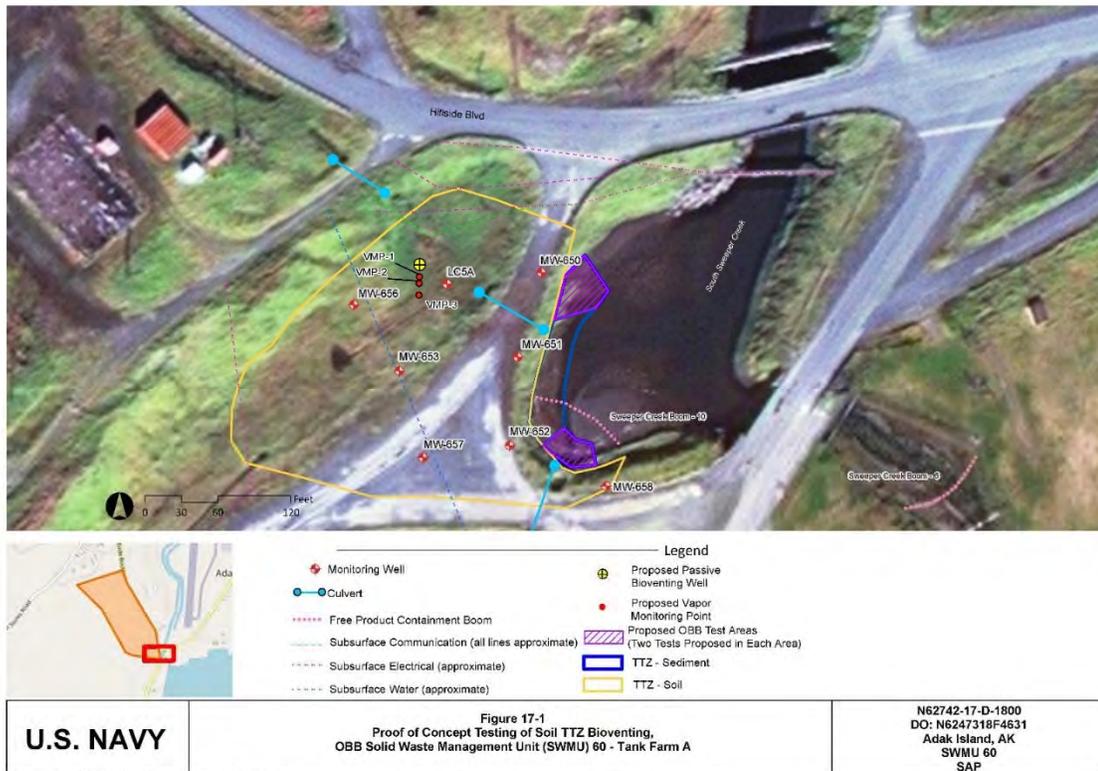
- Installation of one wind-assisted bioventing well and three vadose zone monitoring points at a location with the highest known concentrations of contaminants in soil upgradient from South Sweeper Creek.
- Installation four 3-square-foot OBB test areas at locations with the highest known concentrations of contaminants in sediments at South Sweeper Creek.
- See the following graphic below

- Proof-of-concept testing was conducted at SWMU 60 for the OBB and bioventing technologies July and August 2019. Following the testing period (30-60 days), the collected data will be evaluated to determine if wind-assisted passive bioventing and oleophilic bio-barrier are viable technologies and full-scale remedy design can proceed.

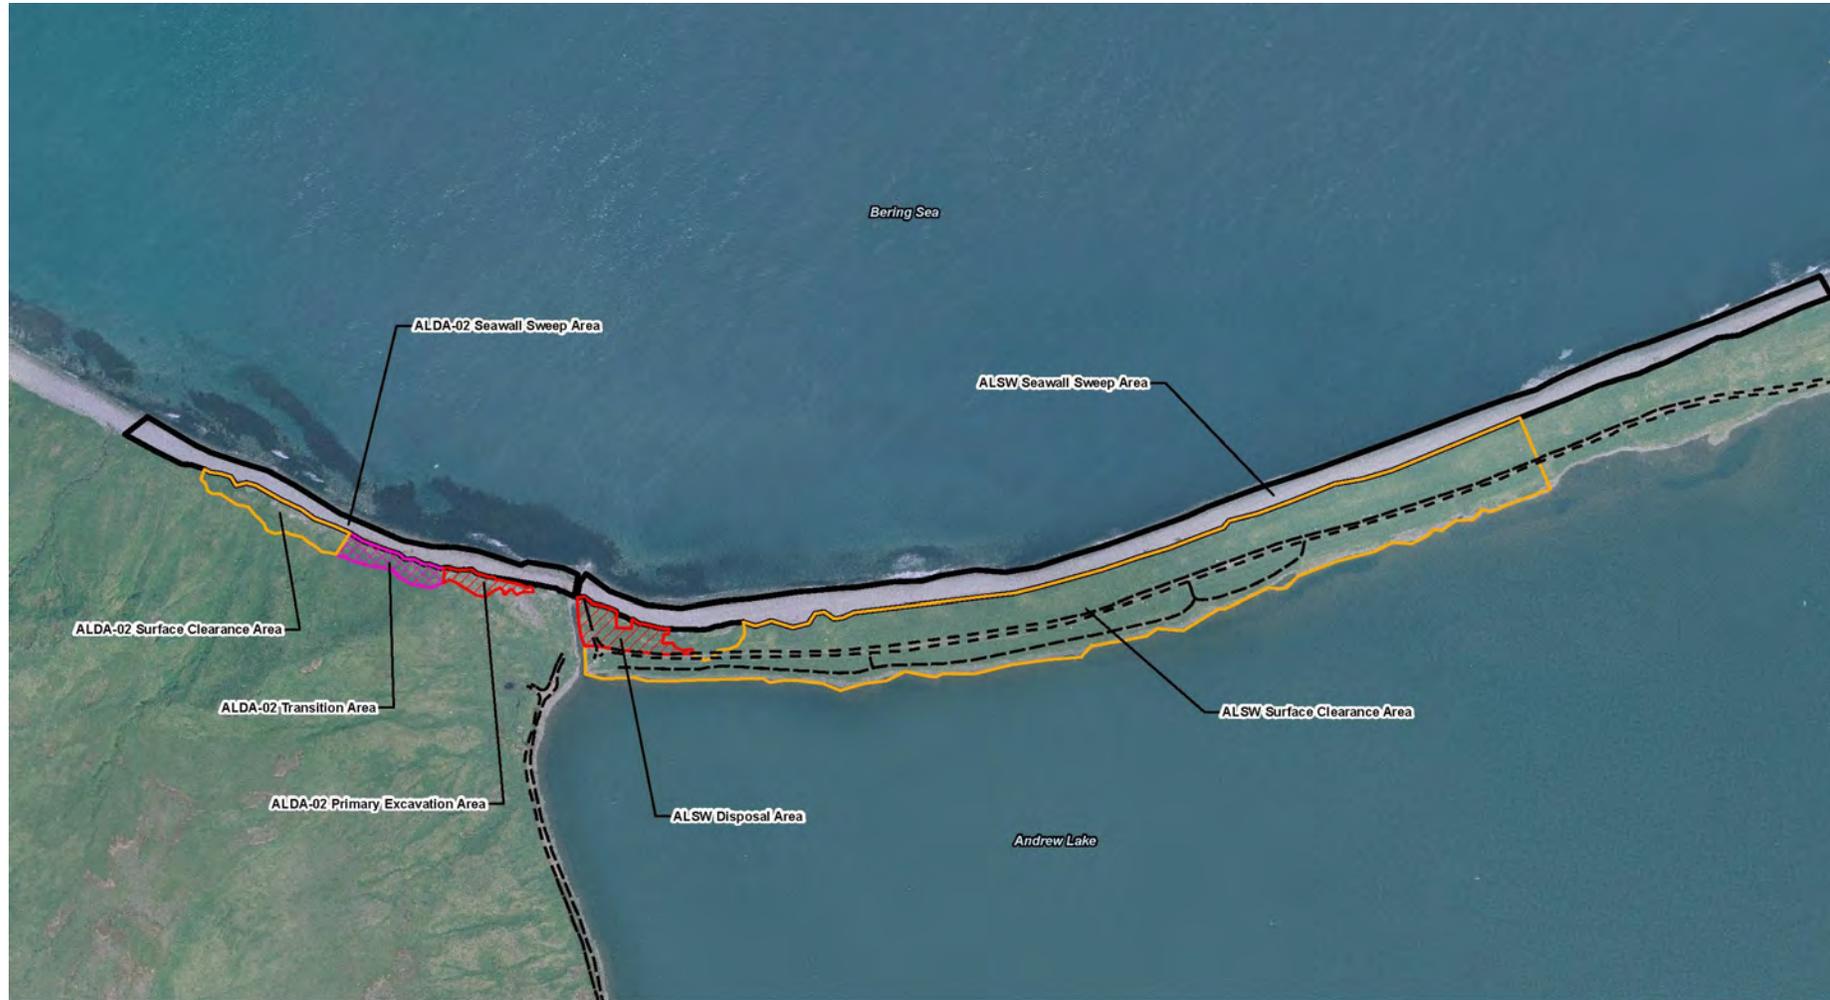
FIGURE NUMBER
H-3

RAA-05
ANDREW LAKE SEAWALL AND
ANDREW LAKE DISPOSAL AREA ;
MEC CLEARANCE AREAS FOR 2019/2020
ADAK NAVAL AIR STATION

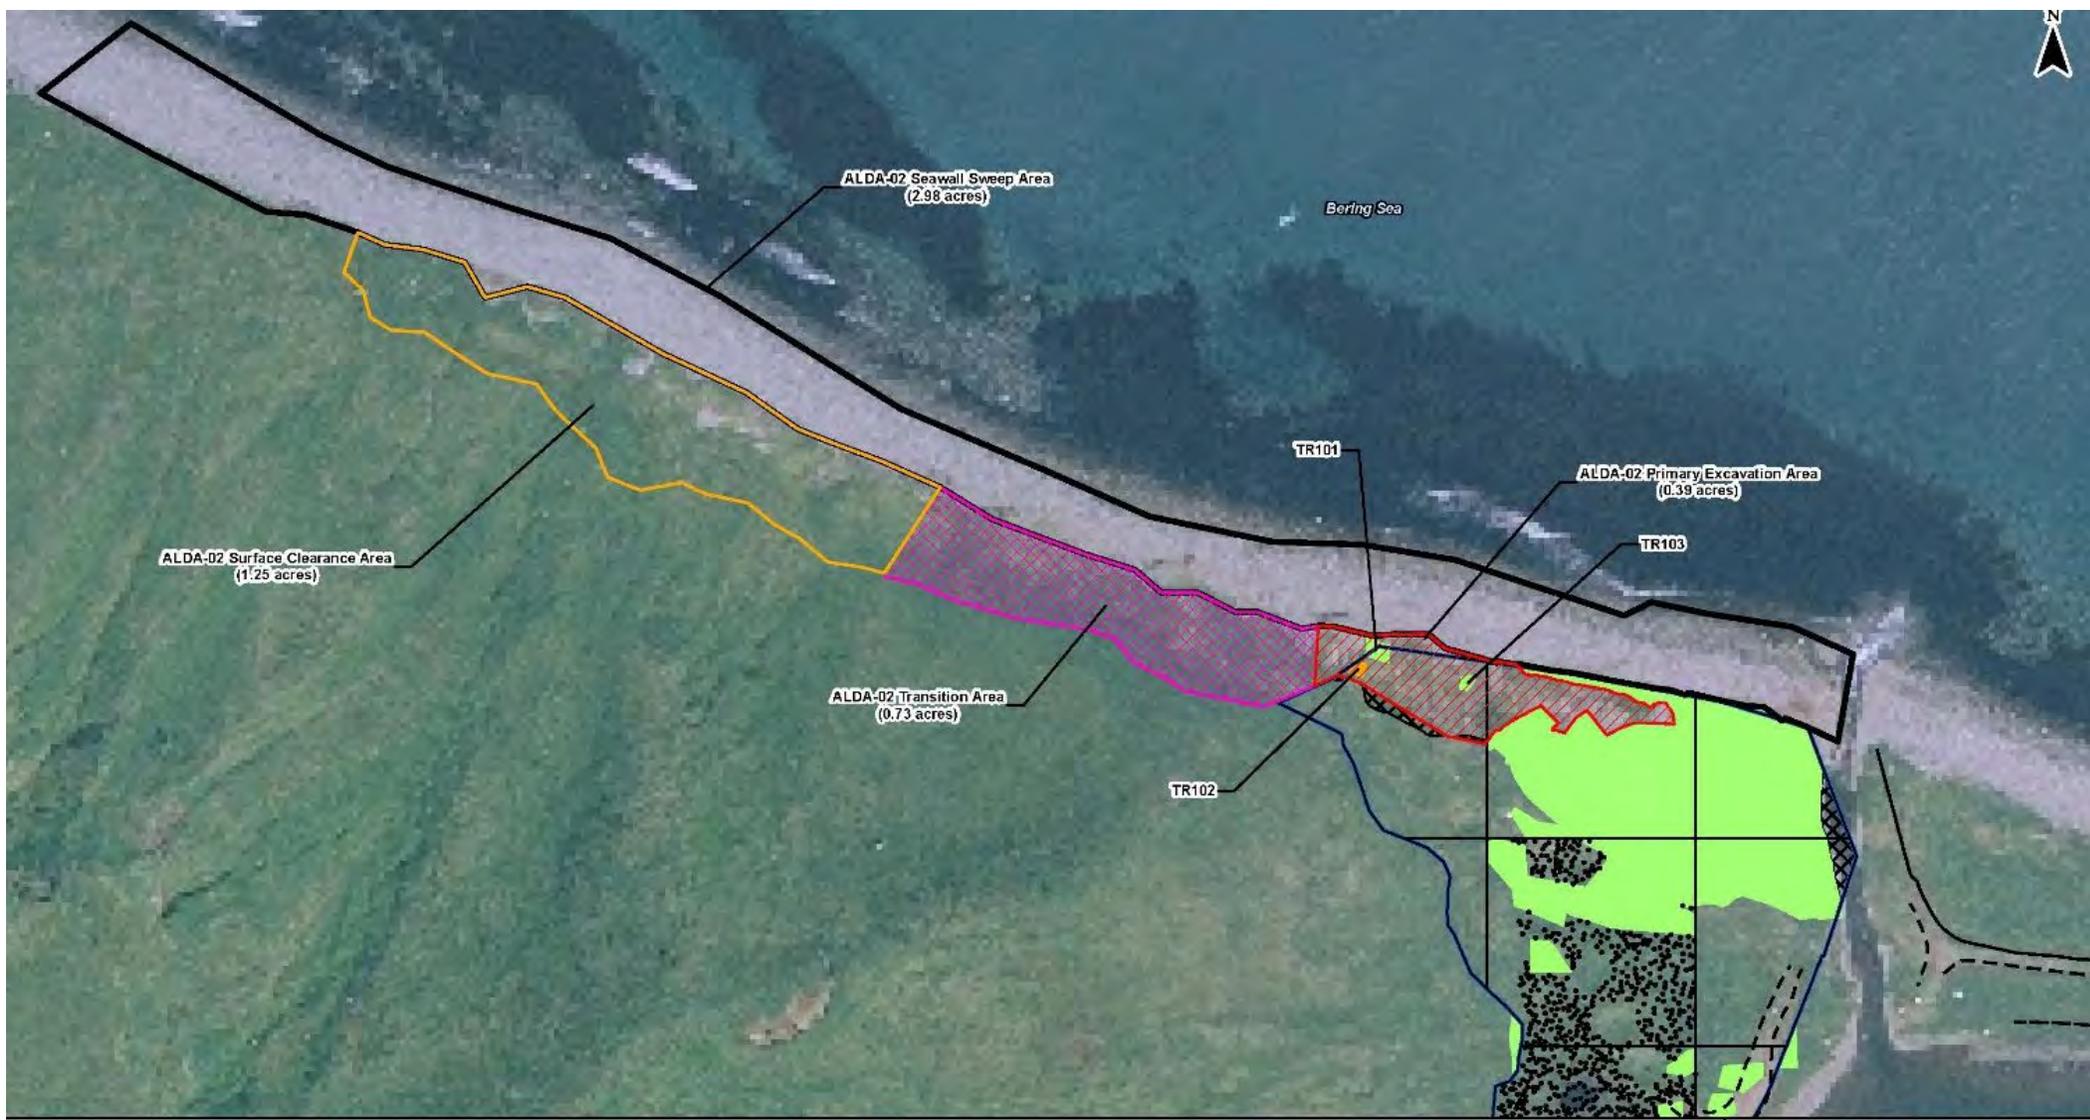
FIGURE NUMBER	RAA-05 ANDREW LAKE DISPOSAL AREA 2 MCC CLEARANCE AREAS FOR 2019/2020 ADAK NAVAL AIR STATION
H-4

RAA-05 ALDA-02 WORK AREAS

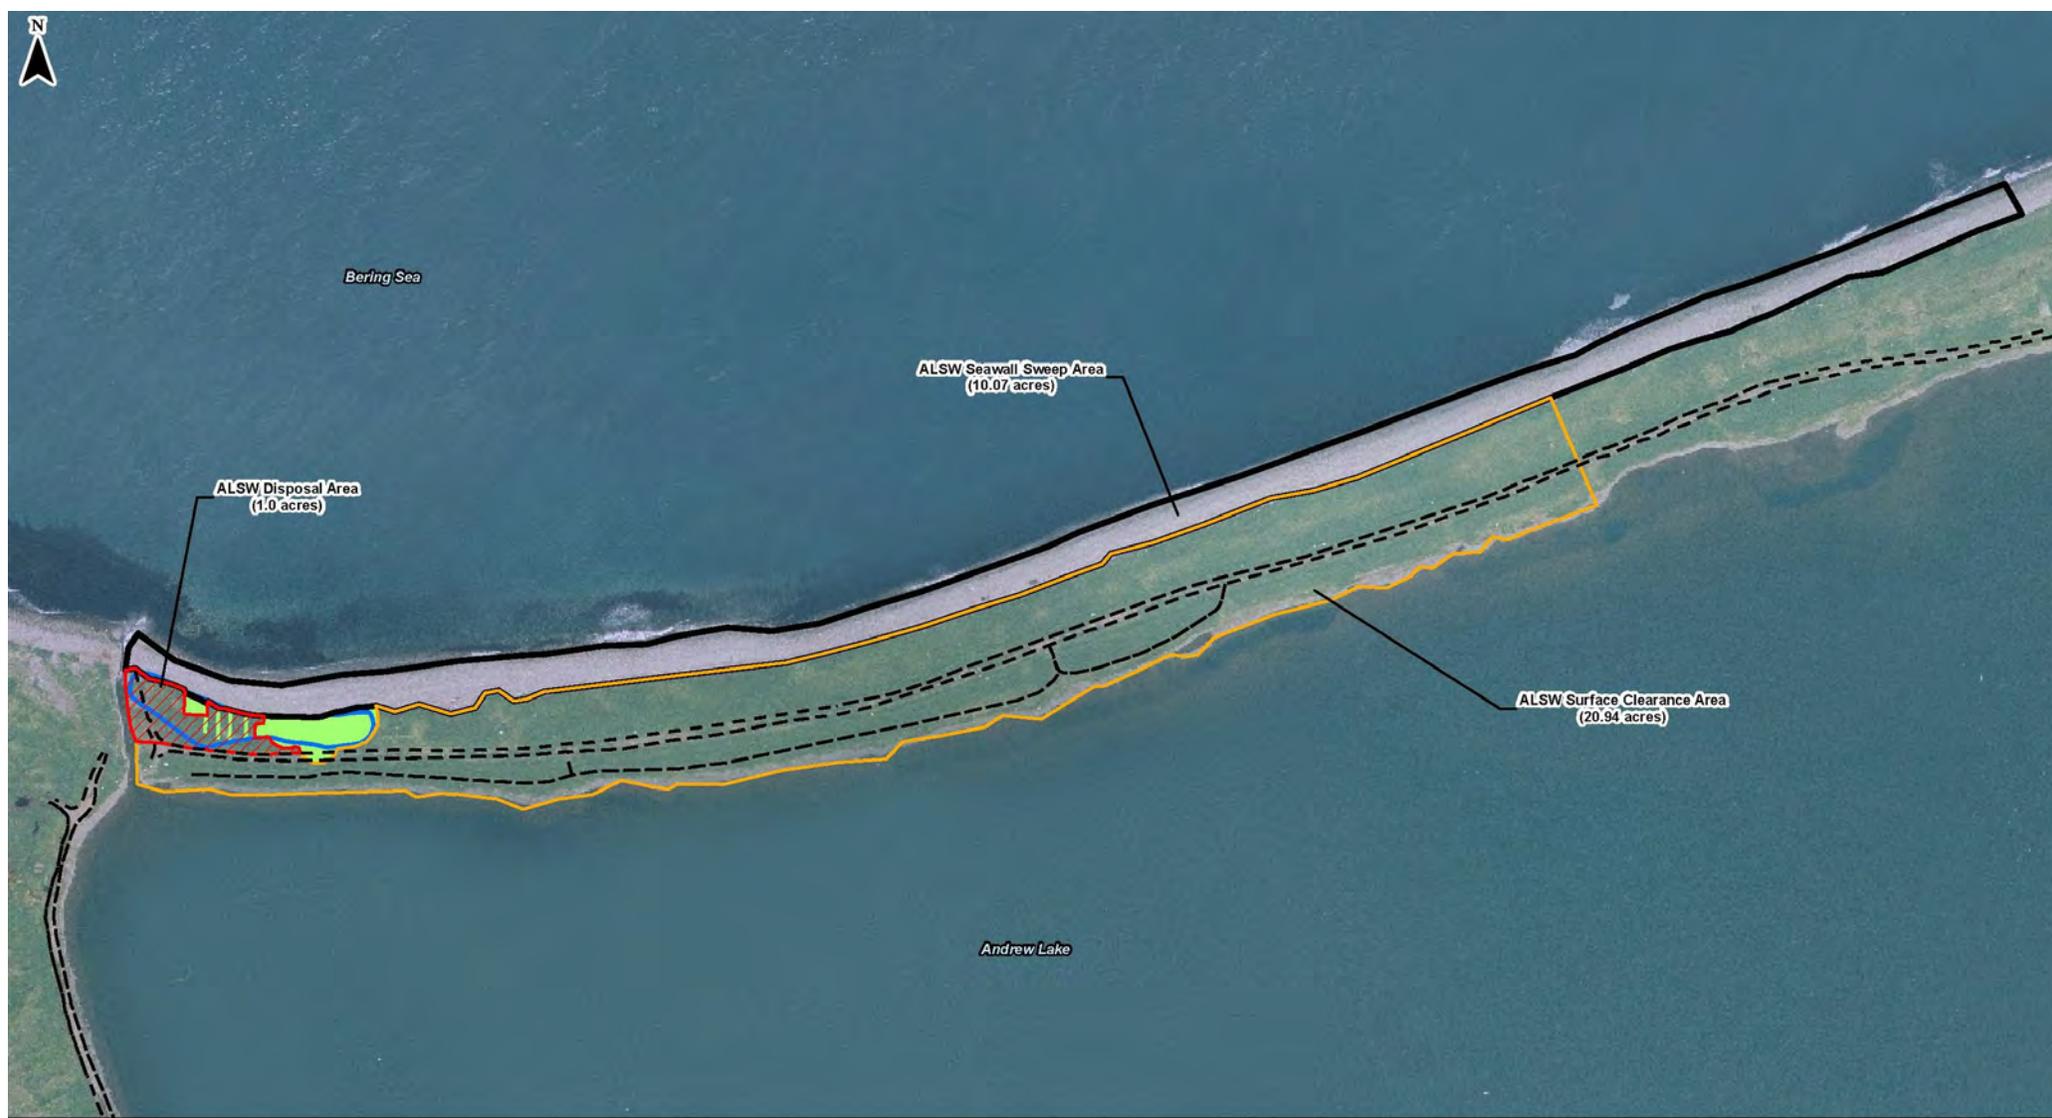
FIGURE NUMBER: **H-5**

RAA-05
ANDREW LAKE SEAWALL
MEC CLEARANCE AREAS FOR 2019/2020
ADAK NAVAL AIR STATION

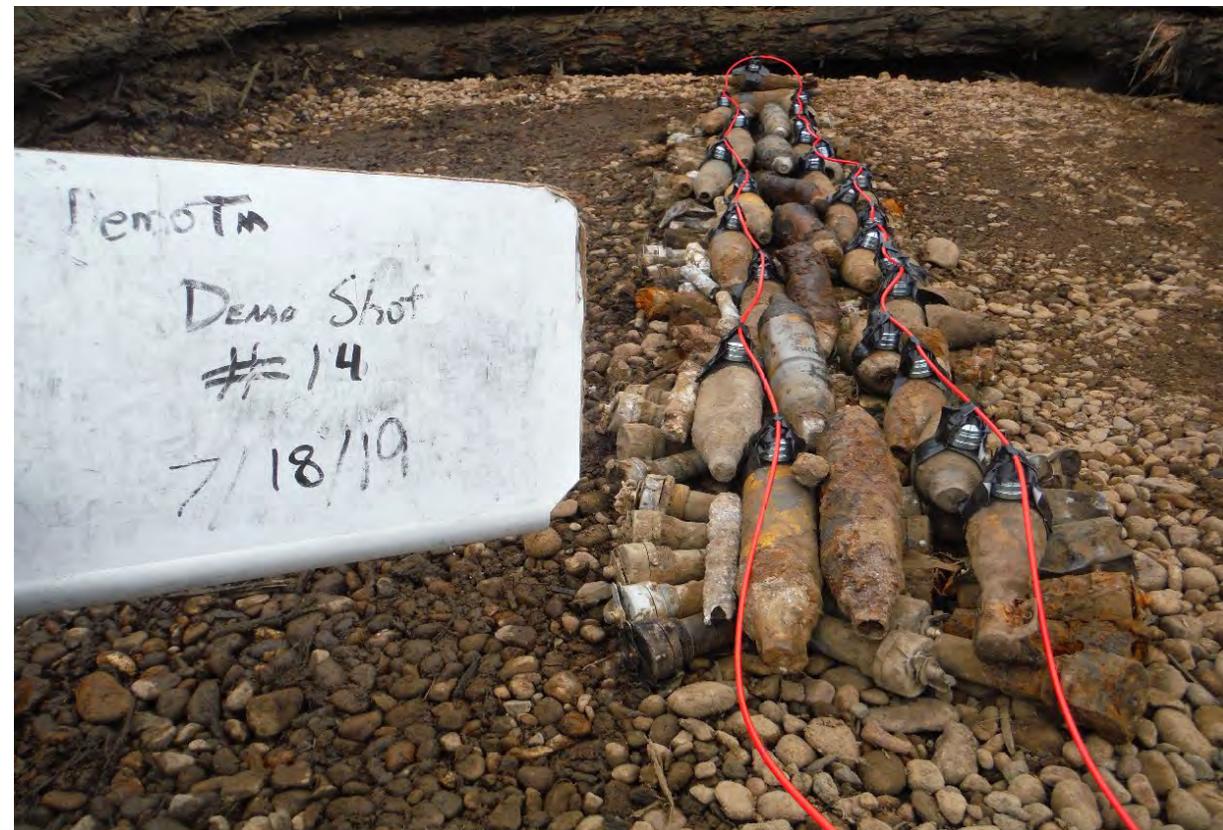
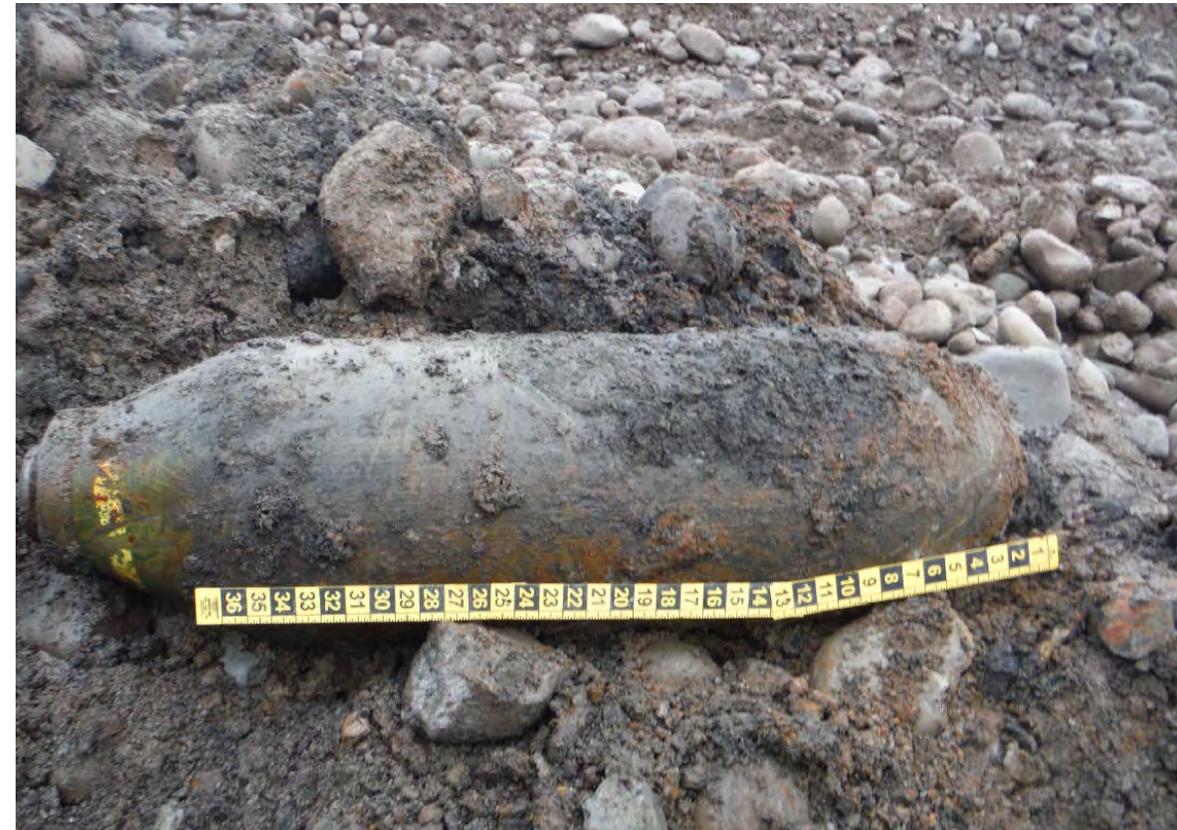
- ▶ Deep burial trenches with a significant number of MEC items
- ▶ 500 lb., general purpose bomb, AN-M64
- ▶ Largest live munition encountered on Adak to date

- ▶ This item is larger than any MEC item anticipated in our explosive safety submission.
 - > The explosive safety submission had to be amended and resubmitted so work could continue
- ▶ This item is larger than can be safely mechanically excavated with an armored excavator in the manner APTIM has been excavating since 2016
- ▶ APTIM will plan the work to use robotic excavators so the excavations in ALDA-02 can be safely completed in 2020

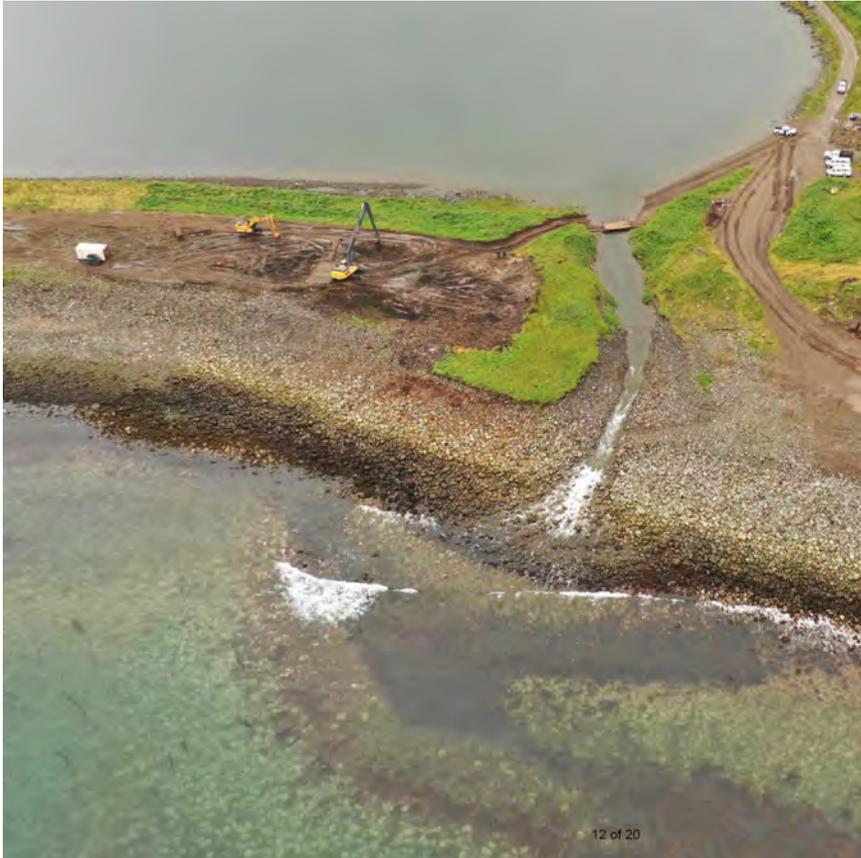
- ▶ Shallower burial trenches with fewer MEC items

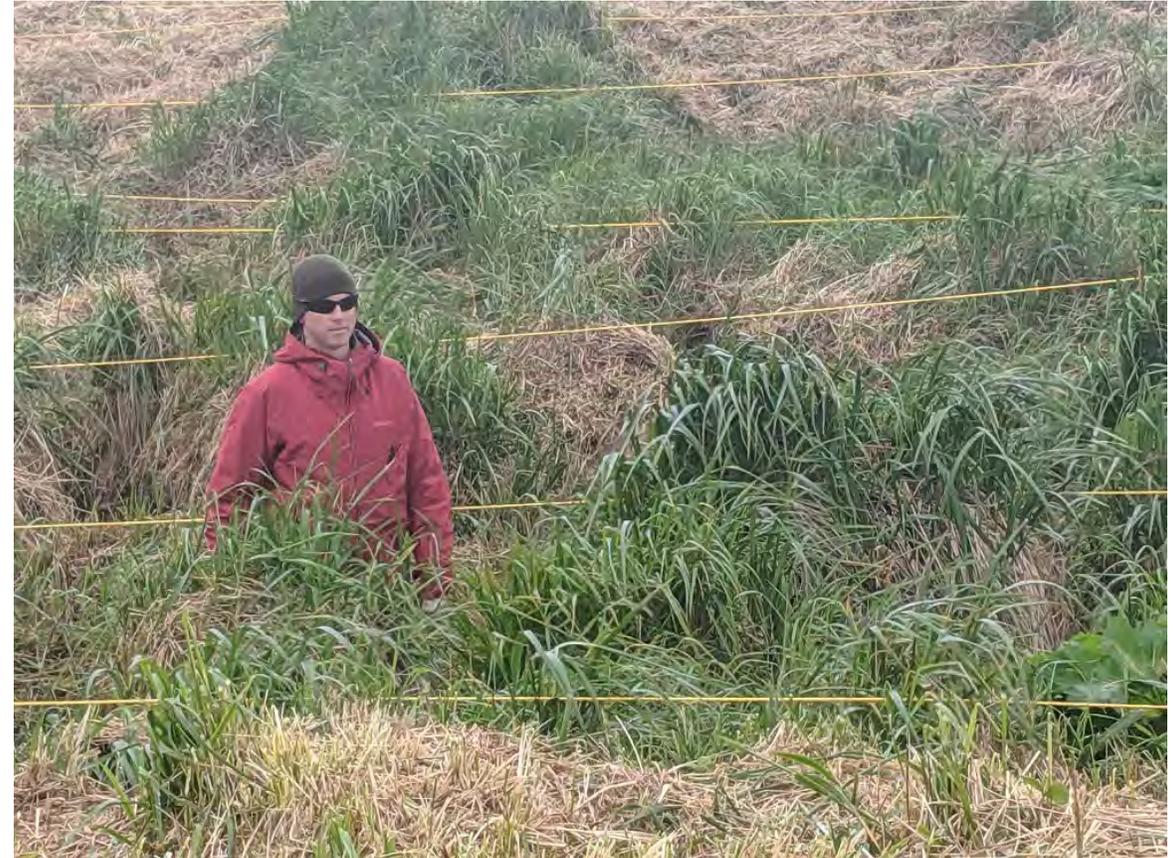
- ▶ Surface Clearance difficult due to thick vegetation

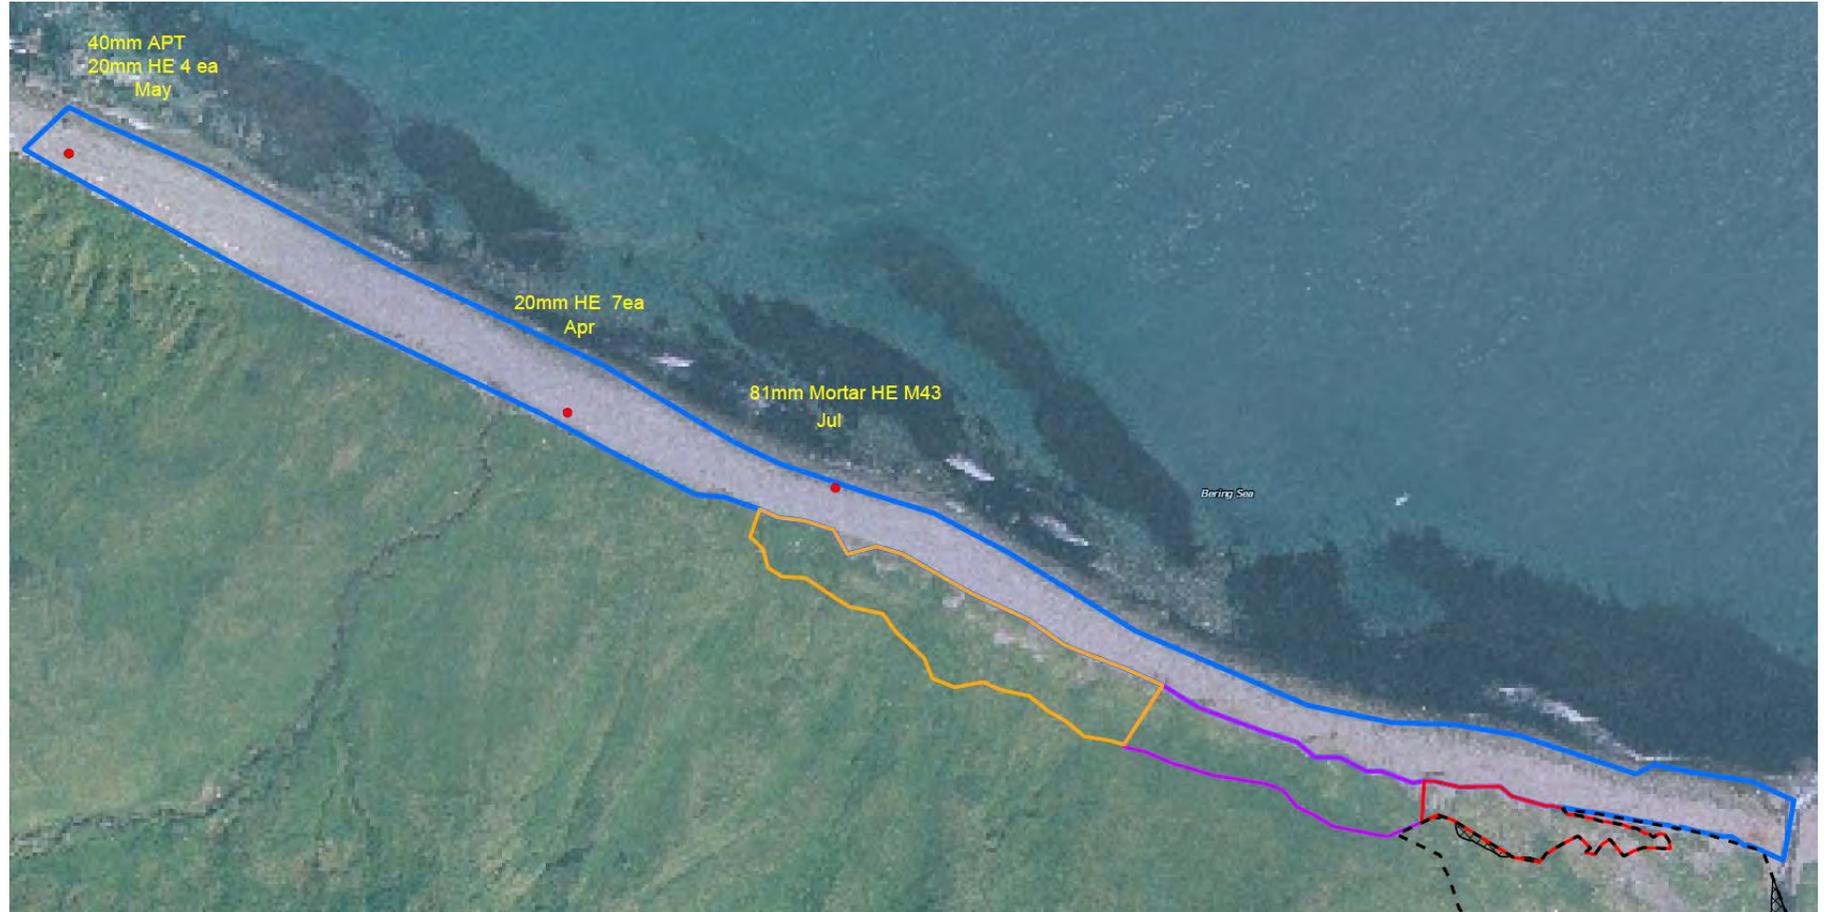
- ▶ Five Monthly Seawall sweeps performed
- ▶ At least one item found in each month except August
- ▶ Total of 17 items

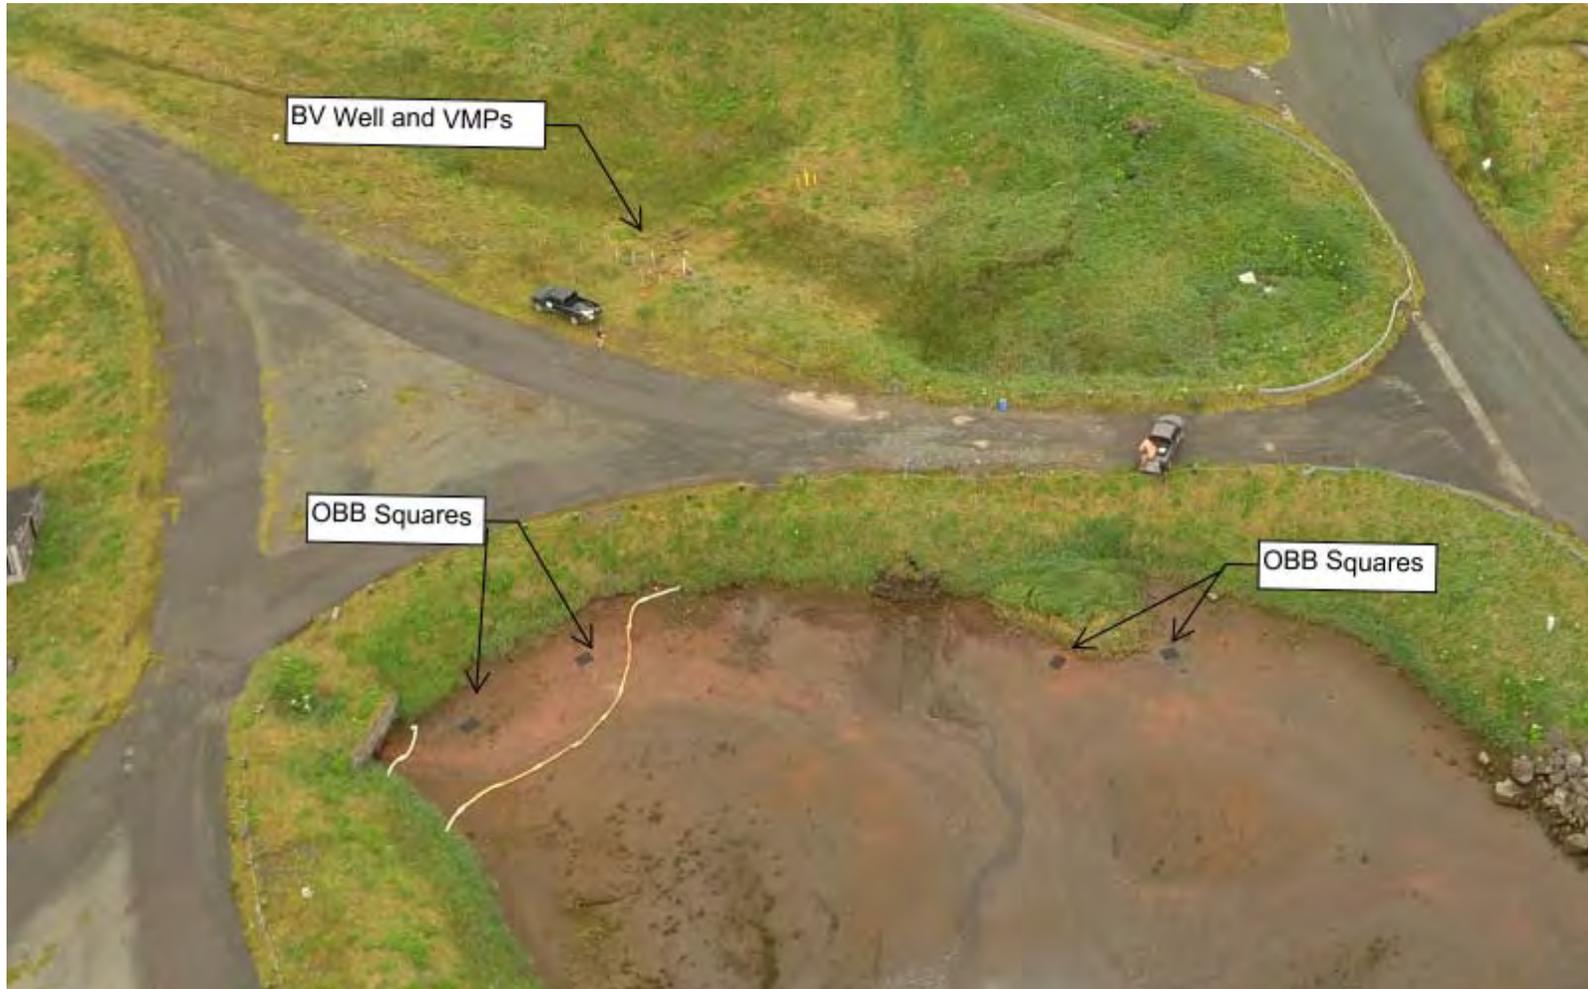
Aerial View of Proof of Concept Testing SWMU60

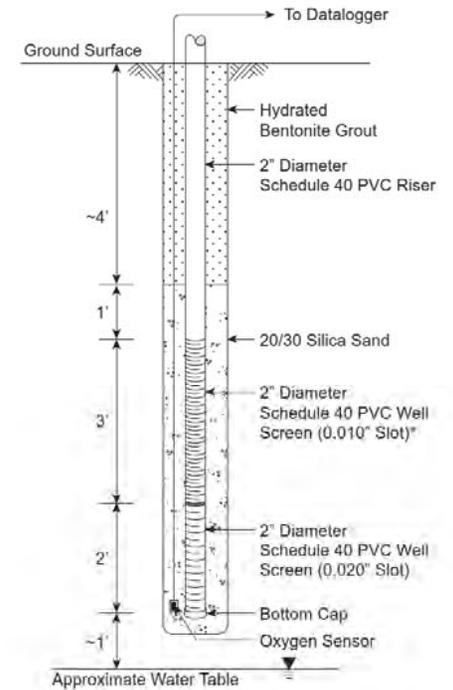
Bioventing Well Schematic

- Directional spout directs air into the subsurface
- Air enters subsurface through well screen
- Low air flow rates provide enough oxygen to sustain microbial activity

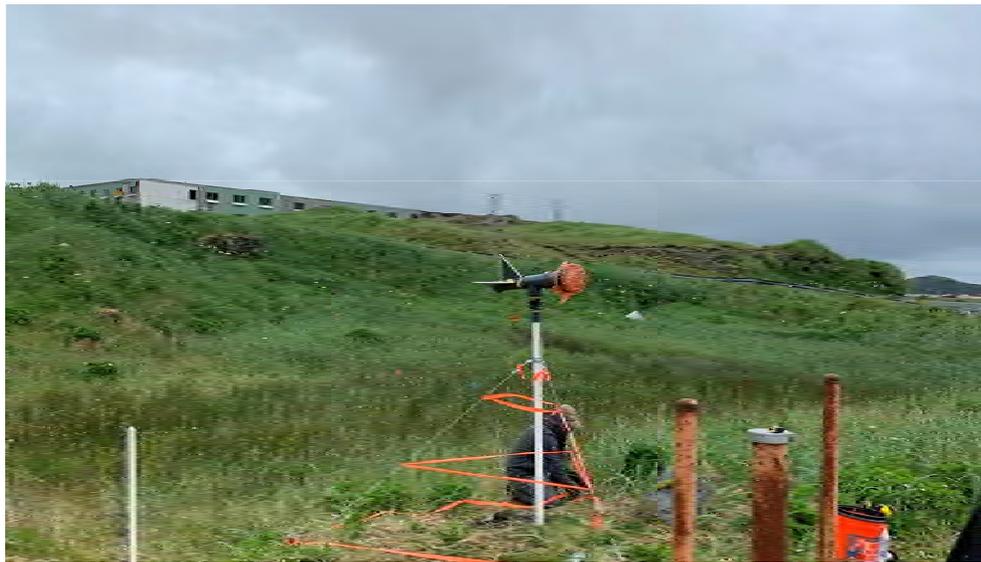
Installed Biovent Well and Vapor Monitoring Points

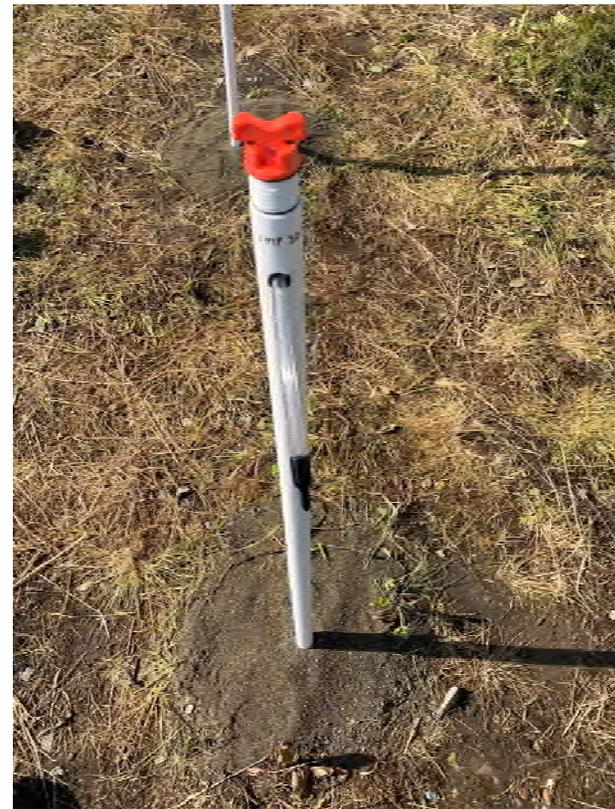
Installed Vapor Monitoring Point

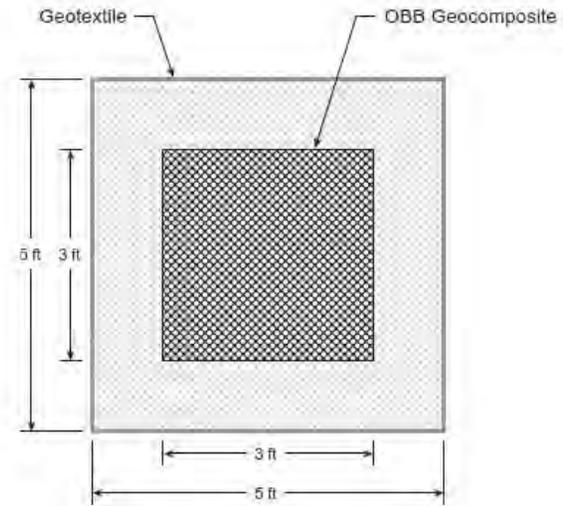
Plan View

- Sand leveling layer placed to minimize surface irregularities
- Clean sand layer covers OBB and this is wrapped in geotextile
- Larger rocks (rip rap) used as anchoring so OBB layer stays in place
- LNAPL absorbs onto fabric as tides change
- Surface water provides oxygen
- Captured product is consumed by microorganisms

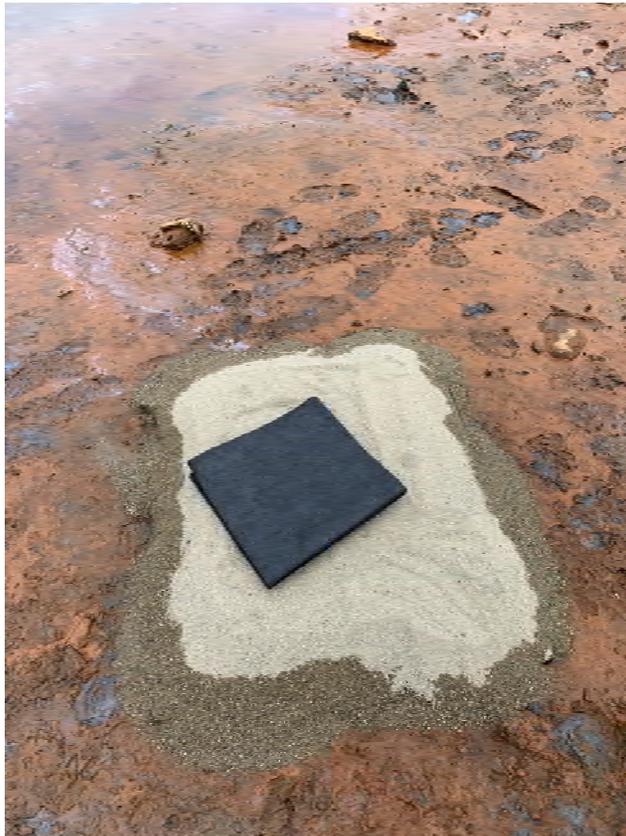
OBB prior to geotextile and anchor rock placement

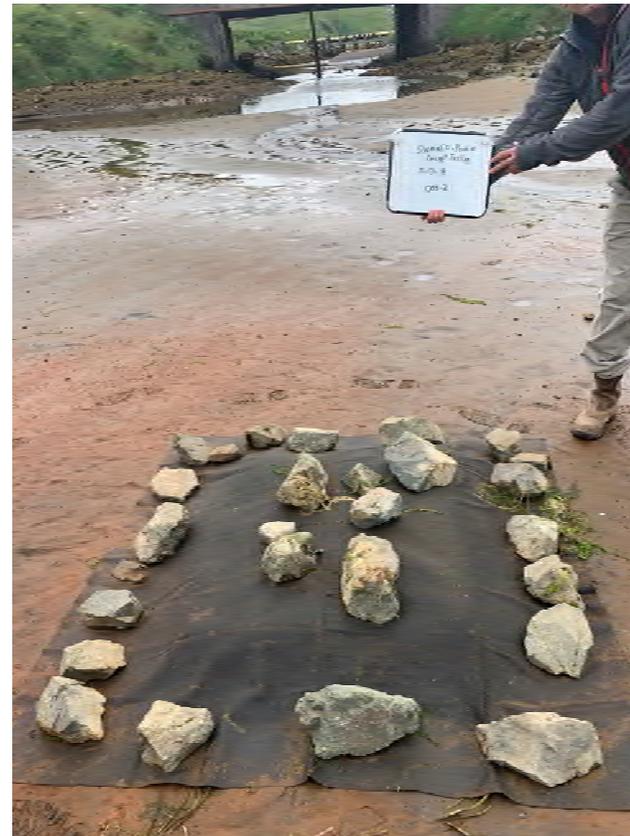
Installed OBB
