AFTER ACTION REPORT

October 2016

RADIOLOGICAL MATERIALS TIME-CRITICAL REMOVAL ACTION
AT FORMER NAVAL STATION PUGET SOUND
SEATTLE, WASHINGTON

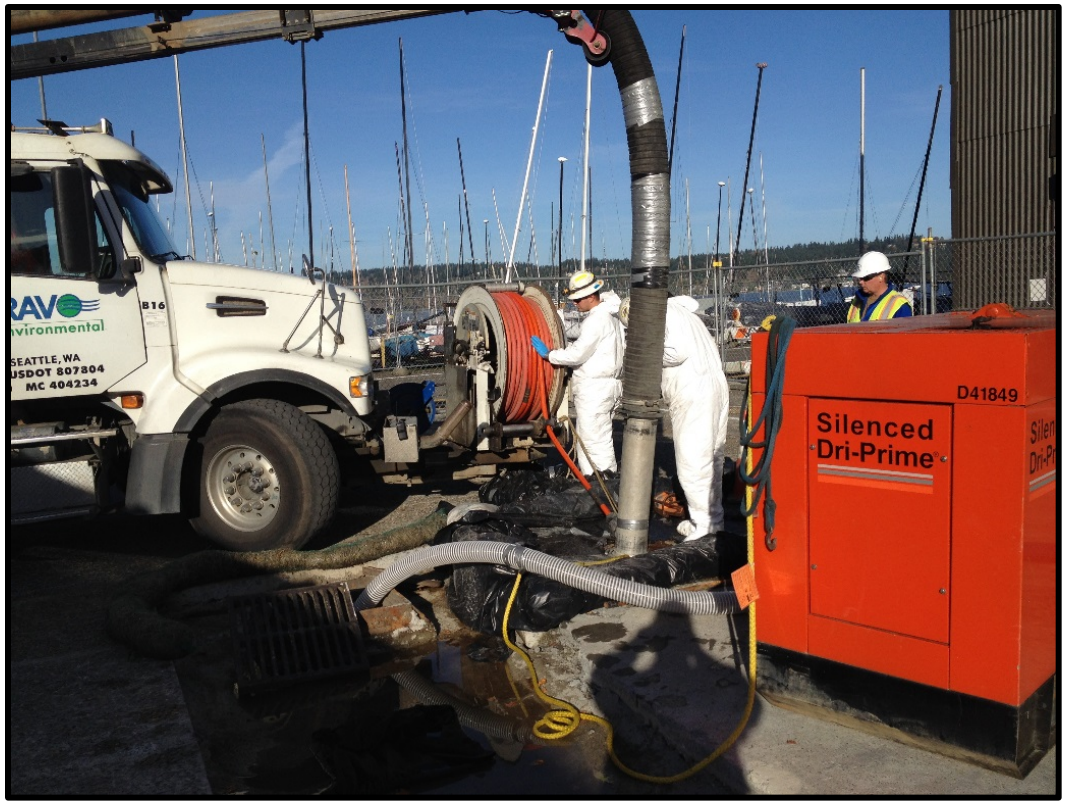
Photograph 1-12: Storm drain cleaning operation at MH-160.

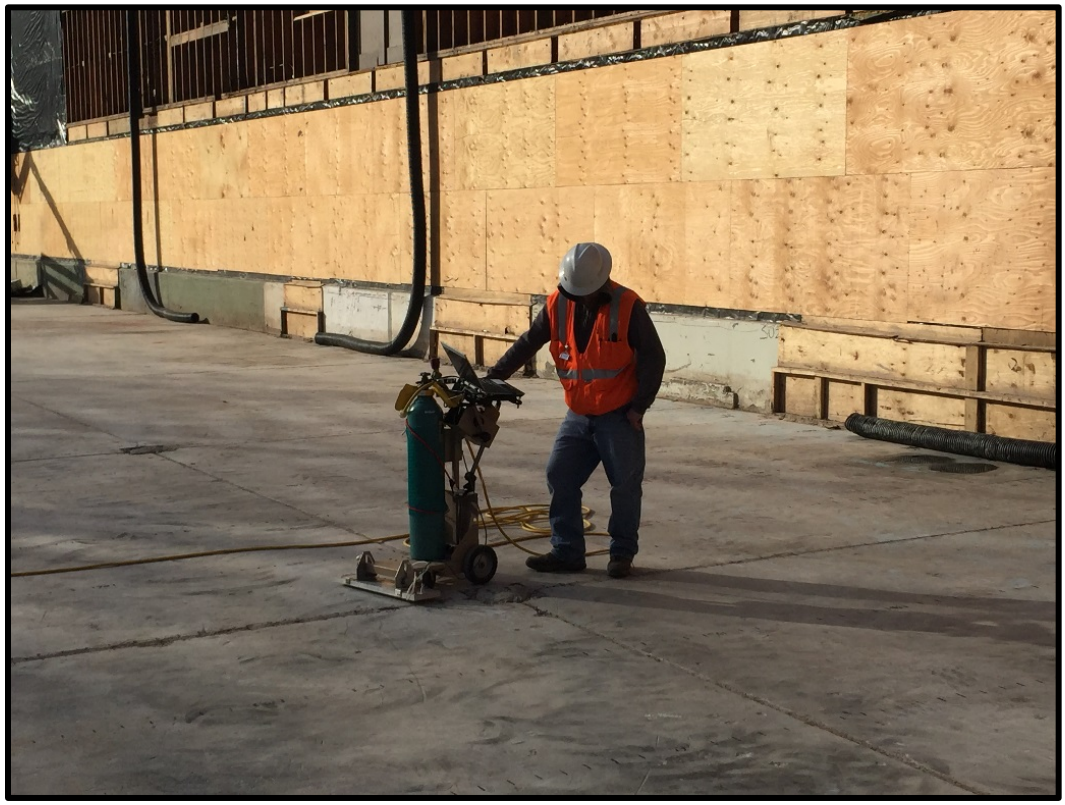
Photograph 1-15: Performing alpha/beta scan survey of the former South Shed concrete slab.
