RADIOLOGICAL REMEDIAL INVESTIGATION REPORT
Former Naval Station Puget Sound
Seattle, Washington

Contract No. N62470-08-D-1007
Task Order FZN4
Shaw Project No. 137165

May 2011

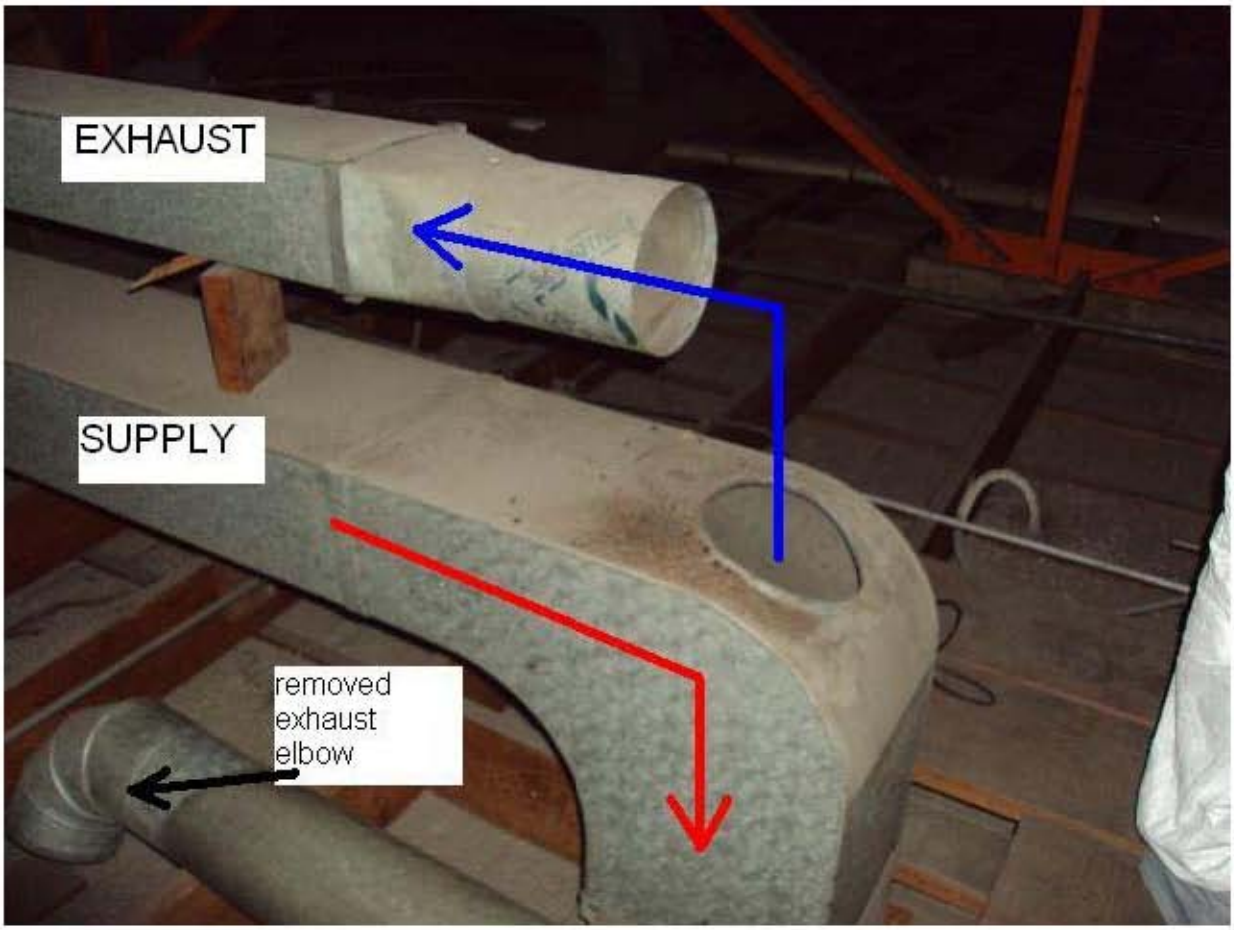
Figure 19
1941 Former Instrument Shop Ventilation System

- With the exception of the 1941 Instrument Shop ventilation system, no radiological contamination above project cleanup criteria was found on the ceiling or ceiling vents (Figure 19) in areas surveyed. The ventilation system exhaust ducts (accessed from the attic) are contaminated with levels exceeding project cleanup criteria. With the 1941 Instrument Shop ventilation being a closed-loop system, there is a potential that contamination exceeding project cleanup criteria extends to other areas of the ventilation system.
