# **Remedial Action Summary Report Free Product Recovery**

SWMU 62 New Housing Fuel Leak Area,  
Area 303, and Additional Sites

## **Former Naval Complex**

Adak, Alaska

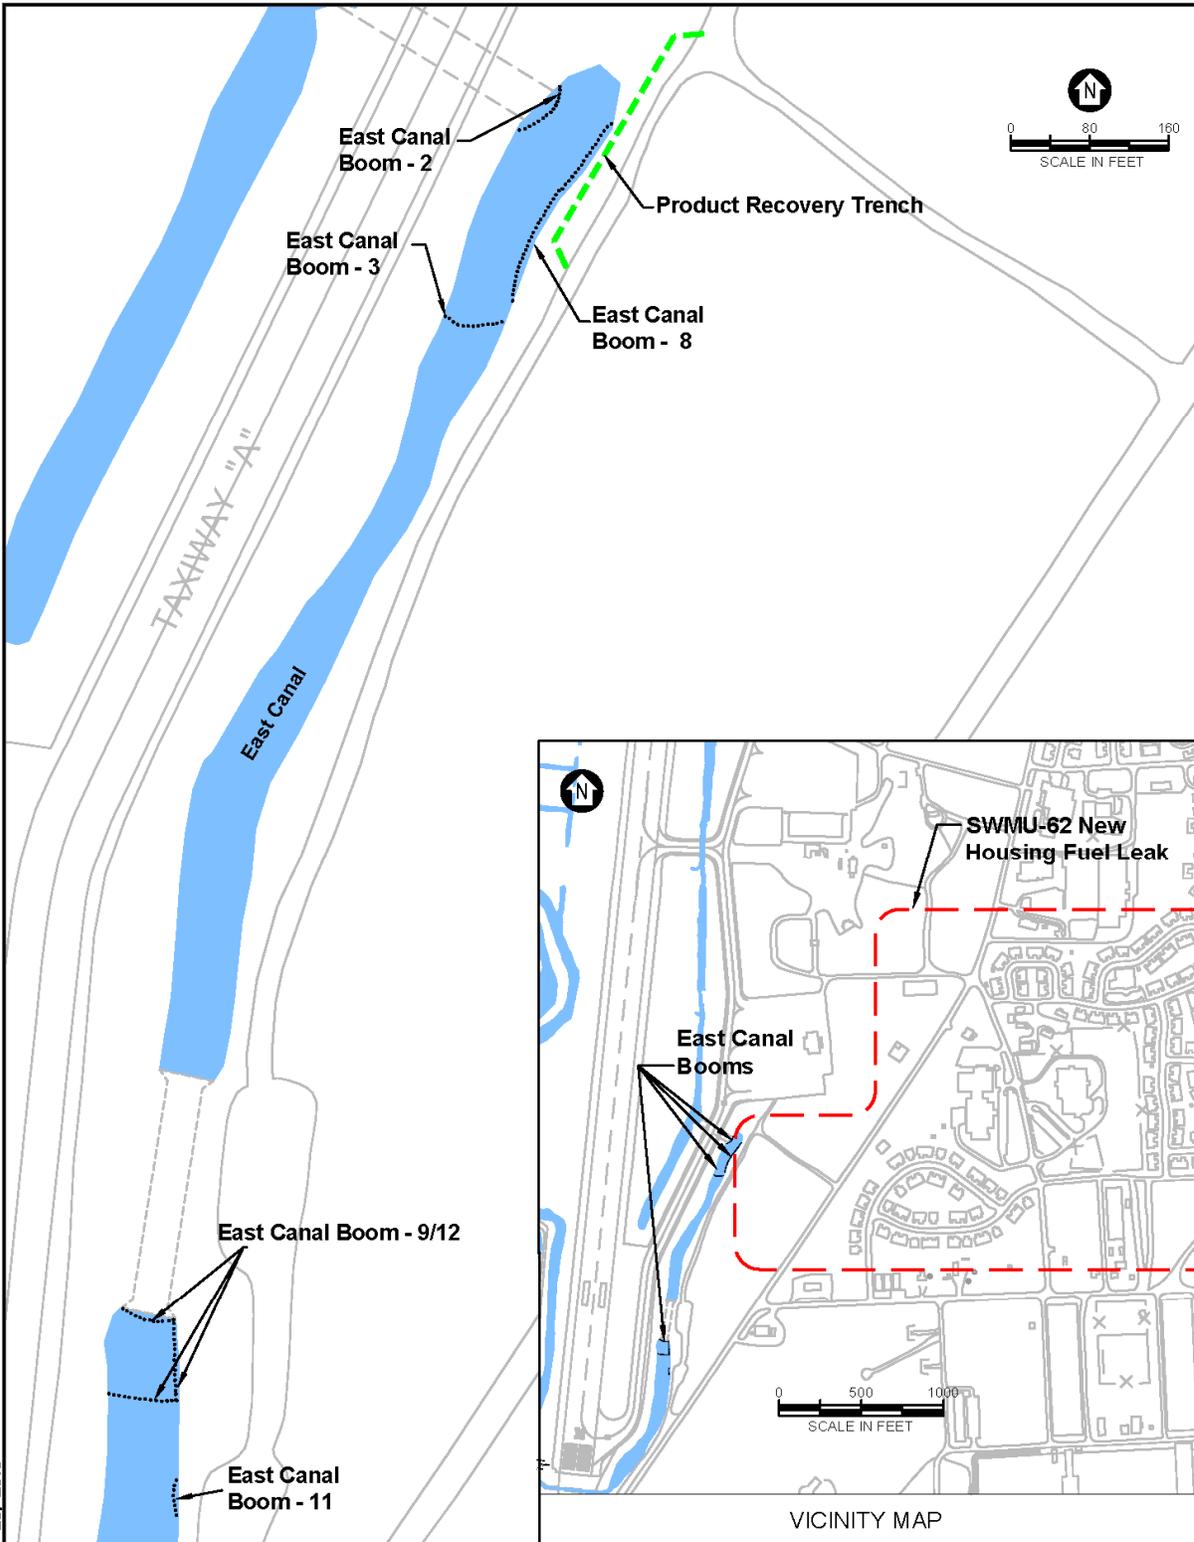
**Figure 5-1  
 East Canal Boom Locations**

Similar to the seep at SWMU 62, the petroleum seep on the shoreline of East Canal downgradient from Former Power Plant, Building T-1451 has previously been characterized by sheen, oil saturated soils, stressed vegetation, and pooled product along the shoreline. To control sheen at this seep, Boom 9/12 was placed across the culvert, along the shoreline, and spanning the East Canal (see Figure 5-1).

A smaller shoreline petroleum seep is located in East Canal approximately 85 feet downstream (south) from Boom 9/12 (see Figure 5-1). At this seep, sheen, oily sediments, and stressed vegetation were observed during 11 of 12 monthly inspections of Boom 11. Free product was not observed in March 2013 due to the presence of ice and snow covering the East Canal and shoreline.

- Expand Booms 2 and 11 by two boom lengths each. Additional boom sections are necessary at Boom 2 to help prevent it from being displaced during high water events in East Canal. The seep at Boom 11 has expanded about 4 feet south of the existing extent of the boom along the shoreline and the surface water sheen is very pronounced. Boom 11 should be expanded to cover the entire length of the seep. Since no seep has been observed at the Booms 9/12, the four boom sections composing the small leg that is right in front of the culverts should be removed. These would provide four boom sections to expand Booms 2 and 11, but not change the total number of boom sections deployed.

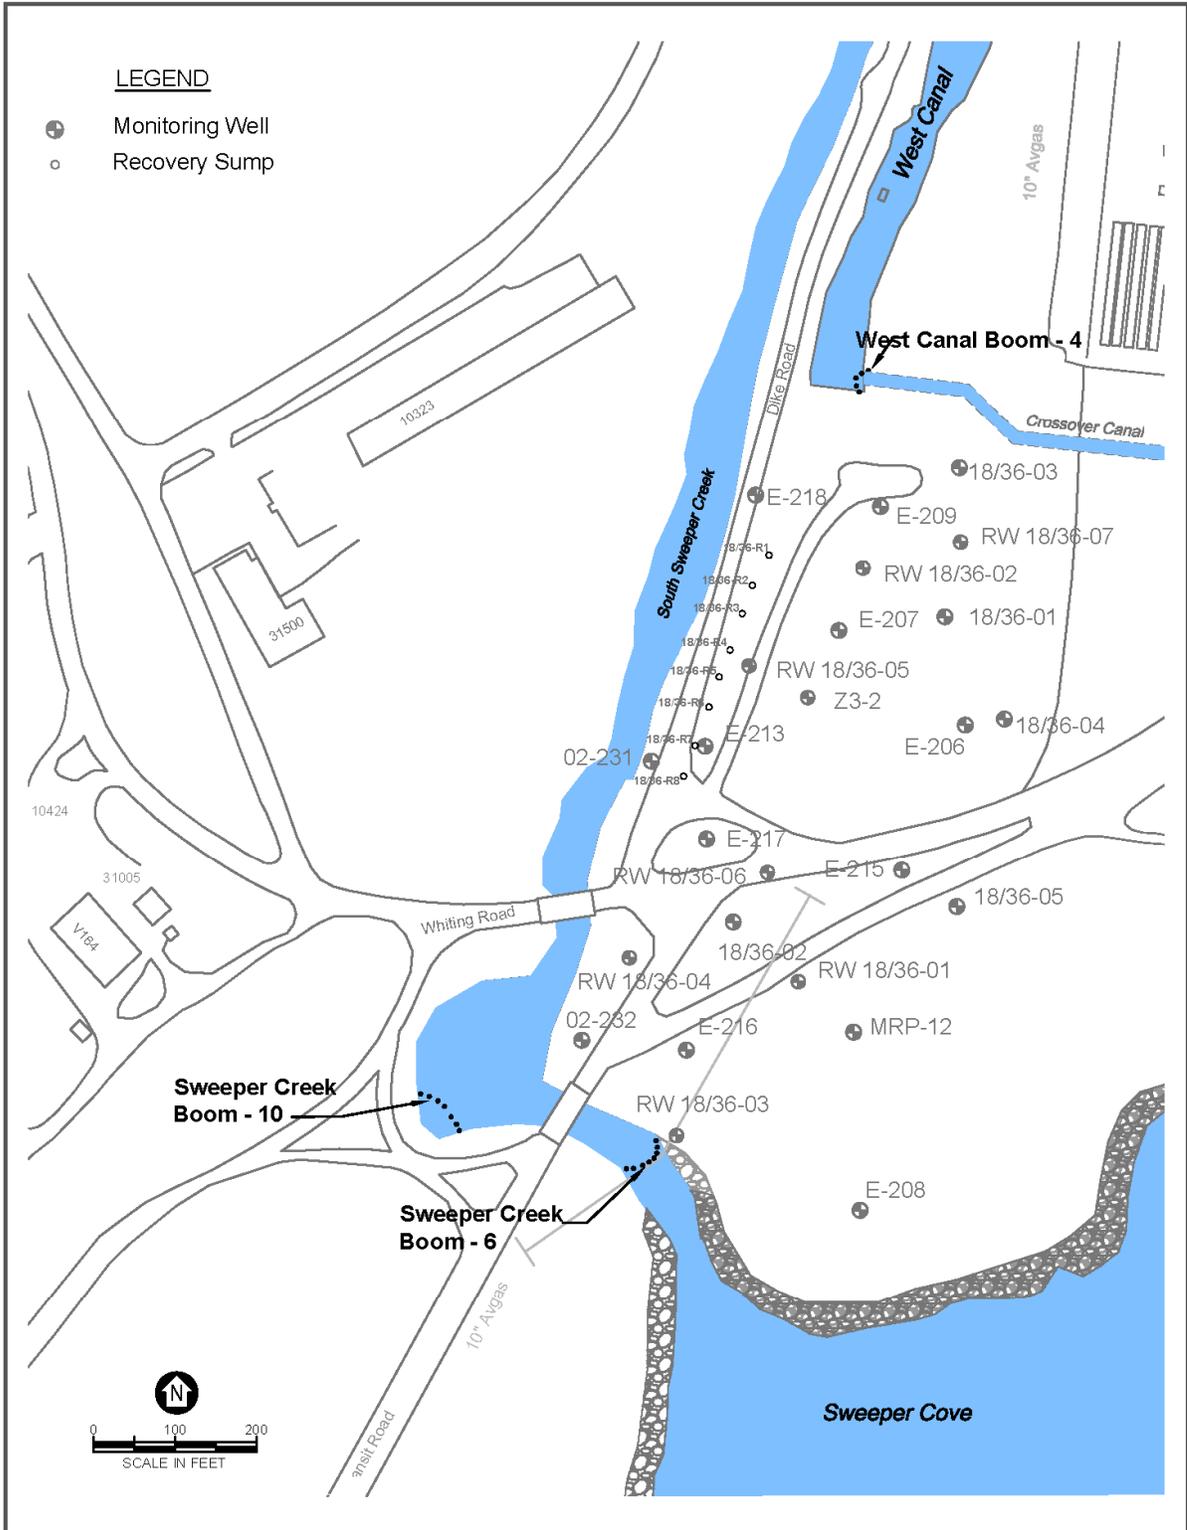
<p><b>U.S. NAVY</b></p>	<p><b>SEALASKA</b></p>	<p><b>Figure 5-2</b>  <b>West Canal and South Sweeper Creek</b>  <b>Boom Locations</b></p>	<p>Task Order 60              Remedial Action              Summary Report              Adak, Alaska</p>
-------------------------	------------------------	--	---

Sheen was not observed at Boom 6 (see Figure 5-2) in South Sweeper Creek during the period of performance. Sheen was observed during 11 of 12 monthly inspections at Boom 10 in South Sweeper Creek lagoon downgradient of SWMU 60, Tank Farm A site. Free product was not observed in March 2013 due to the presence of ice and snow that covered South Sweeper Creek and associated shoreline.

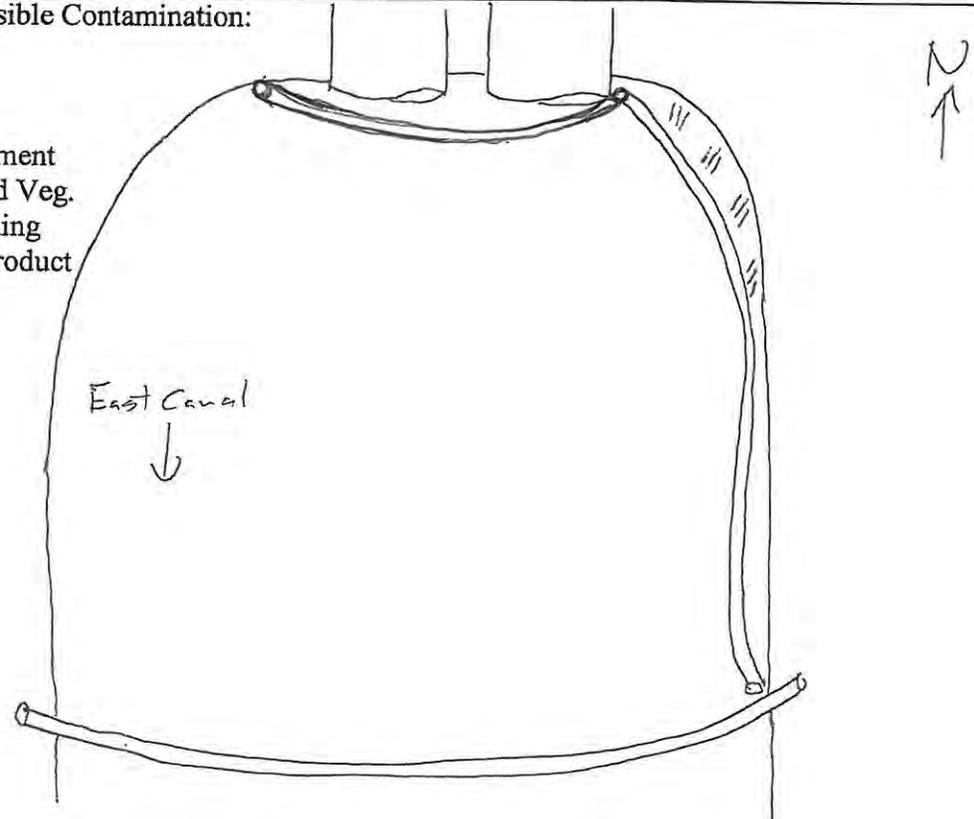
<b>Boom Location:</b> 9/12	<b>Time/Date:</b> 1434 / 10.16.12
<b>Description of Boom Before Maintenance:</b> UNSATISFACTORY - BOOM OUT OF POSITION DUE TO HIGH WATER LEVELS	<b>Photograph (s) Time/Date Stamp:</b>  1434 / 10.16.12
<b>Boom Repaired (Y/N):</b> Description: MOVED BOOM BACK INTO POSITION ONTO POSTS	<b>Boom Replaced (Y/N) / Number of Sections:</b> Description:
<b>Visual Observations</b>	
Visible Contamination (Y/N): <input checked="" type="radio"/> N	Sheen Present on Water (Y/N): <input checked="" type="radio"/> N <sup>DKB</sup>
Iron Staining (Y/N): <input checked="" type="radio"/> N	Is the Boom Containing the Sheen? (Y/N)
Oily Sediment/Soil (Y/N): <input checked="" type="radio"/> N	Pooled Product (Y/N): <input checked="" type="radio"/> N
Distressed Vegetation (Y/N): <input checked="" type="radio"/> N	If yes, was product removed with sorbent pads?
<b>Location of Visible Contamination:</b>

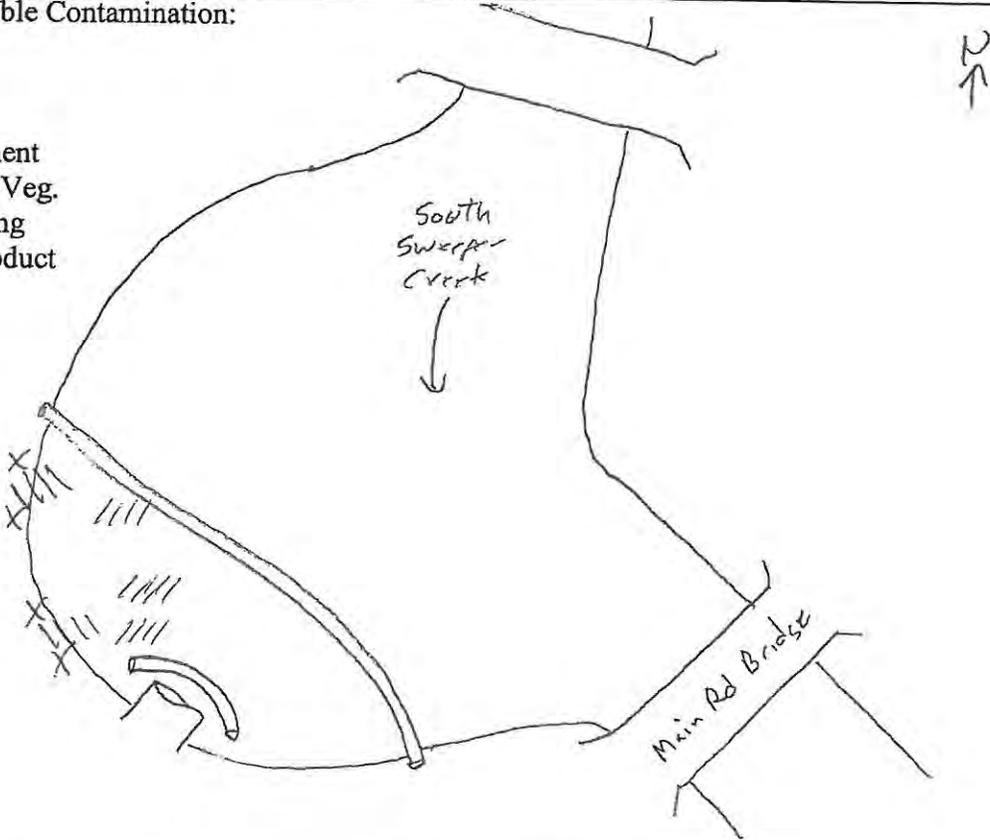
<b>Boom Location:</b> 10	Time/Date: 1452 / 10.16.12		
Description of Boom Before Maintenance: SATISFACTORY	Photograph (s) Time/Date Stamp: 1452 / 10.16.12		
Boom Repaired (Y/N): Description: MOVED BACK INTO POSITION OFF THE SHORELINE	Boom Replaced (Y/N) / Number of Sections: Description:		
<p><b>Visual Observations</b></p> <table style="width: 100%; border: none;"> <tr> <td style="width: 50%; border: none; vertical-align: top;">                 Visible Contamination (Y/N):                  Iron Staining (Y/N):                  Oily Sediment/Soil (Y/N):                  Distressed Vegetation (Y/N):             </td> <td style="width: 50%; border: none; vertical-align: top;">                 Sheen Present on Water (Y/N):                  Is the Boom Containing the Sheen? (Y/N)                  Pooled Product (Y/N):                  If yes, was product removed with sorbent pads?             </td> </tr> </table>		Visible Contamination (Y/N): Iron Staining (Y/N): Oily Sediment/Soil (Y/N): Distressed Vegetation (Y/N):	Sheen Present on Water (Y/N): Is the Boom Containing the Sheen? (Y/N) Pooled Product (Y/N): If yes, was product removed with sorbent pads?

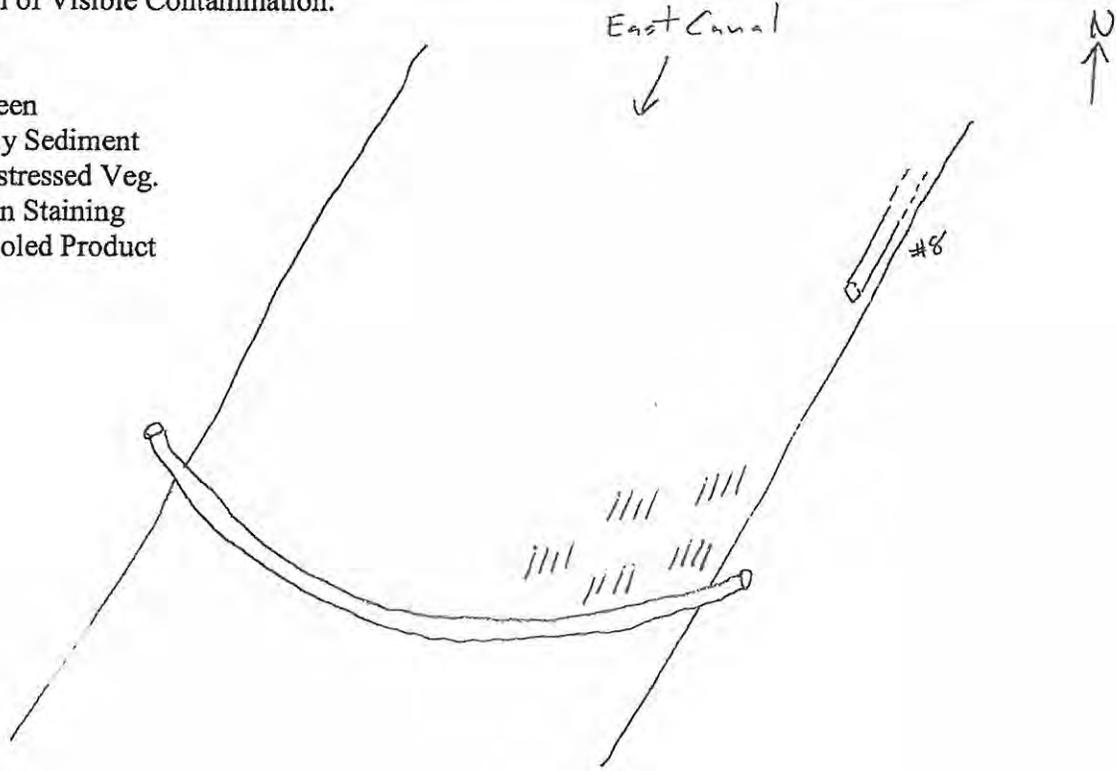
<b>Boom Location: 3</b>	Time/Date: 1420/11.10.12		
Description of Boom Before Maintenance:  SATISFACTORY	Photograph (s) Time/Date Stamp:  1420/11.10.12		
Boom Repaired (Y/N) (N) Description:	Boom Replaced (Y/N) (N) / Number of Sections: Description:		
<p><b>Visual Observations</b></p> <table style="width: 100%; border: none;"> <tr> <td style="width: 50%; border: none;">                 Visible Contamination (Y/N) (Y):                  Iron Staining (Y/N) (N):                  Oily Sediment/Soil (Y/N) (N):                  Distressed Vegetation (Y/N) (N):             </td> <td style="width: 50%; border: none;">                 Sheen Present on Water (Y/N) (Y):                  Is the Boom Containing the Sheen? (Y/N) (Y):                  Pooled Product (Y/N) (N):                  If yes, was product removed with sorbent pads?             </td> </tr> </table>		Visible Contamination (Y/N) (Y): Iron Staining (Y/N) (N): Oily Sediment/Soil (Y/N) (N): Distressed Vegetation (Y/N) (N):	Sheen Present on Water (Y/N) (Y): Is the Boom Containing the Sheen? (Y/N) (Y): Pooled Product (Y/N) (N): If yes, was product removed with sorbent pads?
Visible Contamination (Y/N) (Y): Iron Staining (Y/N) (N): Oily Sediment/Soil (Y/N) (N): Distressed Vegetation (Y/N) (N):	Sheen Present on Water (Y/N) (Y): Is the Boom Containing the Sheen? (Y/N) (Y): Pooled Product (Y/N) (N): If yes, was product removed with sorbent pads?		
Location of Visible Contamination: <div style="display: flex; justify-content: space-between; align-items: flex-start; margin-top: 10px;"> <div style="width: 30%;"> <p><u>Legend</u></p> <ul style="list-style-type: none"> <li>//// Sheen</li> <li>\\ \\ Oily Sediment</li> <li>xxx Distressed Veg.</li> <li>RRR Iron Staining</li> <li>● Pooled Product</li> </ul> </div> <div style="width: 60%; text-align: center;">

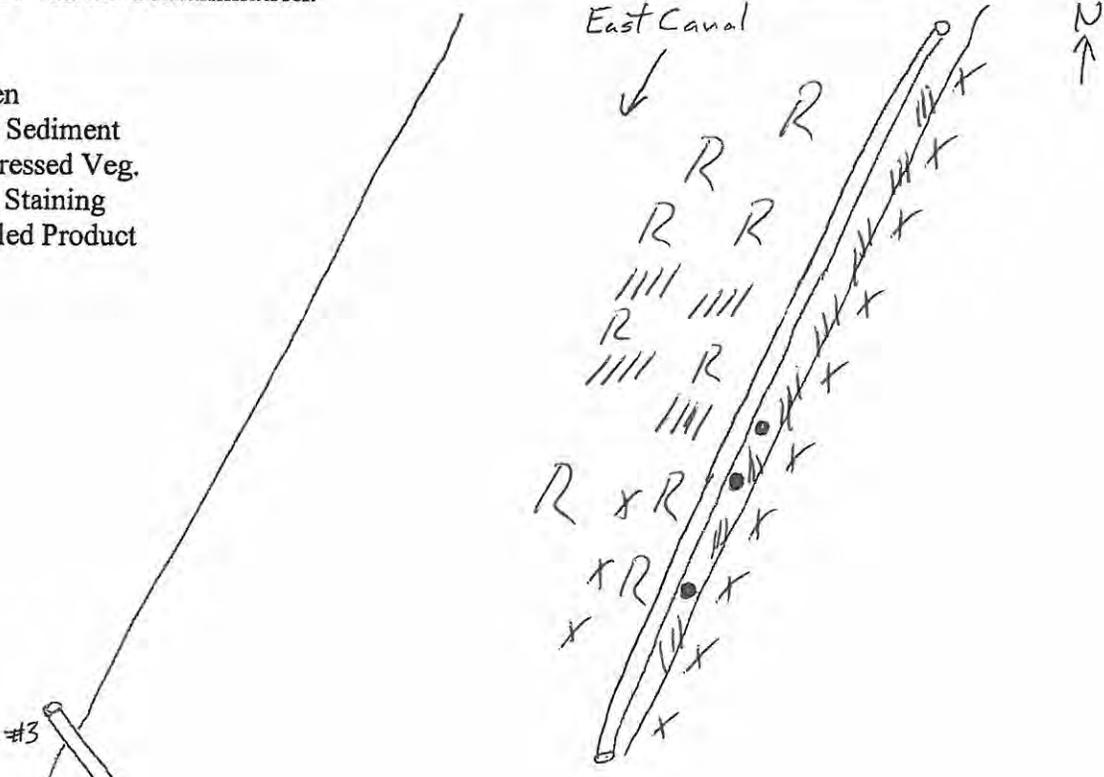
<b>Boom Location: 8</b>	Time/Date: 14/9/11.10.12
Description of Boom Before Maintenance:  SATISFACTORY	Photograph (s) Time/Date Stamp:  14/9/11.10.12
Boom Repaired (Y/N): Description: MOVED BACK INTO POSITION	Boom Replaced (Y/N) / Number of Sections: Description:
<b>Visual Observations</b>	
Visible Contamination (Y/N): Iron Staining (Y/N): Oily Sediment/Soil (Y/N): Distressed Vegetation (Y/N):	Sheen Present on Water (Y/N): Is the Boom Containing the Sheen? (Y/N) Pooled Product (Y/N): If yes, was product removed with sorbent pads? YES - SOAKED UP (5) ABSORBS OF PRODUCT
Location of Visible Contamination:	
<p><u>Legend</u></p> <p>//// Sheen</p> <p>\\ \\ Oily Sediment</p> <p>xxx Distressed Veg.</p> <p>RRR Iron Staining</p> <p>● Pooled Product</p>

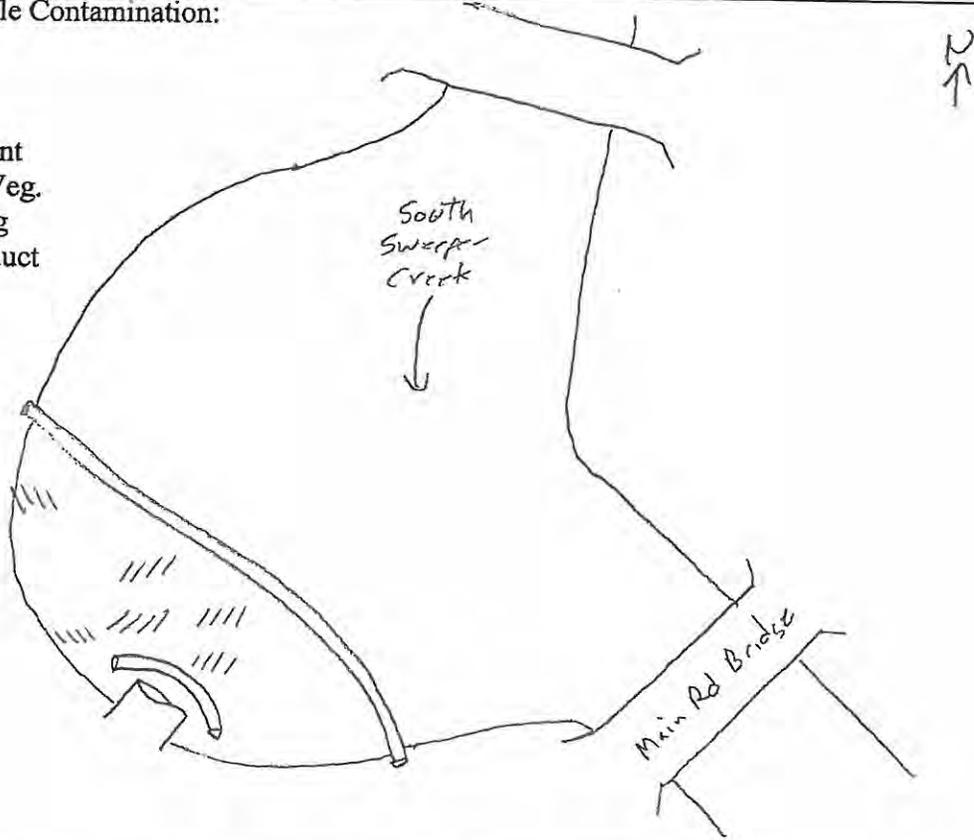
<b>Boom Location:</b> 10	<b>Time/Date:</b> 1442 / 11-10-12		
<b>Description of Boom Before Maintenance:</b>  SATISFACTORY	<b>Photograph (s) Time/Date Stamp:</b>  1442 / 11-10-12		
<b>Boom Repaired (Y/N):</b> Description: MOVED (2) SECTIONS OFF OF ROCKS BACK INTO POSITION	<b>Boom Replaced (Y (N)) / Number of Sections:</b> Description:		
<p><b>Visual Observations</b></p> <table style="width: 100%; border: none;"> <tr> <td style="width: 50%; border: none; vertical-align: top;"> <p>Visible Contamination (Y/N):</p> <p>Iron Staining (Y (N)):</p> <p>Oily Sediment/Soil (Y/N):</p> <p>Distressed Vegetation (Y (N)):</p> </td> <td style="width: 50%; border: none; vertical-align: top;"> <p>Sheen Present on Water (Y/N):</p> <p>Is the Boom Containing the Sheen? (Y/N)</p> <p>Pooled Product (Y (N)):</p> <p>If yes, was product removed with sorbent pads?</p> </td> </tr> </table>		<p>Visible Contamination (Y/N):</p> <p>Iron Staining (Y (N)):</p> <p>Oily Sediment/Soil (Y/N):</p> <p>Distressed Vegetation (Y (N)):</p>	<p>Sheen Present on Water (Y/N):</p> <p>Is the Boom Containing the Sheen? (Y/N)</p> <p>Pooled Product (Y (N)):</p> <p>If yes, was product removed with sorbent pads?</p>
<p>Visible Contamination (Y/N):</p> <p>Iron Staining (Y (N)):</p> <p>Oily Sediment/Soil (Y/N):</p> <p>Distressed Vegetation (Y (N)):</p>	<p>Sheen Present on Water (Y/N):</p> <p>Is the Boom Containing the Sheen? (Y/N)</p> <p>Pooled Product (Y (N)):</p> <p>If yes, was product removed with sorbent pads?</p>		
<p><b>Location of Visible Contamination:</b></p> <div style="display: flex; align-items: flex-start;"> <div style="width: 20%; padding-right: 10px;"> <p><u>Legend</u></p> <p>//// Sheen</p> <p>\\ \\ Oily Sediment</p> <p>xxx Distressed Veg.</p> <p>RRR Iron Staining</p> <p>● Pooled Product</p> </div> <div style="flex-grow: 1;">

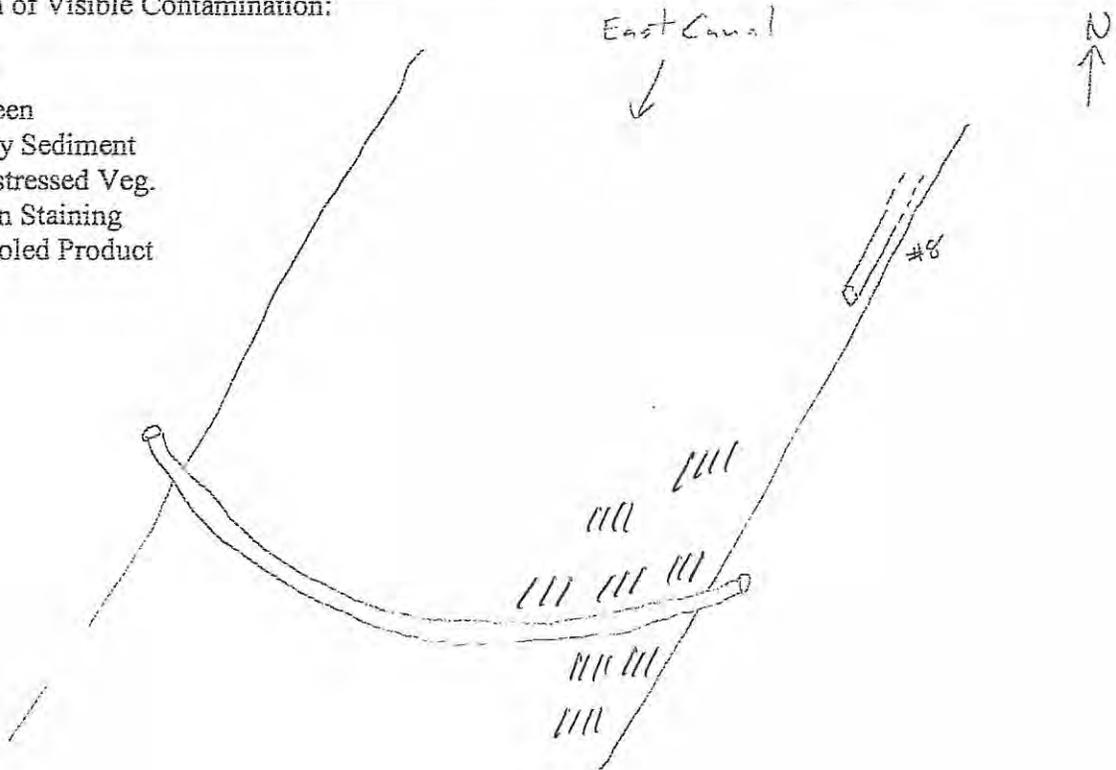
\* SHEEN PRESENT OUTSIDE OF BOOM DUE TO HIGH WATER LEVELS \*

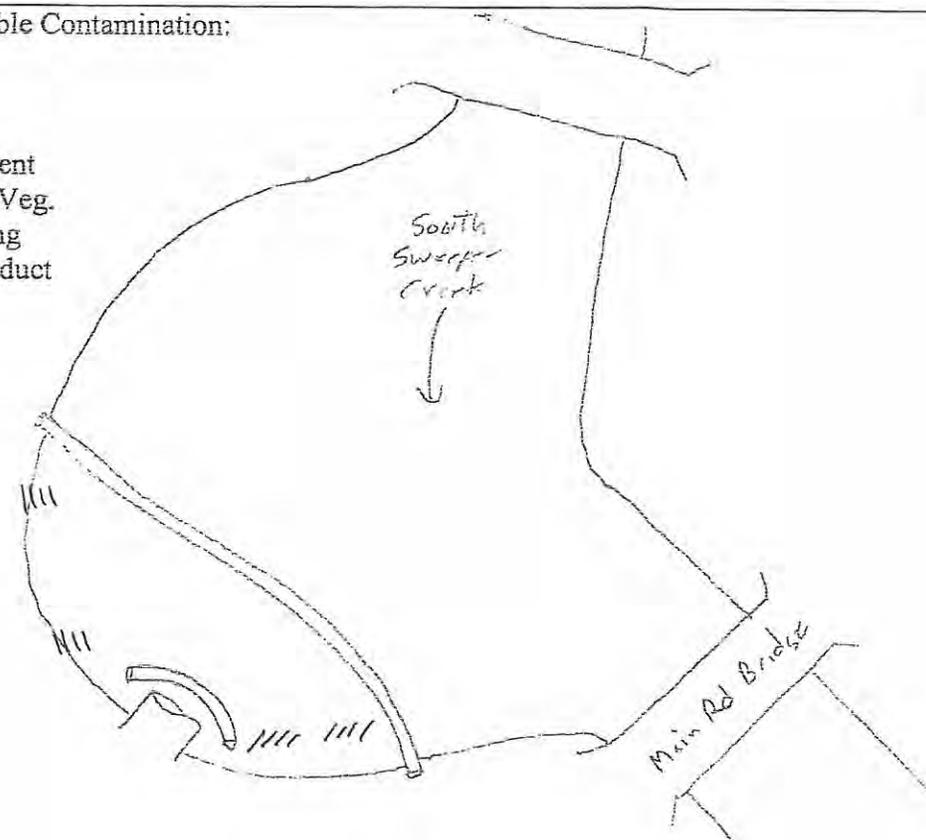
Boom Location: 10	Time/Date: 1545 / 12.4.12		
Description of Boom Before Maintenance: <b>SATISFACTORY</b>	Photograph (s) Time/Date Stamp: 1331 / 12.5.12		
Boom Repaired (Y <input checked="" type="radio"/> N): Description:	Boom Replaced (Y <input checked="" type="radio"/> N) / Number of Sections: Description:		
<p><b>Visual Observations</b></p> <table style="width: 100%; border: none;"> <tr> <td style="width: 50%; border: none; vertical-align: top;">                 Visible Contamination (Y <input checked="" type="radio"/> N):                  Iron Staining (Y <input checked="" type="radio"/> N):                  Oily Sediment/Soil (Y <input checked="" type="radio"/> N):                  Distressed Vegetation (Y <input checked="" type="radio"/> N):             </td> <td style="width: 50%; border: none; vertical-align: top;">                 Sheen Present on Water (Y <input checked="" type="radio"/> N):                  Is the Boom Containing the Sheen? (Y <input checked="" type="radio"/> N)                  Pooled Product (Y <input checked="" type="radio"/> N):                  If yes, was product removed with sorbent pads?             </td> </tr> </table>		Visible Contamination (Y <input checked="" type="radio"/> N): Iron Staining (Y <input checked="" type="radio"/> N): Oily Sediment/Soil (Y <input checked="" type="radio"/> N): Distressed Vegetation (Y <input checked="" type="radio"/> N):	Sheen Present on Water (Y <input checked="" type="radio"/> N): Is the Boom Containing the Sheen? (Y <input checked="" type="radio"/> N) Pooled Product (Y <input checked="" type="radio"/> N): If yes, was product removed with sorbent pads?

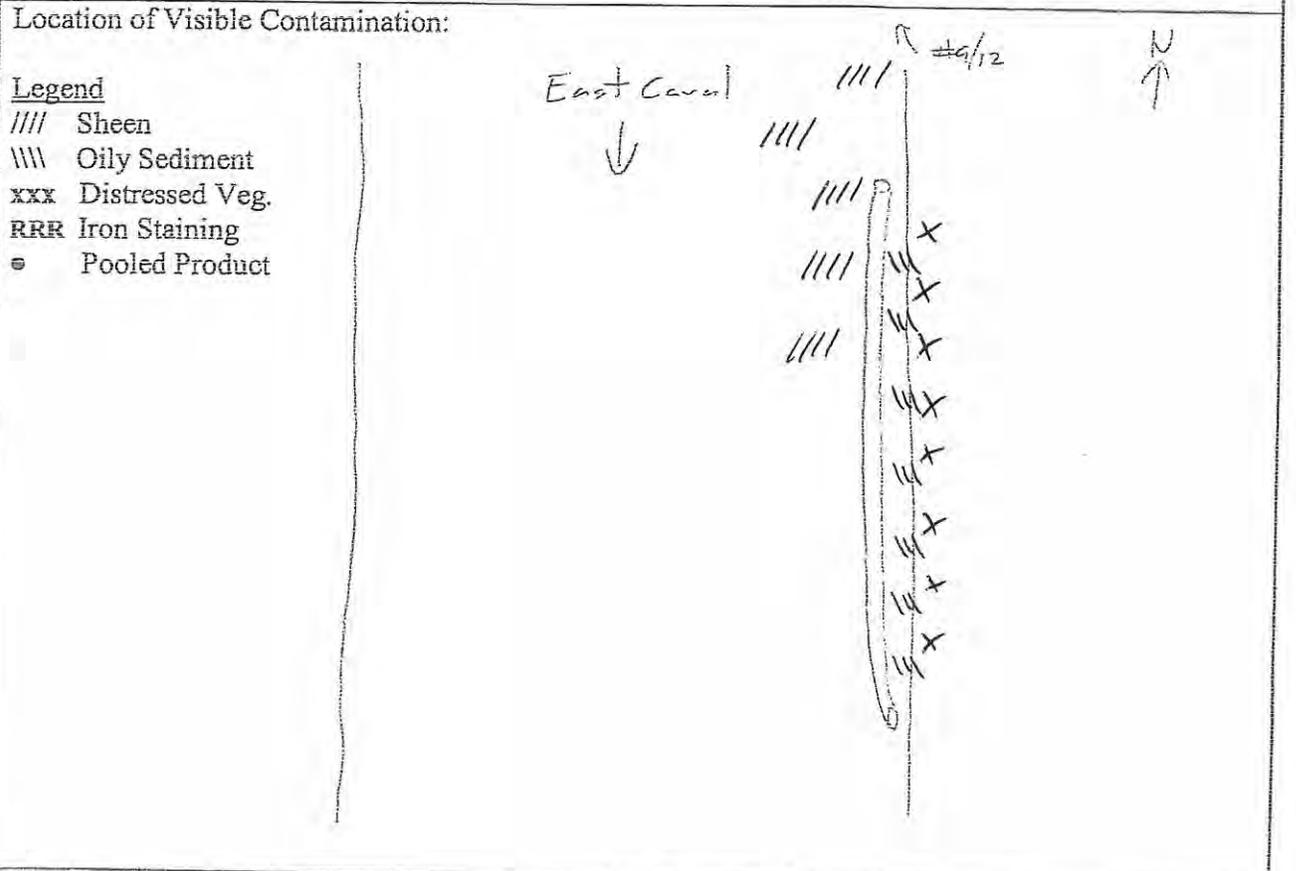
Boom Location: 11	Time/Date: 1520/12.4.12
Description of Boom Before Maintenance: SATISFACTORY	Photograph (s) Time/Date Stamp: 1105/12.5.12
Boom Repaired (Y <input checked="" type="radio"/> N): Description:	Boom Replaced (Y <input checked="" type="radio"/> N) / Number of Sections: Description:

Visible Contamination <input checked="" type="radio"/> N):	Sheen Present on Water <input checked="" type="radio"/> N):
Iron Staining (Y <input checked="" type="radio"/> N):	Is the Boom Containing the Sheen? (Y <input checked="" type="radio"/> N)
Oily Sediment/Soil <input checked="" type="radio"/> N):	Pooled Product (Y <input checked="" type="radio"/> N):
Distressed Vegetation <input checked="" type="radio"/> N):	If yes, was product removed with sorbent pads?

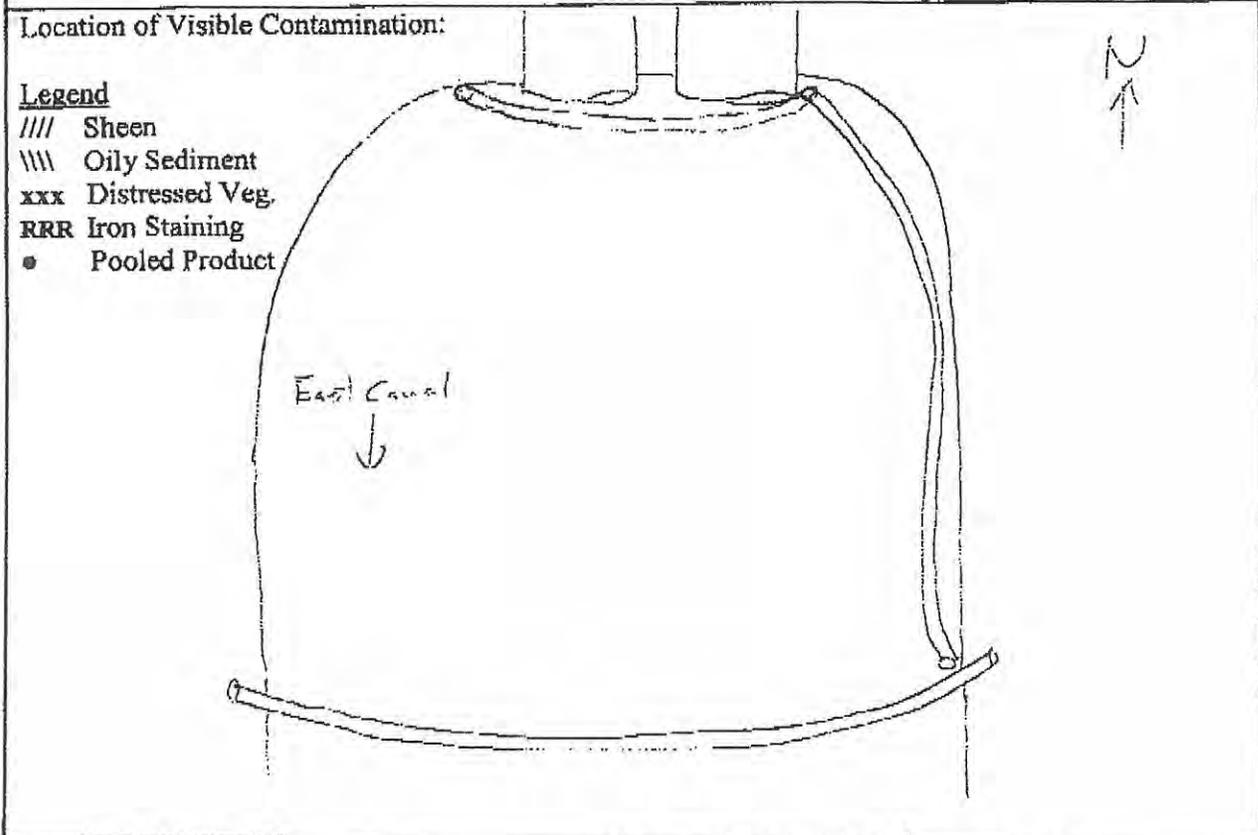
Boom Location: 9/12	Time/Date: 12/04/1.9.13
Description of Boom Before Maintenance: <b>SATISFACTORY</b>	Photograph (s) Time/Date Stamp: 12/04/1.9.13
Boom Repaired (Y <input checked="" type="radio"/> N): Description:	Boom Replaced (Y <input checked="" type="radio"/> N) / Number of Sections: Description:

<b>Visual Observations</b> Visible Contamination (Y <input checked="" type="radio"/> N): Iron Staining (Y <input checked="" type="radio"/> N): Oily Sediment/Soil (Y <input checked="" type="radio"/> N): Distressed Vegetation (Y <input checked="" type="radio"/> N):	Sheen Present on Water (Y <input checked="" type="radio"/> N): Is the Boom Containing the Sheen? (Y / N) Pooled Product (Y <input checked="" type="radio"/> N): If yes, was product removed with sorbent pads?
---	---

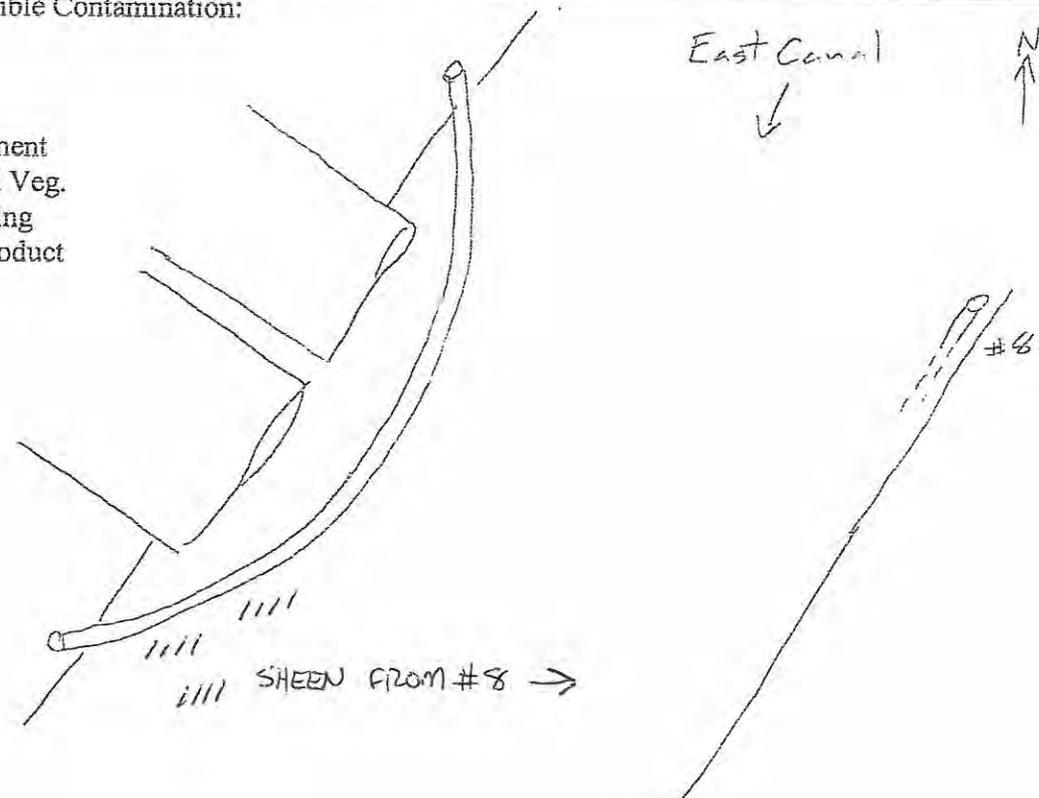
<b>Boom Location: 2</b>	<b>Time/Date:</b> <span style="font-size: 1.2em;">1408-2/6/13</span>
<b>Description of Boom Before Maintenance:</b>  <span style="font-size: 1.2em;">UNSATISFACTORY</span>	<b>Photograph (s) Time/Date Stamp:</b>  <span style="font-size: 1.2em;">1408-2/6/13</span>
<b>Boom Repaired (Y/N):</b> Description: <span style="font-size: 1.2em;">PUT BOOM BACK INTO POSITION OFF OF CULVERTS</span>	<b>Boom Replaced (Y/N) Number of Sections:</b> Description:
<b>Visual Observations</b>	
<b>Visible Contamination (Y/N):</b> Iron Staining (Y (N): Oily Sediment/Soil (Y (N): Distressed Vegetation (Y (N):	<b>Sheen Present on Water (Y/N):</b> Is the Boom Containing the Sheen? (Y (N) Pooled Product (Y (N): If yes, was product removed with sorbent pads?
<b>Location of Visible Contamination:</b>	
<b>Legend</b> /// Sheen \\\ Oily Sediment xxx Distressed Veg. RRR Iron Staining ● Pooled Product

<p style="text-align: right; margin-right: 50px;">East Canal ↓</p> <p style="text-align: right; margin-right: 50px;">N ↑</p> <p style="text-align: center; margin-top: 20px;">/// SHEEN FROM #8 →</p>

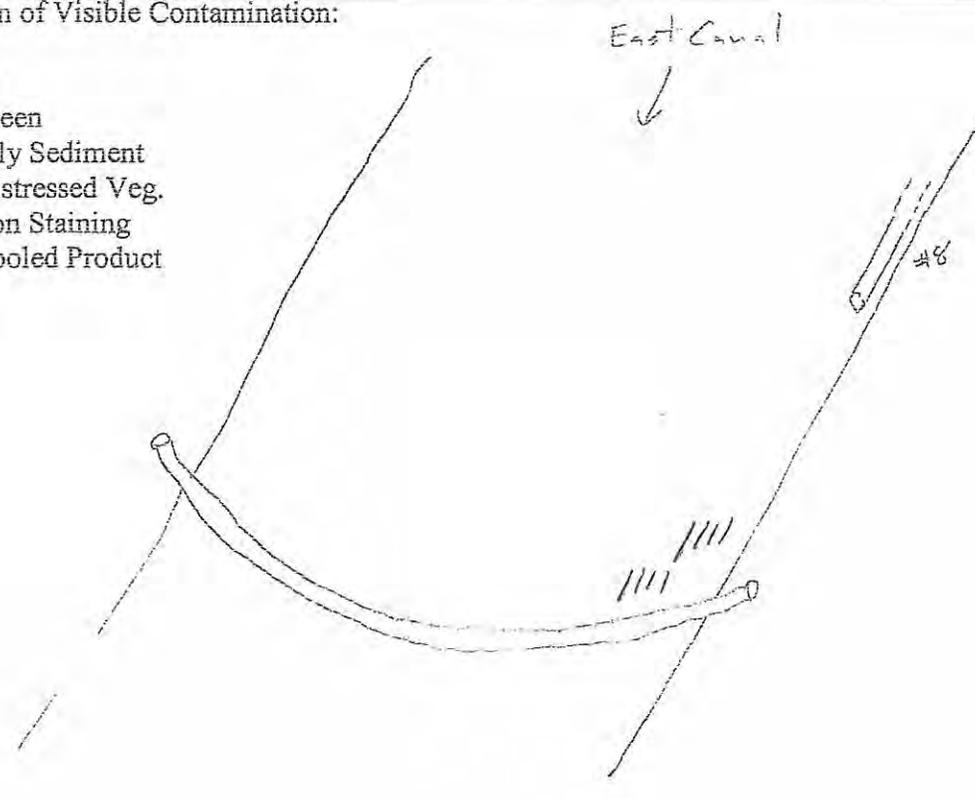
<b>Boom Location: 3</b>	Time/Date: 1410/2.6.13		
Description of Boom Before Maintenance:  <b>SATISFACTORY</b>	Photograph (s) Time/Date Stamp:  1410/2.6.13		
Boom Repaired (Y/N) <input checked="" type="radio"/> (N) Description:	Boom Replaced (Y/N) <input checked="" type="radio"/> (N) / Number of Sections: Description:		
<p><b>Visual Observations</b></p> <table style="width: 100%; border: none;"> <tr> <td style="width: 50%; border: none; vertical-align: top;">                 Visible Contamination <input checked="" type="radio"/> (Y) <input checked="" type="radio"/> (N):                  Iron Staining (Y/N) <input checked="" type="radio"/> (N):                  Oily Sediment/Soil (Y/N) <input checked="" type="radio"/> (N):                  Distressed Vegetation (Y/N) <input checked="" type="radio"/> (N)             </td> <td style="width: 50%; border: none; vertical-align: top;">                 Sheen Present on Water <input checked="" type="radio"/> (Y) <input checked="" type="radio"/> (N):                  Is the Boom Containing the Sheen? <input checked="" type="radio"/> (Y) <input checked="" type="radio"/> (N)                  Pooled Product (Y/N) <input checked="" type="radio"/> (N)                  If yes, was product removed with sorbent pads?             </td> </tr> </table>		Visible Contamination <input checked="" type="radio"/> (Y) <input checked="" type="radio"/> (N): Iron Staining (Y/N) <input checked="" type="radio"/> (N): Oily Sediment/Soil (Y/N) <input checked="" type="radio"/> (N): Distressed Vegetation (Y/N) <input checked="" type="radio"/> (N)	Sheen Present on Water <input checked="" type="radio"/> (Y) <input checked="" type="radio"/> (N): Is the Boom Containing the Sheen? <input checked="" type="radio"/> (Y) <input checked="" type="radio"/> (N) Pooled Product (Y/N) <input checked="" type="radio"/> (N) If yes, was product removed with sorbent pads?

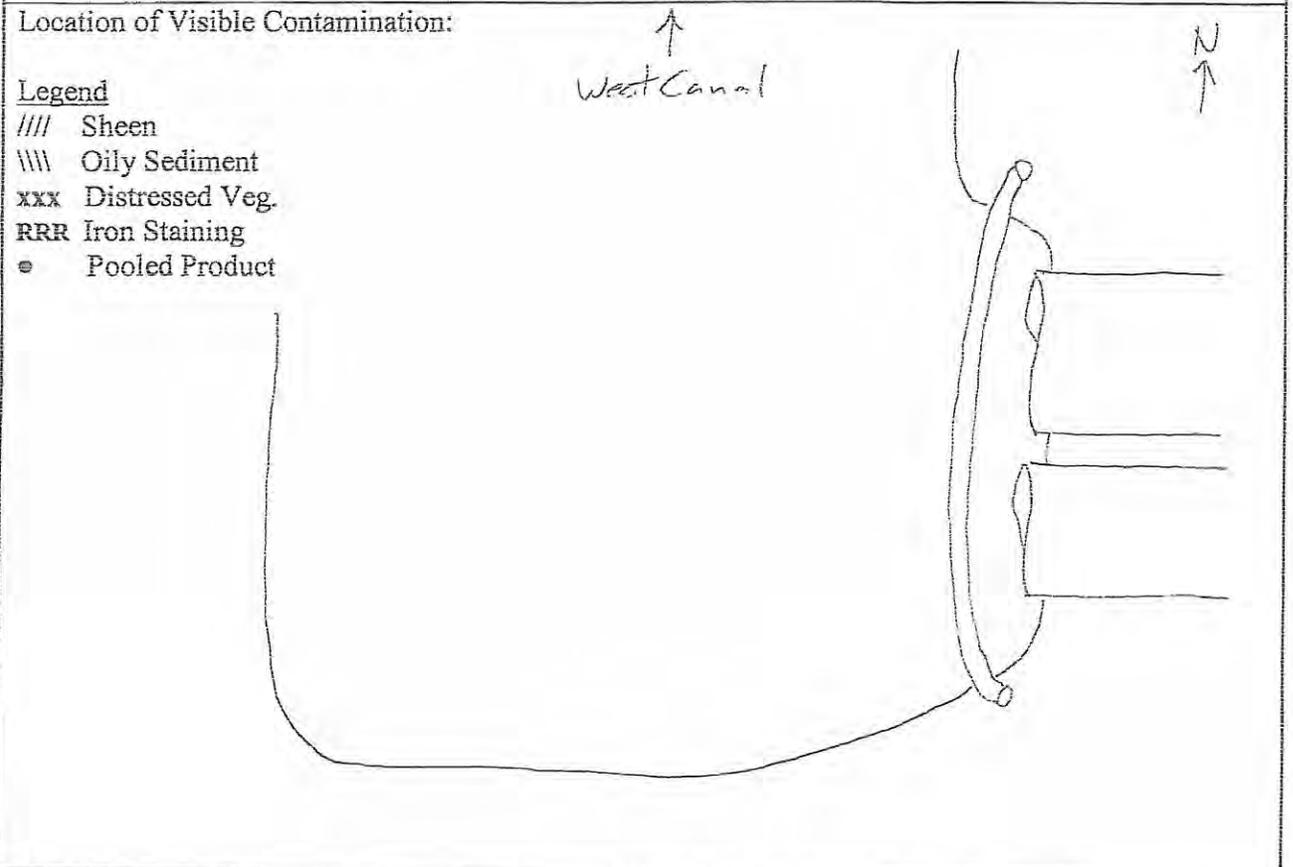
Boom Location: 4	Time/Date: 1428 / 2.6.13
Description of Boom Before Maintenance: <b>SATISFACTORY</b>	Photograph (s) Time/Date Stamp: 1428 / 2.6.13
Boom Repaired (Y/N) <input checked="" type="radio"/> (N) Description:	Boom Replaced (Y/N) <input checked="" type="radio"/> (N) / Number of Sections: Description:

**\* DIKE PUMPS ON AND OPERATING**

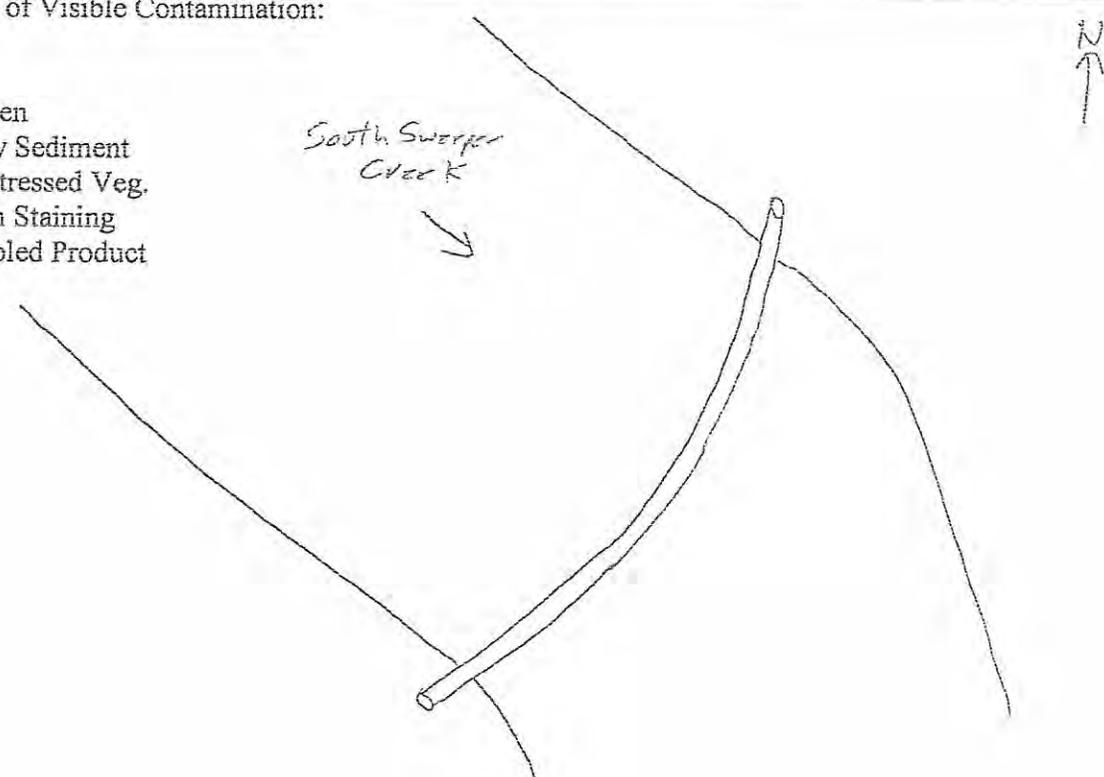
<b>Boom Location:</b> 6	<b>Time/Date:</b> <div style="font-size: 1.2em; font-family: cursive;">1433 / 2-6-13</div>		
<b>Description of Boom Before Maintenance:</b>  <div style="font-size: 1.2em; font-family: cursive;">SATISFACTORY</div>	<b>Photograph (s) Time/Date Stamp:</b>  <div style="font-size: 1.2em; font-family: cursive;">1433 / 2-6-13</div>		
<b>Boom Repaired (Y/N) Description:</b>	<b>Boom Replaced (Y/N) / Number of Sections: Description:</b>		
<p><b>Visual Observations</b></p> <table style="width: 100%; border: none;"> <tr> <td style="width: 50%; border: none;">           Visible Contamination (Y/N):            Iron Staining (Y/N):            Oily Sediment/Soil (Y/N):            Distressed Vegetation (Y/N):         </td> <td style="width: 50%; border: none;">           Sheen Present on Water (Y/N):            Is the Boom Containing the Sheen? (Y/N)            Pooled Product (Y/N)            If yes, was product removed with sorbent pads?         </td> </tr> </table>		Visible Contamination (Y/N): Iron Staining (Y/N): Oily Sediment/Soil (Y/N): Distressed Vegetation (Y/N):	Sheen Present on Water (Y/N): Is the Boom Containing the Sheen? (Y/N) Pooled Product (Y/N) If yes, was product removed with sorbent pads?

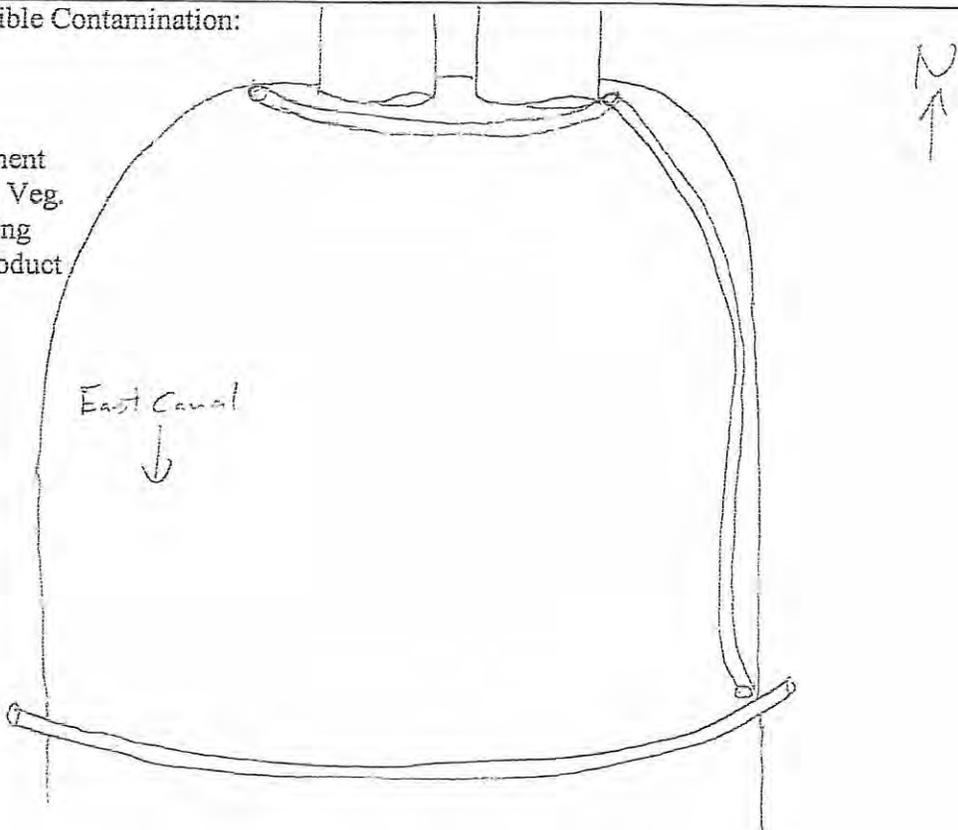
<b>Boom Location:</b> 9/12	<b>Time/Date:</b> 1414 / 2.6.13
<b>Description of Boom Before Maintenance:</b>  SATISFACTORY	<b>Photograph (s) Time/Date Stamp:</b>  1414 / 2.6.13
<b>Boom Repaired (Y (N):</b> Description:	<b>Boom Replaced (Y (N) / Number of Sections:</b> Description:
<b>Visual Observations</b> Visible Contamination (Y (N): Iron Staining (Y (N): Oily Sediment/Soil (Y (N): Distressed Vegetation (Y (N):	
Sheen Present on Water (Y (N) Is the Boom Containing the Sheen? (Y / N) Pooled Product (Y (N): If yes, was product removed with sorbent pads?	
<b>Location of Visible Contamination:</b>	
<b>Legend</b> /// Sheen \\\ Oily Sediment xxx Distressed Veg. RRR Iron Staining ● Pooled Product

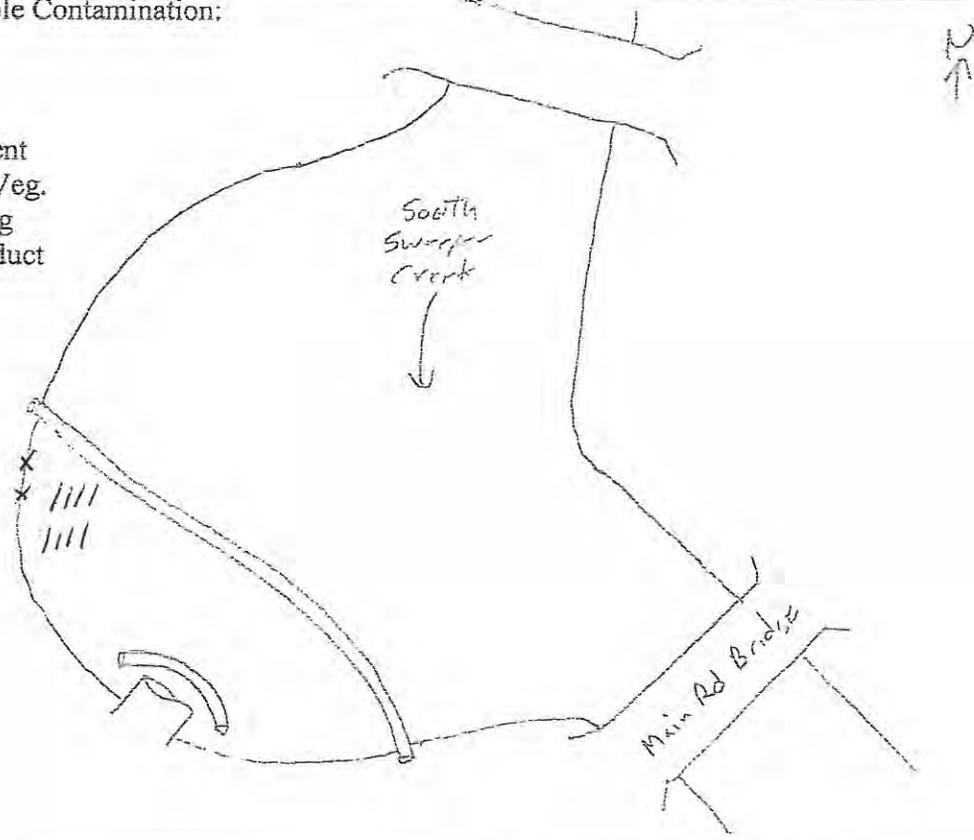
<b>Boom Location:</b> 10	<b>Time/Date:</b> 1430 / 2.6.13
<b>Description of Boom Before Maintenance:</b>  SATISFACTORY	<b>Photograph (s) Time/Date Stamp:</b>  1430 / 2.6.13
<b>Boom Repaired (Y/N):</b> (N) <b>Description:</b>	<b>Boom Replaced (Y/N):</b> (N) / <b>Number of Sections:</b> <b>Description:</b>
<b>Visual Observations</b> Visible Contamination (Y/N): Iron Staining (Y/N): Oily Sediment/Soil (Y/N): Distressed Vegetation (Y/N):	
Sheen Present on Water (Y/N): Is the Boom Containing the Sheen? (Y/N) Pooled Product (Y/N): If yes, was product removed with sorbent pads?	
<b>Location of Visible Contamination:</b>	
<b>Legend</b> /// Sheen \\\ Oily Sediment xxx Distressed Veg. RRR Iron Staining ● Pooled Product
