# **Remedial Action Summary Report Free Product Recovery**

SWMU 62 New Housing Fuel Leak Area,  
Area 303, and Additional Sites

## **Former Naval Complex**

Adak, Alaska

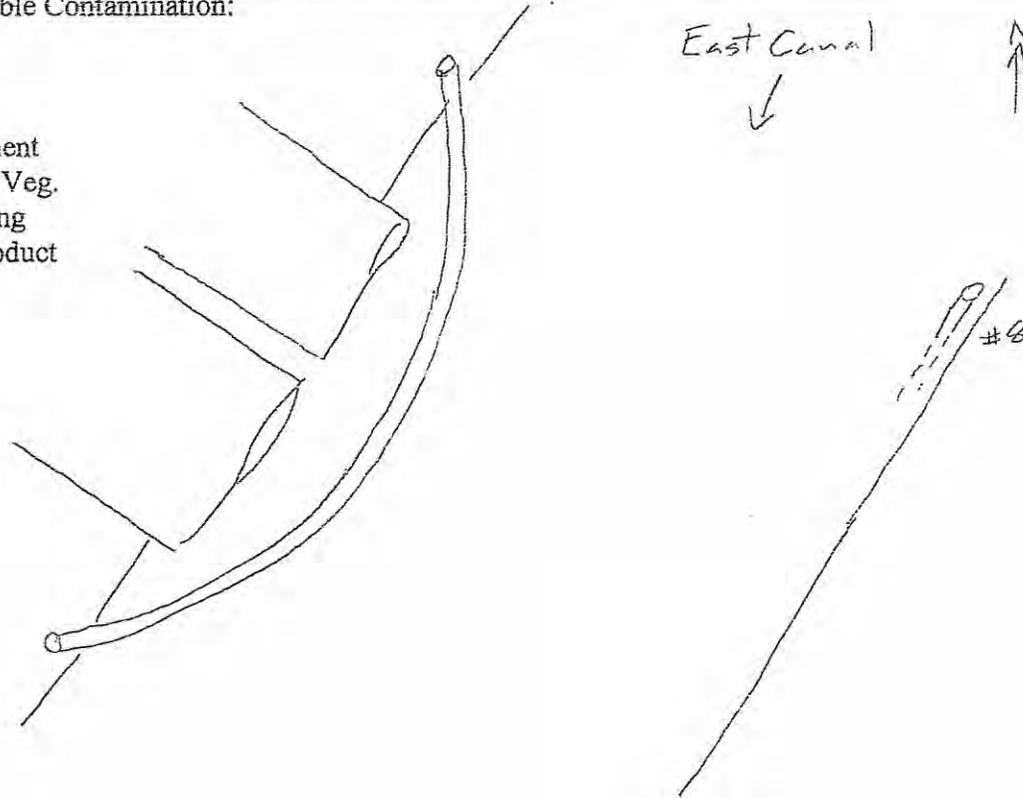
Boom Location: 2	Time/Date: 1333 / 3-6-13		
Description of Boom Before Maintenance:  UNSATISFACTORY	Photograph (s) Time/Date Stamp:  1333 / 3-6-13		
Boom Repaired (Y/N): Description: BOOM NOT IN POSITION, ACROSS COVERTS, UNDER SNOW AND ICE	Boom Replaced (Y/N)/ Number of Sections: Description:		
<p><b>Visual Observations</b></p> <table style="width: 100%; border: none;"> <tr> <td style="width: 50%; border: none; vertical-align: top;">                 Visible Contamination (Y/N):                  Iron Staining (Y/N):                  Oily Sediment/Soil (Y/N):                  Distressed Vegetation (Y/N):             </td> <td style="width: 50%; border: none; vertical-align: top;">                 Sheen Present on Water (Y/N):                  Is the Boom Containing the Sheen? (Y/N)                  Pooled Product (Y/N):                  If yes, was product removed with sorbent pads?             </td> </tr> </table>		Visible Contamination (Y/N): Iron Staining (Y/N): Oily Sediment/Soil (Y/N): Distressed Vegetation (Y/N):	Sheen Present on Water (Y/N): Is the Boom Containing the Sheen? (Y/N) Pooled Product (Y/N): If yes, was product removed with sorbent pads?

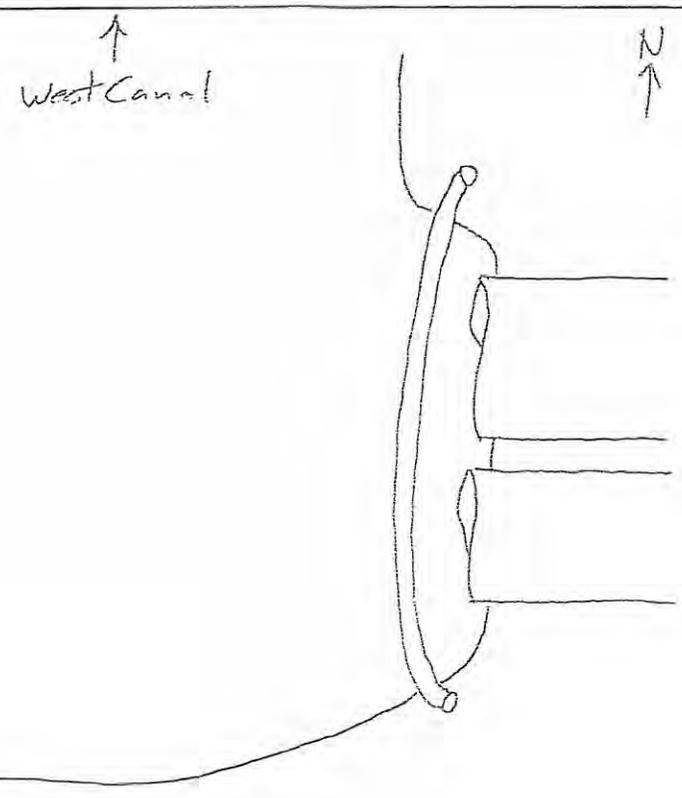
<b>Boom Location:</b> 4	<b>Time/Date:</b> 1348 / 3.6.13
<b>Description of Boom Before Maintenance:</b> SATISFACTORY	<b>Photograph (s) Time/Date Stamp:</b> 1348 / 3.6.13
<b>Boom Repaired (Y/N):</b> (N) <b>Description:</b>	<b>Boom Replaced (Y/N):</b> (N) / <b>Number of Sections:</b> <b>Description:</b>
<b>Visual Observations</b> Visible Contamination (Y/N): (N) Iron Staining (Y/N): (N) Oily Sediment/Soil (Y/N): (N) Distressed Vegetation (Y/N): (N)	
Sheen Present on Water (Y/N): (N) Is the Boom Containing the Sheen? (Y/N): Pooled Product (Y/N): (N) If yes, was product removed with sorbent pads?	
<b>Location of Visible Contamination:</b> <div style="display: flex; justify-content: space-between; align-items: flex-start;"> <div style="width: 40%;"> <p><u>Legend</u></p> <p>/// Sheen</p> <p>\\ \\ Oily Sediment</p> <p>xxx Distressed Veg.</p> <p>RRR Iron Staining</p> <p>● Pooled Product</p> </div> <div style="width: 50%; text-align: center;"> <p>↑ West Canal</p>

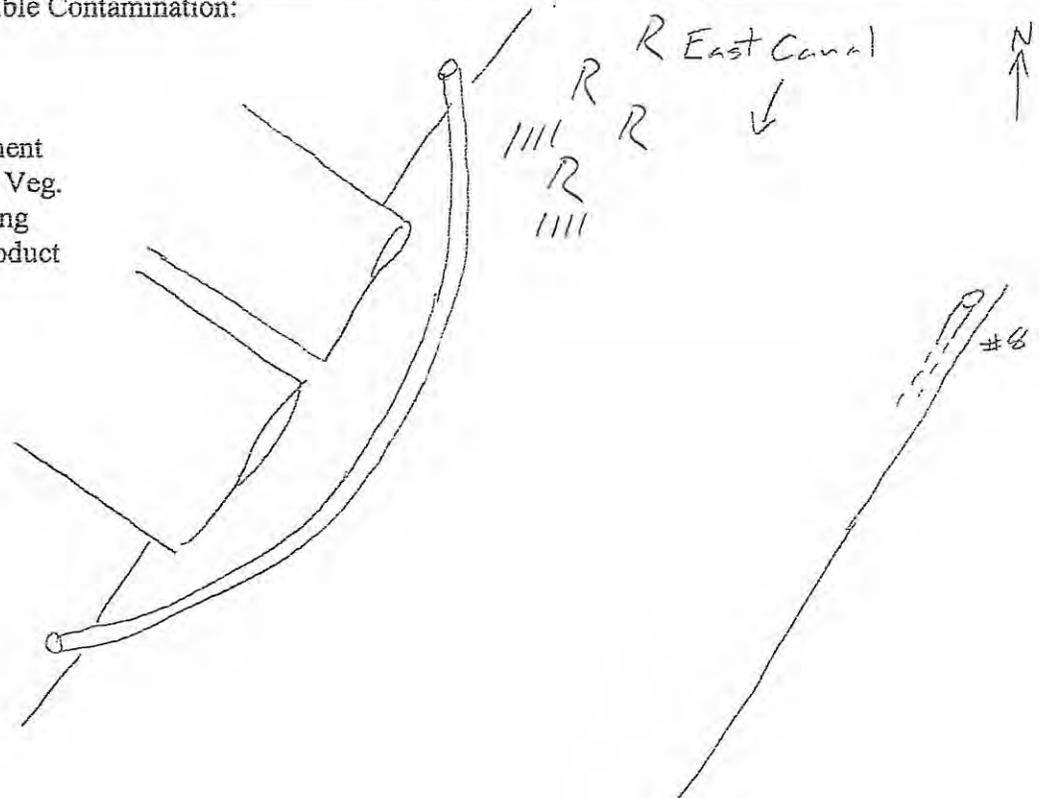
<b>Boom Location:</b> 2	<b>Time/Date:</b> 1518 / 4-16-13
<b>Description of Boom Before Maintenance:</b> UNSATISFACTORY - BOOM OFF POSTS AND SATURATED WITH WATER	<b>Photograph (s) Time/Date Stamp:</b> 1518 / 4-16-13
<b>Boom Repaired (Y/N):</b> Description: REMOVED OLD BOOM SECTIONS AND INSTALLED NEW	<b>Boom Replaced (Y/N) / Number of Sections:</b> 2 Description: 2 SECTIONS SATURATED WITH WATER/OIL
<b>Visual Observations</b>	
<b>Visible Contamination (Y/N):</b> Iron Staining (Y) (N): Oily Sediment/Soil (Y) (N): Distressed Vegetation (Y) (N):	<b>Sheen Present on Water (Y/N):</b> Is the Boom Containing the Sheen? (Y) (N) <b>Pooled Product (Y) (N):</b> If yes, was product removed with sorbent pads?
<b>Location of Visible Contamination:</b>	
<b>Legend</b> /// Sheen \\\ Oily Sediment xxx Distressed Veg. RRR Iron Staining ● Pooled Product

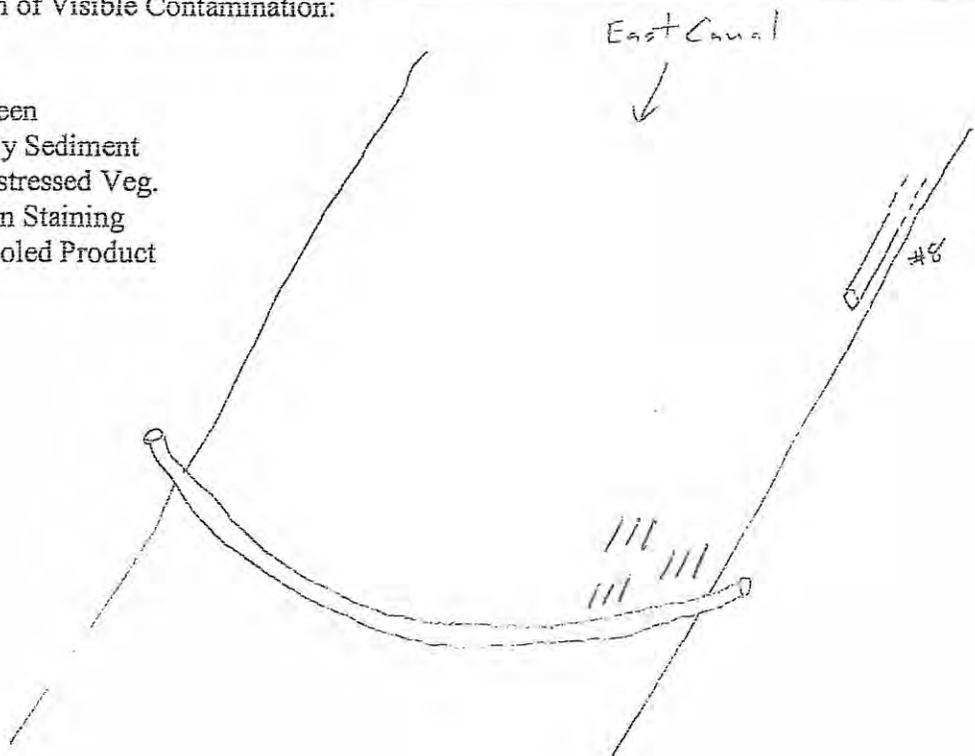
<b>Boom Location:</b> 3	<b>Time/Date:</b> 1520 / 4-16-13
<b>Description of Boom Before Maintenance:</b> UNSATISFACTORY:	<b>Photograph (s) Time/Date Stamp:</b> 1520 / 4-16-13
<b>Boom Repaired (Y/N):</b> Description: REPLACED (8) BOOM SECTIONS	<b>Boom Replaced (Y/N) / Number of Sections:</b> 8 Description: REPLACED OLD BOOM
DUE TO OIL/WATER SATURATION	WITH NEW
<b>Visual Observations</b>	
<b>Visible Contamination (Y/N):</b> Iron Staining (Y (N)) Oily Sediment/Soil (Y (N)) Distressed Vegetation (Y (N))	<b>Sheen Present on Water (Y/N):</b> Is the Boom Containing the Sheen? (Y (N)) Pooled Product (Y (N)) If yes, was product removed with sorbent pads?
<b>Location of Visible Contamination:</b>	
<b>Legend</b> /// Sheen \\\ Oily Sediment xxx Distressed Veg. RRR Iron Staining ● Pooled Product	<div style="text-align: right;">           East Canal            ↓         </div> <div style="text-align: right;">           N            ↑         </div>

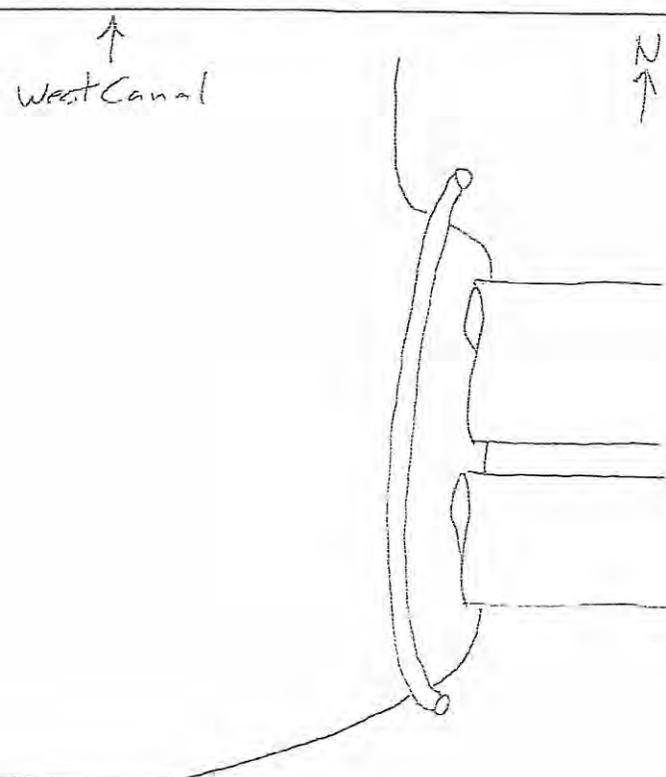
<b>Boom Location:</b> 4	<b>Time/Date:</b> 1545 / 4-16-13
<b>Description of Boom Before Maintenance:</b>  SATISFACTORY	<b>Photograph (s) Time/Date Stamp:</b>  1545 / 4-16-13
<b>Boom Repaired (Y/N):</b> (N) <b>Description:</b>	<b>Boom Replaced (Y/N) / Number of Sections:</b> (N) <b>Description:</b>
<b>Visual Observations</b> <b>Visible Contamination (Y/N):</b> (N) <b>Sheen Present on Water (Y/N):</b> (N) <b>Iron Staining (Y/N):</b> (N) <b>Is the Boom Containing the Sheen? (Y/N)</b> <b>Oily Sediment/Soil (Y/N):</b> (N) <b>Pooled Product (Y/N):</b> (N) <b>Distressed Vegetation (Y/N):</b> (N) <b>If yes, was product removed with sorbent pads?</b>	
<b>Location of Visible Contamination:</b>  <div style="display: flex; justify-content: space-between;"> <div style="width: 40%;"> <p><u>Legend</u></p> <p>//// Sheen</p> <p>\\ \\ Oily Sediment</p> <p>xxx Distressed Veg.</p> <p>RRR Iron Staining</p> <p>● Pooled Product</p> </div> <div style="width: 55%; text-align: center;"> <p>↑ West Canal</p>

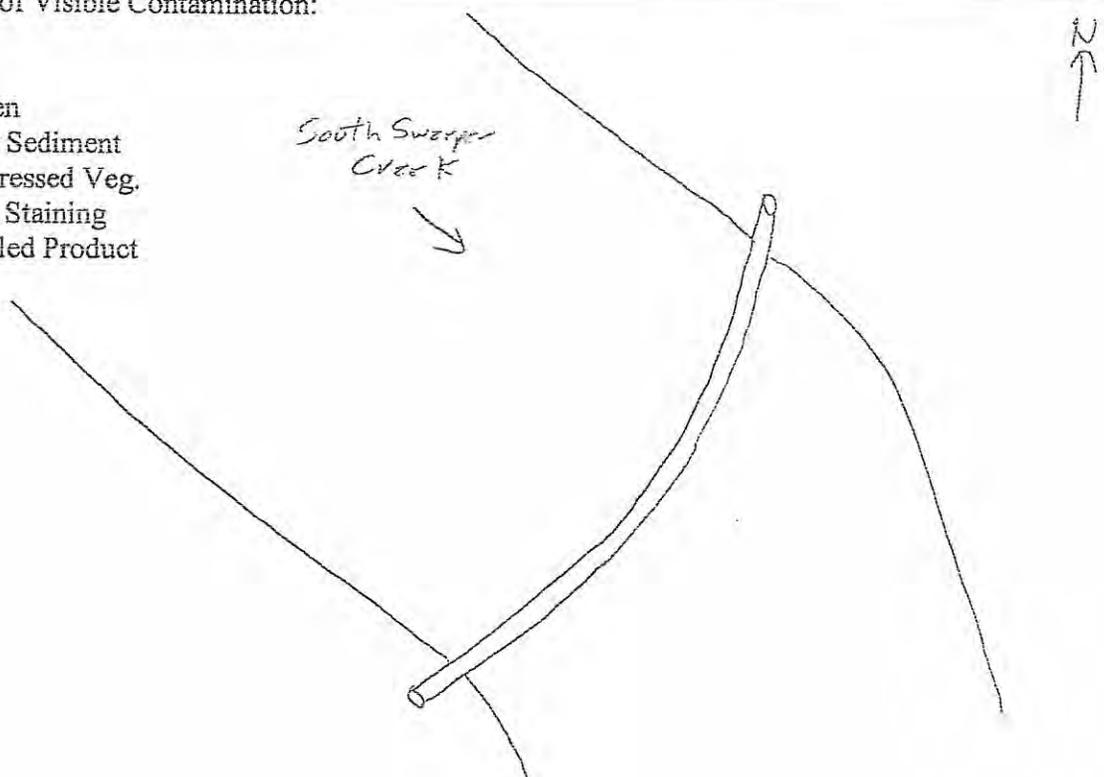
Boom Location: 6	Time/Date: 1550 / 4-16-13								
Description of Boom Before Maintenance: UNSATISFACTORY	Photograph (s) Time/Date Stamp: 1550 / 4-16-13								
Boom Repaired (Y/N): Description: REPLACED 1 SECTION AND RETIED SOUTH END OF SECTIONS	Boom Replaced (Y/N) / Number of Sections: 1 Description: REPLACED (1) SECTION DUE TO TIDAL CURRENTS CAUSING DAMAGE								
<p><b>Visual Observations</b></p>

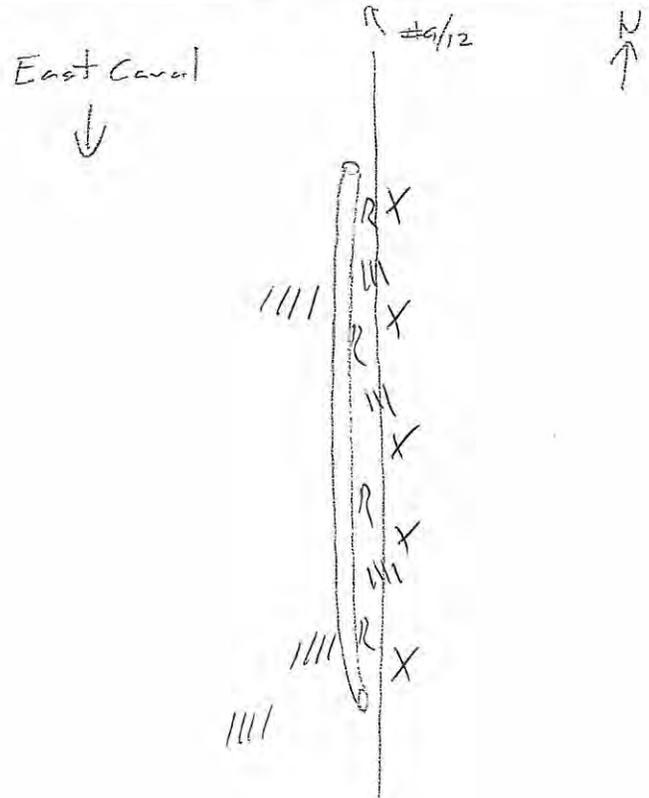
<b>Boom Location: 11</b>	<b>Time/Date:</b> <div style="text-align: right; font-size: 1.2em;">1537 / 4-16-13</div>
<b>Description of Boom Before Maintenance:</b>  <div style="font-size: 1.2em;">UNSATISFACTORY</div>	<b>Photograph (s) Time/Date Stamp:</b>  <div style="text-align: right; font-size: 1.2em;">1537 / 4-16-13</div>
<b>Boom Repaired (Y/N):</b> Description: REPLACED SECTIONS DUE TO OIL / WATER SATURATION	<b>Boom Replaced (Y / N) / Number of Sections: 4</b> Description: REPLACED (4) SECTIONS WITH NEW
<b>Visual Observations</b> Visible Contamination (Y/N): Iron Staining (Y/N): Oily Sediment/Soil (Y/N): Distressed Vegetation (Y/N):	
Sheen Present on Water (Y/N): Is the Boom Containing the Sheen? (Y (N)) Pooled Product (Y (N)): If yes, was product removed with sorbent pads?	
<b>Location of Visible Contamination:</b>  <div style="display: flex; justify-content: space-between;"> <div style="width: 30%;"> <p><u>Legend</u></p> <p>//// Sheen</p> <p>\\ \\ Oily Sediment</p> <p>xxx Distressed Veg.</p> <p>RRR Iron Staining</p> <p>● Pooled Product</p> </div> <div style="width: 65%; text-align: center;"> <p>East Canal</p> <p>↓</p>

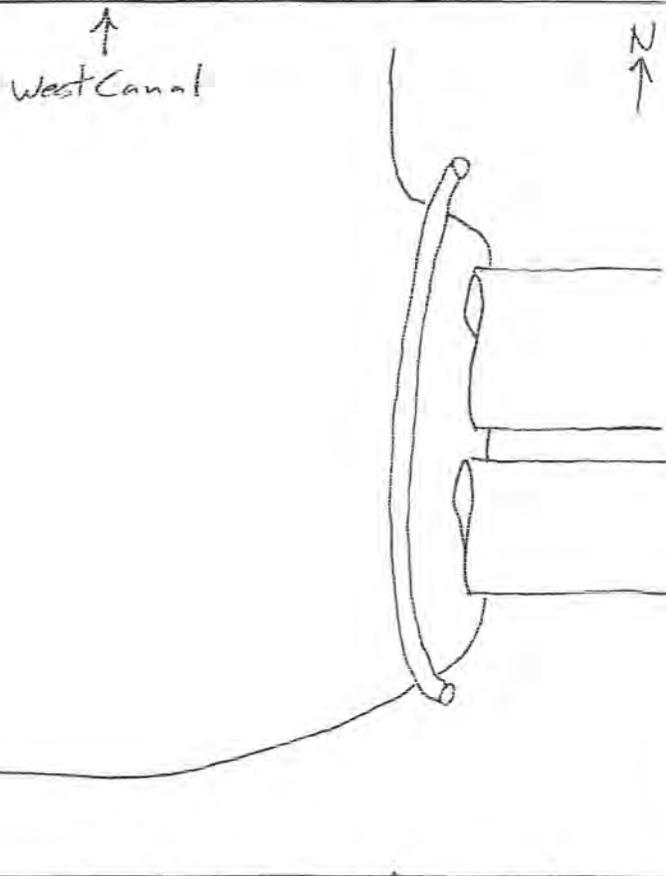
<b>Boom Location:</b> 4	<b>Time/Date:</b> 0843 / 6-8-13
<b>Description of Boom Before Maintenance:</b> SATISFACTORY	<b>Photograph (s) Time/Date Stamp:</b> 0843 / 6-8-13
<b>Boom Repaired (Y/N):</b> Description:	<b>Boom Replaced (Y/N) / Number of Sections:</b> Description:
<b>Visual Observations</b> Visible Contamination (Y/N): Iron Staining (Y/N): Oily Sediment/Soil (Y/N): Distressed Vegetation (Y/N): Sheen Present on Water (Y/N): Is the Boom Containing the Sheen? (Y/N) Pooled Product (Y/N): If yes, was product removed with sorbent pads?	
<b>Location of Visible Contamination:</b> <div style="display: flex; justify-content: space-between;"> <div data-bbox="196 968 487 1178"> <p><b>Legend</b></p> <p>//// Sheen</p> <p>\\ \\ Oily Sediment</p> <p>xxx Distressed Veg.</p> <p>RRR Iron Staining</p> <p>• Pooled Product</p> </div> <div data-bbox="763 890 1429 1766">

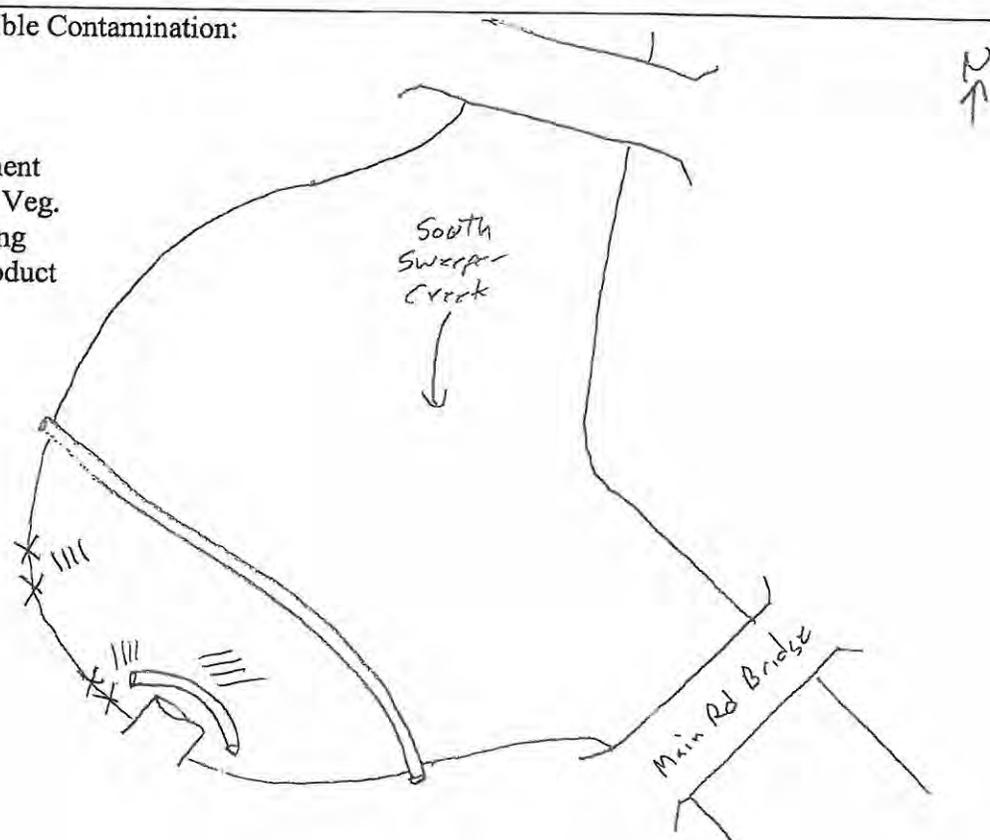
<b>Boom Location: 10</b>	Time/Date: <i>0855 / 7-4-13</i>		
Description of Boom Before Maintenance: <i>Satisfactory</i>	Photograph (s) Time/Date Stamp: <i>0854 / 7-4-13</i>		
Boom Repaired (Y/N): Description:	Boom Replaced (Y/N) Number of Sections: Description:		
<p><b>Visual Observations</b></p> <table style="width: 100%; border: none;"> <tr> <td style="width: 50%; border: none;">                 Visible Contamination (Y/N):                  Iron Staining (Y/N):                  Oily Sediment/Soil (Y/N):                  Distressed Vegetation (Y/N):             </td> <td style="width: 50%; border: none;">                 Sheen Present on Water (Y/N):                  Is the Boom Containing the Sheen? (Y/N)                  Pooled Product (Y/N):                  If yes, was product removed with sorbent pads?             </td> </tr> </table>		Visible Contamination (Y/N): Iron Staining (Y/N): Oily Sediment/Soil (Y/N): Distressed Vegetation (Y/N):	Sheen Present on Water (Y/N): Is the Boom Containing the Sheen? (Y/N) Pooled Product (Y/N): If yes, was product removed with sorbent pads?
Visible Contamination (Y/N): Iron Staining (Y/N): Oily Sediment/Soil (Y/N): Distressed Vegetation (Y/N):	Sheen Present on Water (Y/N): Is the Boom Containing the Sheen? (Y/N) Pooled Product (Y/N): If yes, was product removed with sorbent pads?		
Location of Visible Contamination: <div style="margin-top: 10px;"> <p><u>Legend</u></p> <ul style="list-style-type: none"> <li>//// Sheen</li> <li>\\\\ Oily Sediment</li> <li>xxx Distressed Veg.</li> <li>RRR Iron Staining</li> <li>● Pooled Product</li> </ul> </div> <div style="margin-top: 20px;">

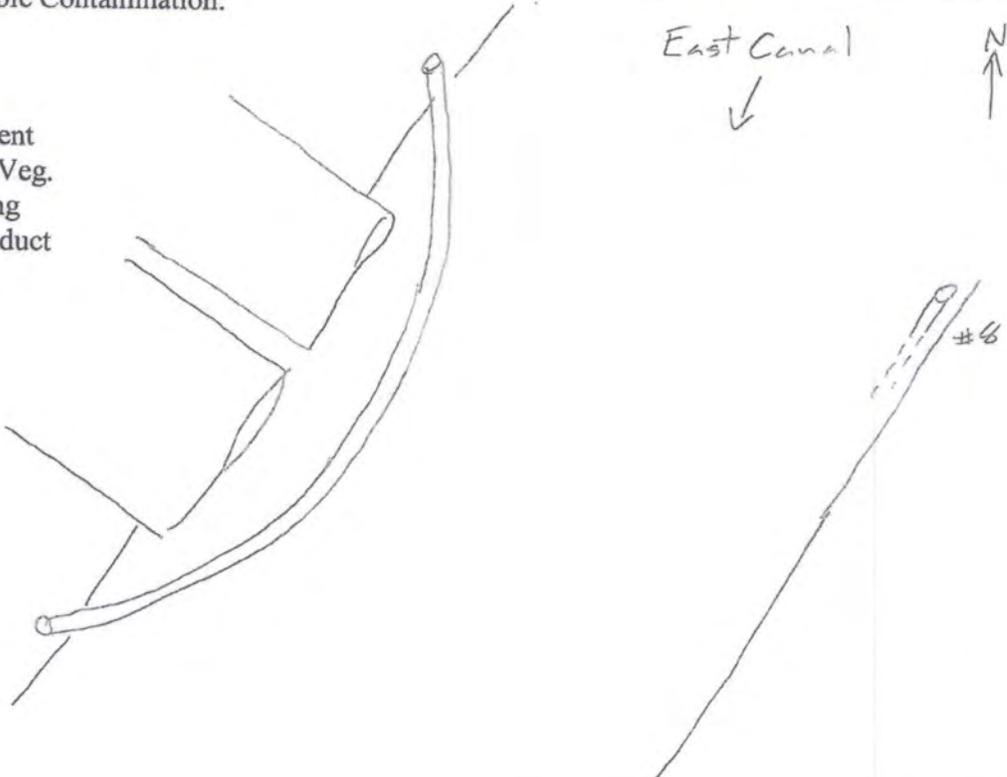
<b>Boom Location: 2</b>	Time/Date: 1238 / 8/2/13
Description of Boom Before Maintenance:  Unsatisfactory	Photograph (s) Time/Date Stamp:  1238
Boom Repaired (Y/N): Description: Connected back to tie off post High water levels due to dike pumps not Running on a regular schedule.	Boom Replaced (Y/N) / Number of Sections: Description:
<b>Visual Observations</b>	
Visible Contamination (Y/N): Iron Staining (Y/N): Oily Sediment/Soil (Y/N): Distressed Vegetation (Y/N):	Sheen Present on Water (Y/N): Is the Boom Containing the Sheen? (Y/N) Pooled Product (Y/N): If yes, was product removed with sorbent pads?
Location of Visible Contamination:	
<p><u>Legend</u></p> <p>//// Sheen</p> <p>\\ \\ Oily Sediment</p> <p>xxx Distressed Veg.</p> <p>RRR Iron Staining</p> <p>● Pooled Product</p>

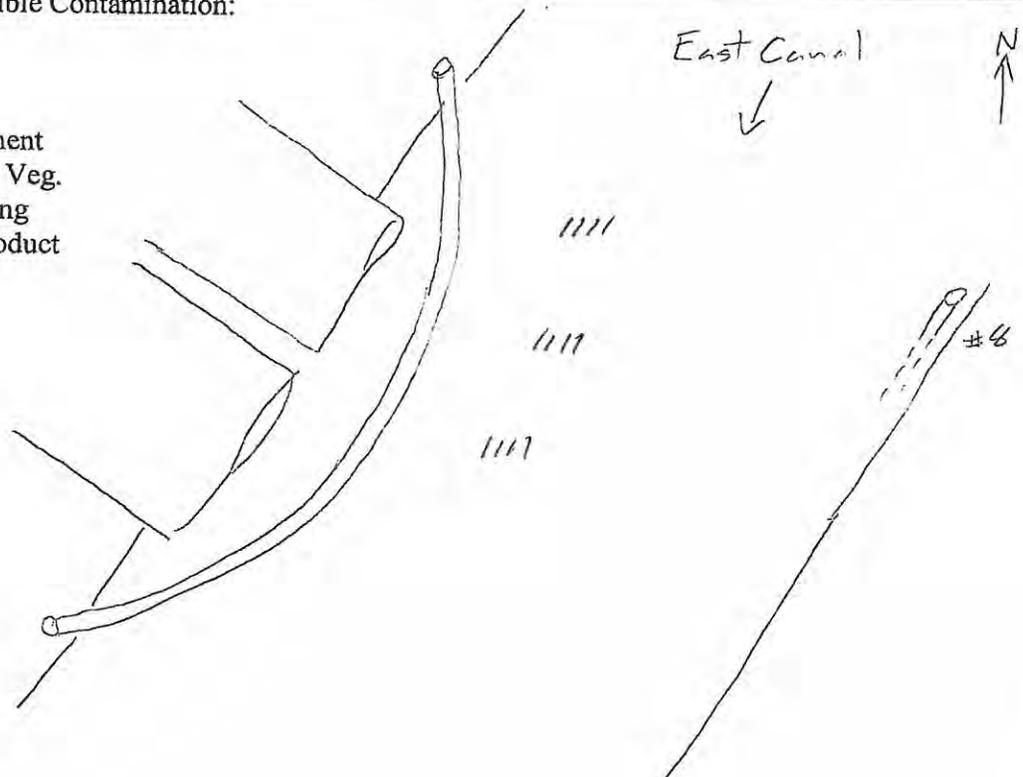
<b>Boom Location: 2</b>	Time/Date: 1138 / 9-4-13
Description of Boom Before Maintenance:	Photograph (s) Time/Date Stamp:
UNSATISFACTORY	1138 / 9-4-13
Boom Repaired (Y/N): Description: NORTH END OF BOOM OFF STAKE DUE TO HIGH WATER LEVELS. INSTALL NEW STAKE + PLACE INTO POSITION	Boom Replaced (Y/N) / Number of Sections: Description:
<b>Visual Observations</b>	
Visible Contamination (Y/N): Iron Staining (Y/N): Oily Sediment/Soil (Y/N): Distressed Vegetation (Y/N):	Sheen Present on Water (Y/N): Is the Boom Containing the Sheen? (Y/N) Pooled Product (Y/N): If yes, was product removed with sorbent pads?
Location of Visible Contamination:	
<p><u>Legend</u></p> <p>//// Sheen</p> <p>\\ \\ Oily Sediment</p> <p>xxx Distressed Veg.</p> <p>RRR Iron Staining</p> <p>● Pooled Product</p>

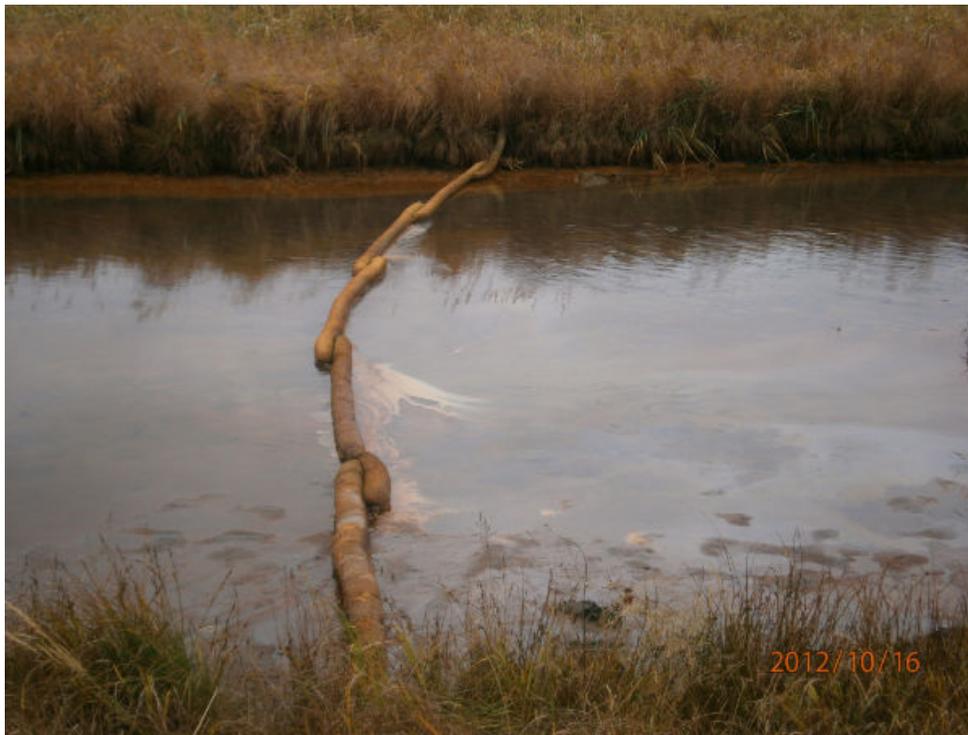
Photo 2 – East Canal Boom 2, March 2013, view west; high water level in canal while the canal pumps were off
