Remedial Action Summary Report, Free Product Recovery

SWMU 62 New Housing Fuel Leak Area and Additional Sites

Former Naval Complex

Adak, Alaska

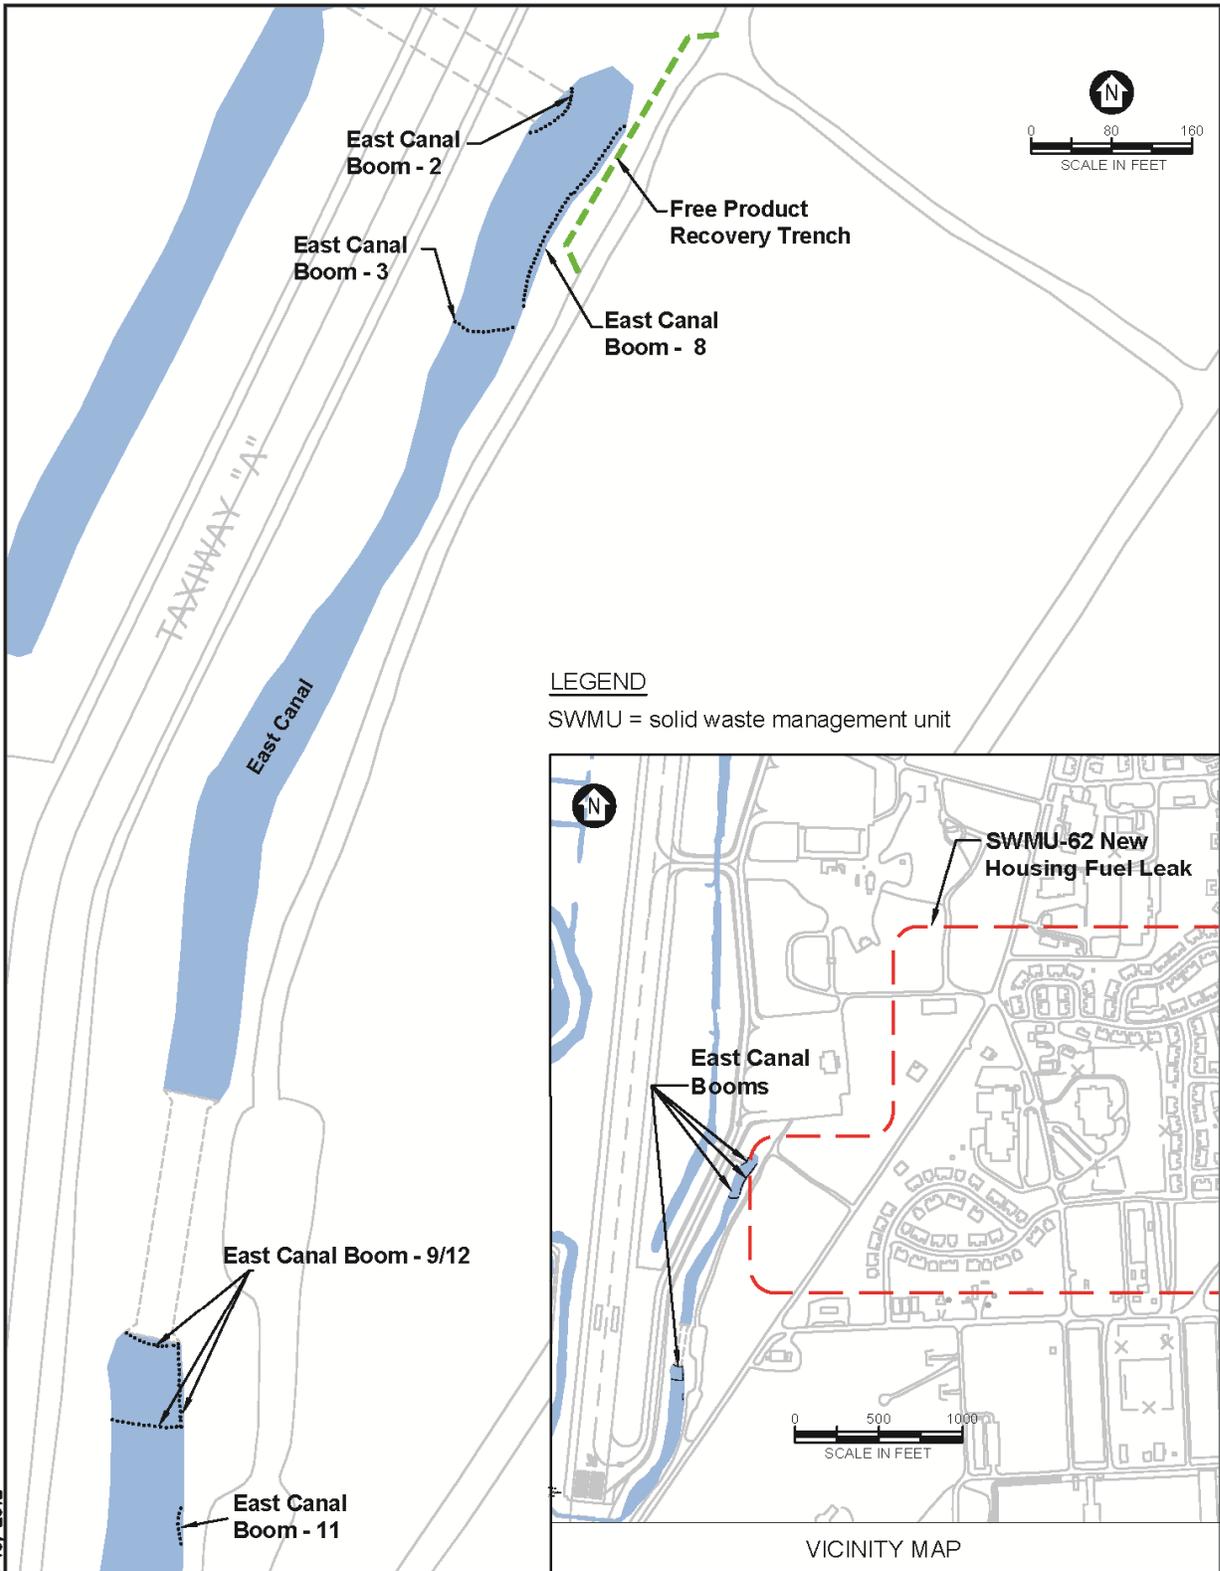
<p>U.S.NAVY SEALASKA</p>	<p align="center">Figure 4-1 East Canal Boom Locations</p>	<p>Task Order 43 2012 Remedial Action Summary Report Adak, Alaska</p>
---------------------------------	--	--

Sheen, oil saturated soils, stressed vegetation, and pooled product along the shoreline typically occurred at the petroleum shoreline seep in East Canal downgradient of the SWMU 62 product recovery trench. Booms deployed to control sheen at this seep include locations 2, 3, and 8 (see Figure 4-1). Sheen was observed during eight monthly inspections at Boom 8 located along the shoreline (Photo 7, Appendix B) and during three monthly maintenance events at Boom 3 (Photo 3, Appendix B) which is downstream of Boom 8. Pooled product was removed by hand using sorbent pads at Boom 8 during five monthly maintenance events. Booms 2 and 3 effectively prevented sheen that escaped from Boom 8 from migrating further downstream in East Canal or upstream during flood events.

Similar to the seep at SWMU 62, the petroleum seep on the shoreline of East Canal downgradient from Former Power Plant, Building T-1451 has been characterized by sheen, oil saturated soils, stressed vegetation, and pooled product along the shoreline. To control sheen at this seep, Boom 9/12 is placed across the culvert, along the shoreline, and spanning East Canal (see Figure 4-1). Sheen was observed during six of the 12 monthly inspections at Boom 9/12.

A smaller shoreline petroleum seep is located in East Canal approximately 85 feet downstream (south) from Boom 9/12 (see Figure 4-1). At this seep, sheen, oily sediments, and stressed vegetation were observed during all monthly inspections of Boom 11 (Photo 12, Appendix B).

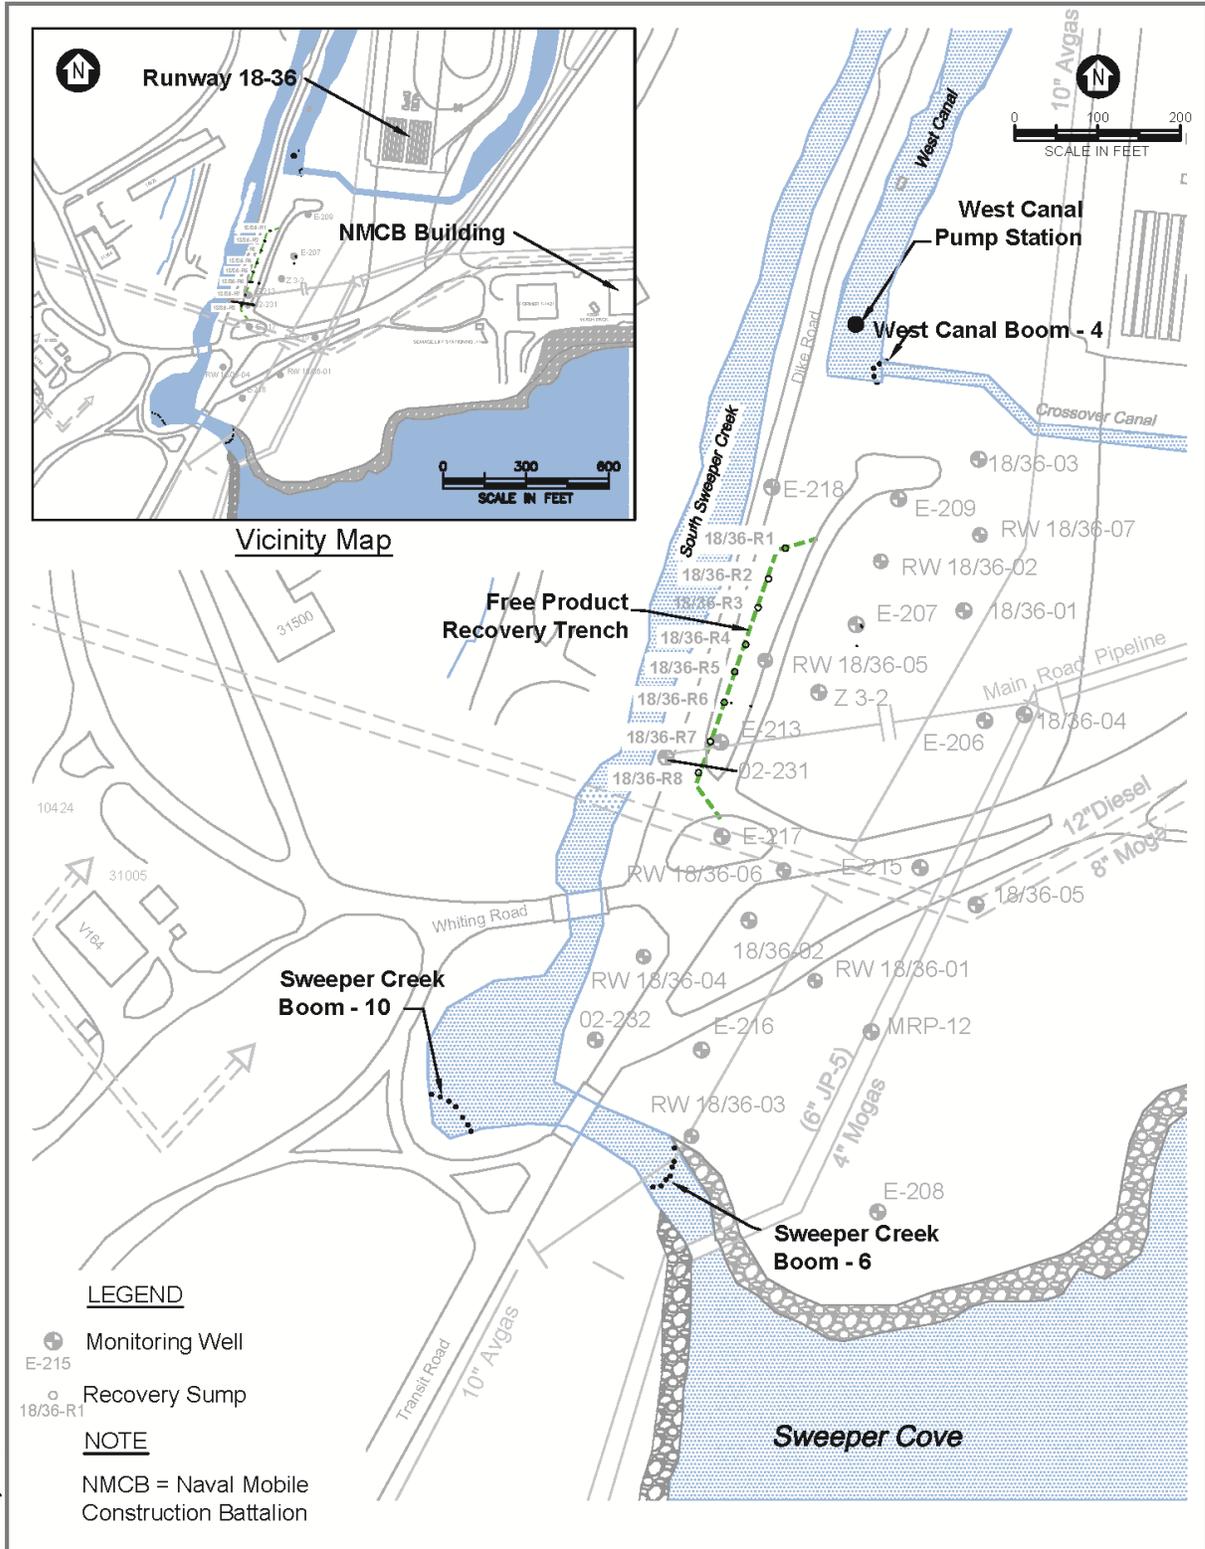
<p>U.S. NAVY</p>	<p>SEALASKA</p>	<p align="center">Figure 4-2 West Canal and South Sweeper Creek Boom Locations</p>	<p>Task Order 43 2012 Remedial Action Summary Report Adak, AK</p>
-------------------------	------------------------	---	--

Sheen was observed once at Boom 6 (see Figure 4-2) in South Sweeper Creek in April 2012. The origin of the sheen was the petroleum shoreline seep at Boom 10 in South Sweeper Creek lagoon downgradient of SWMU 60, Tank Farm A site (Photo 12, Appendix B). Boom 10 was damaged and was not effective at controlling the sheen. The damaged Boom 10 sections were replaced and no additional sheen was observed at the Boom 6 location. Sheen was observed during eight of 12 monthly inspections at Boom 10. During the April 2012 boom inspection the culvert immediately adjacent and south of Boom 10 had collapsed (Photo 11, Appendix B). Additional sheen was observed on the water surface at the culvert location at this time.

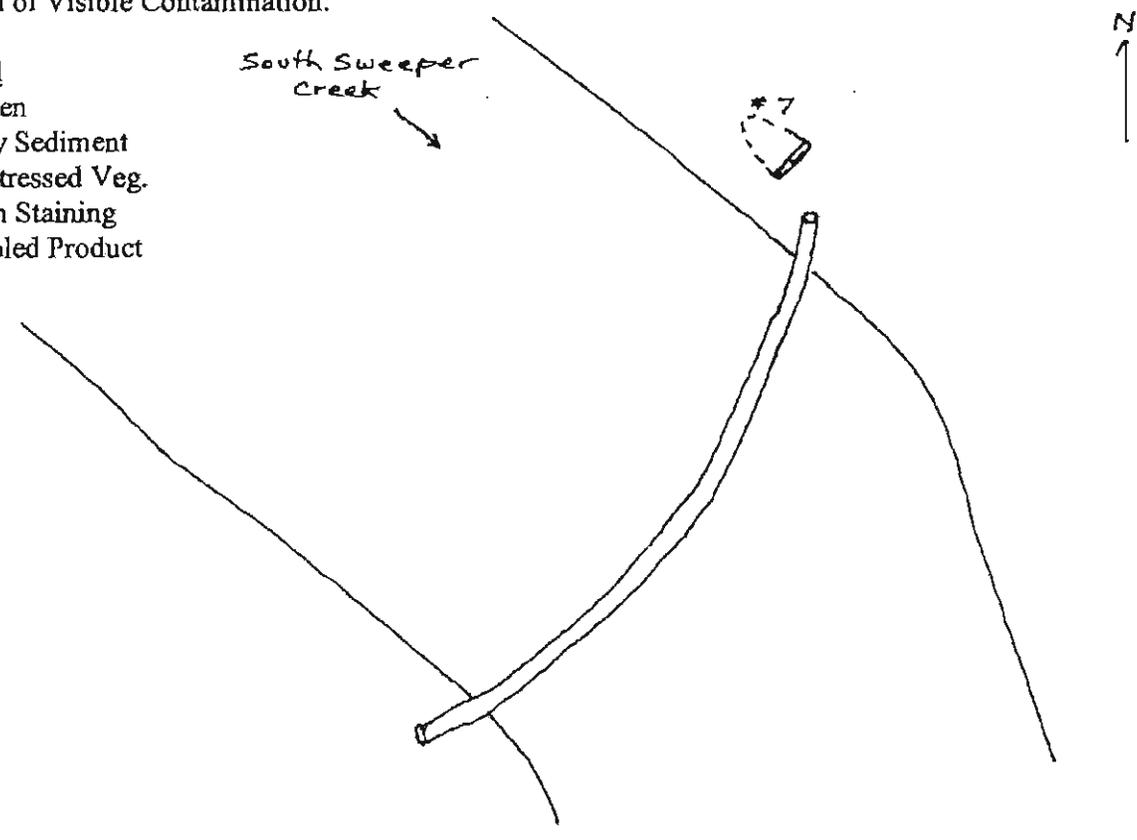
Boom Location: 6	Time/Date: 10:09 8/1/12		
Description of Boom Before Maintenance: UNSATISFACTORY	Photograph (s) Time/Date Stamp: 8/1/12		
Boom Repaired (Y/N): Description: MIDDLE SECTION BAD. REPLACED WITH NEW BOOM	Boom Replaced (Y/N) Number of sections: 1 Description: REPLACED 1 BOOM SECTION AND MOVED BACK INTO POSITION		
Visual Observations <table style="width: 100%; border: none;"> <tr> <td style="width: 50%; border: none;"> Visible Contamination (Y/N): (N) Iron Staining (Y/N): (N) Oily Sediment/Soil (Y/N): (N) Distressed Vegetation (Y/N): (N) </td> <td style="width: 50%; border: none;"> Sheen Present on Water (Y/N): (N) Is the Boom containing the Sheen? (Y/N): Pooled Product (Y/N): (N) If yes, was product removed with sorbent pads? </td> </tr> </table>		Visible Contamination (Y/N): (N) Iron Staining (Y/N): (N) Oily Sediment/Soil (Y/N): (N) Distressed Vegetation (Y/N): (N)	Sheen Present on Water (Y/N): (N) Is the Boom containing the Sheen? (Y/N): Pooled Product (Y/N): (N) If yes, was product removed with sorbent pads?

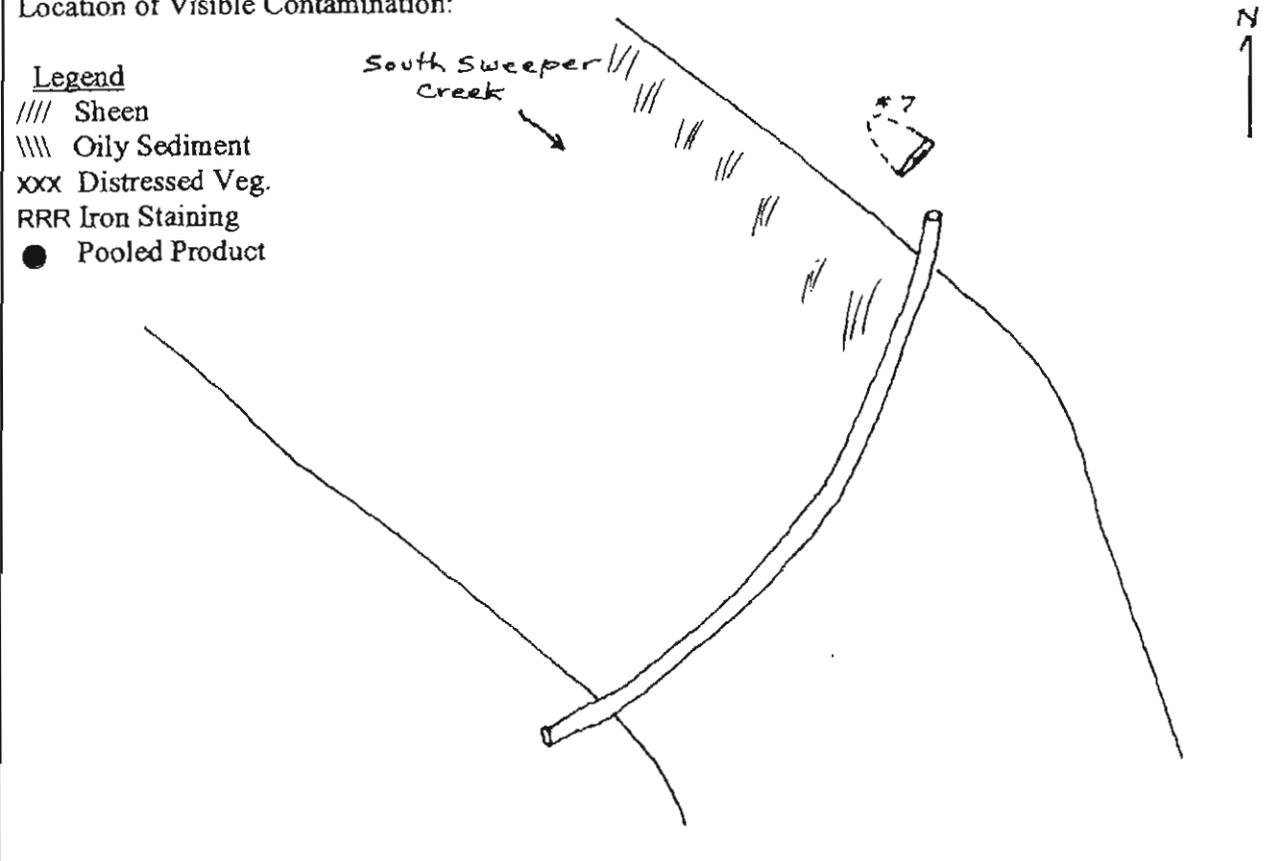
Boom Location: 6	Time/Date: 1100 4-4-12
Description of Boom Before Maintenance: Disconnected in middle	Photograph (s) Time/Date Stamp: 1339 4-5-12
Boom Repaired (Y/N): Description: Boom retied and reconnected.	Boom Replaced (Y/N) Number of sections: 3 Description: 3 middle sections replaced.
Visual Observations	
Visible Contamination (Y/N): * Iron Staining (Y/N): Oily Sediment/Soil (Y/N): Distressed Vegetation (Y/N): Location #6 contained the boom after it was retied and Location #10 could not contain boom until replaced	Sheen Present on Water (Y/N): * Is the Boom containing the Sheen? (Y/N): Pooled Product (Y/N): If yes, was product removed with sorbent pads?
Location of Visible Contamination:	
Legend /// Sheen \\\ Oily Sediment xxx Distressed Veg. RRR Iron Staining ● Pooled Product

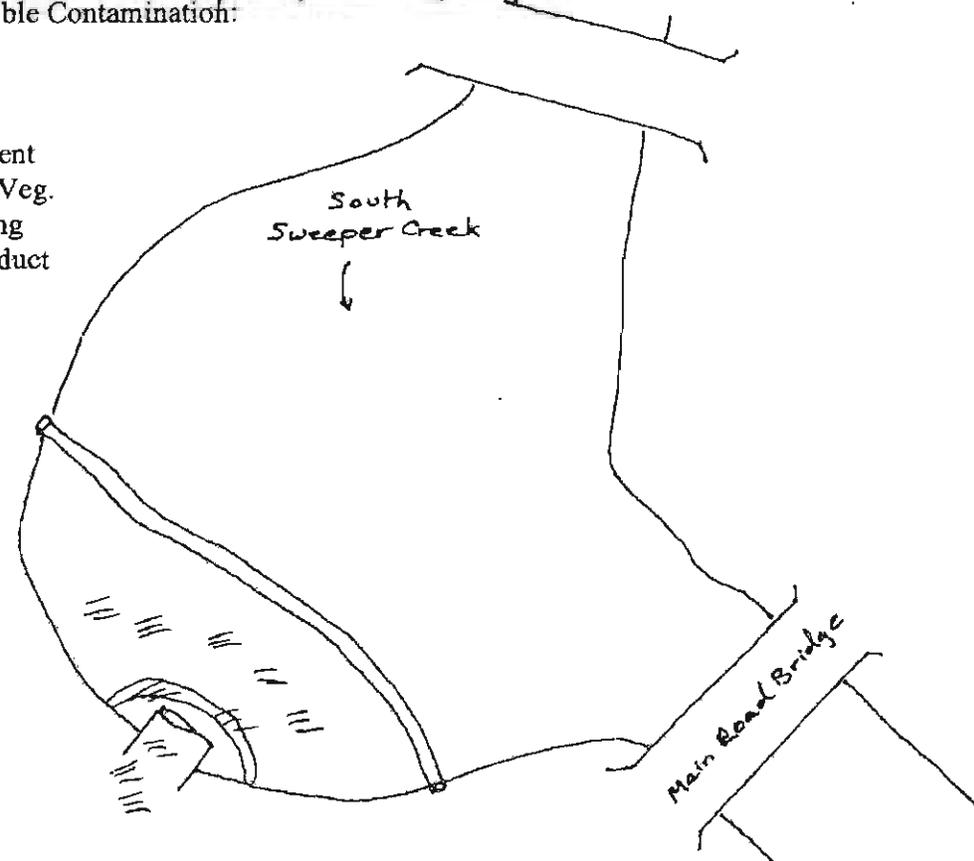
Boom Location: 10	Time/Date: 1100 4-4-12
Description of Boom Before Maintenance: <i>Water logged</i>	Photograph (s) Time/Date Stamp: 1338 4-5-12
Boom Repaired (Y/N): Description:	Boom Replaced (Y/N) Number of sections: 10 Description: <i>Replaced 10 sections</i>
Visual Observations Visible Contamination (Y/N): Iron Staining (Y/N): Oily Sediment/Soil (Y/N): Distressed Vegetation (Y/N):	
Sheen Present on Water (Y/N): Is the Boom containing the Sheen? (Y/N): Pooled Product (Y/N): If yes, was product removed with sorbent pads?	
<i>The culvert had collapsed, leaking into the location</i> Location of Visible Contamination:	
<div style="display: flex; justify-content: space-between;"> <div style="width: 30%;"> <p><u>Legend</u></p> <p>//// Sheen</p> <p>\\ \\ Oily Sediment</p> <p>xxx Distressed Veg.</p> <p>RRR Iron Staining</p> <p>● Pooled Product</p> </div> <div style="width: 60%; text-align: center;">

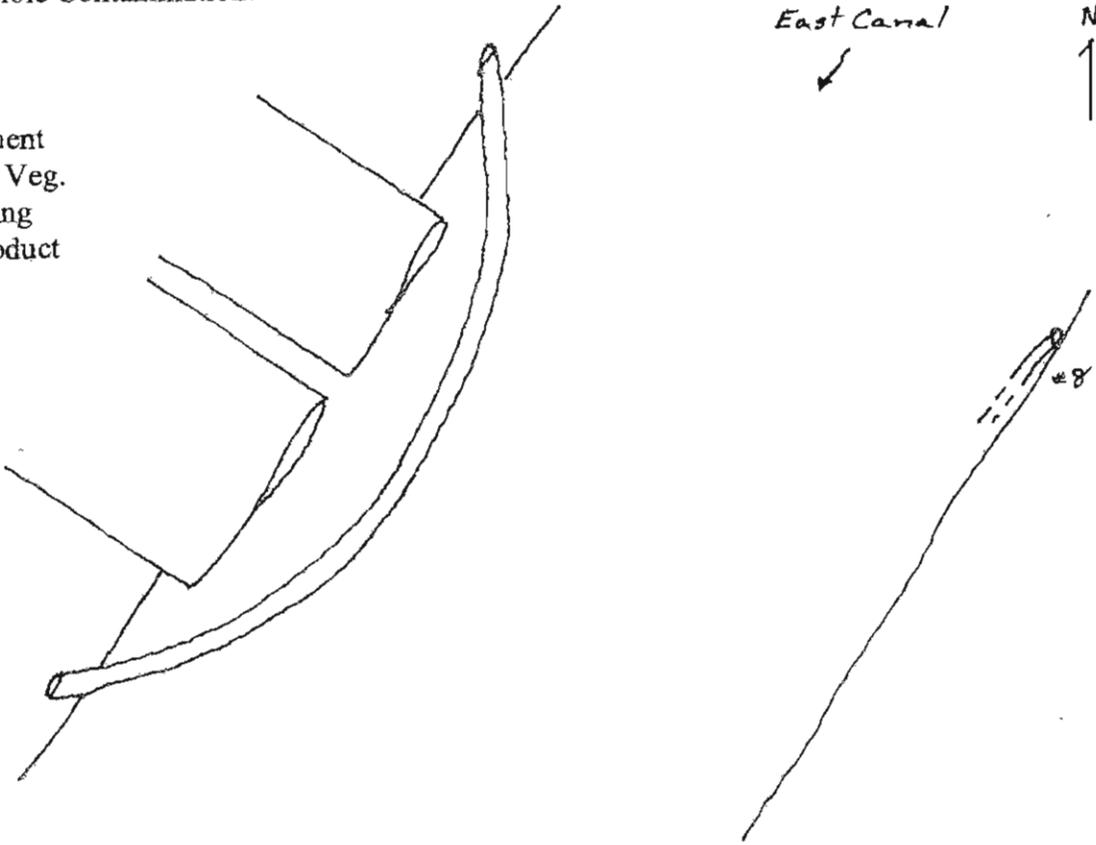
Boom Location: 2	Time/Date: 5-17-12
Description of Boom Before Maintenance: <i>Unsatisfactory, water logged</i>	Photograph (s) Time/Date Stamp: 1502 5-17-12
Boom Repaired (Y/N): Description: <i>Tied boom to new stakes.</i>	Boom Replaced (Y/N) Number of sections: 2 Description: <i>Replaced Both sections</i>
Visual Observations Visible Contamination (Y/N): Iron Staining (Y/N): Oily Sediment/Soil (Y/N): Distressed Vegetation (Y/N): Sheen Present on Water (Y/N): Is the Boom containing the Sheen? (Y/N): Pooled Product (Y/N): If yes, was product removed with sorbent pads?	
Location of Visible Contamination: <div style="display: flex; align-items: flex-start;"> <div style="flex: 1;"> <p><u>Legend</u></p> <p>//// Sheen</p> <p>\\\\\\ Oily Sediment</p> <p>xxx Distressed Veg.</p> <p>RRR Iron Staining</p> <p>● Pooled Product</p> </div> <div style="flex: 2;">

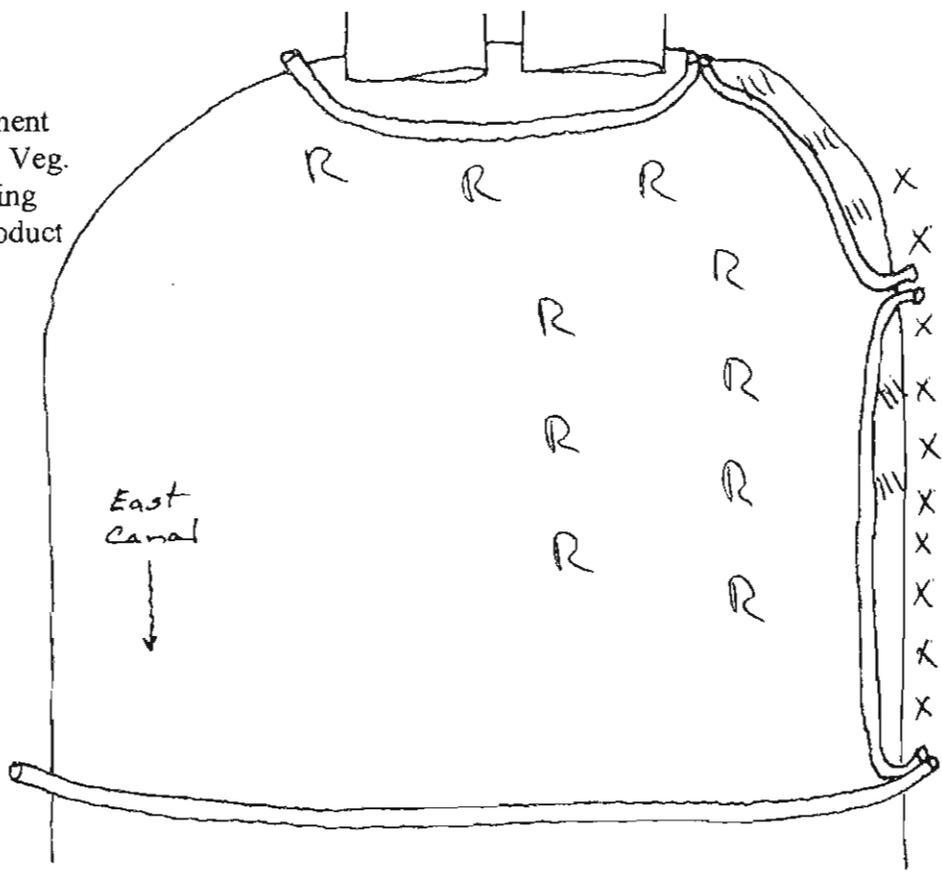
Boom Location: 9/12	Time/Date: <div style="text-align: center; font-size: 1.2em;">5-17-12</div>
Description of Boom Before Maintenance: <i>Unsatifactory, waterlogged</i>	Photograph (s) Time/Date Stamp: <div style="text-align: center;">1505 5-17-12</div>
Boom Repaired (Y/N): Description: <i>Boom Replaced</i>	Boom Replaced (Y/N) Number of Sections: 24 Description: <i>Replaced all sections</i>
Visual Observations	
Visible Contamination (Y/N): Iron Staining (Y/N): Oily Sediment/Soil (Y/N): Distressed Vegetation (Y/N):	Sheen Present on Water (Y/N): Is the Boom containing the Sheen? (Y/N): Pooled Product (Y/N): If yes, was product removed with sorbent pads?
Location of Visible Contamination:	
Legend //// Sheen \\\ Oily Sediment xxx Distressed Veg. RRR Iron Staining ● Pooled Product

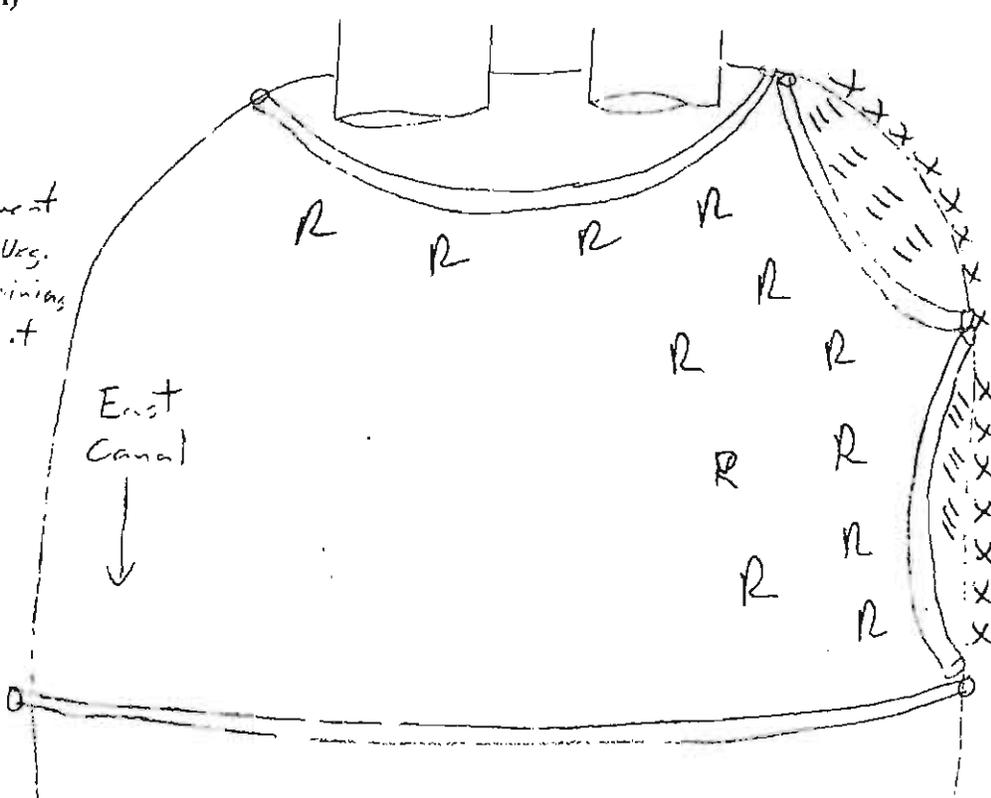
Visible Contamination <input checked="" type="radio"/> (Y) / N):	Sheen Present on Water <input checked="" type="radio"/> (Y) / N):	Iron Staining <input checked="" type="radio"/> (Y) / N):	Is the Boom containing the Sheen? <input checked="" type="radio"/> (Y) / N):	Oily Sediment/Soil <input checked="" type="radio"/> (Y) / N):	Pooled Product (Y <input checked="" type="radio"/> N):	Distressed Vegetation <input checked="" type="radio"/> (Y) / N):	If yes, was product removed with sorbent pads?
Visible Contamination <input checked="" type="radio"/> (Y) / N):	Sheen Present on Water <input checked="" type="radio"/> (Y) / N):									
Iron Staining <input checked="" type="radio"/> (Y) / N):	Is the Boom containing the Sheen? <input checked="" type="radio"/> (Y) / N):									
Oily Sediment/Soil <input checked="" type="radio"/> (Y) / N):	Pooled Product (Y <input checked="" type="radio"/> N):									
Distressed Vegetation <input checked="" type="radio"/> (Y) / N):	If yes, was product removed with sorbent pads?									
<p>Location of Visible Contamination: (draw diagram)</p> <div style="border: 1px solid black; padding: 10px;"> <p><u>Legend</u></p> <p>/// Sheen</p> <p>/// Oily Sediment</p> <p>XXX Distressed Veg.</p> <p>RRR Iron Staining</p> <p>● P. led Product</p>

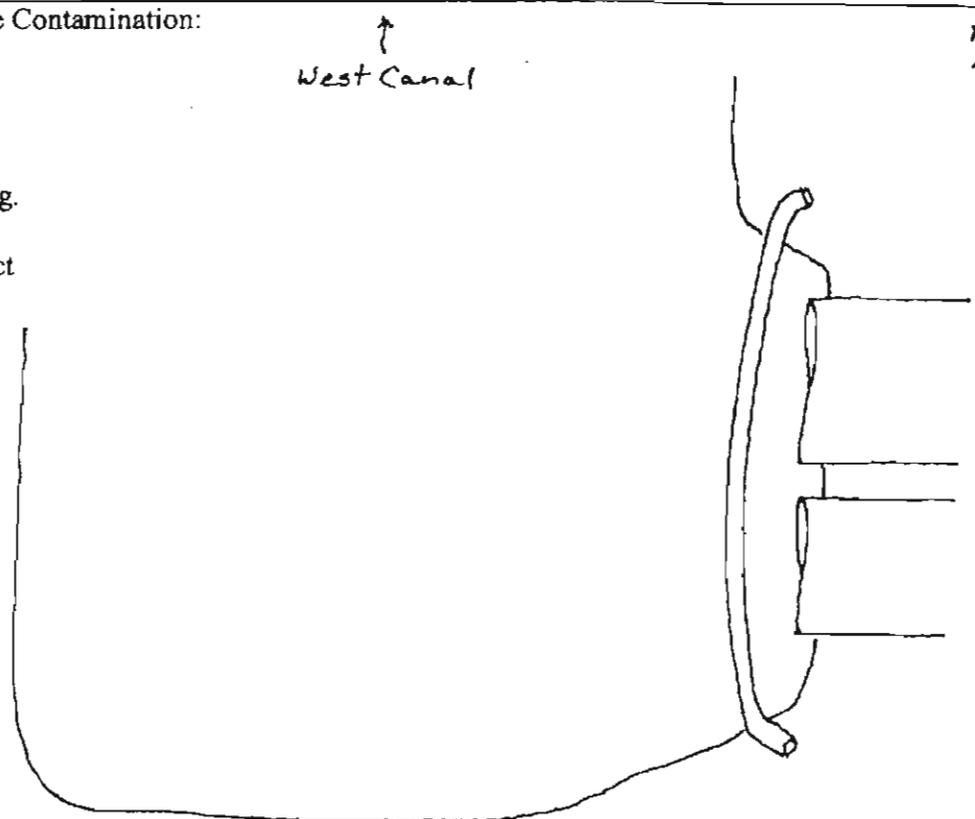
Boom Location: 4	Time/Date: 16:04 8/1/12
Description of Boom Before Maintenance: UNSATISFACTORY	Photograph (s) Time/Date Stamp: 8/1/12
Boom Repaired (Y/N): Description: BOOM WATERLOGGED, REPLACED ALL THREE SECTIONS	Boom Replaced (Y/N) Number of sections: 3 Description: MOVED NEW BOOM INTO POSITION OVER STAKES
Visual Observations Visible Contamination (Y (N)) Iron Staining (Y (N)) Oily Sediment/Soil (Y (N)) Distressed Vegetation (Y (N))	
Sheen Present on Water (Y (N)) Is the Boom containing the Sheen? (Y / N): Pooled Product (Y (N)) If yes, was product removed with sorbent pads?	
Location of Visible Contamination:	
Legend /// Sheen \\\ Oily Sediment xxx Distressed Veg. RRR Iron Staining ● Pooled Product	<div style="text-align: center;"> ↑ West Canal </div> <div style="text-align: right;"> N ↑ </div>

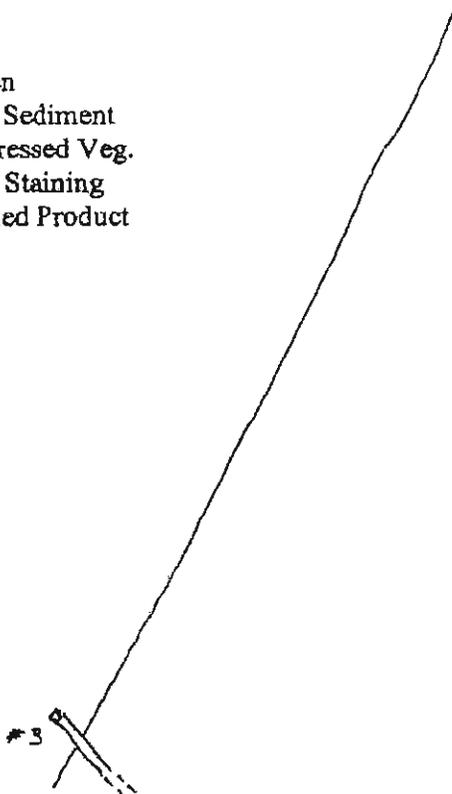
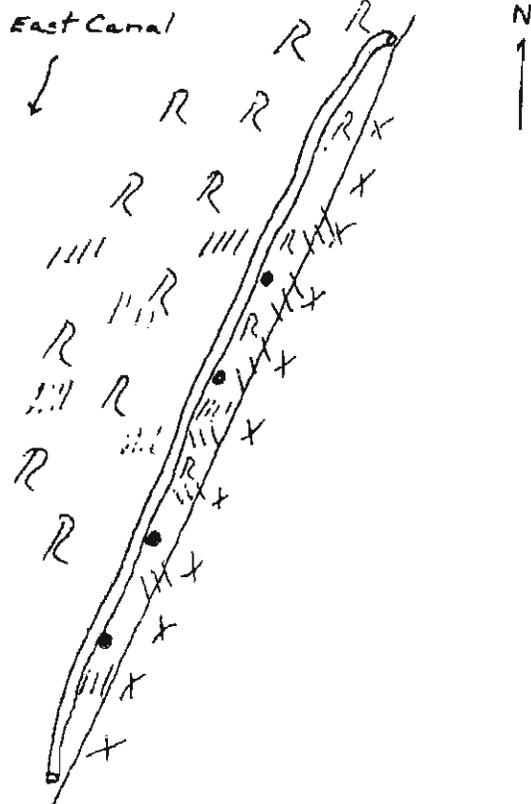
Boom Location: 8	Time/Date: 1002 / 9.6.12
Description of Boom Before Maintenance: SATISFACTORY	Photograph (s) Time/Date Stamp: 1002 / 9.6.12
Boom Repaired (Y/N): Description:	Boom Replaced (Y/N) Number of sections: Description:

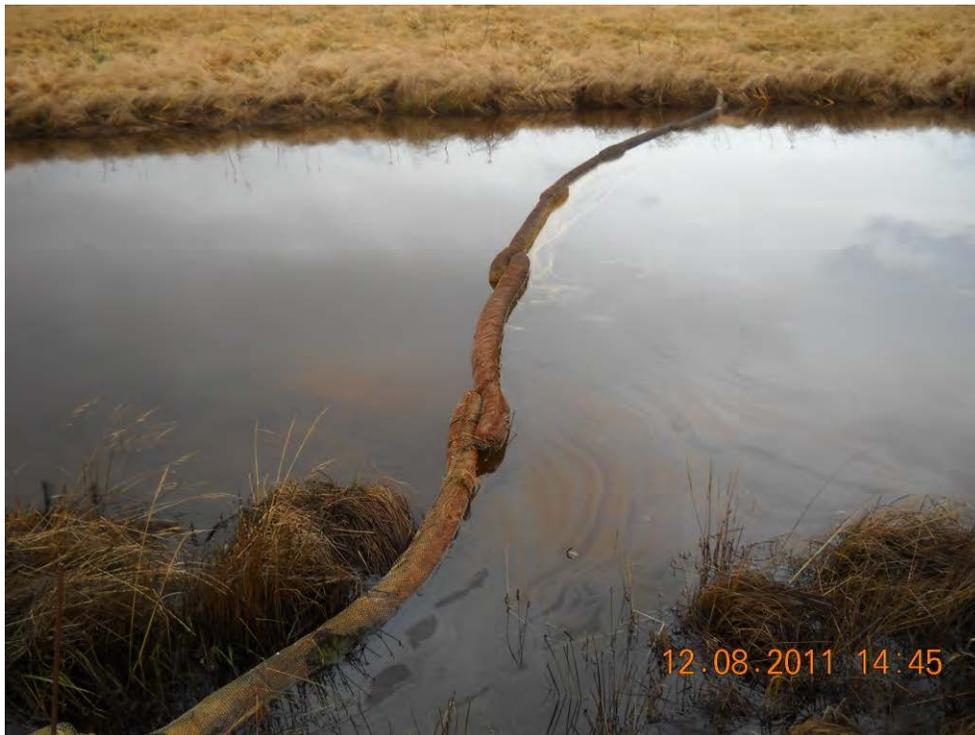
Boom locations were inspected for evidence of contamination, including sheen on surface water, iron staining, oily soil or sediment, stressed vegetation, and pooled product (see Appendix A). Sheen was observed at least once during the reporting period at Booms 3, 6, and 8 through 11 (Photos 3, 5, and 6, Appendix B). Sheen was not observed at Booms 2 or 4 during any monthly inspection (Photos 2 and 4, Appendix B). During April 2012, water elevations in East Canal were approximately 3 feet above normal, effectively submerging the shoreline seeps at Booms 8, 11, and 9/12 (Photo 8, Appendix B).

Photo 3 – West Canal Boom 3, December 2011, view west; visible sheen behind boom

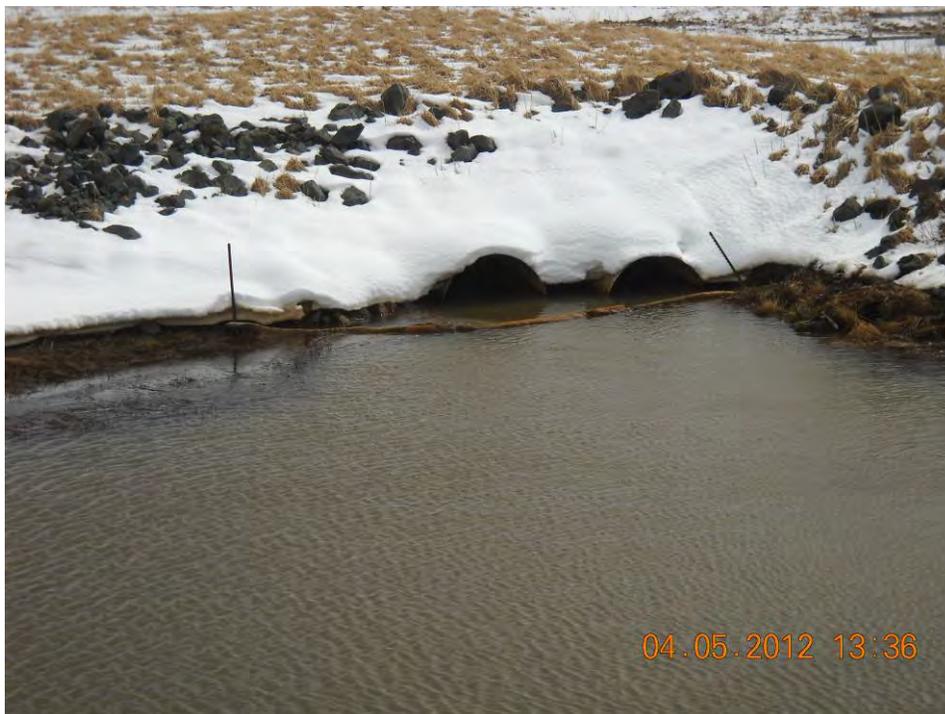
Photo 4 – West Canal Boom 4, April 2012, view east. Boom following start of canal pumps

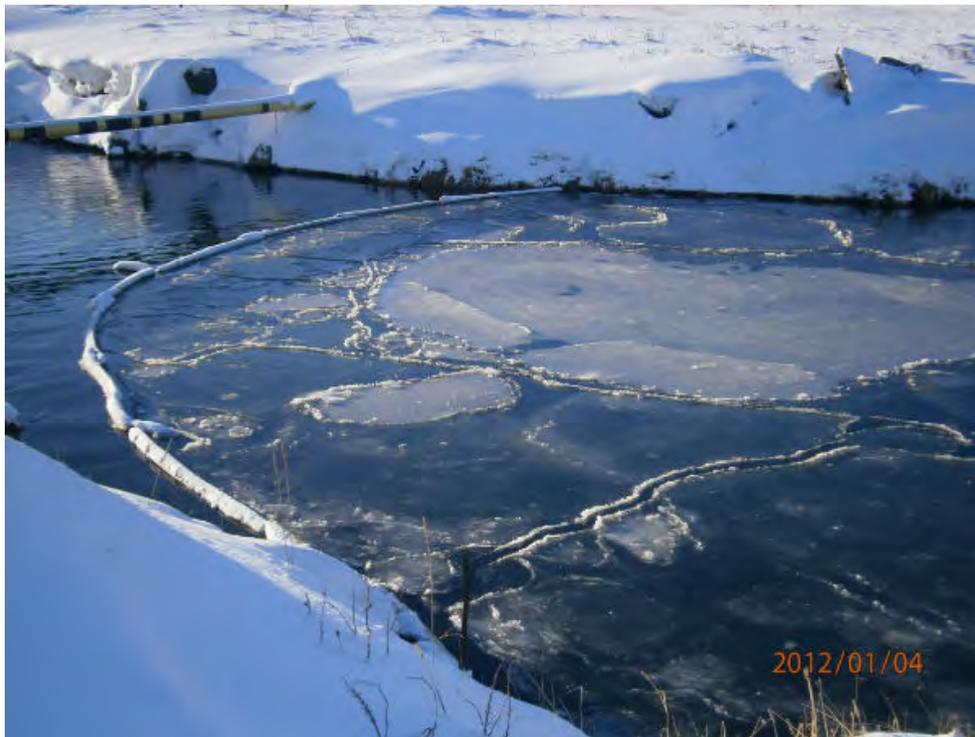
Photo 5 – Sweeper Creek Boom 6, January 2012, view south; showing ice buildup behind the boom

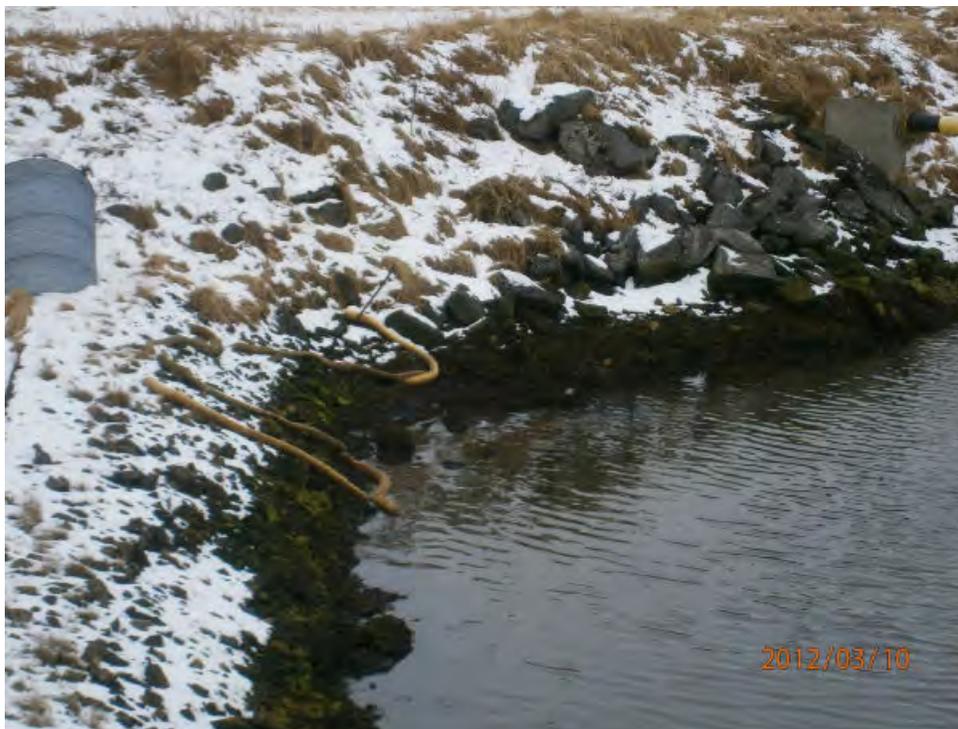
Photo 6 – Sweeper Creek Boom 6, March 2012, view southeast; boom disconnected at center

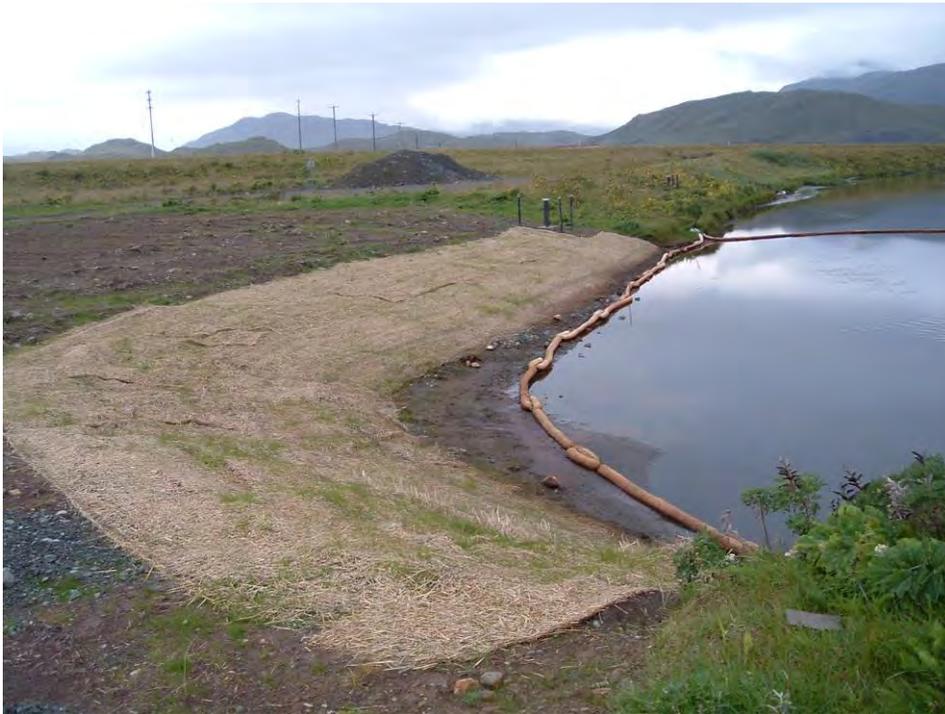
Photo 9 – East Canal Boom 9/12, September 2012, looking north showing remediated shoreline

In June and July 2012, remedial action was conducted in the area of Boom 9/12 to remove sources of petroleum contamination in the soil and seeps along the shoreline on East Canal in this area. The shoreline in this area was excavated, replaced with clean fill amended with Oxygen-Reducing Compound, and re-contoured (Photo 9, Appendix B). During the monthly inspections following completion of remedial action, petroleum sheen was only noted in the area of Boom 9/12 in September 2012. At this time, sheen was observed on both the
