2012 Institutional Controls Site Inspection Report

Operable Units A and B-1

Former Naval Complex

Adak, Alaska

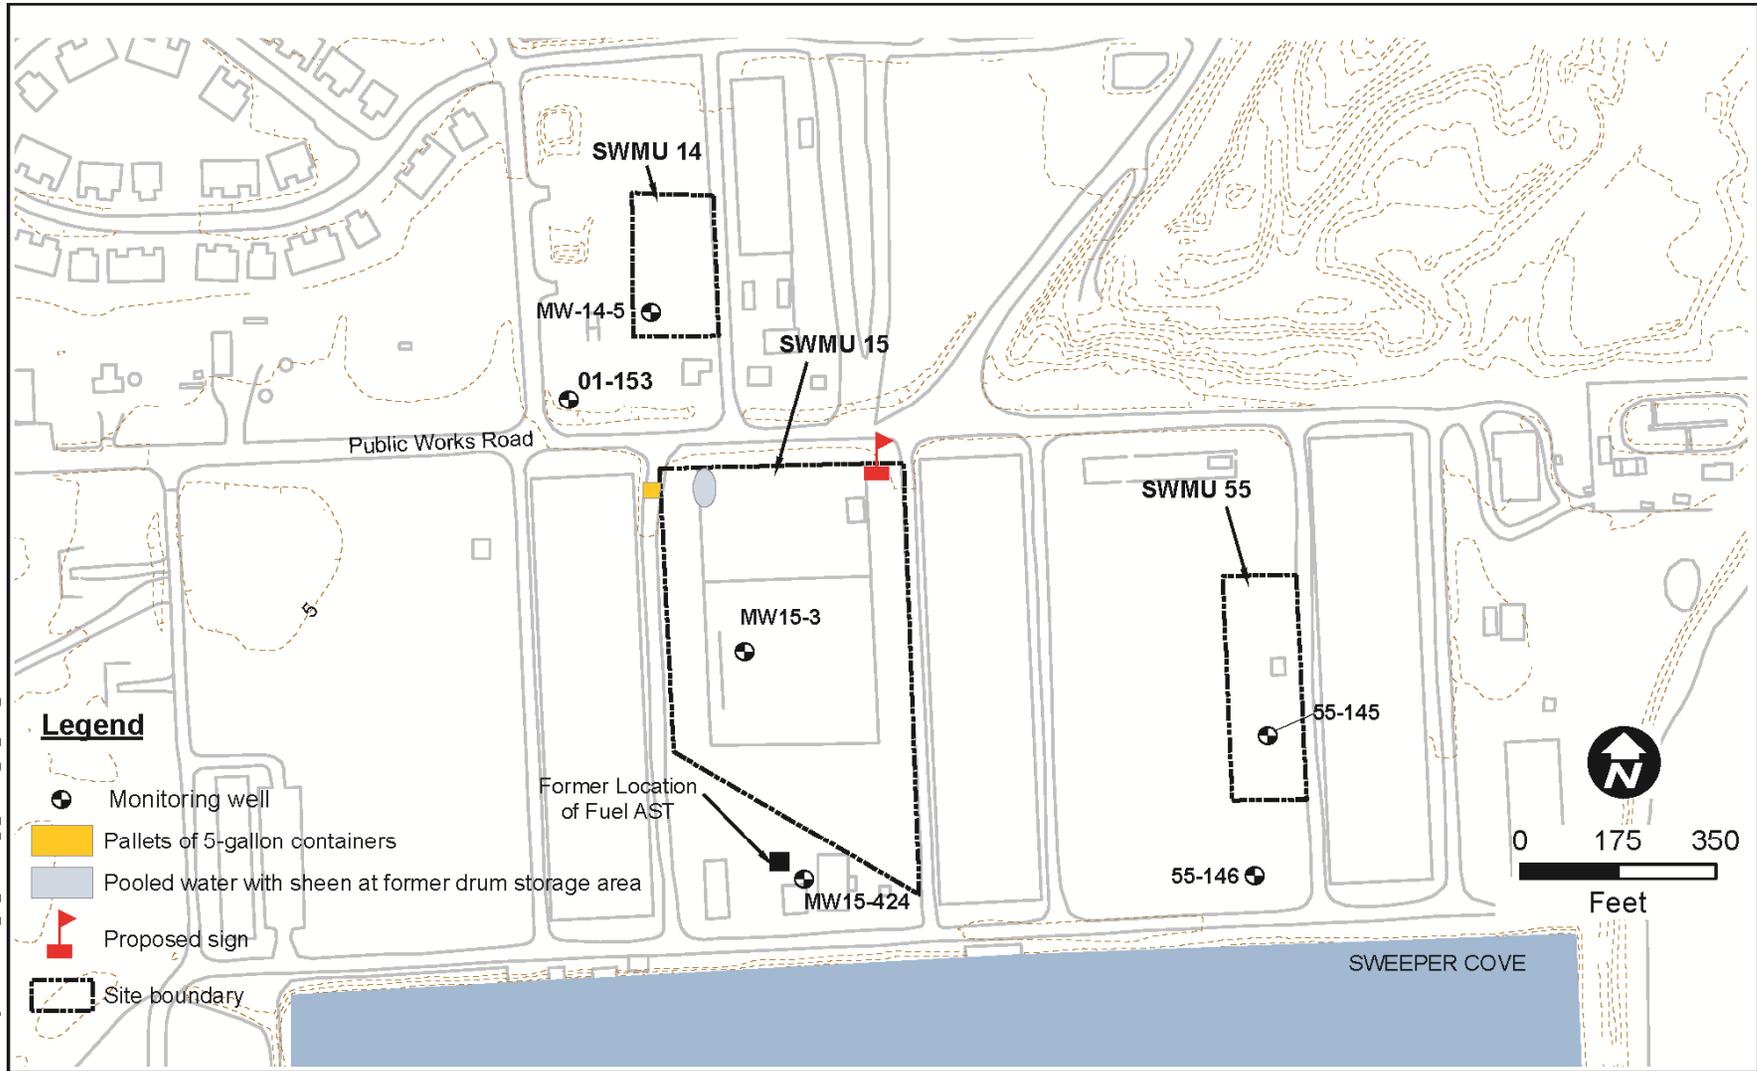
<p>U.S. NAVY</p>	<p>SEALASKA</p>	<p align="center">Figure 2-1 SWMU 15, Future Jobs/Defense Reutilization Marketing Office</p>	<p align="right">Task Order 55 Adak Island, AK 2012 IC Inspection Report</p>
-------------------------	------------------------	---	--

Two pallets of 5-gallon containers of unknown contents were observed adjacent to the blue shed northwest of the site (Figure 2-1). The excavation restriction sign installed in 2010 is missing, and it is recommended that it be replaced. No indications of groundwater use or excavation activities were found. Housekeeping practices onsite are improved and appear adequate. However, potentially contaminated soil remaining onsite may be impacting underlying groundwater. It is recommended that housekeeping practices continue to be monitored at this site.

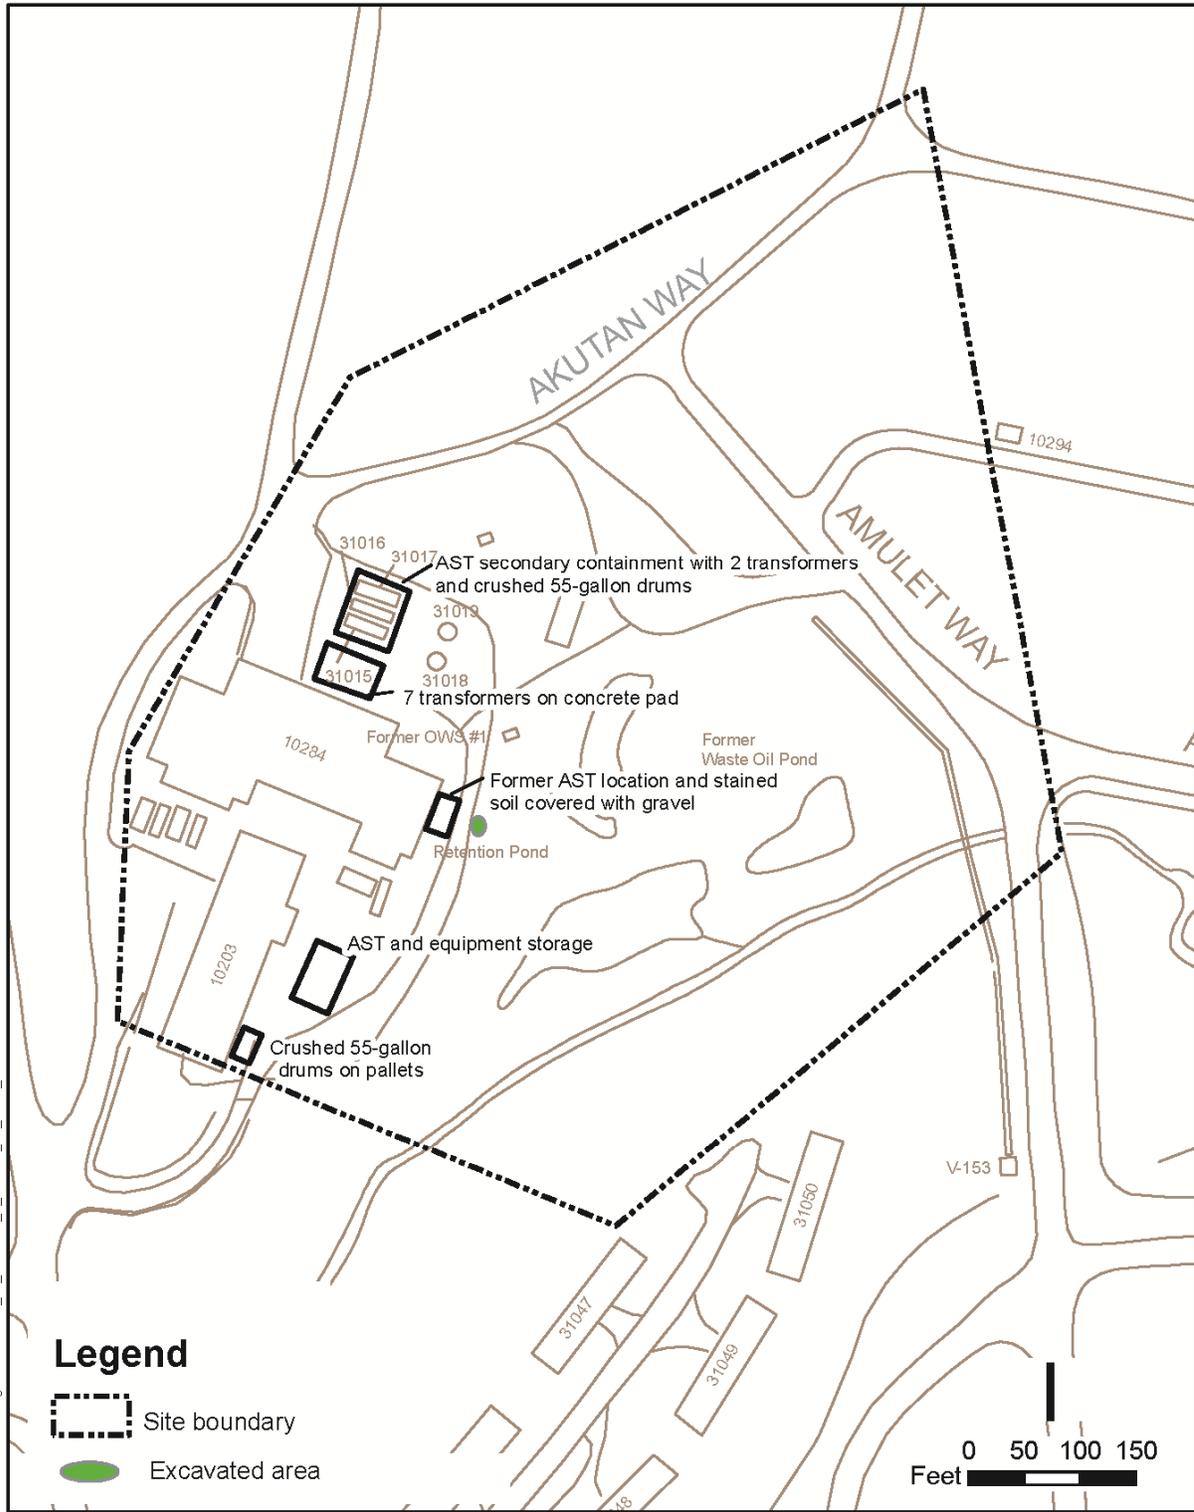
<p>U.S. NAVY</p>	<p>SEALASKA</p>	<p align="center">Figure 2-2 SWMU 17, Power Plant 3 Area</p>	<p align="center">Task Order 55 Adak Island, AK 2012 IC Inspection Report</p>
-------------------------	------------------------	---	---

No other changes to the site were observed compared to the 2011 inspection results. No residential construction had occurred at the site. No indications that groundwater was being used. Excavation restriction signs were clearly visible.

Housekeeping practices have improved at this site but should continue to be monitored. It is recommended that the Treatment Plant Operator be notified to properly remove and dispose of the crushed drums and transformers. It is further recommended that the City be notified of the permit excavation requirement and that the open excavation observed at the site be filled in.

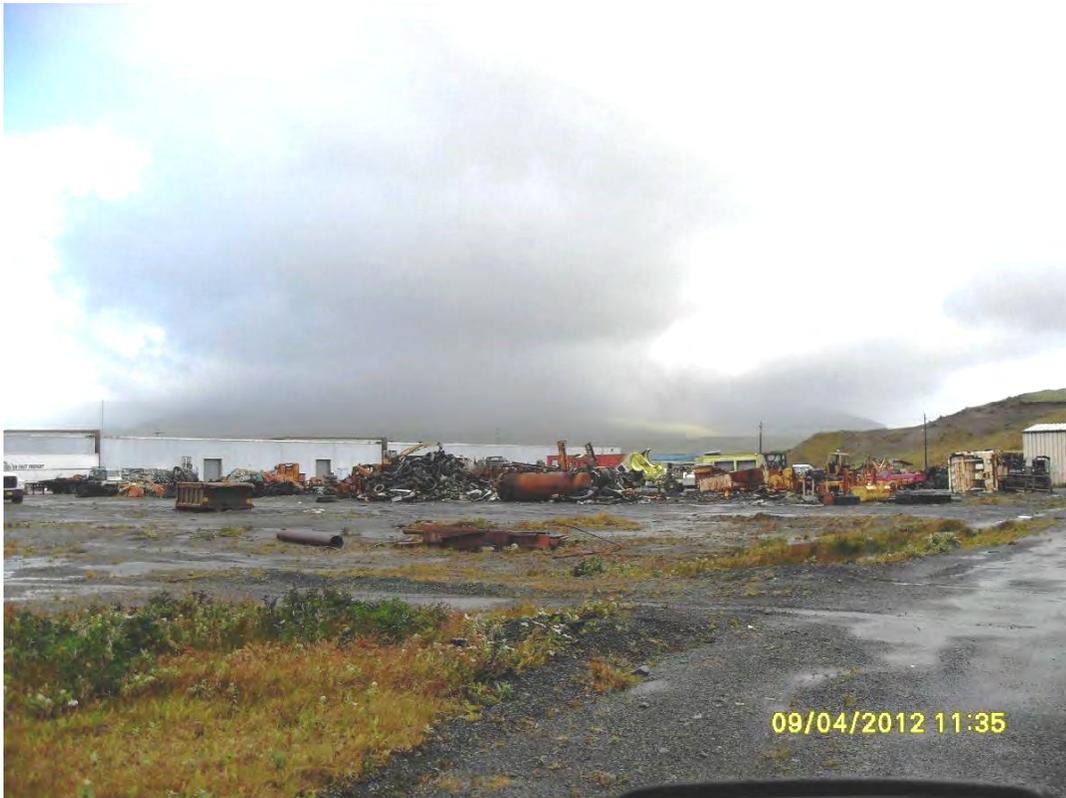
Photograph 2-7. SWMU 55, Public Works Transportation Department Waste Storage Area – overview north of Recycling Center

All but a few of the dilapidated vehicles stored in this area have been removed. However, quantities of materials still remain onsite and include but are not limited to: wood, metal, and building debris; equipment and vehicle parts; various-sized tanks and shipping containers; several crushed and whole 55-gallon drums; containers of various sizes with unknown liquids; and paint wastes. The metal shed located on SWMU 24 and adjacent to SWMU 55 observed in 2011 which contained a large quantity of containers was no longer present during the 2012 inspection. The pink connex box containing 5-gallon containers and underlying stained soil still remains at the site. There is no restricted access or soil barrier at the site.

soil excavation restriction sign is missing and needs to be replaced. There was no evidence of groundwater use. Due to the wastes and conditions observed at this site, there is a concern that contaminants associated with on-site wastes are a threat to residents and are potentially impacting site soils and underlying groundwater. It is therefore recommended that the cleanup of the site continue to be monitored.

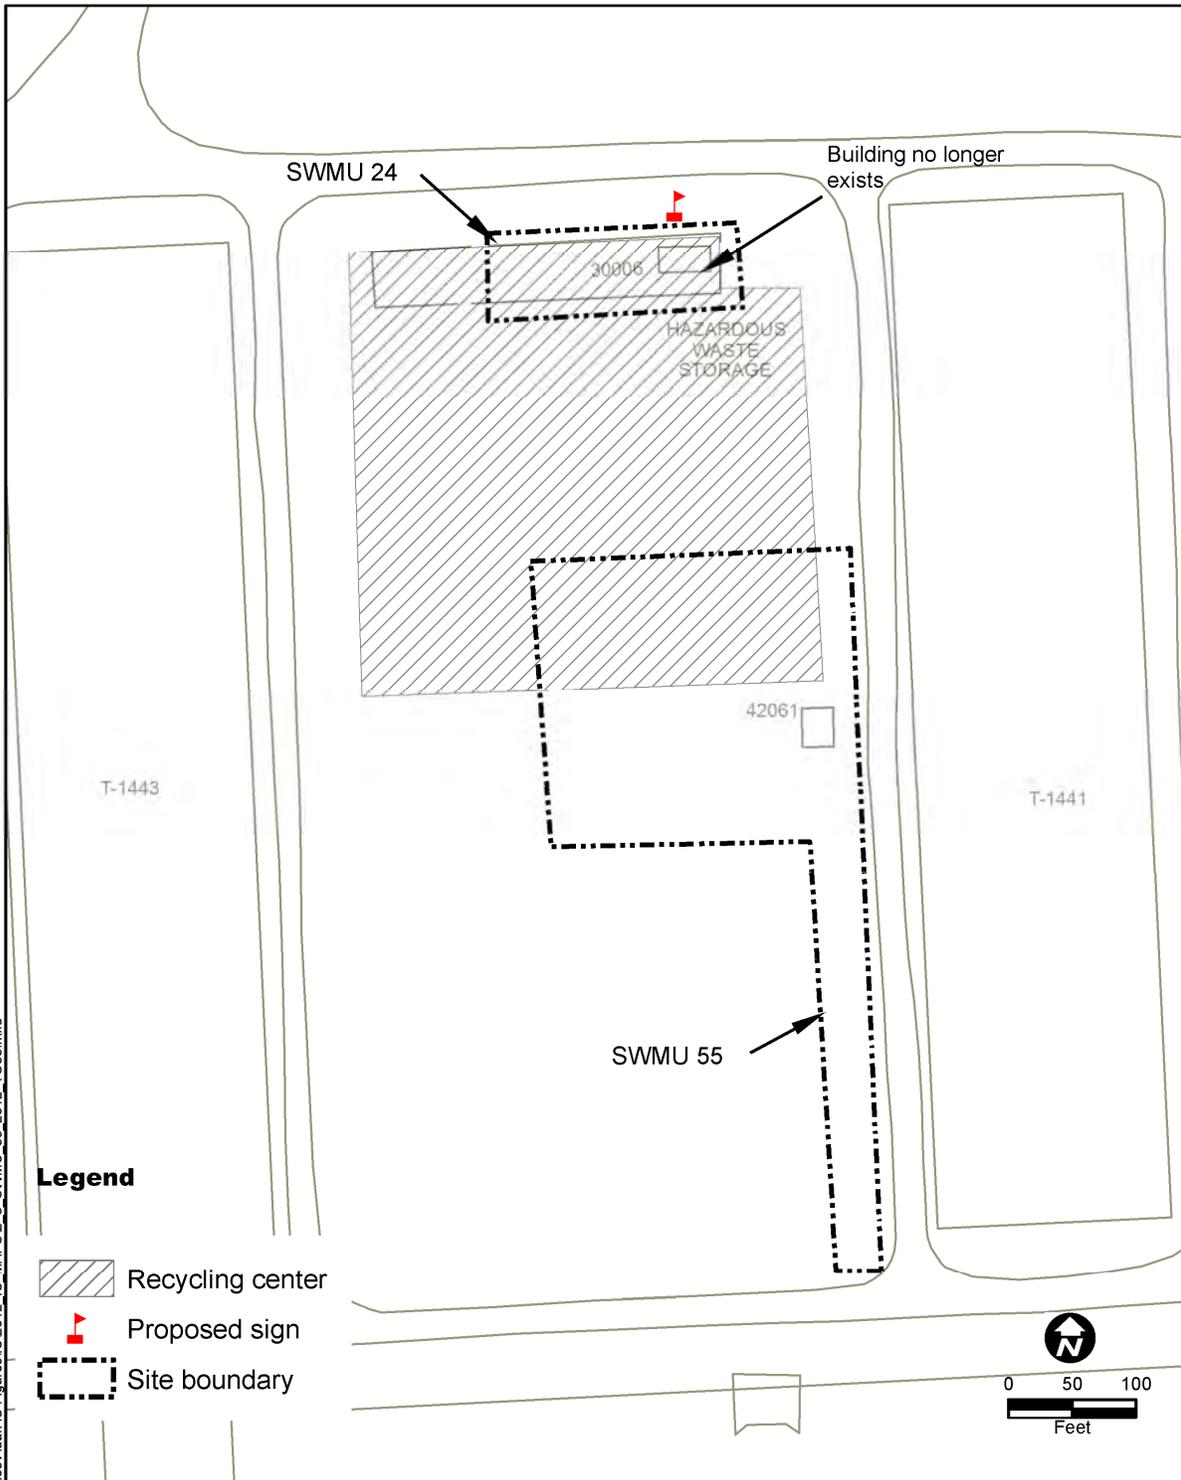
U.S. NAVY	SEALASKA	<p align="center">Figure 2-3 SWMU 55, Public Works Transportation Department Waste Storage Area and SWMU 24, Hazardous Waste Storage Facility</p>	<p align="center">Task Order 55 Adak Island, AK 2012 IC Inspection Report</p>
-----------	----------	--	--

While no evidence of excavation was noted during the inspection, the large amount of debris at the site prevented certain confirmation that unauthorized excavation has not occurred. The

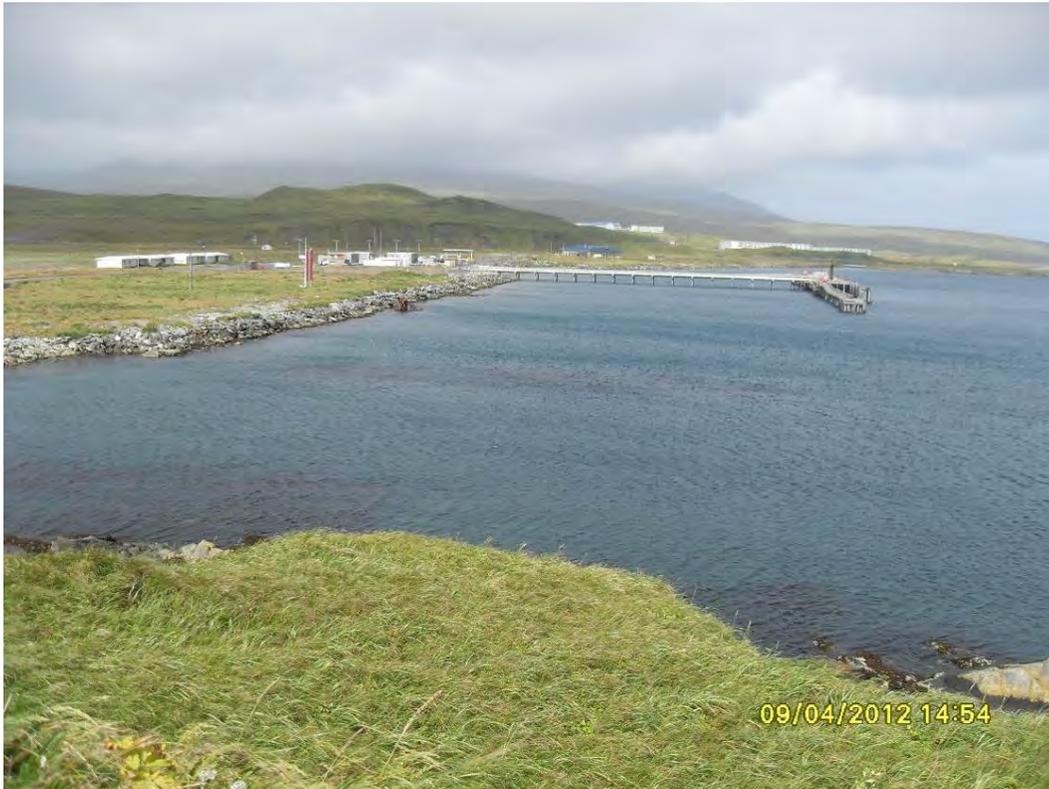
Photograph 2-10. Sweeper Cove – looking north from Finger Bay Road

Sweeper Cove and Kuluk Bay were evaluated separately due to different upland sites that may drain into them (Photographs 2-10 and 2-11, respectively). Aroclor 1254 (Kuluk Bay) and Aroclor 1260 (Sweeper Cove) have been detected in rock sole and blue mussels at these locations. In 2003, the 5 years of marine sampling required by the ROD for OU A was completed. Those 5 years of data established the baseline for temporal trend evaluations.

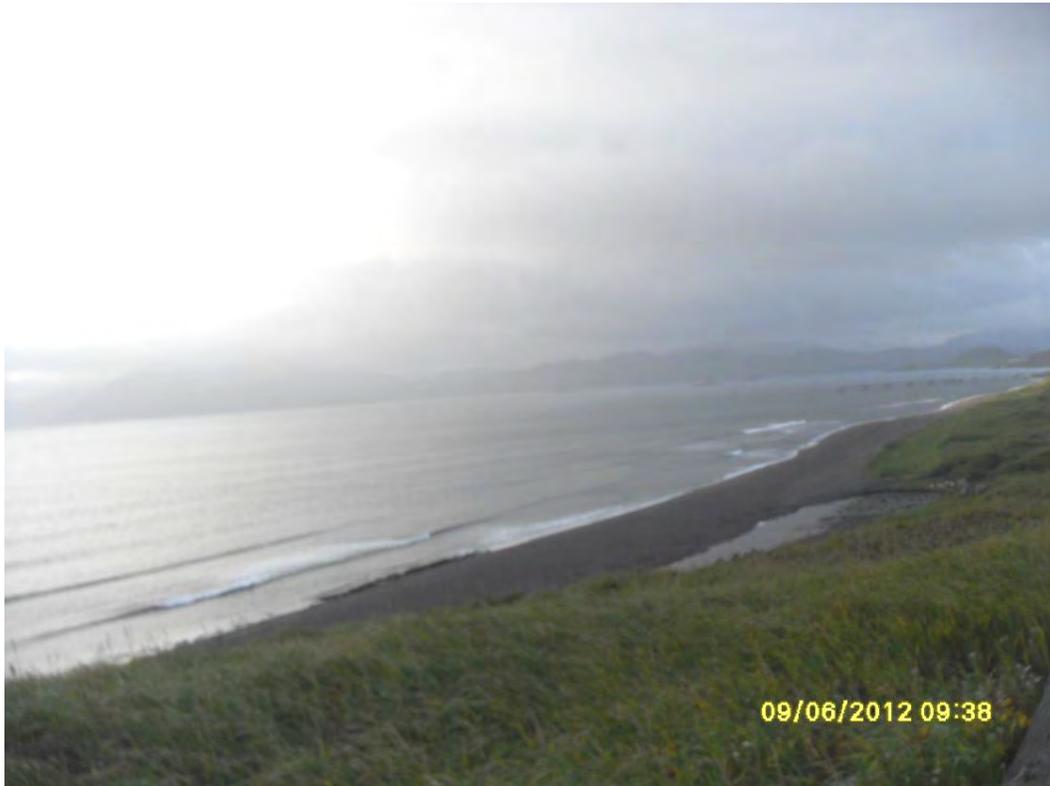
Photograph 2-11. Kuluk Bay – looking southeast

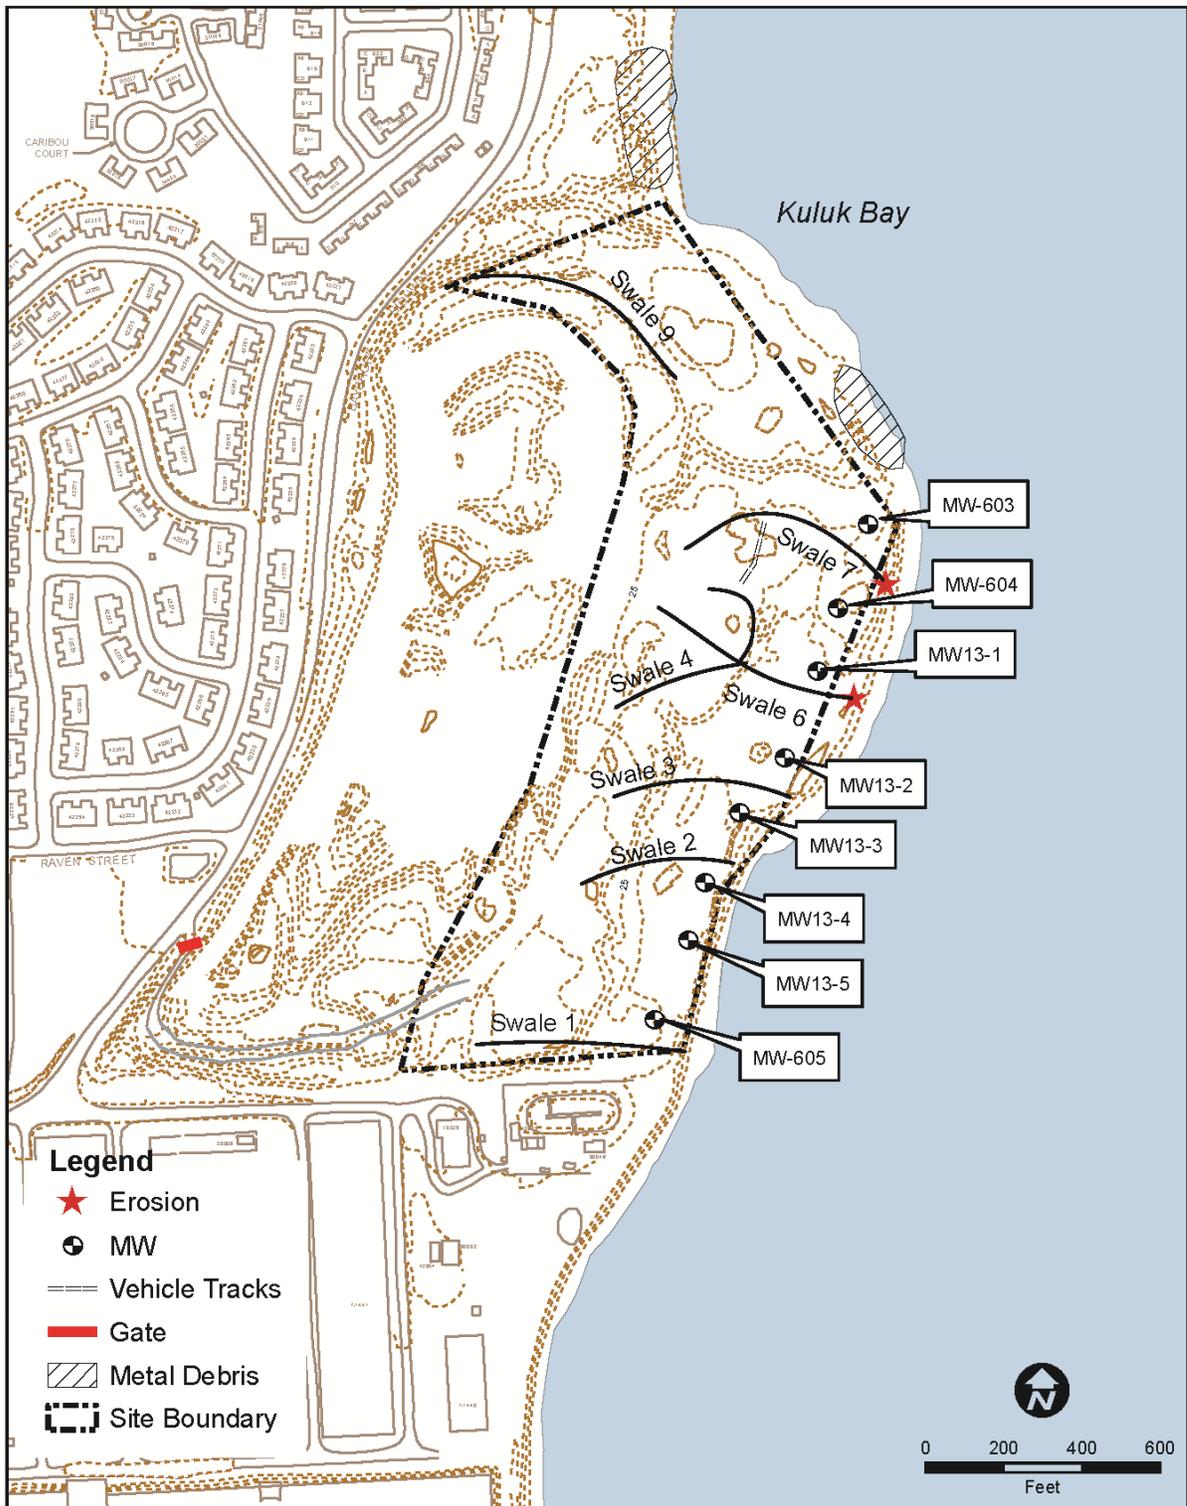
<p>U.S. NAVY SEALASKA</p>	<p align="center">Figure 2-4 SWMU 13, Metals Landfill</p>	<p>Task Order 55 Adak Island, AK 2012 IC Inspection Report</p>
----------------------------------	---	---

The northern-most swale, Swale 7, is eroding at the cliff and the liner is exposed. As observed in 2011, Swale 6 north of monitoring well 13-2 is eroding at the cliff, and the liner is exposed and torn (Photograph 2-13, Figure 2-4). The remaining swales were observed to be in good condition. Small amounts of metal debris were visible throughout the armor wall

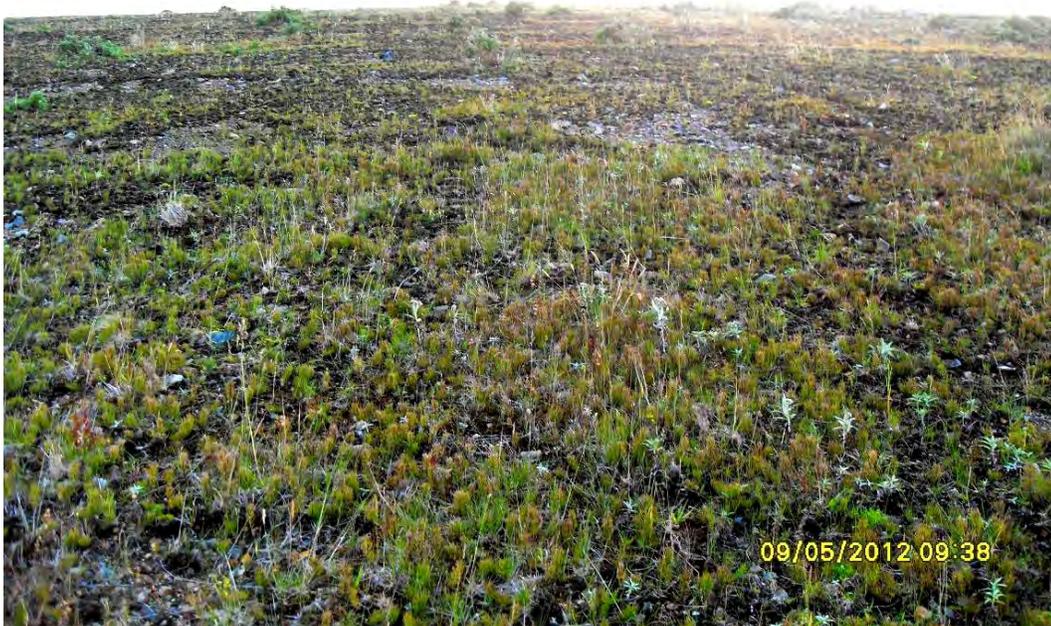
Photograph 2-14. SWMU 25, Roberts Landfill – central portion of landfill with improved vegetated cap

During the 2009 through 2011 inspections, a large, sparsely vegetated area was noted in the central portion of the landfill. Vegetation in this area shows improvement in that the vegetation was generally thicker and taller than in previous inspections (Photograph 2-14). The two sparsely vegetated areas in the southern portion of the landfill were not observed during the September 5, 2012 inspection. In general, the remainder of the vegetative cap appears adequate.

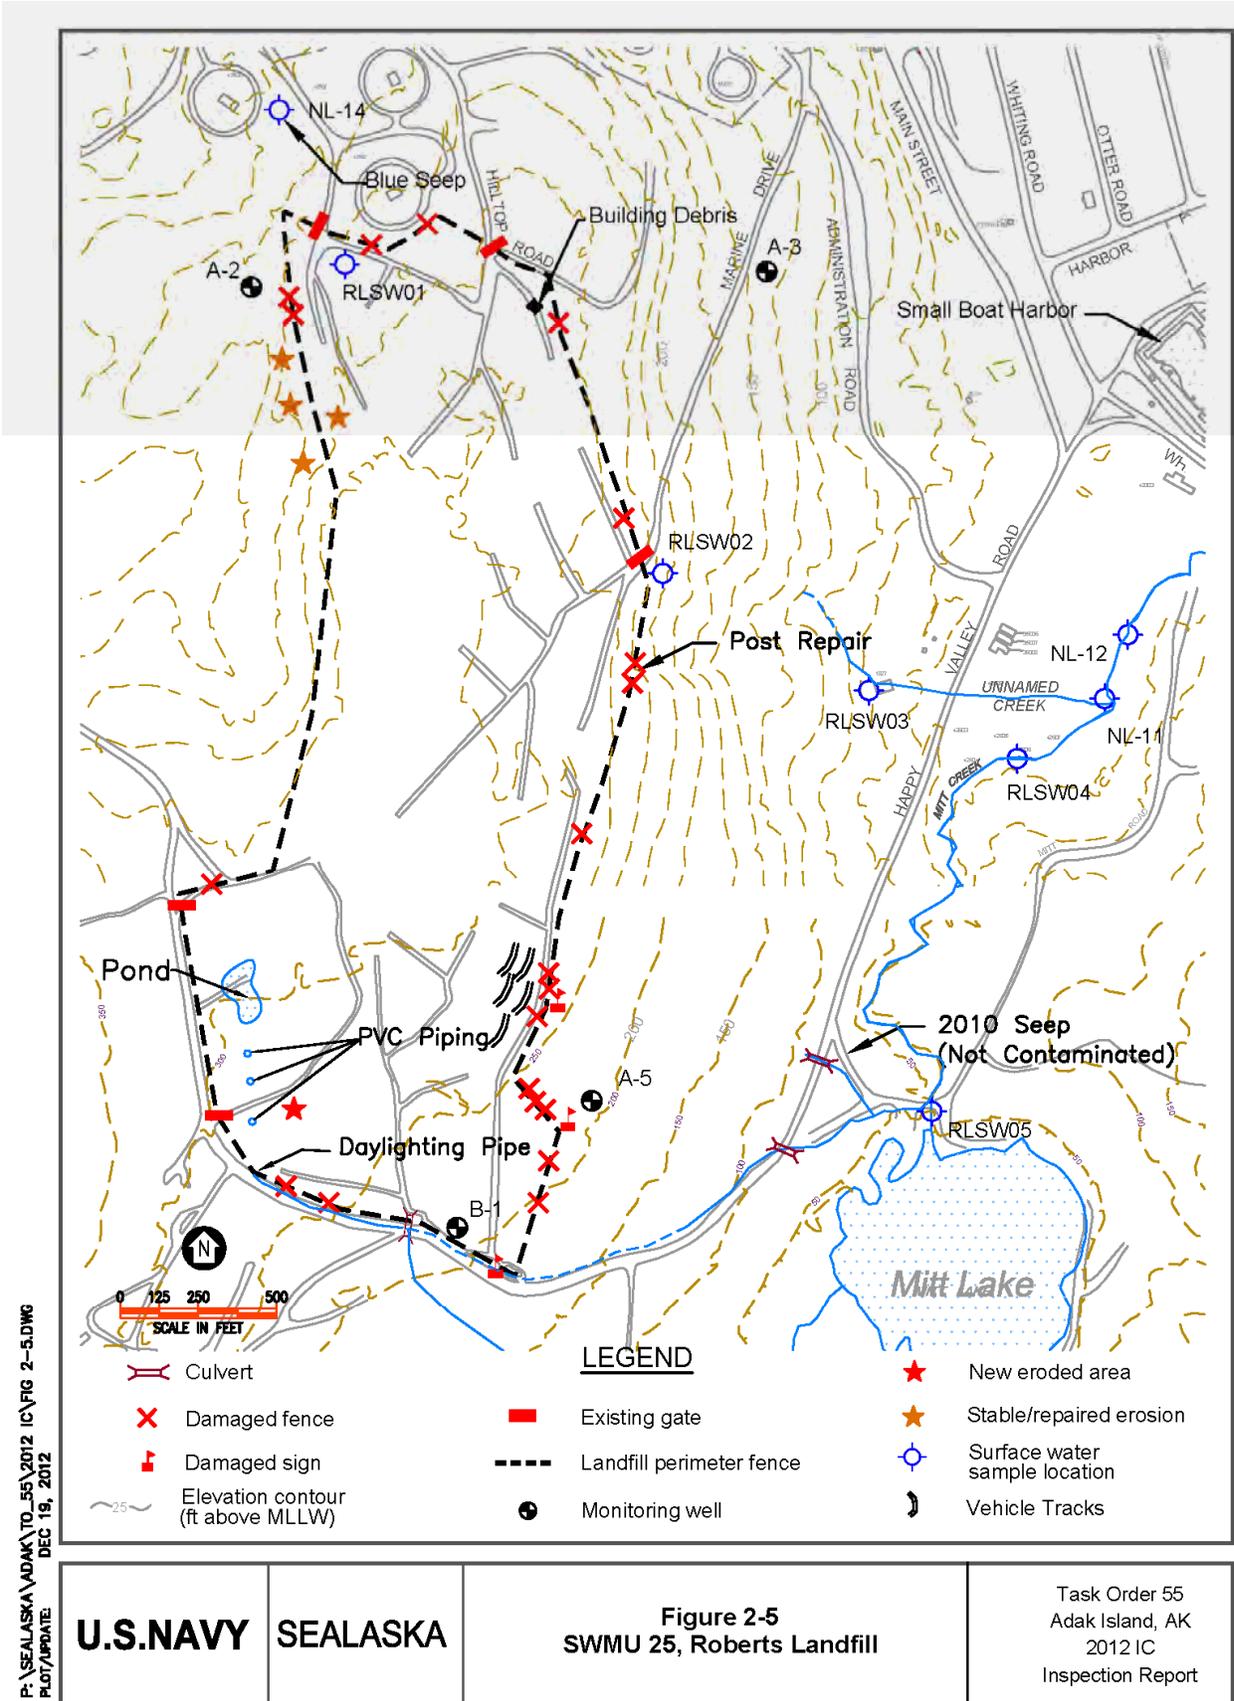
U.S.NAVY SEALASKA	Figure 2-5 SWMU 25, Roberts Landfill	Task Order 55 Adak Island, AK 2012 IC Inspection Report
--------------------------	--	--

The all-terrain vehicle (ATV) tracks observed southwest of the northeastern gate in 2011 were not present during the 2012 inspection. The truck tracks observed on the southern portion of the cap were still visible in 2012. Wooden and metal debris associated with a collapsed building was again observed on the northeast side of the landfill; however, this debris is not located on the landfill cap (Figure 2-5).

The north gate at the Fuels Facility was open and unlocked at the time of the inspection. The gate was not able to close because the locking bars would not align and need to be repaired. Two signs on the eastern perimeter and one along the southern perimeter have fallen off the fence and need to be re-attached. The three asbestos signs located on the buried bunkers west across the road from the landfill need to be replaced. These bunkers are not part of the

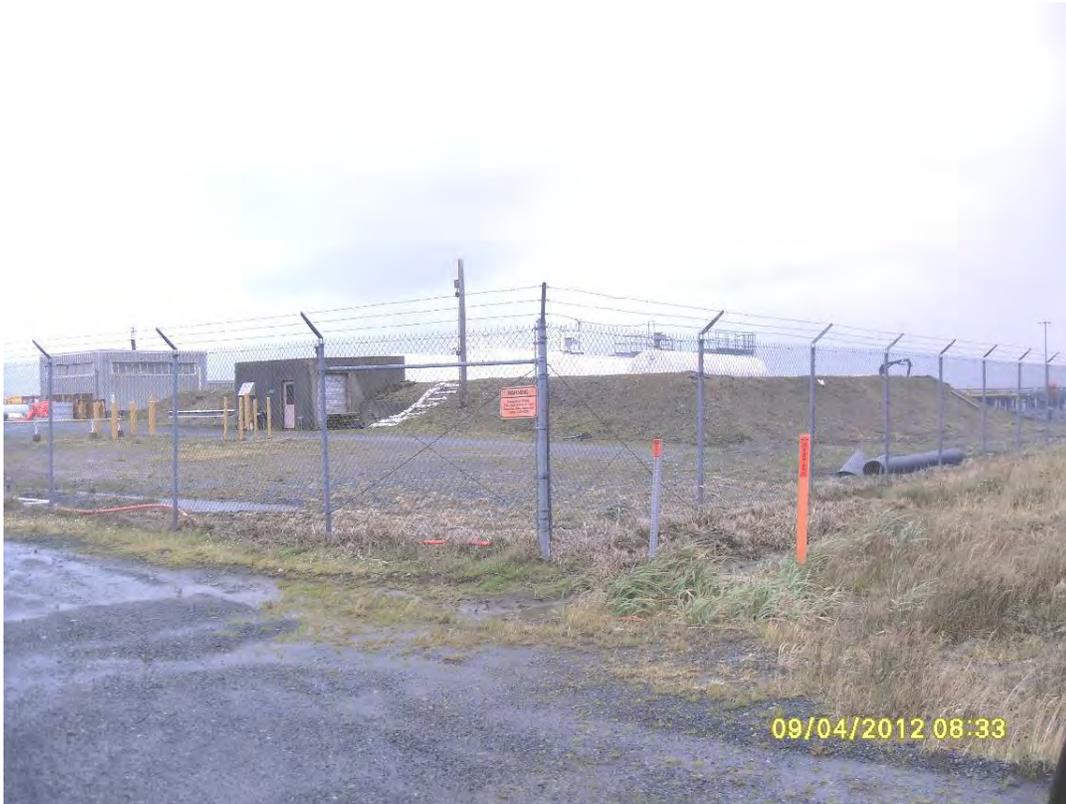
Photograph 2-19. SA 77, Small Drum Storage Area – looking northeast

The site was closed under RCRA in 1995 because the data collected during the RCRA closure showed that RCRA-regulated hazardous wastes were not present at the SDSA at concentrations warranting corrective action. The area is currently used as a parking apron for Adak Fuels trucks and fuel drums (Photograph 2-19).

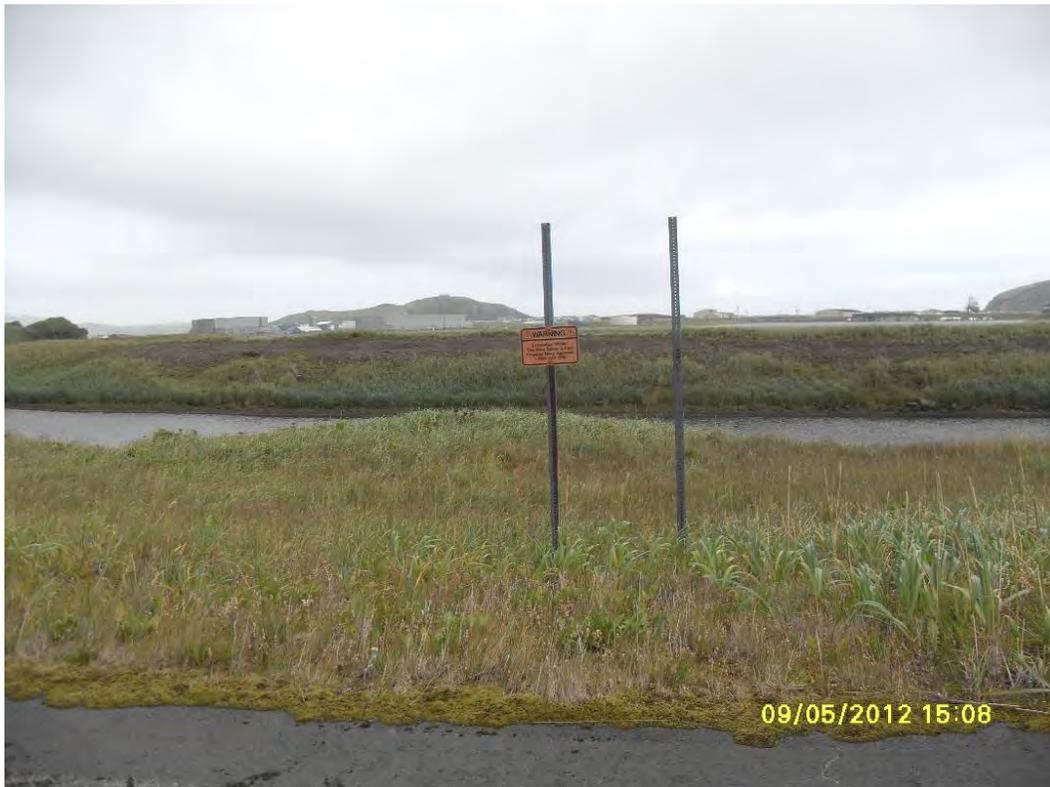
Photograph 2-20. Amulet Housing, Well AMW-706– looking northeast at Sweeper Creek

During the inspection in September 5, 2012, no changes to the site were observed compared to the 2011 inspection results. The site is currently not being used. No residential construction had occurred, and no indications of groundwater use or excavation activities were found. Excavation restriction signs were clearly visible. Therefore, ICs appear to be functioning as intended to protect human receptors from exposure to contaminated soil or groundwater.

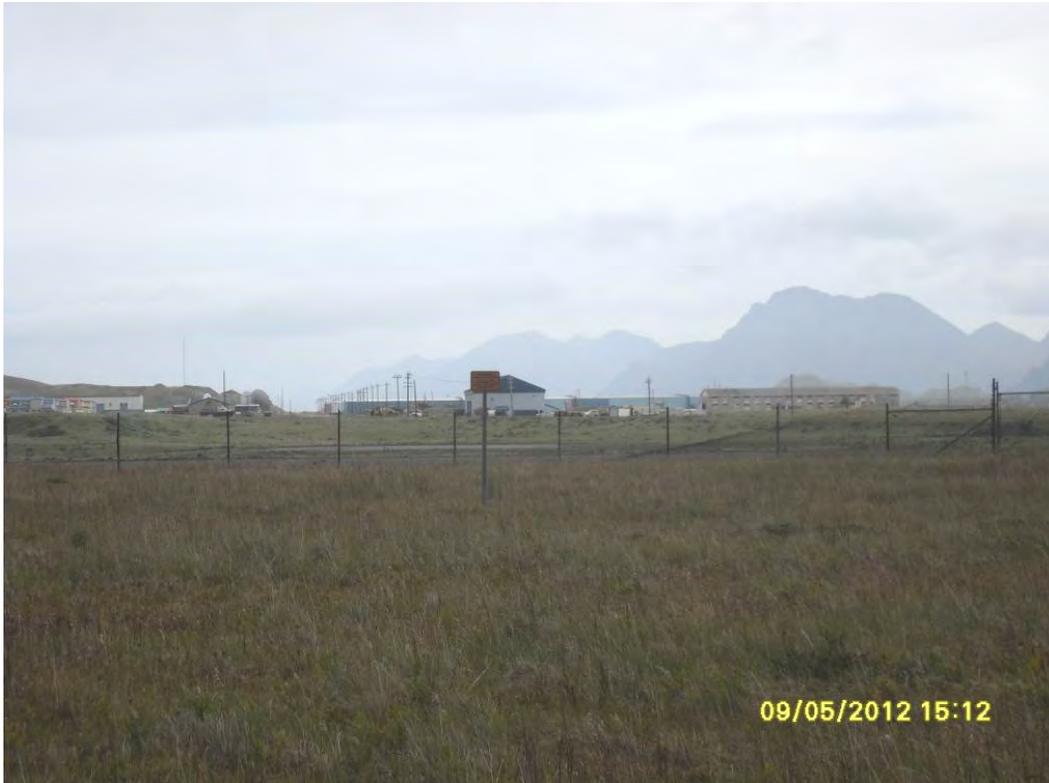
Photograph 2-21. Amulet Housing, Well AMW-709 – looking southeast

The ICs at Amulet Housing, Well AMW-709 Area are the restriction of land use to industrial or commercial activities and the restriction of groundwater use, which are included in an equitable servitude, and a requirement to complete an excavation notification before intrusive work to a depth greater than 2 feet is conducted (see Table 1-1). During the September 5, 2012 inspection, no changes to the site were observed compared to the 2011 inspection results. The site is currently not being used. No residential construction had occurred at the IC restricted area. No indications that groundwater use or excavation activities were found at this site. Excavation restriction signs were clearly visible. Therefore, ICs appear to be functioning as intended to protect human receptors from exposure to contaminated soil or groundwater.

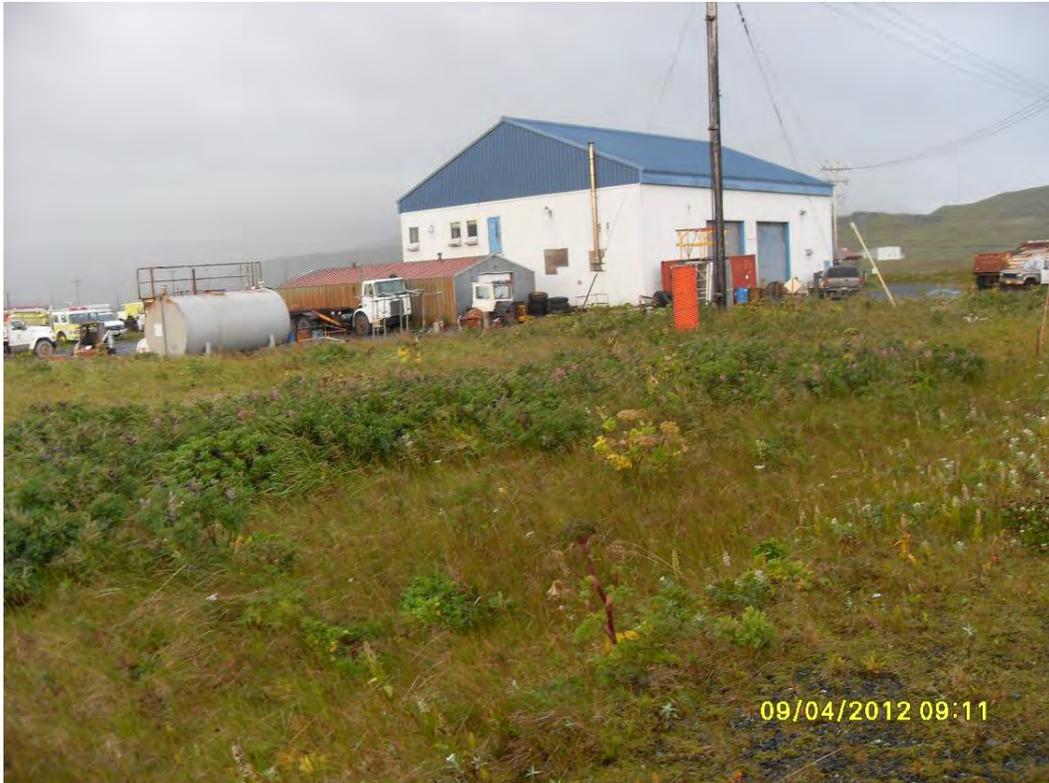
Photograph 2-22. Former Power Plant Building T-1451 – looking northwest

east of the building. The Navy conducted remedial actions in July 2012 at the East Canal shoreline west of the property. Actions included limited soil removal, replacement with amended clean fill, and installation of monitoring wells; however, these actions were not performed within the site boundaries. Therefore, ICs appear to be functioning as intended to protect human receptors from exposure to contaminated soil or groundwater.

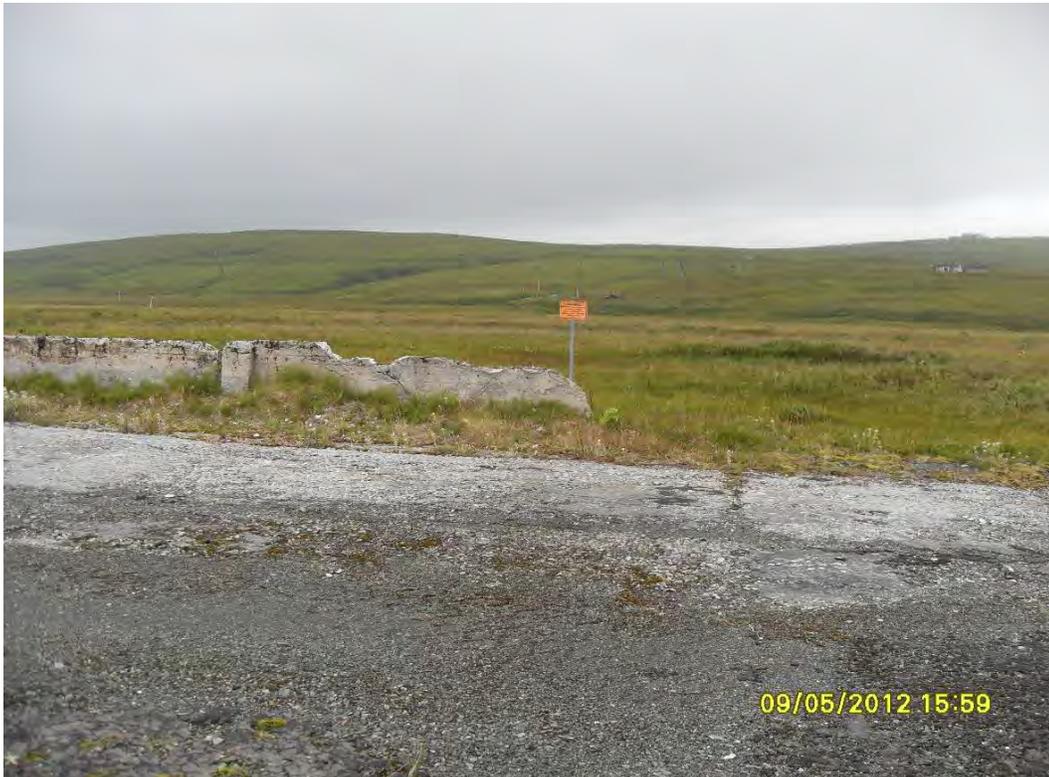
Photograph 2-23. ROICC Contractor's Area – looking west

During the inspection on September 5, 2012, no changes to the site were observed compared to the 2011 inspection results. The site is currently not being used (Photograph 2-23). No residential construction had occurred at the site. No indications that groundwater was being used and no indications of excavation activities were found. An excavation restriction sign was present on site. Therefore, ICs appear to be functioning as intended to protect human receptors from exposure to contaminated soil or groundwater.

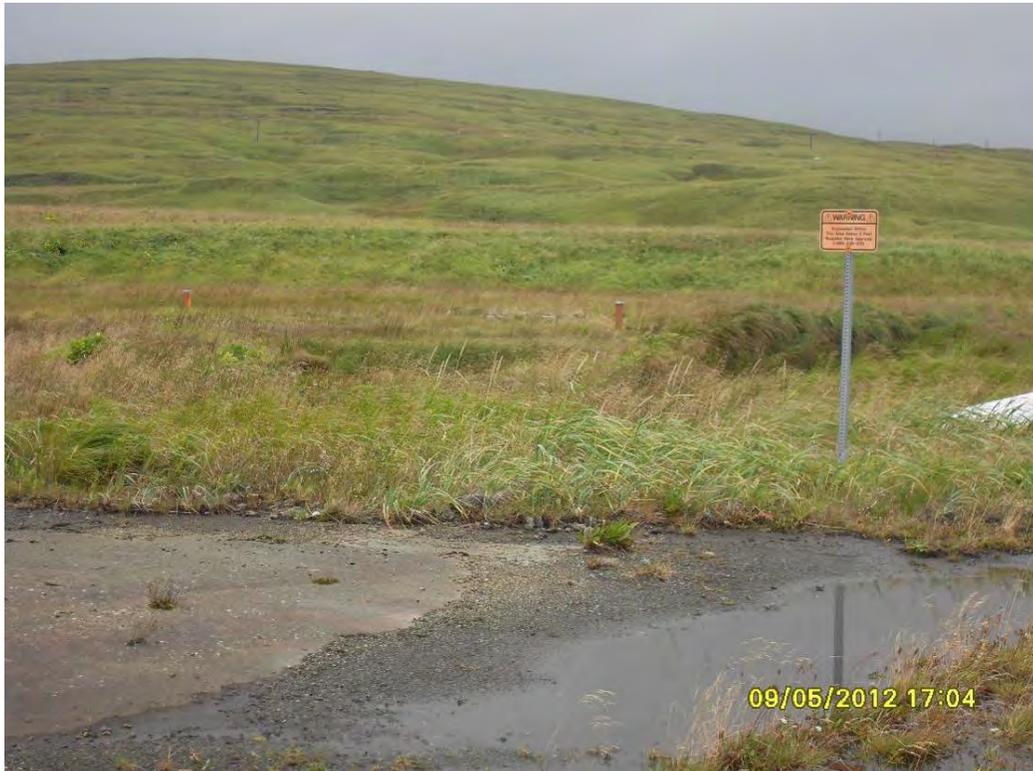
Photograph 2-24. Runway 5-23, Avgas Valve Pit – looking north at former route of avgas transfer pipeline

Runway 5-23, Avgas Valve Pit is associated with an abandoned 6-inch-diameter aviation avgas transfer pipeline that supplied fuel to the Runway 5-23 truck fill stand. The site is located approximately 800 feet south of the southern end of Runway 5-23 and 50 feet west of a former truck fill stand. The pipeline has been closed and the site is not currently used (Photograph 2-24). This site is approximately 0.42 acres.

During the September 5, 2012 inspection, no changes to the site were observed compared to the 2011 inspection results. The site is currently not being used. No residential construction had occurred at the site. No indications of groundwater use or excavation activities were found.

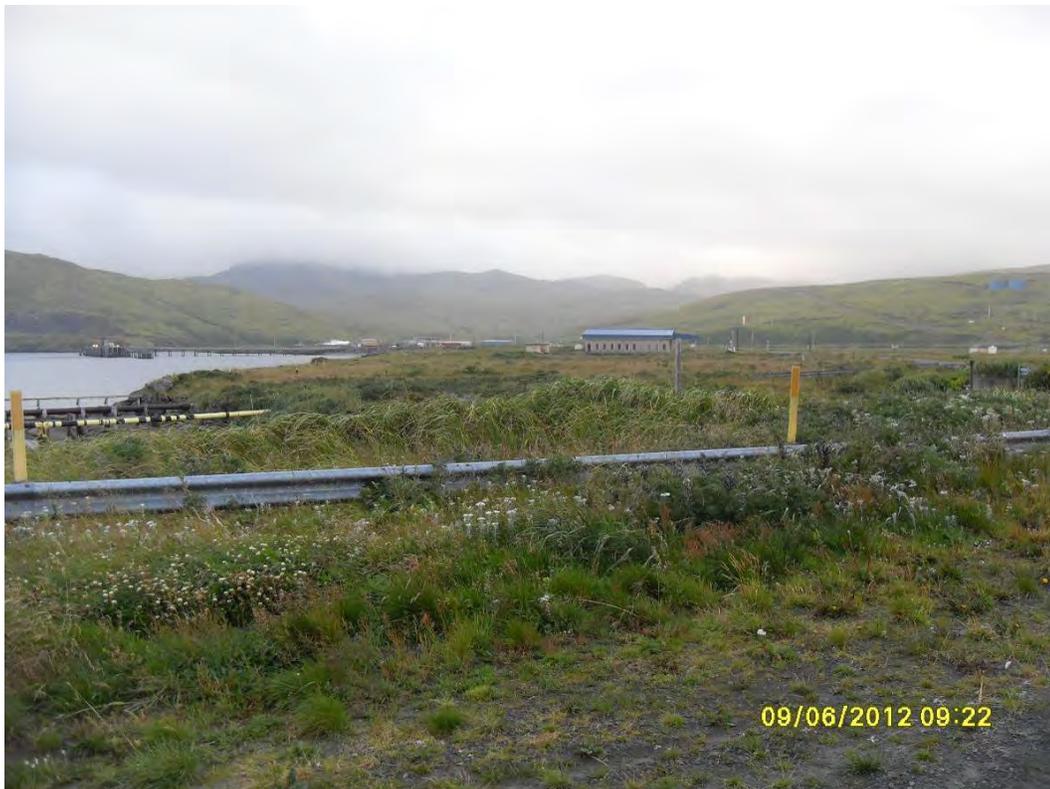
Photograph 2-25. SA 79, Main Road Pipeline - looking south across Sweeper Creek

During the September 6, 2012 inspection, no changes to the site were observed compared to the 2011 inspection results. The site is currently not being used. No residential construction had occurred, and no indications of groundwater use or excavation activities were found at the site. An excavation restriction sign was present on site and is located north of Sweeper Creek. ICs appear to be functioning as intended to protect human receptors from exposure to contaminated soil or groundwater.

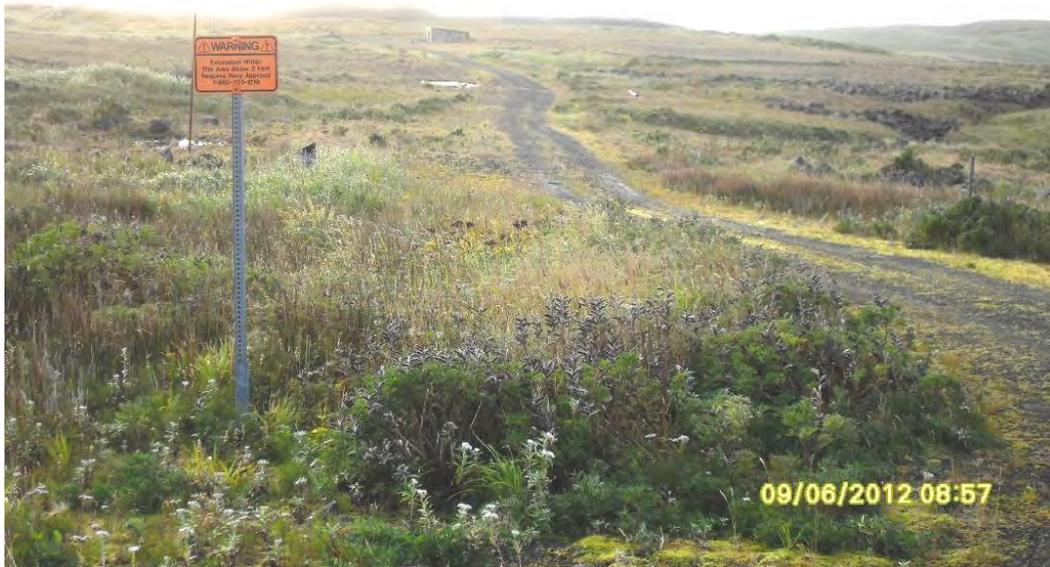
Photograph 2-27. SWMU 61, Tank Farm B – looking northeast

During the inspection on September 6, 2012, no changes to the site were observed compared to the 2011 inspection results. The site is currently not being used. No residential construction had occurred at the site. No indications that groundwater was being used and no indications of excavation activities were found at the site. Excavation restriction signs were clearly visible (Photograph 2-27). Therefore, ICs appear to be functioning as intended to protect human receptors from exposure to contaminated soil or groundwater.

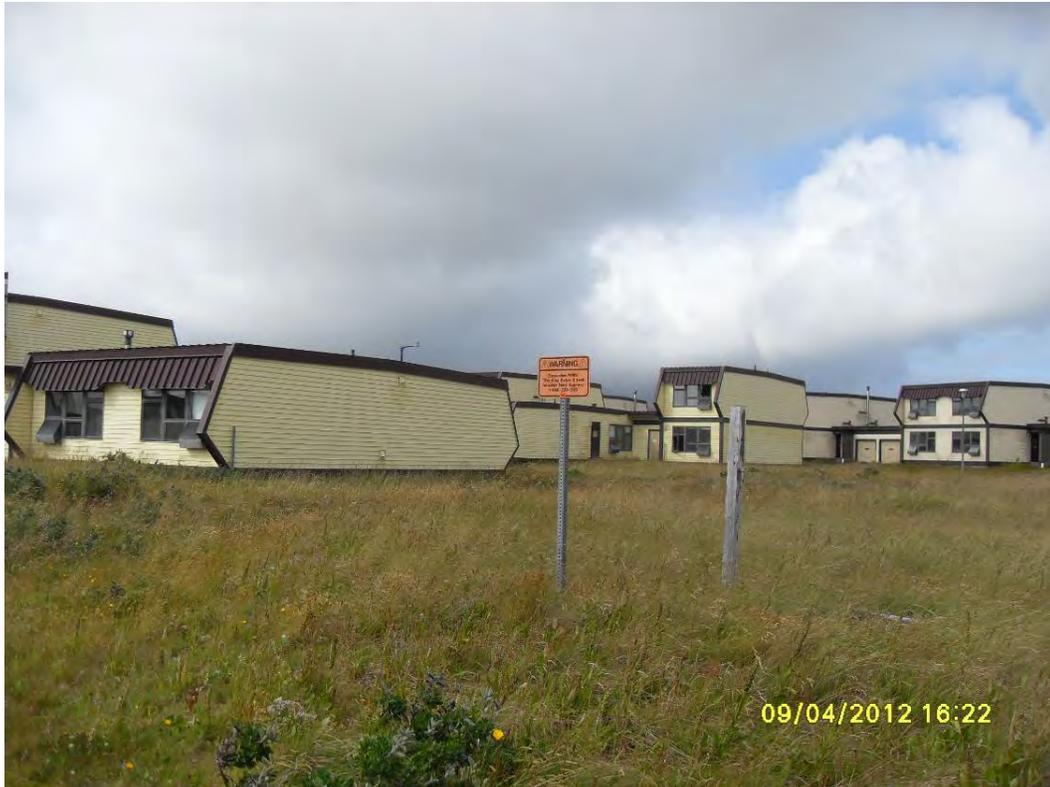
Photograph 2-28. Housing Area (Arctic Acres) – looking northwest

The housing units remain uninhabited, and the site is currently not being used. No excavations and no residential construction were observed at the site during the September 4, 2012 inspection. Excavation restriction signs are clearly visible (Photograph 2-28). No indications that groundwater was being used were observed. Therefore, ICs appear to be functioning as intended to protect human receptors from exposure to contaminated soil or groundwater.
