2012 Institutional Controls Site Inspection Report

Operable Units A and B-1

Former Naval Complex

Adak, Alaska

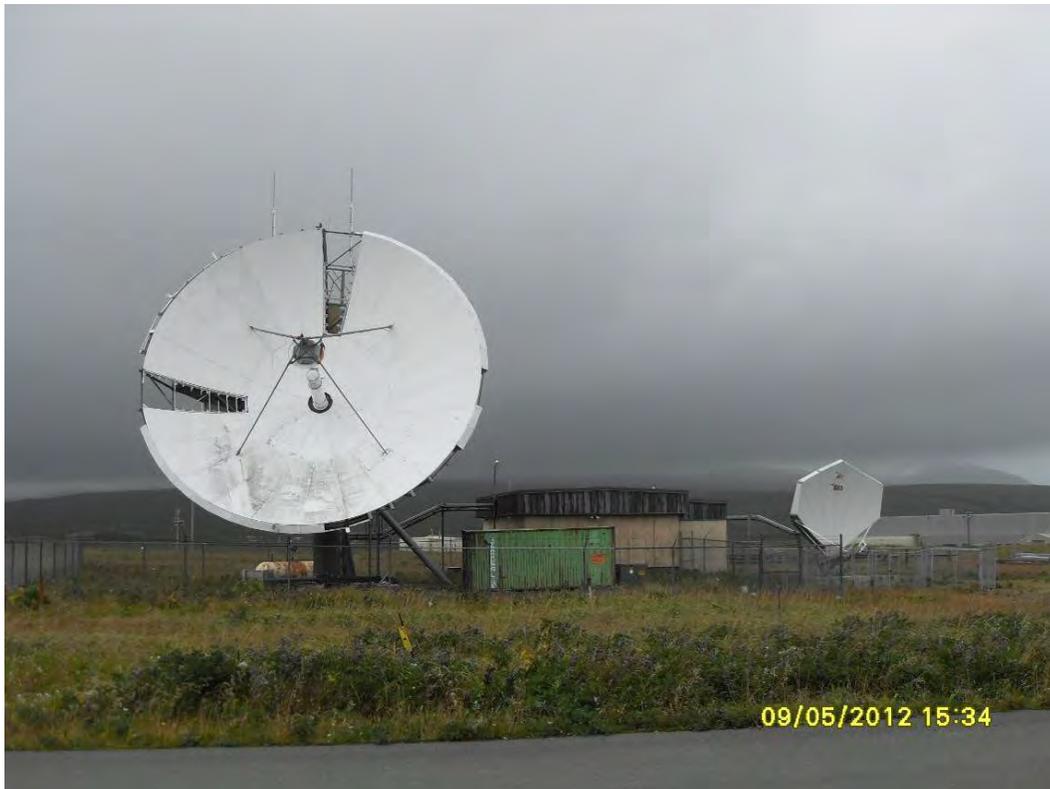
Photograph 2-29. GCI Compound (UST GCI-1) – looking west

the fenced area (Photograph 2-29). The closest surface water body, East Canal, is located approximately 1,000 feet southwest of the site. A UST was removed from the site in 1995. Free product recovery has ceased at the site, and the final remedy for the GCI Compound is monitored natural attenuation.

During the inspection on September 5, 2012, no changes to the site were observed compared to the 2011 inspection results. No residential construction had occurred at the site, and excavation restriction signs are clearly visible. No indications of groundwater use or excavation activities were found at this site. Therefore, ICs appear to be functioning as intended to protect human receptors from exposure to contaminated soil or groundwater.

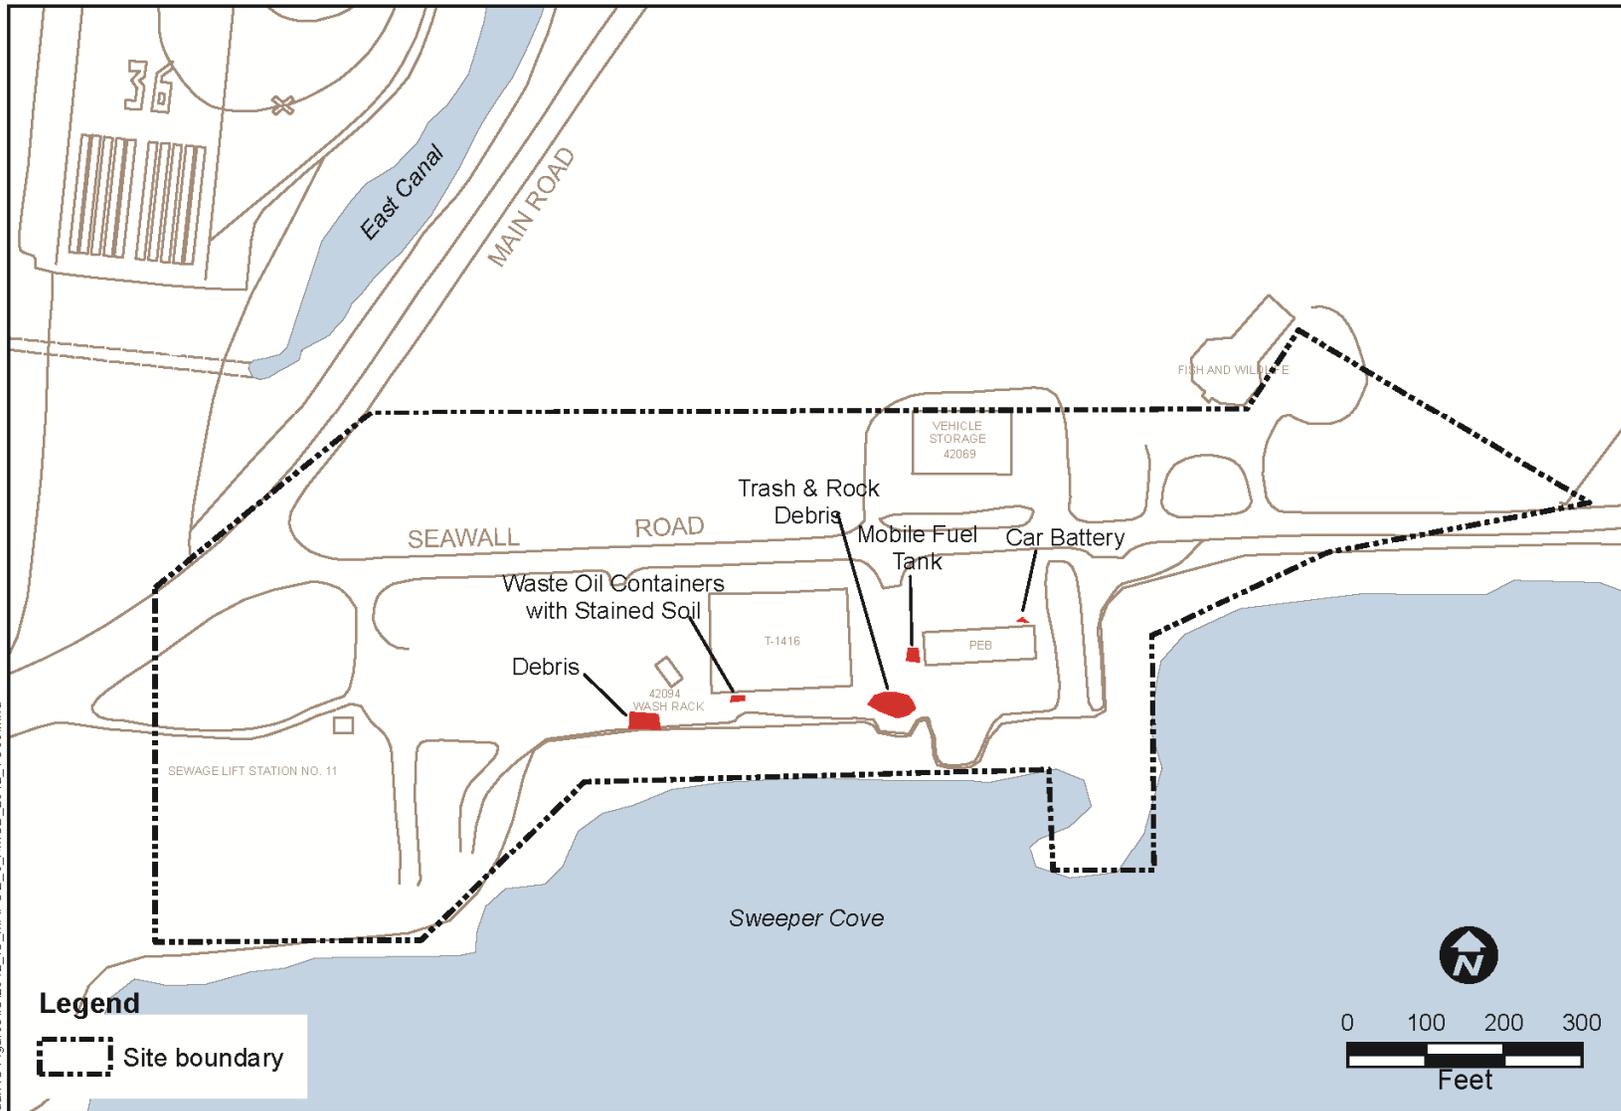
U.S. NAVY	SEALASKA	Figure 2-6 NMCB Expanded Area	Task Order 55 Adak Island, AK 2012 IC Inspection Report
-----------	----------	--	---

As observed during previous inspections, rock debris was being stored on the south side and between the two buildings. Five poly drums not belonging to the Navy, were observed to be located in the same place on the south side of the west building and appeared to contain oil (Photograph 2-30). An approximately 5-foot-diameter area of oil-stained soil was still present under the drums. A portable, 150-gallon gasoline tank was located on the west side

of the east building in a lined, bermed area which is in poor condition. One car battery remains on the northeast corner of the east building (Figure 2-6). Because these poor housekeeping practices may be contributing to groundwater contamination, it is recommended that the owners be notified to remove the on-site wastes, address the areas of actual or potential spills, and improve housekeeping practices.

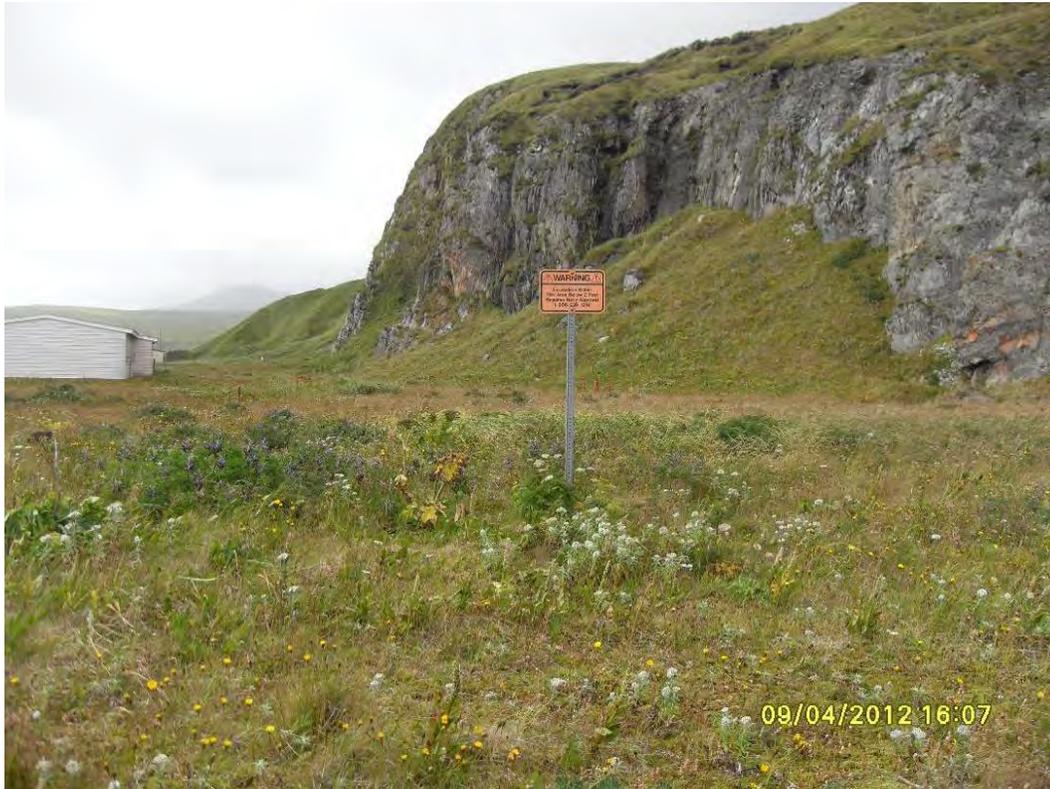
Photograph 2-31. NORPAC Hill Seep Area - looking west

During the inspection on September 4, 2012, no changes to the site were observed compared to the 2011 inspection results. No residential construction has occurred at the site, and no indications of groundwater use or excavation activities were found. Excavation restriction signs were clearly visible. Therefore, ICs appear to be functioning as intended to protect human receptors from exposure to contaminated soil or groundwater.

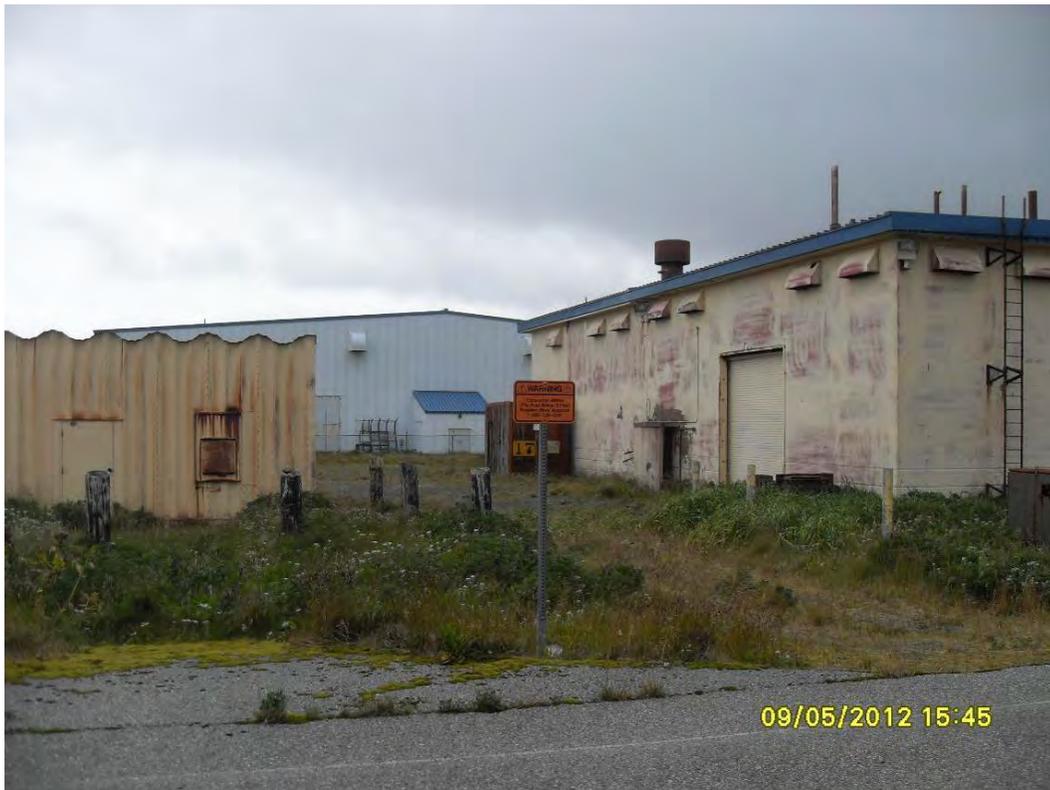
Photograph 2-32. SA 80, Steam Plant 4 – looking south

The final remedy for SA 80 is monitored natural attenuation and ICs. During the inspection on September 5, 2012, no changes to the site were observed compared to the 2011 inspection results. No residential construction had occurred at the site. No indications of groundwater use or excavation activities were found. Excavation restriction signs were clearly visible (Photograph 2-32). Therefore, ICs appear to be functioning as intended to protect human receptors from exposure to contaminated soil or groundwater.

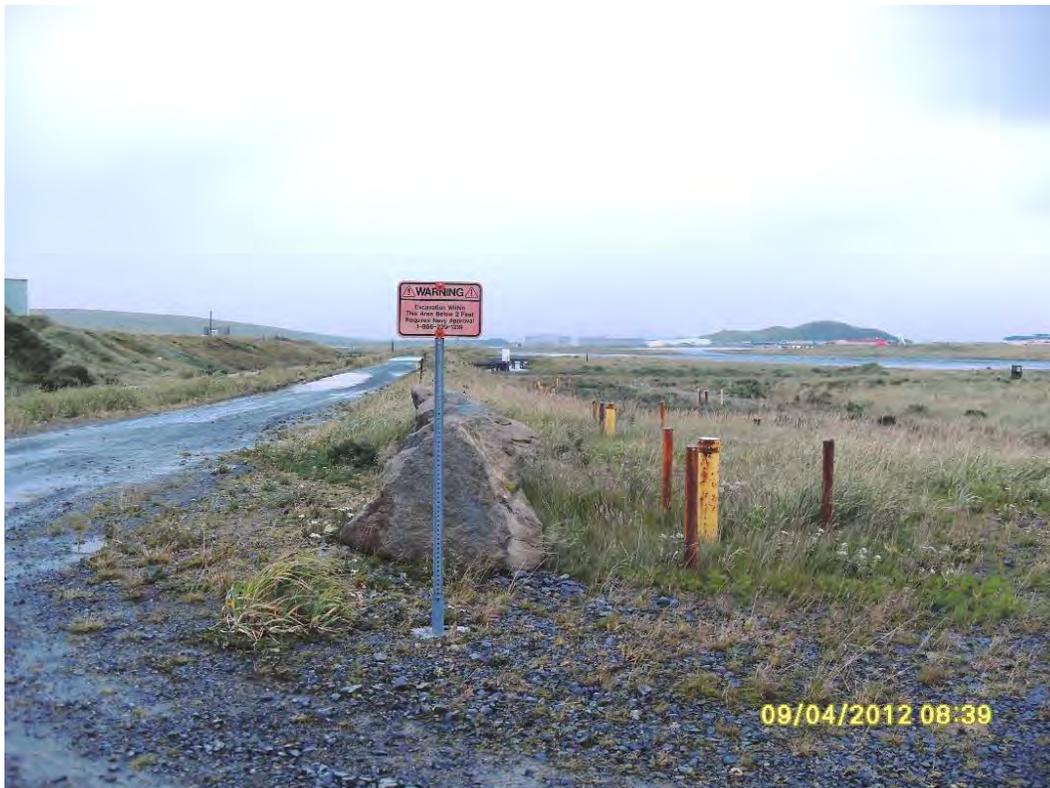
Photograph 2-34. South of Runway 18-36 - looking northeast from south end of Runway 18-36 at yellow recovery trench wells and sign

During the inspections on September 4, 2012, no changes to the site were observed compared to the 2011 inspection results. No residential construction had occurred at the site. No indications of groundwater use or excavation activities were found at the site. No excavations were identified during the inspection, and excavation restriction signs were clearly visible. The product recovery trench system located onsite is no longer in use as

agreed upon with ADEC. ICs appear to be functioning as intended to protect human receptors from exposure to contaminated soil or groundwater.

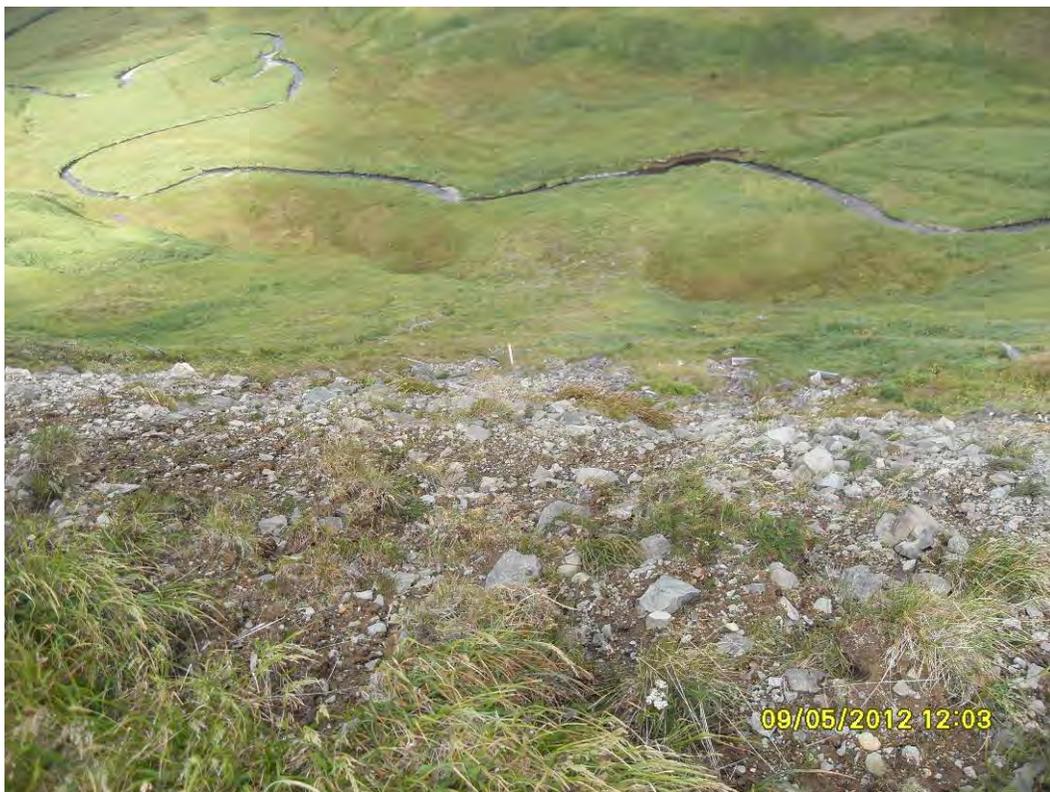
Photograph 3-1. SWMU 20, White Alice/Trout Creek Disposal Area – looking north down towards Trout Creek

During the inspection on September 5, 2012, no indications of a change in land use in this area were found. No residential construction had occurred at the site. No indications of excavation activities were found, and no excavation notifications had been filed the previous year for this site. IC repairs were made to the eroded cliff face in 2010 which included re-grading and re-seeding. No erosion to the cliff face was observed during the 2012 inspection and the 2010 repairs have remained intact (Photograph 3-1). Therefore, ICs appear to be functioning as intended to protect human receptors from exposure to contaminated soil or groundwater.

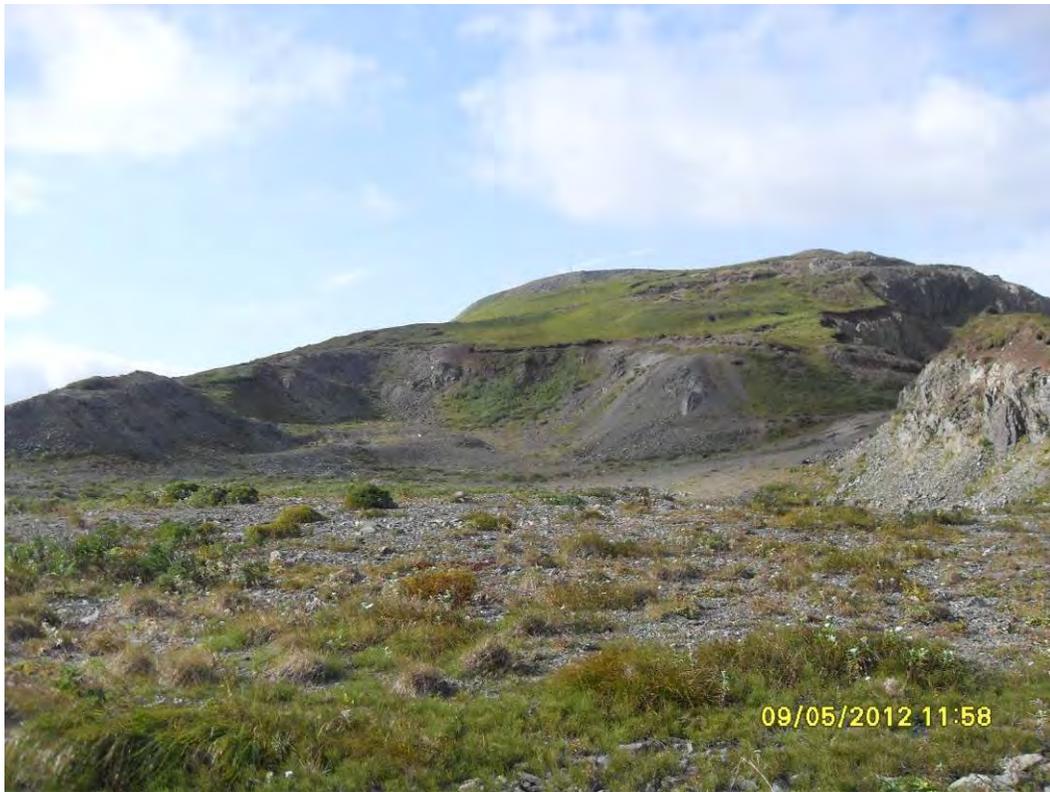
Photograph 3-2. SWMU 21A, White Alice Upper Quarry – looking southeast

During the inspection on September 5, 2012, no changes to the site were observed compared to the 2011 inspection results. No residential construction had occurred at the site. No excavations were identified during the inspection and excavation restriction signs were clearly visible (Photograph 3-2). The site appeared not to be in use. Therefore, ICs appear to be functioning as intended to protect human receptors from exposure to contaminated soil or groundwater.

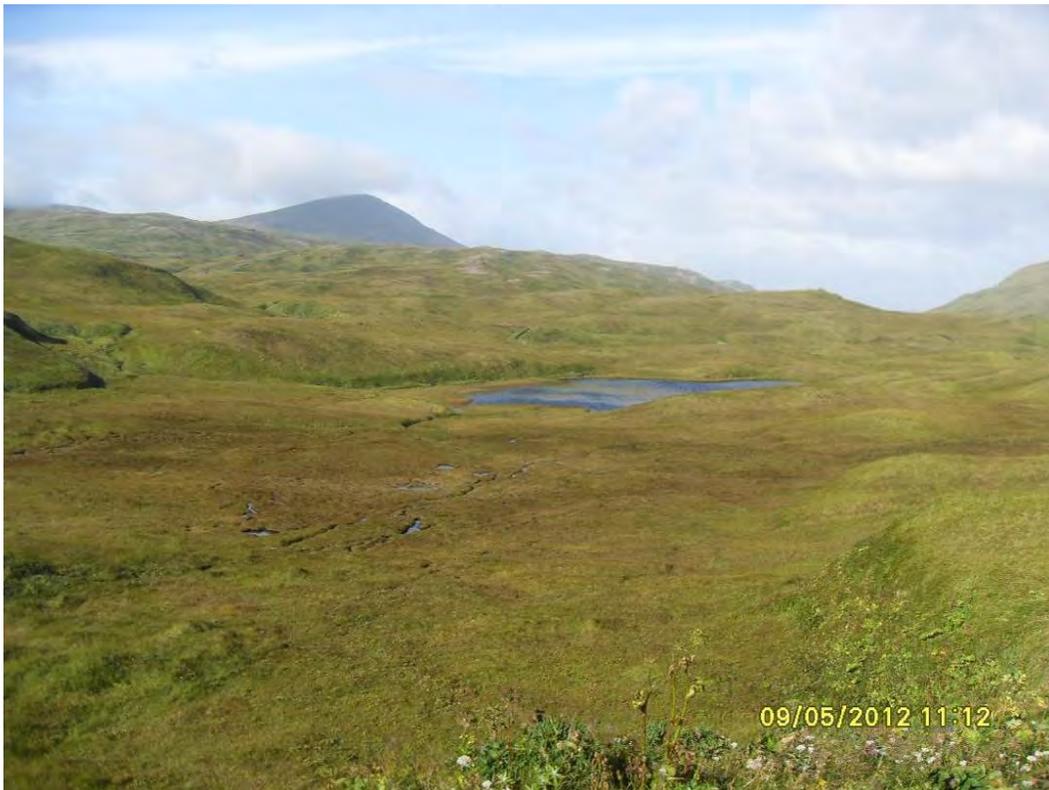
Photograph 3-3. SWMU 23, Heart Lake Drum Disposal– looking west

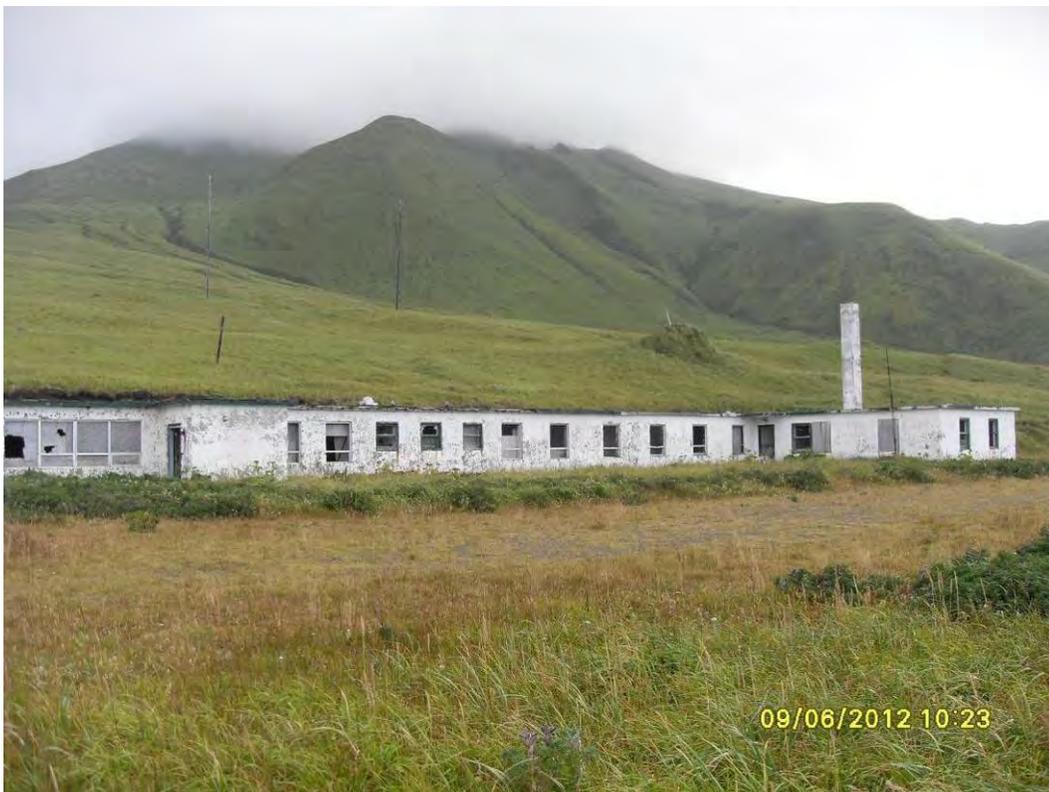
Photograph 3-4. SWMUs 52, 53, and 59, Former LORAN Station – looking east

During the inspection on September 6, 2012, no changes to the site were observed compared to the 2011 inspection results. No indications of excavation activities were found and excavation restriction signs are clearly visible. Some recreational use of the site was evident which included graffiti and empty beverage cans but was within the requirements of the ROD. The site is not accessible by on-road vehicles due to a landslide on the access road approximately a mile from the site. Therefore, ICs appear to be functioning as intended to protect human receptors from exposure to contaminated soil or groundwater.

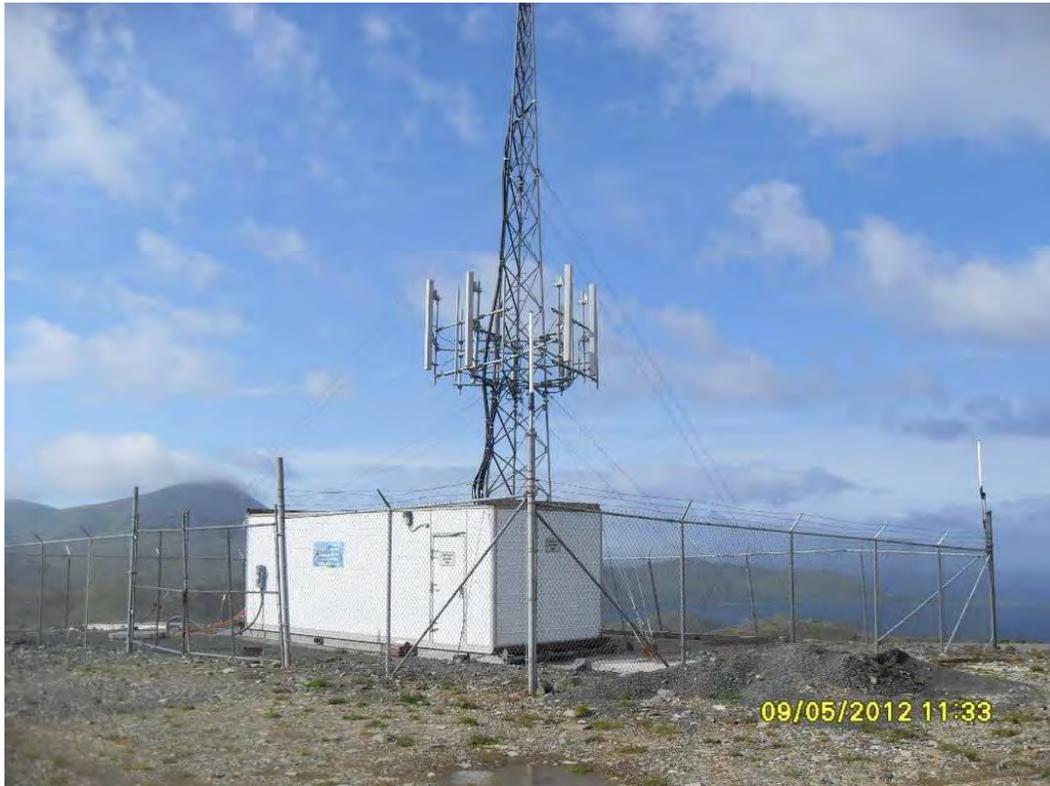
Photograph 3-5. SWMU 67, White Alice PCB Spill Area –
looking southwest at the new cell tower

During the inspection on September 5, 2012, a new cellular tower and building within a fenced area was observed to be installed where the new concrete pads were observed during the 2011 inspection (Photograph 3-5). No new excavation was observed at this site. The use of the communication equipment onsite is consistent with intended reuse. No indications of a change in land use in this area were found. Excavation restriction signs are clearly visible. Therefore, ICs appear to be functioning as intended to protect human receptors from exposure to contaminated soil or groundwater.

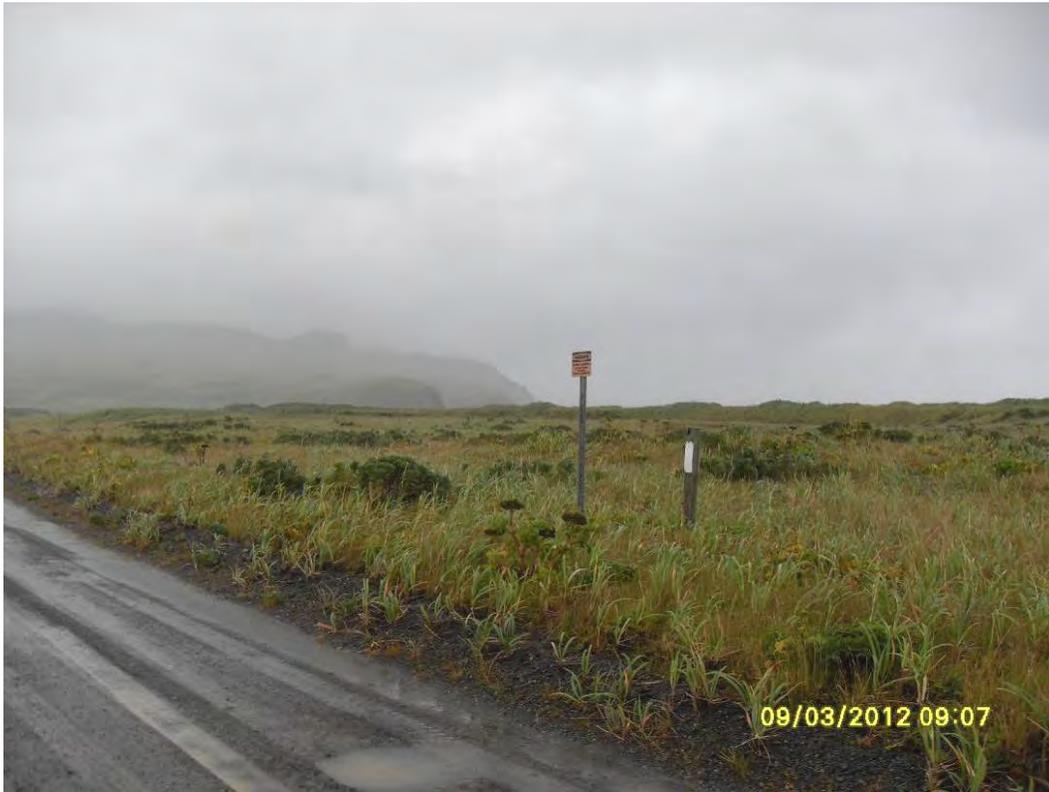
Photograph 3-6. SWMU 2, Causeway Landfill – looking northwest

During the inspection on September 3, 2012, no changes to the site were observed compared to the 2011 inspection results. No residential construction or excavation had occurred at the site. Engineering controls that were implemented at SWMU 2 include signs and soil cover. At the time of inspection, the landfill cap appeared to be intact and undisturbed with good vegetative cover and no evidence of ponding. Three landfill notification signs were intact and visible along the road (Photograph 3-6). Therefore, ICs appear to be functioning as intended to protect human receptors from exposure to contaminated soil or groundwater.

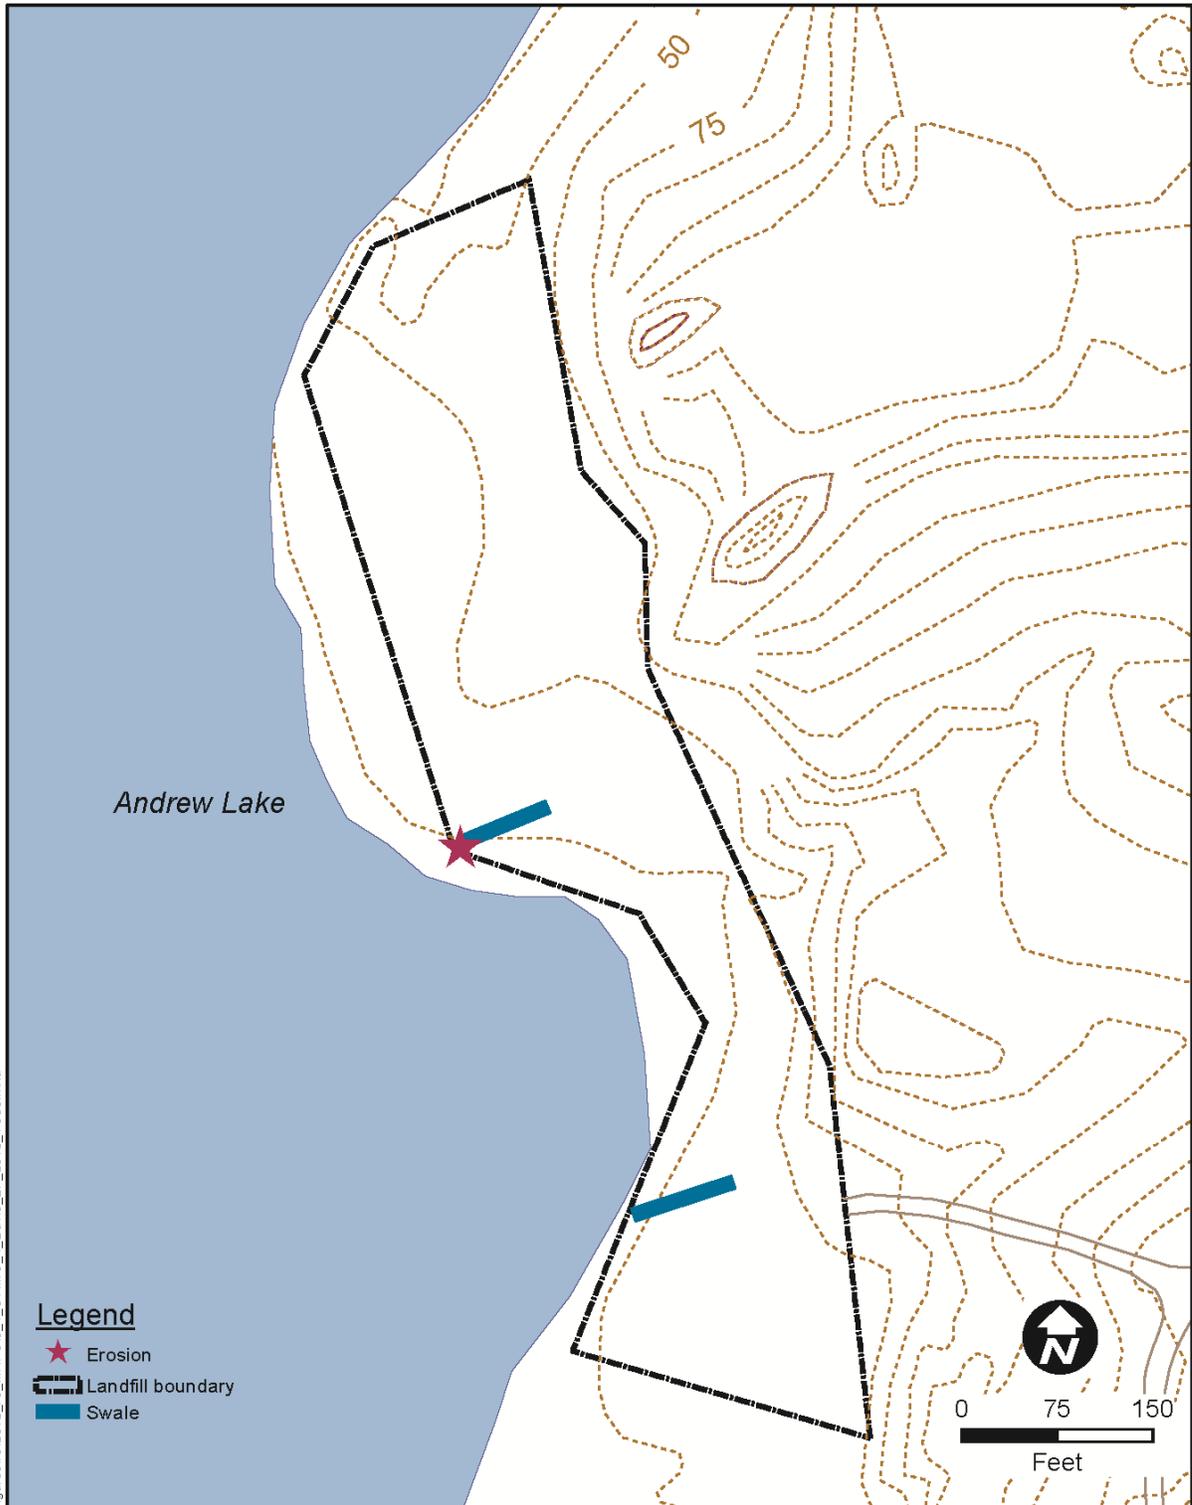
U.S. NAVY SEALASKA		Figure 3-1 SWMU 4, South Davis Road Landfill	Task Order 55 Adak Island, AK 2012 IC Inspection Report
---------------------------	--	---	--

During the inspection on September 3, 2012, the erosion observed during the 2011 inspection at the west end of the northern swale was still present (Photograph 3-7, Figure 3-1). A silt fence that had been installed here was observed to be torn with rocks and sediment piled on top. It is recommended that the silt fence and eroded area be repaired. No other indications of a change in land use in this area were found and no residential construction had occurred at the site. No indications of excavation activities were found and restriction signs were clearly visible. The landfill cap was well vegetated.

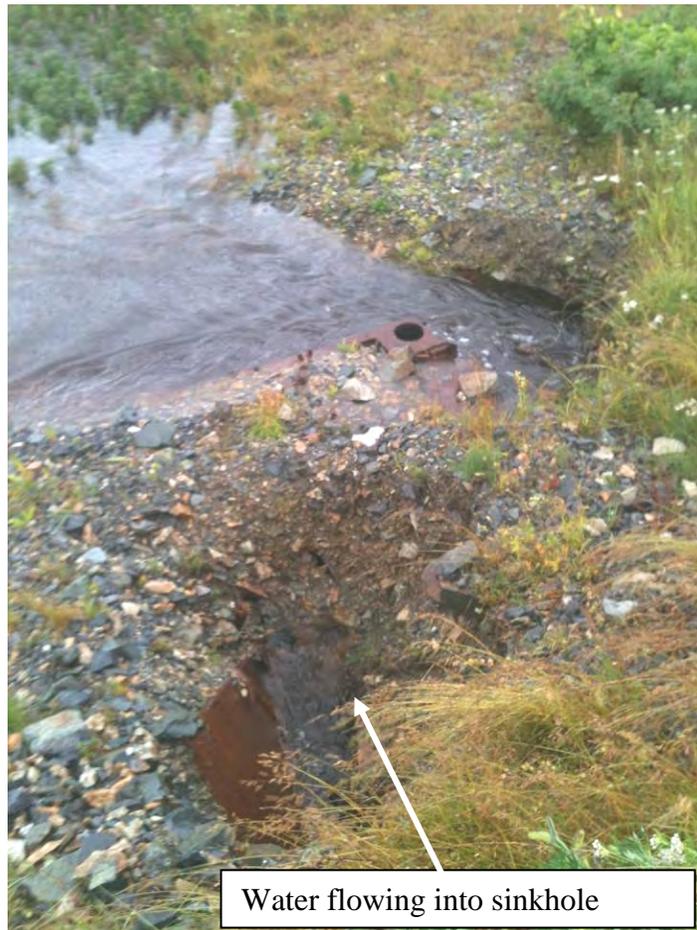
Photograph 3-8. SWMU 11, Palisades Landfill – looking northwest at water from the pond flowing into the sinkhole with debris

The pond with metal debris located in the ravine on north central portion of landfill noted during previous inspections was observed during the 2012 inspection, but it was much larger with elevated water levels due to extensive rain prior to and during the inspection. The pond was approximately 40 feet across at its widest and filled the ravine approximately half way (Figure 3-2). Water was observed flowing into the previously noted sinkhole at the southern end of the pond (Photograph 3-8). Although, it could not be visually confirmed, it is presumed the water was flowing underground and exiting further down the ravine. The sinkhole, which was repaired in 2010, contains metal debris. The sinkhole was approximately 10 feet in diameter with an unknown depth. Metal debris was also observed in the pond and protruding along the water's edge on the west side of the pond. It is recommended that the sinkhole be repaired and that the condition of the culvert that is supposed to drain the pond be evaluated. It is further recommended that during the next IC repairs that the culvert in the pond will be inspected for functionality and that solutions for repair will be recommended as required.

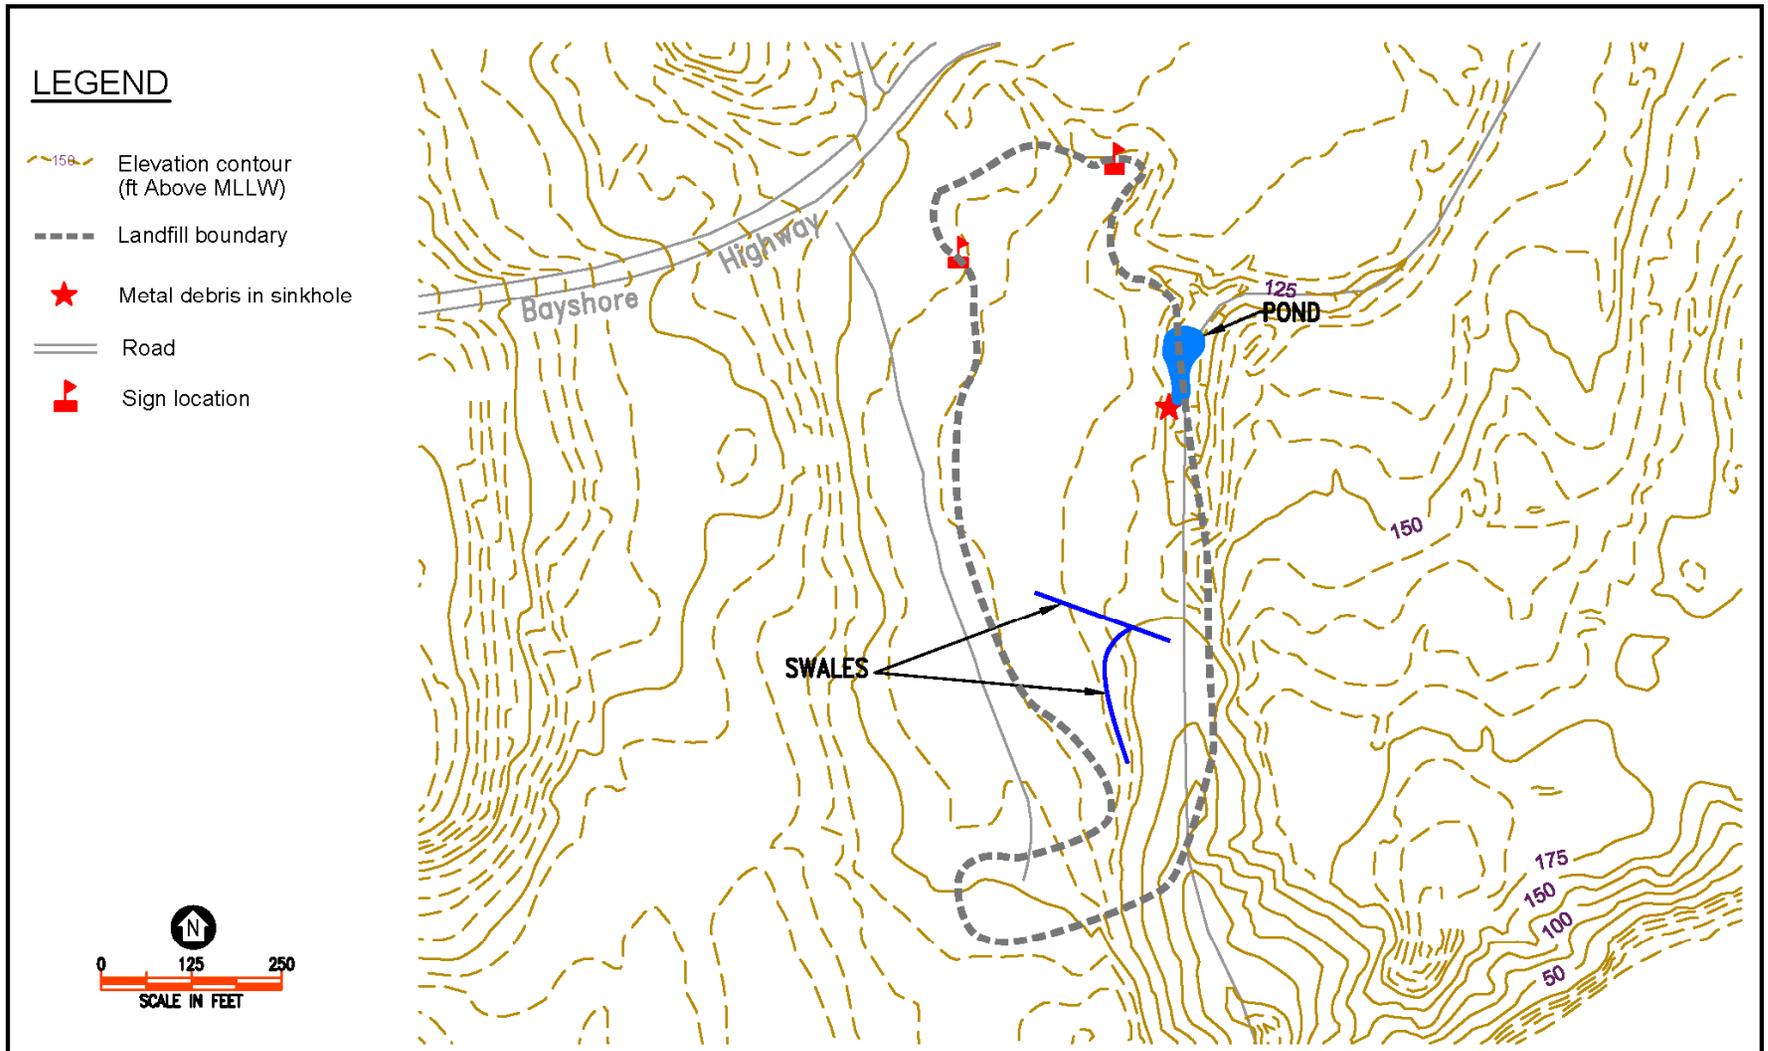
<p>U.S.NAVY SEALASKA</p>	<p align="center">Figure 3-2 SWMU 11, Palisades Landfill</p>	<p>Task Order 55 Adak Island, AK 2012 IC INSPECTION REPORT</p>
---------------------------------	---	---

During the inspection on September 3, 2012, the sign northwest of the landfill was observed to be blown over, and the sign northeast of the landfill is leaning. It is recommended that these signs be repaired. Swales were in good condition, and cap was heavily vegetated and appeared in good condition. No indications of a change in land use in this area were found and no residential construction had occurred at the site. No indications of excavation activities were found. Therefore, ICs appear to be functioning as intended to protect humans and the environment.

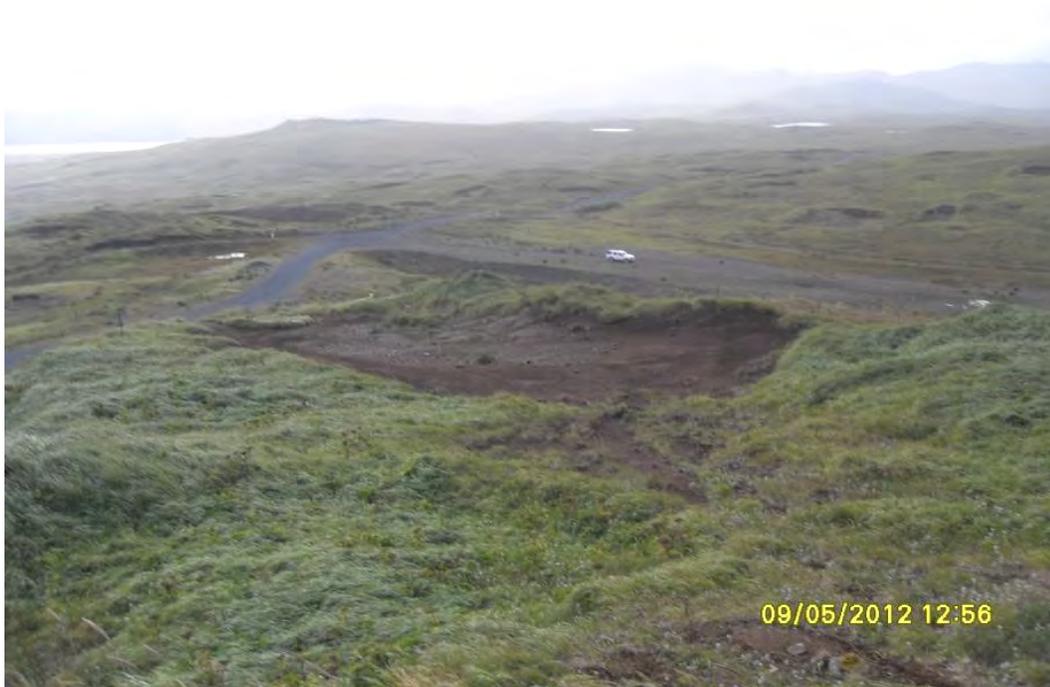
- An eroded area was observed on the southeast side of the site behind the sign by the south entrance gate. The eroded area is 42 feet by 96 feet but is not on the cap (Photograph 3-10).

Photograph 3-10. SWMUs 18 and 19 White Alice Landfill – looking southeast at the eroded area north of the southeast gate

- Continue to monitor the ponding outside the northern landfill boundary for potential erosion along the fence line.
- Seed and fertilize the eroded area north of the entrance gate.
- The non-vegetated areas will be re-seeded. Use of other tundra mixes than what has been used previously will be investigated to yield better re-seeding results..
- Re-rock the swale so the liner is not exposed. Install some type of flow dissipater within the channel at several locations to prevent rock from sliding down the incline.
- Move the sign near the gate so the vegetation does not obscure it.
- Repair broken fencing.
- Re-attach the fallen sign.

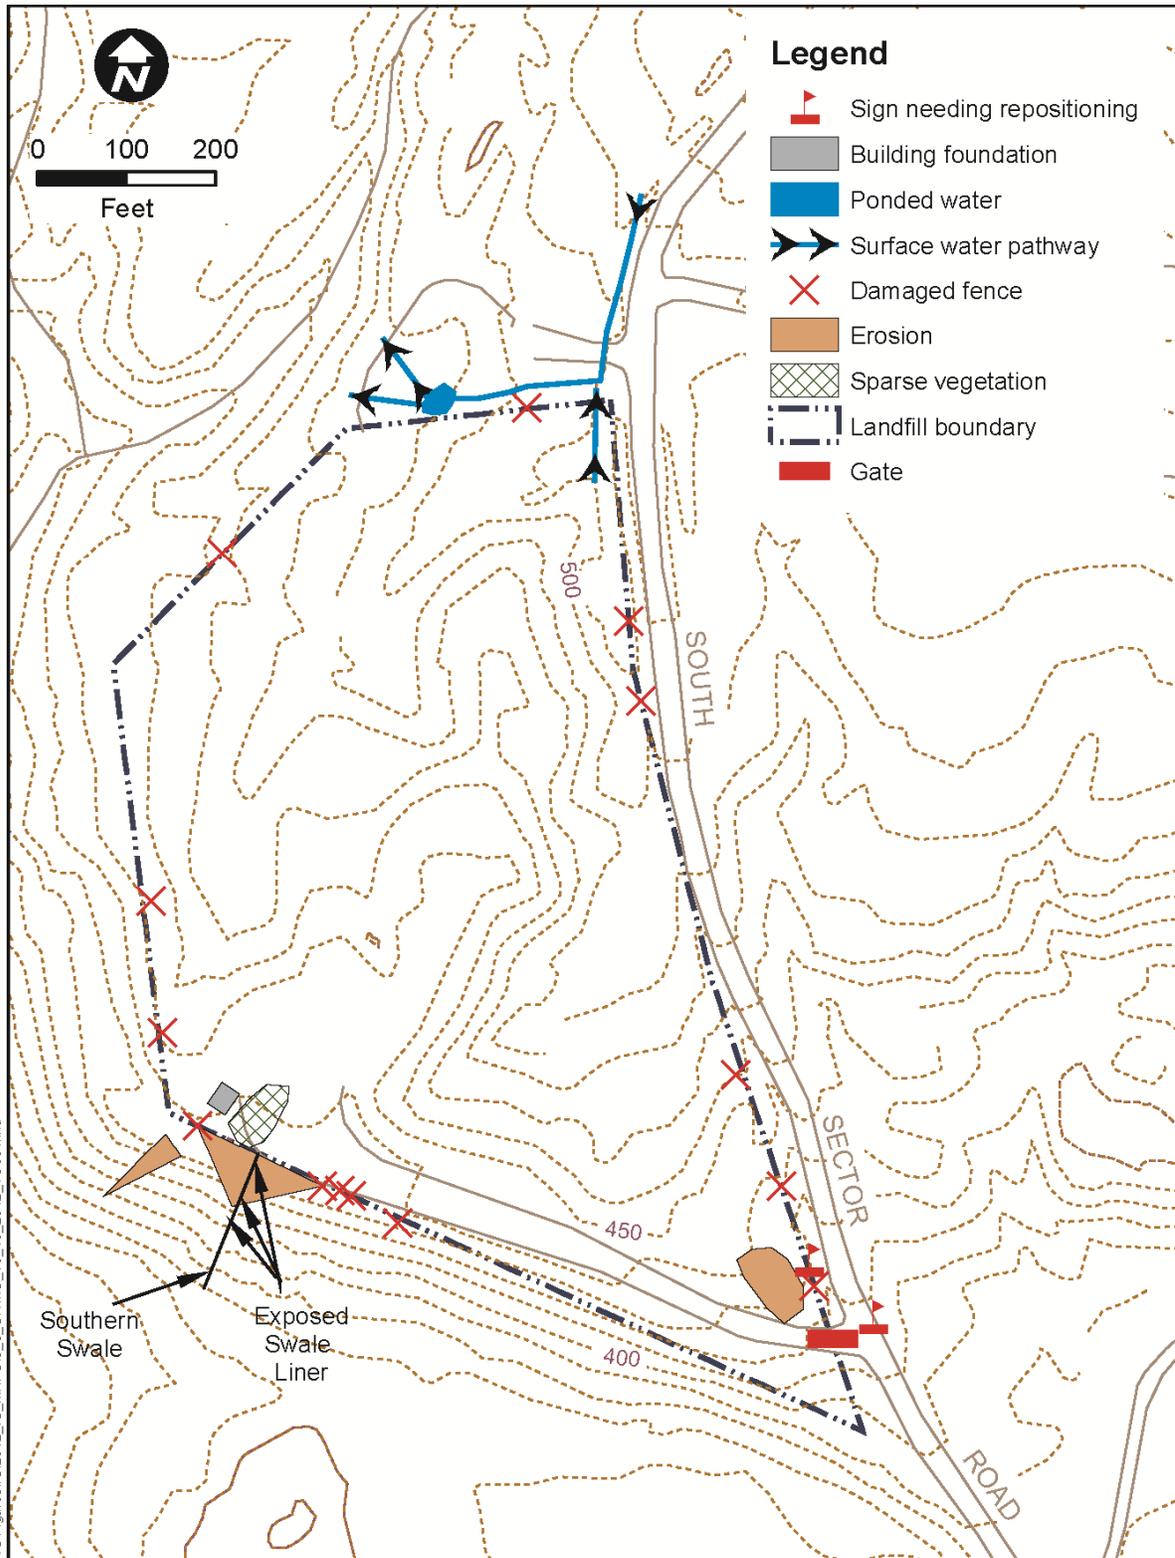
<p>U.S. NAVY</p>	<p>SEALASKA</p>	<p align="center">Figure 3-3 SWMU 18/19, White Alice Landfill</p>	<p>Task Order 55 Adak Island, AK 2012 IC Inspection Report</p>
-------------------------	------------------------	--	---

- Ponding observed during the 2011 inspection outside and adjacent to the northern landfill perimeter fence is still present. This pond receives surface water from the northeast swale and roadside ditch. This ponding did not appear to be affecting the cap integrity in 2012.

- The area observed in 2011 to be sparsely vegetated on the northern portion of the landfill has re-vegetated and no longer exists.
- A sparsely vegetated 50 x 100 ft area near the old building foundation on the south inside the fence was observed previously in 2011 and was still present in 2012 but appears to be stable.

- The eroded area approximately 100 feet by 30 feet by 100 feet triangle outside the landfill on the southwest on the cliff is still present but appears to be stable and in the same condition as observed in 2011. It is currently not affecting landfill cap integrity but will continue to be monitored for stability and possible encroachment into the landfill.

- A total of seventeen sections of fencing are in need of repair on the north, south, east and west perimeters.
- One sign on the west perimeter fence needs to be reattached.

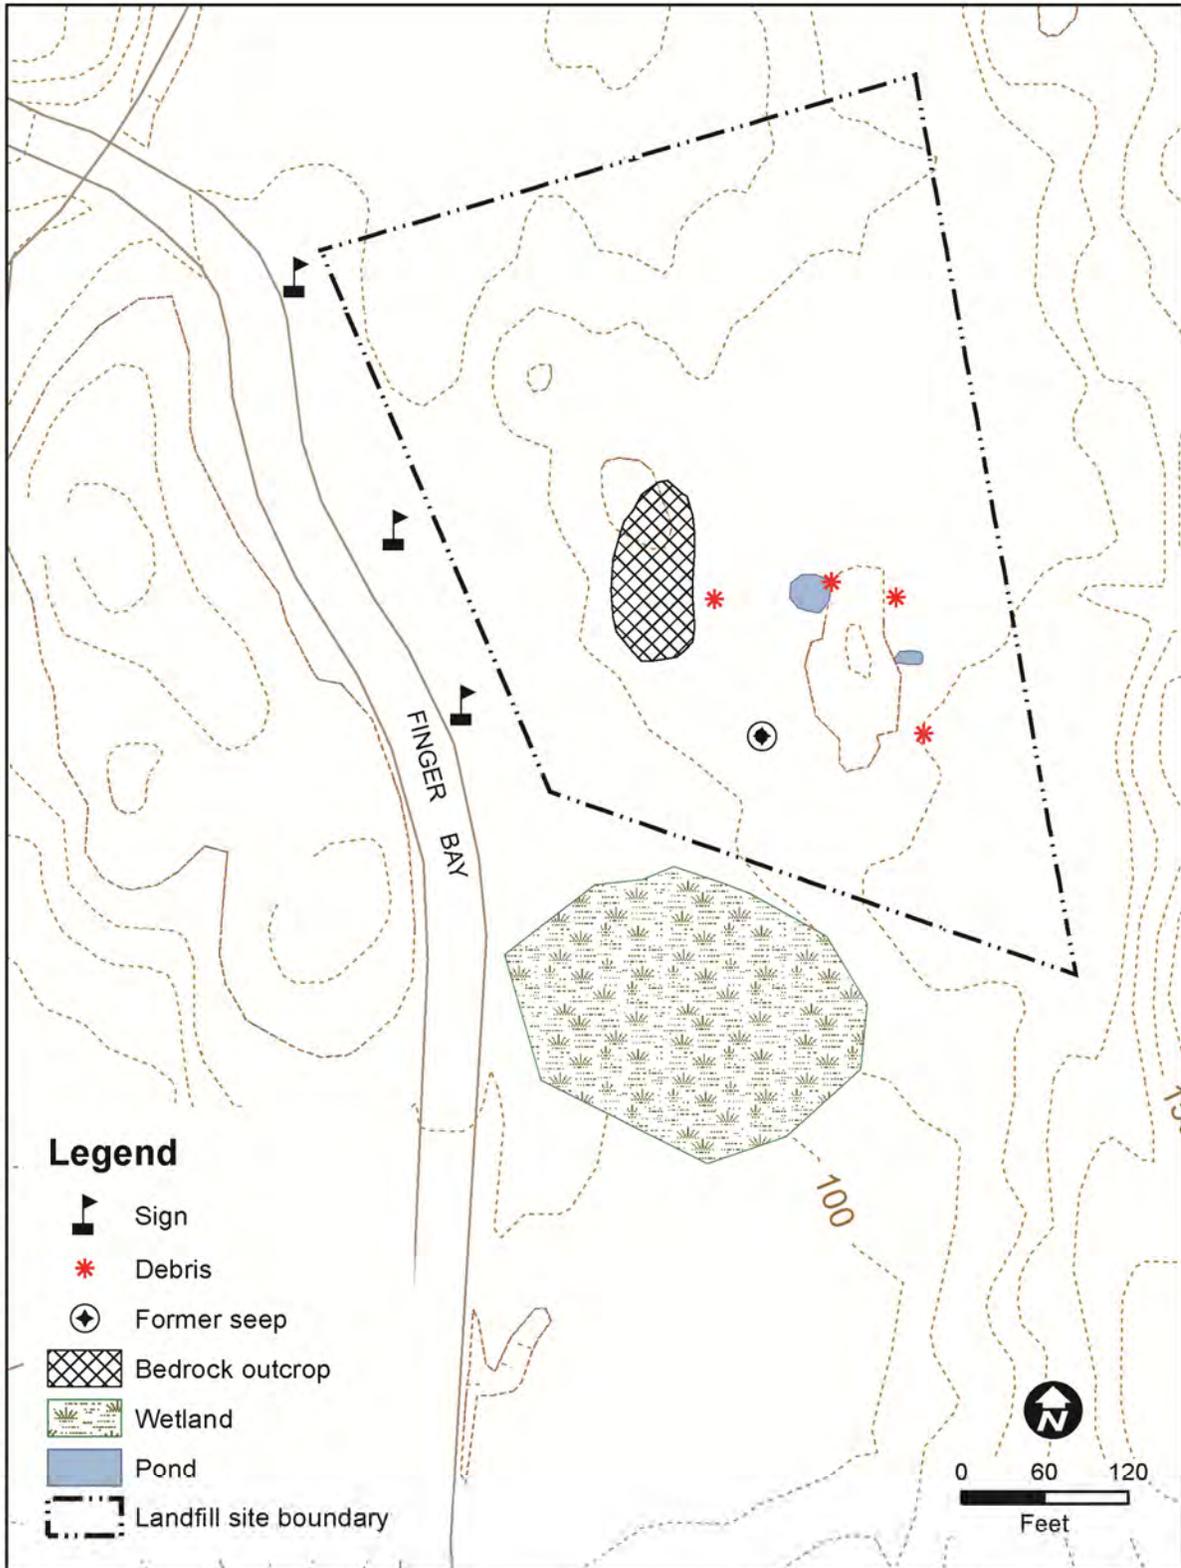
U.S. NAVY	SEALASKA	Figure 3-4 SWMU 29, Finger Bay Landfill	Task Order 55 Adak Island, AK 2012 IC Inspection Report
-----------	----------	--	--

Much of the area is marshy with thick tundra. Due to recent rains, saturated ground, ponding, and overland surface water flow were observed across the site. The water levels in the ponds noted in 2012 were elevated compared to the 2011 inspection. Surface water was observed on the north, east, and south sides of the site in the marshy areas flowing down from the higher elevation to the east. The pond observed on east side of site high point in 2011 was observed to be approximately 5 feet by 20 feet in size during the 2012 inspection. The pond observed in 2010 and 2011 containing wood and metal debris which is located in the central section of the landfill was estimated to be approximately 30 feet in diameter in 2012 (Photograph 3-11). The metal and wood debris observed in the pond in the central portion of the landfill in 2011 were mostly submerged during the 2012 inspection. Small quantities of debris were noted on the surface of the landfill east of the high point (Figure 3-4).
