2012 Institutional Controls Site Inspection Report

Operable Units A and B-1

Former Naval Complex

Adak, Alaska

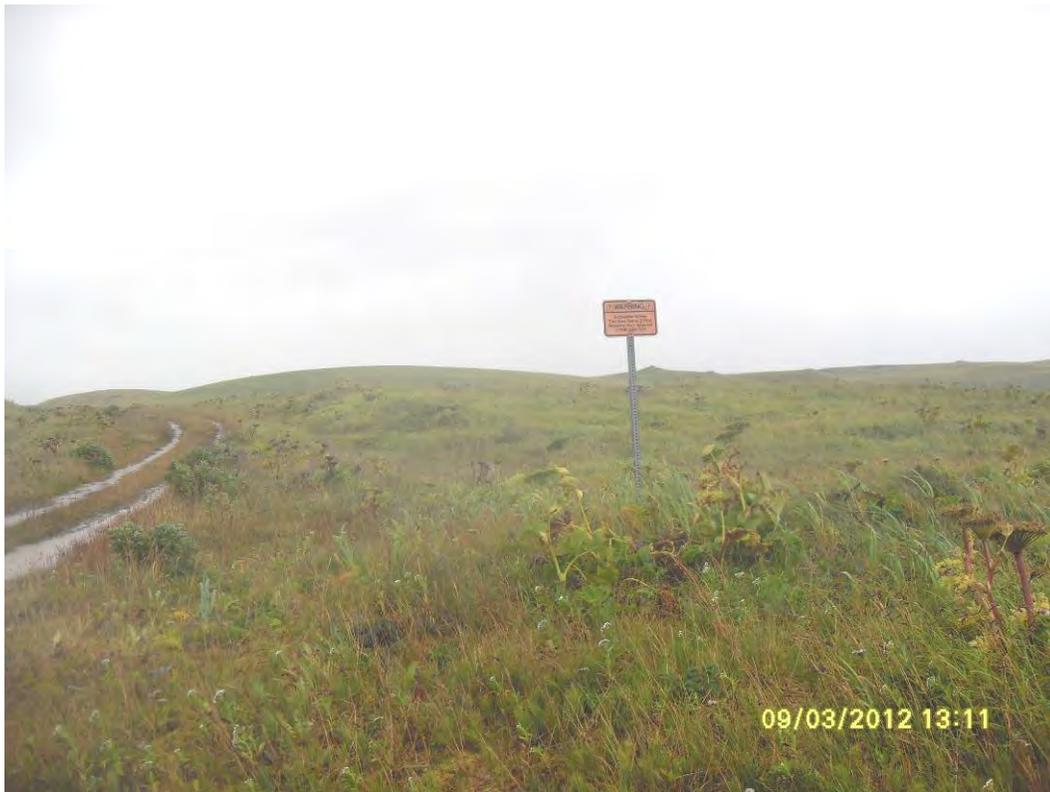
Photograph 3-13. Antenna Field – looking north at excavation restriction sign

During the inspection on September 3, 2012, no other changes to the site were observed compared to the 2011 inspection results. No indications of a change in land use in this area were found and no residential construction had occurred at the site. No indications of groundwater use or excavation activities were found, and excavation restriction signs were clearly visible (Photograph 3-13). Therefore, ICs appear to be functioning as intended to protect human receptors from exposure to contaminated soil or groundwater.

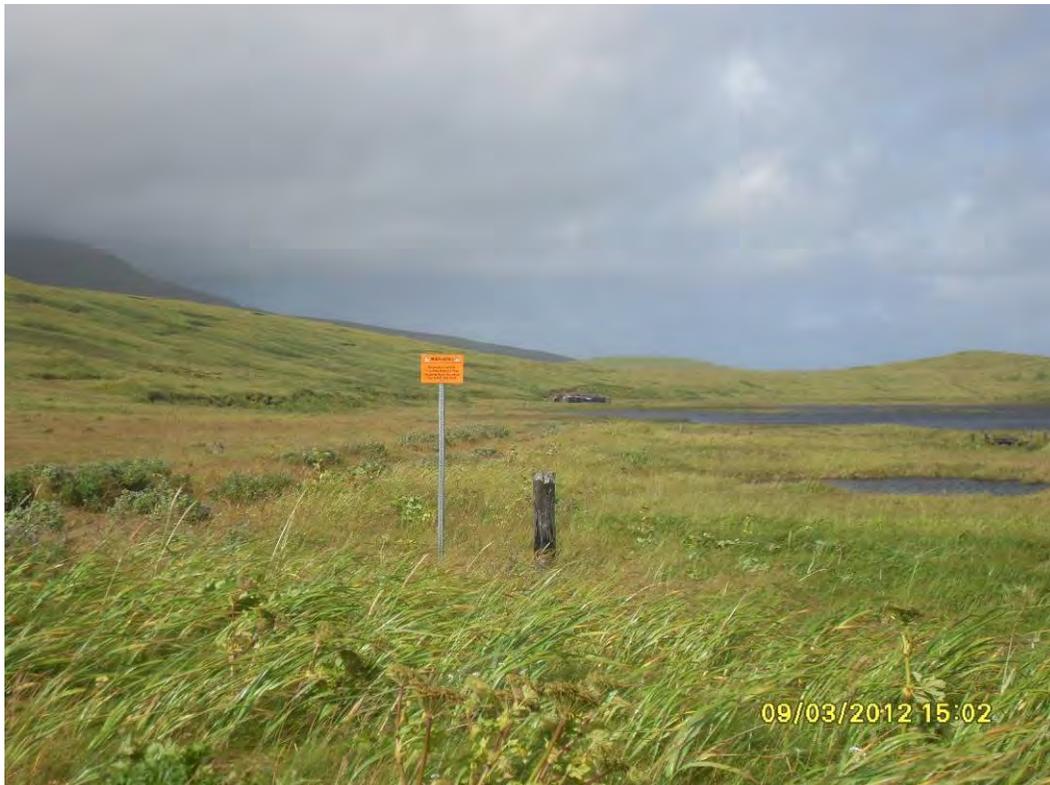
Photograph 3-14. Boy Scout Camp – looking north at the sign and site in the background

During the inspection on September 3, 2012, no changes to the site were observed compared to the 2011 inspection results. No indications of a change in land use in this area were found and no residential construction had occurred at the site. No indications of groundwater use or excavation activities were found. Excavation restriction signs are present at this site at the northern and southern entrances. Therefore, ICs appear to be functioning as intended to protect human receptors from exposure to contaminated soil or groundwater.

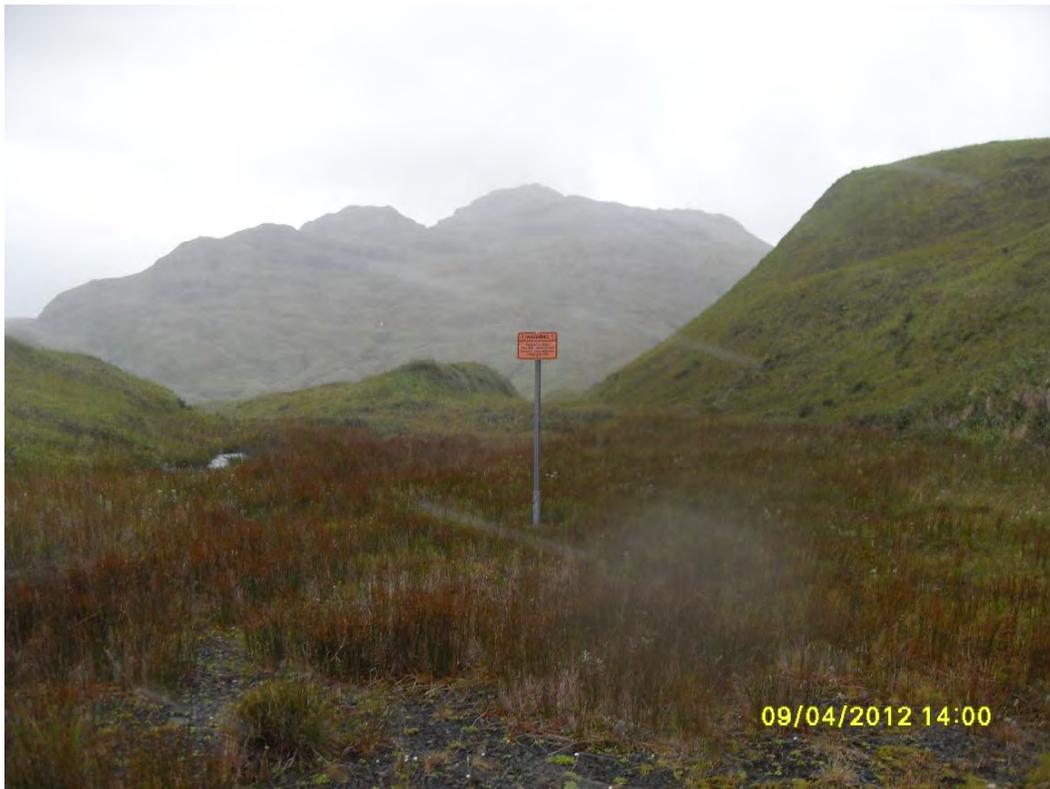
Photograph 3-15. Finger Bay Quonset Hut – looking west at the site sign

During the inspection on September 4, 2012, no changes to the site were observed compared to the 2011 inspection results. No indications of a change in land use in this area were found and no residential construction had occurred at the site. No indications of groundwater use or excavation activities were found, and the excavation restriction sign was clearly visible (Photograph 3-15). The sign was observed to have bullet holes in it, but it was still legible.

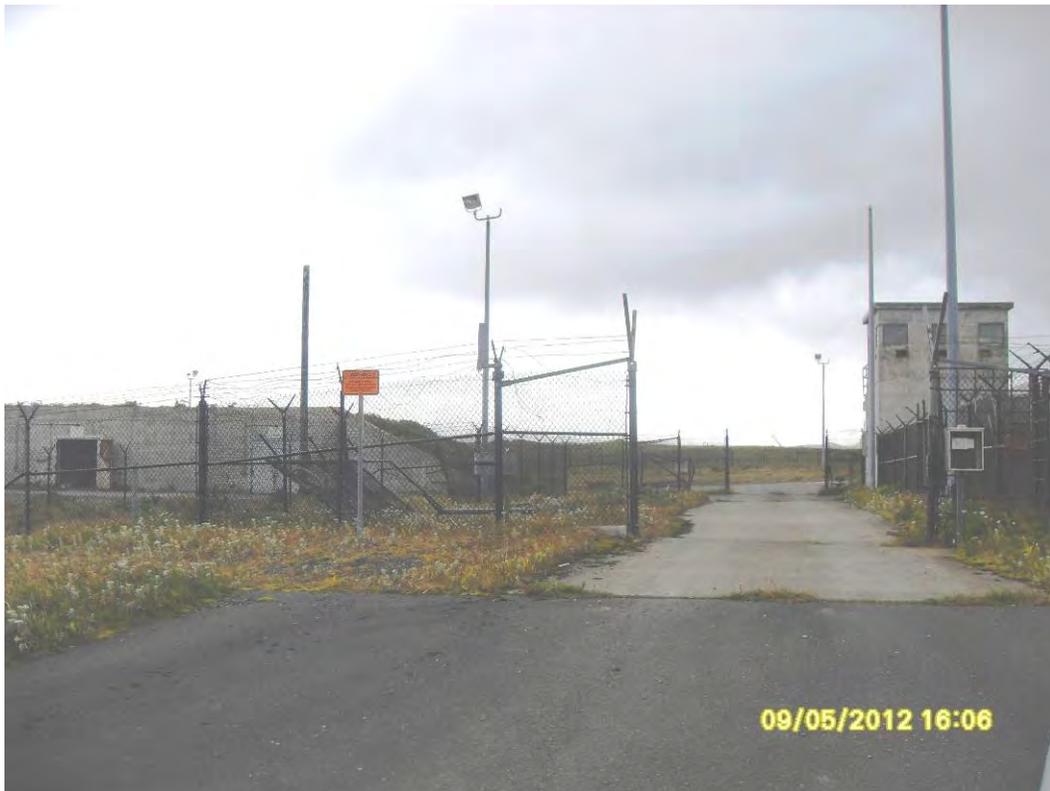
Photograph 3-16. MAUW Compound – looking south

During the inspection on September 5, 2012, no indications of a change in land use in this area were found and no residential construction had occurred at the site. However, the site no longer appears to be used for storage and as a vehicle maintenance and rental shop. No indications of groundwater use or excavation activities were found, and excavation restriction signs were clearly visible (Photograph 3-16). Therefore, ICs appear to be functioning as intended to protect human receptors from exposure to contaminated soil or groundwater.

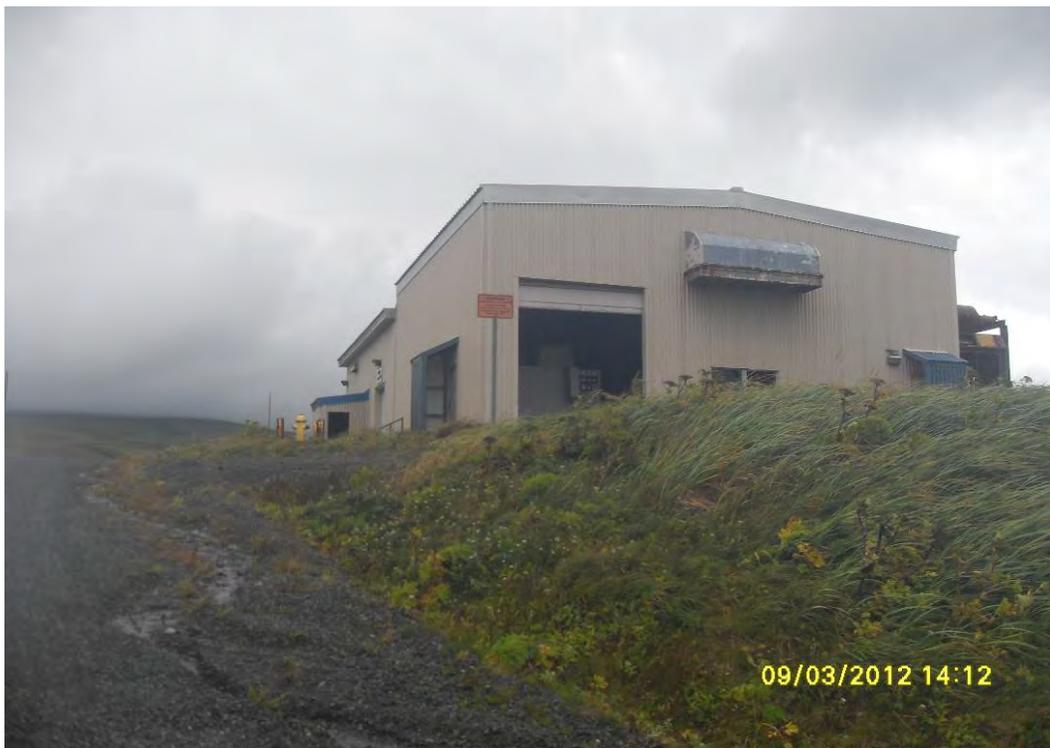
Photograph 3-17. Mount Moffett Power Plant 5 – looking west

During the inspection on September 3, 2012, no indications of a change in land use in this area were found. No indications of groundwater use or excavation activities were found, and excavation restriction signs were clearly visible (Photograph 3-17). No excavation had occurred at the site. Therefore, ICs appear to be functioning as intended to protect human receptors from exposure to contaminated soil or groundwater.

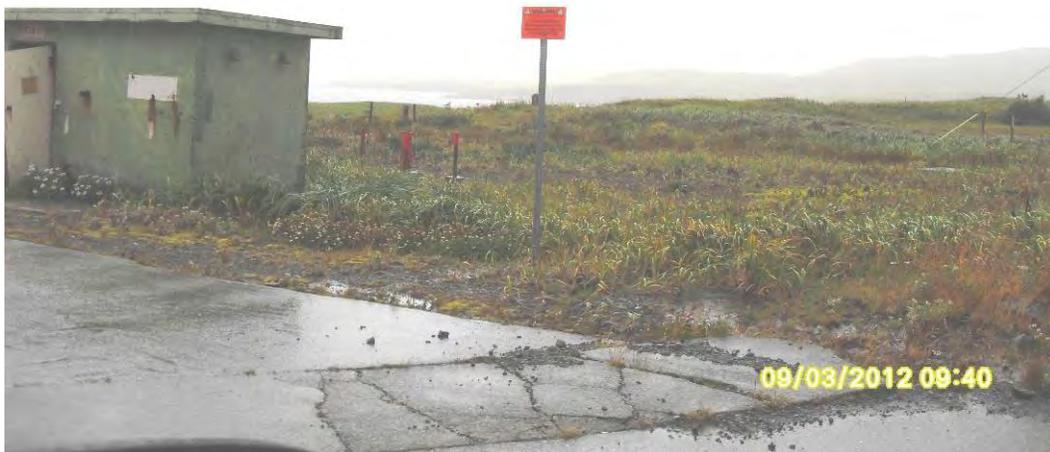
Photograph 3-18. SWMU 58 and SA 73, Heating Plant 6 – looking northwest at the sign and monitoring wells

During the inspection on September 3, 2012, no indications of a change in land use in this area were found. No indications of groundwater use or excavation activities were found, and

excavation restriction signs were clearly visible (Photograph 3-18). Based on these findings, ICs appear to be functioning properly to protect humans and the environment.

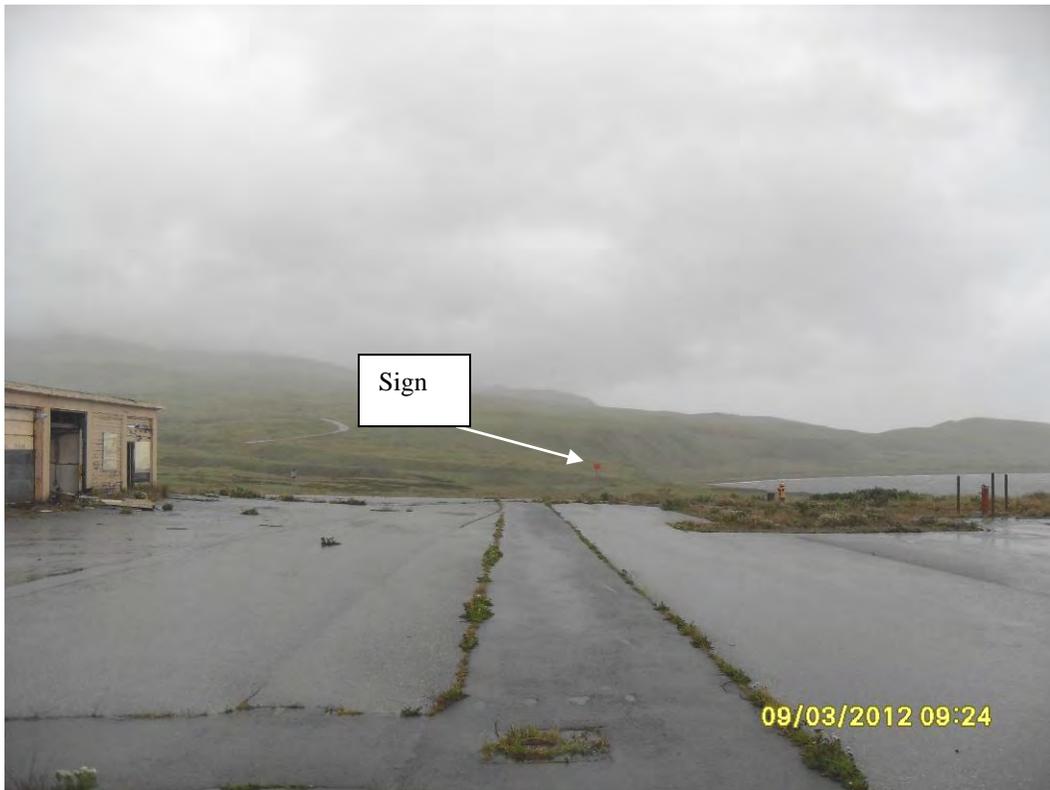
During the inspection on September 3, 2012, no indications of a change in land use in this area were found and no residential construction had occurred at the site. No indications that groundwater was being used and no indications of excavation activities were found at the site. Excavation restriction signs were clearly visible onsite (Photograph 3-19). Based on these findings, ICs appear to be functioning properly to protect humans and the environment.

Photograph 3-19. SA 78, Old Transportation Building – looking north at site with excavation restriction sign in background

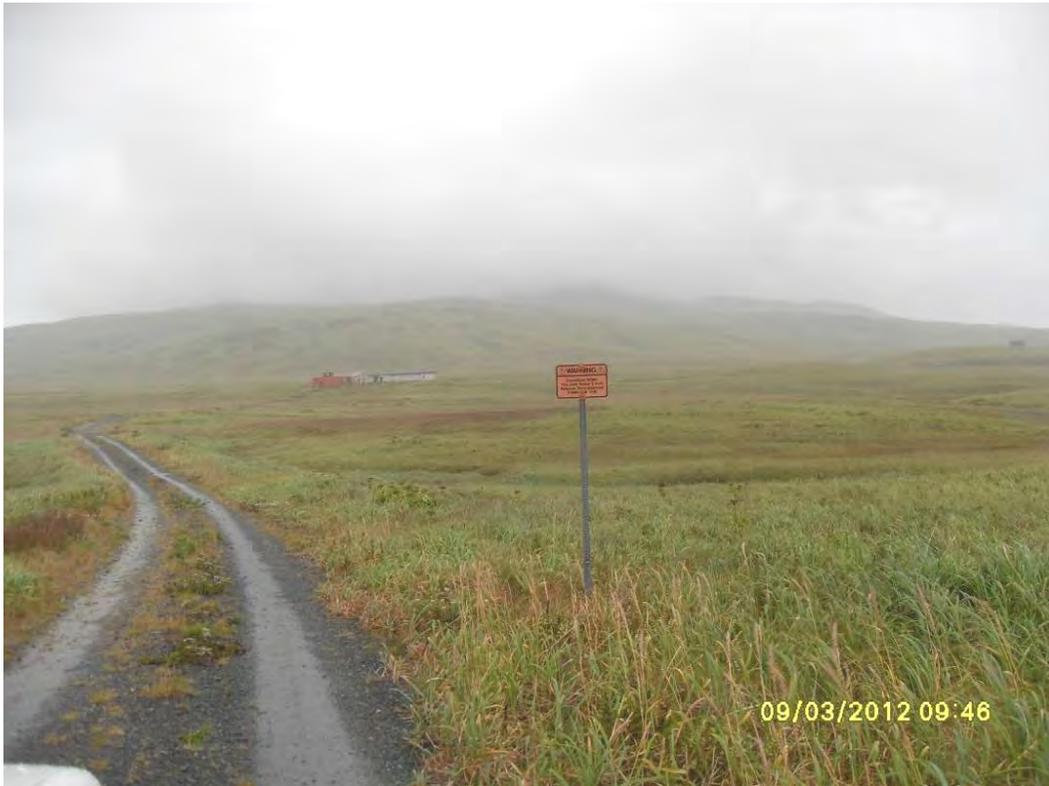
During the inspection on September 3, 2012, no changes to the site were observed compared to the 2011 inspection results. No indications of a change in land use in this area were found and no residential construction had occurred at the site. No indications that groundwater was being used were found at the site. No indications of excavation were found and excavation restriction signs were clearly visible (Photograph 3-20). Therefore, ICs appear to be functioning as intended to protect human receptors from exposure to contaminated soil or groundwater.

Photograph 3-20. SA 82, P-80/P-81 Buildings site – looking north

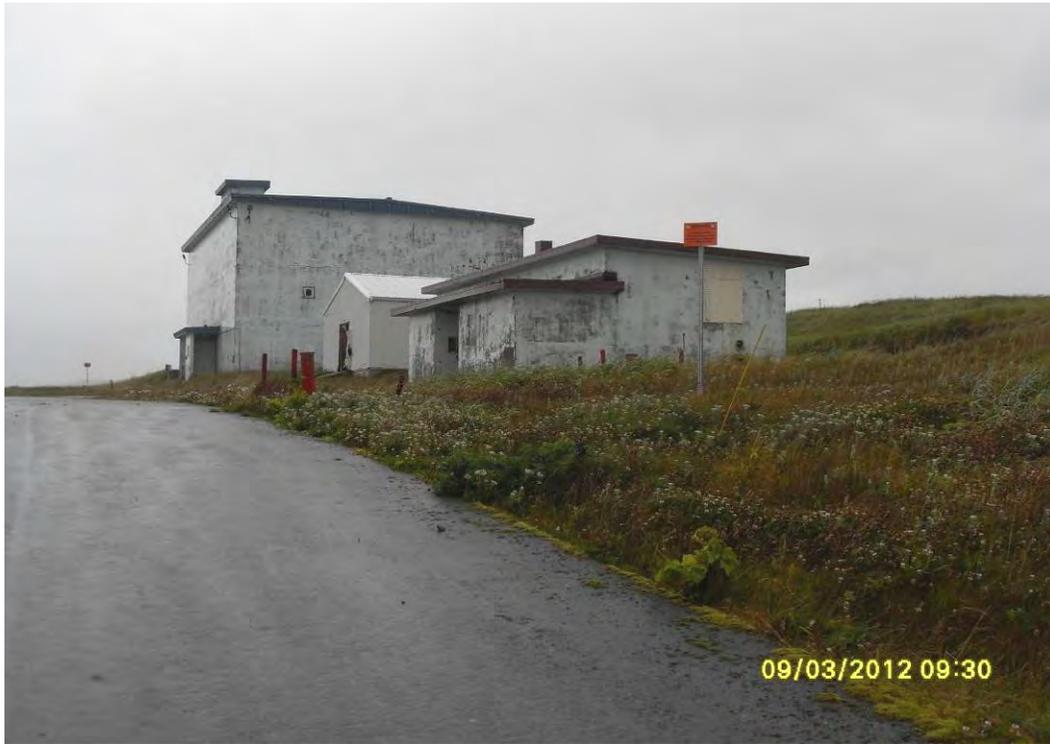
Photograph 3-21. SA 88, Building P-70 Energy Generator, UST 10578 Site – looking west

During the September 3, 2012 inspection, no indications of a change in land use were found in this area and no residential construction had occurred at the site. No indications that groundwater was being used were found at the site. No indications of excavation were found and excavation restriction signs were clearly visible (Photograph 3-21). Therefore, ICs appear to be functioning as intended to protect human receptors from exposure to contaminated soil or groundwater.

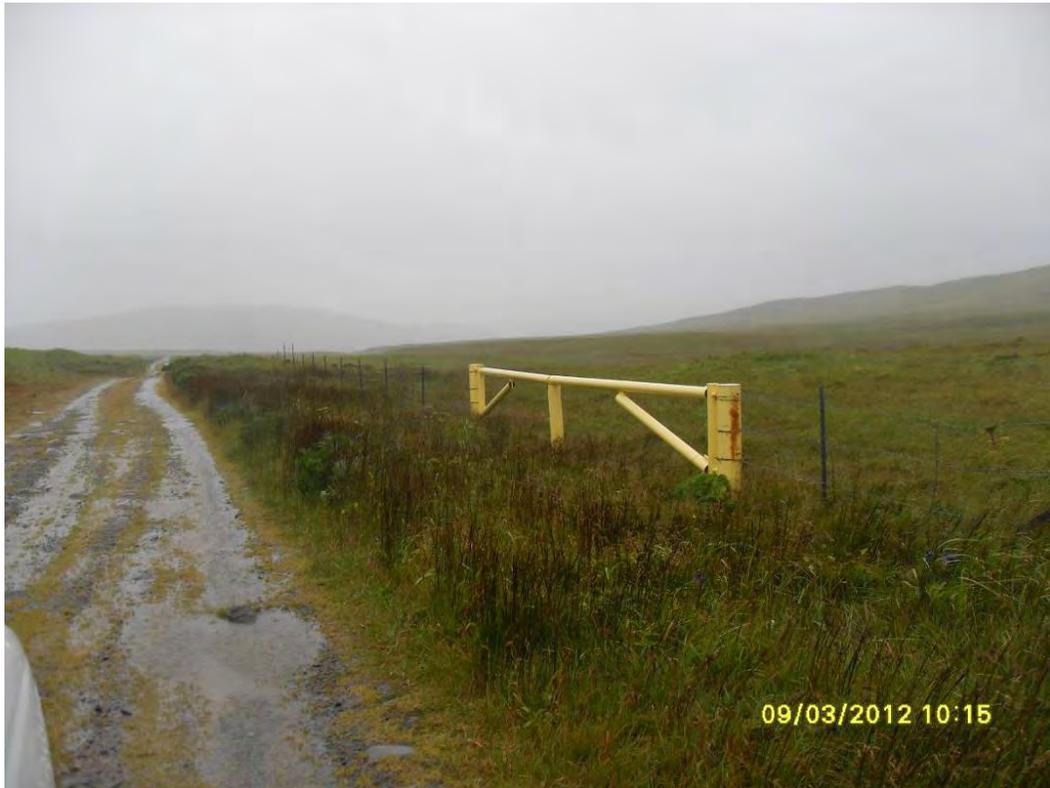
Photograph 3-22. SA 93, WWII Mortar Impact Area (Parcel 4) – looking southwest at east perimeter fence and new gate next to road

- The sign by the northeast corner gate is missing and needs to be installed (Photograph 3-22).
- Six sections of fencing along the north perimeter fence and two sections along the east perimeter fence need to be repaired.
- Nine UXO warning signs on the east perimeter fence are in poor condition and need replacing (Photograph 3-23).
- A sign has fallen off the fence behind the Andrew Lake Recreation Center and needs to be re-attached (Figure 3-5).
- The gate along the southwestern entrance to SA 93 at the Andrew Lake Recreational Center was inspected and found to be locked and in good condition. There is no sign present at the gate and it is recommended that one be installed at the gate location.

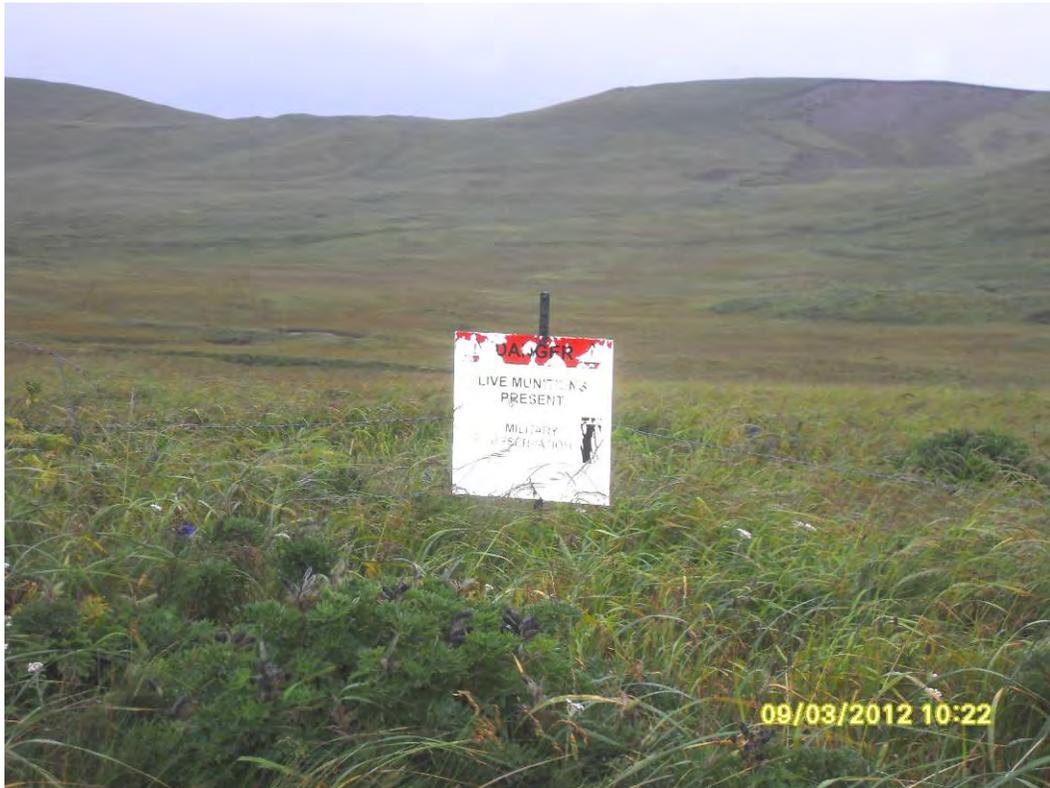
Photograph 3-23. SA 93, WWII Mortar Impact Area (Parcel 4) – looking west at east perimeter fence sign

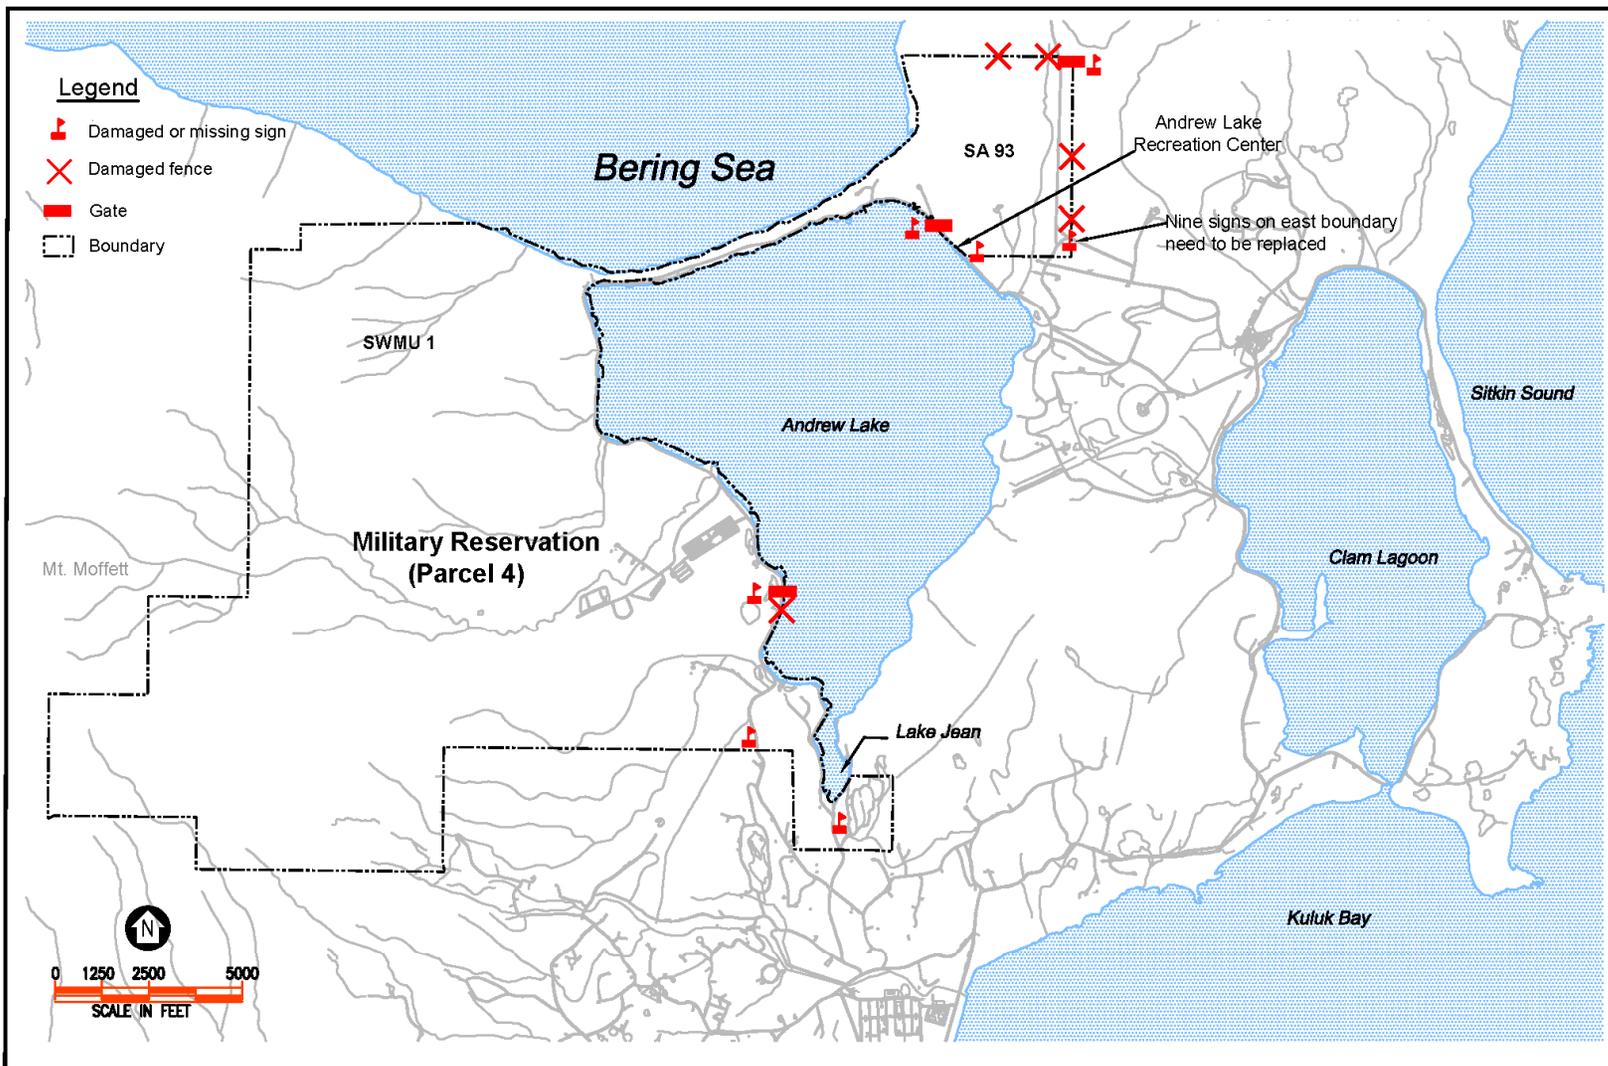
<p>U.S.NAVY</p>	<p>SEALASKA</p>	<p>Figure 3-5 Parcel 4</p>	<p>Task Order 55 Adak Island, AK 2012 IC Inspection Report</p>
------------------------	------------------------	---------------------------------------	--

The perimeter fencing and access gates of SA 93, WWII Mortar Impact Area were inspected. The September 3, 2012 inspection results included the following and are presented on Figure 3-5:

The signs, south perimeter fencing, and southern gate of SWMU 1, Andrew Lake Waste Ordnance Demolition Range was inspected. The September 3, 2012 inspection results included the following and are illustrated on Figure 3-5:

- The gate along the southeast entrance to SWMU 1 was inspected and found to be closed, locked, and in good condition. UXO activities were being performed within SWMU 1 at the time of the inspection.
- South perimeter fencing near the gate has three sections that need to be repaired.
- The two UXO warning signs on Lake Jean road, the south entrance road, and one on the south gate were missing during the 2012 inspection and need to be replaced.

SA 93, WWII Mortar Impact Area: The gate at the northeast entrance was inspected and observed to be locked and in good condition. The sign is missing and should be replaced. During the 2012 inspection, six sections of fencing along the north fence line and two sections along the east fence line needed to be repaired. Nine signs along the eastern fence line need to be replaced because they are not legible. The fence and gate at the Lake Andrew Recreation Center appeared to be in good condition during the time of inspection. As observed during the previous inspection, the sign on the fence behind the Recreation Center was lying on the ground and should be re-attached. However, there is no restricted access sign on the gate near the Andrew Lake Recreation Center (see Figure 3-5).

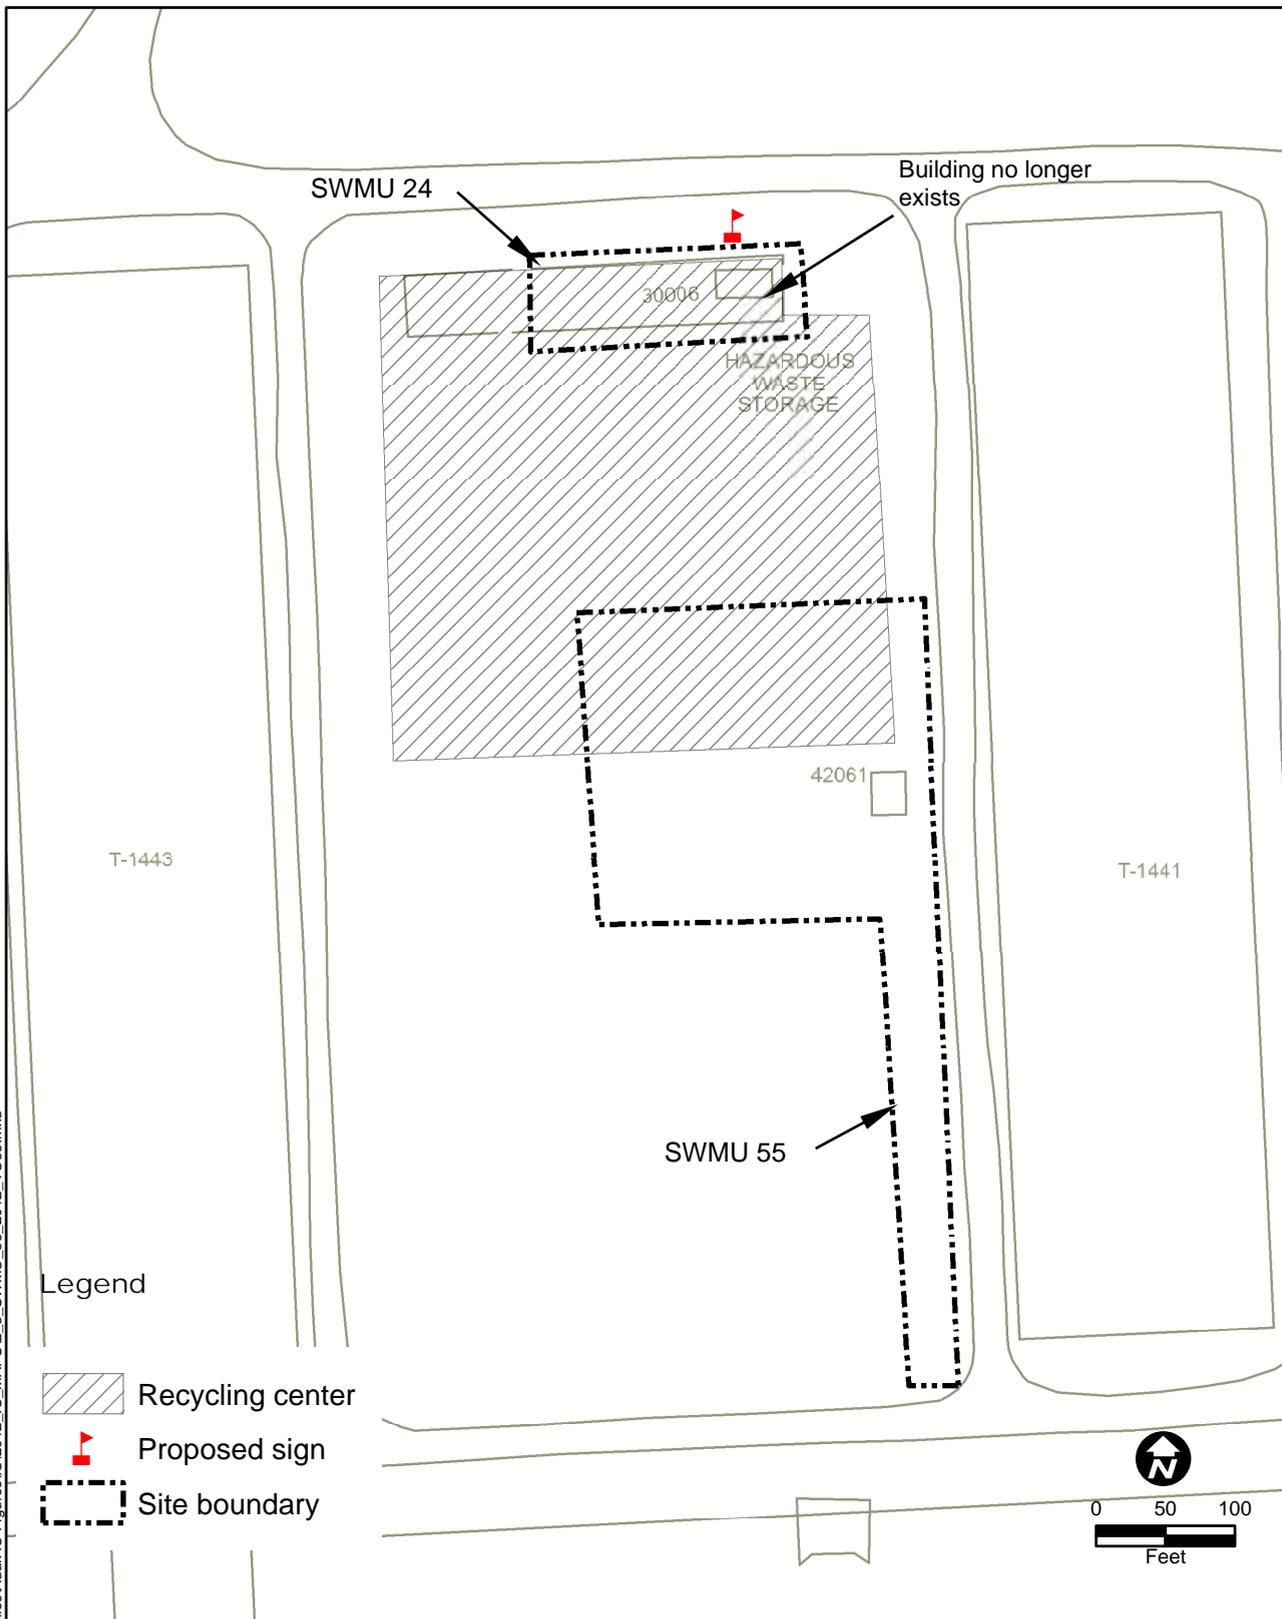
Additional notes: Area is still being used as the island “Recycling Center.” Large amounts of the materials and debris observed in 2011 have since been removed. All but a few of the dilapidated vehicles staged in this area have been removed. However, quantities of materials still remain onsite and include but are not limited to: wood, metal, and building debris; equipment and vehicle parts; various-sized tanks and shipping containers; several crushed and whole 55-gallon drums; containers of various sizes with unknown liquids; and paint wastes. The metal shed located on SWMU 24 and adjacent to SWMU 55 observed in 2011 which contained a large quantity of containers was no longer present during the 2012 inspection. The pink connex box containing 5-gallon containers and underlying stained soil still remains at the site. There is no restricted access or soil barrier at the site.

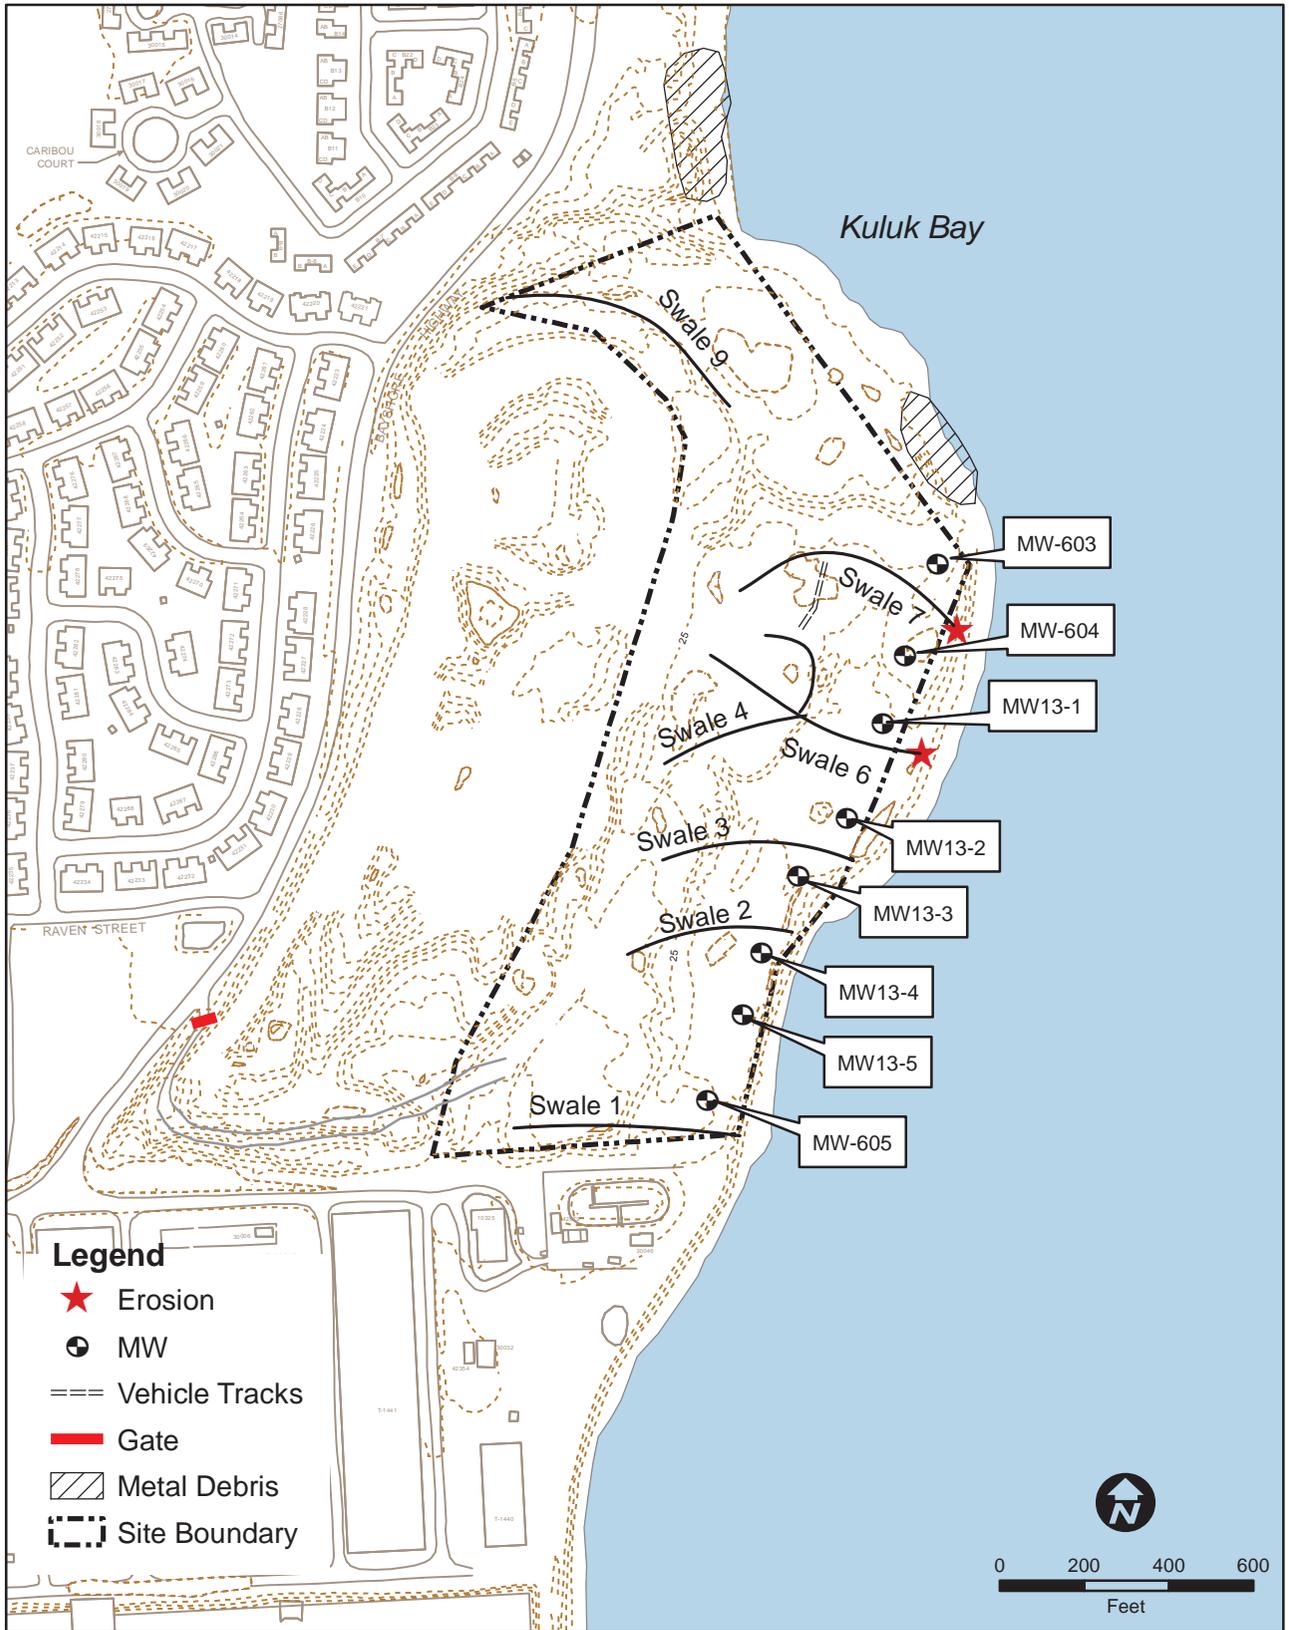
Figure 2-4
SWMU 13, Metals Landfill

Additional notes: Armor wall on shoreline is in good condition. Some minor metal debris was observed in the armor wall along landfill shoreline. ATW tracks observed in 2011 on the center of the landfill approximately 200 ft long are still visible. Vegetation is growing within the tracks and not affecting the integrity of the landfill cap. Scrap metal on cliff north of landfill is still present.

Install sign on north side of site as shown in Figure 2-4.

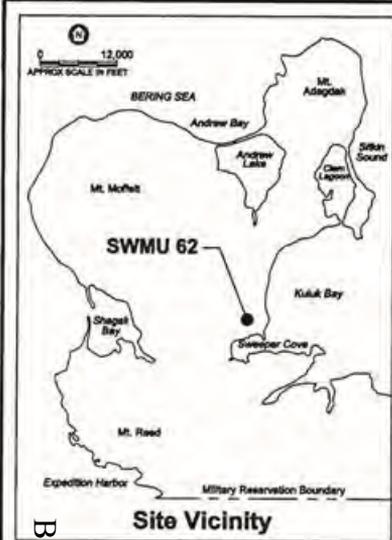
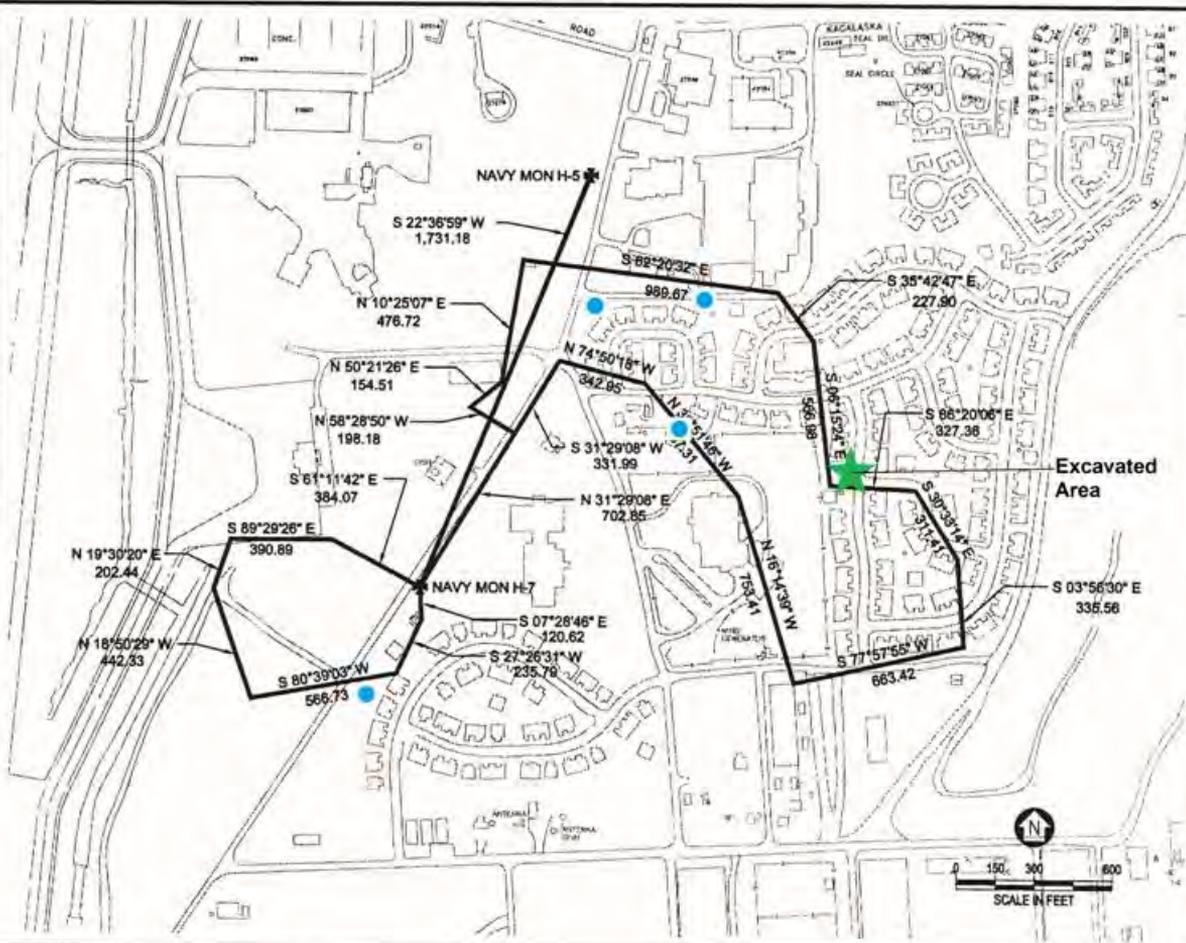
Figure 2-7
SWMU 62, New Housing Fuel Leak

During the September 4, 2012 inspection, one excavated area, approximately 7 feet by 7 feet and less than 2 feet deep, was observed in front of housing unit 140D (Photograph 2-33, Figure 2-7). These excavated areas are located outside the site boundary to the east. An excavation notification was not submitted to the Navy. It is recommended that the City and TAC be contacted in an attempt to determine the cause and purpose of the excavation and then to notify the appropriate party that notifications are required for excavations in the downtown area.

No sites were impacted by the excavation notifications listed in Table 4-1. An excavation approximately 7 feet by 7 feet was observed at housing unit 140D in the downtown housing area in Sandy Cove housing. As shown in Figure 2-7, the excavation is just outside the eastern boundary of SWMU 62. An excavated area approximately 15 feet by 10 feet and 5 feet deep was observed on the east side of SWMU 17 Power Plant 3 on the east side of the access road behind the main building during the 2012 inspections (Figure 2-2). According to a power plant employee, the City conducted the excavation to repair a leak in the City's water main line. Excavation Notifications were not submitted to the Navy for any of these excavations.

Additional notes: Three old fuel recovery systems located in Sandy Cove were identified during the 2011 inspection and are presented on Figure 2-7. These system were scheduled for removal in October 2012.

Five excavation notification requests were filed with the Navy for excavations performed during the reporting period. An area approximately 7 feet by 7 feet was observed in the front yard of housing unit 140D at the Sandy Cove Housing Area site. An excavation notification for this area was not submitted. As shown in Figure 2-10, the excavation is just outside the eastern boundary of SWMU 62. An excavated area approximately 15 feet by 10 feet and 5 feet deep was observed on the east side of SWMU 17 Power Plant 3 on the east side of the access road behind the main building during the 2012 inspections (Figure 2-3). According to a power plant employee, the City conducted the excavation to repair a leak in the City's water main. An Excavation Notification was not submitted to the Navy. No other unauthorized excavations were observed in areas where excavation restrictions have been established as ICs. The Navy will contact the Power Plant Operator to and the City to inquire about the unauthorized excavations and reiterate the need for notifications.

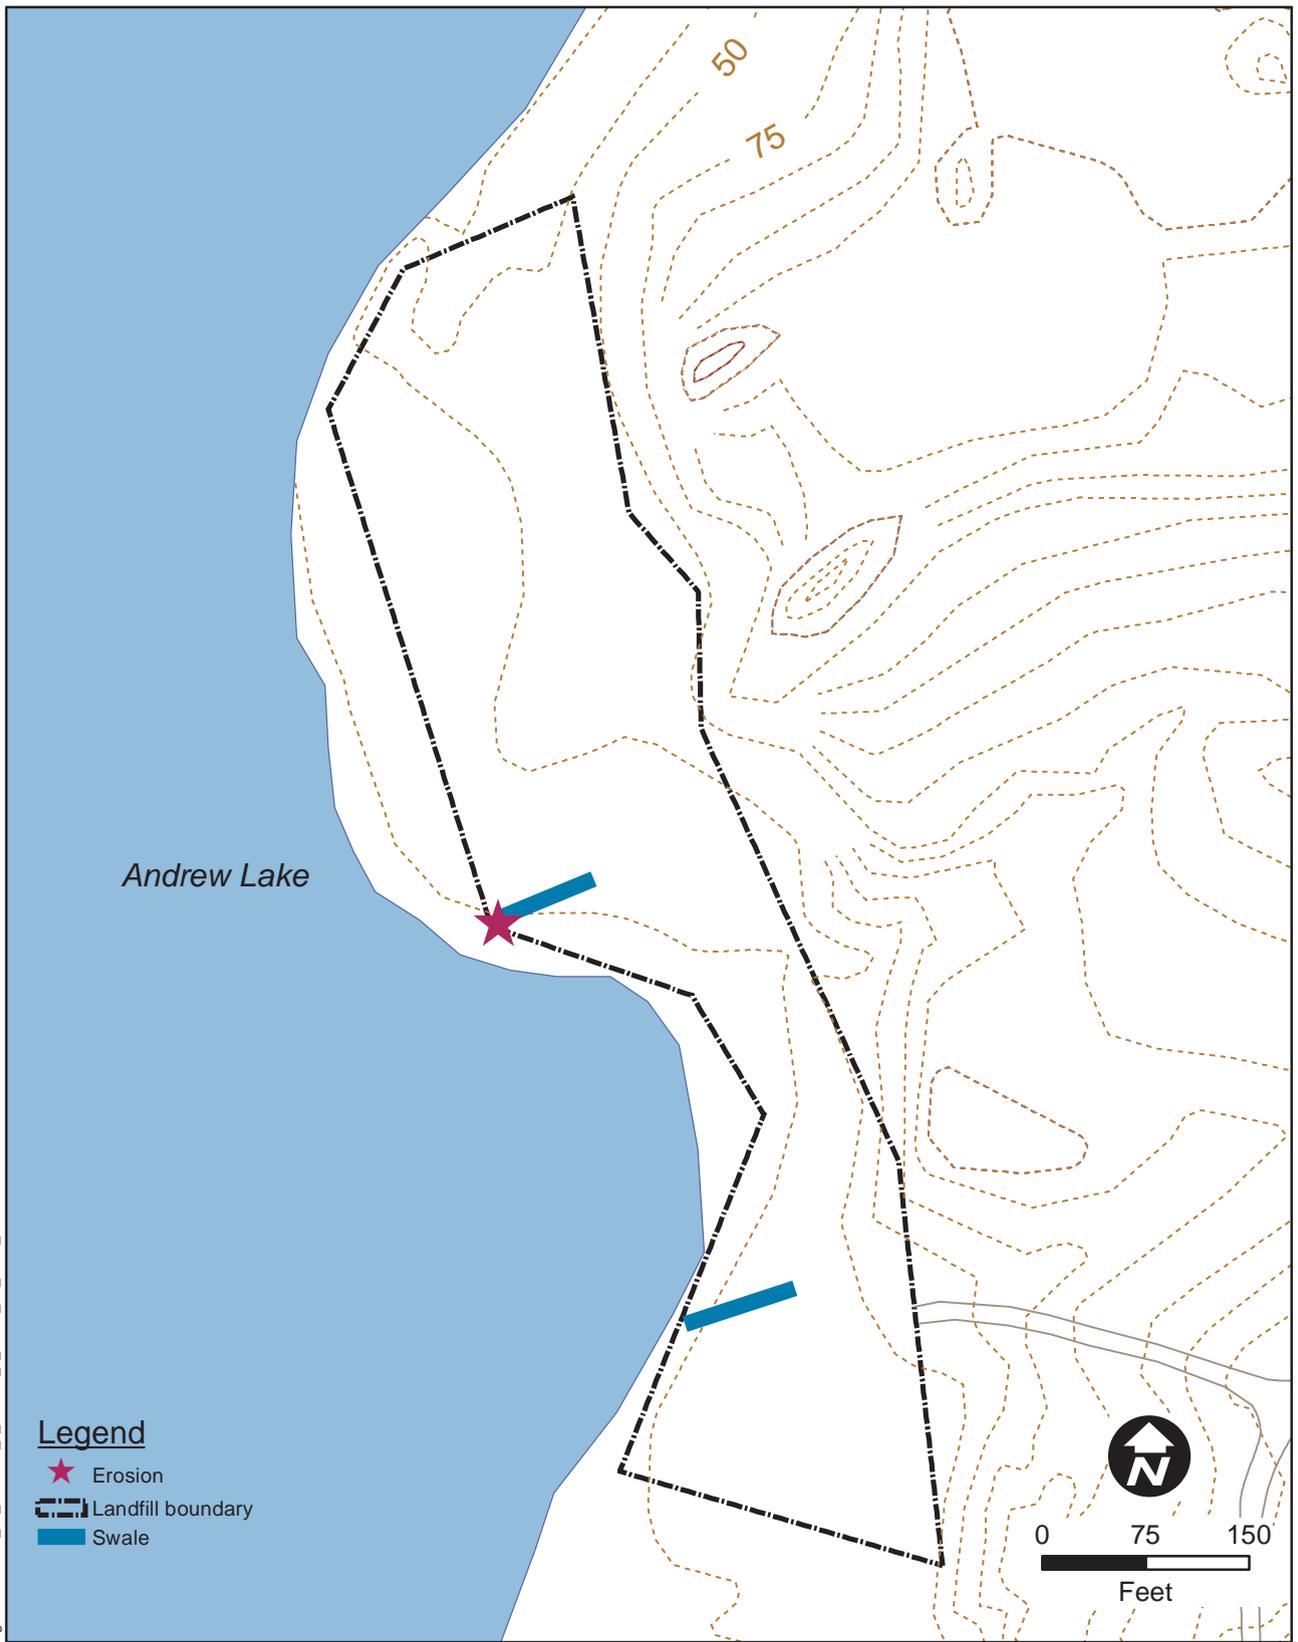
**Figure 3-1
SWMU 4, South Davis Road Landfill**

During the inspection on September 3, 2012, the erosion observed during the 2011 inspection at the west end of the northern swale was still present (Photograph 3-7, Figure 3-1). A silt fence that had been installed here was observed to be torn with rocks and sediment piled on top. It is recommended that the silt fence and eroded area be repaired. No other indications of a change in land use in this area were found and no residential construction had occurred at the site. No indications of excavation activities were found and restriction signs were clearly visible. The landfill cap was well vegetated.
