# **Remedial Action Summary Report Free Product Recovery**

SWMU 62 New Housing Fuel Leak Area,  
Area 303, and Additional Sites

## **Former Naval Complex**

Adak, Alaska

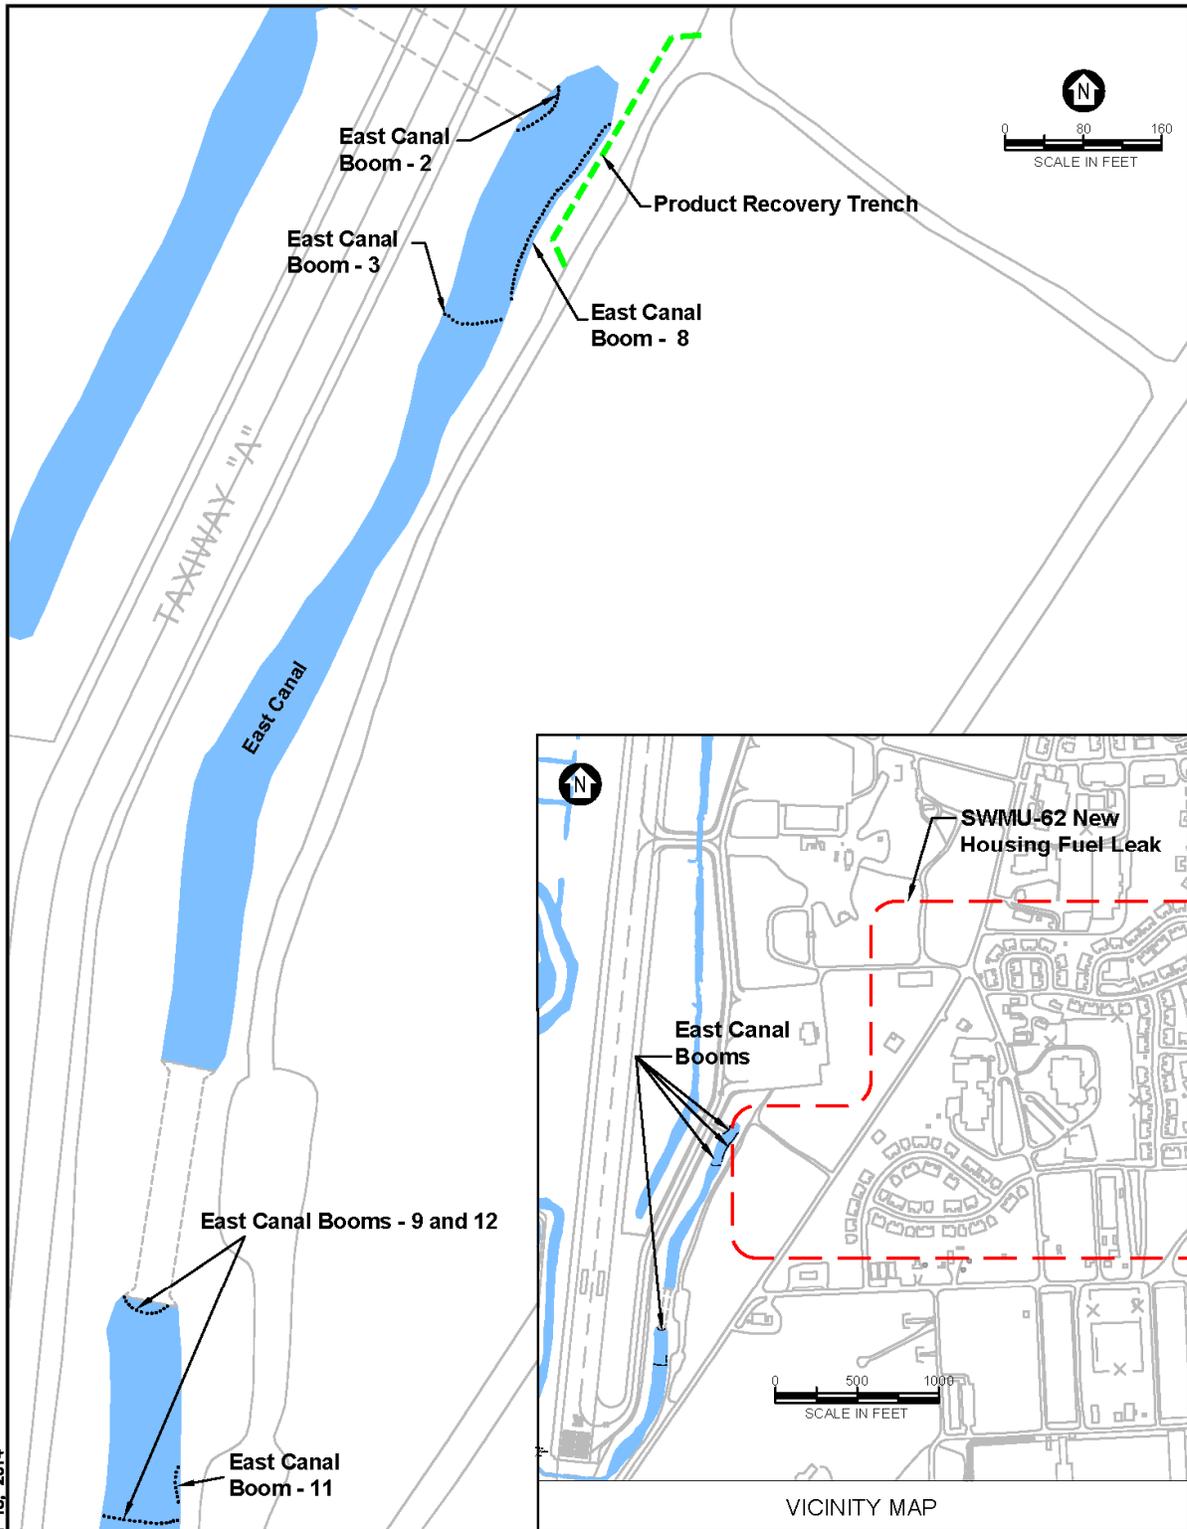
**Figure 5-1  
 East Canal Boom Locations**

Similar to the seep at SWMU 62, the petroleum seep on the shoreline of East Canal downgradient from Former Power Plant, Building T-1451, has previously been characterized by sheen, oil saturated soils, stressed vegetation, and pooled product along the shoreline. To control sheen at this seep, Boom 9/12 was placed across the culvert, along the shoreline, and spanning the East Canal (see Figure 5-1).

A smaller shoreline petroleum seep is located in East Canal just downstream (south) of the Former Power Plant removal action (see Figure 5-1). At this seep, sheen, oily sediments, and stressed vegetation were observed during all 12 monthly inspections of Boom 11, which is placed along the shoreline.

Booms 9/12 were reconfigured in May 2014, with a designated Boom 9 located downstream of the East Canal culvert and Boom 12 located downstream of Boom 11 (Figure 5-1). Both booms cross East Canal to contain seepage from Boom 11. Sheen was observed behind Boom 12 during three monthly maintenance visits following its placement downstream of Boom 11.

A soil removal action was conducted along the East Canal shoreline in 2012 to address the petroleum seep at the Boom 9/12 location. With approval of ADEC, the layout of Boom 9/12 was revised in May 2014. The boom length previously located along the East Canal shoreline south of the adjacent culvert was removed and a new boom length installed at the downstream end of the culvert. No oily sheen or other signs of contamination had been observed along the shoreline since October 2012. The boom section previously located perpendicular to the canal flow just north of Boom 11 was moved to a new position south of Boom 11 to provide additional containment for any oily sheen escaping Boom 11 (Figure 5-1).

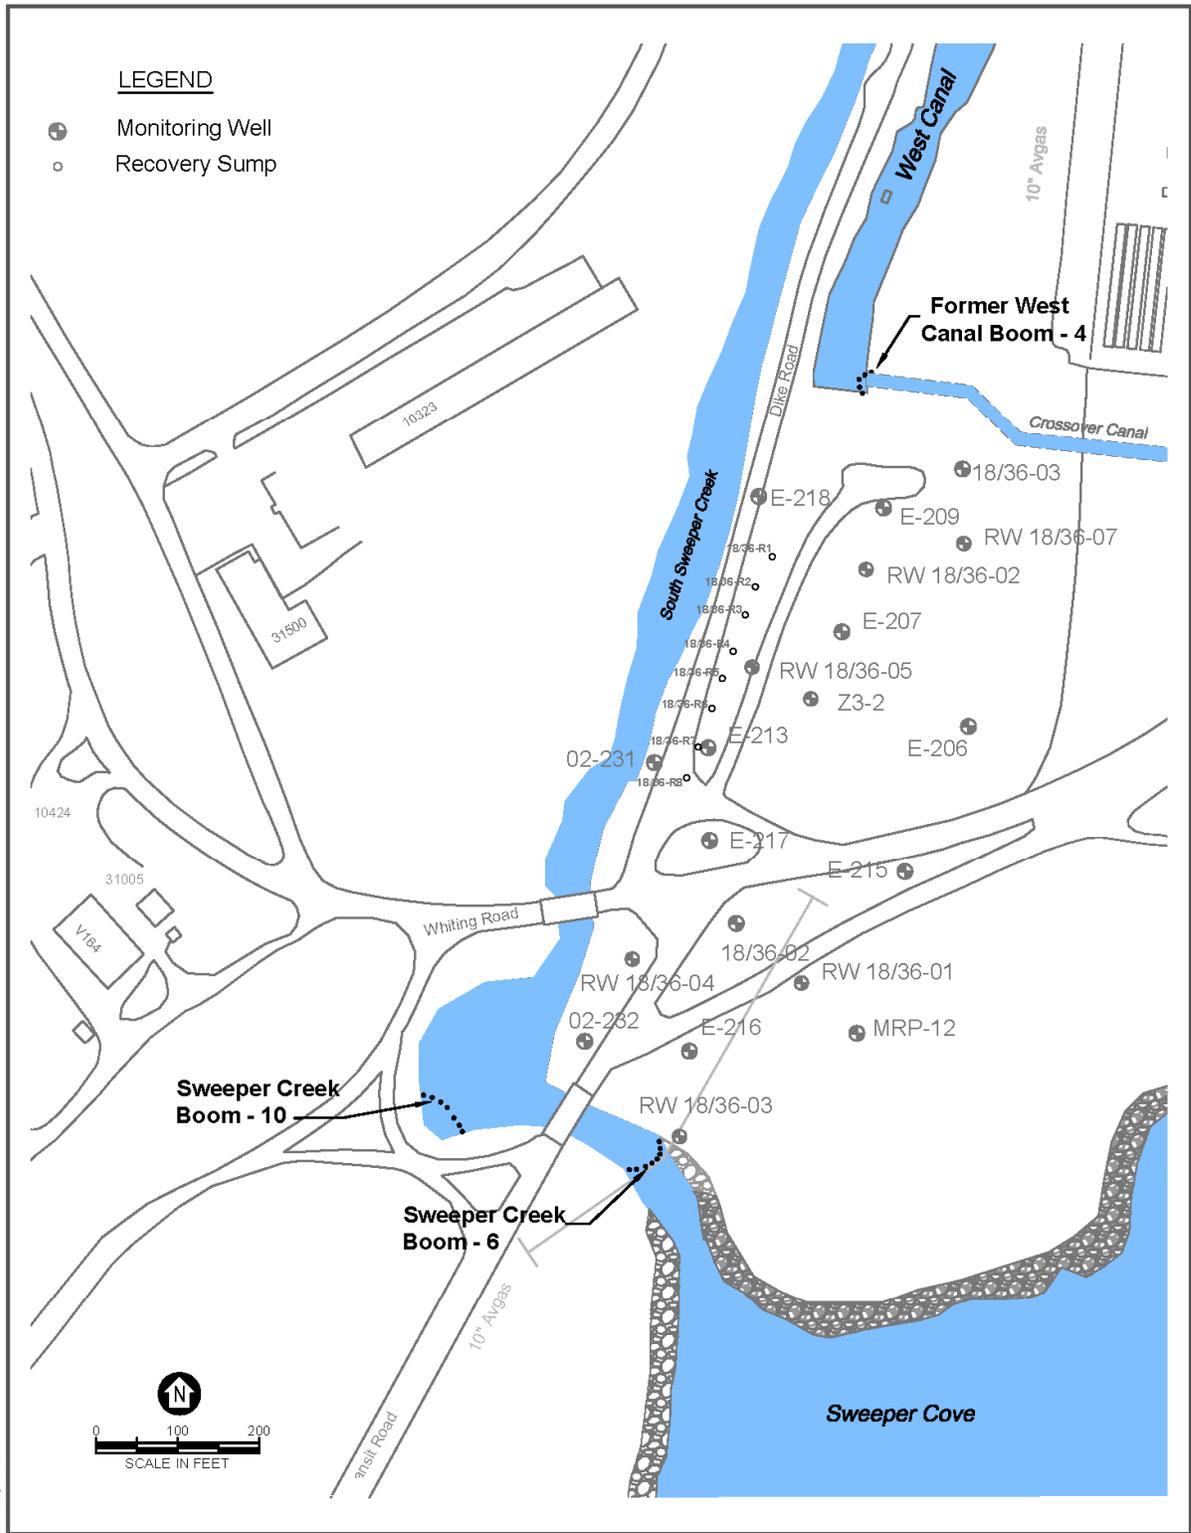
Sheen was not observed at Boom 6 (see Figure 5-2) in South Sweeper Creek during the period of performance. However, sheen, or oil-stained sediment, was observed during all 12 monthly inspections at Boom 10 in South Sweeper Creek lagoon downgradient of SWMU 60, Tank Farm A site.

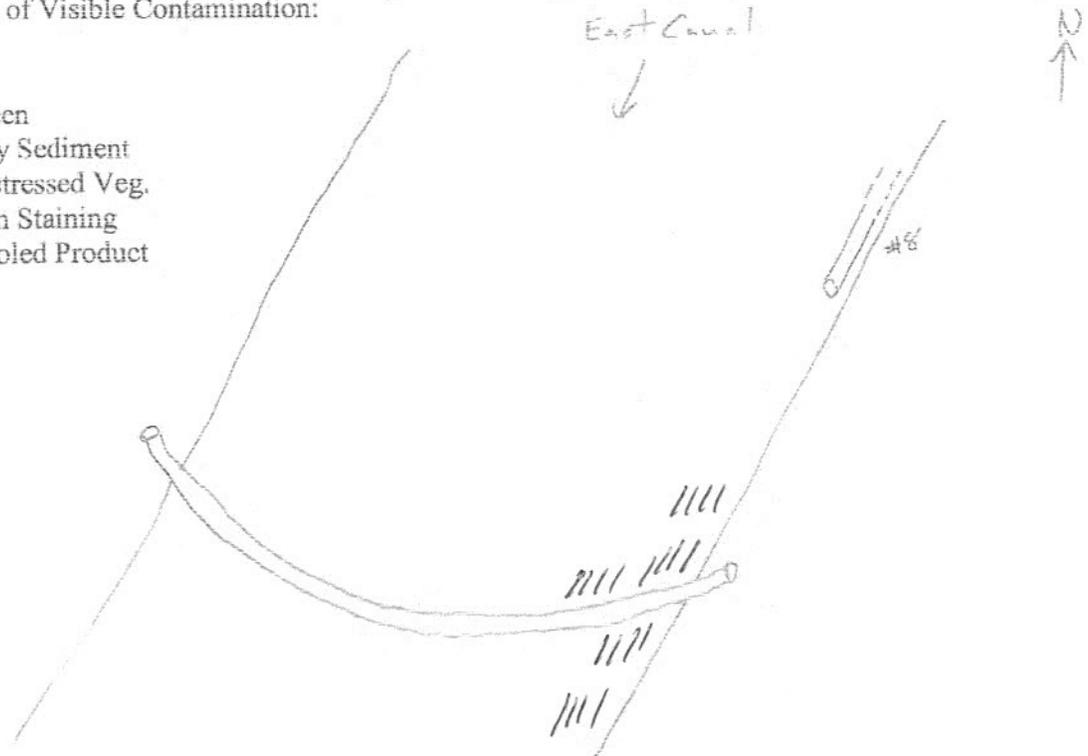
<b>Boom Location:</b> 3	<b>Time/Date:</b> 1338 / 2-7-14
<b>Description of Boom Before Maintenance:</b> <div style="font-size: 1.5em; font-weight: bold; text-align: center;">SATISFACTORY</div>	<b>Photograph (s) Time/Date Stamp:</b> <div style="font-size: 1.5em; text-align: center;">1338 / 2-7-14</div>
<b>Boom Repaired (Y/N)</b> (Y) (N) <b>Description:</b>	<b>Boom Replaced (Y/N) / Number of Sections:</b> (Y) (N) <b>Description:</b>
<b>Visual Observations</b>	
<b>Visible Contamination (Y/N):</b> (Y) (N): <b>Iron Staining (Y/N):</b> (Y) (N) <b>Oily Sediment/Soil (Y/N):</b> (Y) (N) <b>Distressed Vegetation (Y/N):</b> (Y) (N)	<b>Sheen Present on Water (Y/N):</b> (Y) (N): <b>Is the Boom Containing the Sheen? (Y/N):</b> (Y) (N) <b>Pooled Product (Y/N):</b> (Y) (N) <b>If yes, was product removed with sorbent pads?</b>
<b>Location of Visible Contamination:</b>	
<b>Legend</b> /// Sheen \\\ Oily Sediment xxx Distressed Veg. RRR Iron Staining ● Pooled Product	<div style="text-align: center;">East Canal</div>

\* SOME SHEEN ESCAPING PAST BOOM DUE TO WINDS AND HIGH WATER LEVELS.

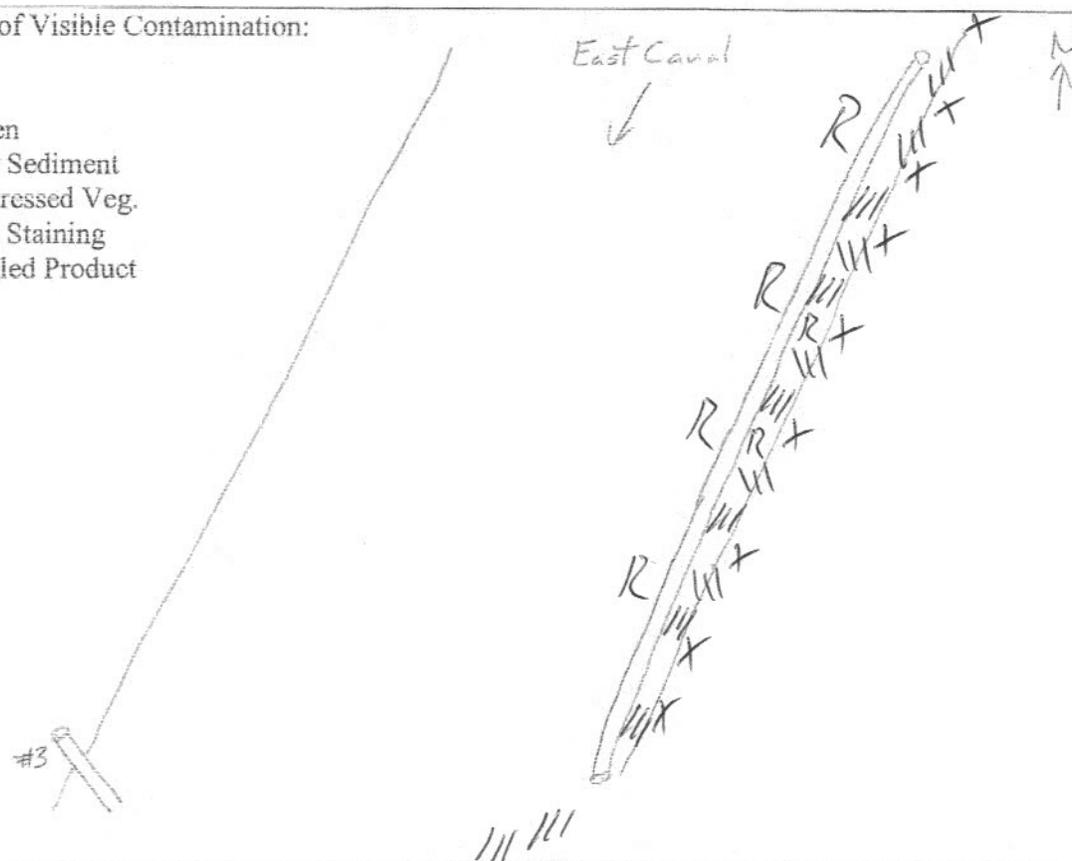
<b>Boom Location: 8</b>	<b>Time/Date:</b> 1339/2-7-14
<b>Description of Boom Before Maintenance:</b> SATISFACTORY	<b>Photograph (s) Time/Date Stamp:</b> 1339/2-7-14
<b>Boom Repaired (Y/N):</b> Description:	<b>Boom Replaced (Y/N):</b> (N) Number of Sections: Description:
<b>Visual Observations</b> Visible Contamination (Y/N): Iron Staining (Y/N): Oily Sediment/Soil (Y/N): Distressed Vegetation (Y/N):	
Sheen Present on Water (Y/N): Is the Boom Containing the Sheen? (Y/N) Pooled Product (Y/N): If yes, was product removed with sorbent pads?	
<b>Location of Visible Contamination:</b>  <div style="display: flex; justify-content: space-between;"> <div style="width: 30%;"> <p><u>Legend</u></p> <p>//// Sheen</p> <p>\\ \\ Oily Sediment</p> <p>xxx Distressed Veg.</p> <p>RRR Iron Staining</p> <p>● Pooled Product</p> </div> <div style="width: 65%;">

\* SHEEN ESCAPING BOOM DUE TO HIGH WATER LEVELS.

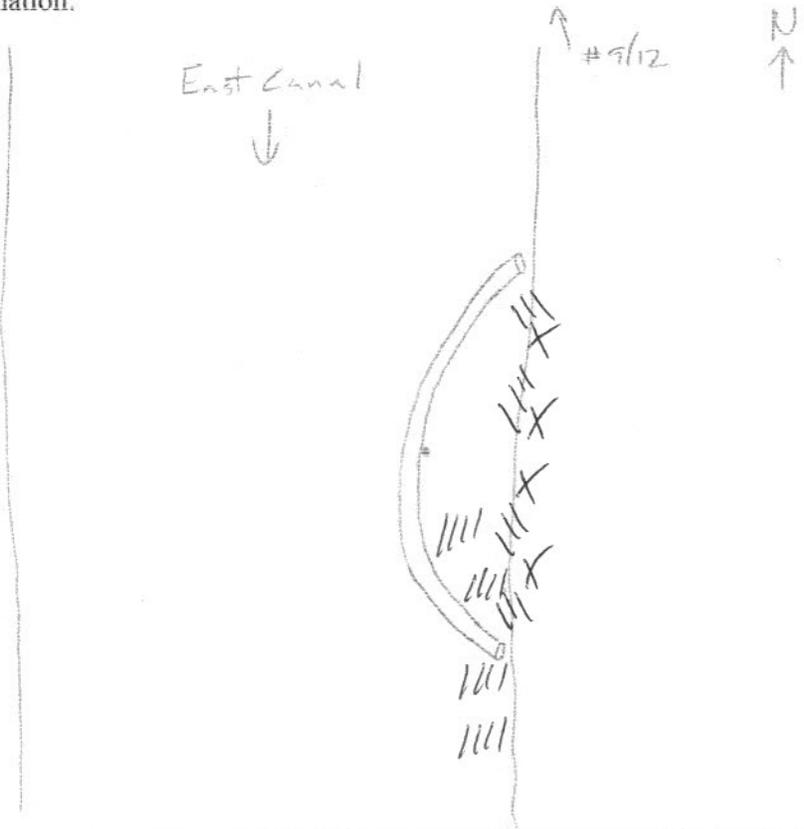
\* SHEEN ESCAPING BOOM DUE TO WIND AND HIGH WATER LEVELS

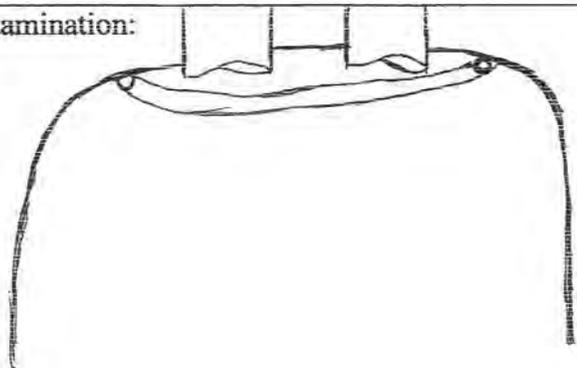
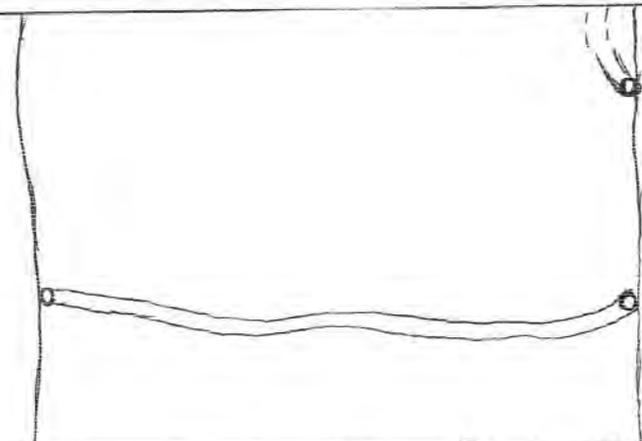
<b>Boom Location:</b> 912	<b>Time/Date:</b> 1438-1441 / 5-7-2014
<b>Description of Boom Before Maintenance:</b>  SATISFACTORY	<b>Photograph (s) Time/Date Stamp:</b>  1438-1441 / 5-7-2014
<b>Boom Repaired (Y/N):</b> (N) <b>Description:</b>	<b>Boom Replaced (Y/N) / Number of Sections:</b> (N) <b>Description:</b>
<b>Visual Observations</b> Visible Contamination (Y/N): Iron Staining (Y/N): Oily Sediment/Soil (Y/N): Distressed Vegetation (Y/N):	
Sheen Present on Water (Y/N): Is the Boom Containing the Sheen? (Y/N) Pooled Product (Y/N): If yes, was product removed with sorbent pads?	
<b>Location of Visible Contamination:</b>	
<b>Legend</b> /// Sheen \\\ Oily Sediment xxx Distressed Veg. RRR Iron Staining ● Pooled Product

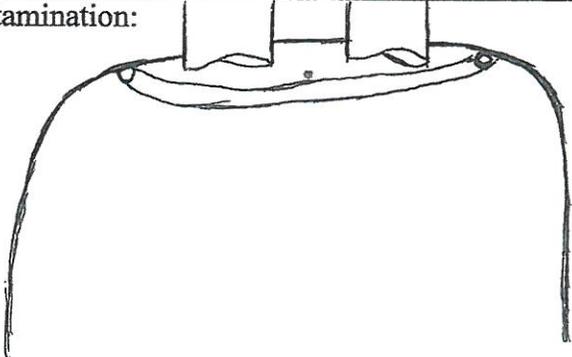
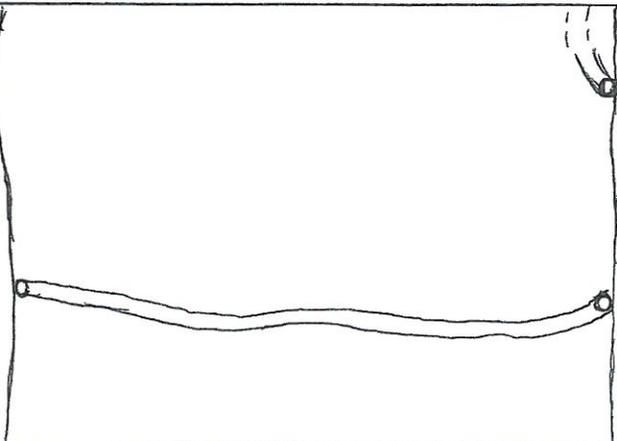
<b>Boom Location:</b> 912	<b>Time/Date:</b> 1113/1124 / 6-4-14
<b>Description of Boom Before Maintenance:</b>  SATISFACTORY	<b>Photograph (s) Time/Date Stamp:</b>  1113/1124 / 6-4-14
<b>Boom Repaired (Y/N):</b> Description: INSTALL STAKE AT NORTH SECTION TO PREVENT CHAFFING ON CULVERTS	<b>Boom Replaced (Y/N)/ Number of Sections:</b> Description:
<b>Visual Observations</b> Visible Contamination (Y/N): Iron Staining (Y/N): Oily Sediment/Soil (Y/N): Distressed Vegetation (Y/N):	
Sheen Present on Water (Y/N): Is the Boom Containing the Sheen? (Y/N) Pooled Product (Y/N): If yes, was product removed with sorbent pads?	
<b>Location of Visible Contamination:</b>	
<b>Legend</b> /// Sheen \\\ Oily Sediment xxx Distressed Veg. RRR Iron Staining ● Pooled Product

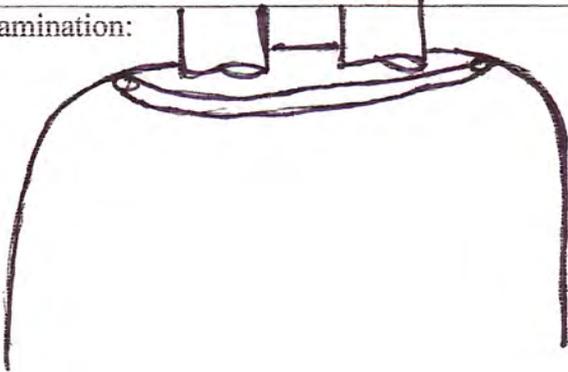
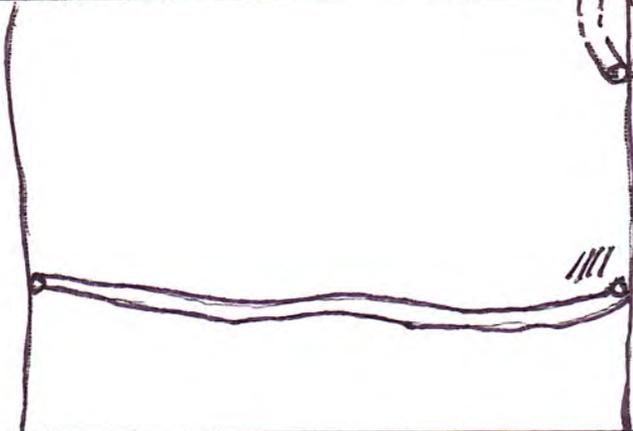
<b>Boom Location:</b> 912	<b>Time/Date:</b> 0923-0926 / 7-9-14
<b>Description of Boom Before Maintenance:</b>  SATISFACTORY	<b>Photograph (s) Time/Date Stamp:</b>  0923-0926 / 7-9-14
<b>Boom Repaired (Y/N):</b> (N) <b>Description:</b>	<b>Boom Replaced (Y/N) / Number of Sections:</b> (N) <b>Description:</b>
<b>Visual Observations</b> Visible Contamination (Y/N): (Y) N): Iron Staining (Y/N): (N) Oily Sediment/Soil (Y/N): (N) Distressed Vegetation (Y/N): (N)	
Sheen Present on Water (Y/N): (Y) N): Is the Boom Containing the Sheen? (Y/N): (Y) N) Pooled Product (Y/N): (N) If yes, was product removed with sorbent pads?	
<b>Location of Visible Contamination:</b>	
<b>Legend</b> /// Sheen \\\ Oily Sediment xxx Distressed Veg. RRR Iron Staining ● Pooled Product	N ↑

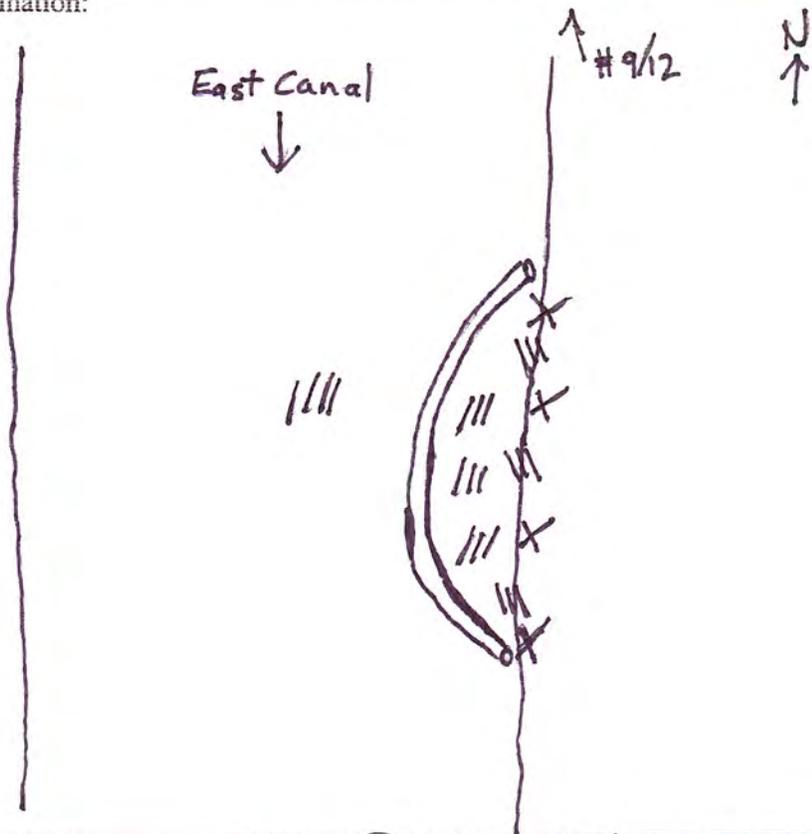
Boom Location: 11	Time/Date: 0923 / 7-9-14
Description of Boom Before Maintenance: SATISFACTORY	Photograph (s) Time/Date Stamp: 0923 / 7-9-14
Boom Repaired (Y/N): Description:	Boom Replaced (Y/N) / Number of Sections: Description:

Visible Contamination (Y/N):  
 Iron Staining (Y/N):  
 Oily Sediment/Soil (Y/N):  
 Distressed Vegetation (Y/N):

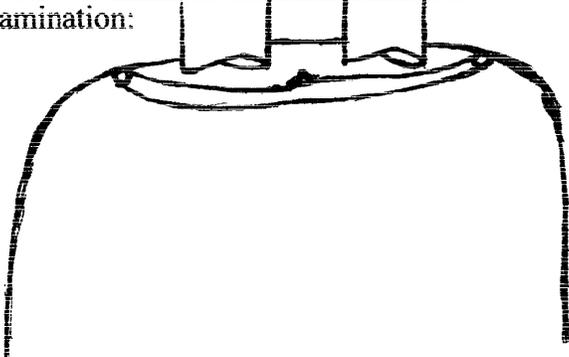
<b>Boom Location:</b> 912	<b>Time/Date:</b> 1235-1239 / 8-4-14
<b>Description of Boom Before Maintenance:</b>  Satisfactory	<b>Photograph (s) Time/Date Stamp:</b>  1235-1239 / 8-4-14
<b>Boom Repaired (Y/N):</b> <input checked="" type="radio"/> N <b>Description:</b>	<b>Boom Replaced (Y/N):</b> <input checked="" type="radio"/> N / <b>Number of Sections:</b> <b>Description:</b>
<b>Visual Observations</b>	
<b>Visible Contamination (Y/N):</b> <input checked="" type="radio"/> N <b>Iron Staining (Y/N):</b> <input checked="" type="radio"/> N <b>Oily Sediment/Soil (Y/N):</b> <input checked="" type="radio"/> N <b>Distressed Vegetation (Y/N):</b> <input checked="" type="radio"/> N	<b>Sheen Present on Water (Y/N):</b> <input checked="" type="radio"/> N <b>Is the Boom Containing the Sheen? (Y/N):</b> <input checked="" type="radio"/> N <b>Pooled Product (Y/N):</b> <input checked="" type="radio"/> N If yes, was product removed with sorbent pads?

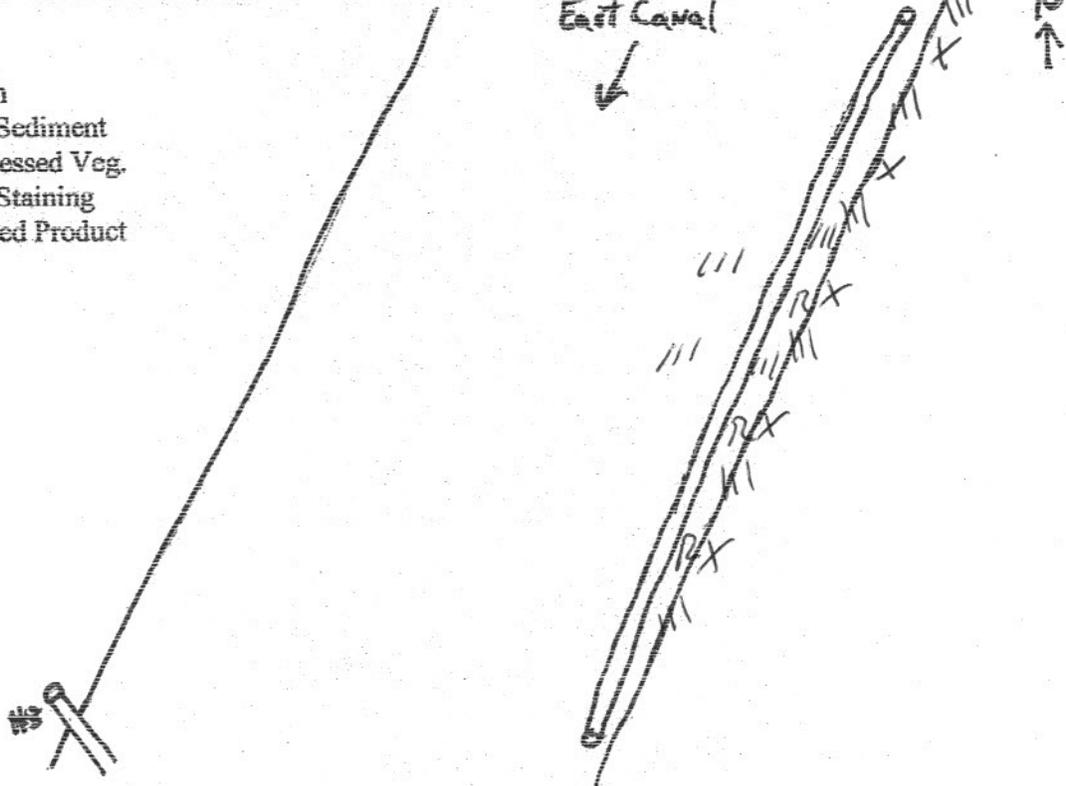
Boom Location: 8	Time/Date: 1107 / 9-6-14
Description of Boom Before Maintenance: SATISFACTORY	Photograph (s) Time/Date Stamp: 1107 / 9-6-14
Boom Repaired (Y (N): Description:	Boom Replaced (Y (N) / Number of Sections: Description:

Visible Contamination (Y) (N):  
 Iron Staining (Y) (N):  
 Oily Sediment/Soil (Y) (N):  
 Distressed Vegetation (Y) (N):

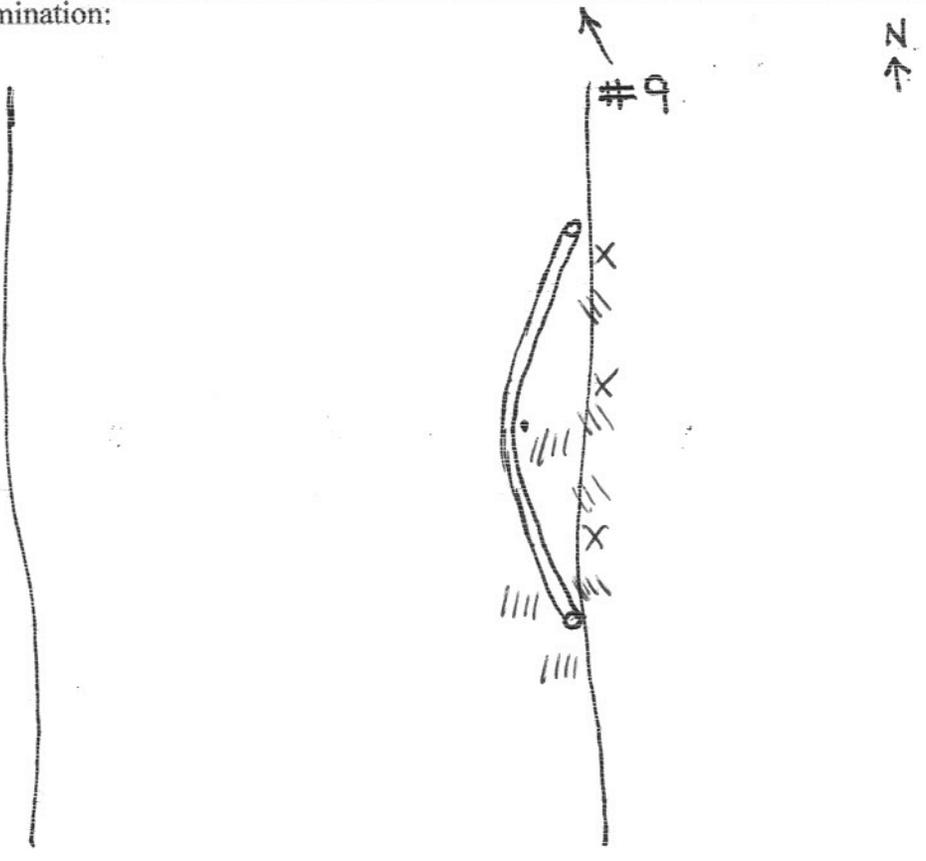
<b>Boom Location:</b> <u>11</u>	<b>Time/Date:</b> <u>1042 / 9-6-14</u>
<b>Description of Boom Before Maintenance:</b>  <u>SATISFACTORY</u>	<b>Photograph (s) Time/Date Stamp:</b>  <u>1042 / 9-6-14</u>
<b>Boom Repaired (Y/N):</b> Description:	<b>Boom Replaced (Y/N) / Number of Sections:</b> Description:
<b>Visual Observations</b> Visible Contamination (Y/N): Iron Staining (Y/N): Oily Sediment/Soil (Y/N): Distressed Vegetation (Y/N):	
Sheen Present on Water (Y/N): Is the Boom Containing the Sheen? (Y/N) Pooled Product (Y/N): If yes, was product removed with sorbent pads?	
<b>Location of Visible Contamination:</b>  <div style="display: flex; justify-content: space-between;"> <div style="width: 30%;"> <p><u>Legend</u></p> <p>//// Sheen</p> <p>\\ \\ Oily Sediment</p> <p>xxx Distressed Veg.</p> <p>RRR Iron Staining</p> <p>● Pooled Product</p> </div> <div style="width: 60%; text-align: center;">

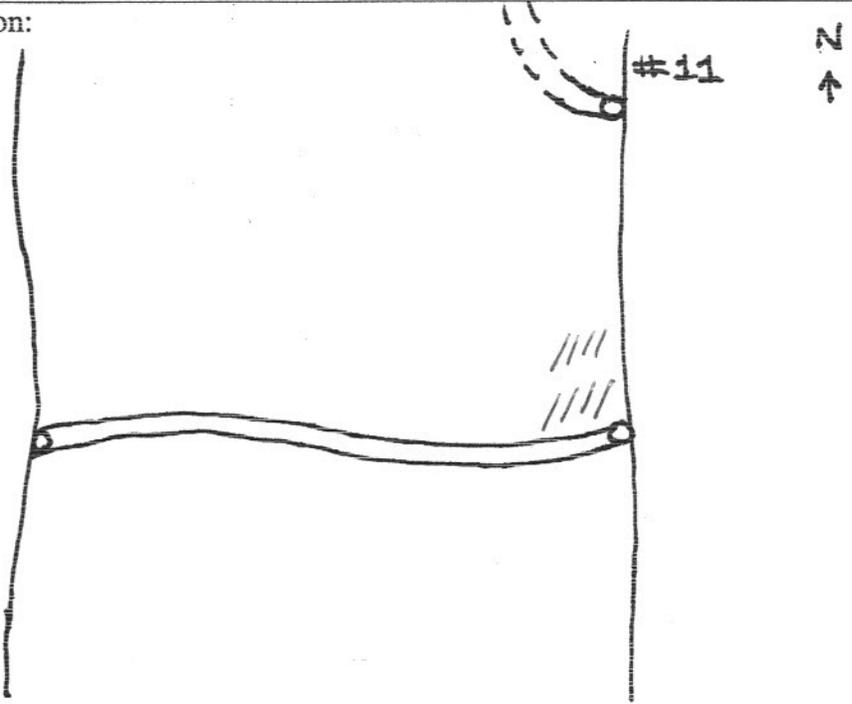
<b>Boom Location:</b> 12	<b>Time/Date:</b> 1043 / 9-6-14
<b>Description of Boom Before Maintenance:</b>  SATISFACTORY	<b>Photograph (s) Time/Date Stamp:</b>  1043 / 9-6-14
<b>Boom Repaired (Y/N):</b> (N) <b>Description:</b>	<b>Boom Replaced (Y/N) / Number of Sections:</b> (N) <b>Description:</b>
<b>Visual Observations</b> Visible Contamination (Y/N): (Y) (N) Iron Staining (Y/N): (N) Oily Sediment/Soil (Y/N): (N) Distressed Vegetation (Y/N): (N)	
Sheen Present on Water (Y/N): (Y) (N) Is the Boom Containing the Sheen? (Y/N): (Y) (N) Pooled Product (Y/N): (N) If yes, was product removed with sorbent pads?	
<b>Location of Visible Contamination:</b>	
<u>Legend</u> /// Sheen \\\ Oily Sediment xxx Distressed Veg. RRR Iron Staining ● Pooled Product

SHEEN COMING FROM BOOM # 11. HIGH WATERS DUE TO EXCESSIVE RAINS.

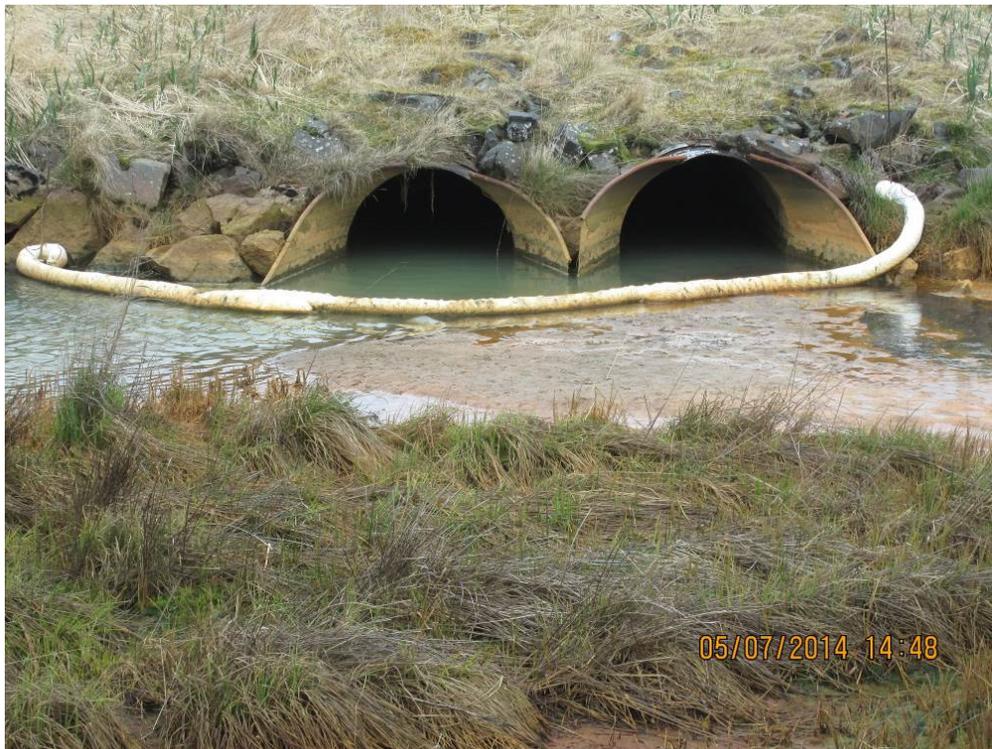
Photo 1. – East Canal Boom 2, May 2014, view west.

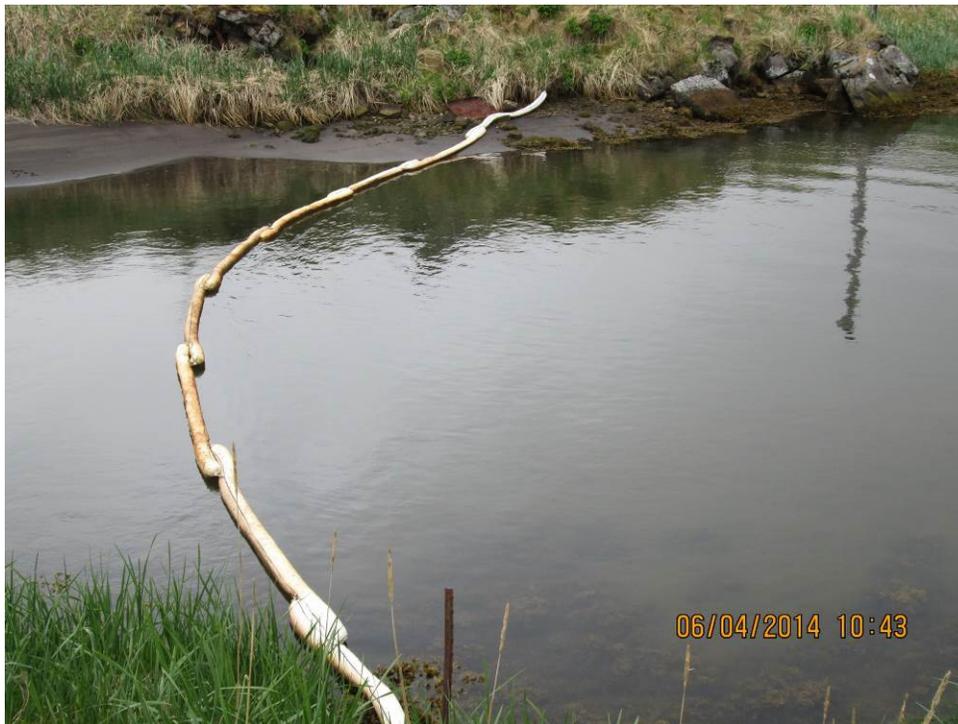
Photo 5. – Sweeper Creek Boom 6, June 2014, view south.

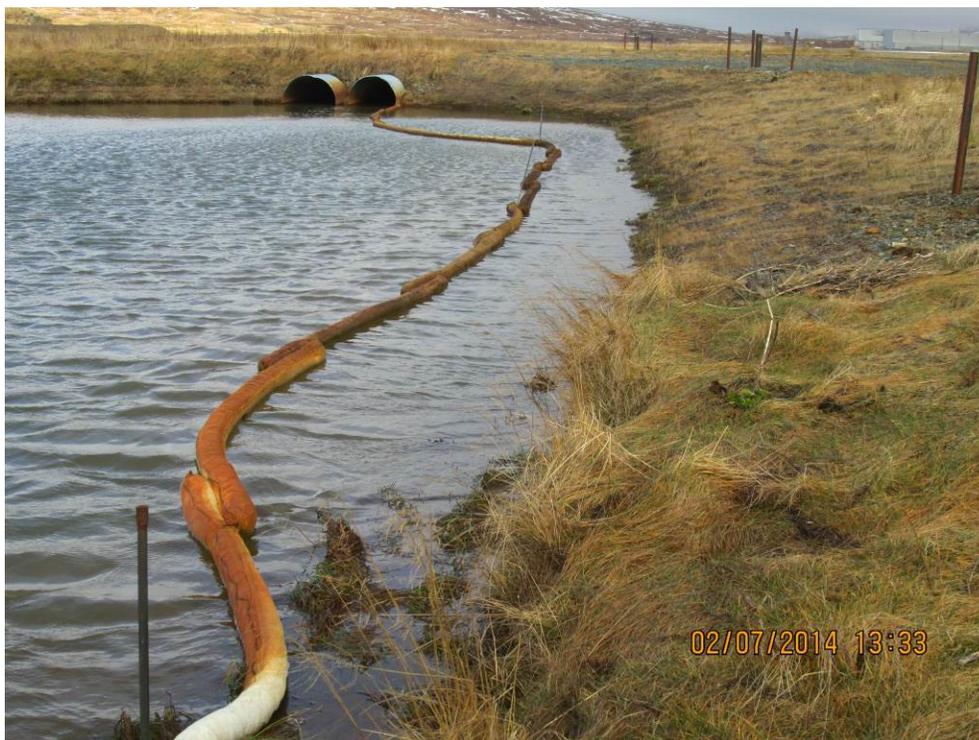
Photo 8. – East Canal Boom 9/12, February 2014, view north; upper segment location prior to April.

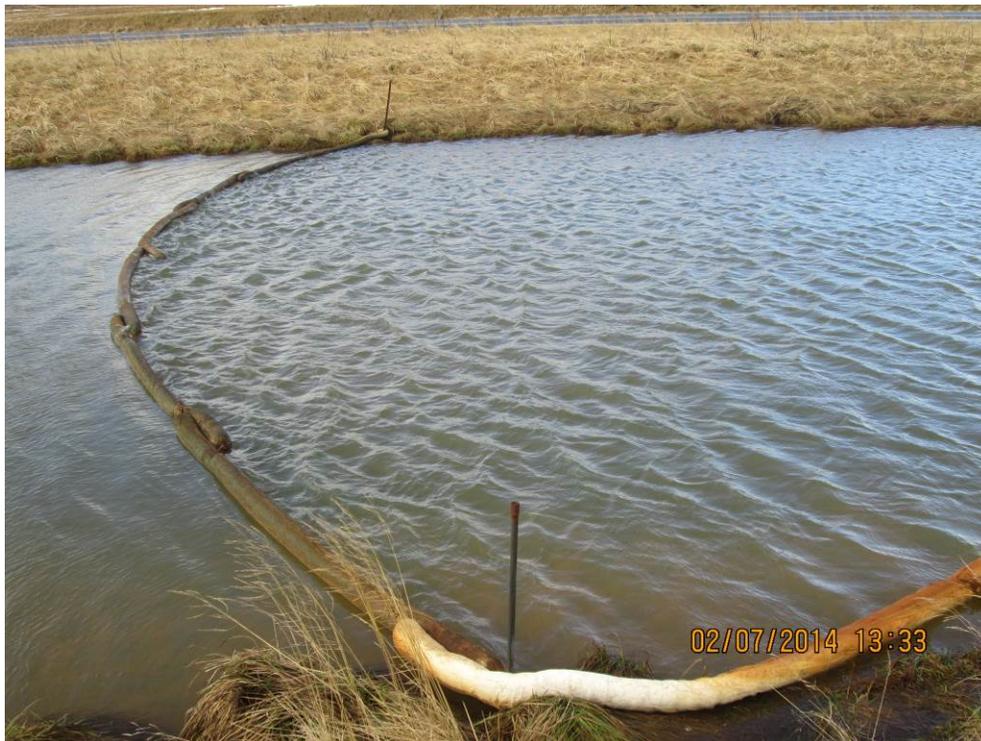
Photo 9. – East Canal Boom 9/12, February 2014, view west; lower segment upstream of Boom 11 prior to April.

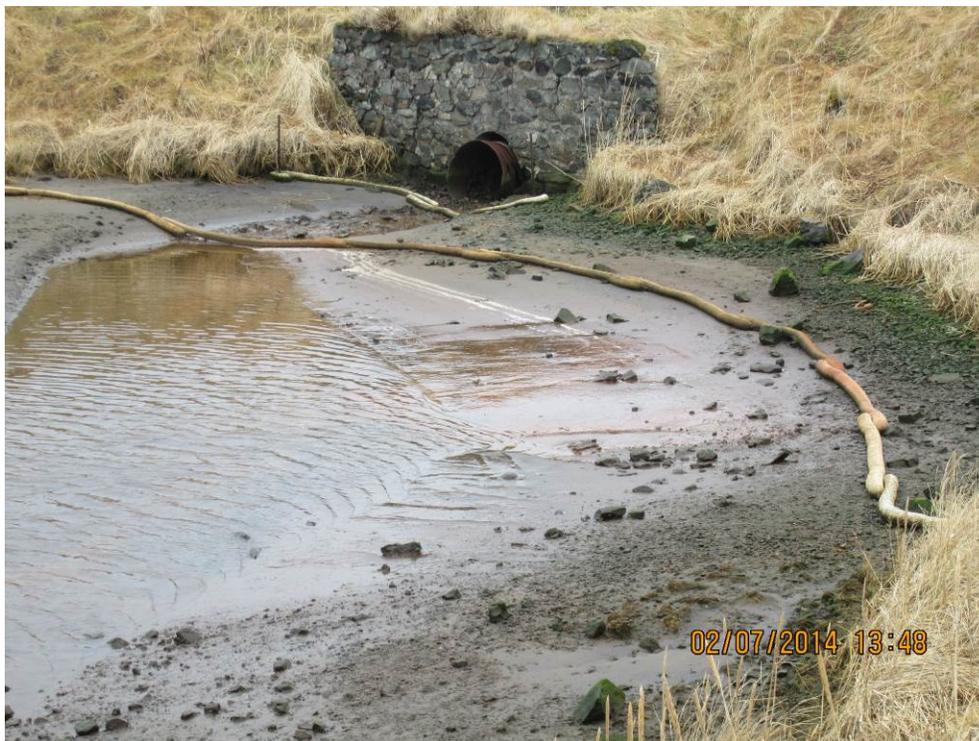
Photo 12. – Sweeper Creek Boom 10, February 2014, view southeast; low tide.

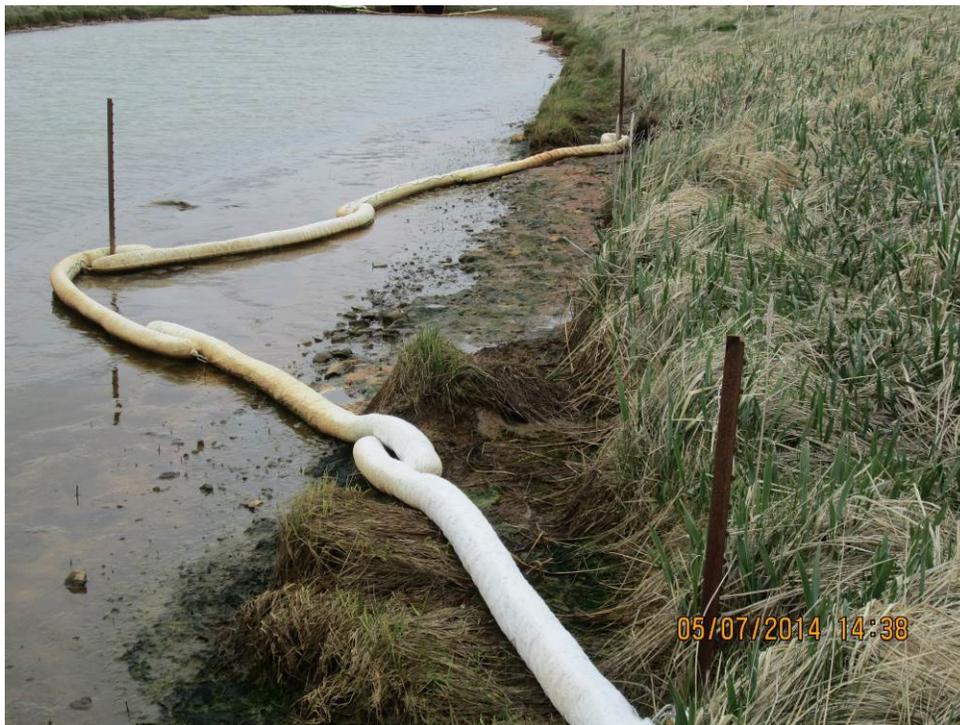
Photo 14. – East Canal Boom 11, May 2014, view north.
