**FINAL  
PHASE I SUPPLEMENTAL ENVIRONMENTAL BASELINE SURVEY  
DEPARTMENT OF DEFENSE HOUSING FACILITY  
NOVATO, CALIFORNIA**

April 21, 1997

**Department of the Navy  
Engineering Field Activity West  
San Bruno, California 94066-2402**

**PRC Environmental Management, Inc.**

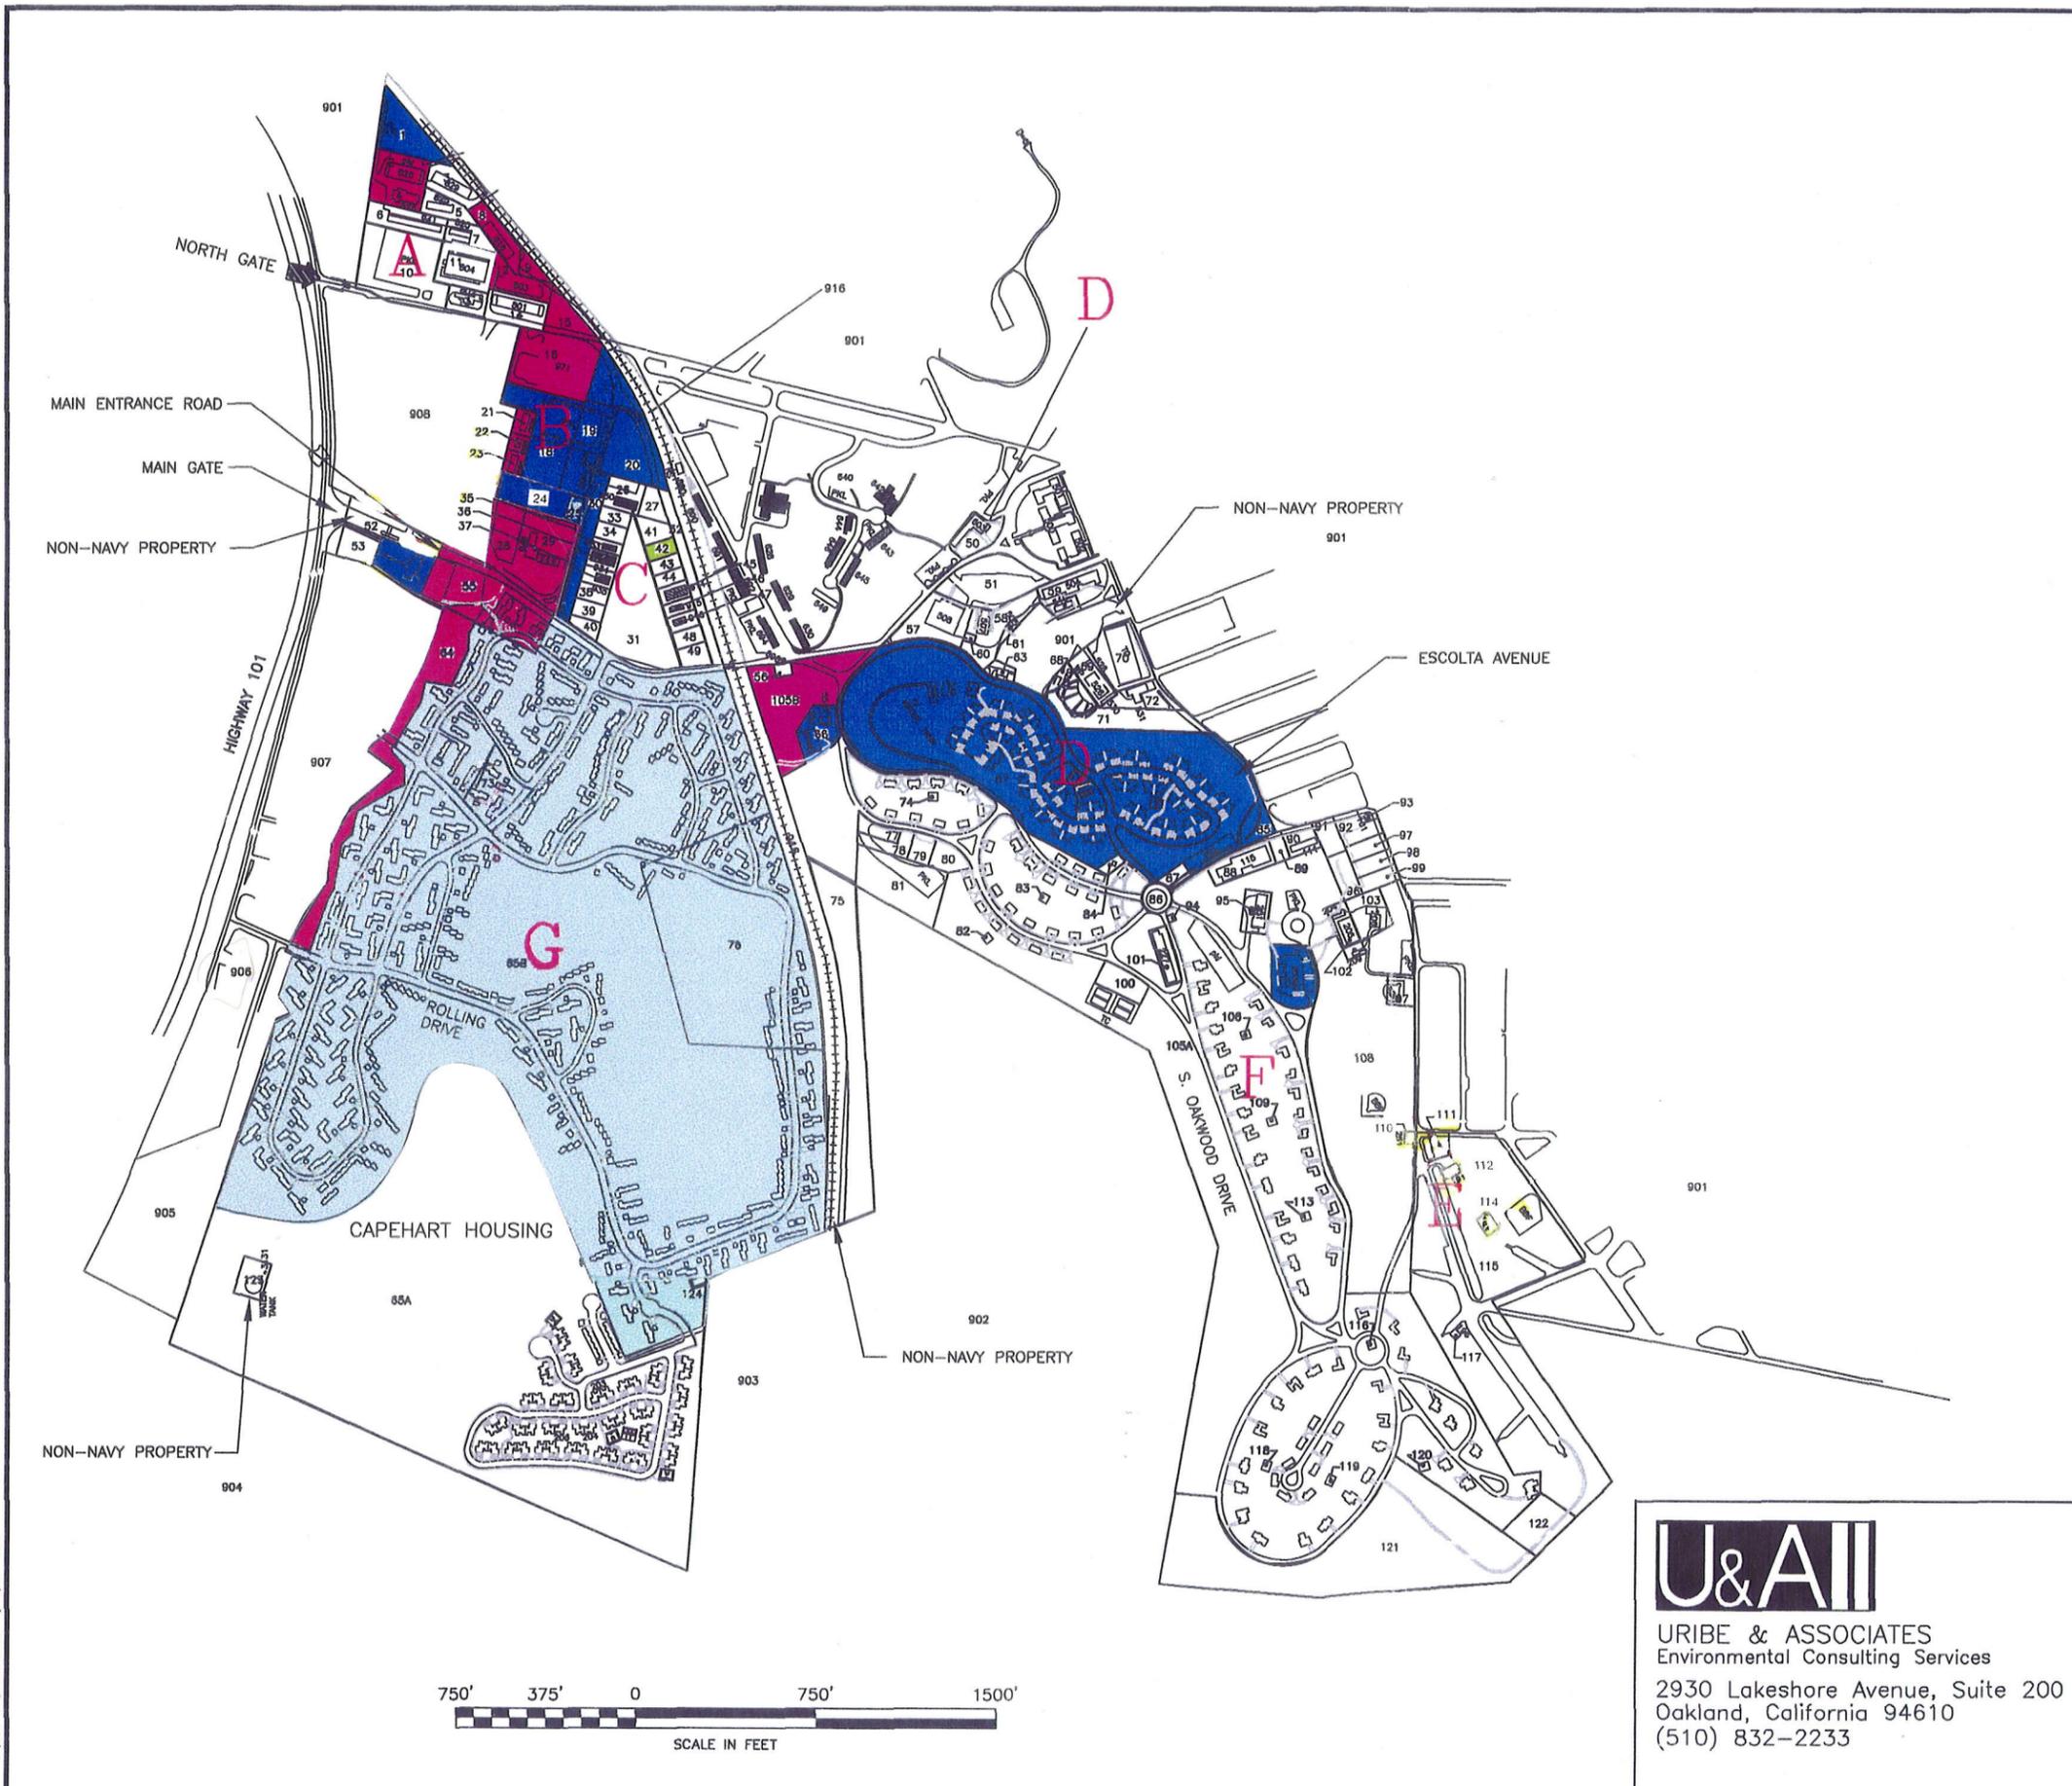
- ECP AREA TYPE 1
- ECP AREA TYPE 2
- ECP AREA TYPE 3
- ECP AREA TYPE 6
- ECP AREA TYPE 7
- 124 = PARCEL NUMBERS
- PARCEL BOUNDARY

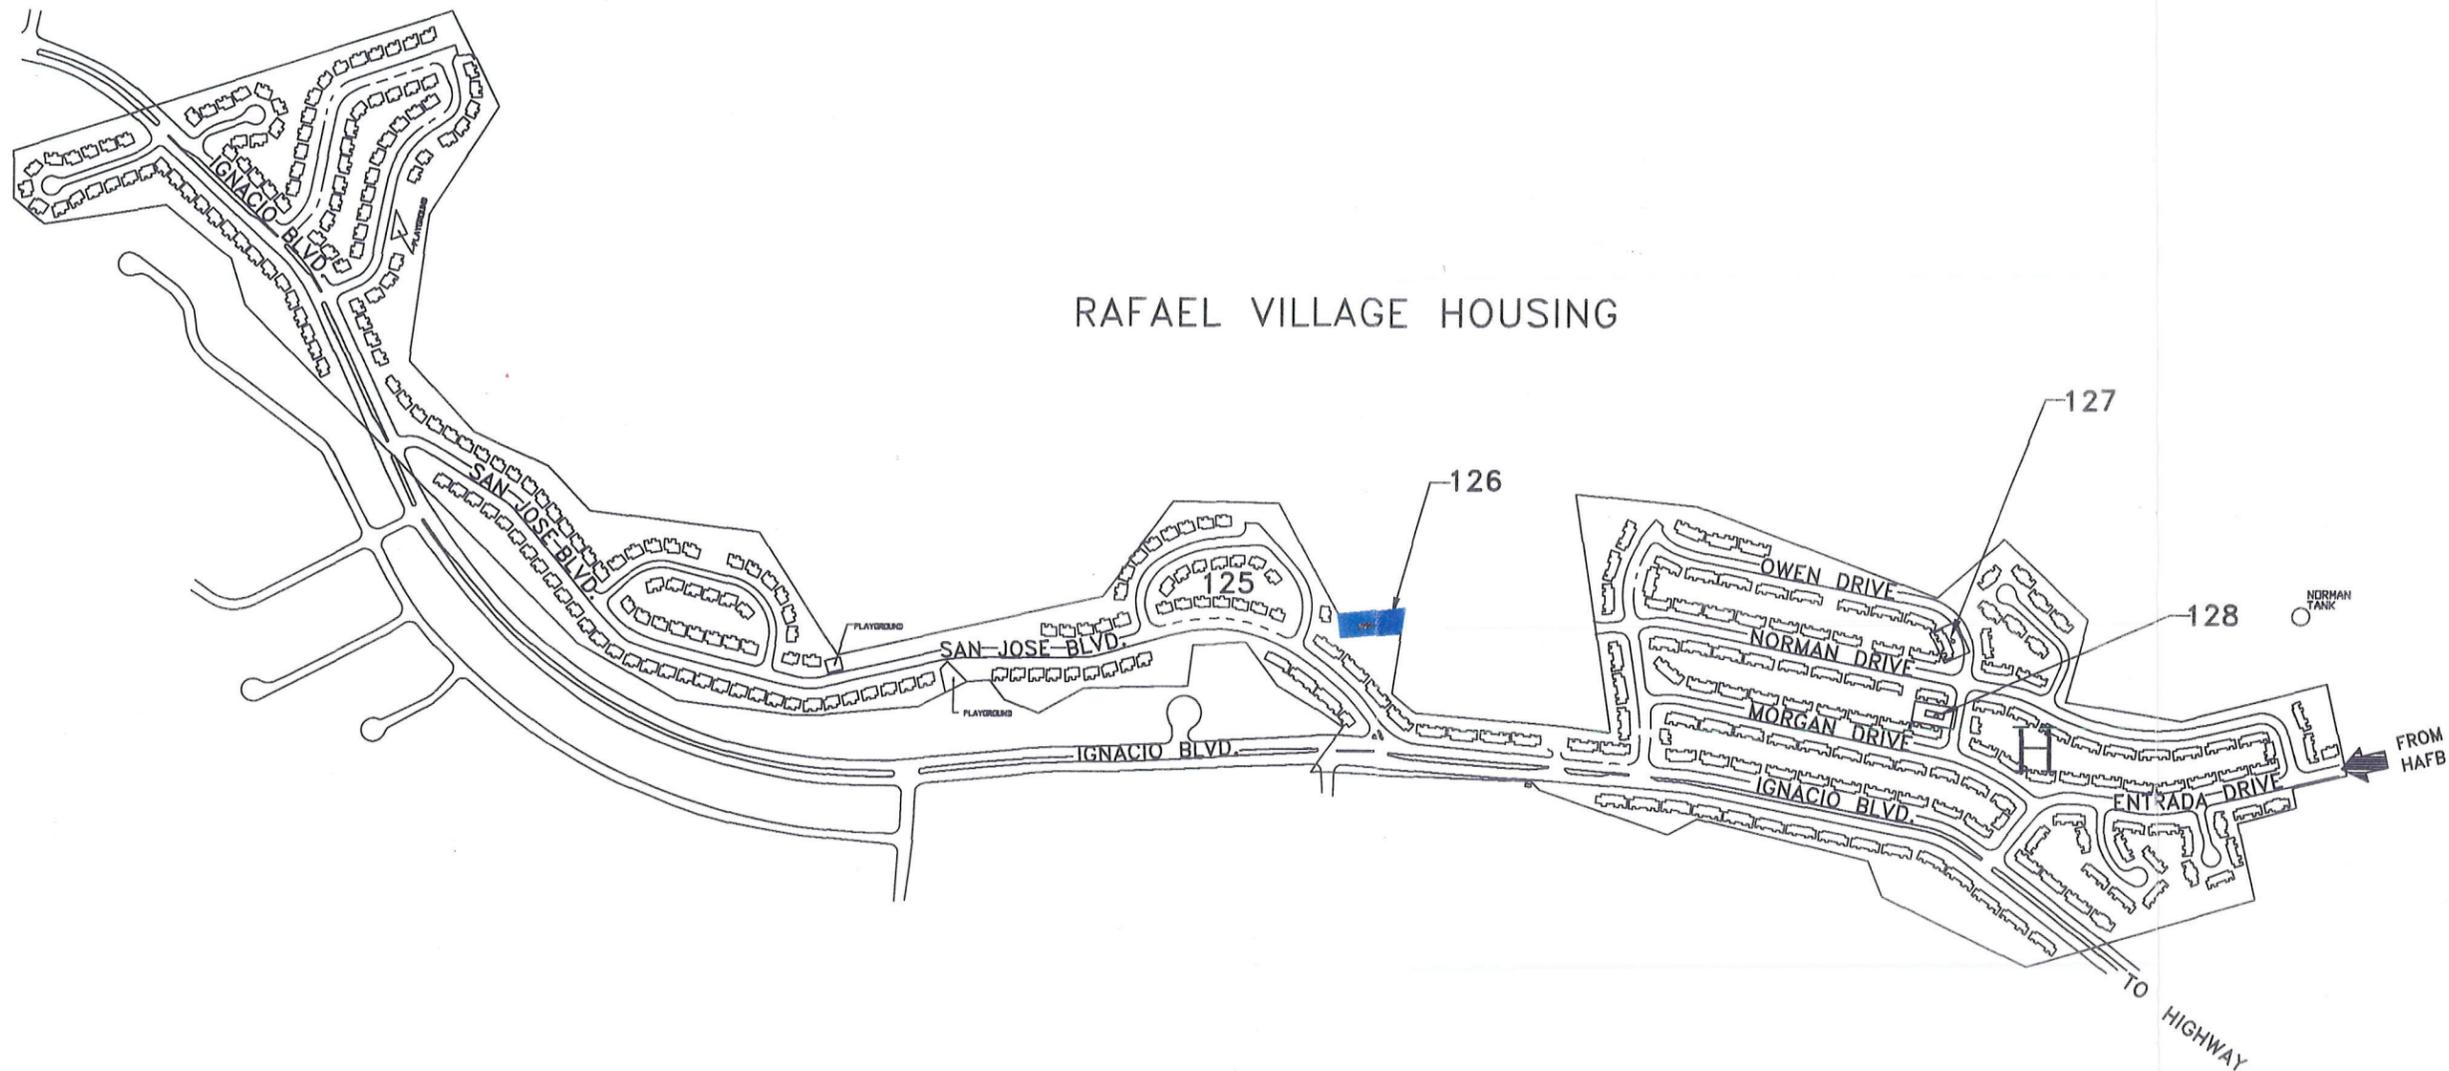
# RAFAEL VILLAGE HOUSING

- LEGEND**
- ECP AREA TYPE 1
  - ECP AREA TYPE 2
  - 124 = PARCEL NUMBERS
  - PARCEL BOUNDARY
