NAVAL STATION TREASURE ISLAND
ENVIRONMENTAL RESTORATION ADVISORY BOARD MEETING
Tuesday, 16 October 2012
7:00 PM.
Casa de la Vista Building 271
Treasure Island
MEETING NO. 162

Treasure Island Radiological Program Update

Former Naval Station Treasure Island

Restoration Advisory Board Meeting
October 16, 2012

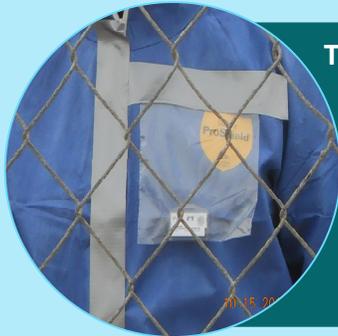
Thermoluminescent Dosimetry (TLD) is worn by all workers. TLDs record radiation dose received within a radiologically controlled area (RCA). Additionally, Personal Protective Equipment (PPE), e.g., blue Tyvek suit, is worn when working in an RCA. TLD allows the Navy to track radiation exposure trends to determine if additional controls are warranted.

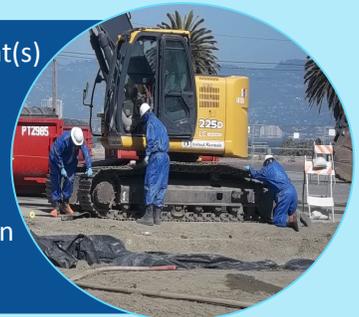
Radiological Controlled Areas (RCA) are fenced and posted with an access point(s) that can be secured for either personnel and or for vehicles/trucks. These access points will be manned to ensure only authorized personnel enter the site and comply with all Personal Protective Equipment requirements. They also ensure only authorized, clean vehicles enter and leave the site. Radiation surveys of all personnel and vehicles leaving the site are performed to ensure that contamination is not spread outside of the RCA.

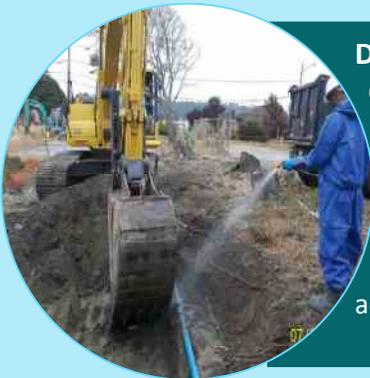
Dust Control Measures (DCMs) are performed at all excavation sites and during transportation of soil. DCMs are critical to limit inadvertent movement of contaminated materials, soils or dust within the work area. Measures include spraying of water during excavations or loading of materials into bins or trucks; wetting areas where heavy equipment is moving during excavations or surveying; and wetting and covering of areas where materials are stockpiled. Mesh screening may also be fitted to temporary fencing as an additional dust control measure.

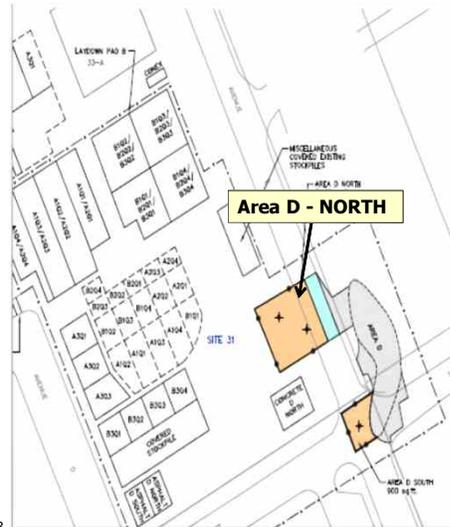
Site 31 – Area D-North

- Excavation of Area D-North was performed between July 24 and August 2. Area D-North was excavated to its planned depth of 6 feet bgs.
- A total of ~700 cubic yards of soil was excavated for radiological characterization. Soil was placed on the laydown pad, GWS performed and all radiological static measurements were below the investigation level.
- 62 confirmatory soil samples were collected for radiological analysis. ²²⁶Ra results all below release criterion. ¹³⁷Cs and ⁹⁰Sr (20%) 'non-detect'.

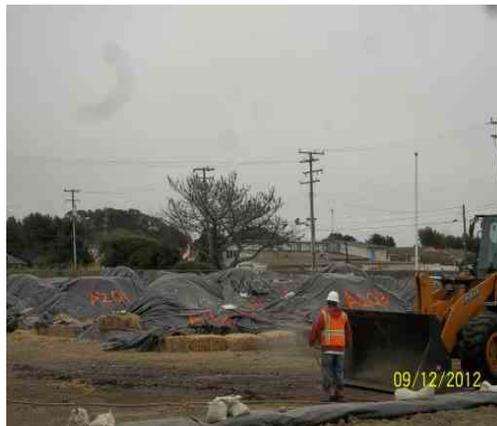
Site 31

Dust suppression is used on the general area. The storage stockpiles are labeled for identification.

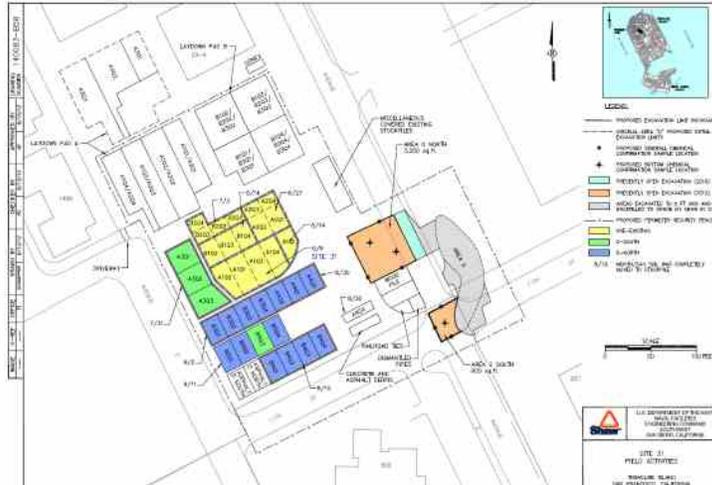
Site 31

Figure showing the soil storage stockpiles at Site 31. Soil is stored in the stockpiles pending approval of RACR and disposal. All stockpiles are covered and maintained.

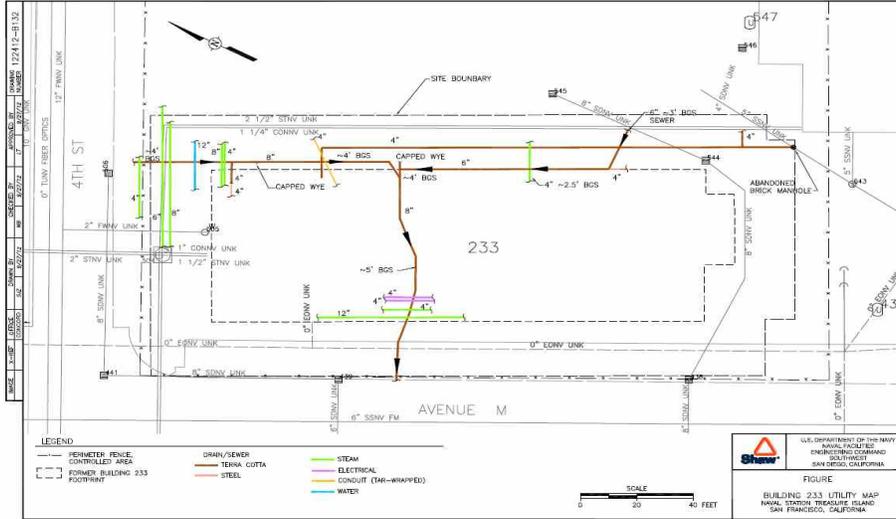
Building 233

Figure showing utility lines.

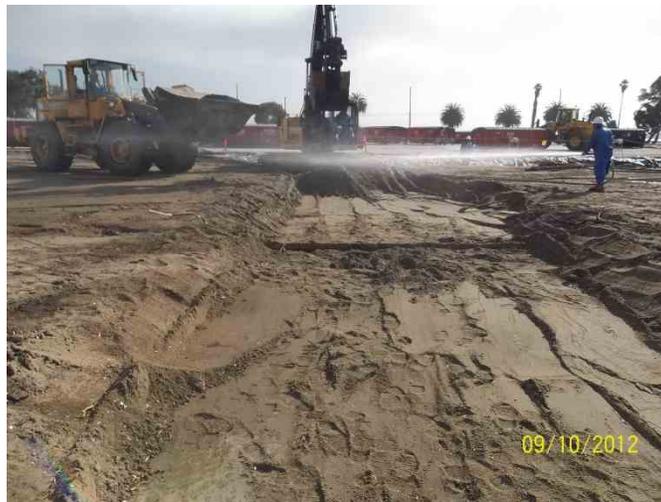
Building 233

Dust suppression during trenching activities.

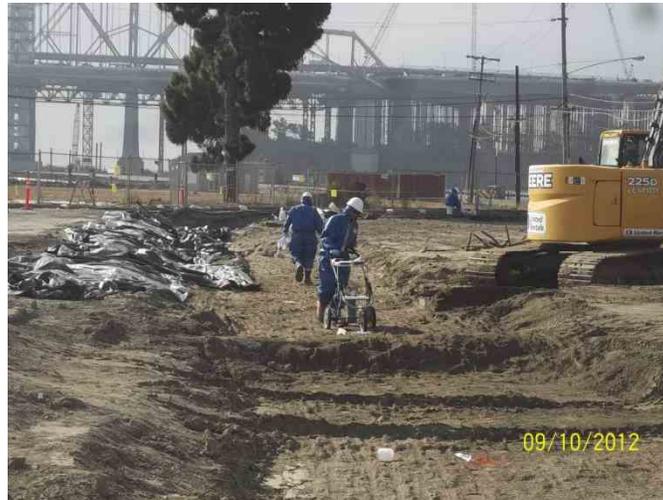
Building 233

GWS of soil layer while trenching down to the terra cotta drain line. Note the white sample jar in the foreground already placed in position for soil sampling.

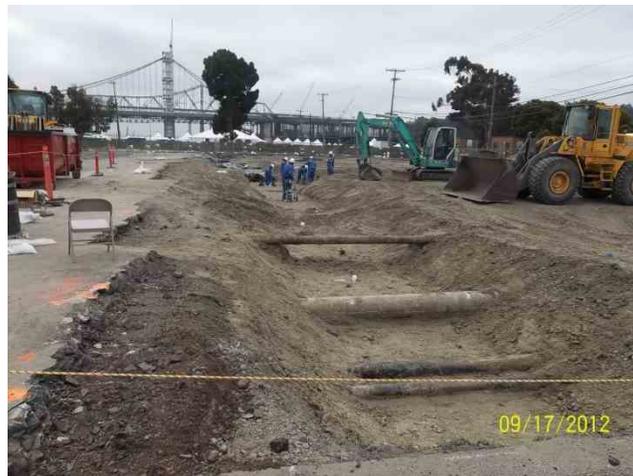
Building 233

Northern end of the site, view looking southeast. Utility lines discovered while trenching down to the terra cotta line (from foreground to background): 6 and 8-inch steam lines, 12-inch water line, and 8-inch steam line.

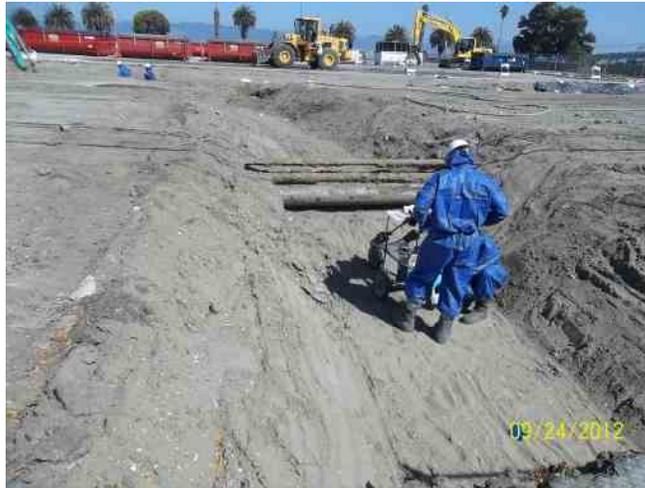
Building 233

Western edge of the site looking northeast. Utility lines discovered while trenching down to the terra cotta line: 4, 6 and 12-inch steam lines.

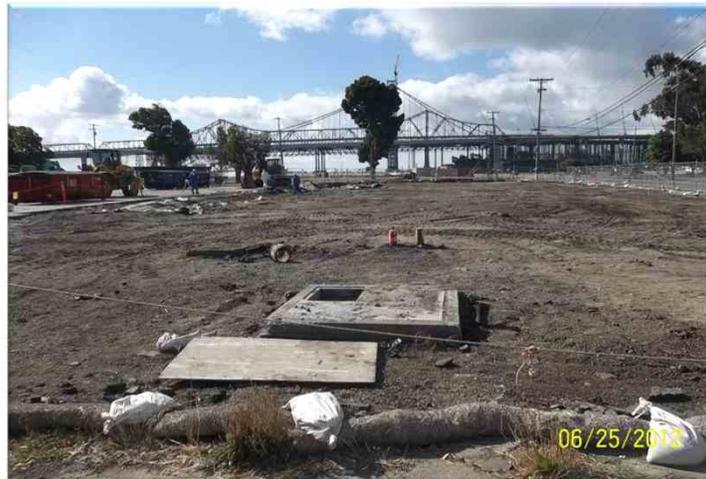
Building 233

Steam-line utility vault at north end of the site; removed as LLRW week of October 8th.

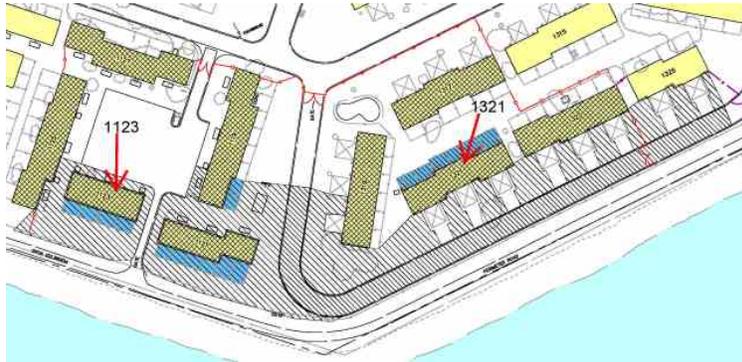
- Radiological surveys of Buildings 1123 and 1321 began in mid-September and continue. Demolition is tentatively planned for late 2012.

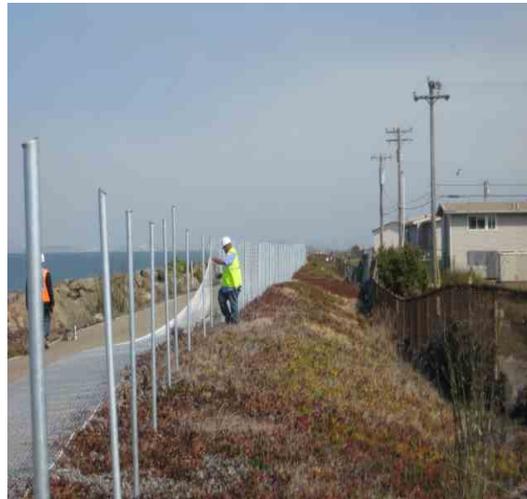
Site 12 - SWDA A&B

- Weather and age-damaged fencing of SWDA A&B was improved by installing a new chain link fence along the western perimeter.

Chain link fence is erected along the western perimeter of SWDA A&B for security. Older perimeter fence is visible on the right.
