NAVAL AIR STATION JOINT RESERVE BASE (NAS JRB) WILLOW GROVE Restoration Advisory Board (RAB) Meeting Minutes RAB Meeting No. 47

Meeting Date: December 7, 2011

NAS JRB WILLOW GROVE

December 7, 2011
Meeting Number 47

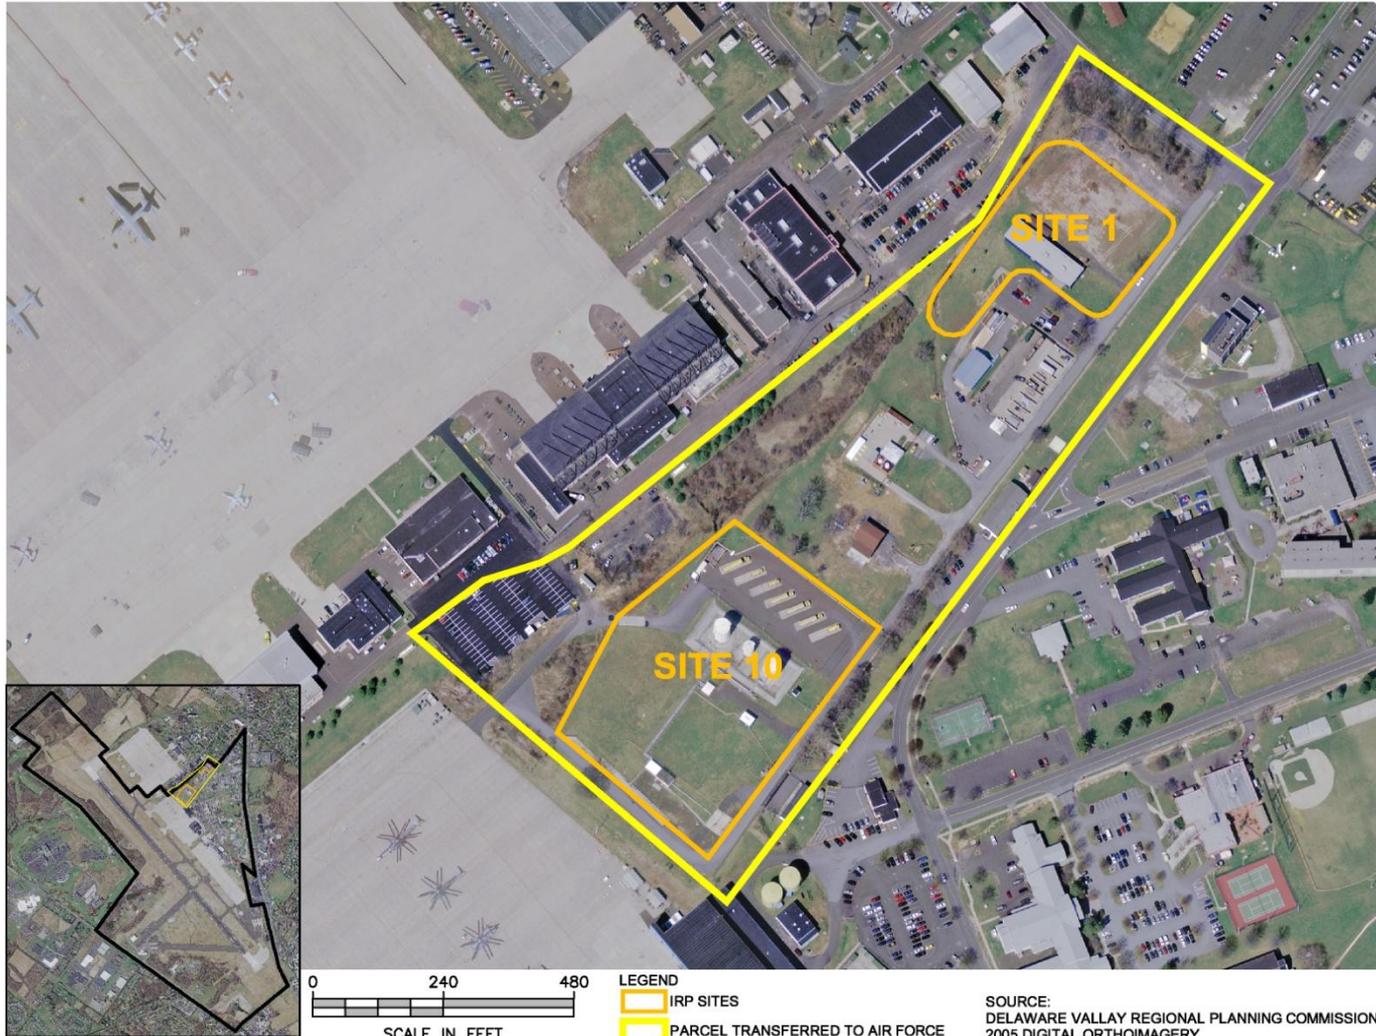
Site 1 – Privet Road Compound

Mr. Frebowitz provided an update for Site 1 - the Privet Road Compound. The last time the RAB met, TetraTech was just getting ready to mobilize in the field for a round of monitoring well and supply well sampling. Referring to a figure, Mr. Frebowitz showed monitoring well clusters one and six and the two supply wells. Wells in well cluster one were replacement wells because the old wells were located in the new retention basin built for the new reserve center. The

- Annual Land Use Control Inspection conducted August 2011
 - No compliance issues identified
 - 4 monitoring wells identified in drainage swale could be subject to flooding (Recommendation for abandonment)
 - No risks identified
- Groundwater monitoring conducted August 2011
 - Shallow monitoring wells (01MW01S-R, 01MW01SO-R, 01MW06S) sampled for PCE, TCE and degradation products
 - Supply Wells (01MWNW1 and 01MWNW02) sampled for VOCs and metals
 - Operating permit for supply wells transferred to PAANG (9/14/11)

- Monitoring well results below project action levels
- Supply wells still above drinking water standards and continue to be treated
- Results similar to 2009 sampling event
- Recommend additional round of sampling in 2013

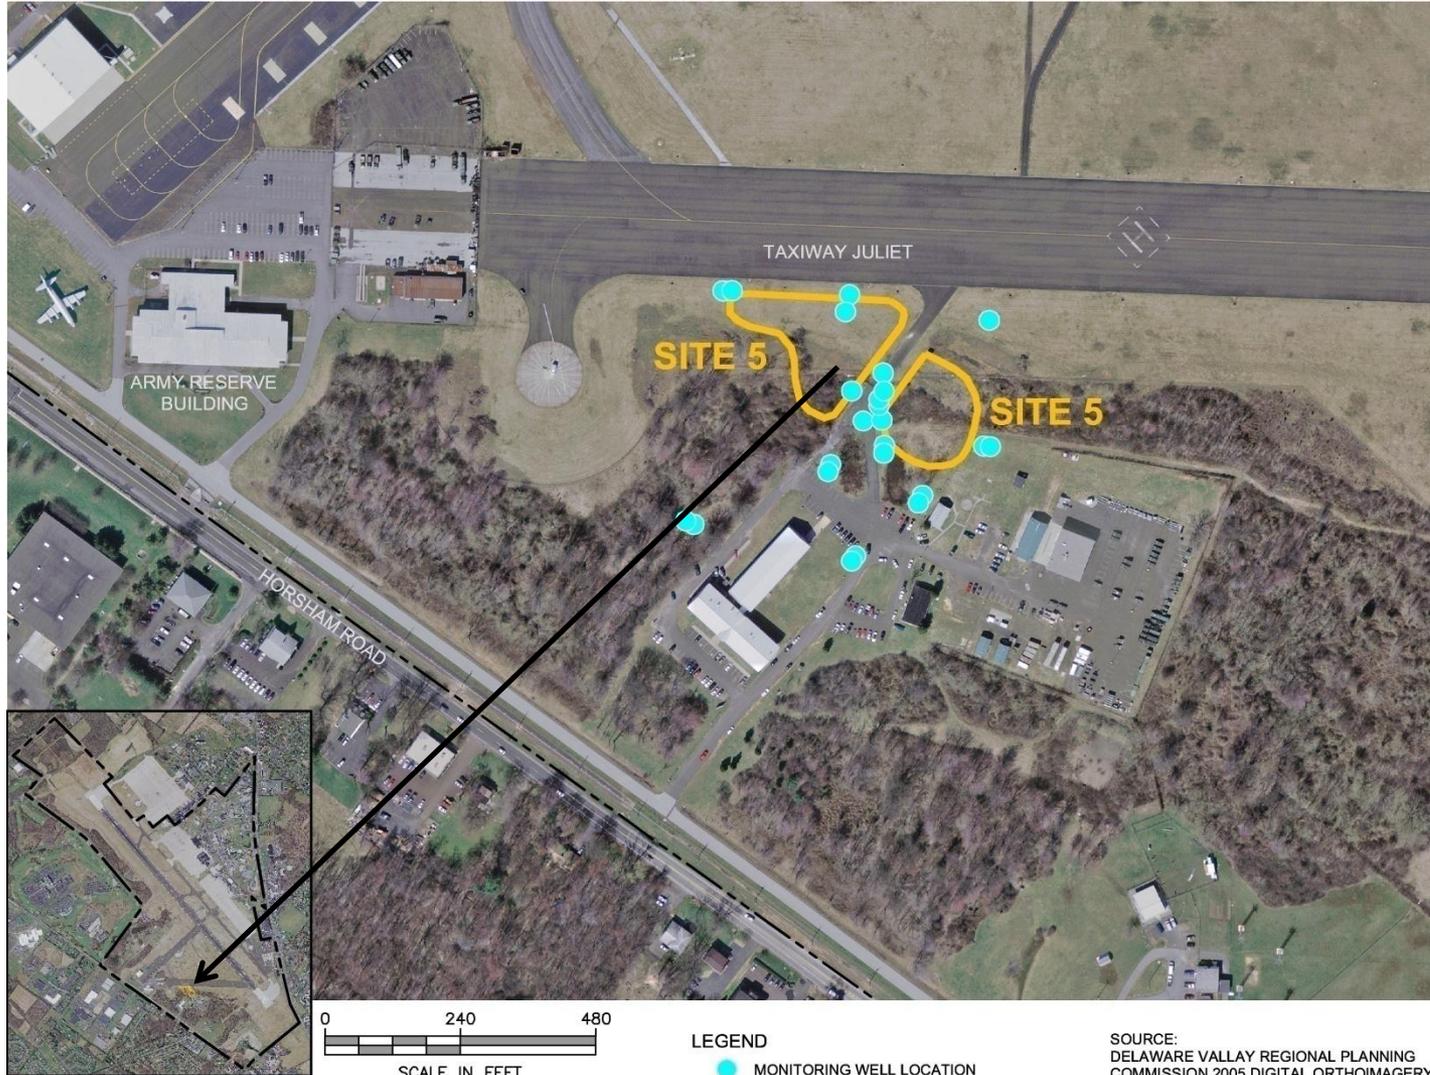
Site 5 – Fire Training Area Groundwater

Mr. Frebowitz introduced Kevin Kilmartin to provide an update on the Site 5 – Former Fire Training Area pilot test and bioremediation. Mr. Kilmartin stated that the goal for this meeting was provide a very brief update on what's going on at Site 5, not an in-depth discussion as provided in the past. As part of the bioremediation pilot test for the chlorinated solvents in the groundwater, a groundwater recirculation system was set up where three of these wells can serve as either injection or extraction wells. The fourth well serves as an injection well only. Water is piped out of the ground through the treatment trailer where the amendments are added to add the microbes or other chemicals to the groundwater to make the environment more favorable for the bacteria before it's sent back out and reinjected into the aquifer. Referring to a figure, Mr. Kilmartin showed the source of the solvents where the drums were temporarily staged before the contents were burned in the burn ring. The recirculation area basically surrounds the source area as shown on the figure.

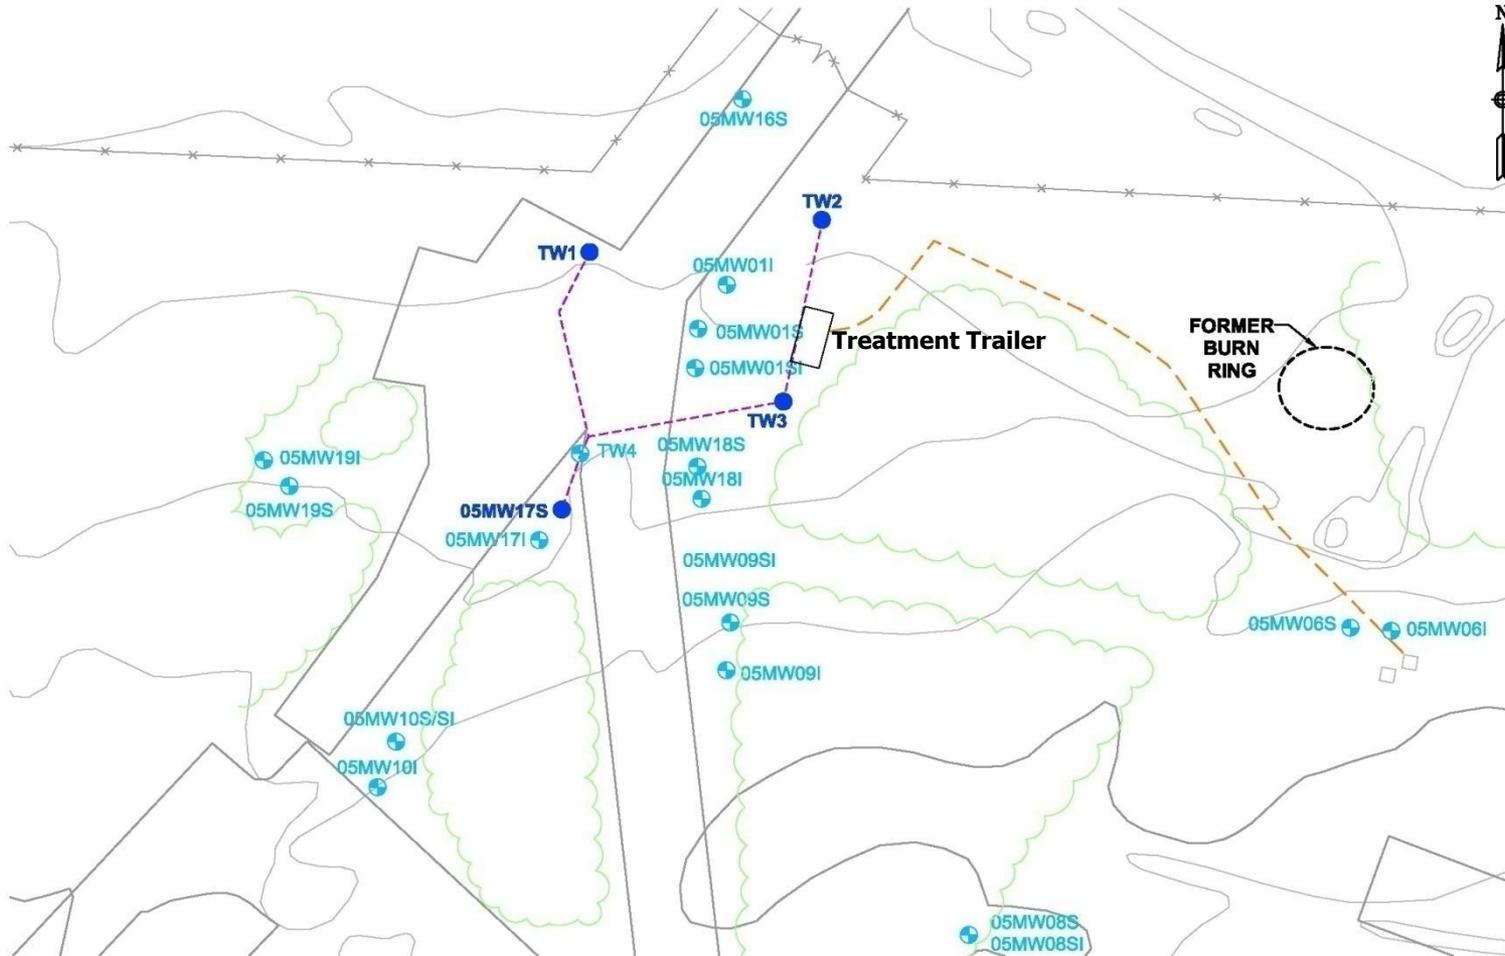
Site 5 – Fire Training Area Groundwater

- MONITORING WELL LOCATION
- INJECTION/EXTRACTION WELL LOCATION
- UNDERGROUND ELECTRIC AND WATER LINE
- UNDERGROUND ELECTRIC LINE

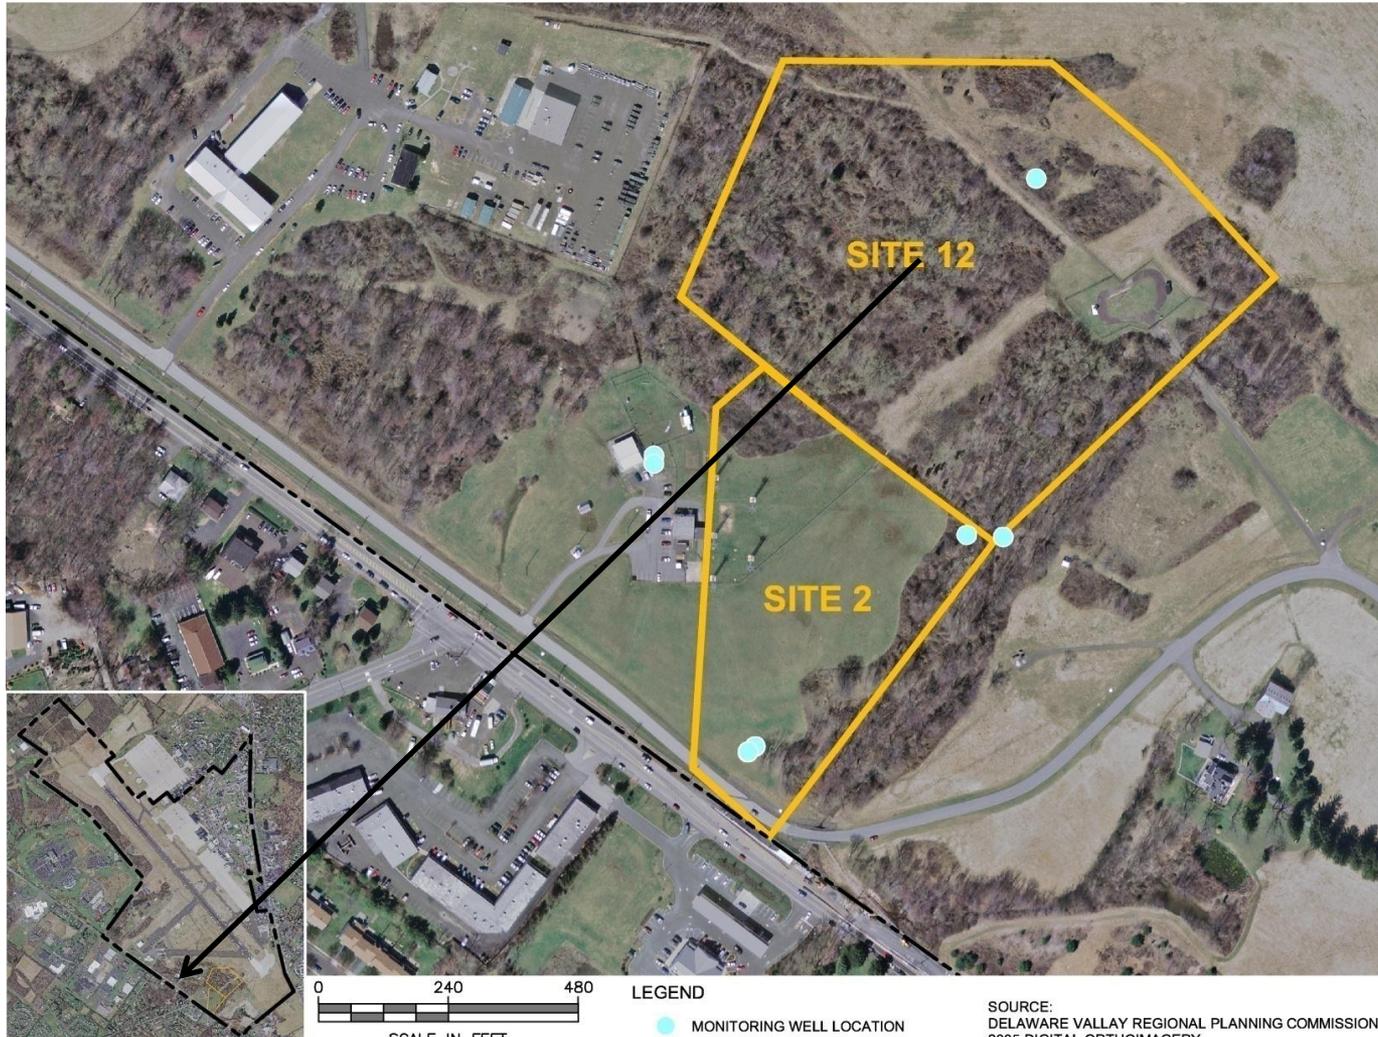
Site 12 – South Landfill Phase II Remedial Investigation

- Sampling and Analysis Plan Finalized
- Phase II investigation – In Progress
 - Test pits at 2 linear anomalies in southeastern portion
 - 25 shallow soil borings outside EM anomalies (VOCs, SVOCs, metals/cyanide, pesticides, PCBs; hexavalent chromium at some locations)
 - 29 shallow soil borings at step-out locations based on Phase I results (low level PAHs and/or metals or pesticides)
 - Chromium speciation at some Phase I and Site 3 test pits
 - 4 new monitoring well clusters (overburden, shallow bedrock) within the landfill (VOCs, SVOCs, pesticides, PCBs, metals/cyanide; dioxins and furans at well cluster downgradient of Phase I test pit 12TP02)
 - Site 2 monitoring wells (VOCs)

pesticides, PCBs. Twenty-nine locations will be step-out areas where we will only analyze for the one or two contaminants found in Phase 1 to determine their extent. We will also install four new monitor well clusters within the landfill, both in the overburden and in shallow bedrock. Site 2 monitoring wells will be sampled as well. The proposed sampling locations and monitoring well clusters were shown to the attendees on a figure.

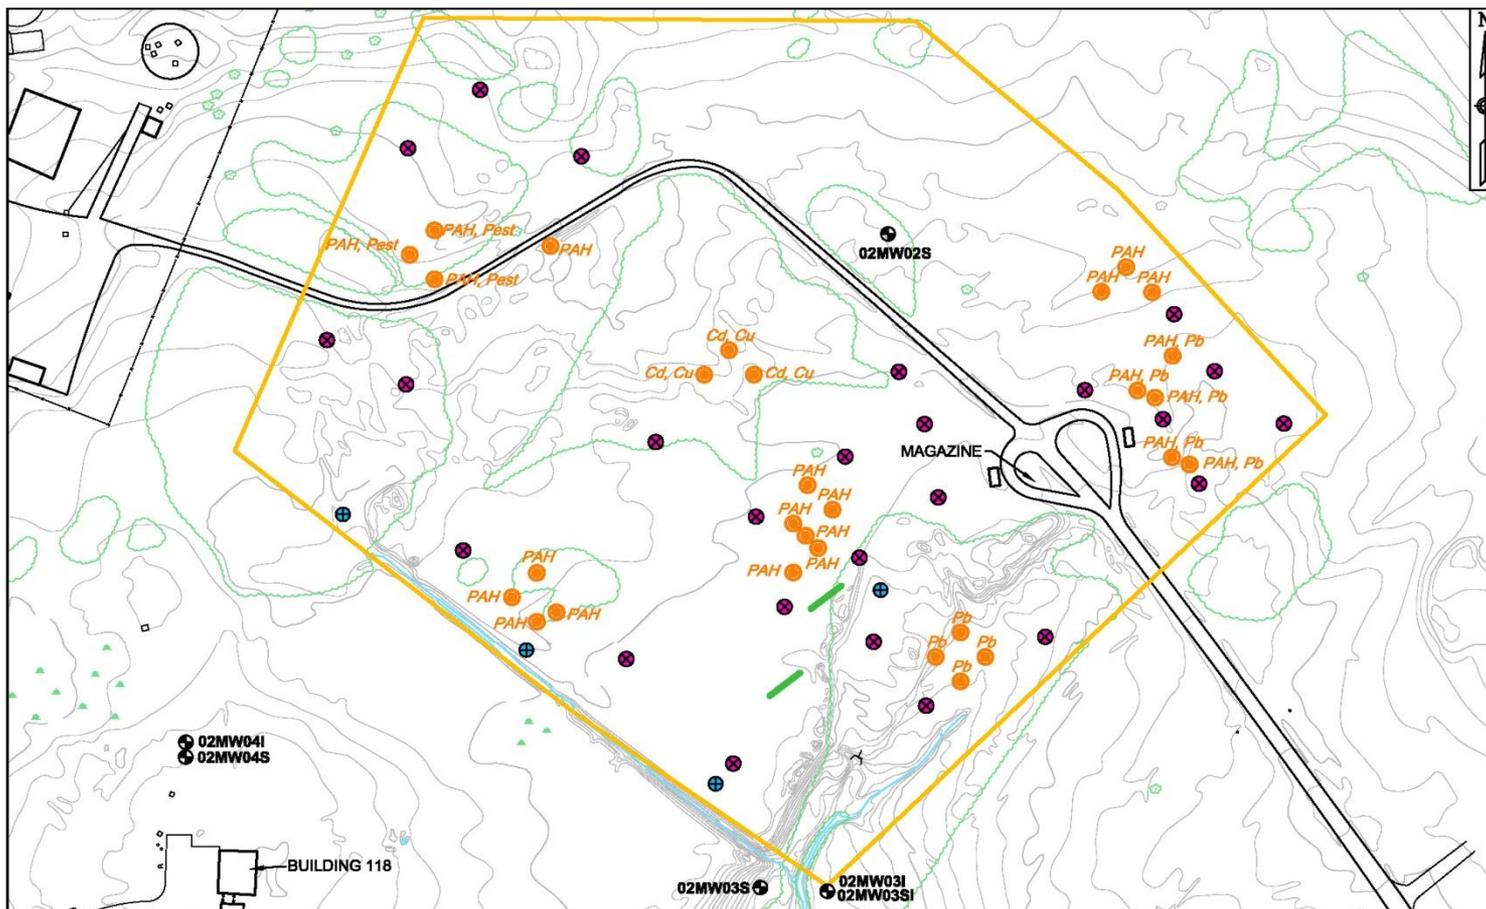
Site 12 – South Landfill Phase II Remedial Investigation

(VOCs, SVOCs, PESTICIDES/PCBs, METALS) ⊕ MONITORING WELL LOCATION (EXISTING) ⊕ MONITORING WELL LOCATION (PROPOSED) (4) ● STEP-OUT SOIL SAMPLE LOCATION (PROPOSED) | <ul style="list-style-type: none"> <i>Cd</i> CADMIUM <i>Cu</i> COPPER <i>PAH</i> POLYCYCLIC AROMATIC HYDROCARBONS <i>Pb</i> LEAD <i>Pest</i> PESTICIDES | <ul style="list-style-type: none"> — TEST PIT LOCATION (PROPOSED) (2) — SITE 12 BOUNDARY ○ OUTLINE OF EM ANOMALOUS AREA - - - EM LINEAR ANOMALY |

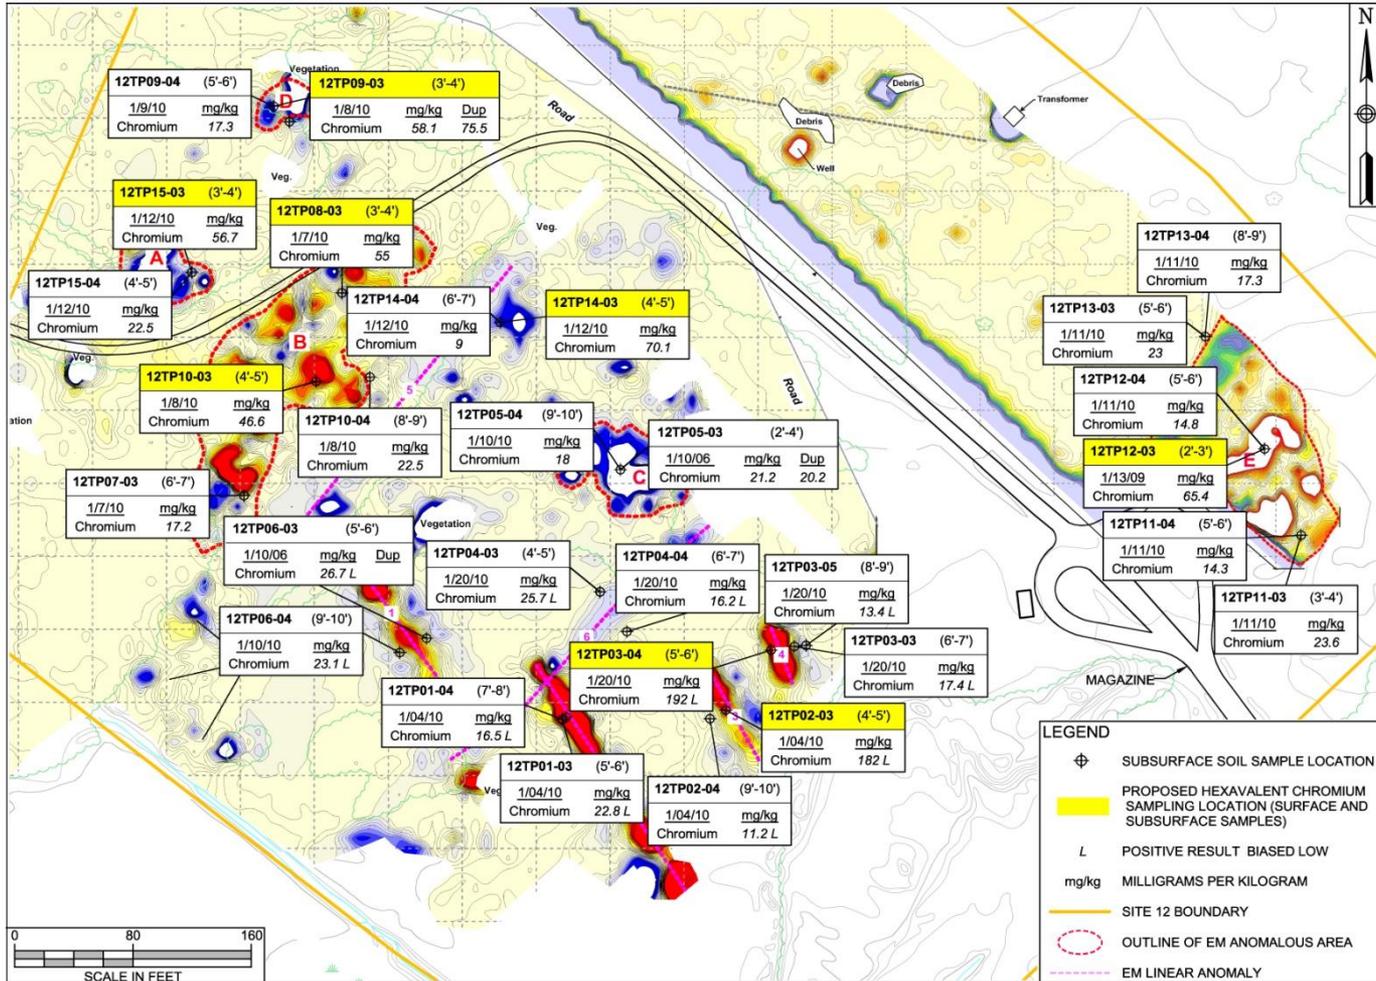
Site 12 Chromium Speciation

Mr. Frebowitz referred to another figure showing the locations where elevated chromium was found during Phase 1. Locations selected for chromium speciation were highlighted. Even though we submitted a final RI for Site 3, we also plan to conduct chromium speciation at Site 3 to aid in preparation of the feasibility study. The next slide showed proposed sample locations at Site 3 for chromium speciation.

As part of this investigation, we will conduct chromium speciation analysis of samples from locations where we found chromium in Phase 1, to determine the levels of hexavalent and trivalent chromium, and determine the actual toxicity of the chromium. Mr. Frebowitz showed a figure with the sampling locations.

Mr. Lewandowski added that the reason for that speciation is because the hexavalent chromium is many times more toxic than the trivalent chromium, so it makes a significant difference in the calculation of risk.

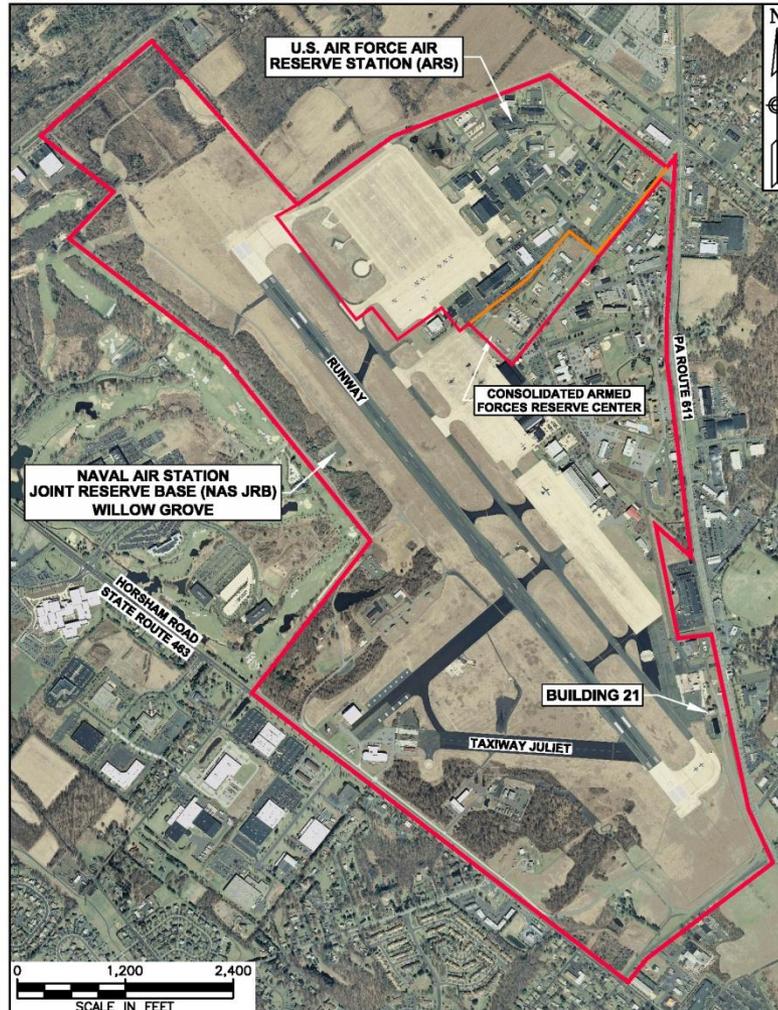
BUILDING 21 LEAD INVESTIGATION

- Former paint blasting and painting facility
- 1995 soil investigation showed lead in five surface soil samples from 186 mg/kg to 2,210 mg/kg
- Work plan for additional sampling approved by EPA and PADEP (September 2010)
- Lead sampling at 15 locations from 0 -0.5 ft, 0.5 to 1.0 feet, and 1.5 to 2.0 feet conducted October 2011 (results pending)

Mr. Frebowitz discussed the status of Building 21. Building 21, in the southeastern corner of the property, was a former paint blasting and painting facility. In 1995, five samples were taken around the building and four of the samples showed levels above action levels. The PADEP action level is 500 milligrams per kilogram and EPA's screening level is 400 milligrams per kilogram. We prepared a work plan to further investigate that area that was approved in September. 15 locations were sampled in early October at different intervals including the surface, half a foot to 1 foot, and down to 2 feet. Samples were collected all around the building and also in the grassy area around the transformer area. Results are just starting to come in and are going through the data validation process. By the next meeting we'll be able to discuss the results. There were no comments from the attendees regarding the status of the Building 21 investigation.

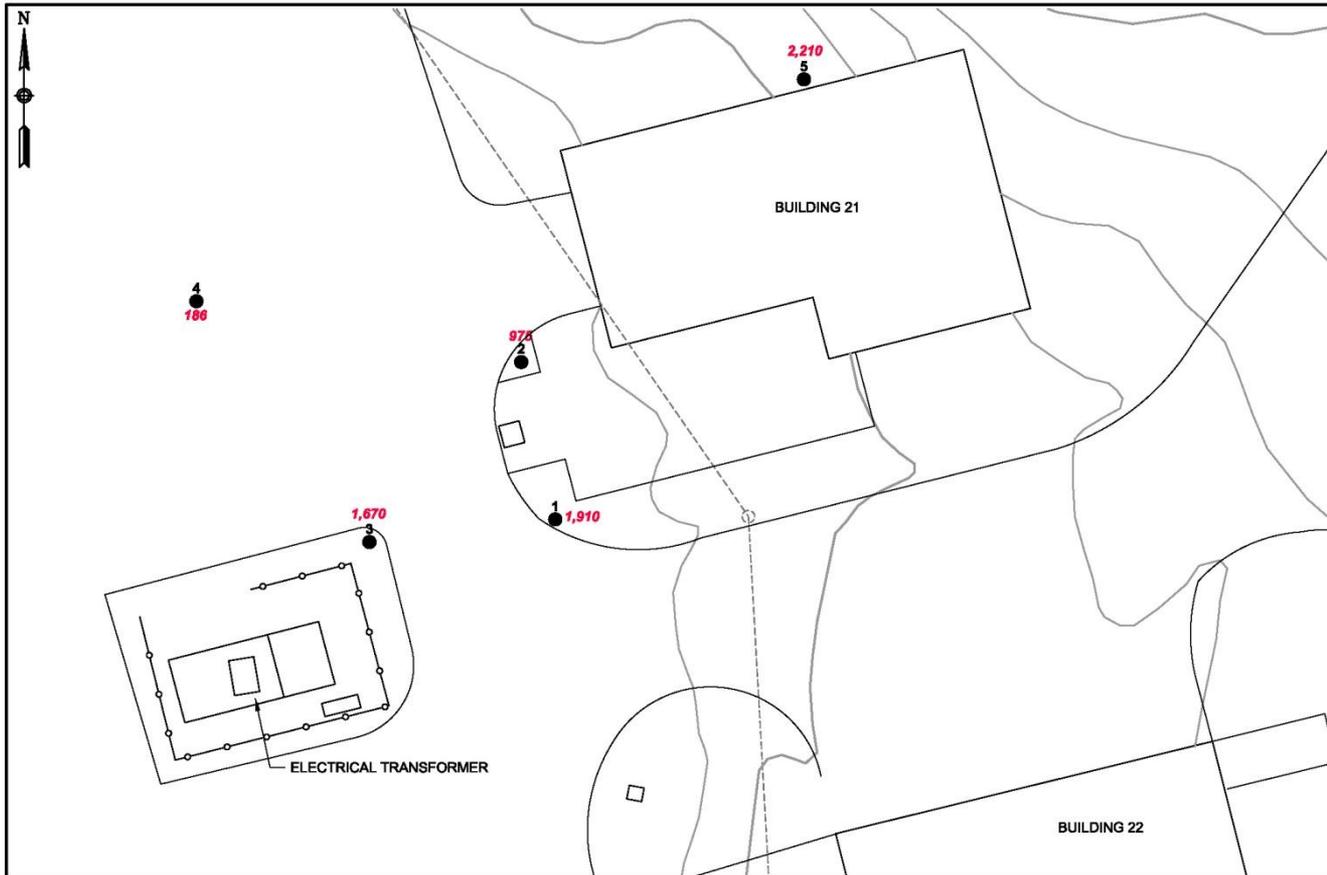
BUILDING 21 1995 LEAD RESULTS

- APPROXIMATE SOIL SAMPLE LOCATION
- SANITARY SEWER MANHOLE
- 975 1995 LEAD RESULT IN mg/kg
- FENCE
- SANITARY SEWER
