**FINAL**  
**NAVAL AIR STATION ALAMEDA RESTORATION ADVISORY BOARD**  
**MEETING SUMMARY**

February 1, 2007

### **III. Six-Phase Heating Removal Action Update**

#### **IV. EDC Parcel 17 Site Inspection Presentation**

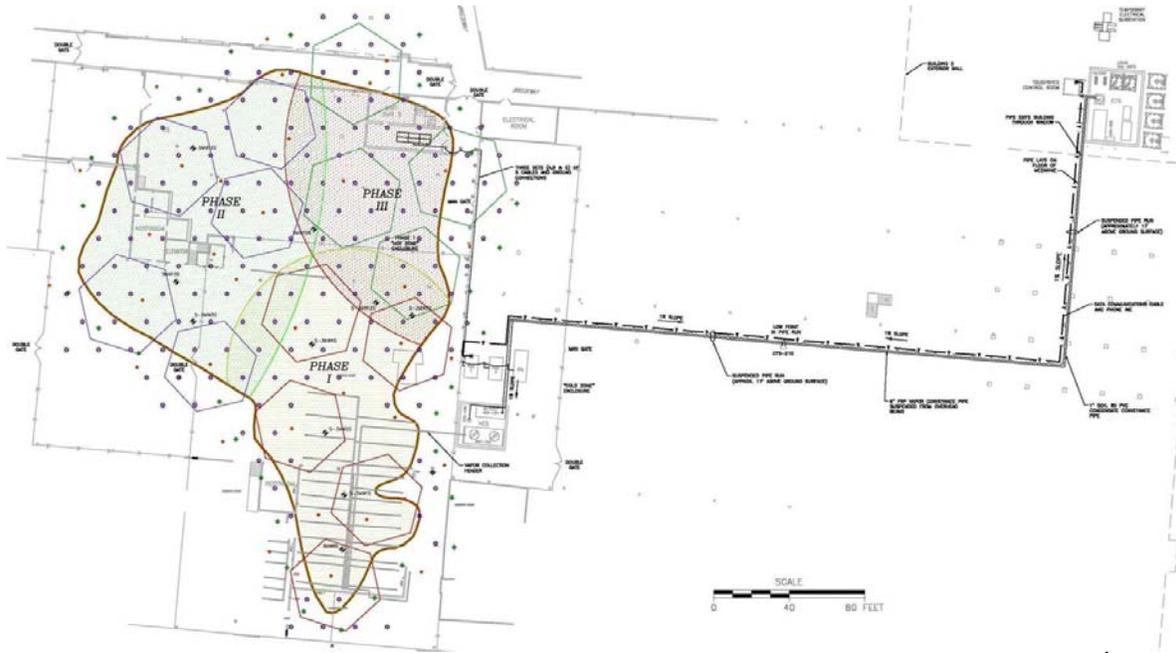
# SPH Layout at Plume 5-3

Slide 7 showed a map of the SPH layout at Plume 5-3. Mr. McGuire identified the areas of Phase I, II, and III on the map. Electrodes and groundwater monitoring wells are shown on the map. The current work is moving into Phase II. Mr. Peterson asked if work continues on Phase I during work on Phase II. Mr. McGuire replied that work will stop on Phase I before it begins on Phase II. Mr. Peterson asked if the various phases apply to different parts of the plume. Mr. McGuire replied that they apply to different parts of the plume. Mr. Peterson asked if contaminated groundwater might migrate back into the areas that have already been treated. Mr. McGuire replied that groundwater will be monitored to make sure contaminants to not migrate back into treated areas. Mr. Peck noted that the groundwater moves slowly. Mr. Peterson asked if Plume 5-1 was treated in three phases. Mr. McGuire replied that Plume 5-3 is two

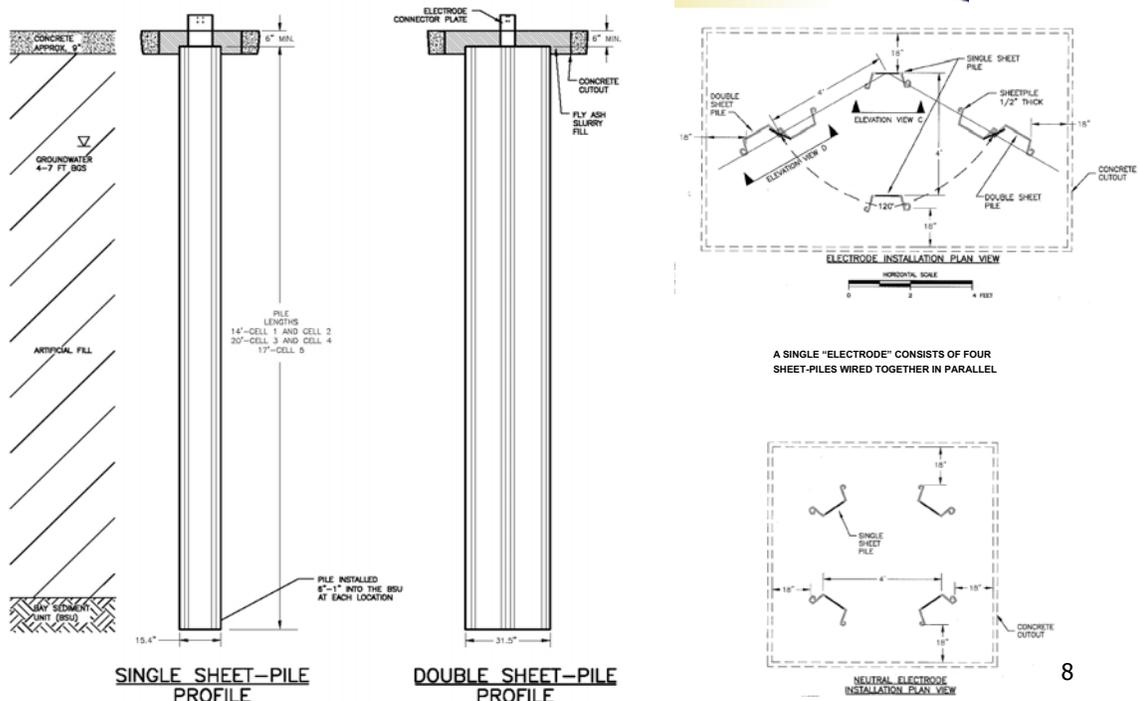
# Sheet-pile Electrodes

Slide 8 showed a diagram of the sheet-pile electrodes. The depth of installation varies, and the electrodes are designed to penetrate into the bay sediment unit 6 to 12 inches. Each electrode consists of four sheet piles. Inside the building, the concrete was broken so the sheet piles could be driven in. An electrical connection is then welded to the sheet pile. The hole is then filled with fly ash slurry to make it easier and more cost-effective to remove the sheet piles in the future. When the sheet piles are removed, concrete will be used to fill the holes. Mr. Peterson commented that the sheet piles are large. Mr. McGuire also said that the fastest way to heat the groundwater is to use the largest sheet pile possible. Mr. Humphreys asked why the groundwater is not heated to the boiling point. Mr. McGuire replied that it is necessary to heat the groundwater to the temperature that will volatilize the compounds in the water, but not the water itself.

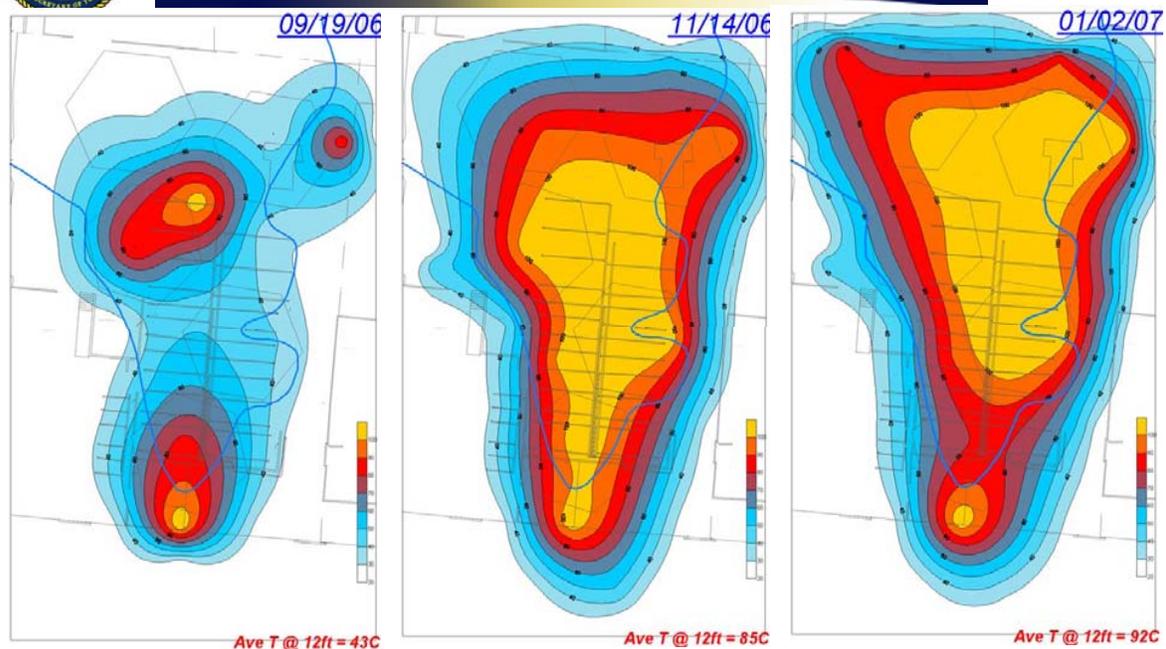
# Temperature Profiles @ 12 ft bgs

Phase I operations at Plume 5-3 began in August 2006 and were complete on February 1, 2007. The operations were extended to reach asymptotic mass removal. To date, 2.6 million kWhrs total power has been applied, and the total VOCs removed exceeds 200 pounds. There has been more than 99 percent reduction in contaminant concentrations. In addition, 90,000 gallons of condensate was treated and discharged. The current average internal temperature was 98°C. Mr. Peck commented that the efficiency of the system has been maximized. Mr. Peterson asked about the amount of power used for Plume 5-1 treatment. Mr. McGuire replied that it was about 1.5 million kWhrs. Slide 10 showed the temperature profiles at 12 feet bgs of the Phase I area in September 2006, November 2006, and January 2007. The temperature has increased throughout the plume over time.

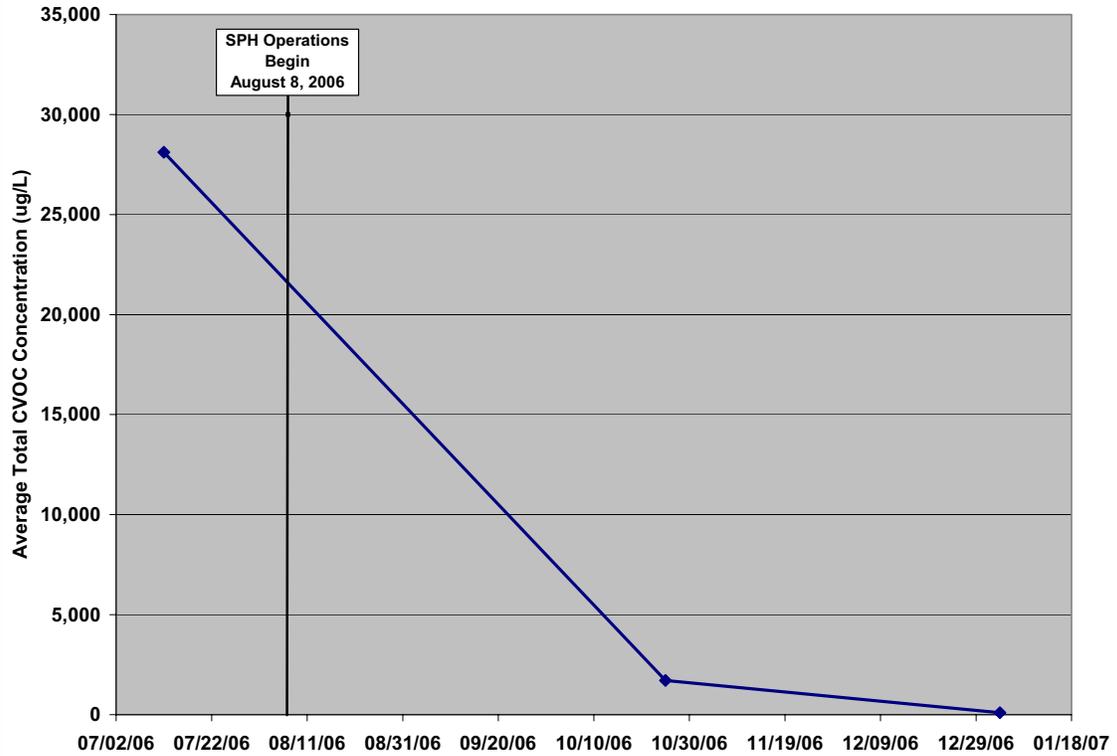
### Total CVOC Removal in Groundwater

Slide 11 showed a graph of total CVOC removal in groundwater. The average total CVOC concentration in the groundwater before SPH operations began was about 30,000 ppb. By October 2006, the concentration was 2,000 ppb, and in January 2007, the concentration was near 100 ppb. Ms. Sweeney asked if this technology is new and unusual and was attracting interest. Mr. McGuire replied that the U.S. Environmental Protection Agency (EPA) and even Australia's EPA have viewed the technology. Many heating projects have been implemented across the country, but not on the scale of this project, and it has also been successful. Mr. Peck commented that Alameda was used as a case study in recent reports on heating technology. Mr. Peterson asked about the concentration goal for the plume. Mr. McGuire replied that the goal was 10,000 ppb and had been reached by the October 2006 sample date. Mr. Peterson asked if any chemicals are more difficult to extract. Mr. McGuire replied that no issues have arisen with the target chemicals. Mr. Peck commented that the electricity costs for this technology are \$1,300 per day. He added that the maximum efficiency has been reached when the concentration curve starts to flatten out.

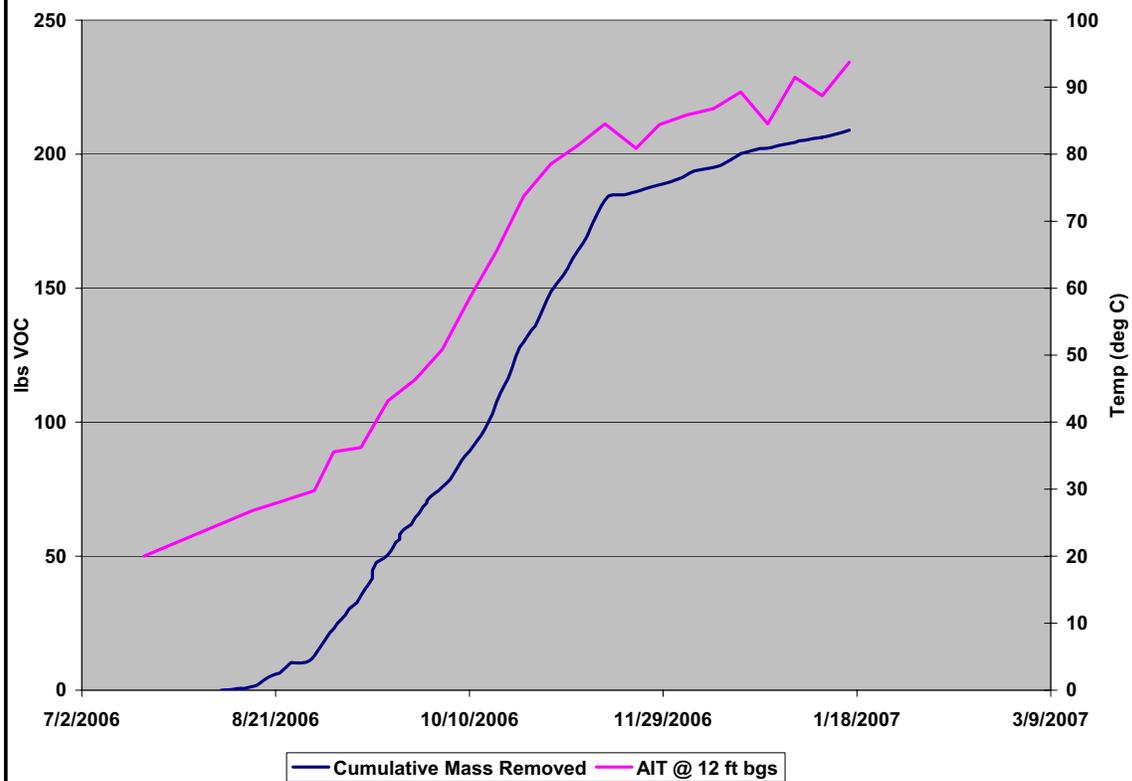
### Cumulative Mass Removed and Average Internal Temperature

Slide 12 showed a graph of cumulative mass removed and the average internal temperature. Mass removed was measured in pounds of VOCs removed. The recovery rate declines at about 80°C and it is expected that the rate will drop even farther.

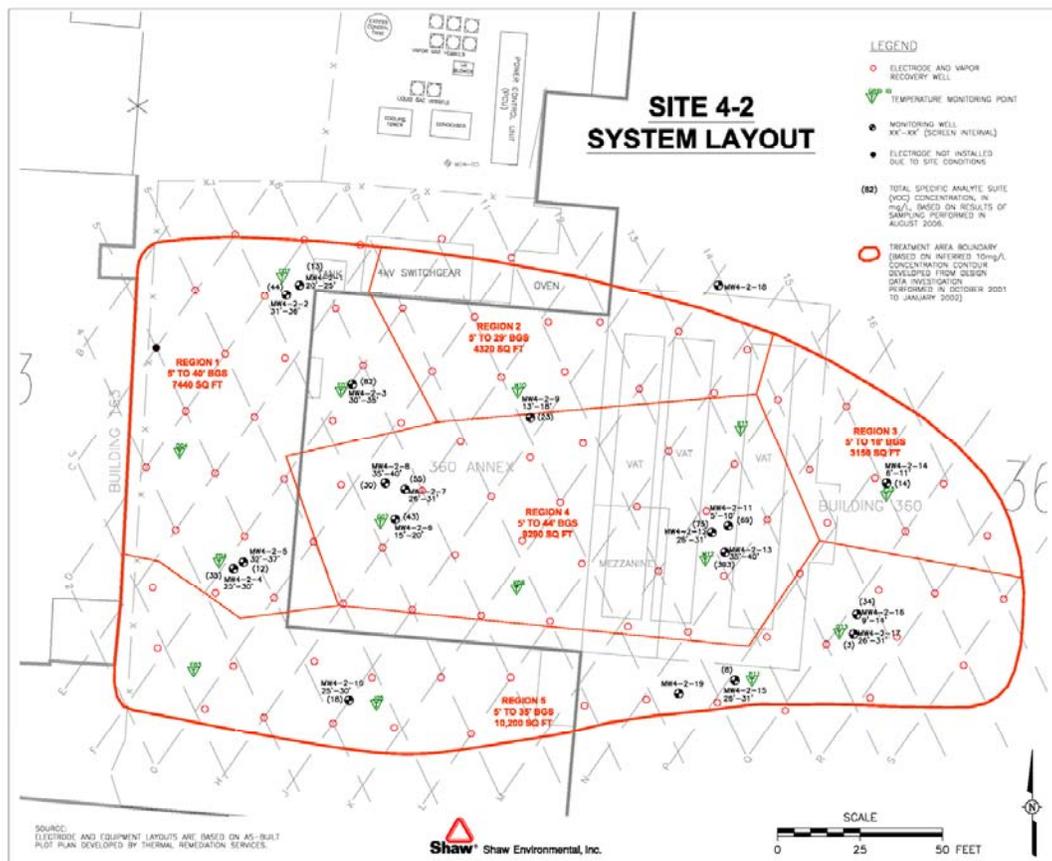
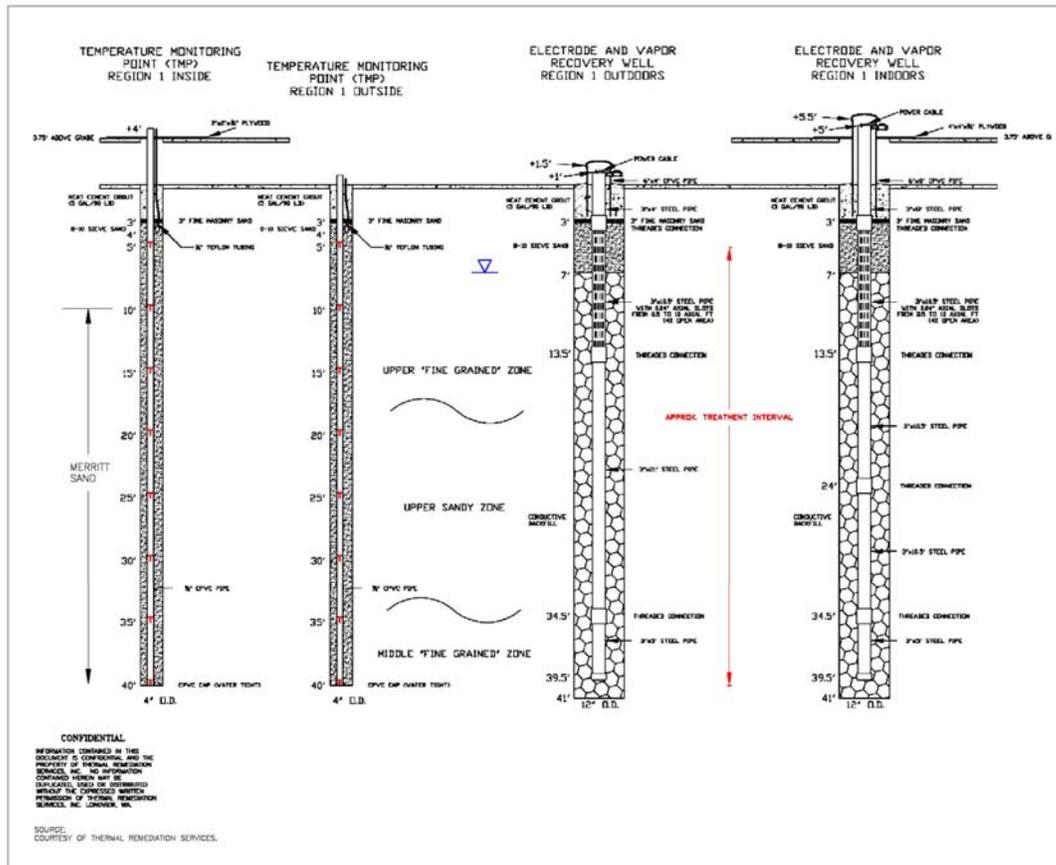
# Plume 4-2 System Layout

Slide 16 showed a map of the Plume 4-2 system layout. The treatment area extends from the center of Building 360 to the edge of Building 163. The map showed the five regions, the electrode and vapor recovery wells, and the temperature monitoring points.

Slide 17 showed a diagram of the temperature monitoring points and the electrode and vapor recovery wells for Region 1. The diagrams show the setup of these systems for concrete and areas where the concrete floor is raised. TRS uses electrodes that consist of a steel conductor pipe set with graphite backfill. The Plume 4-2 system began operation in late October 2006 with all 91 electrodes energized. The average groundwater temperature rose from 18°C to 67°C, with a maximum temperature reaching 120°C at 45 feet bgs. More than 100 pounds of VOCs have been captured by the vapor recovery system to date, with more than 50 percent reduction in concentrations of total VOCs in groundwater observed at

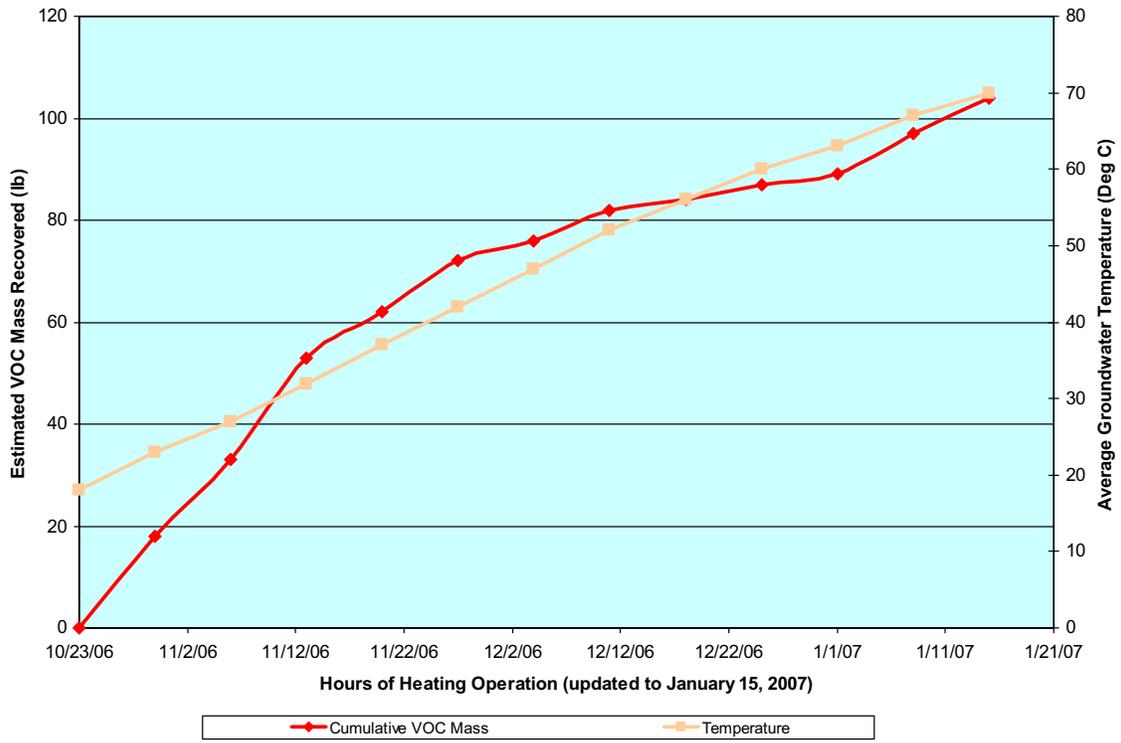
Cumulative VOC Mass Recovery Trend During Groundwater Heating  
at Plume 4-2, Alameda Point, California

the location where the highest water temperature was recorded. Slide 19 showed a graph of the cumulative VOC mass recovered and the average groundwater temperature for Plume 4-2. The cumulative mass recovered is just above 100 pounds as of January 15, 2007. Ms. Sweeney asked about the progress of treatment. Mr. McGuire replied that the results of the groundwater sampling have been received and that 1 or 2 months of additional operation will be required. Mr. Biggs asked if the concentration of DNAPL is expected to rise once the ground cools. Mr. McGuire replied that there may be a slight increase. It was observed that levels did not rebound at Plume 5-1. Mr. Biggs asked about the time for the ground to cool. Mr. McGuire replied that it would cool in about a year and a half.

- System operation began late October 2006 with all 91 electrodes energized
- Average groundwater temperature rose from 18°C to 67°C, with maximum temperature reaching 120°C (boiling) at ~45 feet below ground surface within former plating shop
- Over 100 pounds of VOC captured by the vapor recovery system to date
- Over 50% reduction in total VOC concentration in groundwater observed at the location where the highest water temperature was recorded

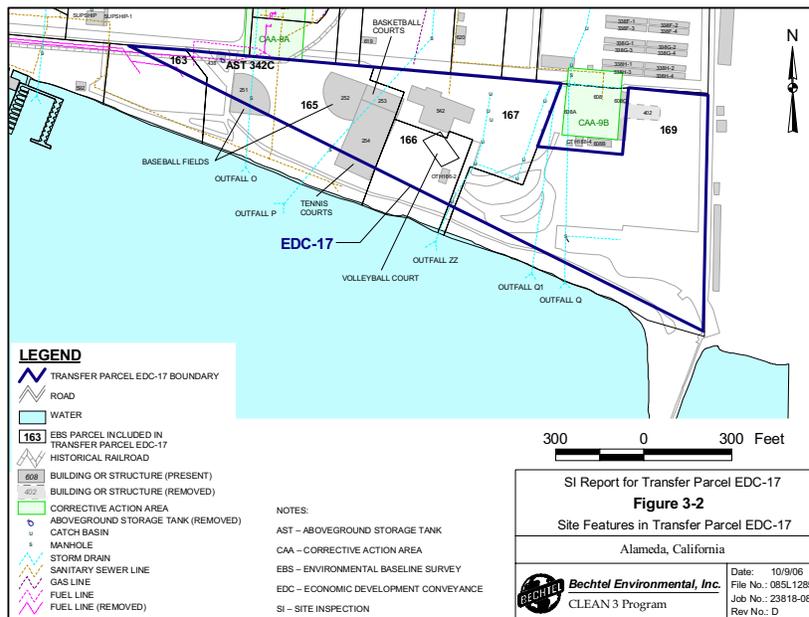
# Site Features

Slide 8 showed a site feature map of EDC-17. Ms. Barnes identified the former tank-truck loading facility, the maintenance shop, and the drum, chemical, and material storage area on the map. She also identified the fields, tennis courts, and the RV park area on the map. Mr. Peterson asked if EBS Parcel 169 is the asphalt area where cars are stored. Ms. Barnes identified the area on the map. She also pointed out where streets and paths are shown on the map.

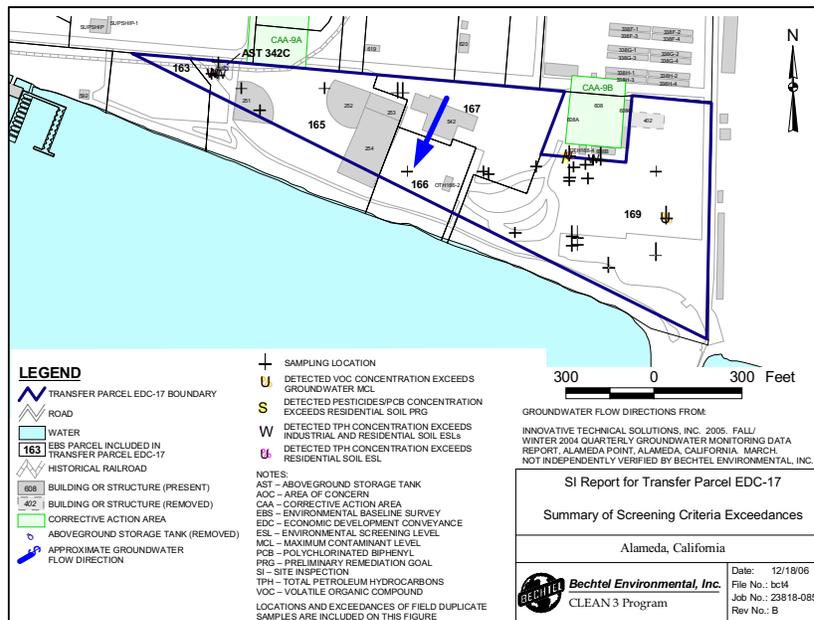
## Data Evaluation Findings

The data evaluation findings for soil included the following: all VOCs, semivolatile organic compounds (SVOCs), polycyclic aromatic hydrocarbons (PAHs), and metals were below the screening criteria. TPH was above the screening criteria in 4 of 22 samples in EBS Parcels 165 and 169. A TPH data gap was identified at EBS Parcel 165. The concentration of chlordane was found to exceed the screening level in one of four samples at EBS Parcel 169. The data evaluation findings for groundwater included the following: concentrations of all metals and TPH were below the screening criteria; one sample was found with methyl tertiary-butyl ether (MTBE) at a concentration above the screening criteria in EBS Parcel 169.

Slide 13 showed a map of the data evaluation findings. Ms. Barnes identified the locations where TPH and MTBE were found to exceed criteria. Ms. Sweeney asked why no samples were collected for analysis at the outfalls and the source of the water. Ms. Barnes replied that no samples are collected as part of the SI and that the objective is to review existing data. If data are collected outside of the transfer parcel, they are not presented in the SI, although data still may have been collected. A storm sewer was investigated and no contamination was found. Mr. Peterson said that he was concerned that only one sample was collected in the eastern area closest to the high school. Ms. Barnes commented that the Navy is also concerned, as will be discussed later in the presentation.

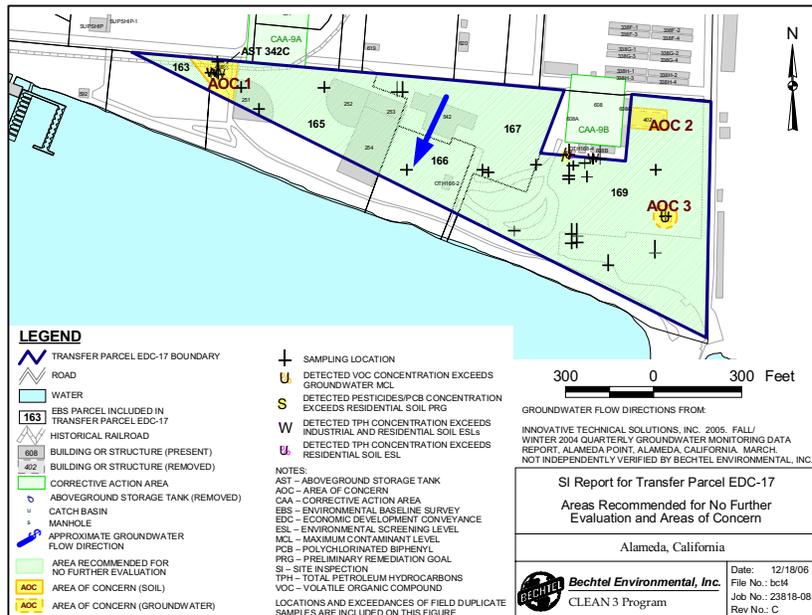
# Conclusions/Recommendations EDC-17

In conclusion, three AOCs were identified and recommended for further action. AOC 1 consists of the western portion of EBS Parcel 165, where there is a concern with TPH in soil. AOC 2 consists of the northern portion of EBS Parcel 169 and was identified because of a lack of sampling at the area of the former maintenance shop and sandblast shelter. AOC 3 consists of the eastern portion of EBS Parcel 169, where there is a concern with VOCs in groundwater. No further action is recommended for all other areas. Slide 18 showed a map of the AOCs at EDC-17. Ms. Barnes identified the three AOCs on the map. The boundaries of the AOCs do not reflect the extent of the contamination, but identify the areas that require further evaluation.

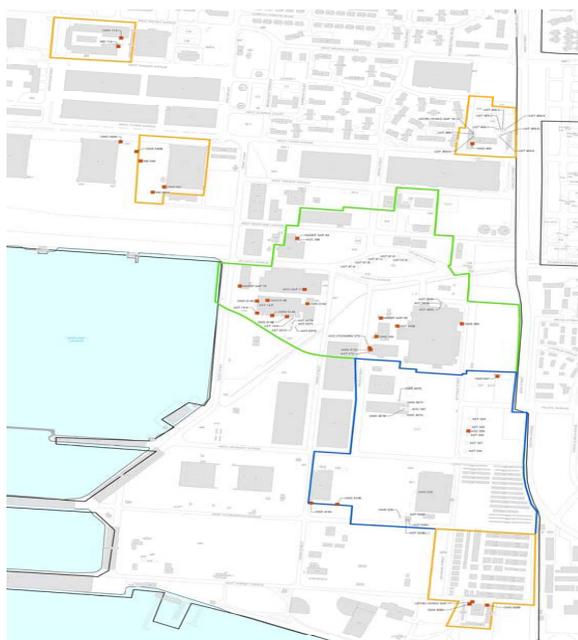
# SMWUs Location

There was a site walk with the regulators to identify which SWMUs need to be sampled. The objective is twofold. The first is to demonstrate in a report that samples were collected, so that in the future the sites can be closed under the Resource Conservation and Recovery Act (RCRA) program. The second is to remediate any SWMUs where contamination is found under the CERCLA program, which will also satisfy RCRA. A total of 104 SWMUs have been identified, 43 that will require no further action, 30 that will be covered under the TPH program, and 31 that have been identified for additional sampling. The SWMUs include the following: 18 oil-water separators (OWSs), 3 wash-down areas (WDs), 5 USTs or ASTs, 4 generator accumulation points (GAPs), and 1 AOC in OU-2A. Slide 28 showed a map of the SWMU locations. Slide 29 showed a table of proposed SWMU sample totals.
