IR Site 32 Update

Prepared by: Cecily Sabedra, Navy RPM

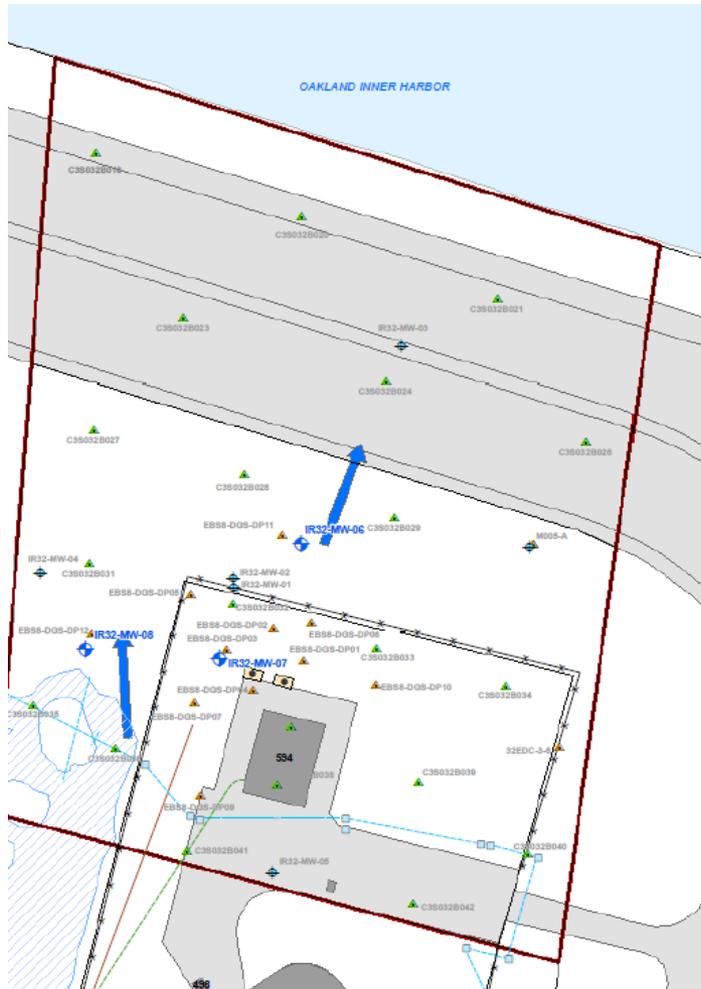
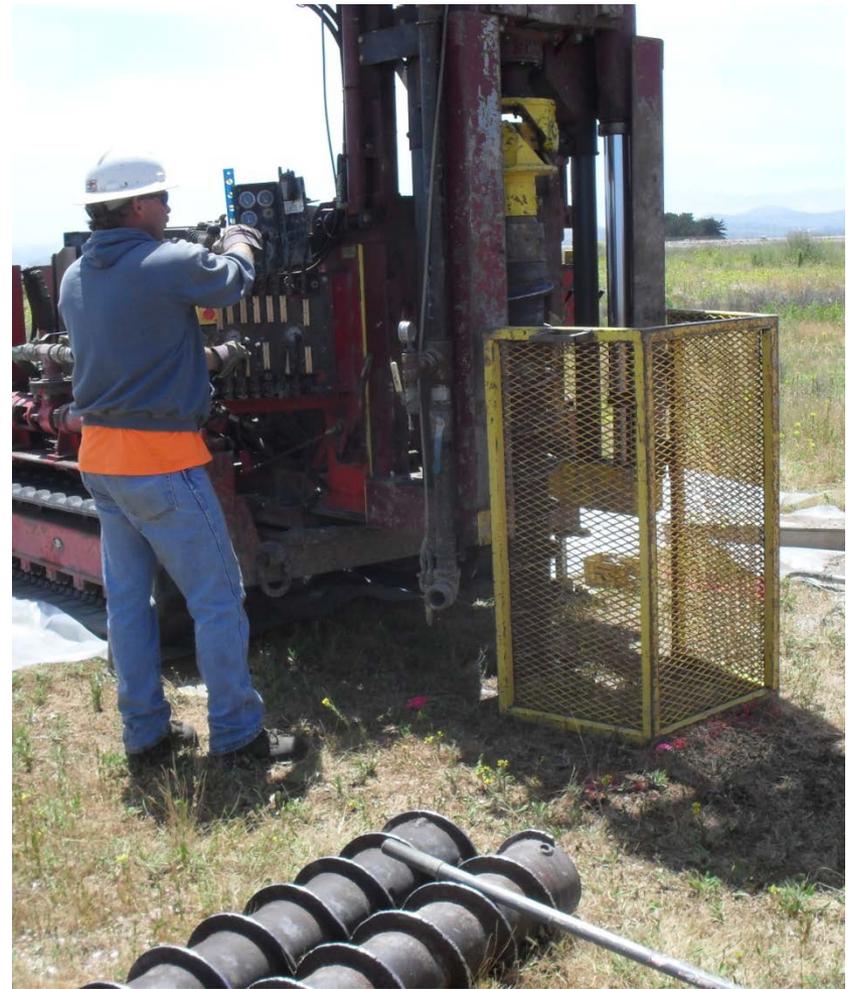
Groundwater Monitoring Wells

- ✓ Installation of three monitoring wells – June 2010.

- Confirm the current maximum concentrations in the VOC groundwater plumes for the three chemicals of concern: TCE, chlorobenzene, and vinyl chloride.
- Assess whether radiological contamination has affected groundwater

- VOC results below the screening criteria
- Radiological concentrations below drinking water standards

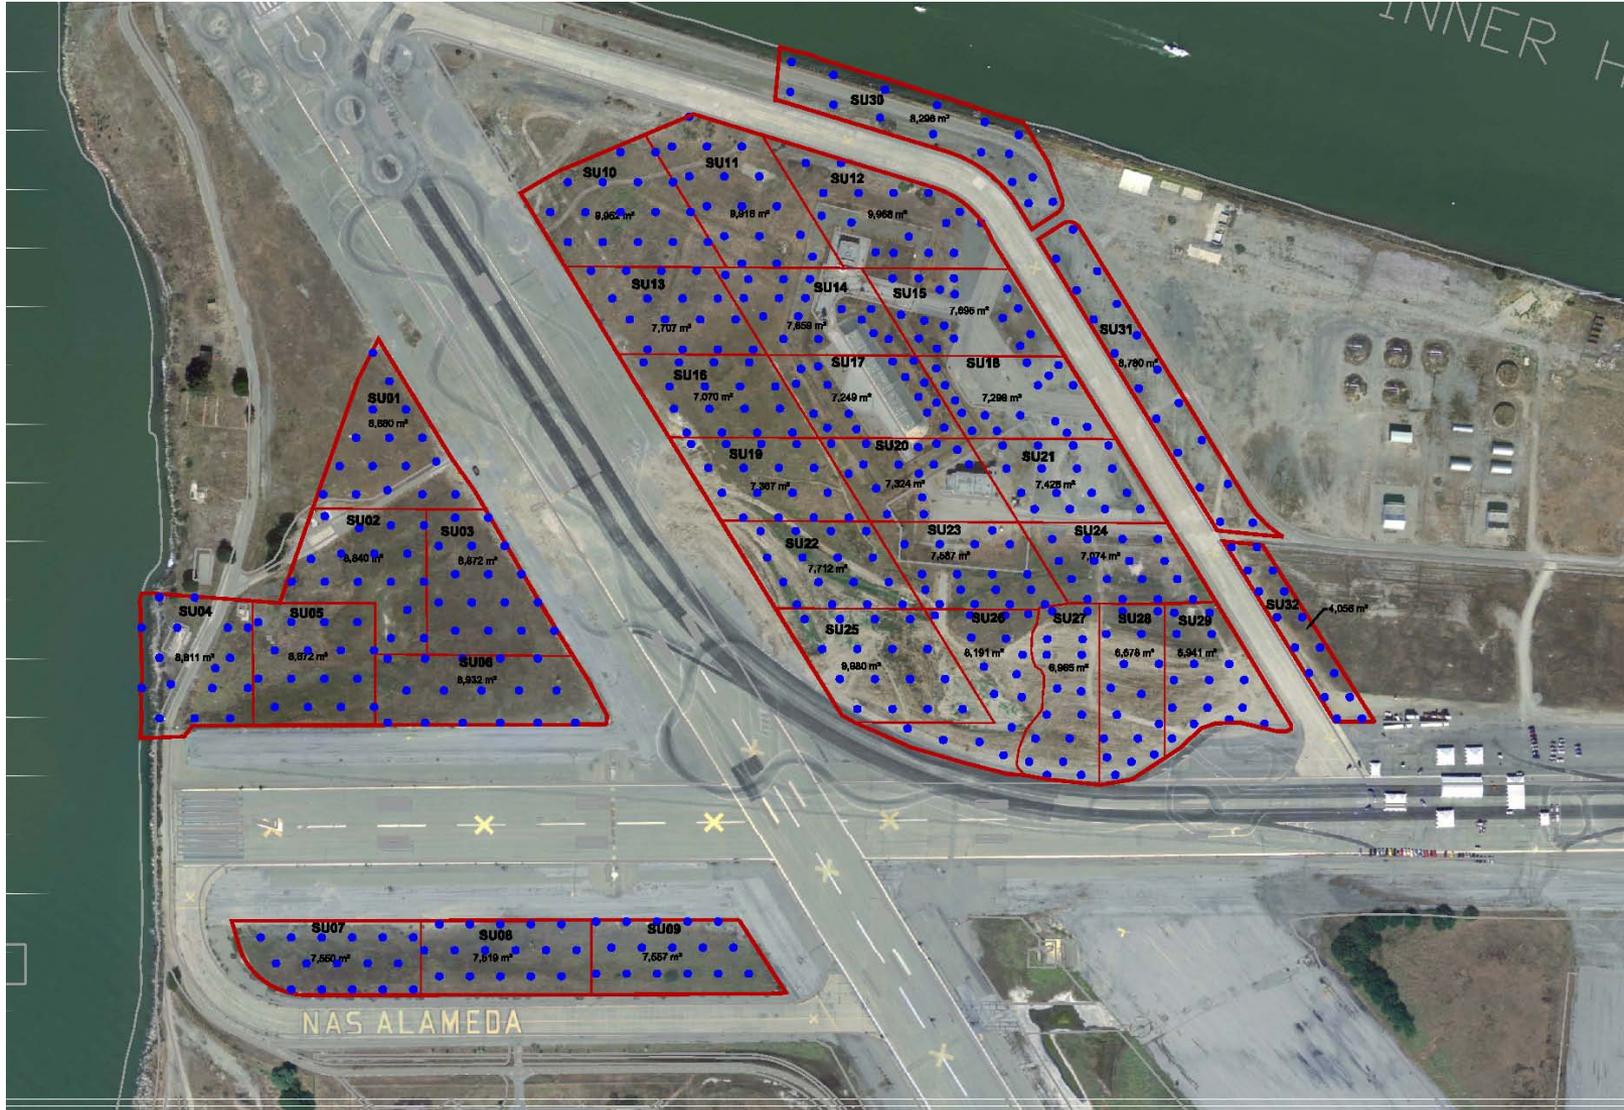
Radiological Survey Units and Systematic Soil Sampling

- Surface gamma scan to identify radiological anomalies
- Soil sampling and laboratory analysis

- Localized areas of elevated radioactivity greater than established investigation levels
- No systematic soil samples results exceed the release criteria for radium-226
- Discrete radium-226 in soils in four of the twenty five biased sampling locations and two anomalies were found and removed during biased sampling activities
